Re: **Settlement Agreement**
Section B. Fire Safety Research

Field Investigation of Motor Vehicle Collision-Fires

Robert R. Scheibe
Golder Associates Inc.

ABSTRACT

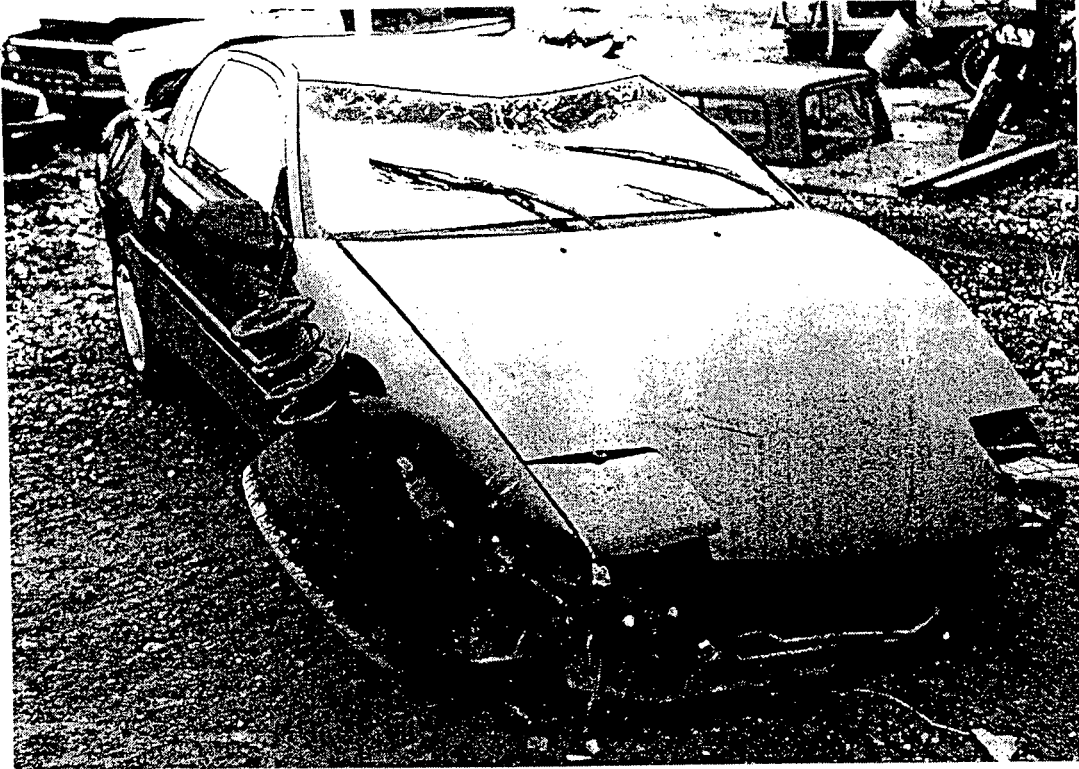
Impact with the culvert and subsequent rollover severely damaged the front suspension, engine oil pan and exhaust system (Figures 1 and 2). The right front suspension strut was pulled from its upper mount. The oil pan was breached and spilled its contents onto the exhaust pipe located adjacent to the oil pan. Black oil was observed on the grass in the culvert two days after the incident. Portions of the exhaust pipe including the catalytic converter were missing and appear to have been separated from the vehicle as a result of the impact with the culvert.

Figure 1. Investigation 1 small car, showing rollover damage and no fire damage to exterior

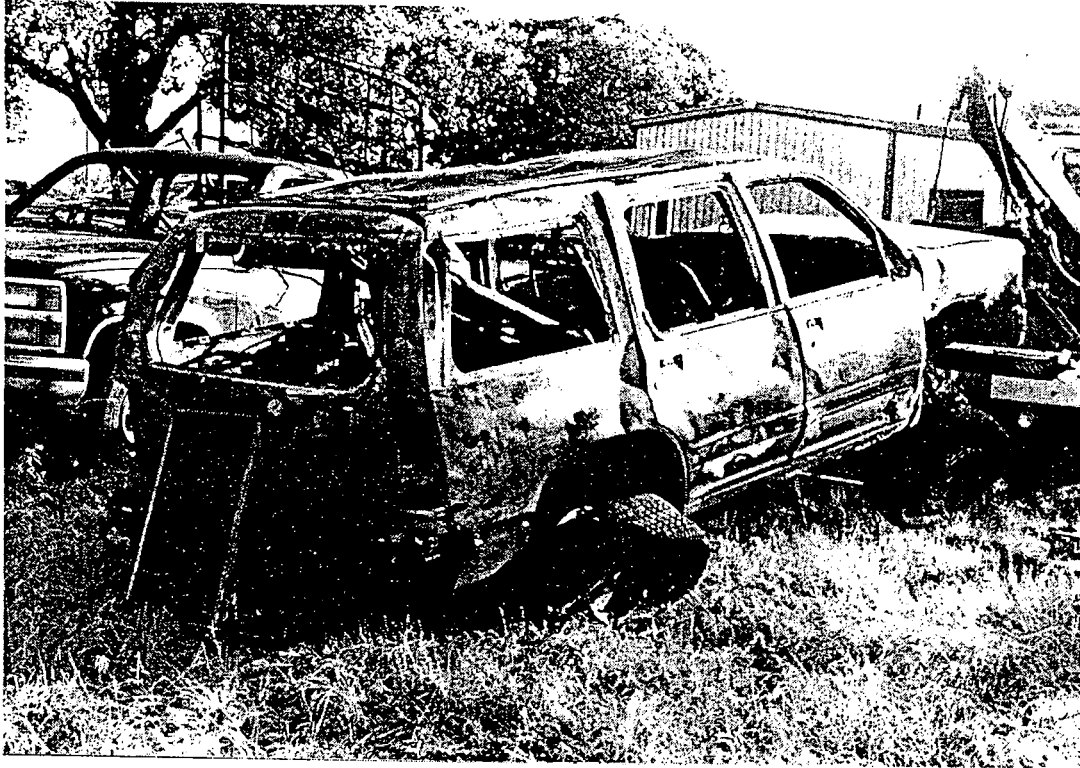
The driver of the SUV said she immediately got up and ran to the vehicle to assist two children in exiting. By the time either driver observed the SUV, they believe within one minute of impact, flames of 6-15 inches high were observed. Impact damage was limited though the vehicle was eventually totally consumed by fire (Figure 3).

Figure 3. Investigation 2 SUV, showing impact to right front and overall fire damage

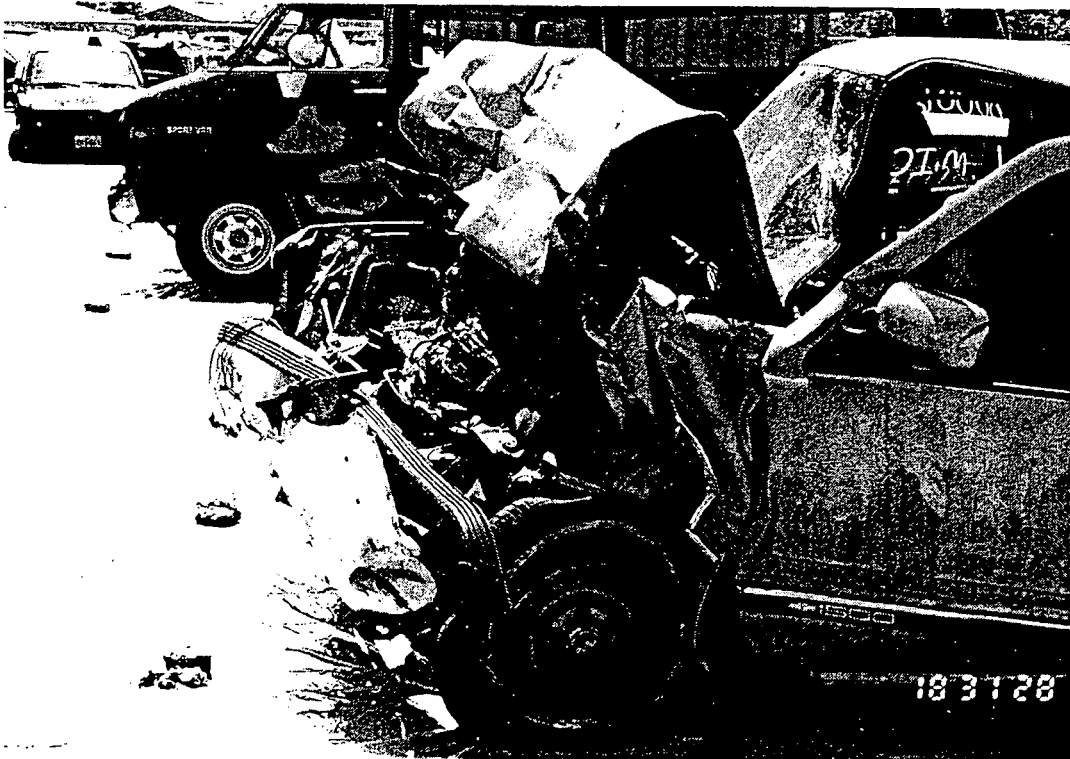
The front bumper of the pickup truck (Figure 6) contacted the lower edge of the rear bumper of the van (Figure 7). The pickup front bumper rotated approximately 90 degrees and under-rod the van while the van's bumper also rotated approximately 90 degrees and crushed the front structure and engine compartment of the pickup, primarily above the pickup bumper. The front license plate of the pickup was found lodged between the forward edge of the van rear bumper and the fuel tank approximately 15 inches to the right of the van longitudinal centerline, indicating an offset collision occurred.

Figure 6. Investigation 3 pickup truck, showing frontal override collision damage

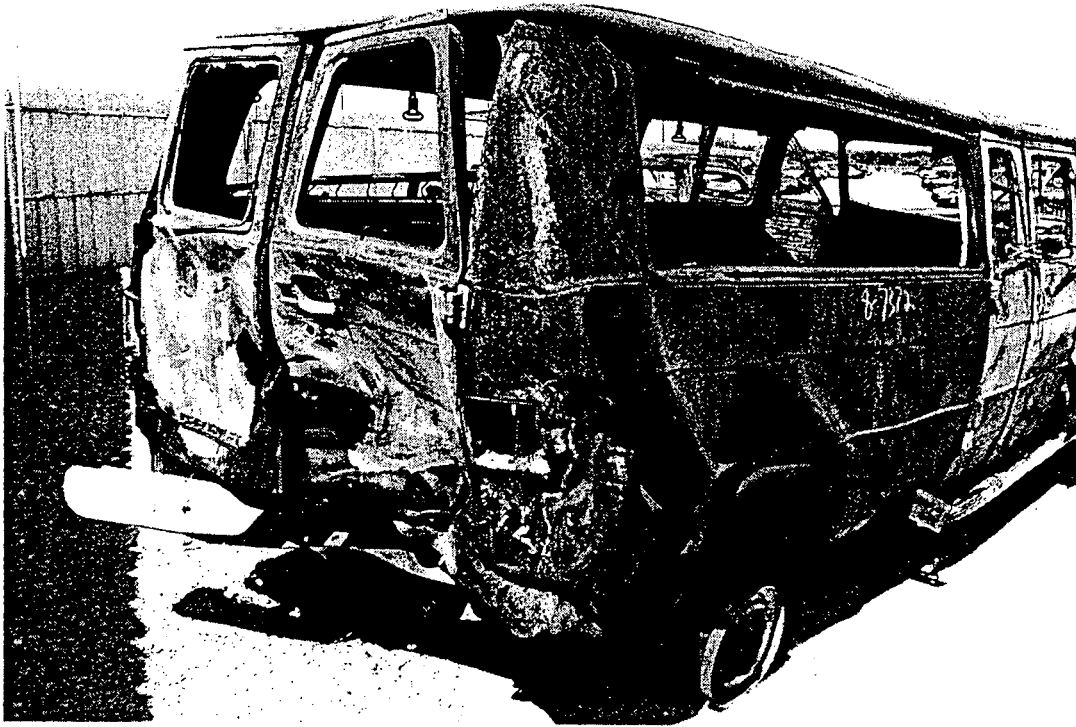
Figure 7. Investigation 3 van, showing rear underride collision damage and overall fire damage

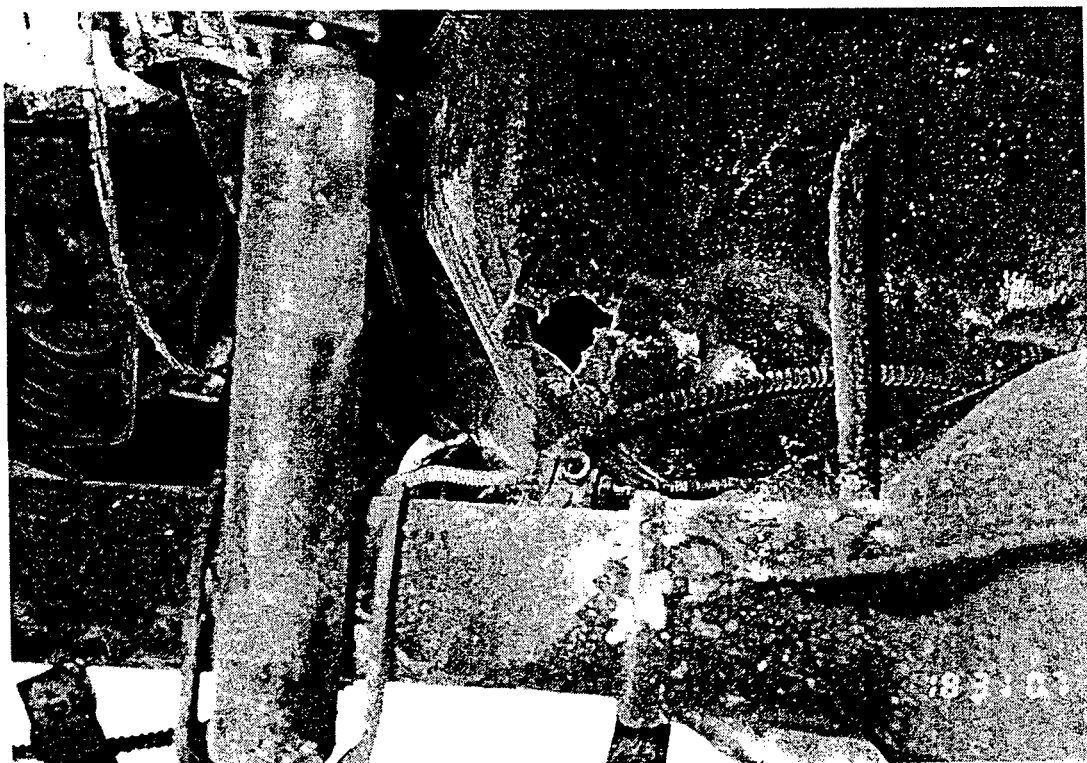
Figure 9. Investigation 3 van, showing largest breach in fuel tank
