**Evaluation of Motor Vehicle Fire Initiation and Propagation  
Part 3: Propagation of an Engine Compartment Fire in a 1996 Passenger  
Van**

Jeffrey Santrock  
General Motors Corporation

**ABSTRACT**

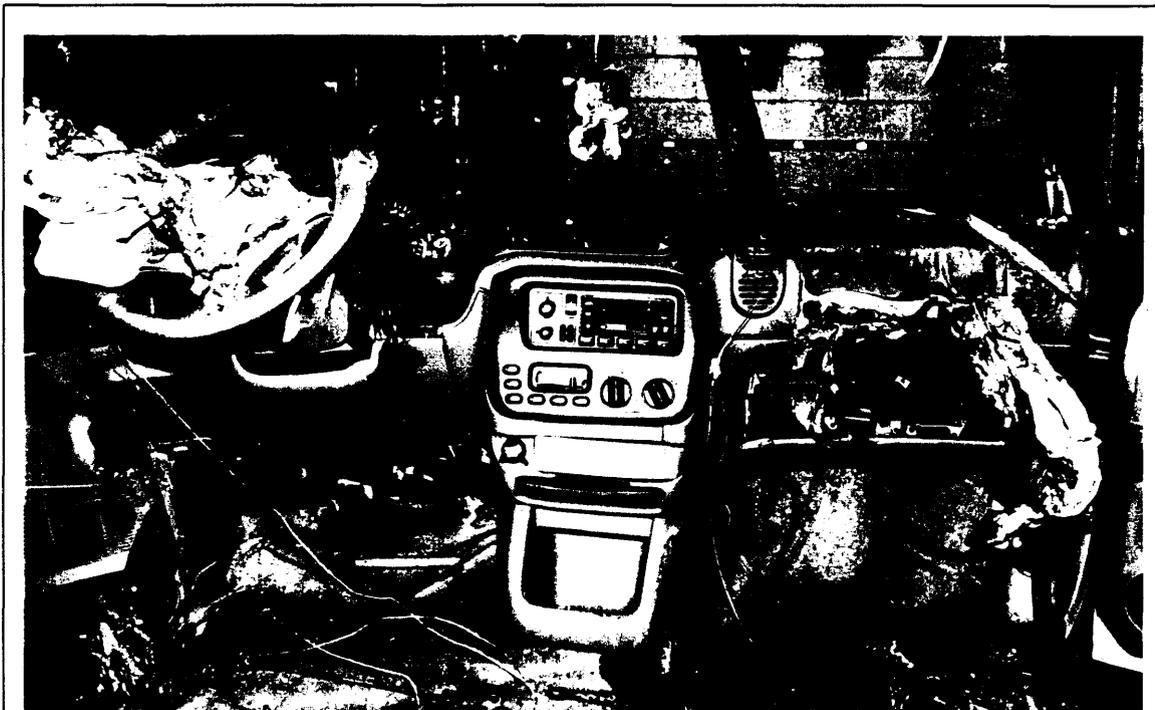
Figure 40. Fire Test F961115. Photograph showing fire damage to the front of the instrument panel and front carpet.

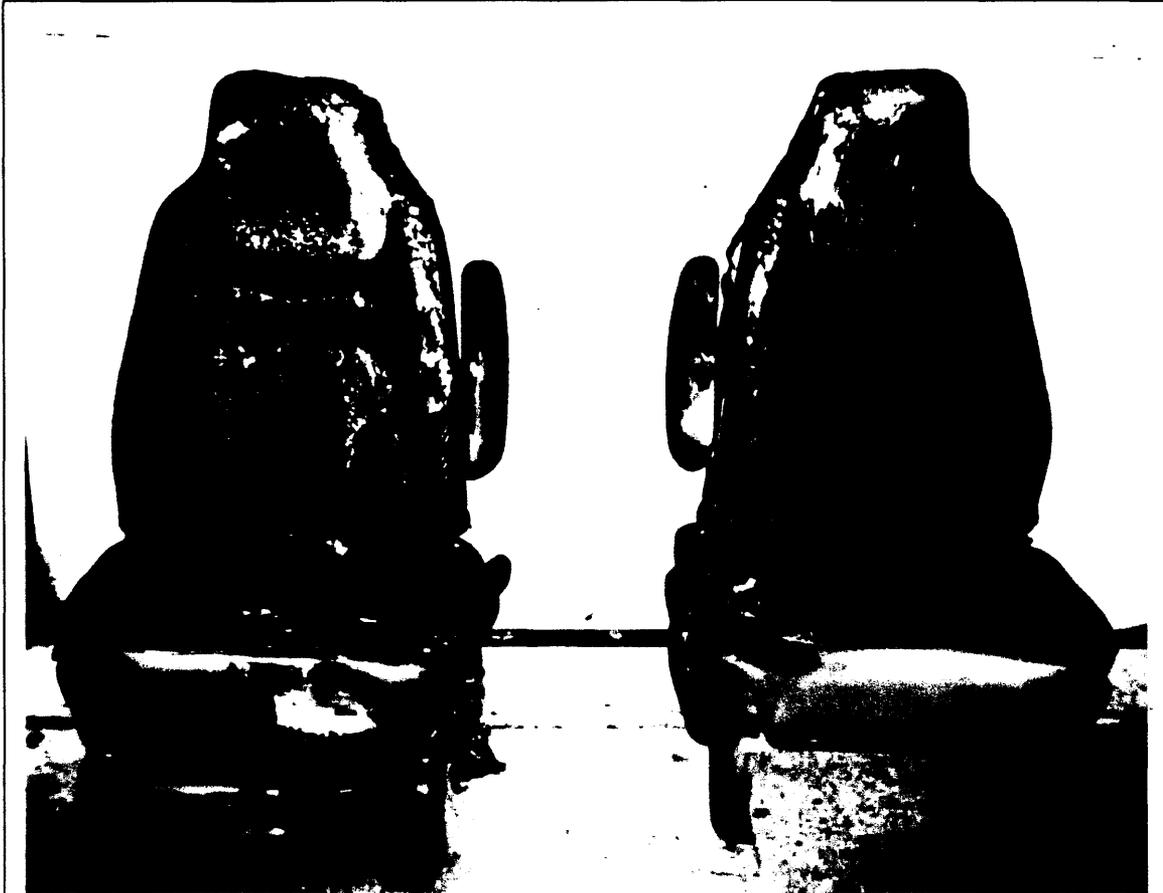
Figure 43. Fire Test F961115. Photograph showing fire damage to driver's (right photograph) and front passenger's (left photograph) seats.

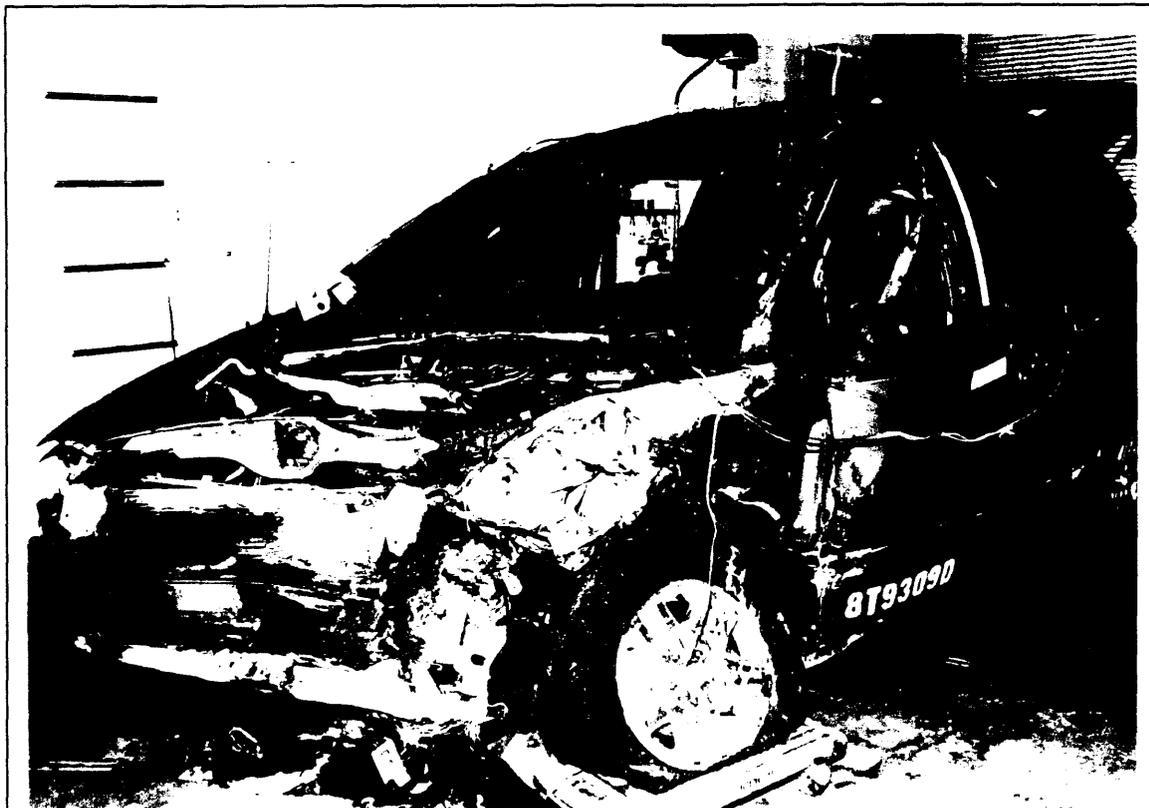
Figure 44. Fire Test F961115. Photograph showing fire damage to the front of the test vehicle after the fire test.

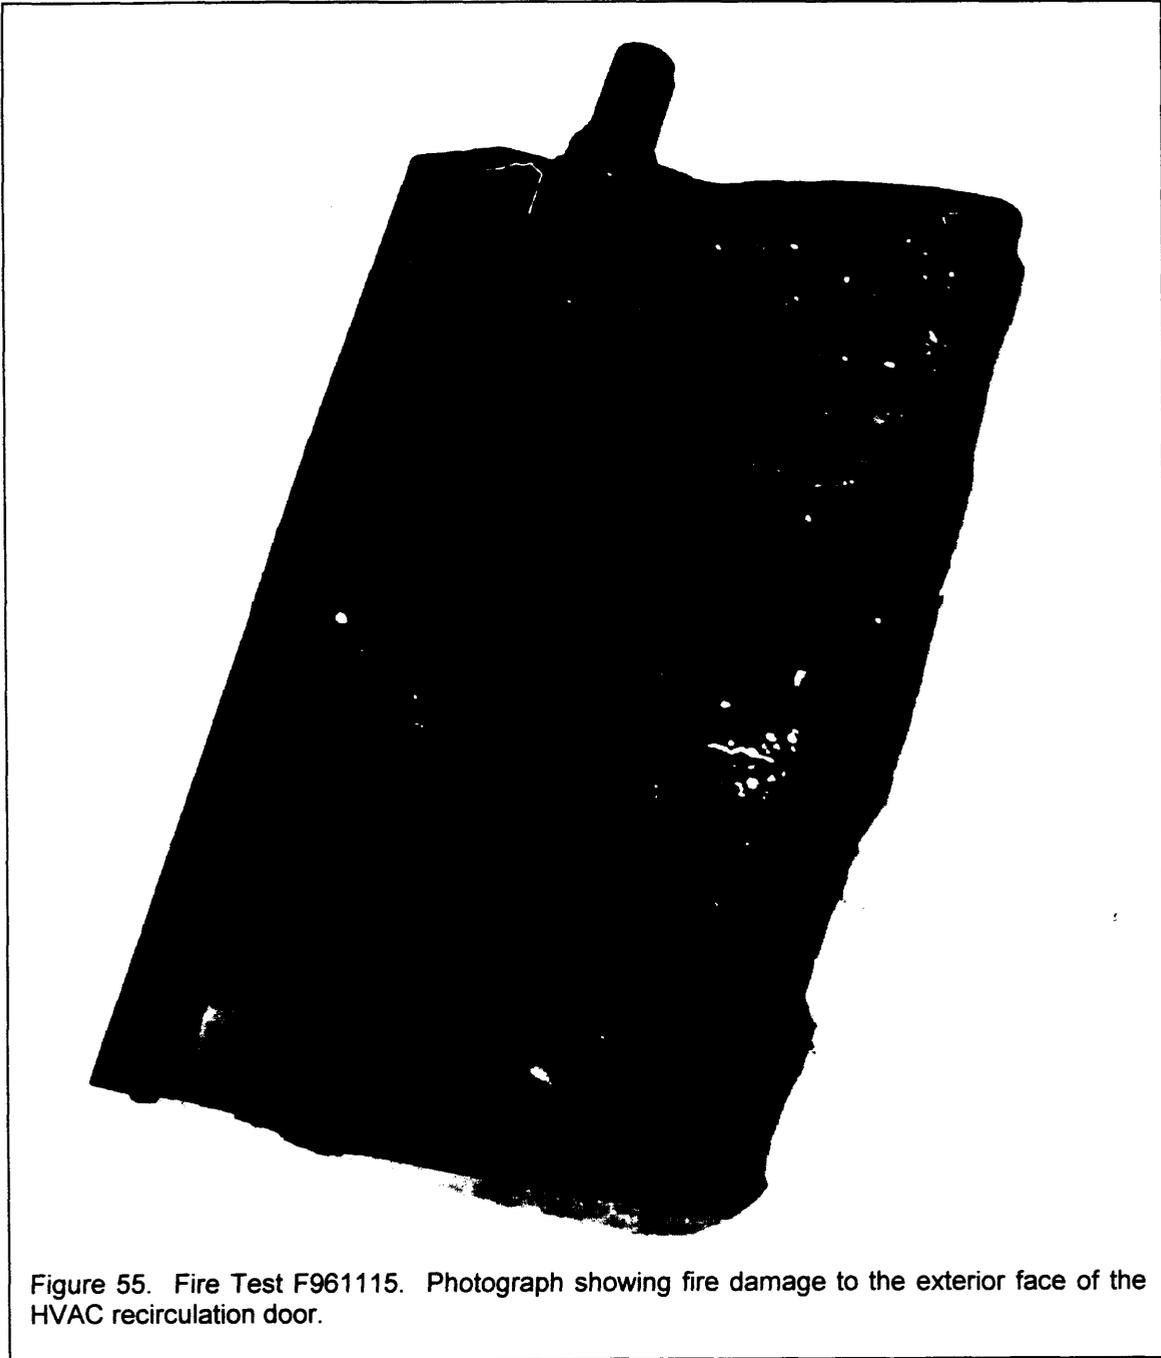
Figure 55. Fire Test F961115. Photograph showing fire damage to the exterior face of the HVAC recirculation door.
