Evaluation of Motor Vehicle Fire Initiation and Propagation

Part 5: Crash Tests on a Rear Wheel Drive Passenger Car

Jack L. Jensen, Jeffrey Santrock

General Motors Corporation

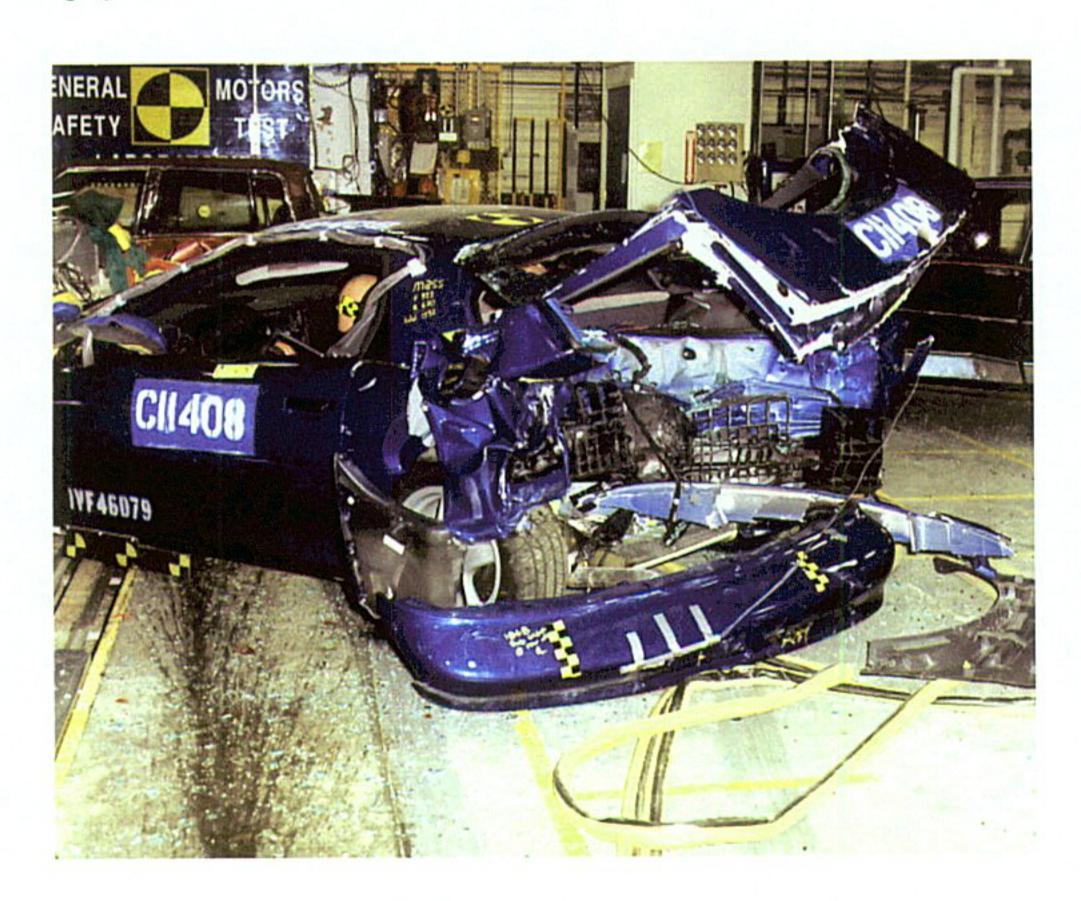
Figure 4
Post-Test Photograph of Test C11408, Left-Rear View

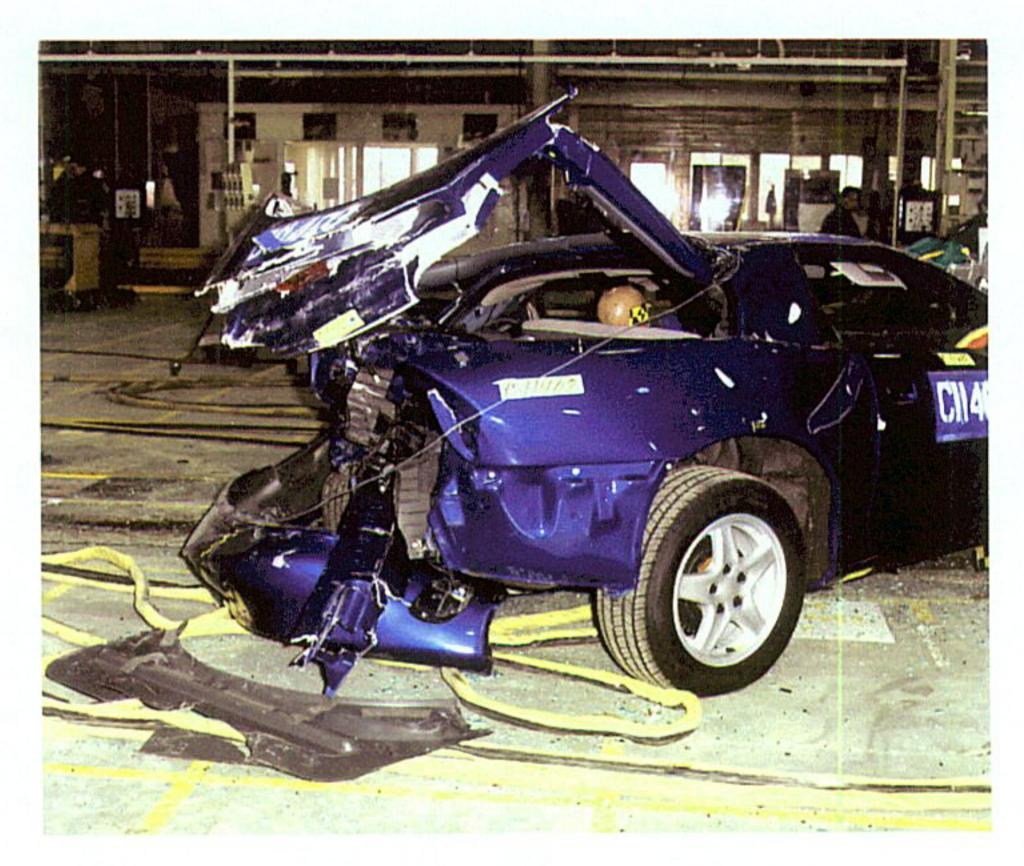
Figure 5
Post-Test Photograph of Test C11408, Right -Rear View

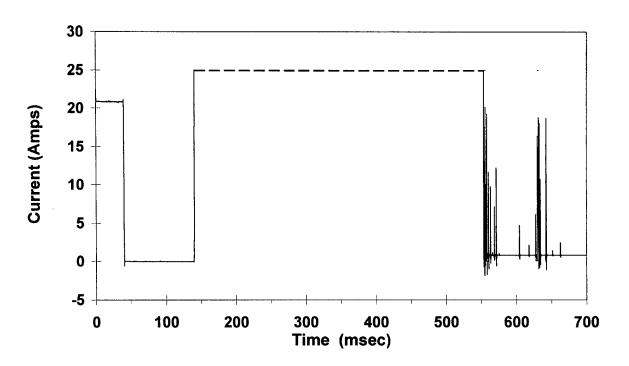
The rear window defroster current measurement indicated a current draw of about 21 amps at impact (the defroster was on for the test.) This measurement is shown in Plot 118 and Figure 9. Note that Plot 118 only has a duration of 240 msec, while Figure 9 has a duration of 700 msec. At 40 msec, however, the current dropped to near zero, possibly due to the circuit being cut during the impact. This is also supported by the rear window defroster voltage measurement (Plot 111 and Figure 10) which increased from about 11 volts (during normal operation at impact) to 12 volts at 40 msec. If the circuit was cut at 40 msec, then the normal voltage drop due to current draw would end at 40 msec and a slight increase of voltage would be expected.

Figure 9
Rear Defroster Current, Test C11408

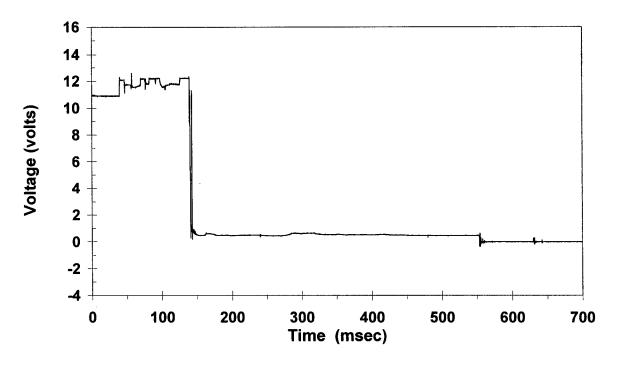
Figure 10
Rear Defroster Voltage, Test C11408

An inspection of the ignition voltage also supported the hypothesis of a defroster circuit short at 140 msec, with the breaker opening at 550 msec. The ignition voltage (Plot 109) dropped from 12 to 11 volts at 140 msec and returned to 12 at about 550 msec. Again, Plot 109 only shows the first 240 msec of the test, however an inspection of the recorded data past 240 msec indicated this return to 12 volts at 550 msec.

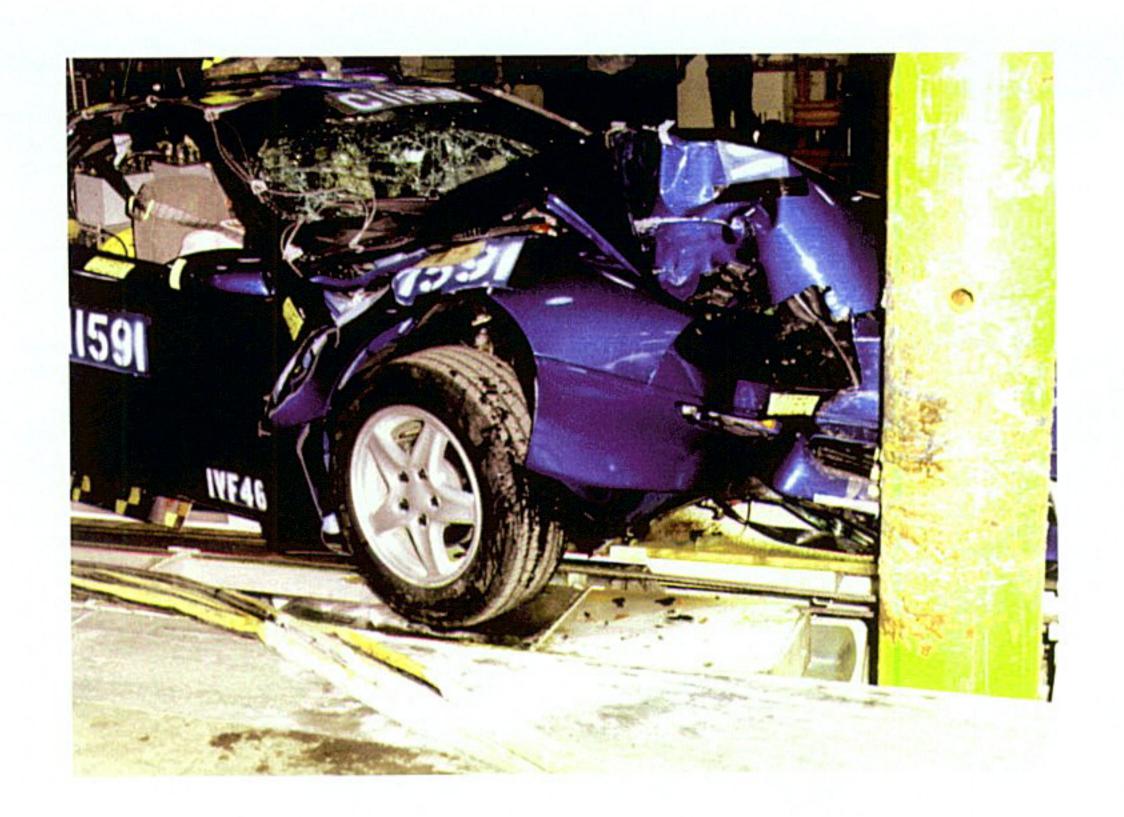
Figure 15
Post-Test Photograph of Test C11591, Front-Right View

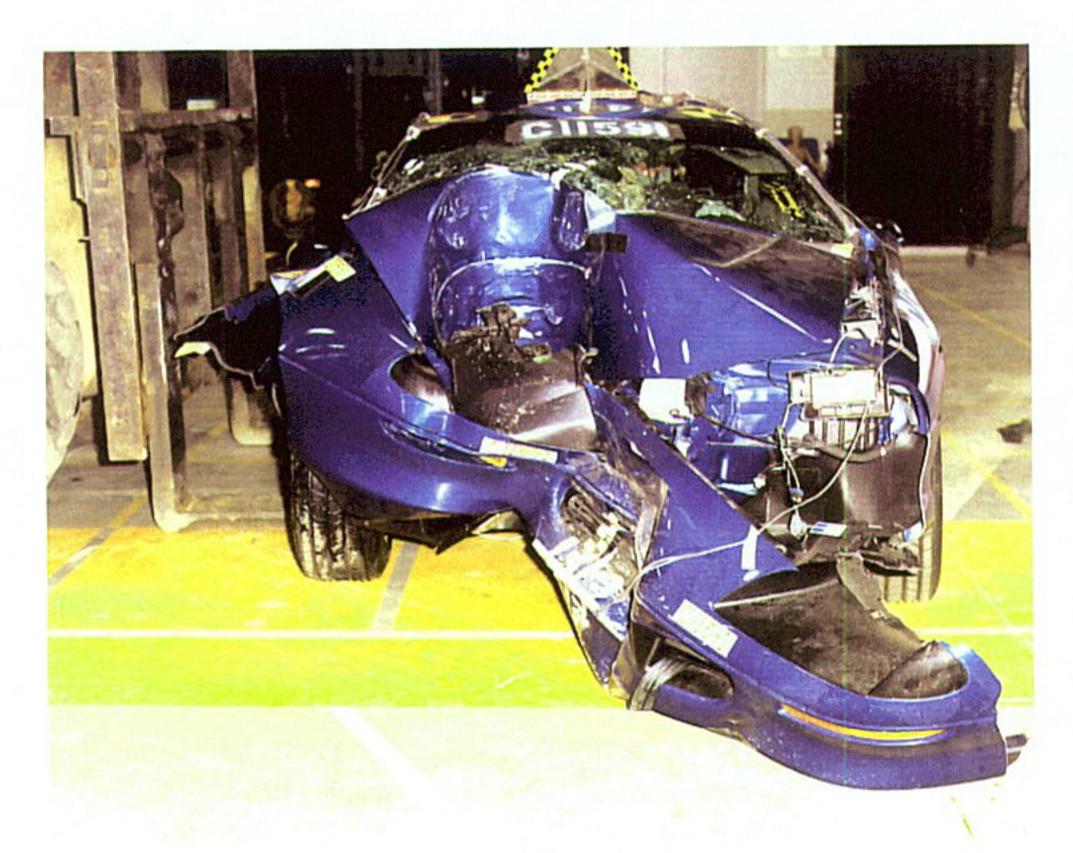
Figure 16
Post-Test Photograph of Test C11591, Front View

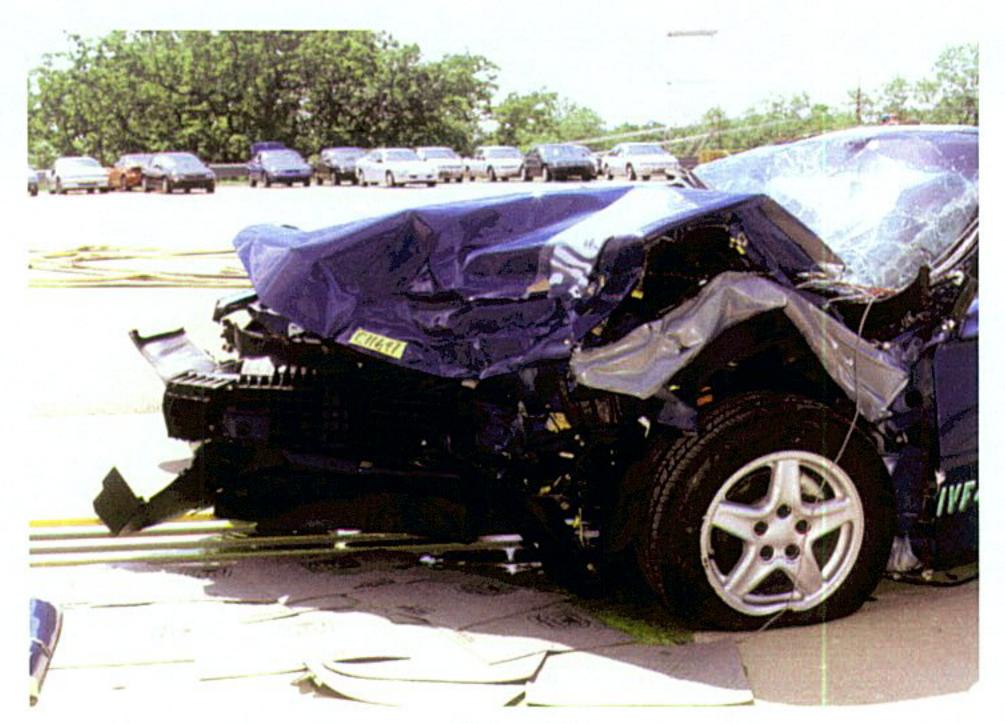
Figure 29
Post-Test Photograph of Test C11647, Front Left View

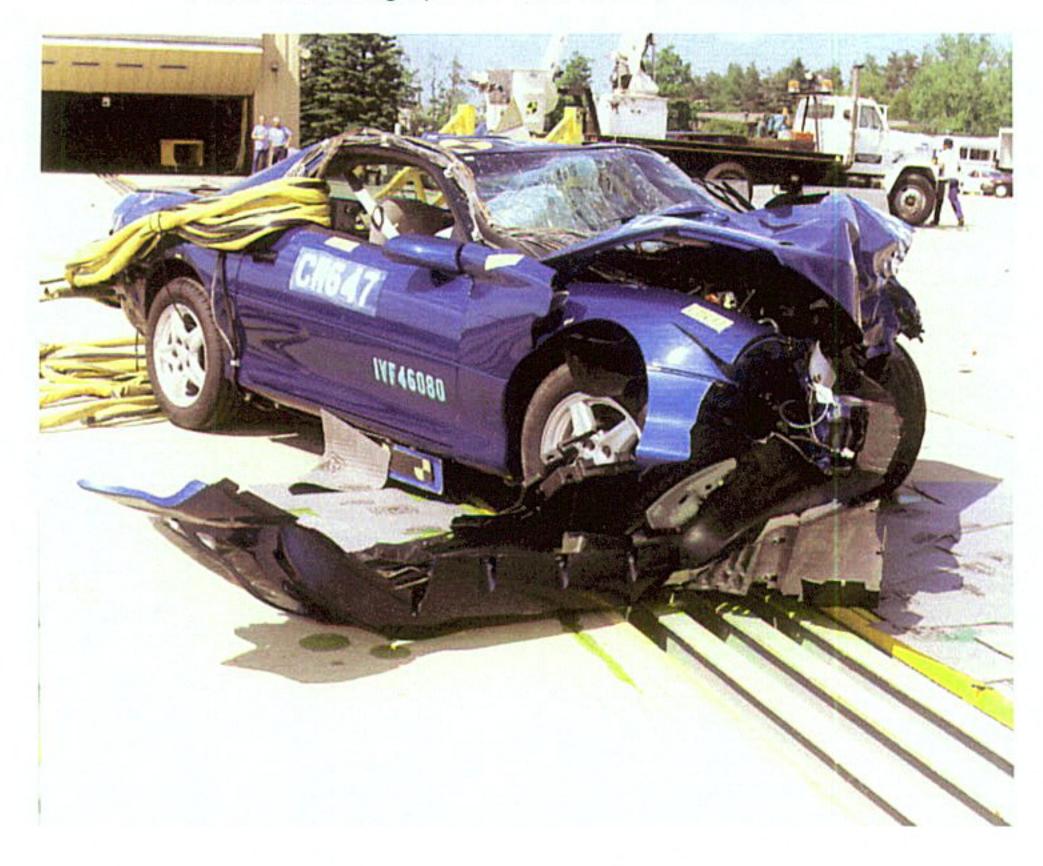
Figure 30
Post-Test Photograph of Test C11647, Front Right View
