# Evaluation of Motor Vehicle Fire Initiation and Propagation

## Part 8: Crash Tests on a Sport-Utility-Vehicle

Jack L. Jensen, Jeffrey Santrock

General Motors Corporation

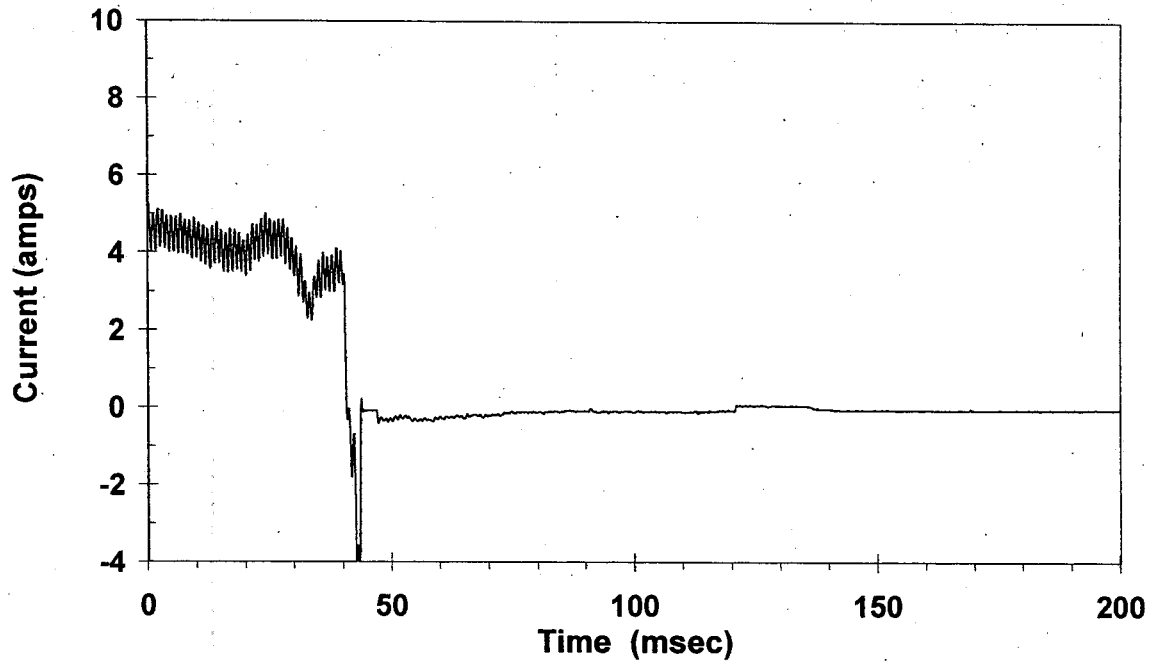
**Figure 13**  
**Fuel Pump Current**  
**Test C11687**

Figure 13 and plot 109 in Appendix B show the fuel pump current draw during the impact. The fuel pump was drawing about 4.5 amps while it was operating at impact. The current dropped to zero at about 40 msec after impact indicating the pump was off. This is consistent with the other frontal tests of this series in that, the fuel pumps have lost electrical power early (before 100 msec) in every test conducted. The fuel pump was likely stopped due to the drop in main vehicle voltage.

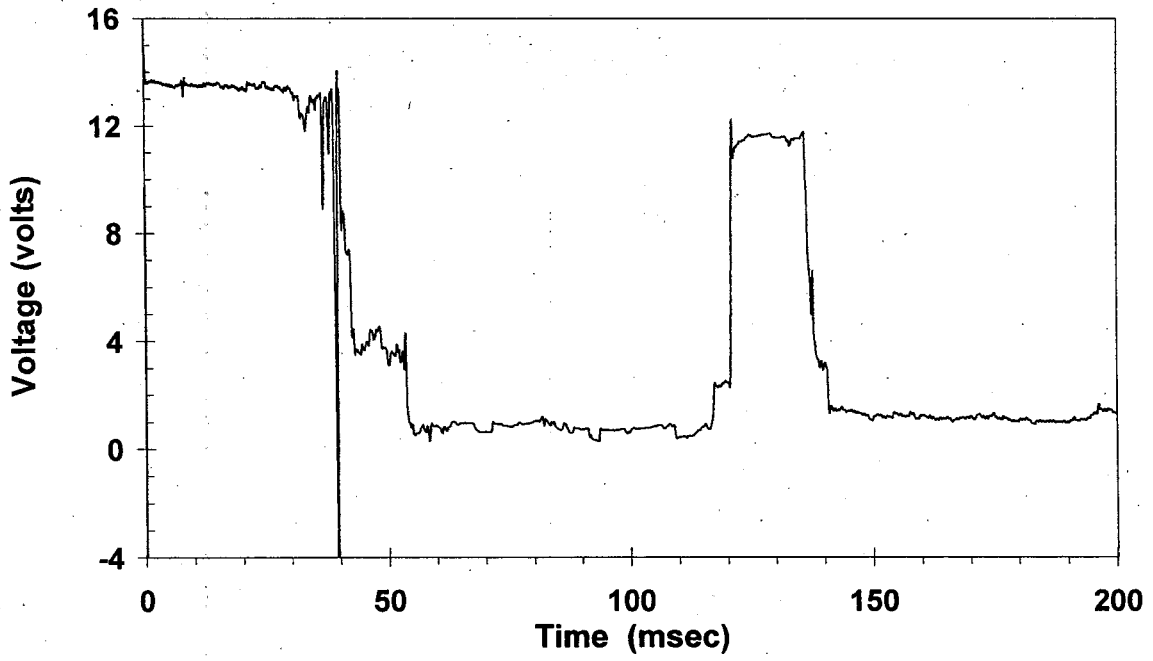
**Figure 14**  
Ignition Voltage  
Test C11687

From 40 msec to 60 msec, the ignition voltage dropped from 13 volts to near zero in a stepwise manner (Figure 14 and Plot 85 in Appendix B). The fuel pump voltage decayed from 13 volts to near zero from about 40 msec to 180 msec as shown in Figure 15 and Plot 81 (Appendix B). Bench-tests on fuel pumps for other vehicles in the project [2], [3] indicated a gradual decay in voltage (lasting 40-150 msec) when current flow was stopped to the motor. This is likely due to the windings of the motor producing a voltage drop as the motor stops. The decay shown in Figure 15 is consistent with the observations from other tests.

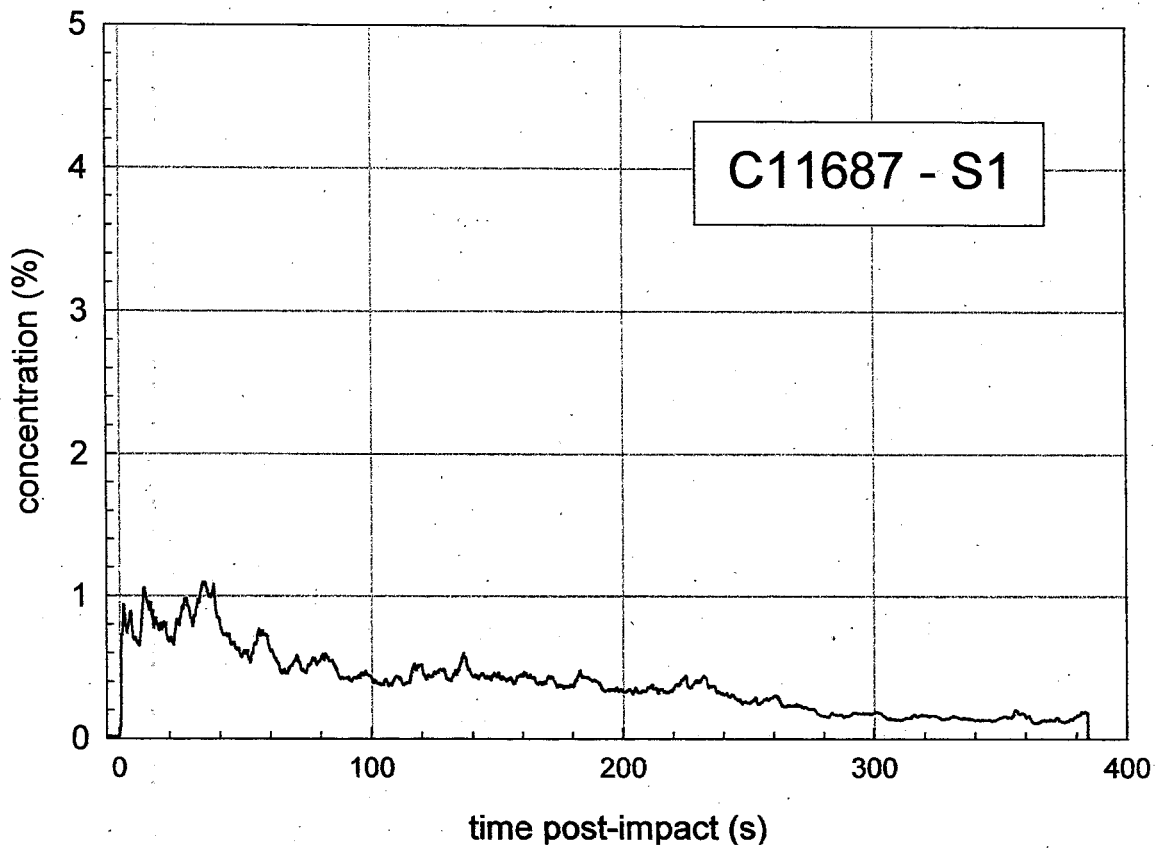
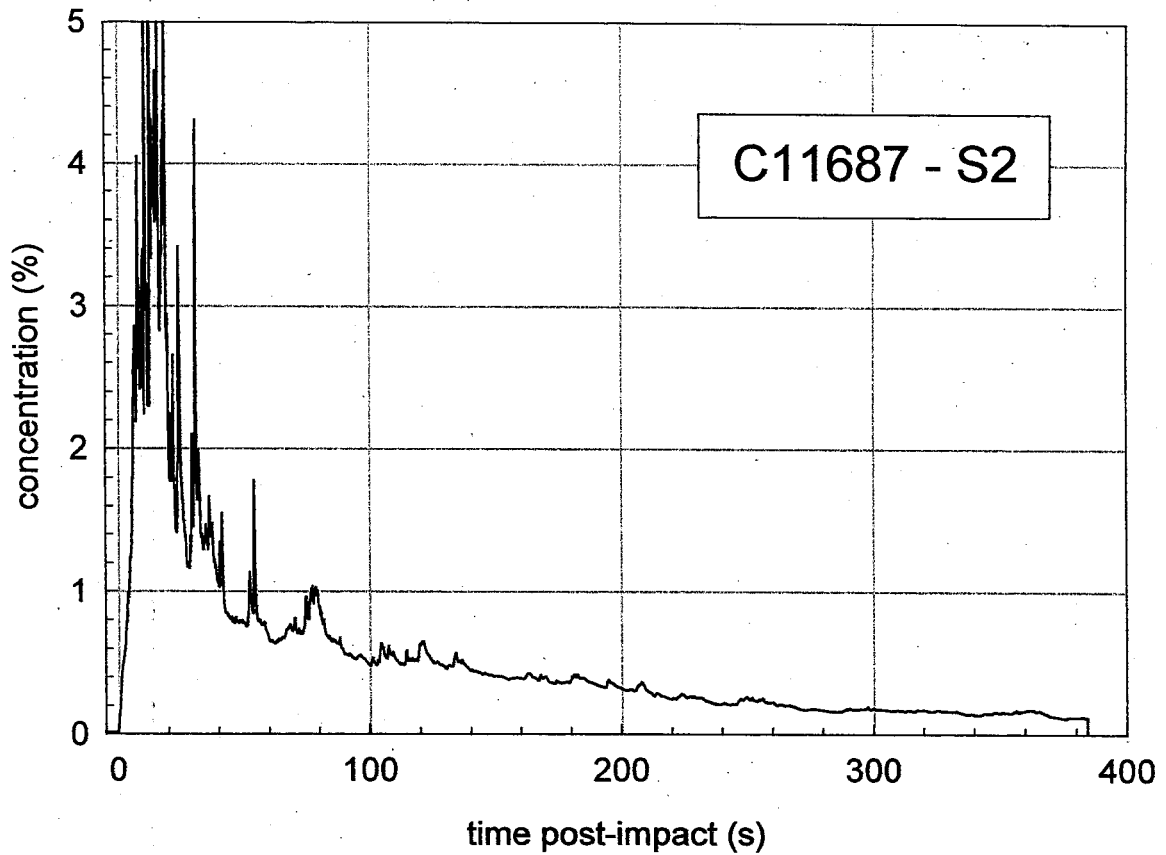
engine (location #3) was destroyed during the test. Of the remaining three locations, the right upper engine (location #1), and the left exhaust manifold (location #2) indicated the highest concentrations of hydrocarbon vapors. These two sensor outputs are recreated here as Figure 19 and Figure 20.

The vapor concentration at location #1 increased to slightly greater than 1% in the first 60 seconds following the impact, while the concentration at location #2 exceeded 3% during the first 60 seconds. The GCMS analysis was completed on the vapors collected from these same locations [1]. The results of the GCMS analysis for locations #1 and #2 were similar. The results of the GCMS analysis for location #2 is recreated here as Figure 21 and Figure 22. The GCMS analysis indicated the source of the vapors were gasoline, stoddard solvent and oils.

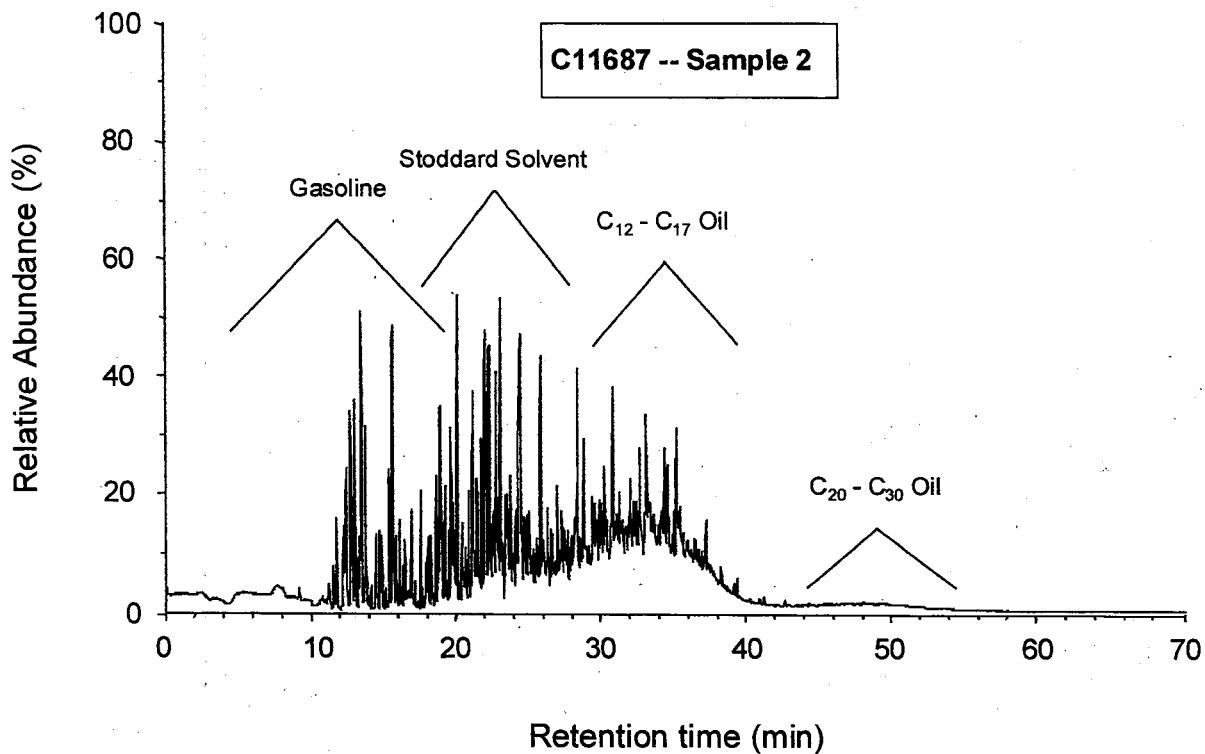
**Figure 22**  
 GCMS Analysis of Vapor Sample Collected near Left Exhaust Manifold (Location #2)  
 Post-test, Test C11687

The source of the oil vapor observed in this test could not be positively identified through the GCMS analysis. The analysis does not distinguish vapors with similar molecular makeup. In this case, any of the heavy oils such as power steering fluid, transmission fluid, or motor oil could be the source of the vapor. Of these fluids, only transmission fluid and power steering systems leaked during the impact, so one of those two may have been the likely source. At ambient temperatures, these fluids do not vaporize, thus contact with a hot surface likely occurred vaporizing the fluid.

The source of the Stoddard vapor was likely the Stoddard that leaked out of the fuel tank during the impact. (Section 2.2.6.) Unlike the oils, Stoddard and gasoline will vaporize at ambient conditions, thus the presence of vapor does not necessarily indicate contact with a hot surface.

Gasoline vapor was also indicated in the GCMS analysis. However, there were no leaks identified in the pressurized fuel system (Section 2.2.5.) (The fuel tank contained Stoddard for the test, but the pressurized fuel system contained gasoline.) The source of the gasoline vapor could have been from a damaged (during the impact) air intake or manifold in which the air/fuel mixture could escape to the atmosphere from the normal flow to the engine. Since the fuel pump stopped early, this would result in only a small amount of gasoline vapor (not liquid gasoline) released and does not necessarily present an increased fire risk. An alternate source of the gasoline vapor could have been from contaminated Stoddard Solvent. To reduce the volume of hazardous waste generated in conducting full-vehicle crash tests, Stoddard Solvent is re-used in most crash test laboratories; that is, it is removed from fuel tanks from crash-tested vehicles and re-used for other tests. Thus the Stoddard, over time, can be contaminated with residual gasoline from fuel tanks.

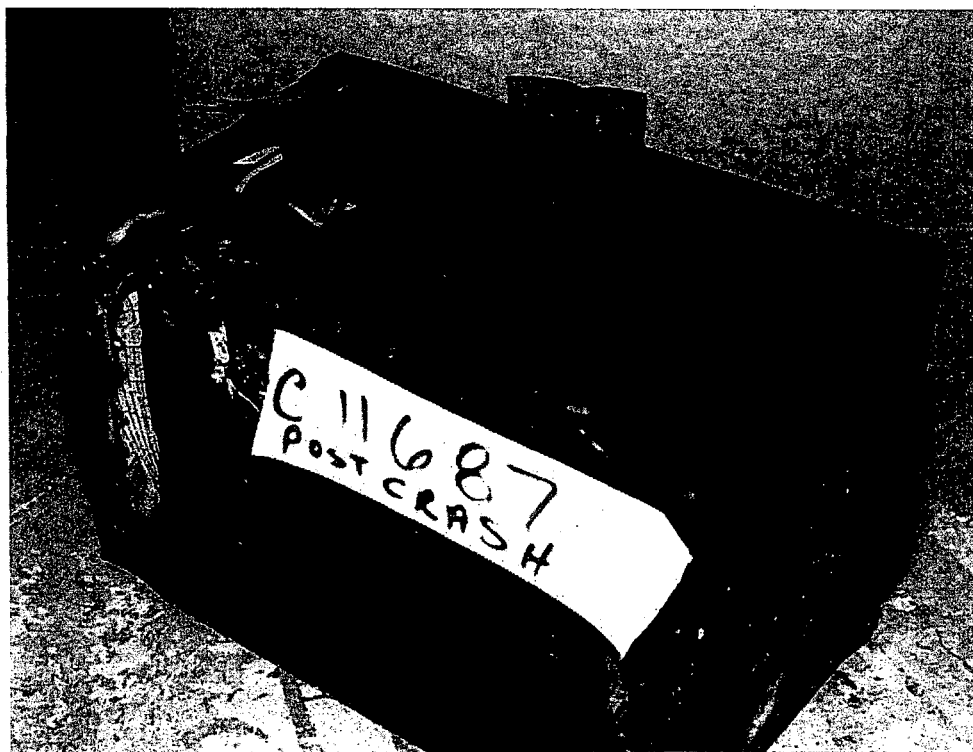
**Figure 24**  
Battery  
(The test number tape is attached to the bottom of the battery)  
Test C11687

The starter voltage (plot 78), alternator voltage (plot 80), and ignition voltage (plot 85) all show similar results. They all drop from 13 volts to less than 5 volts starting at about 40 msec. They all recover to 12 volts from 120 to 140 msec before returning to less than 2 volts. The main vehicle electrical voltage dropping intermittently and then recovering intermittently has been an observation of nearly every test conducted for this project [2], [3]. For tests on other vehicles, specific causes for the voltage drops have been identified such as the shorting of the starter cable to ground causing additional loading on the battery [2]. However, for this test, no specific cause was identified. Neither the post-test inspection nor the current measurements indicated a specific short to any of the large gage cables such as the alternator or starter cables. (Although all underhood electrical circuits were not measured and inspected.) The cause of the drops in the main vehicle voltage likely was caused by the opening and re-connection of the individual cells internal to the battery or by additional loading to the battery by un-identified shorts. The battery was in the crush zone and the post-test inspection did reveal significant damage to the battery housing and the cells inside the battery supporting the likelihood that internal damage to the battery resulted in the voltage drops. A photograph showing the bottom and side of the battery is shown in Figure 24.

- Battery electrolyte: 3 cells cracked and leaking

14. The main vehicle electrical voltage dropped from 13 volts to less than 5 volts intermittently during the impact. The cause of this drop was not positively identified. Intermittent drops in vehicle voltage have been observed in most frontal tests conducted for this project, and usually were caused by temporary shorts drawing the battery voltage down. In this case, the cause of the voltage drops was likely either unidentified shorts or damage to the internal cells of the battery.

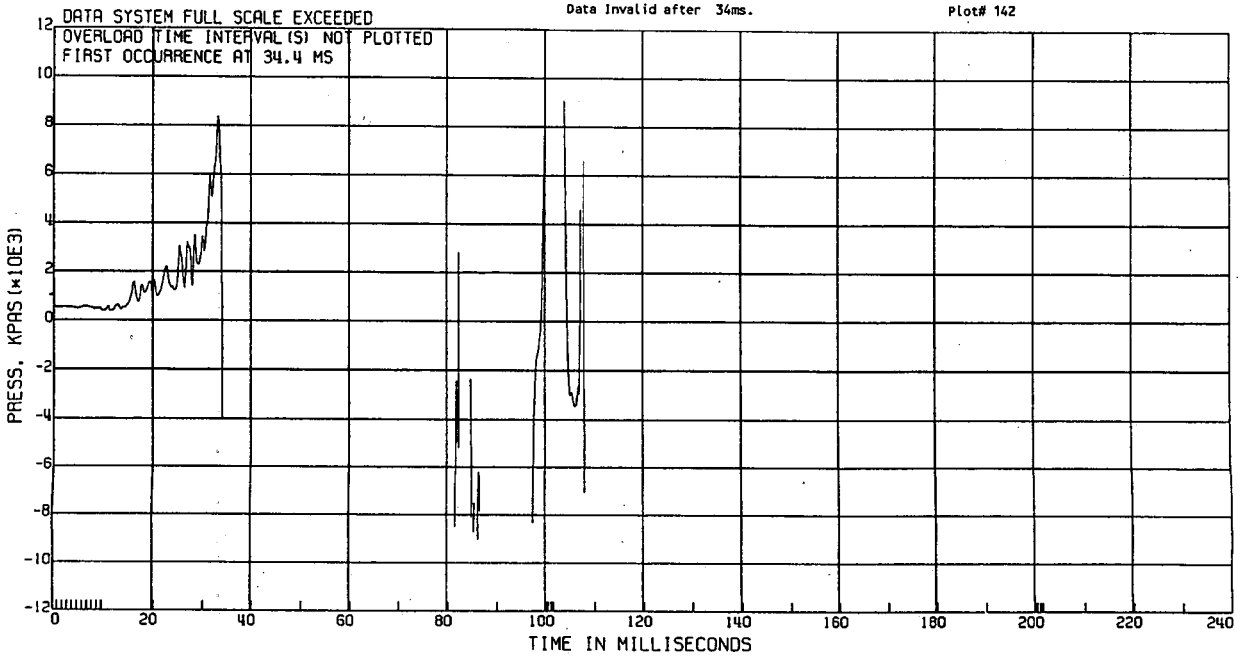
Appendix B, plot # 142

The power steering fluid pressure data (Plot 142) is inconclusive due to an instrumentation malfunction (likely caused by damage to the transducer during the vehicle crush.) However, the post-test inspection revealed that the pump housing was cracked and fluid was lost during the impact.

TRANSDUCER WIRES WERE DAMAGED/CUT
