Enclosed is a final report prepared by Jeffrey Santrock of General Motors Corporation, entitled, "Evaluation of Motor Vehicle Fire Initiation and Propagation Part 4: Propagation of an Underbody Gasoline Pool Fire in a 1996 Passenger Van."

**Evaluation of Motor Vehicle Fire Initiation and Propagation
Part 4: Propagation of an Underbody Gasoline Pool Fire in a 1996
Passenger Van**

Jeffrey Santrock
General Motors Corporation

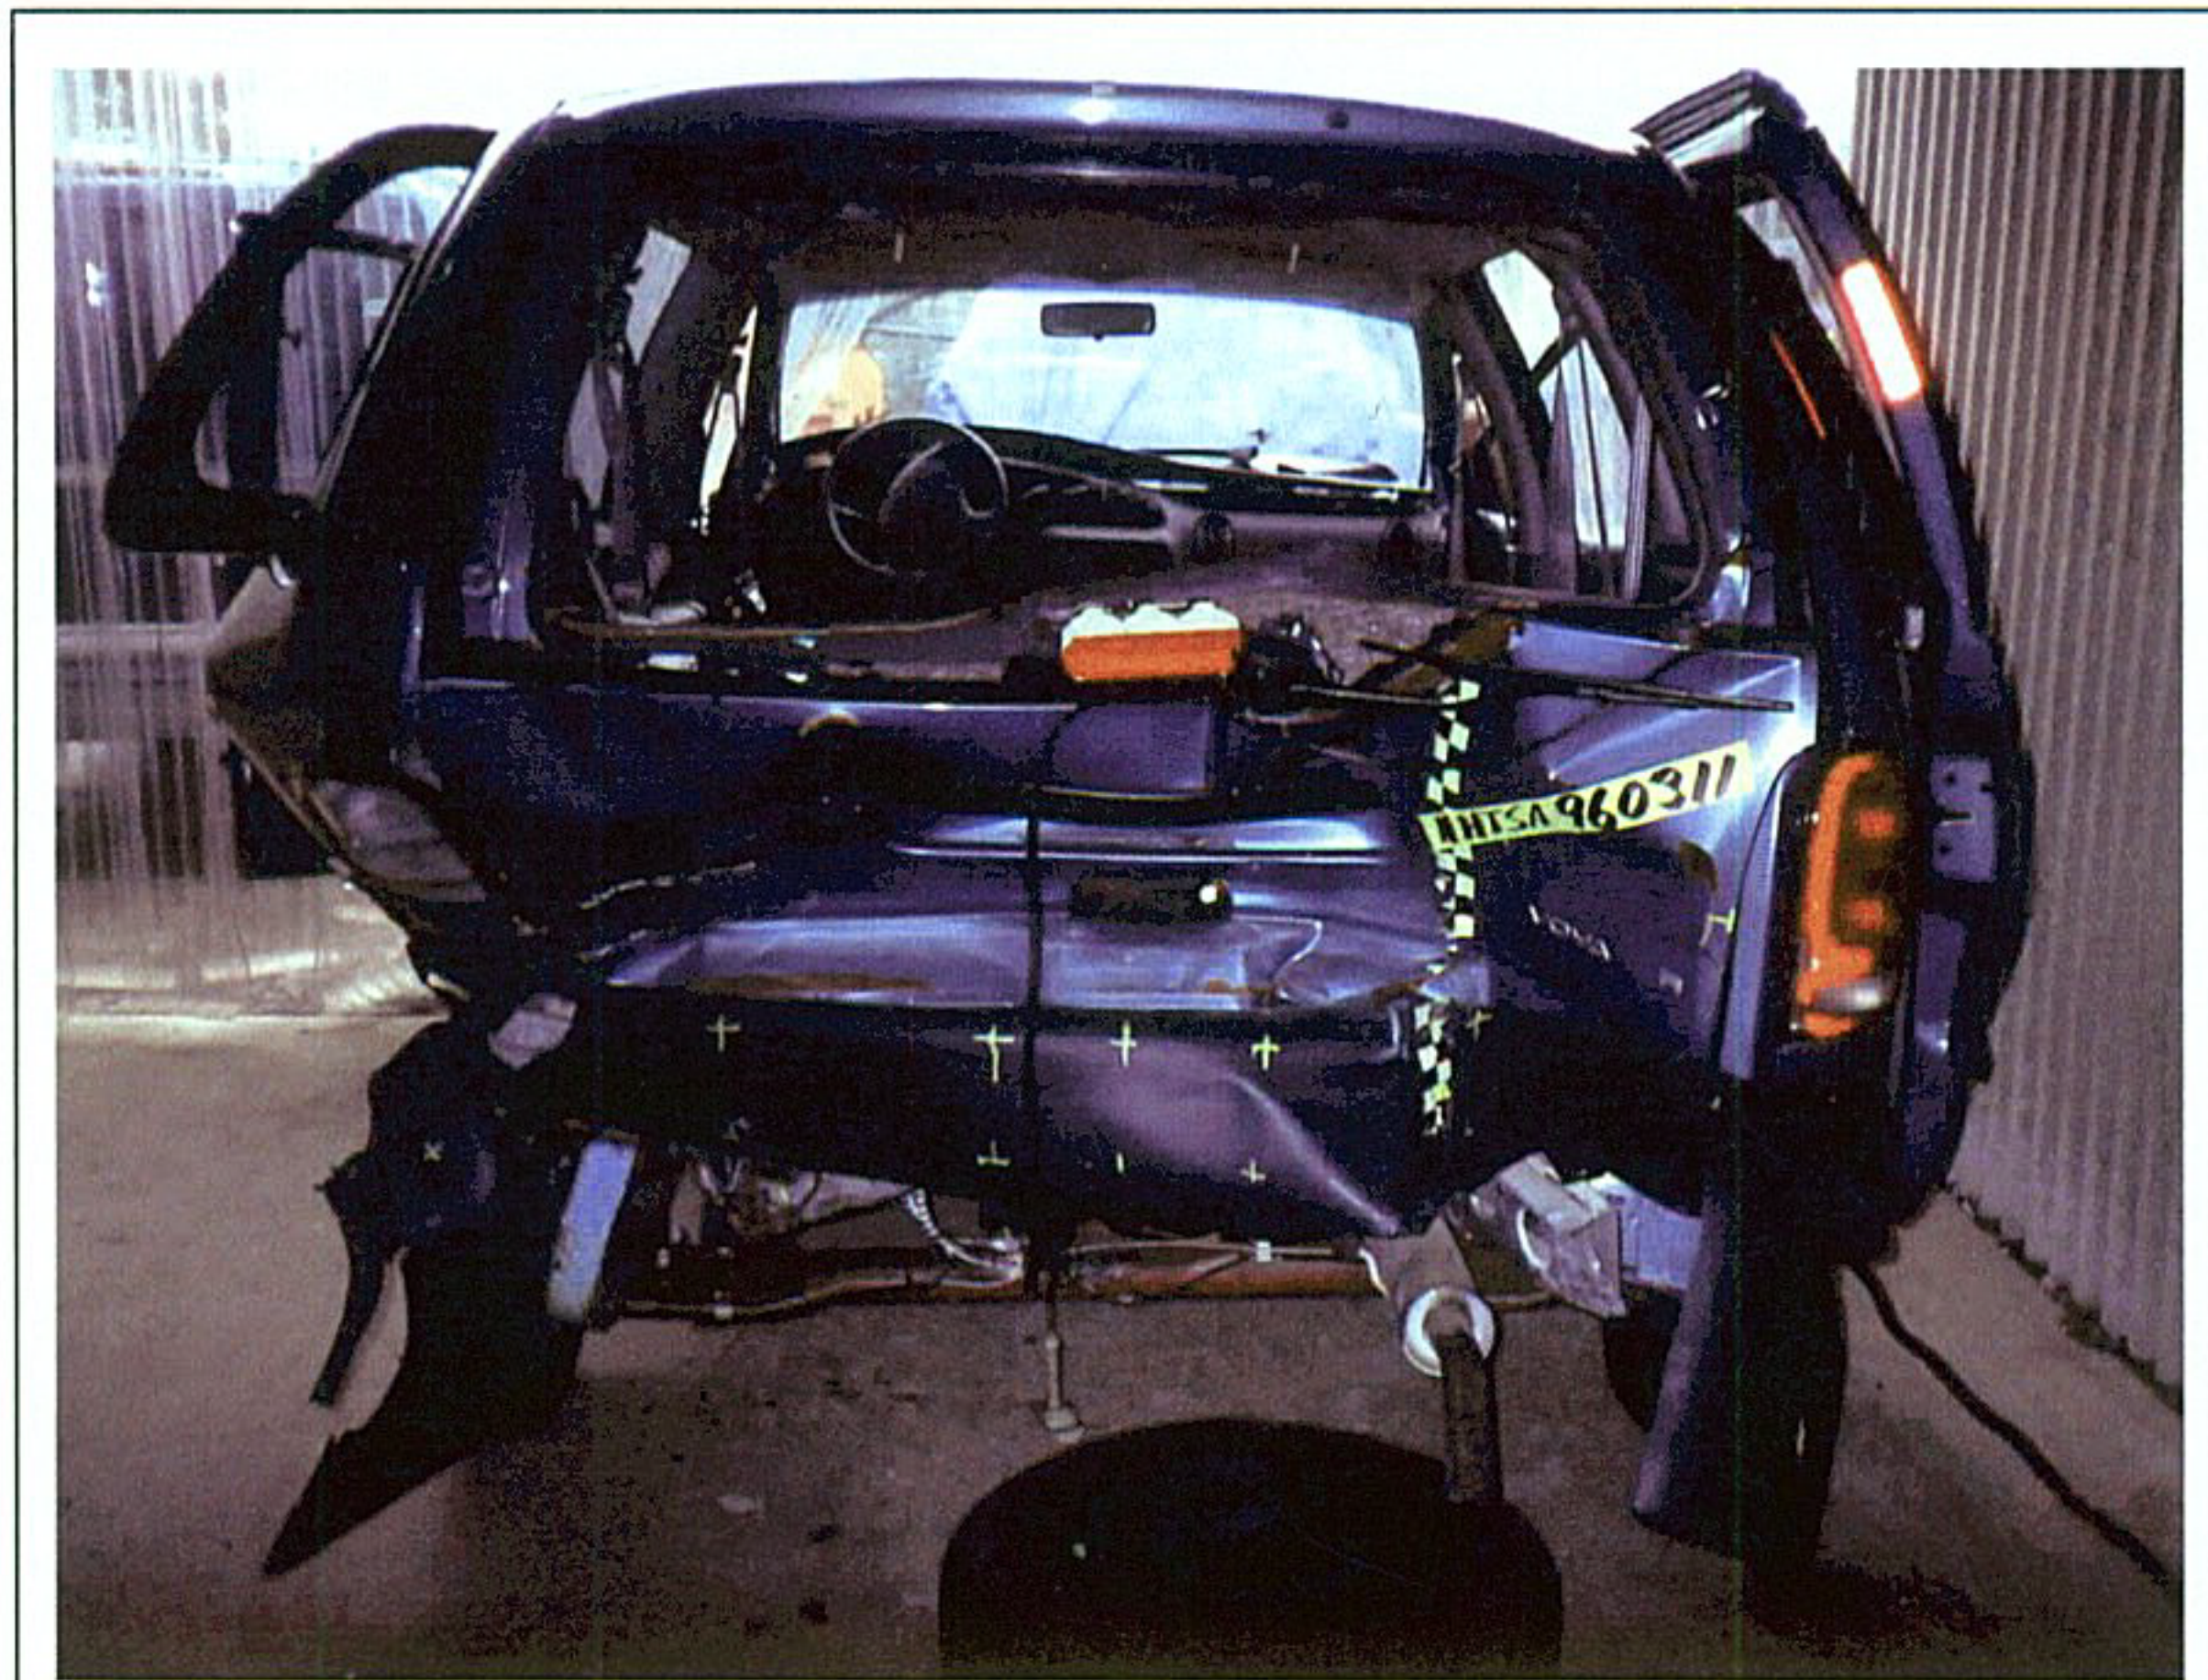
Figure 1 shows photograph of the rear of the test vehicle as it was received from the Transportation Research Corporation. The static crush of the left rear of the vehicle was 435 mm. The rear hatch window was broken. The left rear vent window was pinned open by the deformed left quarter panel.

Figure 1. Fire Test F961116. View of the rear of the test vehicle after shipment from Transportation Research Corporation.

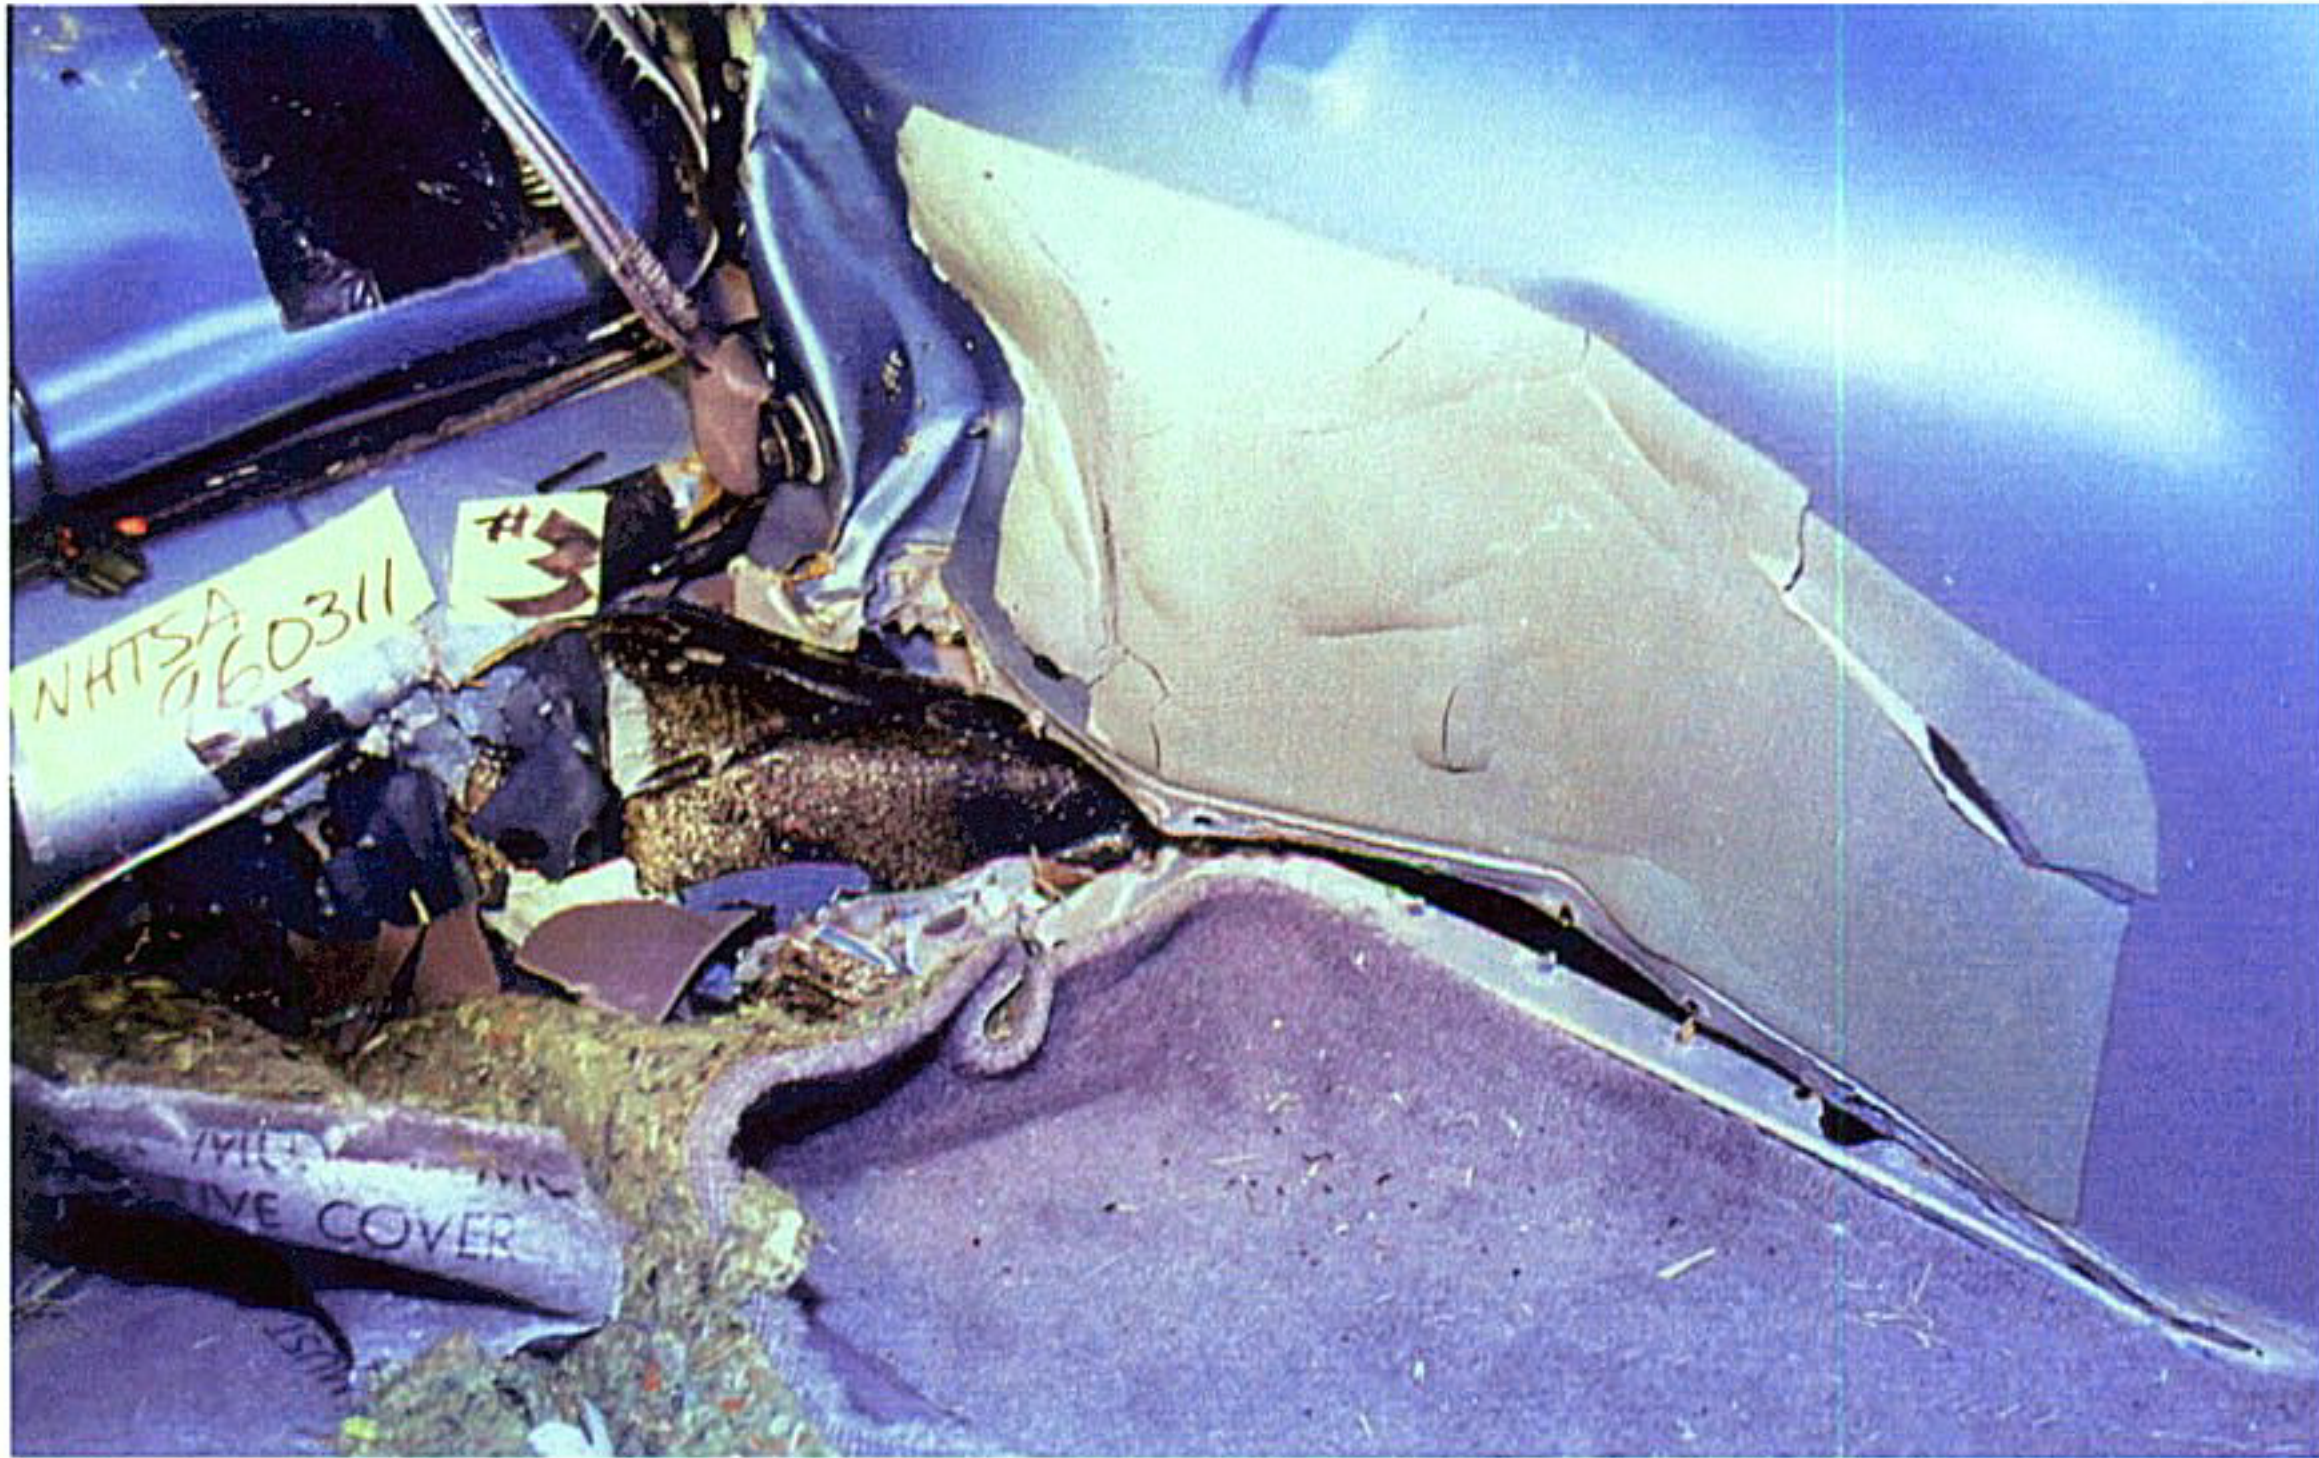
Figure 2. Fire Test F961116. Interior view of the left rear wheelhouse, floor pan, and lift gate of the test vehicle. The torn spot weld seams between the wheelhouse and the floor pan and the inner and outer wheelhouse panels are shown here. The second bench seat and interior trim were removed for this photograph.

Flames from the burning gasoline pool entered the left rear wheelhouse and ignited the filler shield. The filler shield melted and sagged onto the tire as it burned. Flames spread into the passenger compartment through the open spot weld seam at the rear of the left rear wheelhouse and the left rear vent window. The carpet, the left rear quarter trim panel, the molding on the D-pillar, the interior trim panel on the lift gate, and the lower surface of the cushion in the second bench seat were burning within 150 seconds after the gasoline pool was ignited. Flames started to spread across the headlining panel approximately 175 sec after ignition.

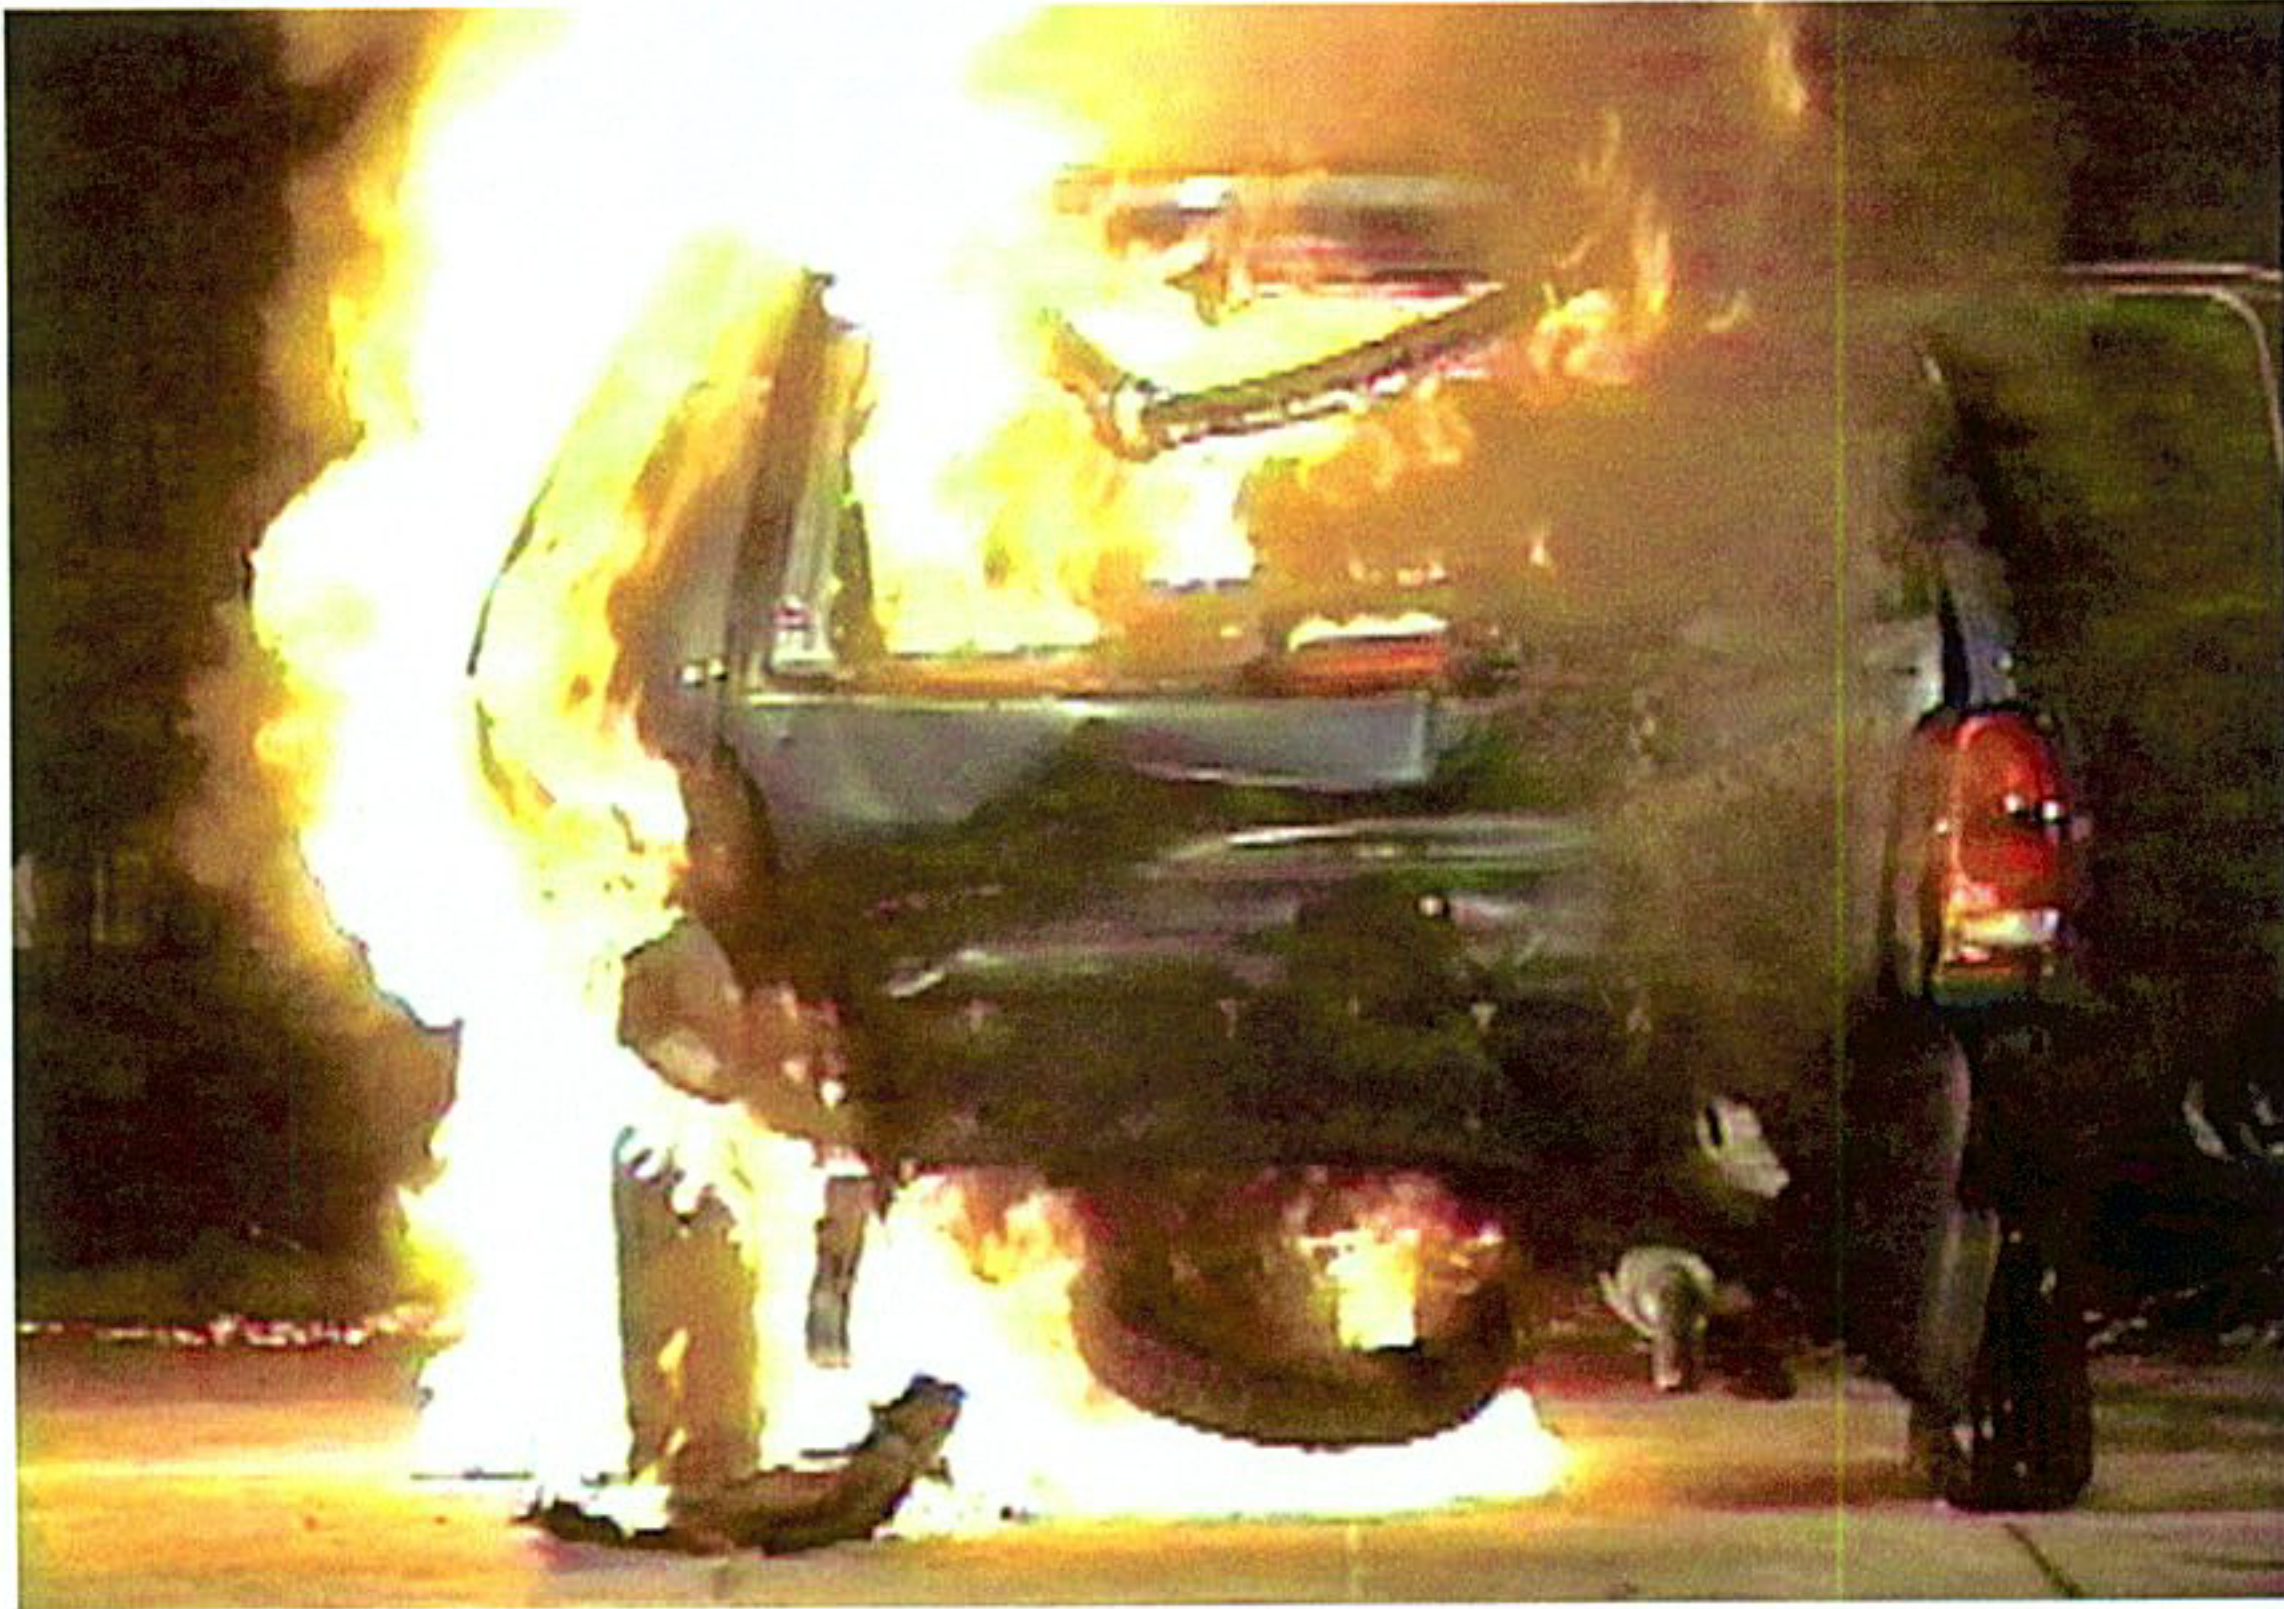
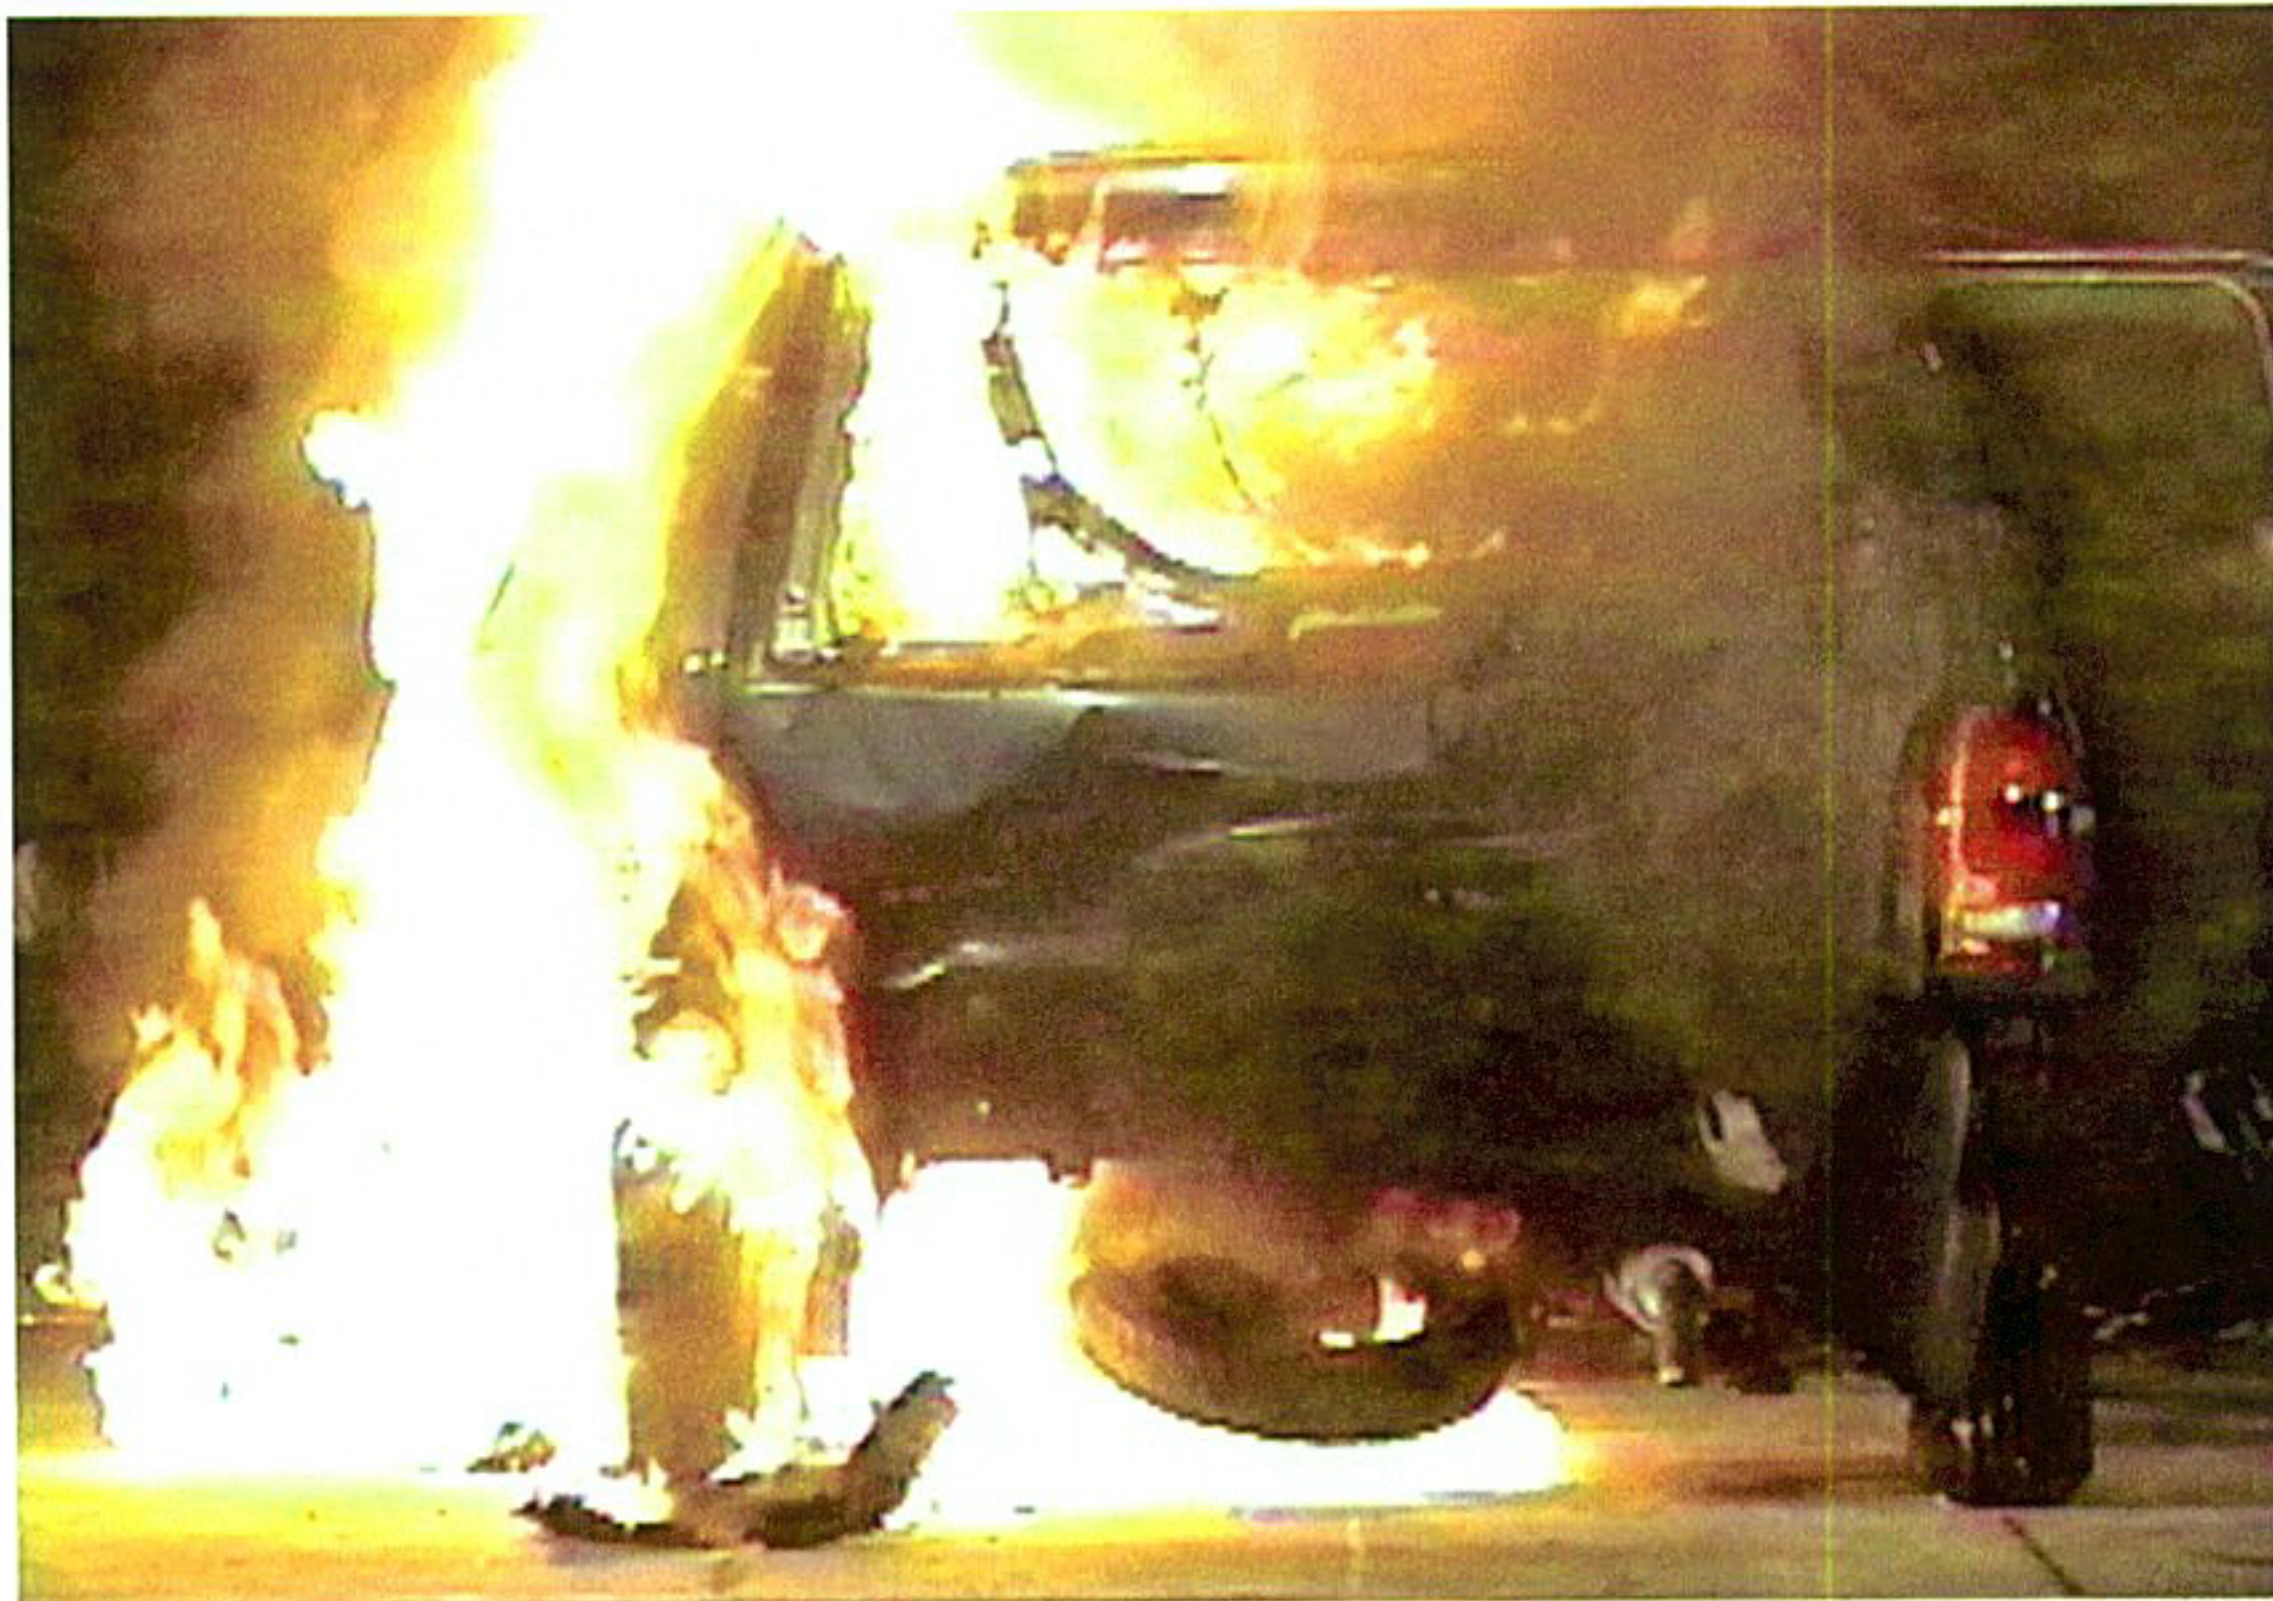
An increase in the size of the fire immediately to the left of the test vehicle occurred at approximately 213 seconds post-ignition (Fig. 18). This cause of this appears to have been combustible solid material, that was already burning, falling from the left side of the vehicle. Possible sources of this material could have been the rocker molding or the molding on the left quarter panel.

Figure 18. Fire Test F961116. Video stills from Camera 1 at 210 (upper) and 213 (lower) seconds post-ignition.

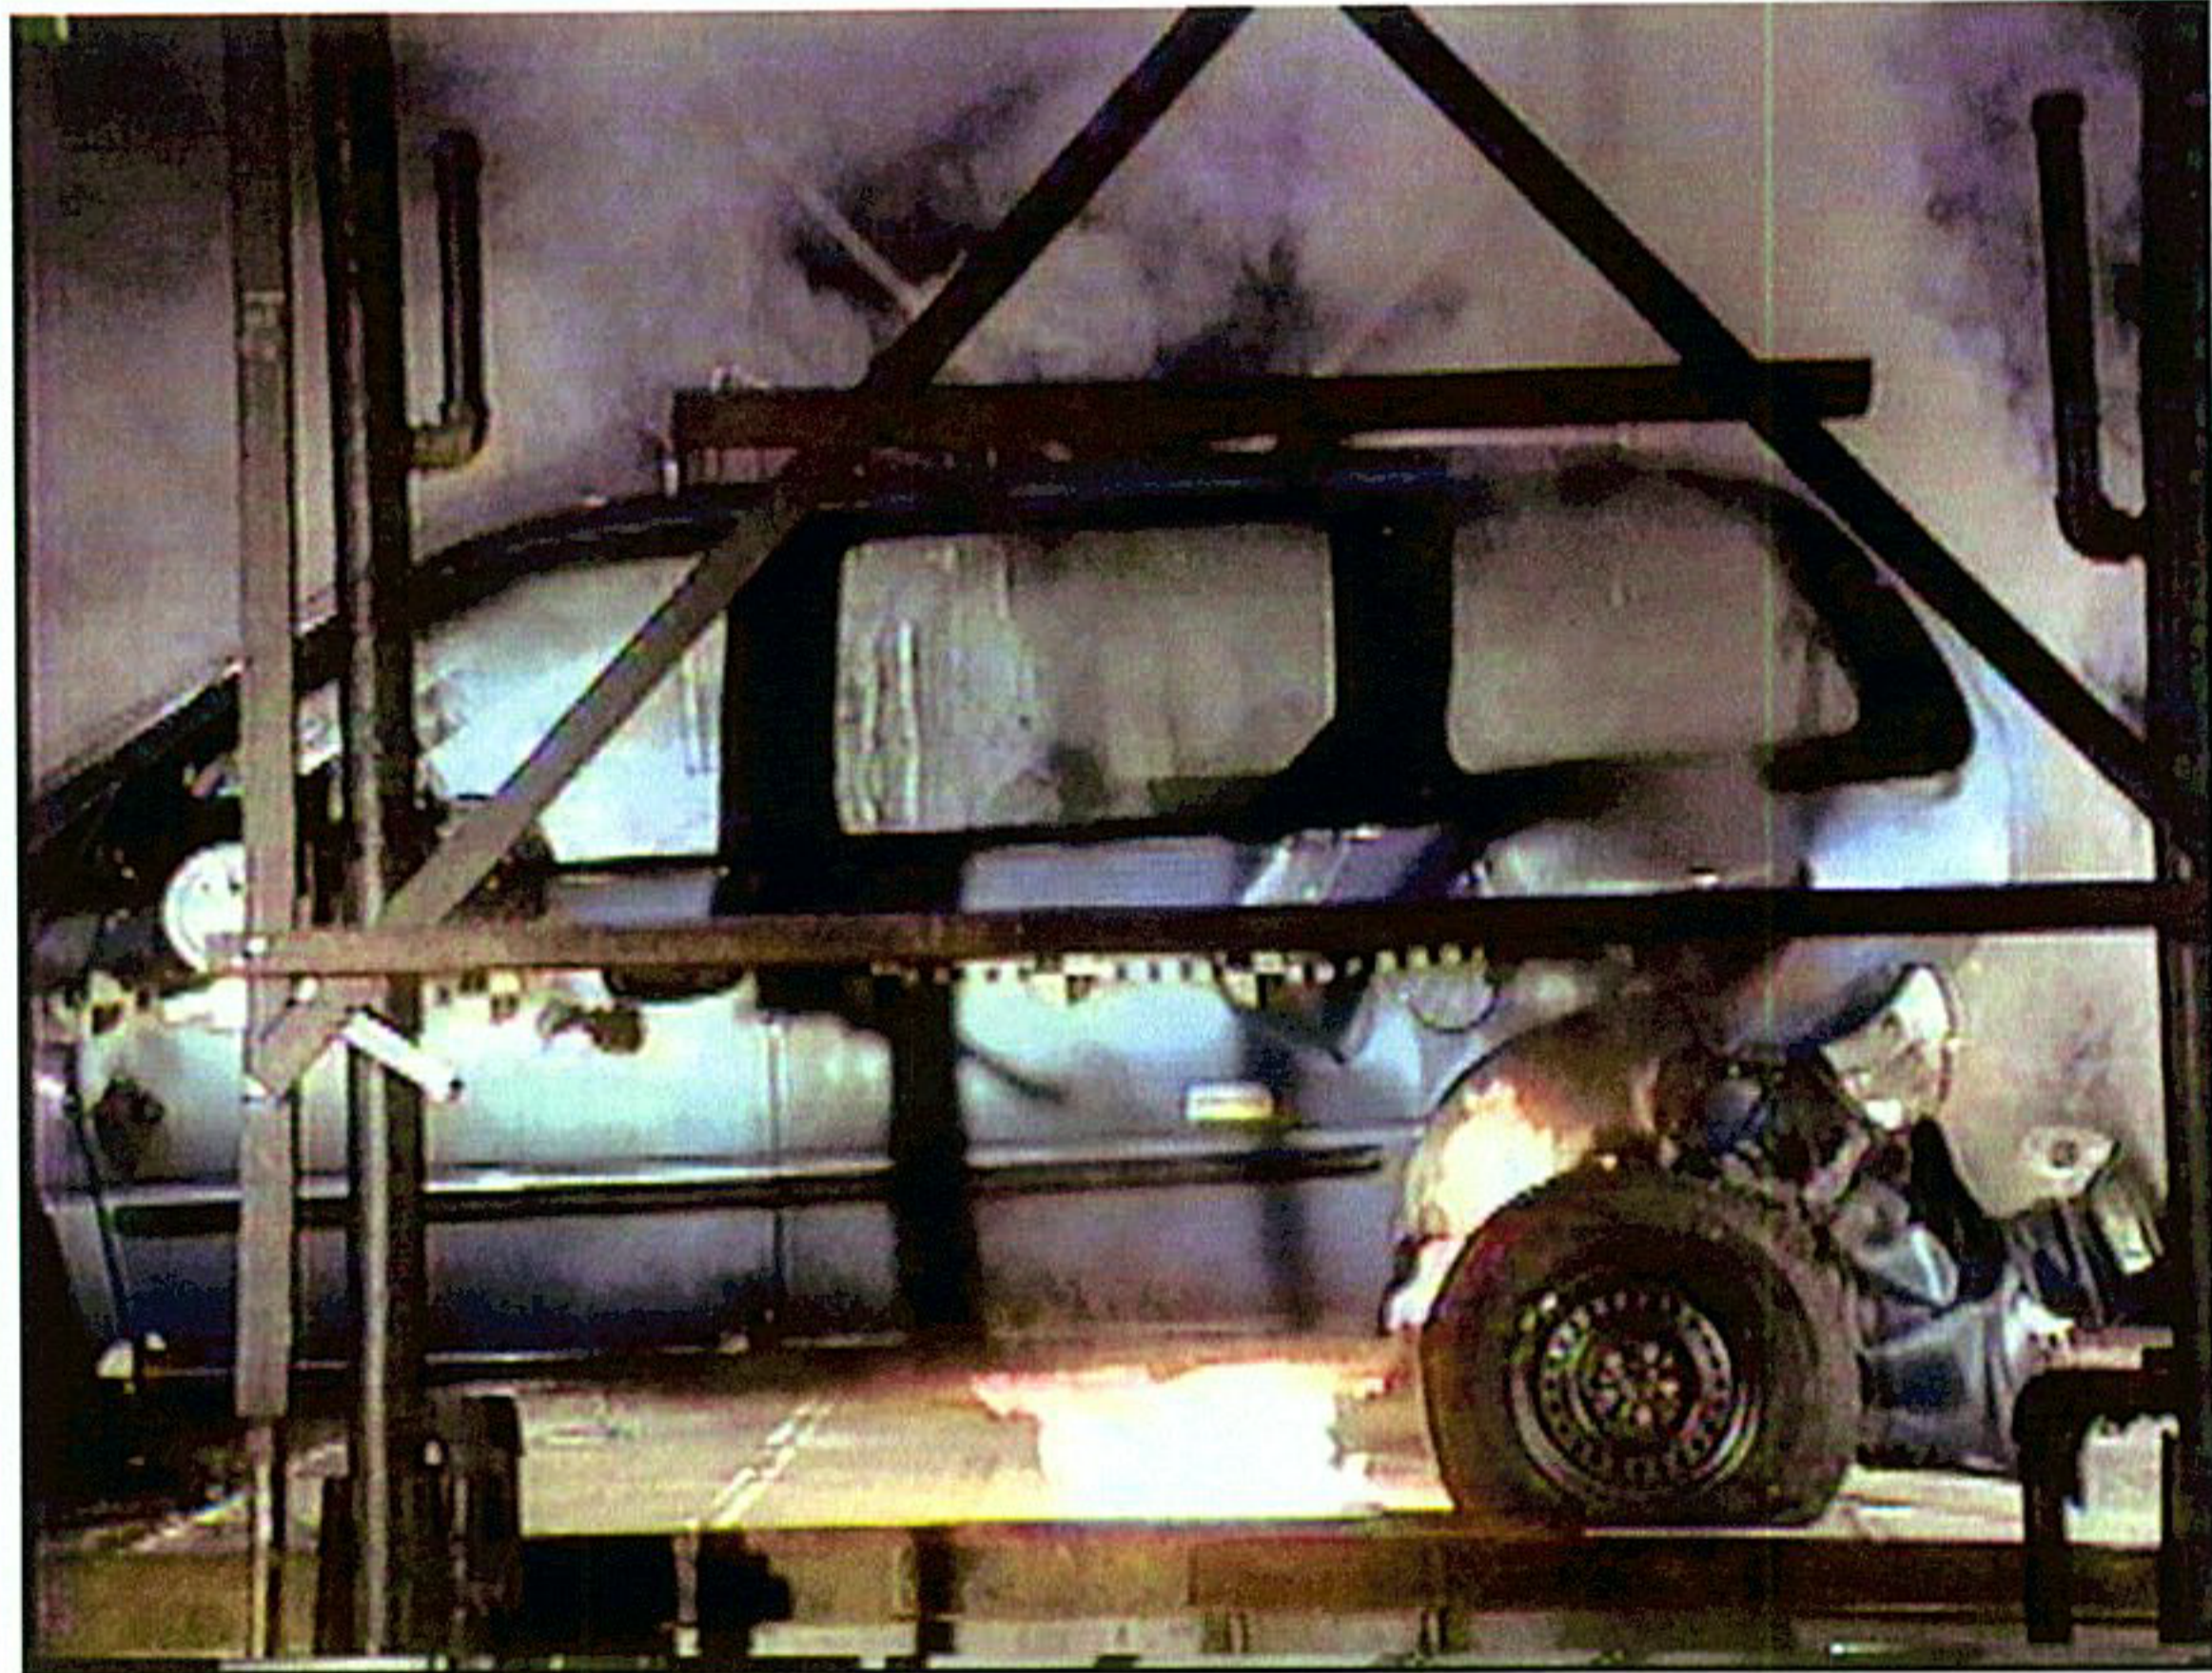
Figure 19. Fire Test F961116. Video still from Camera 2 at 30 seconds post-ignition showing flames spreading radially along the lower surface of the fuel tank, and channeled into the left rear wheelhouse.

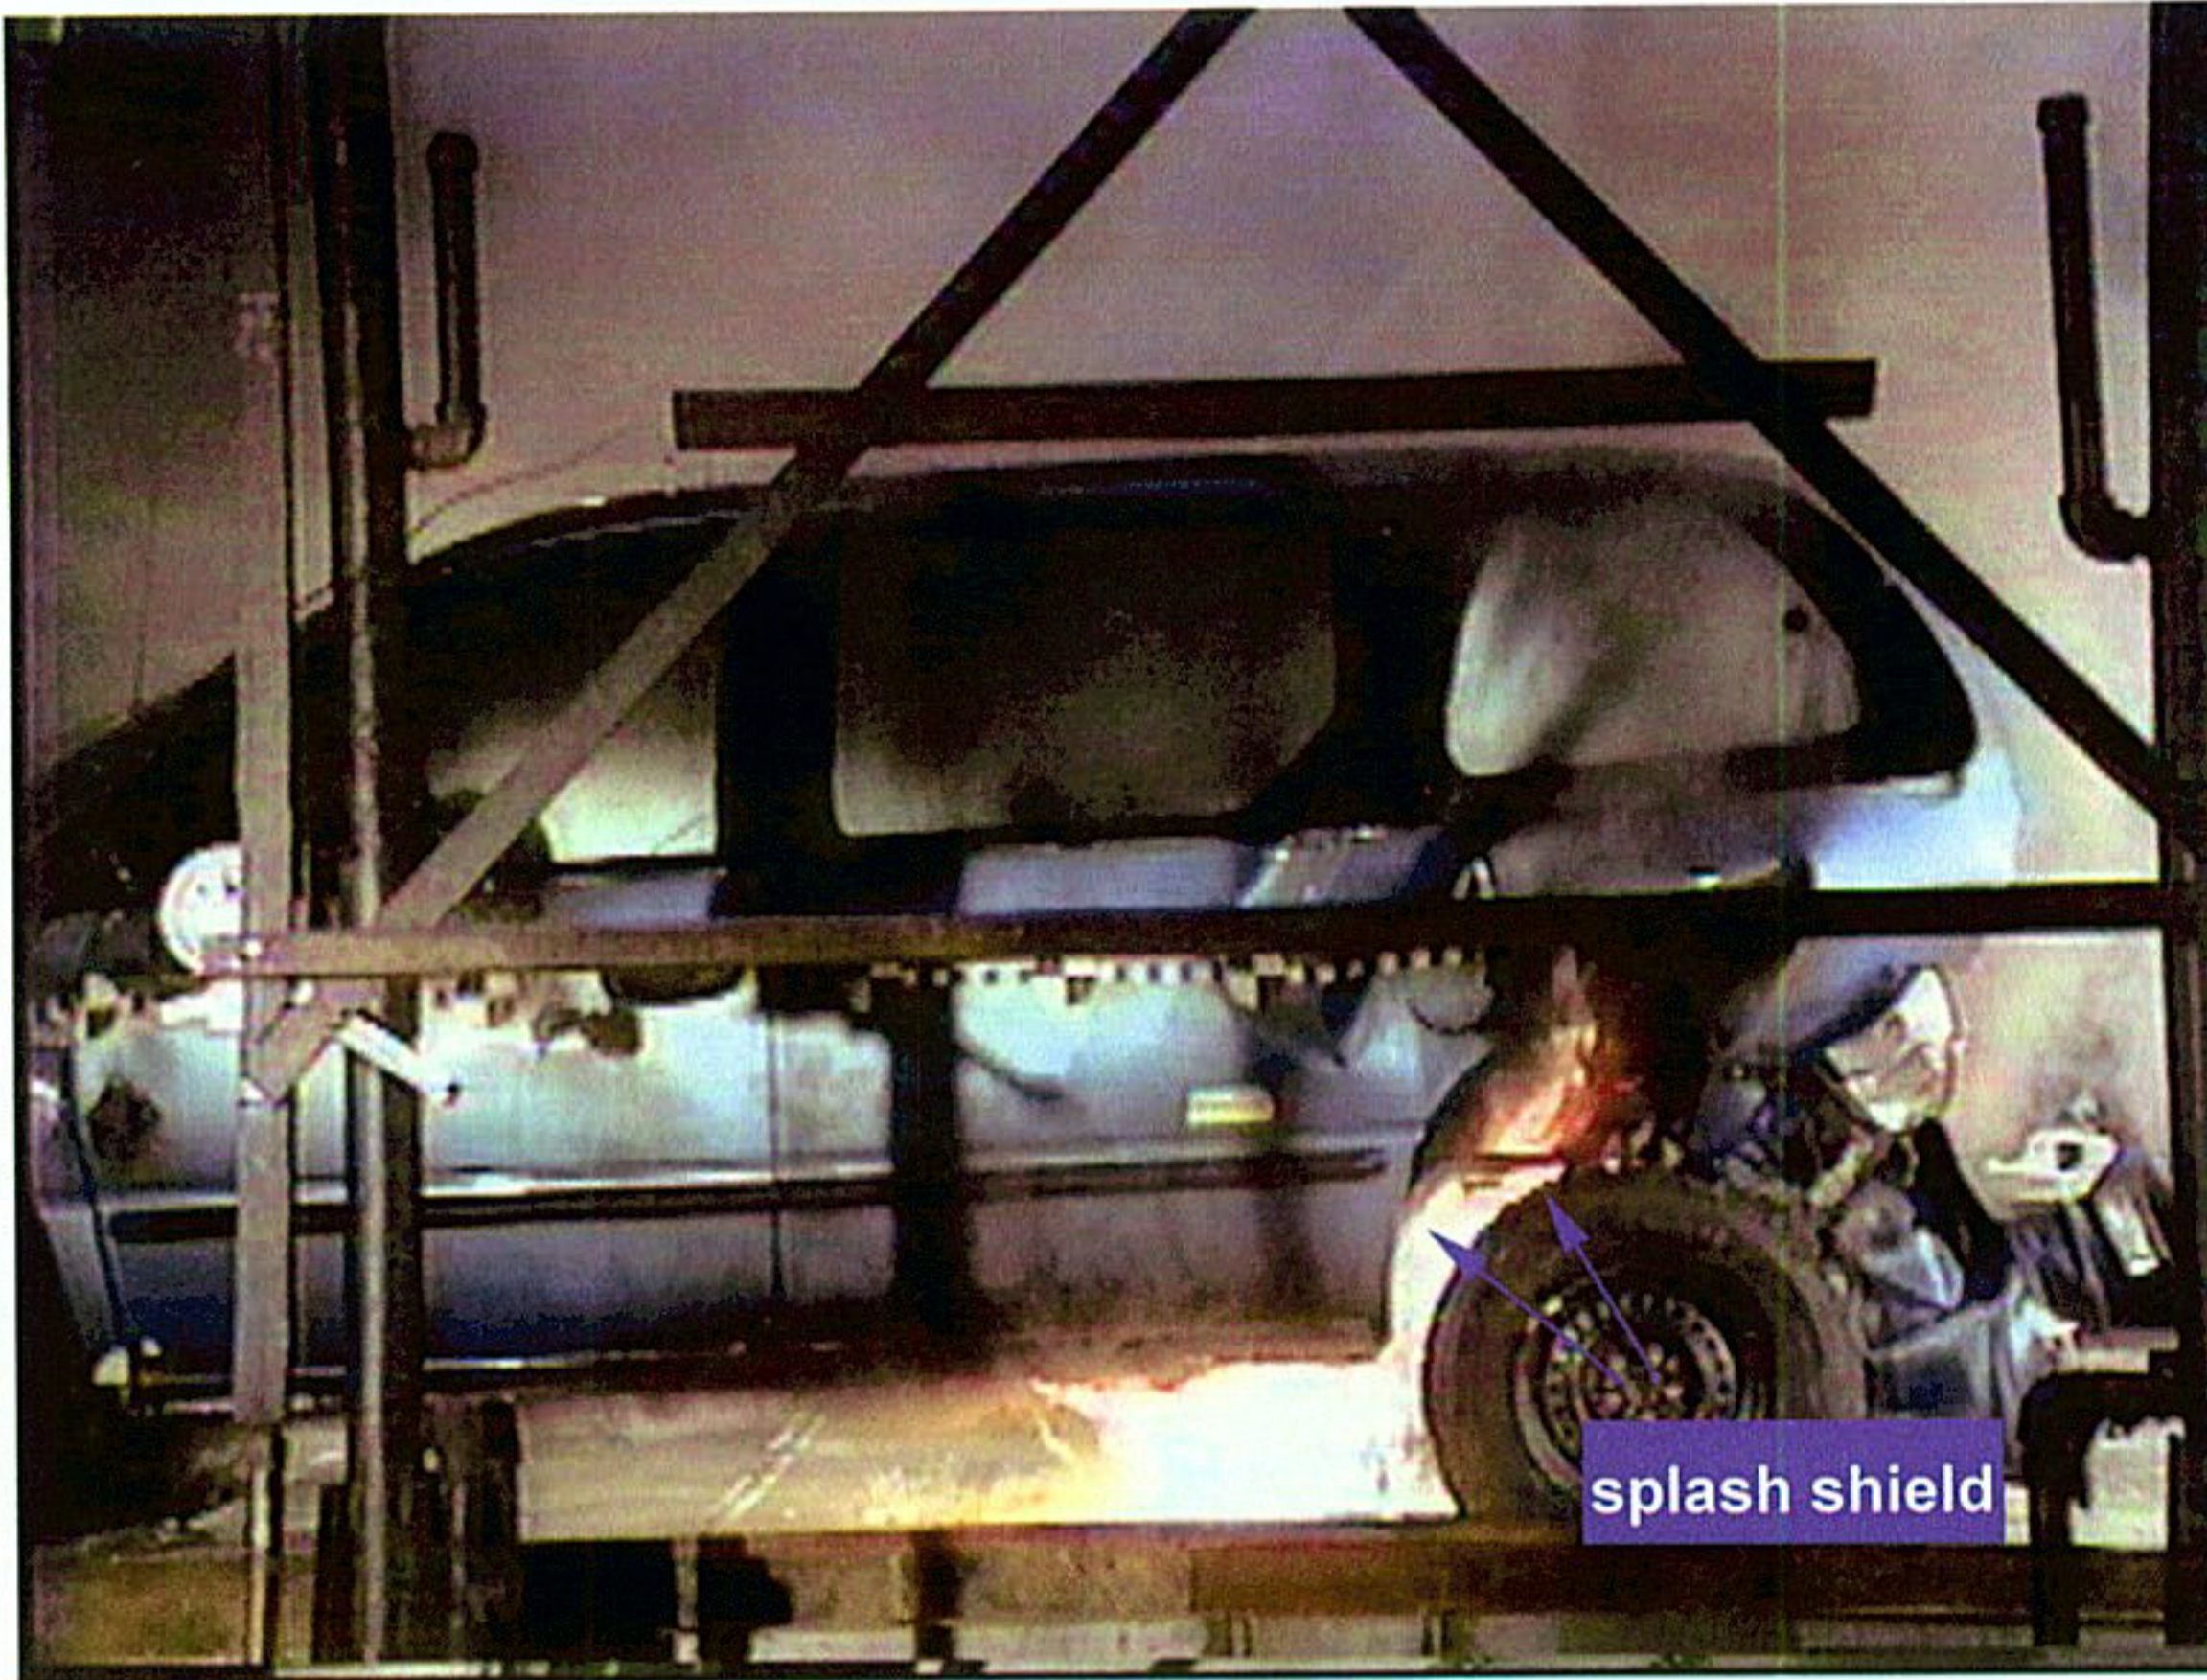
Figure 20. Fire Test F961116. Video still from Camera 2 at 75 seconds post-ignition showing wheelhouse splash shield melting and sagging onto the left rear tire (arrows).
