Enclosed is a final report prepared by Jeffrey Santrock of General Motors Corporation, entitled, "Evaluation of Motor Vehicle Fire Initiation and Propagation Part 4: Propagation of an Underbody Gasoline Pool Fire in a 1996 Passenger Van."

**Evaluation of Motor Vehicle Fire Initiation and Propagation
Part 4: Propagation of an Underbody Gasoline Pool Fire in a 1996
Passenger Van**

Jeffrey Santrock
General Motors Corporation

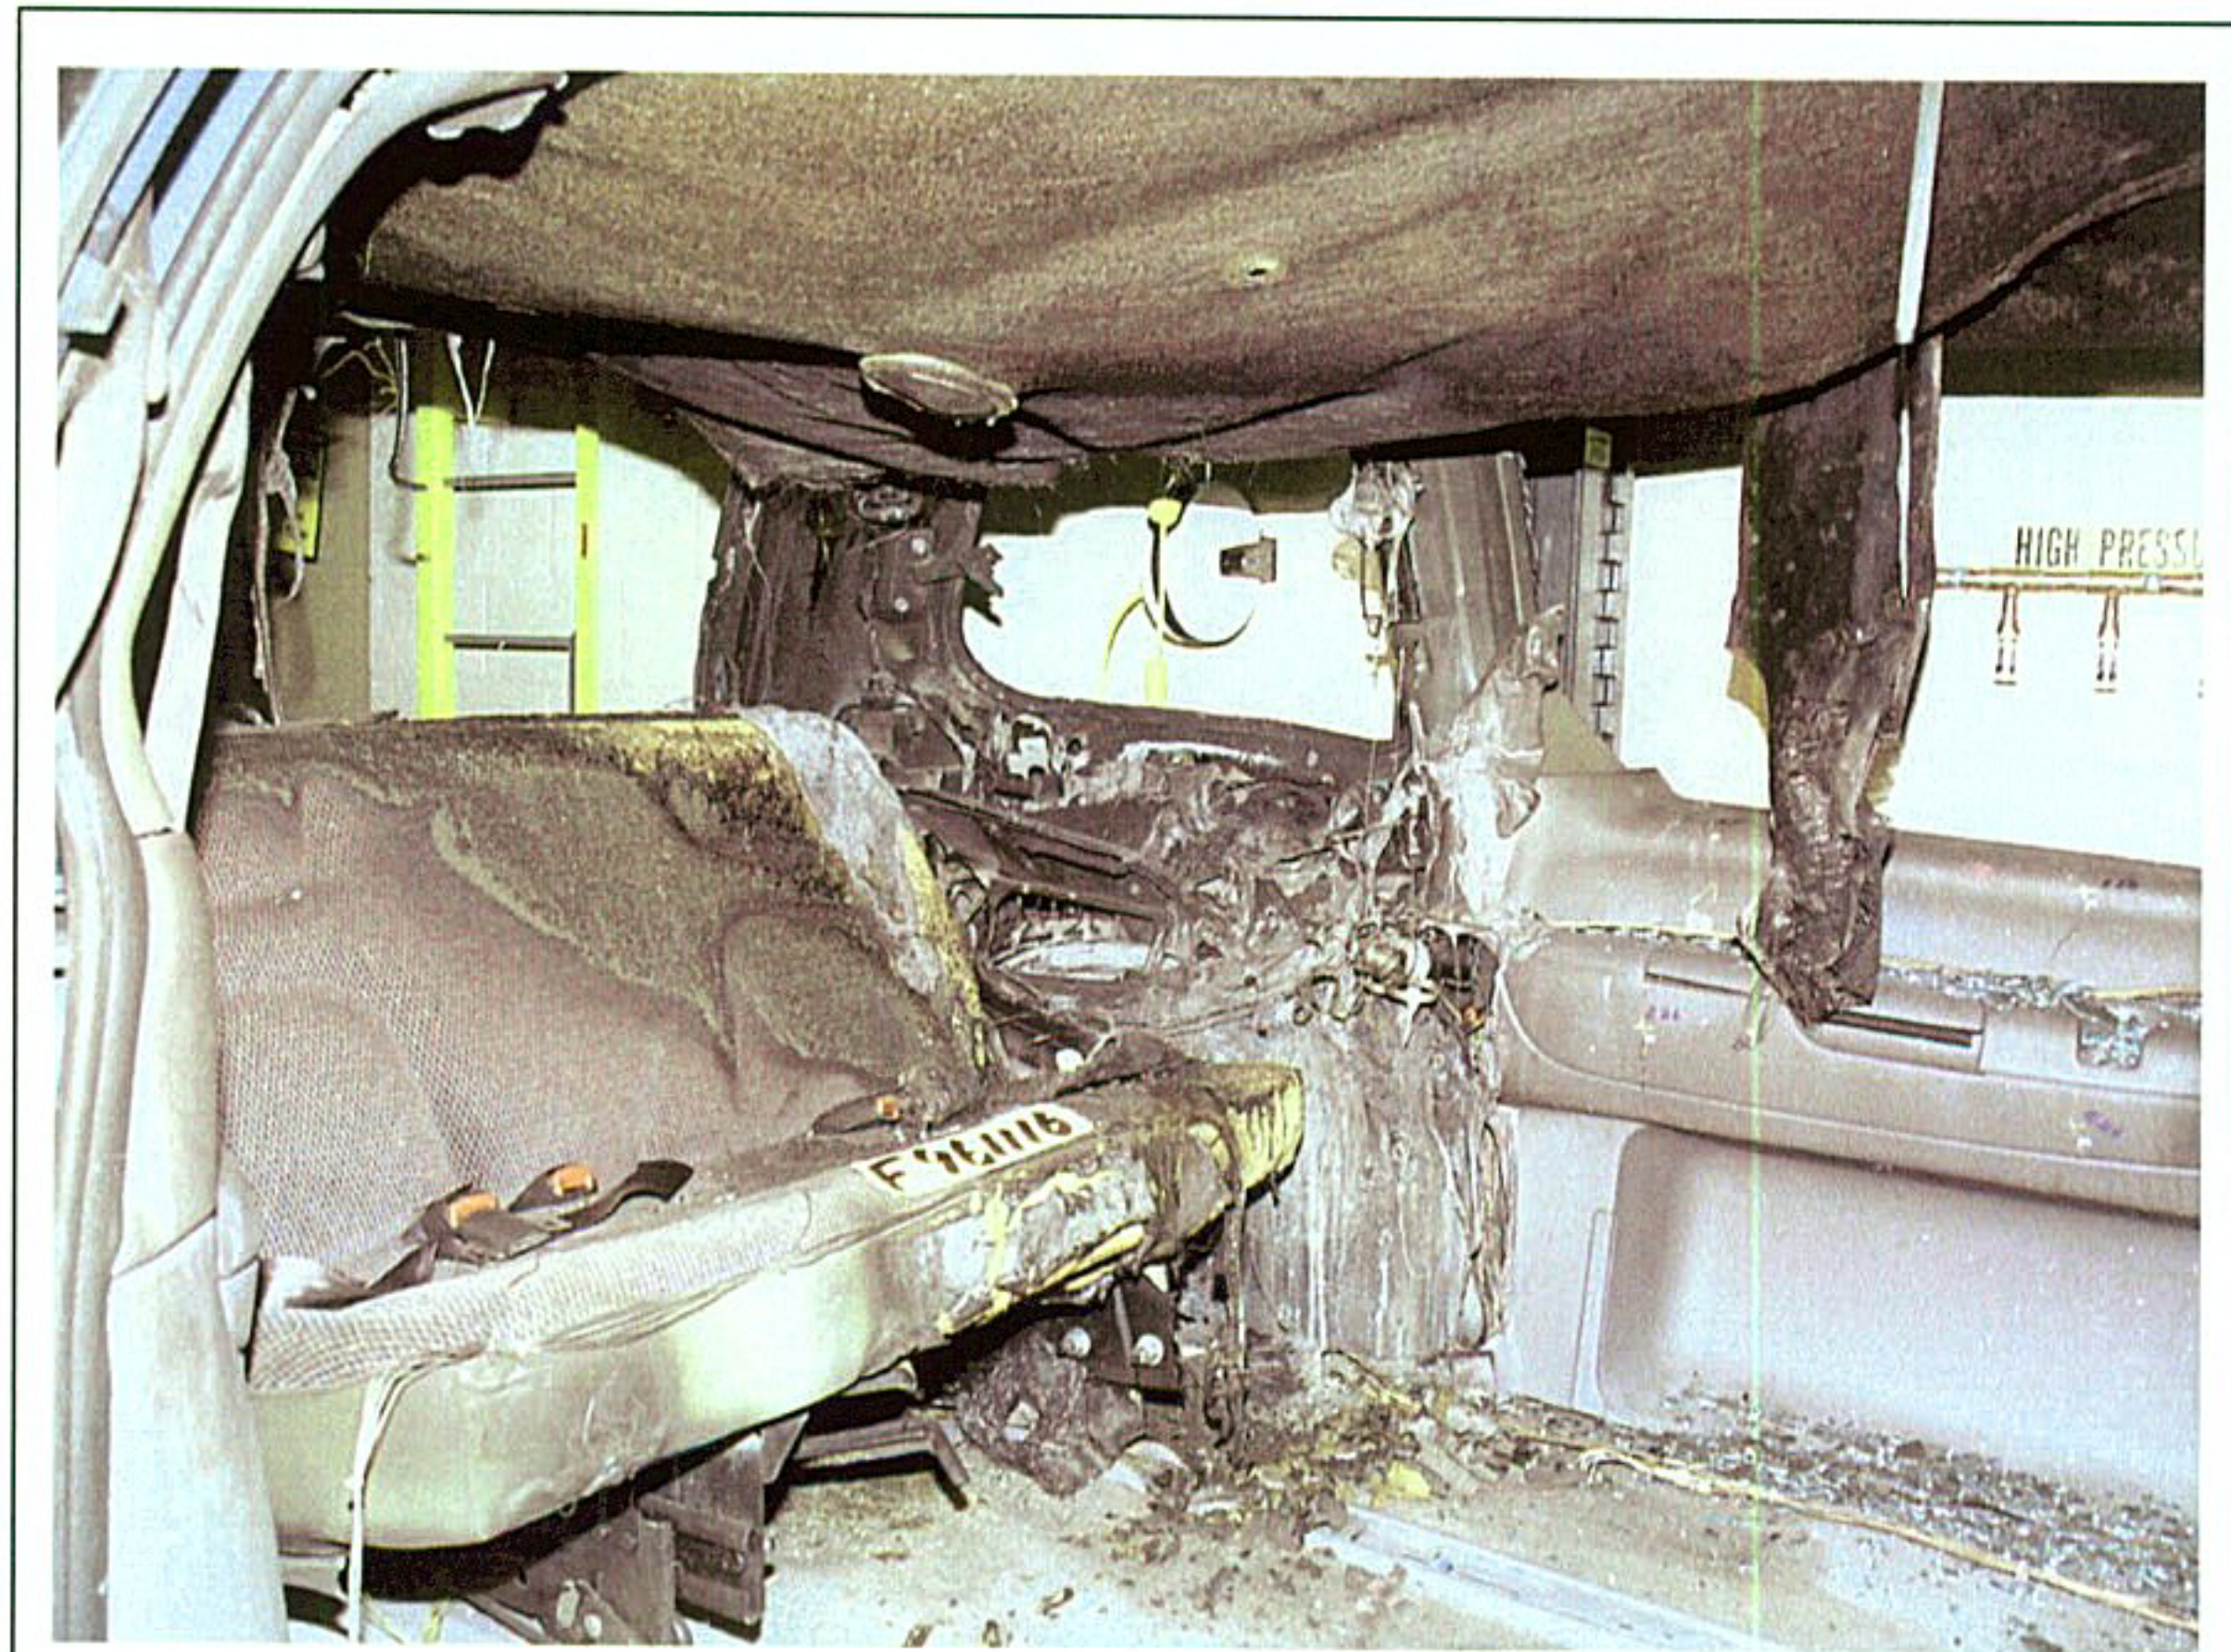
Figure 36. Fire Test F961116. Photograph showing fire damage to the second bench seat, the left quarter trim panel, the C- and D-pillar trim panels, and the headlining.

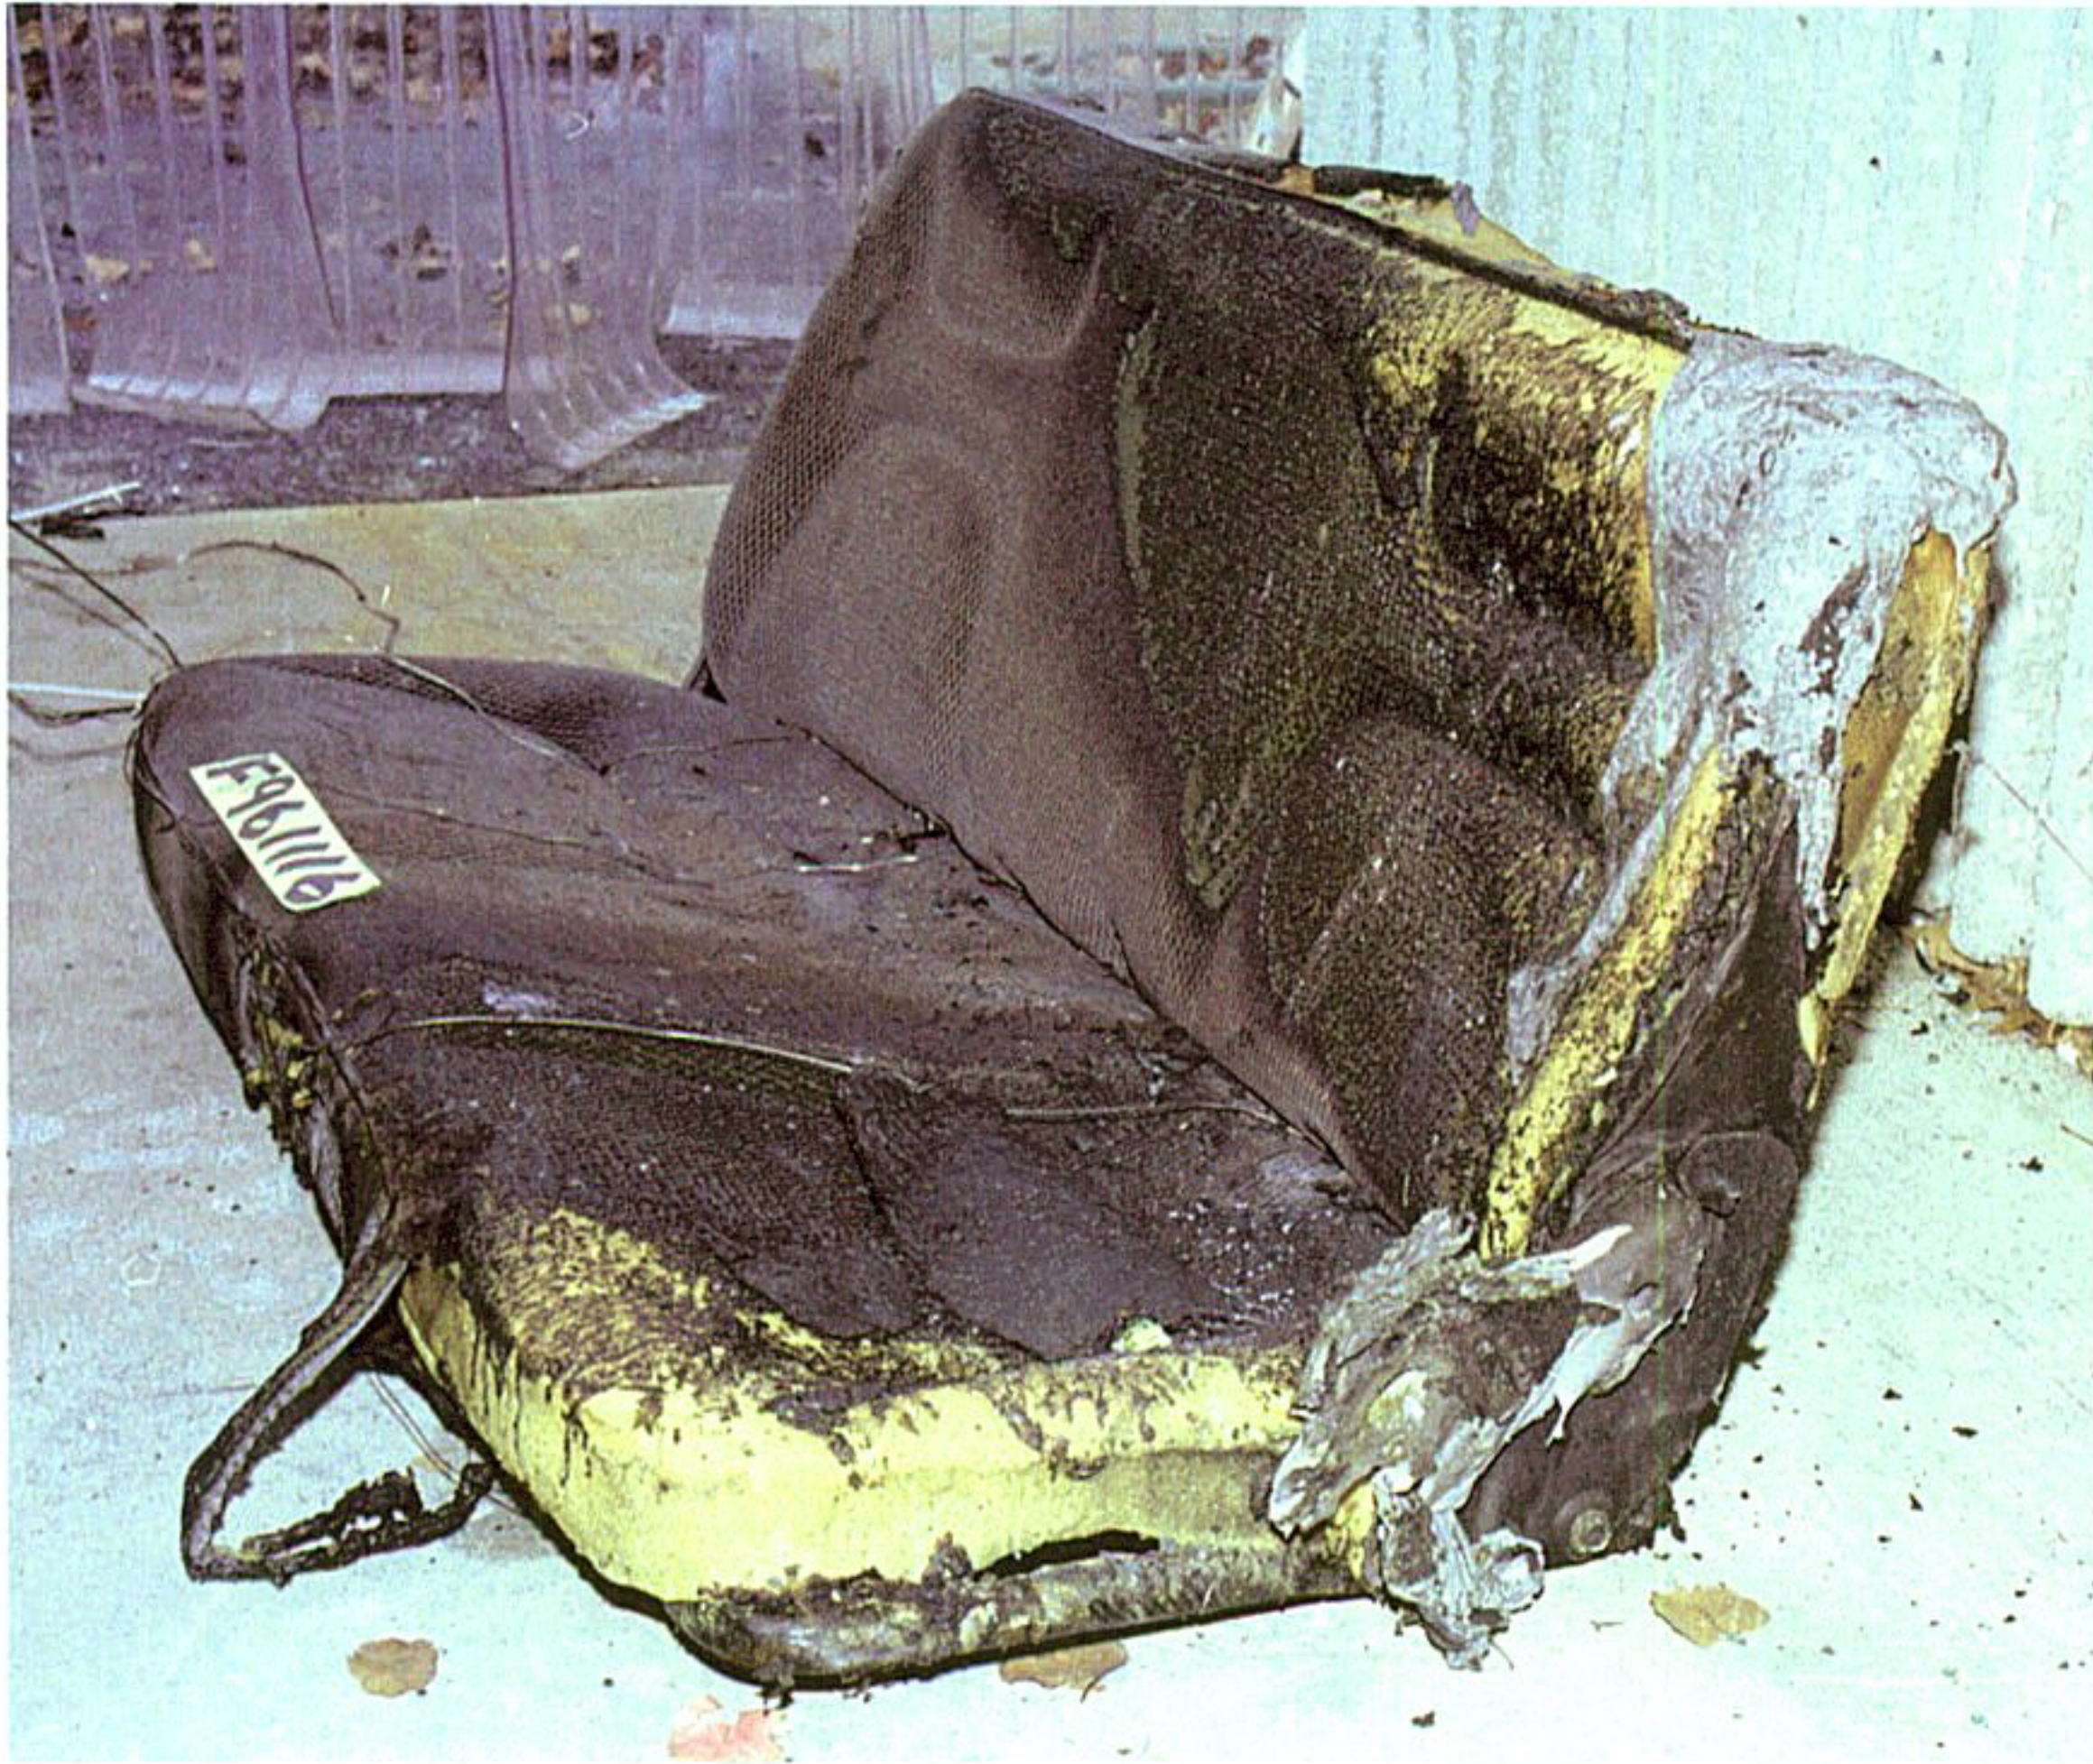
Figure 39. Fire Test F961116. Photograph showing fire damage to the seating areas of the second bench seat.

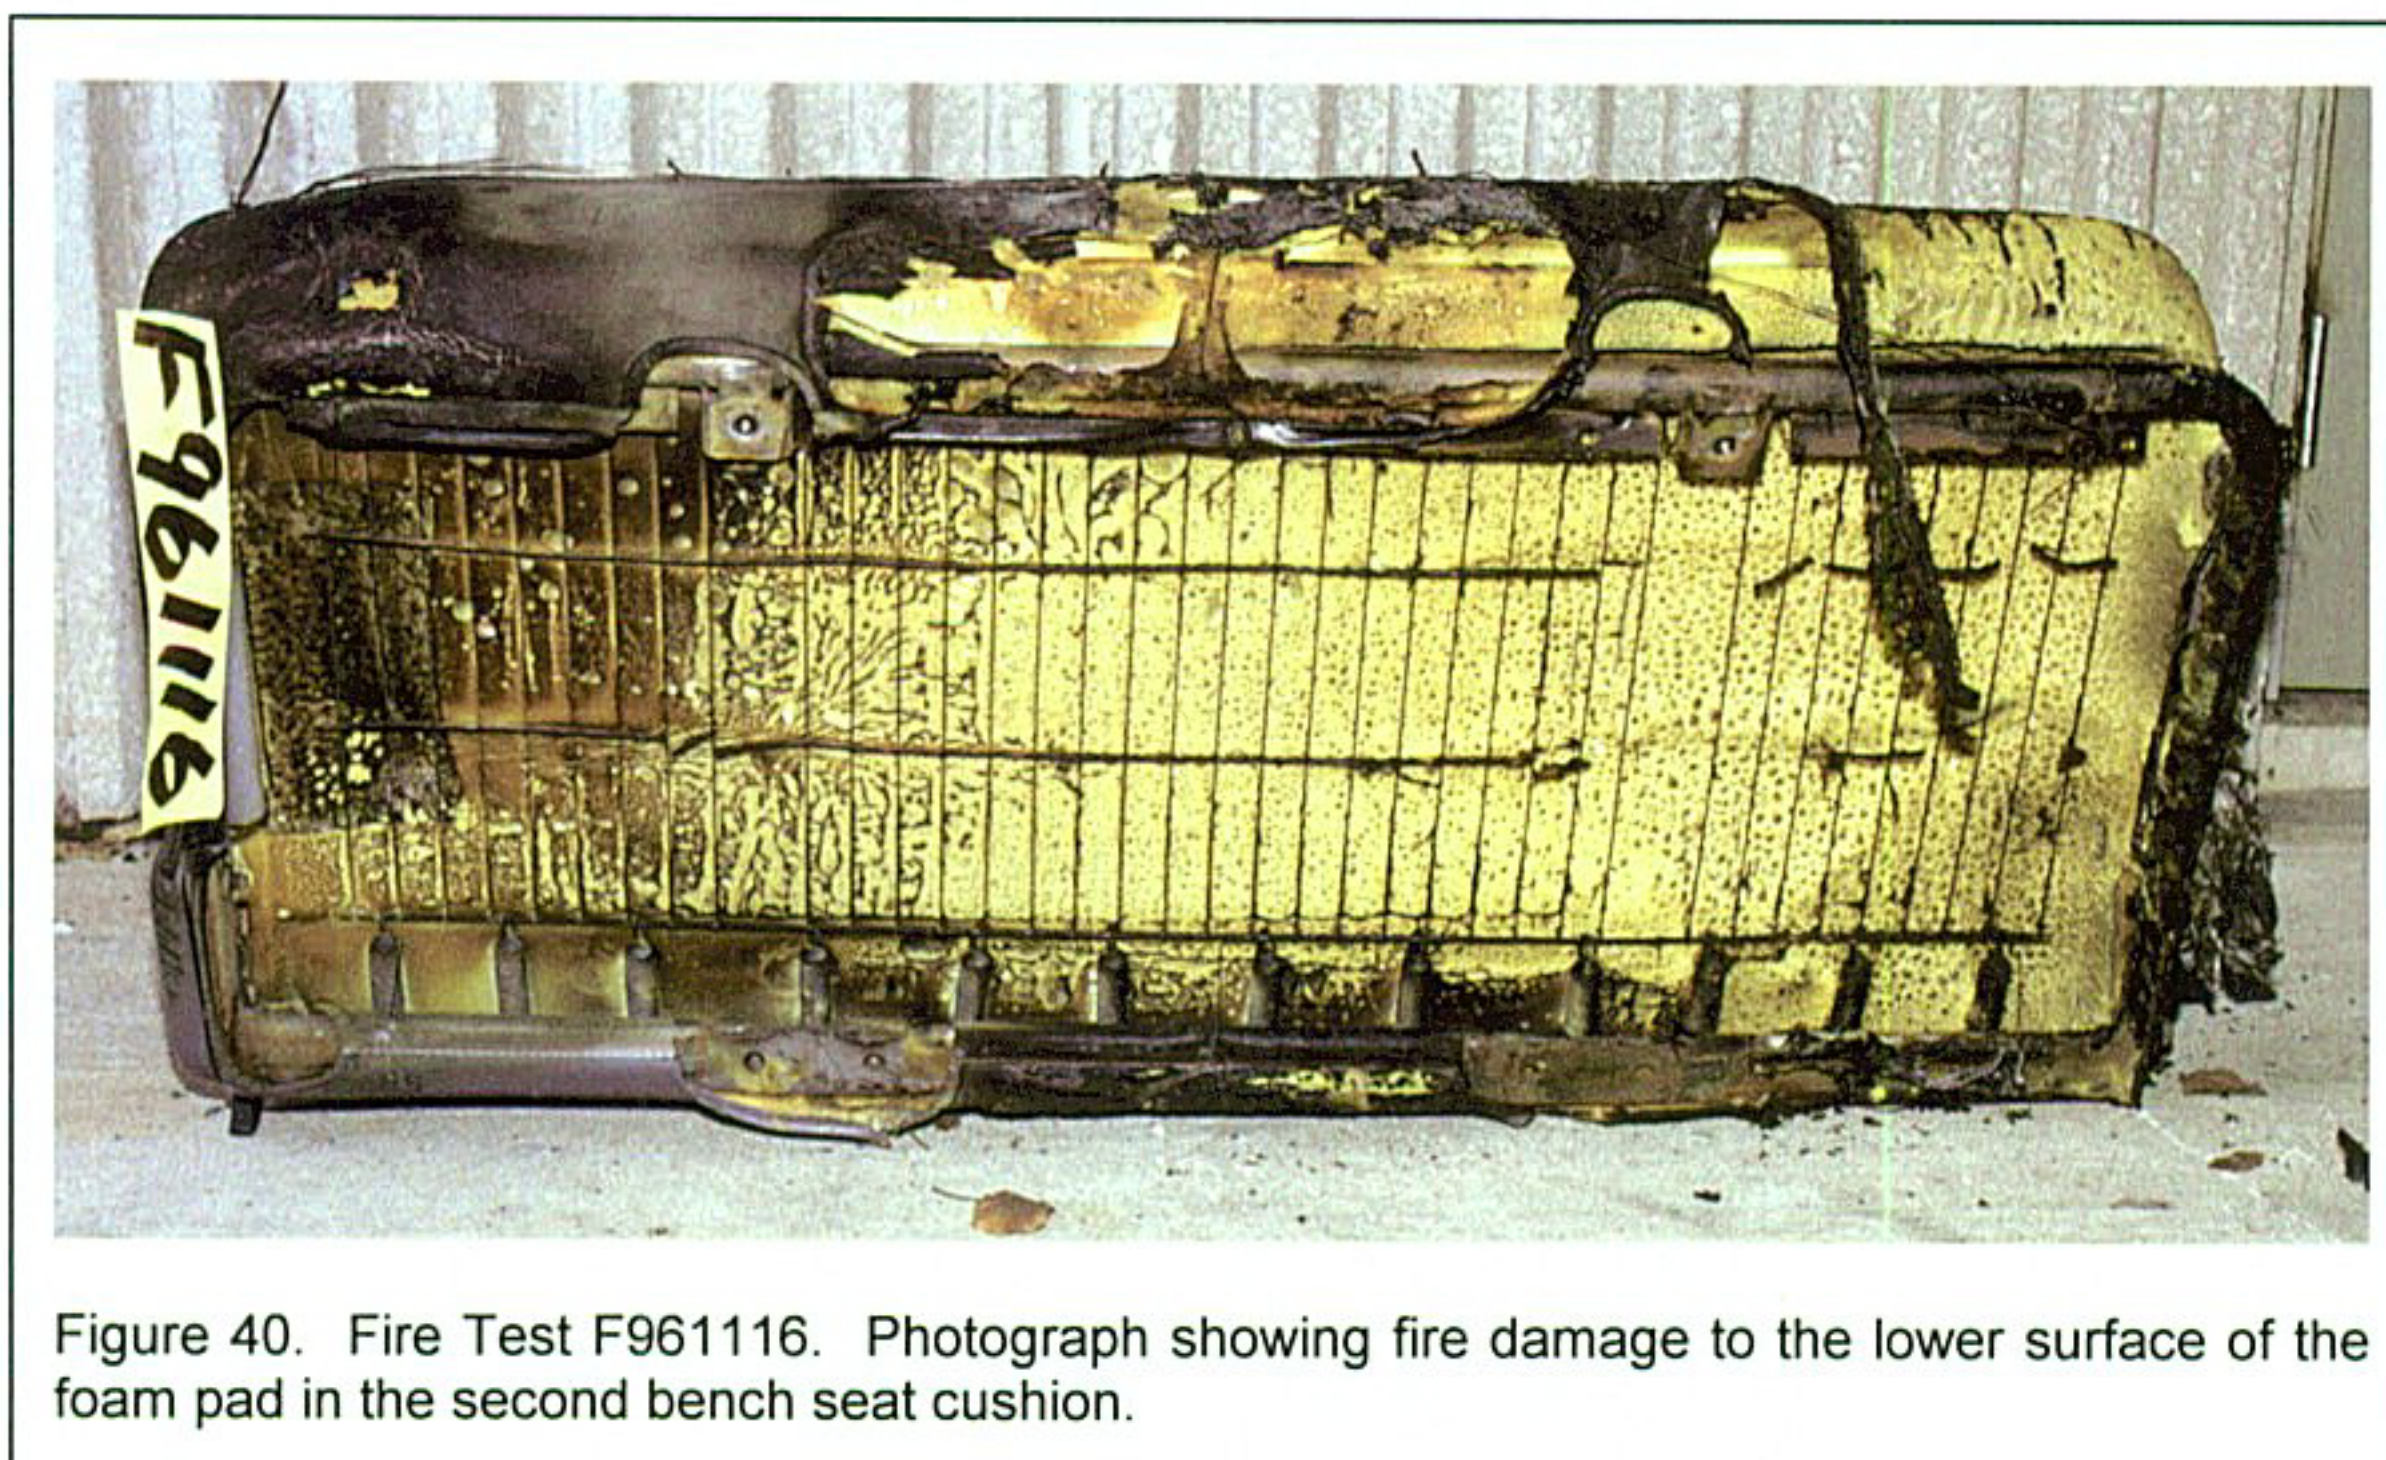
Figure 40 is a photograph of the under-side of the second bench seat removed from the test vehicle after this fire test. The pattern of smoke and fire damage observed on the lower surface of the foam pad in the seat cushion is consistent with the pattern of flame-spread inferred from the estimated isothermal contours shown in Figure 38. Inspection of the seat revealed that material was eroded from lower surface of the foam pad¹⁵ along the central (between the risers) and left (outboard of the left riser) sections¹⁶ of the seat cushion (Fig. 40). Deposits of brown and black soot were observed evident on the right section. The isothermal contour plots in Figure 38 suggest that flames spread along the lower surface of the seat cushion up to the left riser by 170 seconds post-ignition. Smoke and gases produced in the fire plume spread to the right along the central and right sections of the seat cushion. The estimated temperatures along the central section of the seat cushion (Fig. 38) were greater than the thermal decomposition temperature of

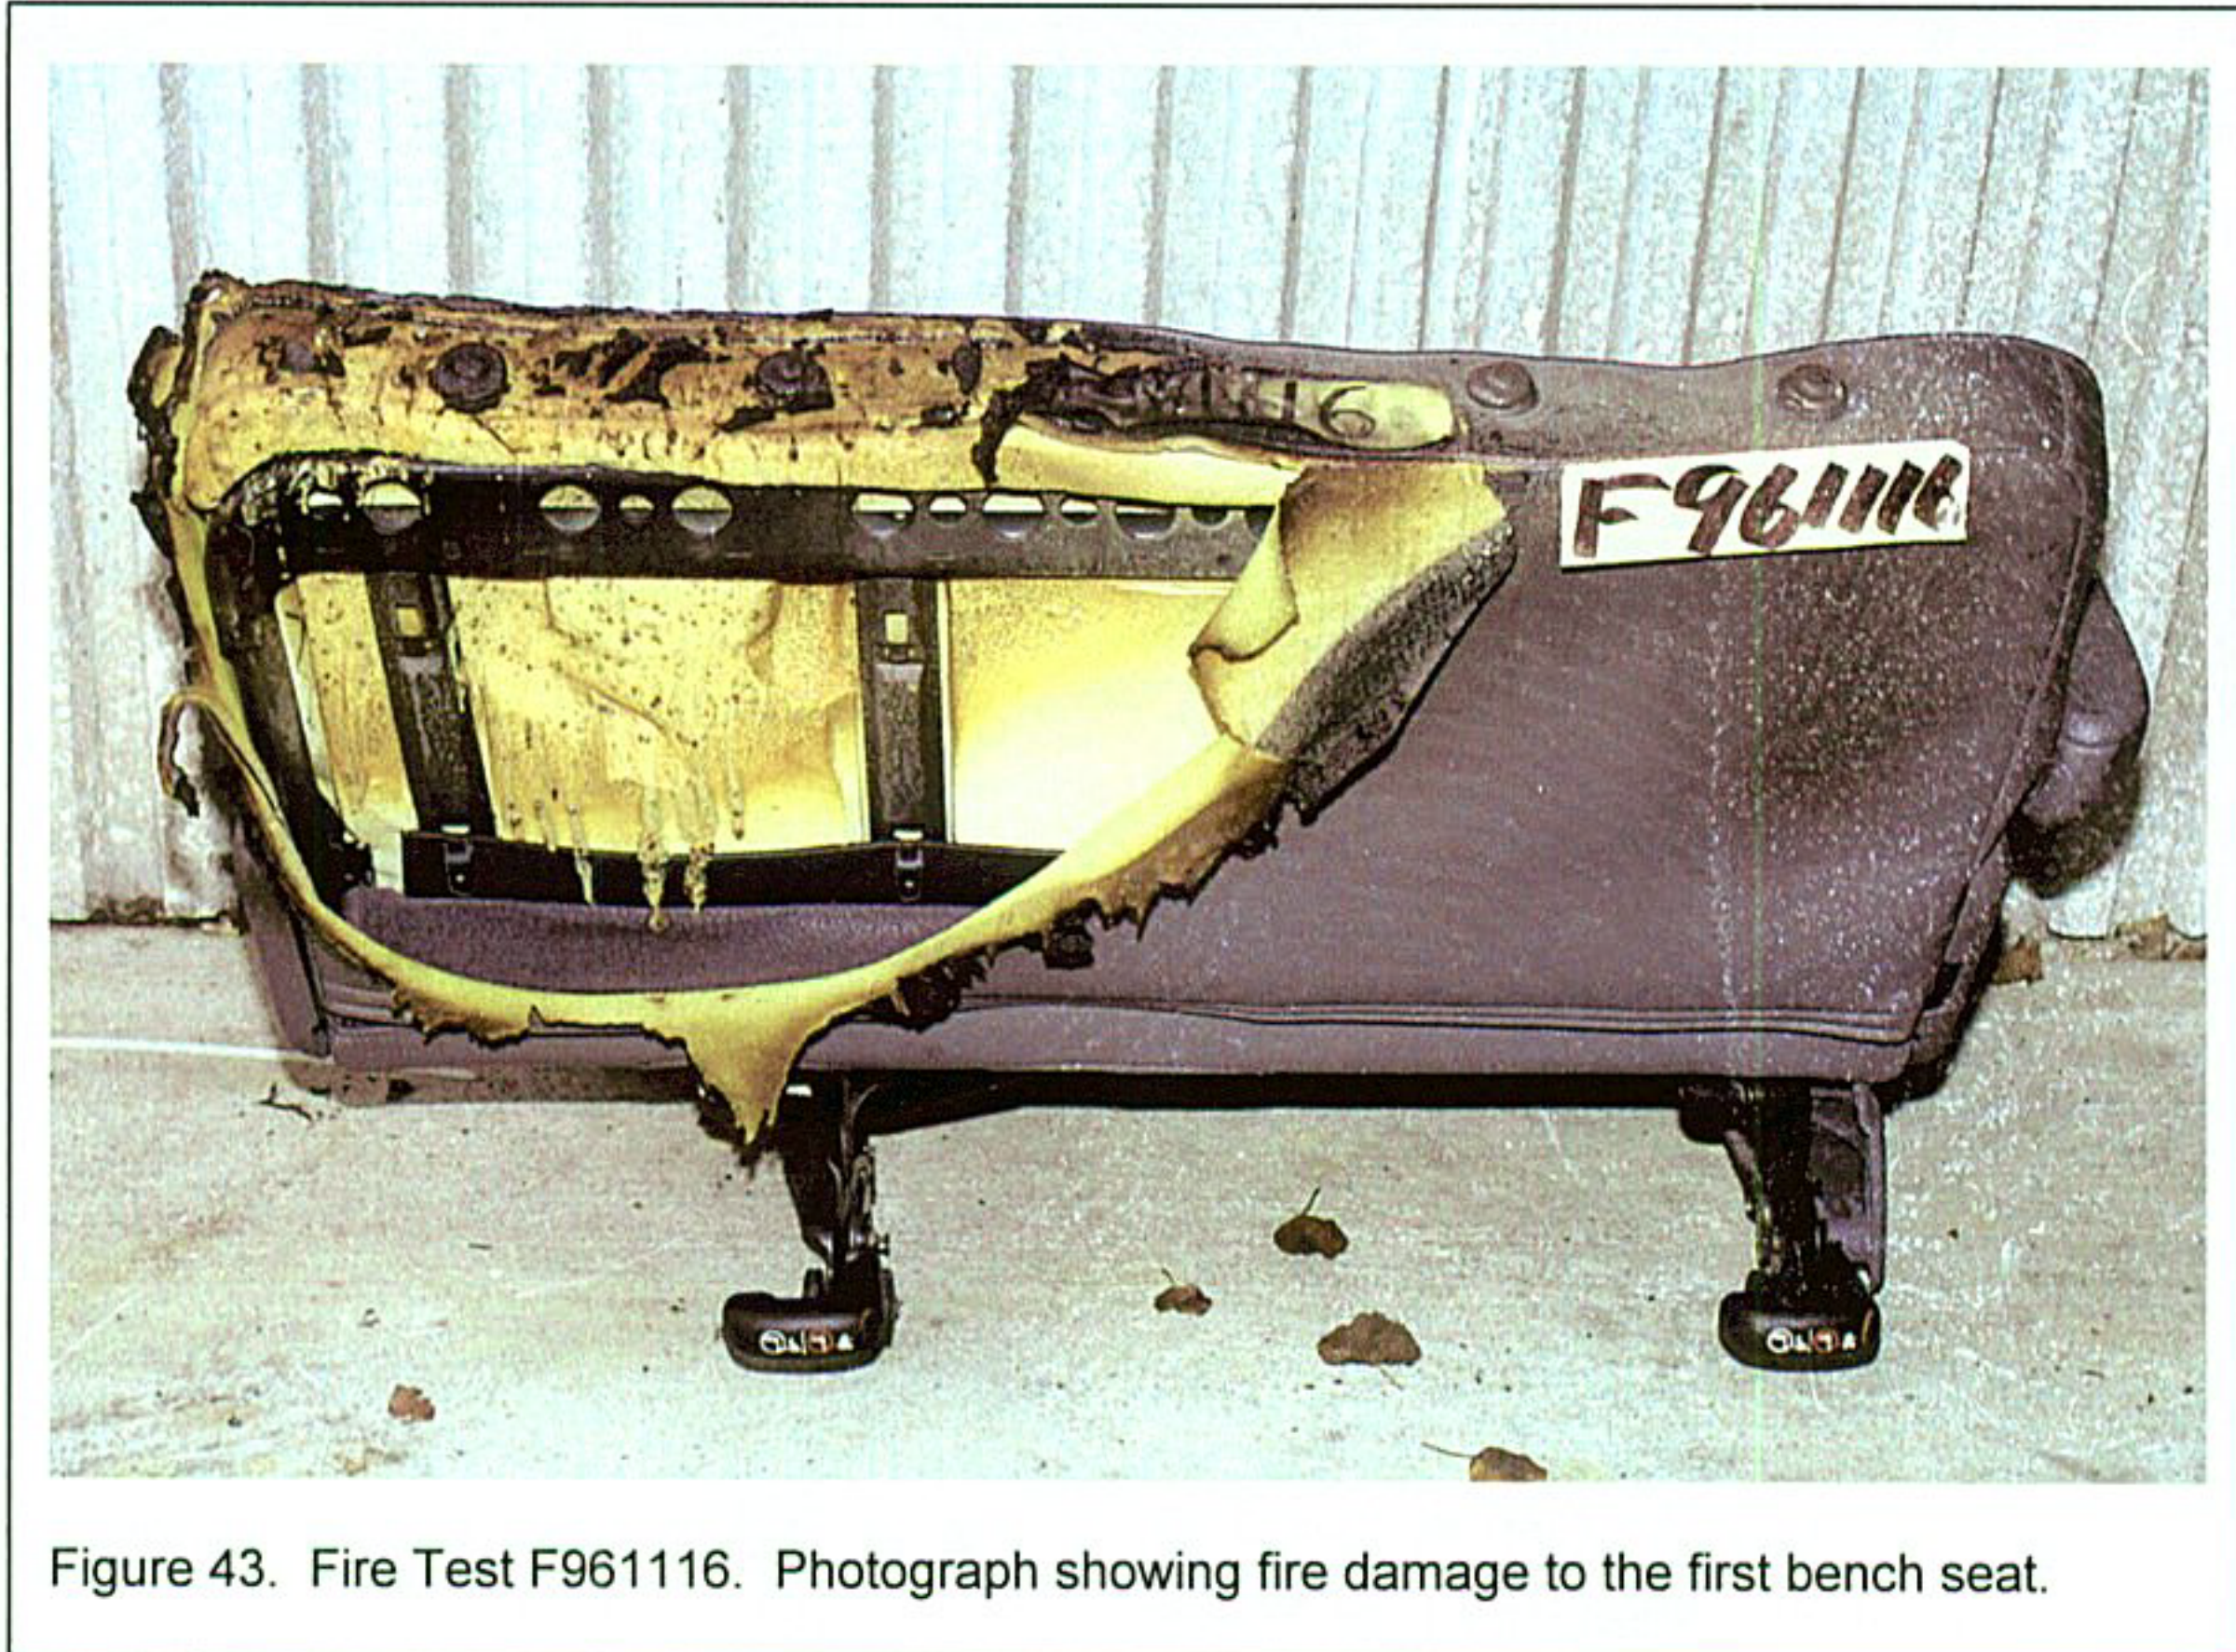
Figure 43. Fire Test F961116. Photograph showing fire damage to the first bench seat.

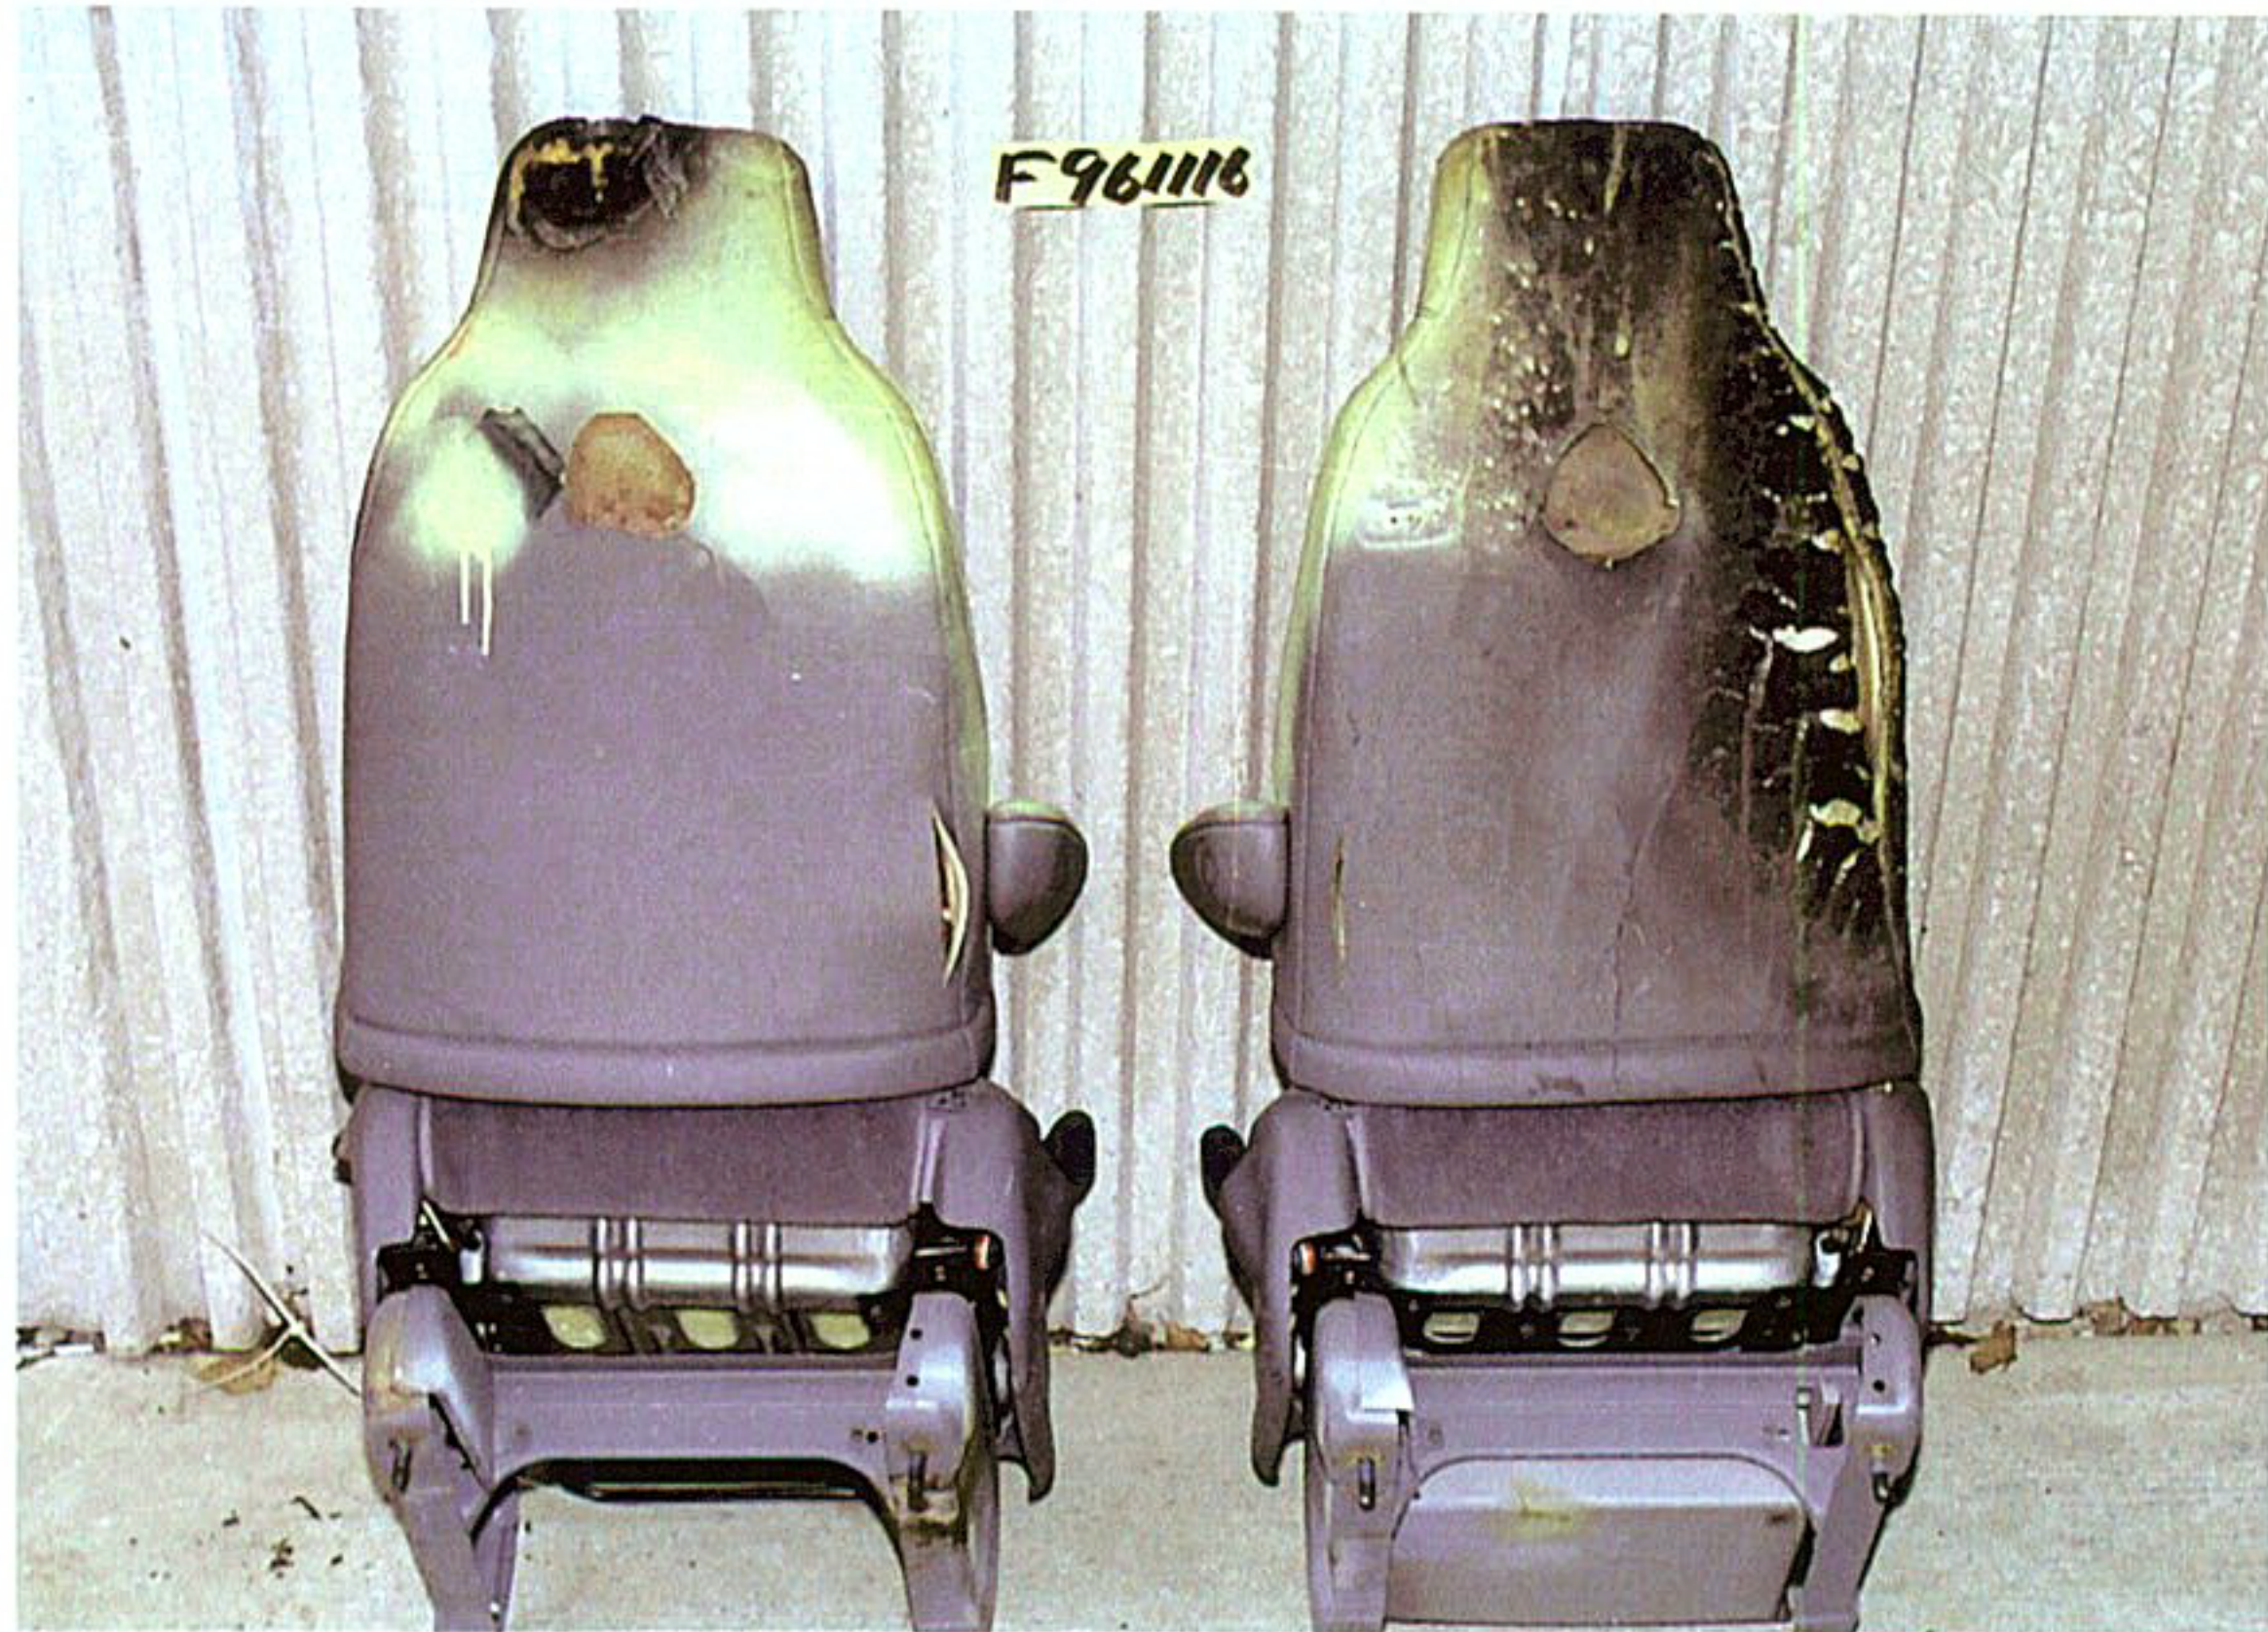
Figure 44. Fire Test F961116. Photograph showing fire damage to the driver's and front passenger's seats. (The yellow paint on the upper sections of the back panels and holes in the back panels were present when the test vehicle was received from Transportation Research Corporation.)

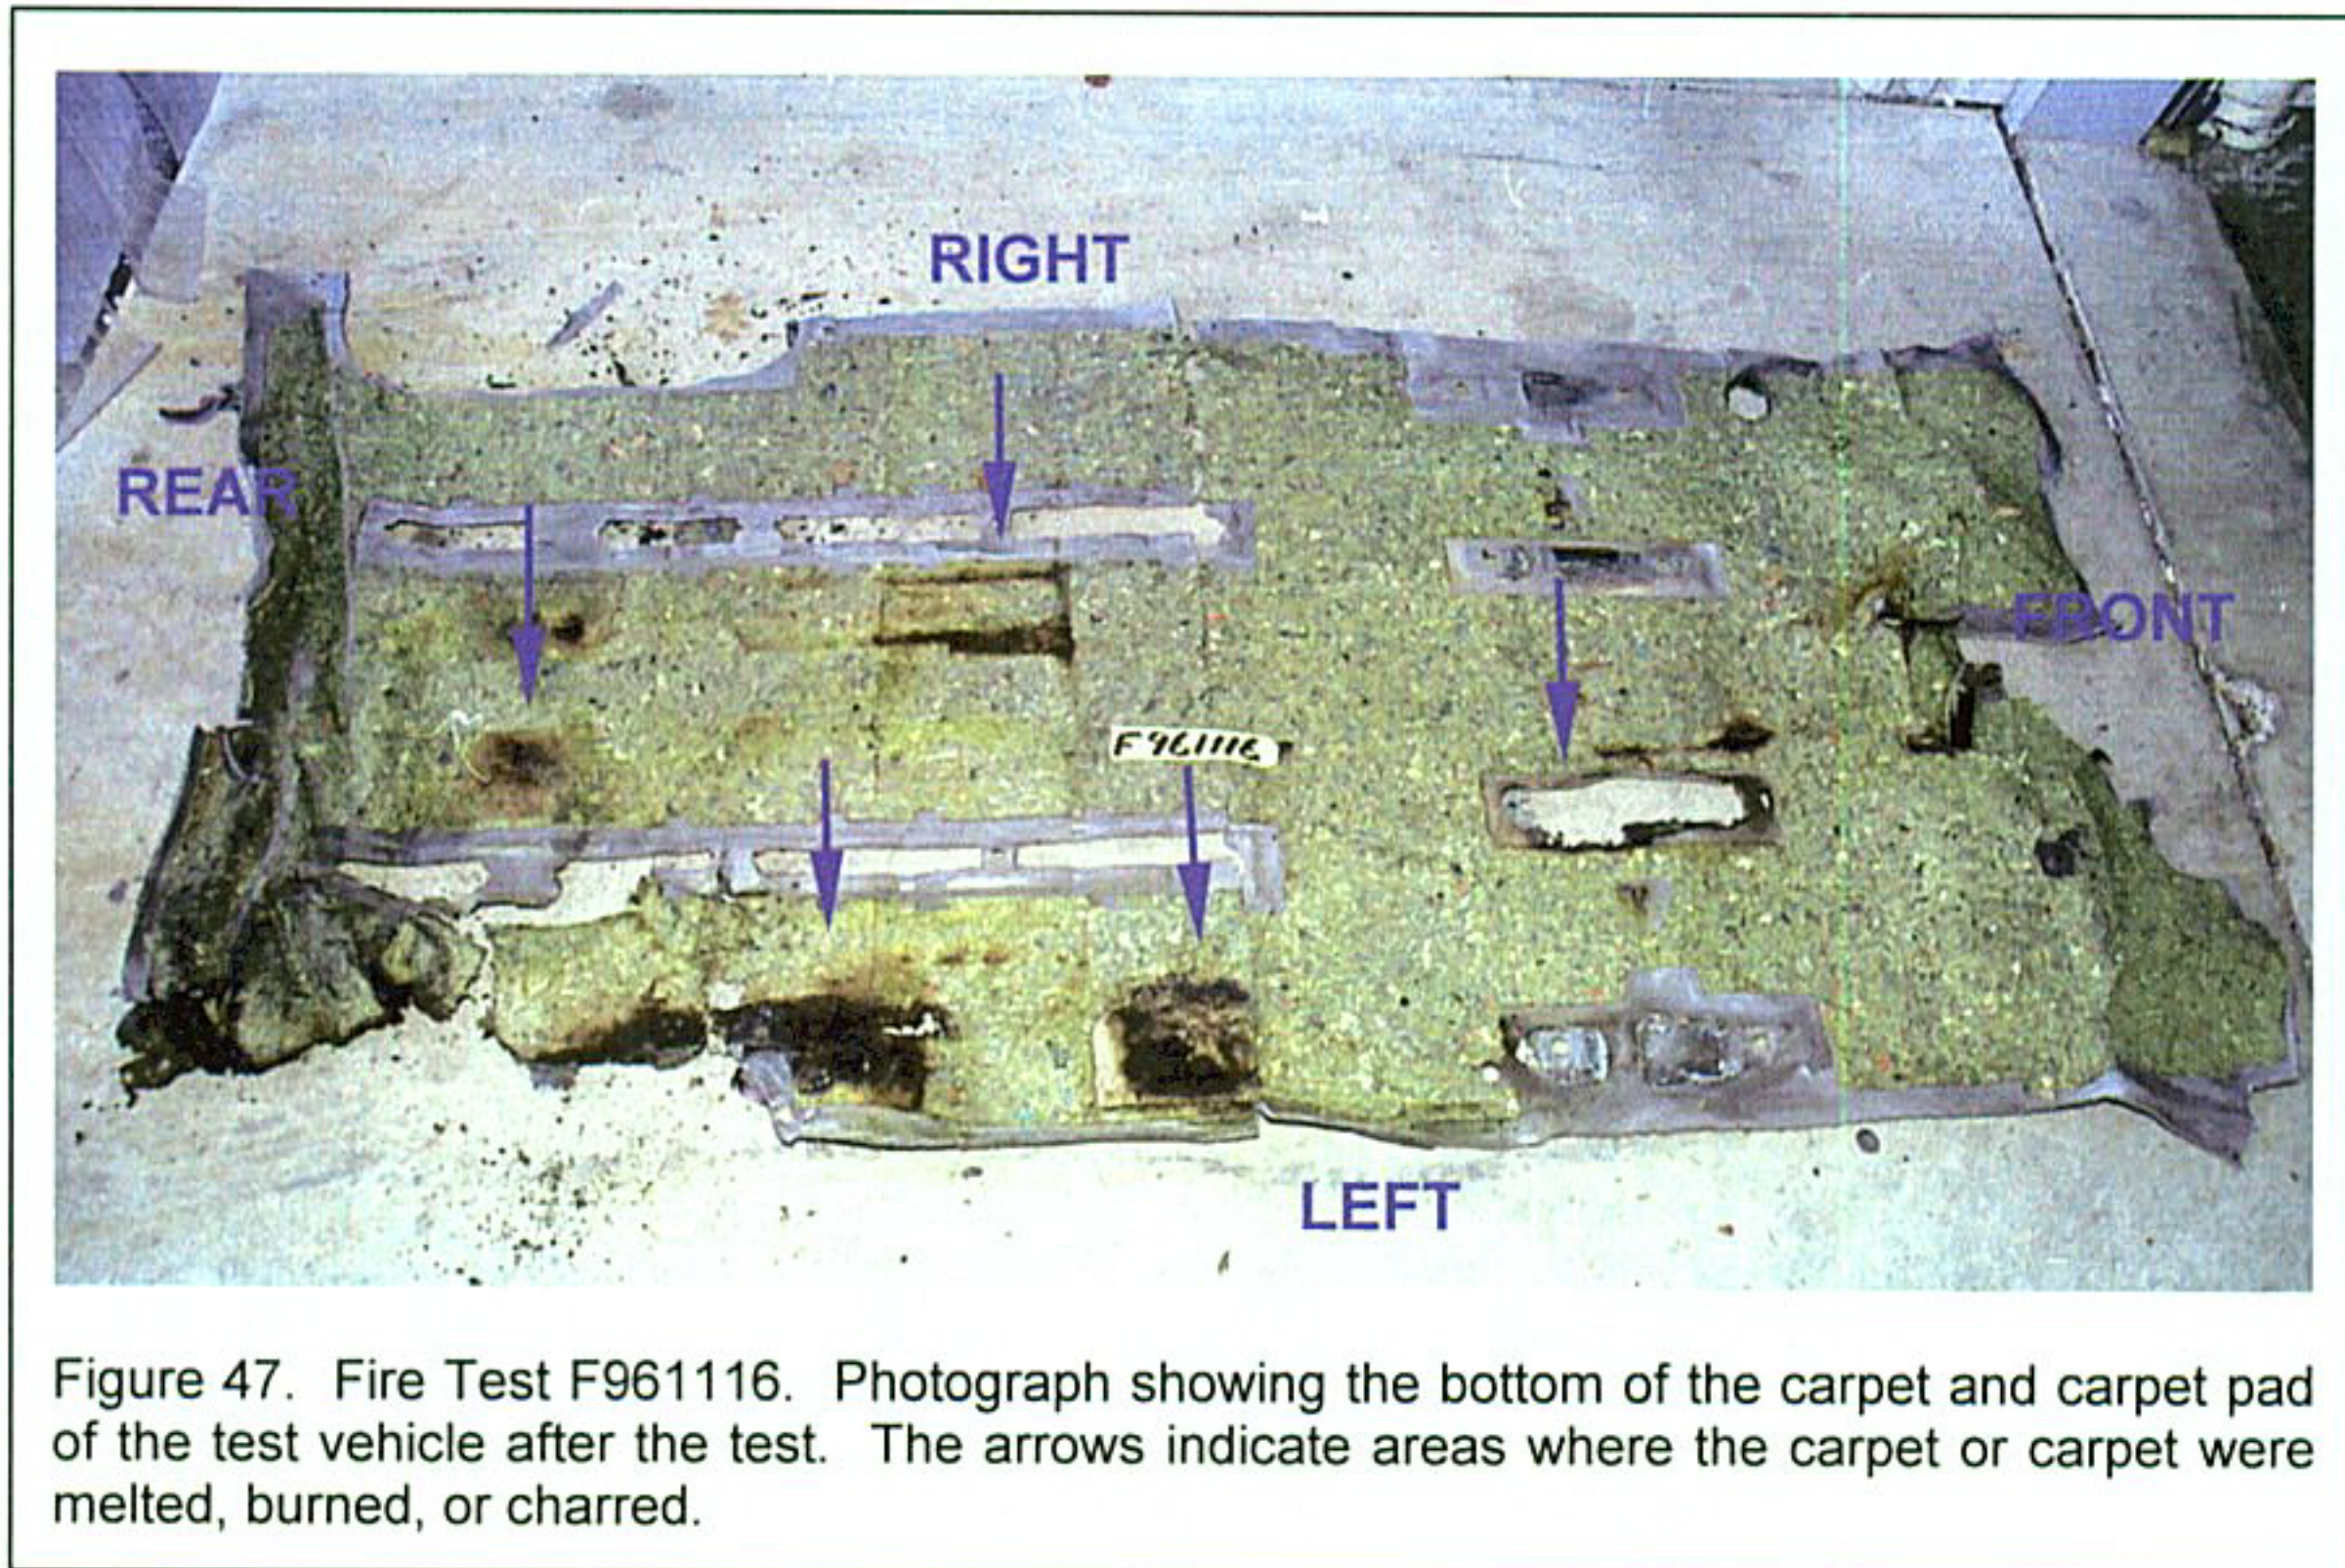
The pattern of fire damage to the lower surface of the carpet pad indicated that, over most of the floor pan, conduction through the floor pan did not result in ignition of the carpet before fire was extinguished (Fig. 47).

Figure 47. Fire Test F961116. Photograph showing the bottom of the carpet and carpet pad of the test vehicle after the test. The arrows indicate areas where the carpet or carpet were melted, burned, or charred.
