Re: **Settlement Agreement**
Section B. Fire Safety Research

On August 31, 2001, GM submitted a final report for Project B.3 (Fire Initiation and Propagation Tests), entitled, "Evaluation of Motor Vehicle Fire Initiation and Propagation/Part 6: Propagation of an Underbody Gasoline Pole Fire in a 1997 Rear Wheel Drive Passenger Car." This letter supplements that report.

This report describes a vehicle fire propagation test conducted pursuant to the GM/DOT Settlement Agreement. This fire test was conducted on September 30, 1997. The test vehicle was a crash-tested 1997 Chevrolet Camaro. In the crash test, the test vehicle was stationary and struck in the rear by a moving barrier. No leaks were detected in the fuel system of the test vehicle during the crash test or the subsequent roll test performed after the crash test. No fire was observed during the crash test, nor was there evidence of fire present in the test vehicle after the crash test. To create a gasoline pool under the test vehicle for the fire test, a gasoline delivery system consisting of a gasoline reservoir, compressed nitrogen reservoir, a pressure regulator, and a flow regulator was used to deliver liquid gasoline u

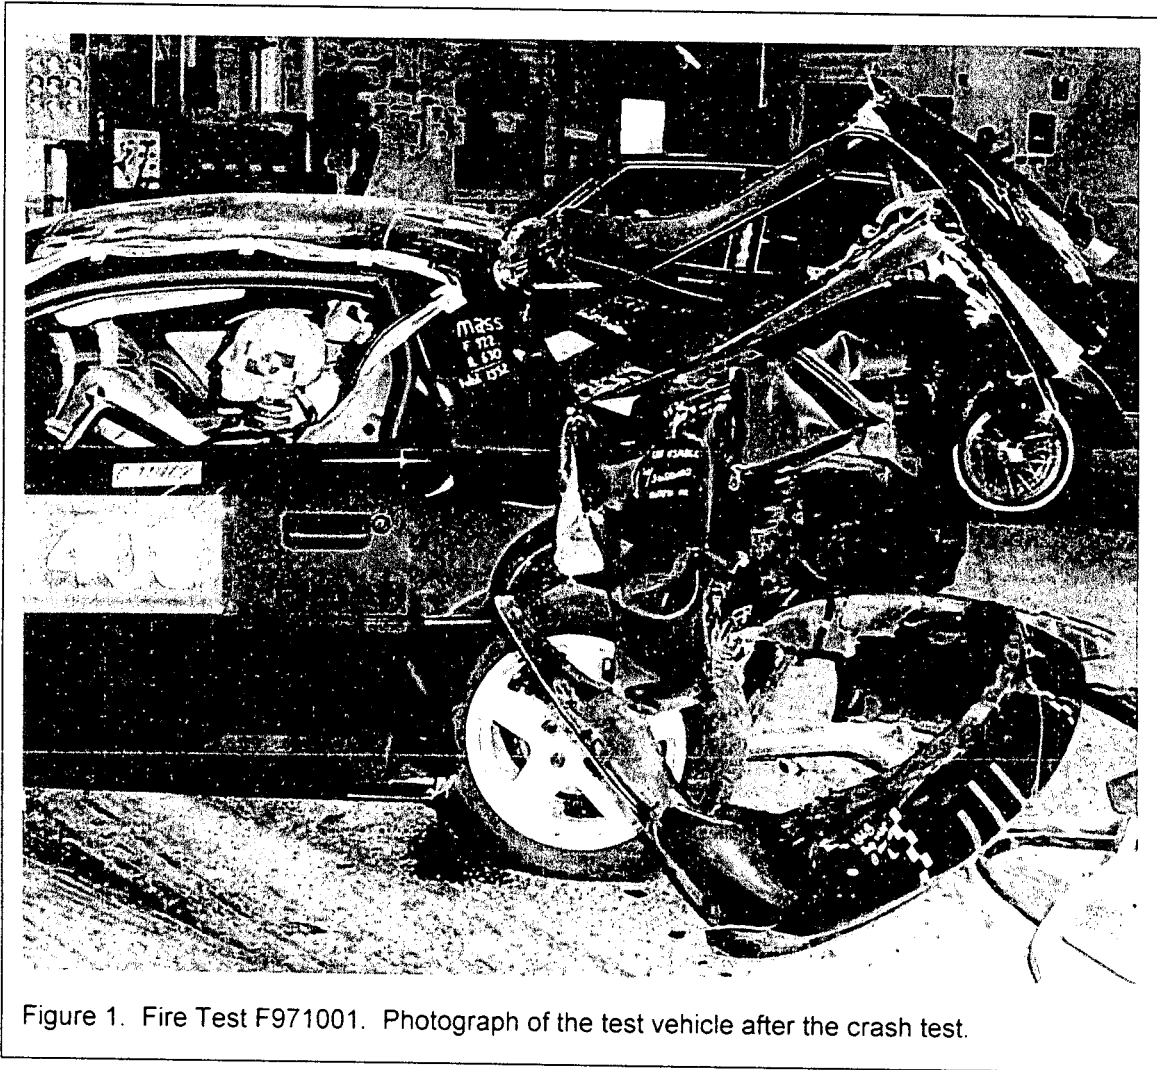
Figure 1 is a photograph of the test vehicle after the crash test. The residual crush to the test vehicle was 1080 mm on the left side of the test vehicle and 610 mm on the right side of the test vehicle. The left side door window shattered during the crash test. The rear compartment lift window panel was broken and the rear compartment lift window was glass shattered. The left quarter interior trim finishing panel was dislodged and pushed forward (Fig. 1). The left door was pushed outward slightly creating a gap between the bottom of the door and the lower section of doorframe (Fig. 1). The carbon absorbant from the evaporative emission canister, which ruptured during the crash test, spilled onto the ground in front of the left rear tire (Fig. 1).

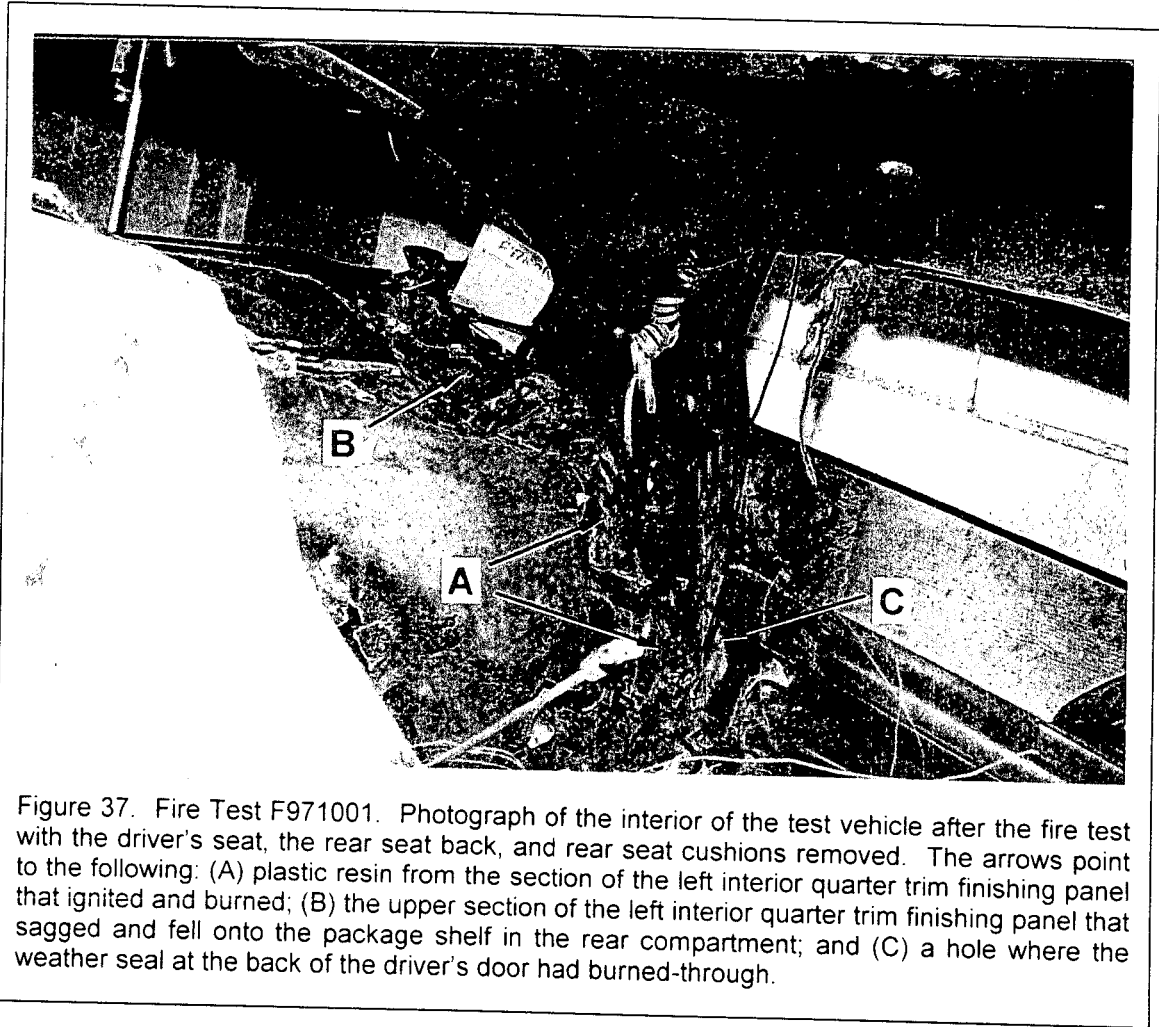
Figure 37. Fire Test F971001. Photograph of the interior of the test vehicle after the fire test with the driver's seat, the rear seat back, and rear seat cushions removed. The arrows point to the following: (A) plastic resin from the section of the left interior quarter trim finishing panel that ignited and burned; (B) the upper section of the left interior quarter trim finishing panel that sagged and fell onto the package shelf in the rear compartment; and (C) a hole where the weather seal at the back of the driver's door had burned-through.

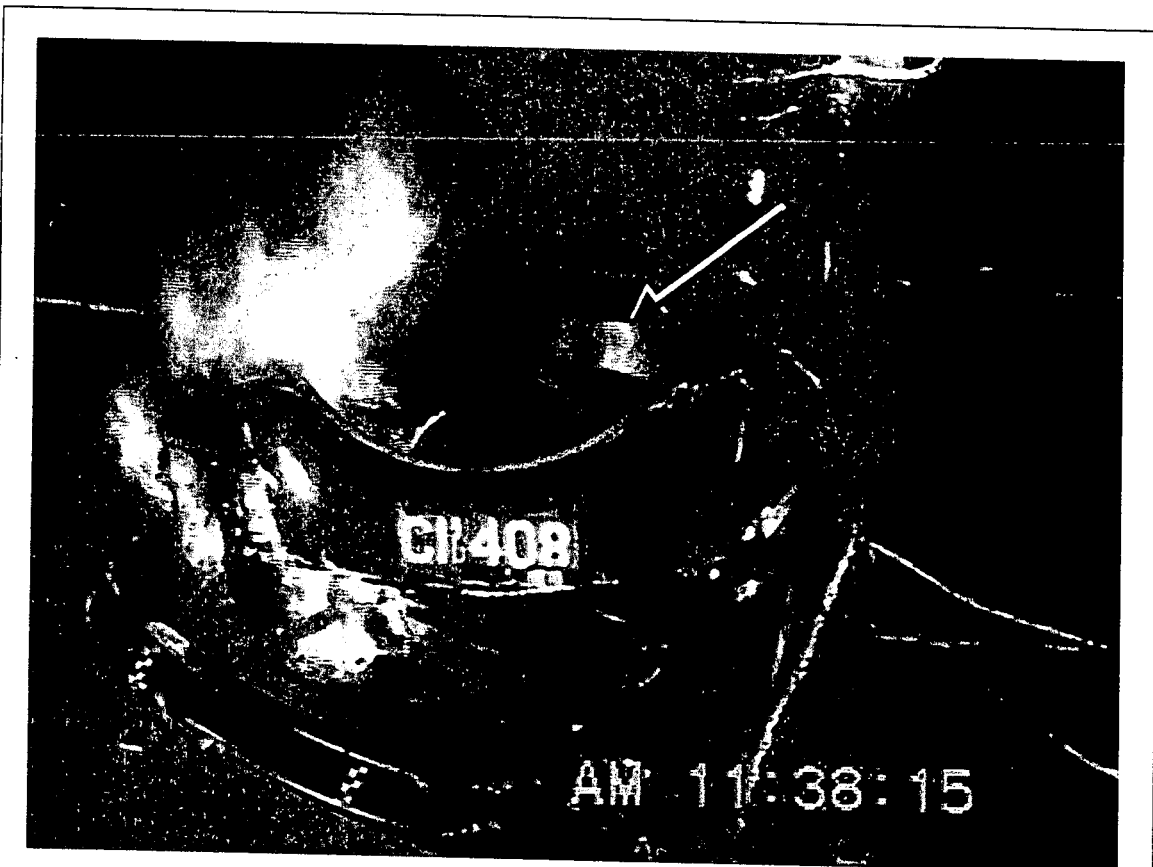
Figure 40. Fire Test F971001. Video Still from Camera 4 at 189 seconds post-ignition. The arrow indicated a fire plume in front of the middle section of the rear seat back.

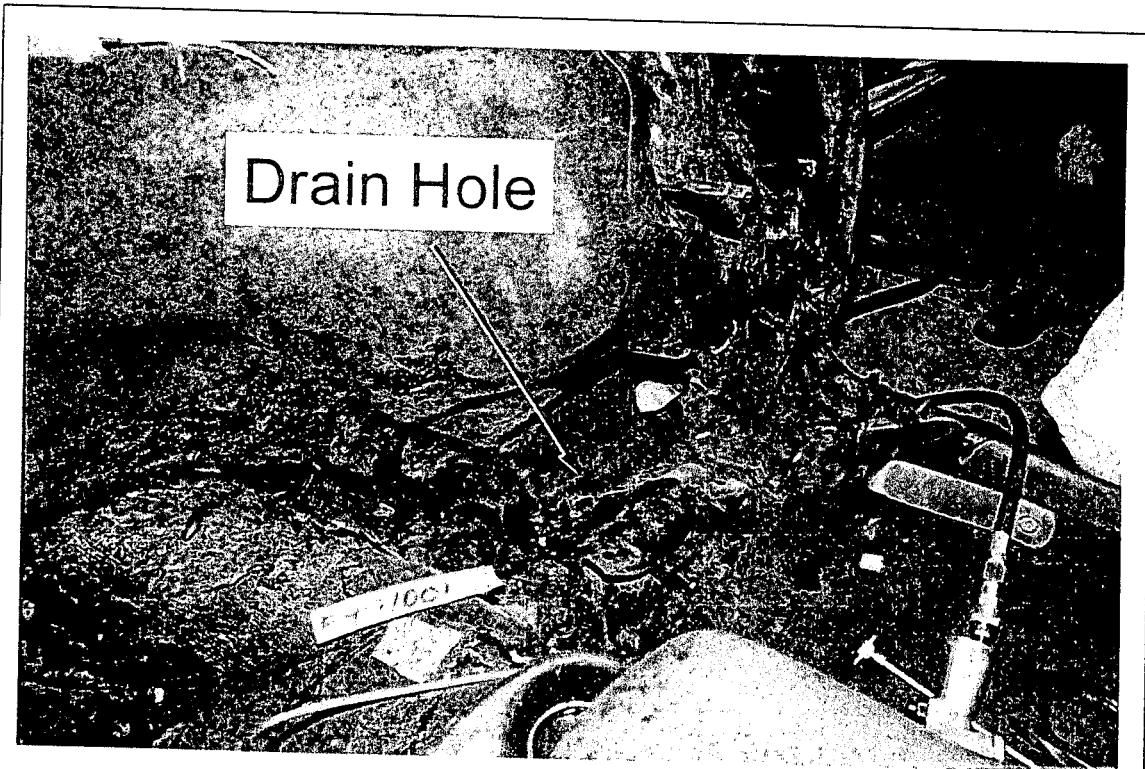
Figure 43. Fire Test F971001. Photographs of the carpet with the rear seat back and cushions removed (upper) and the floor pan with the carpet removed (lower) in the rear left corner of the test vehicle after this fire test. The arrows in the lower photograph indicated the probable directions of flame-spread under the carpet indicated by the pattern of char and soot deposits on the interior surfaces of the floor pan panels.

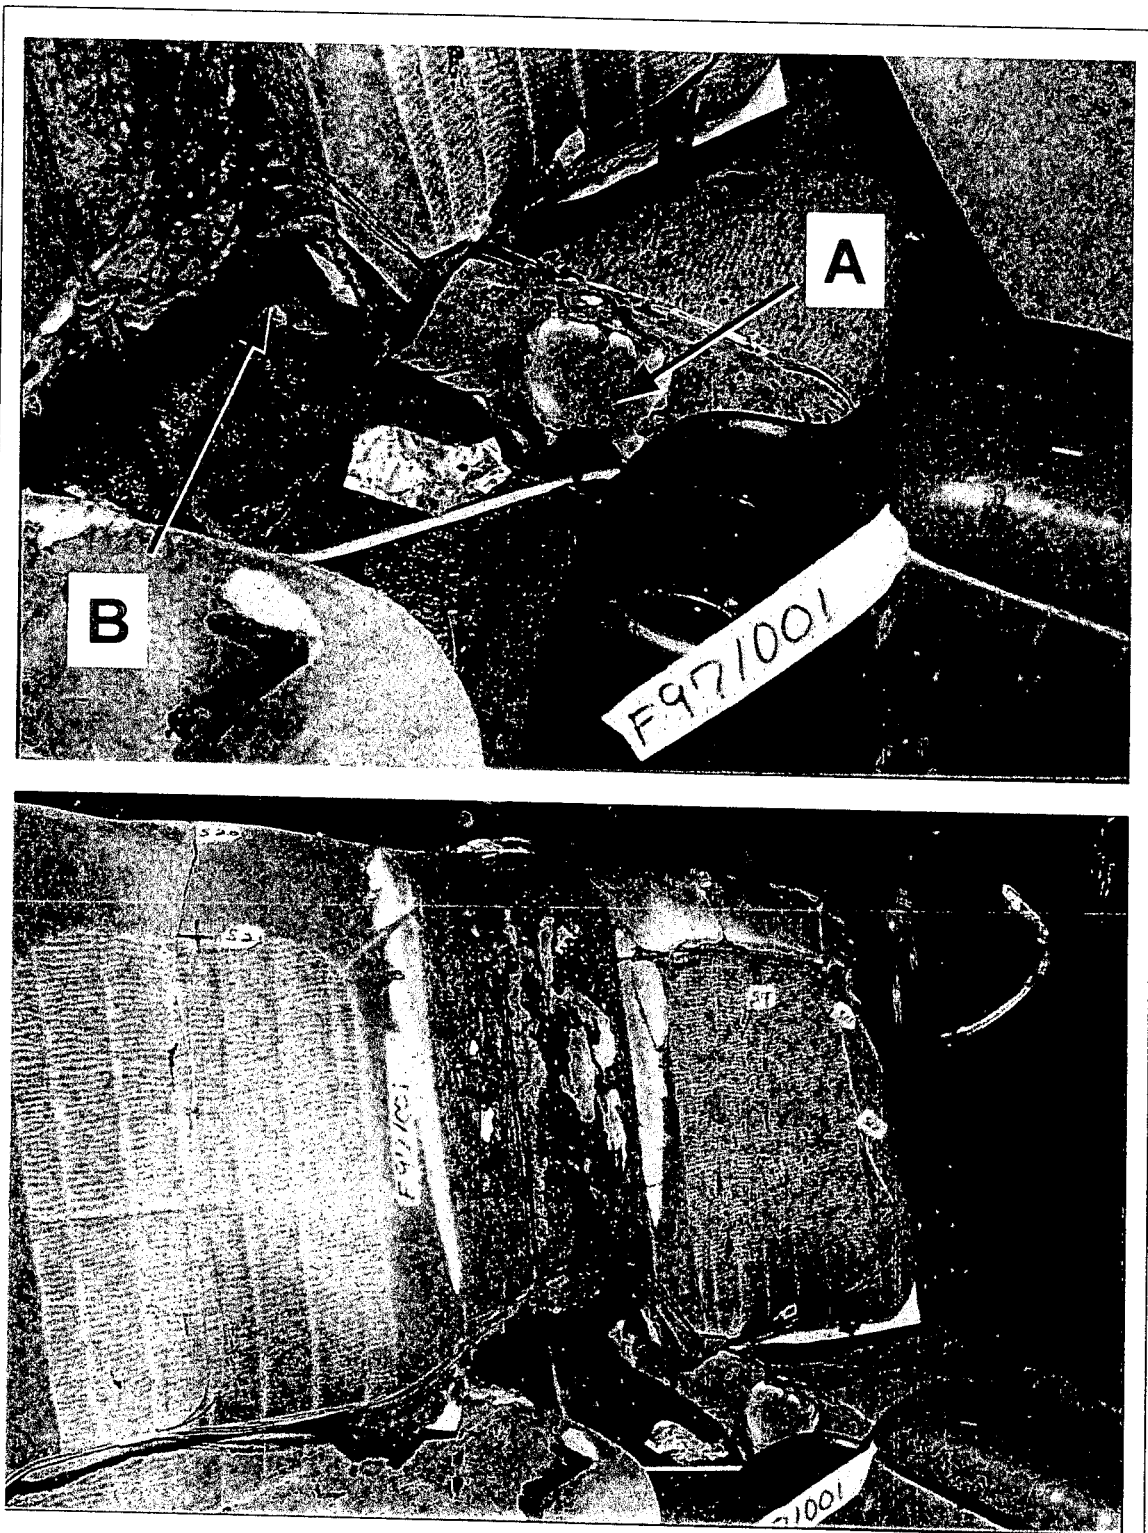
Figure 44. Fire Test F971001. Photographs of the carpet (upper) and floor pan (lower) in the rear left corner of the test vehicle after this fire test. The arrows in the upper photograph indicated areas where the seat cushion (Arrow A) and the seat back (Arrow B) appear to have been exposed to flames.
