Re: **Settlement Agreement**
Section B. Fire Safety Research

This final report relates to Project B.3 (Fire Initiation and Propagation Tests).

Evaluation of Motor Vehicle Fire Initiation and Propagation
Part 11: Crash Tests on a Front-Wheel Drive Passenger Vehicle

Jack L. Jensen, Jeffrey Santrock
General Motors Corporation

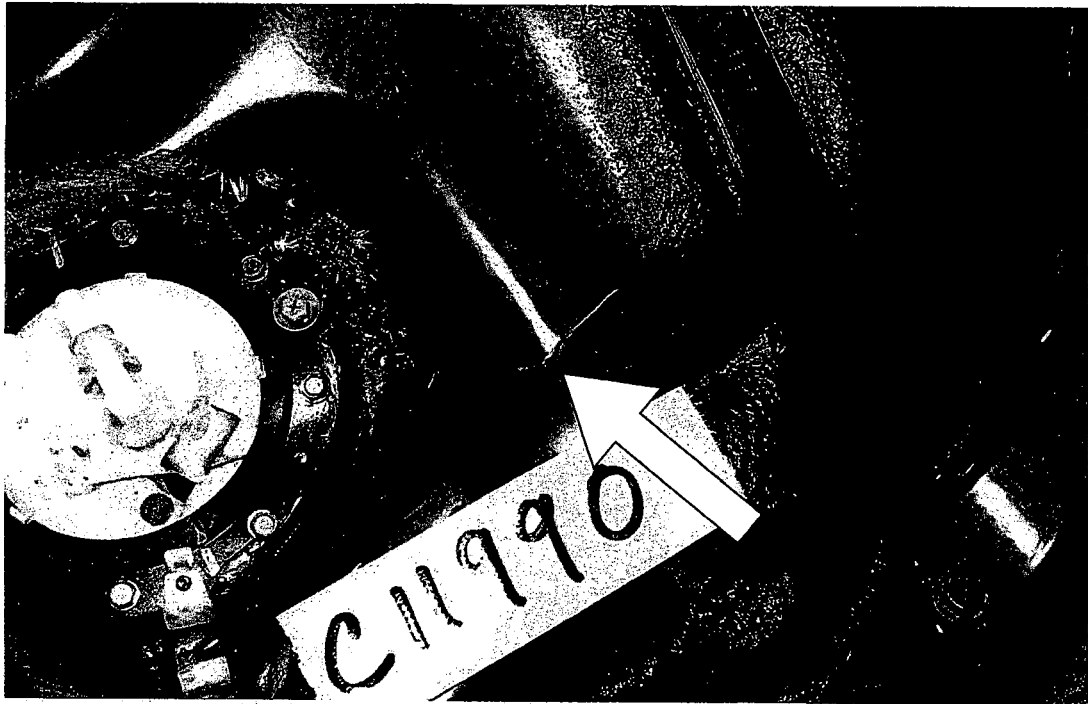
During the post-test vehicle inspection, several possible sources of the Stoddard leak were identified. There was a small rip in the top surface of the fuel tank to the right of and just slightly rear of the fuel pump assembly. The rip was less than 15 mm long and less than 3 mm wide. A photograph of the rip is shown in Figure 10. The rip appeared to be caused by the fuel tank material buckling over on itself while the fuel tank was crushed during the impact. In addition to the rip in the fuel tank wall material, the nylon top of the fuel pump assembly was cracked and broken pieces were missing during the inspection. The missing pieces resulted in an opening approximately 50 square mm. The rip in the upper surface of the tank, however, was lower than the opening in the nylon cap of the fuel pump assembly, so it was likely the primary source of the Stoddard leak. Although the leak rate through the rip was not measured at the crash test site, it was later measured during laboratory experiments on the fuel tank. The measured leak rate of Stoddard Solvent was approximately 400 cc/min for the first minute and 200 cc/min for the fifth minute.

Figure 10
Post-Test Photograph of Rip in Top Surface of Fuel Tank
Test C11990

3. Stoddard Solvent leaked out of the fuel tank immediately after the impact. The leak rate was not measured at the crash test site. The source of the leak was later identified as a rip in the upper surface of the fuel tank. The leak rate was later measured in laboratory experiments on the tank after it was removed from the vehicle. The measured leak rate was approximately 400 cc/min during the first minute and slowed to 200 cc/min by 5 minutes.

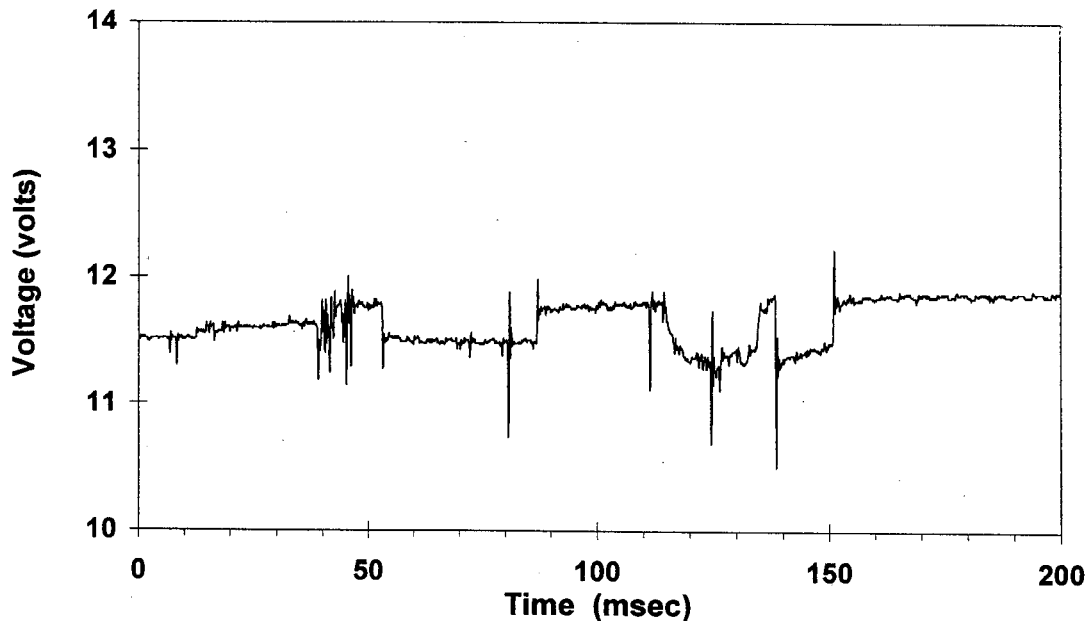
The battery voltage, ignition voltage, rear taillight voltage, and rear window defroster voltage are shown in Appendix B, plots 43,37,41, and 39 respectively. The results of these four measurements are very similar. As an example, the ignition voltage is recreated here as Figure 11. This signal can be considered a good indication of the status of the overall vehicle electrical voltage available during the crash. That is, the overall voltage was maintained during and after the impact however, there were small discrete drops in available voltage from 53 msec to 86 msec, from 110 msec to 135 msec, and again from 138 msec to 151 msec. These small drops in available current were likely caused by circuits intermittently shorting to ground during the impact, putting additional load on the battery for discrete periods of time.

Figure 11
Ignition Voltage
Test C11990

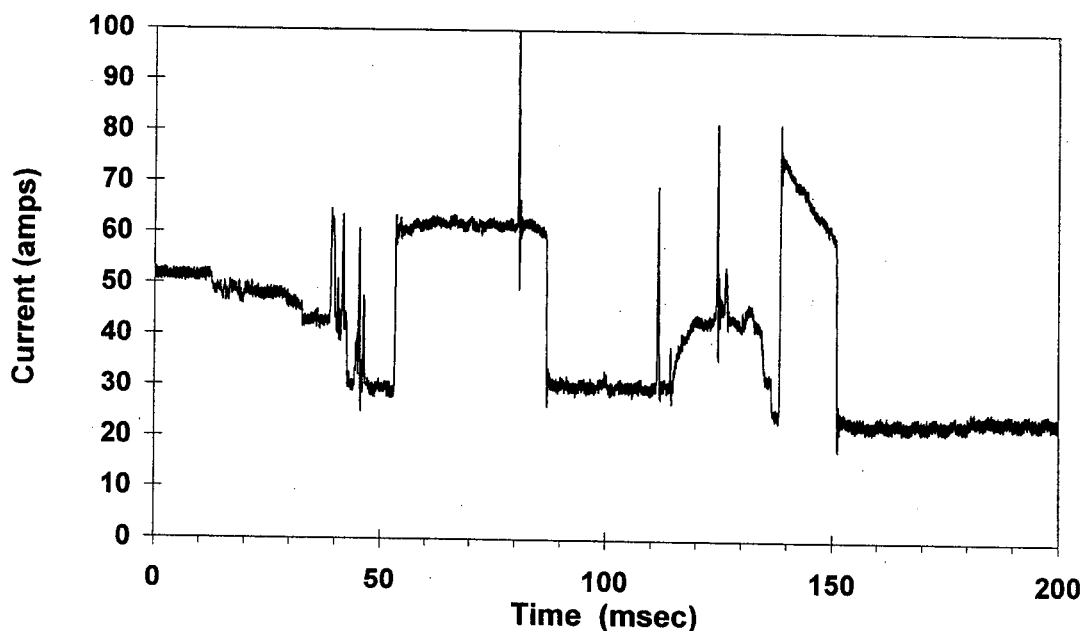
This is supported by the battery current (Figure 12 and Plot 51) which indicates an increase in overall current leaving the battery from about 53 msec to 86 msec, again from 110 msec to 135 msec, and again from 138 msec to 151 msec. The specific circuits shorted during the test were not identified and were likely not one of the circuits monitored during the test. However the ignition current (Appendix B, Plot 52 indicates an increase in current from 110 msec to 135 msec, indicating that one of the three shorts was on a circuit controlled through the ignition.

Figure 12
Battery Current
Test C11990

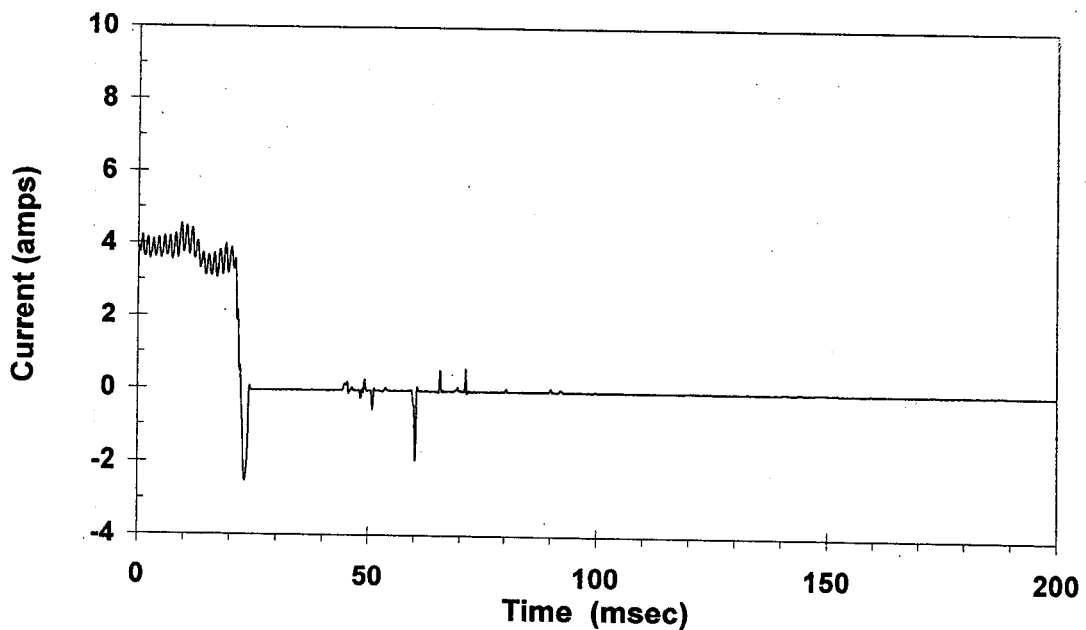
Figure 24 and plot 95 in Appendix D show the fuel pump current draw during the impact. The fuel pump was drawing about 4 amps while it was operating at impact. The current dropped to zero at about 20 msec after impact indicating the pump was off. This is consistent with the other frontal tests of this series in that, the fuel pumps have lost electrical power early (before 100 msec) in every test conducted. The fuel pump was likely stopped due to the drop in main vehicle voltage.

Figure 24
Fuel Pump Current
Test C12127

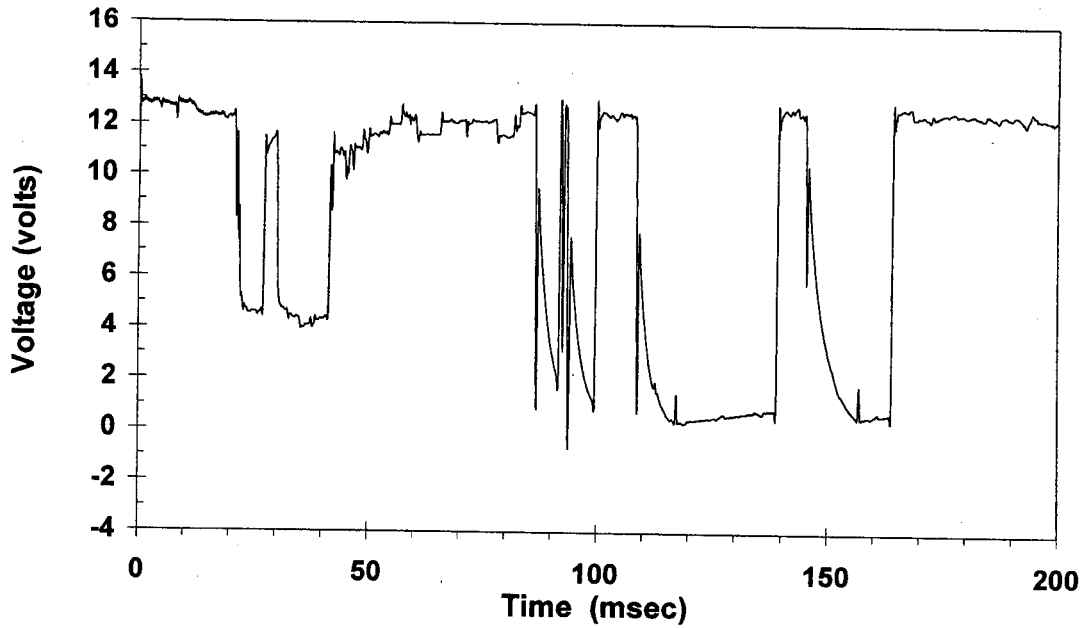
The ignition feed voltage, battery voltage and starter voltage all indicated intermittent drops from the nominal 13 volts throughout the impact. These voltages are shown in Figure 25 (plot 79), plot 80 and plot 81 respectively. The first drop in system voltage however, occurred at 20 msec coinciding with the loss in current to the fuel pump. Consistent with other frontal tests in this series, the fuel pump shut down at the first drop, albeit partial drop, in system voltage. The fuel pump voltage decayed from 12 volts to near zero from about 20 msec to 200 msec as shown in Figure 26 and Plot 83 (Appendix D), due to the loss of supplied voltage at 20 msec. Bench-tests on fuel pumps for other vehicles in this project [2] also indicated a gradual decay in voltage (lasting 40-150 msec) when current flow was stopped to the motor. This is likely

Figure 25
Ignition Voltage
Test C12127

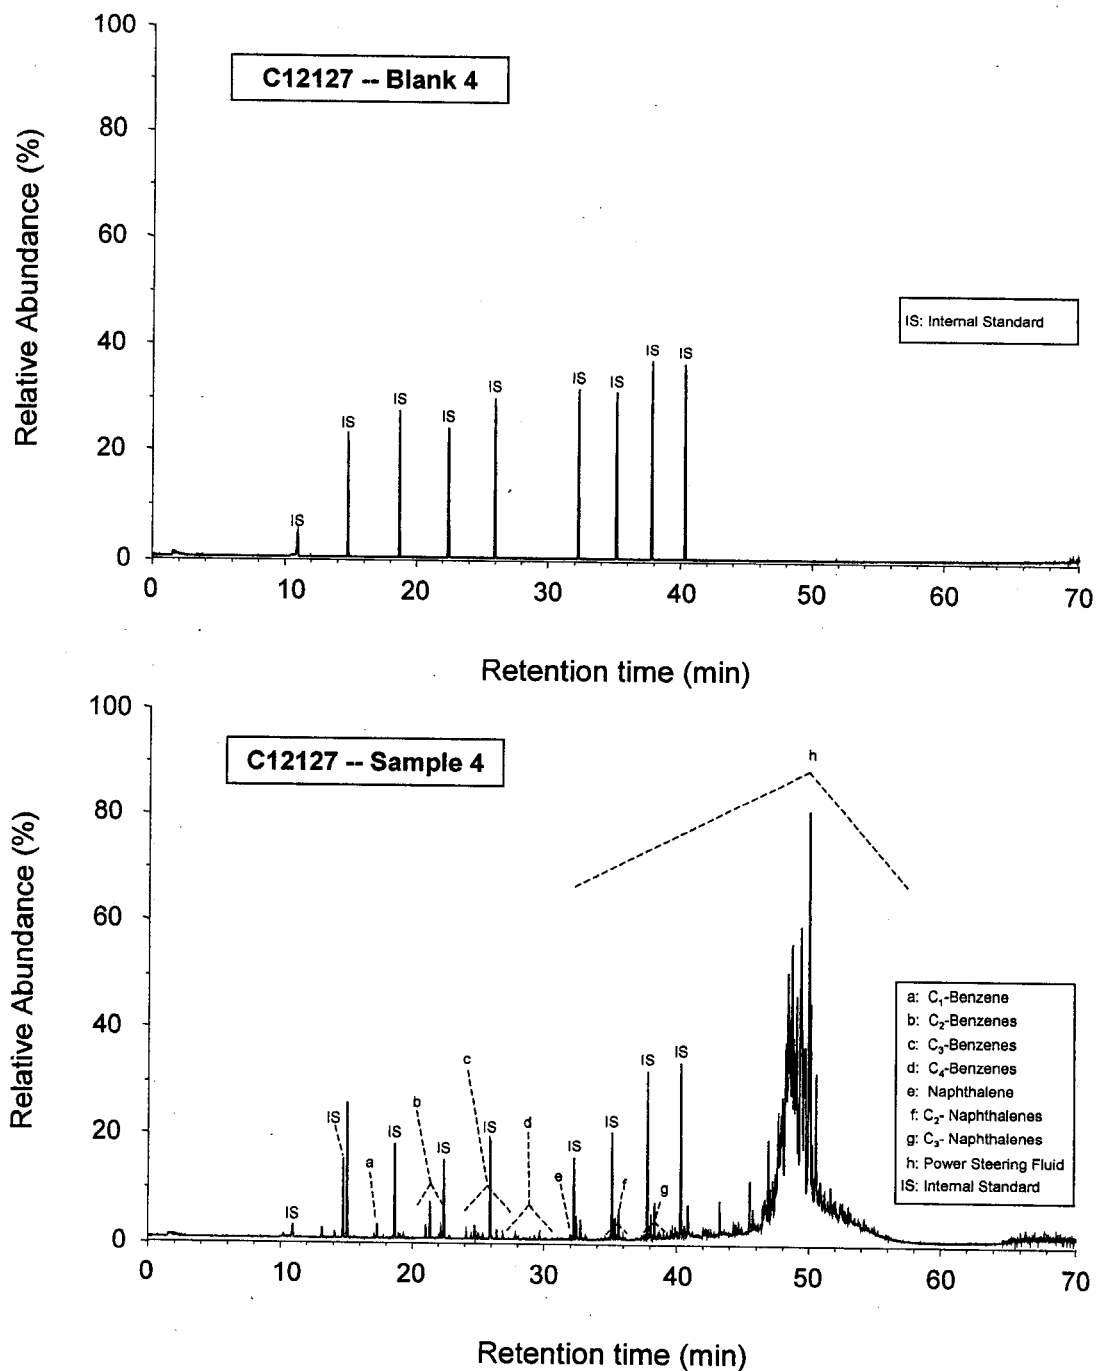
The GC/MS analysis was completed on the vapors collected from all 5 locations [1], and the results are shown in Appendix E Figures EE1 through EE5. Samples from locations 1 through 5 contained trace amounts of aromatic hydrocarbons (substituted benzenes and substituted naphthalenes) that can be produced during combustion of petroleum products as shown in Figures EE1 through EE5. Samples from locations 3 and 4 (above left and below right manifold shield) also contained relatively large amounts of mixtures of aliphatic hydrocarbons in the range of C12 to C26. These chromatograms are shown in Figures EE3 and EE4 in Appendix E. Figure EE4 is recreated here as Figure 28.

Figure 28
 GC/MS analysis of hydrocarbon vapor sample from near the right manifold shield (location #4) during Crash Test C12127. The top panel is the chromatogram of background sample and the bottom panel is the chromatogram of the post-crash sample.

None of the vapor samples collected from the engine compartment of the test vehicle during this test contained gasoline, brake fluid, or engine coolant. The test vehicle did not leak motor oil and only a very small amount of transmission fluid during this test as described in Section 3.2.12. Thus, neither motor oil or transmission fluid was tested in these laboratory tests.

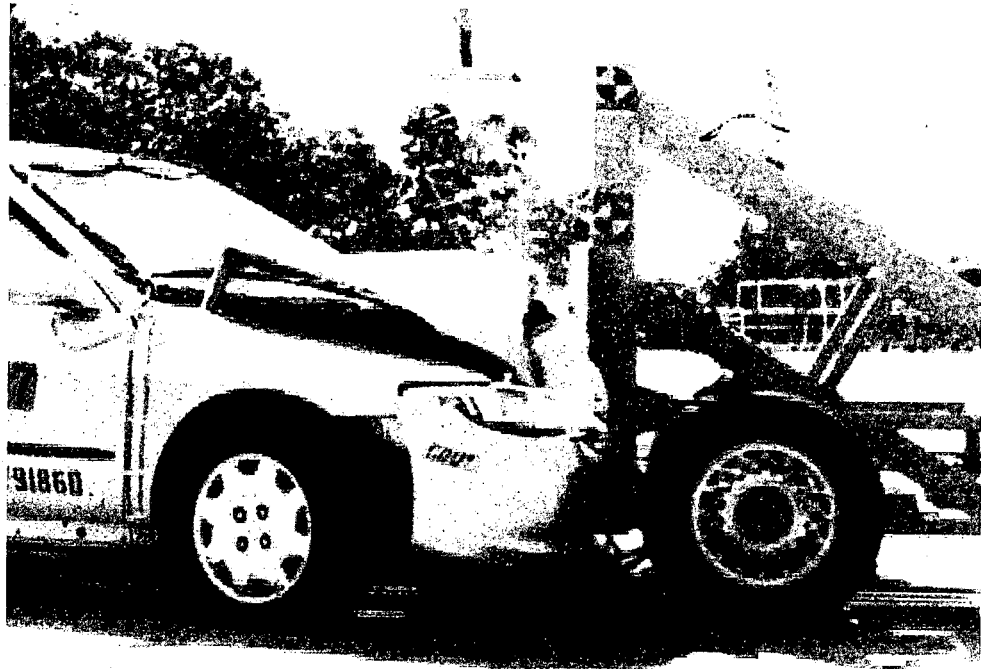
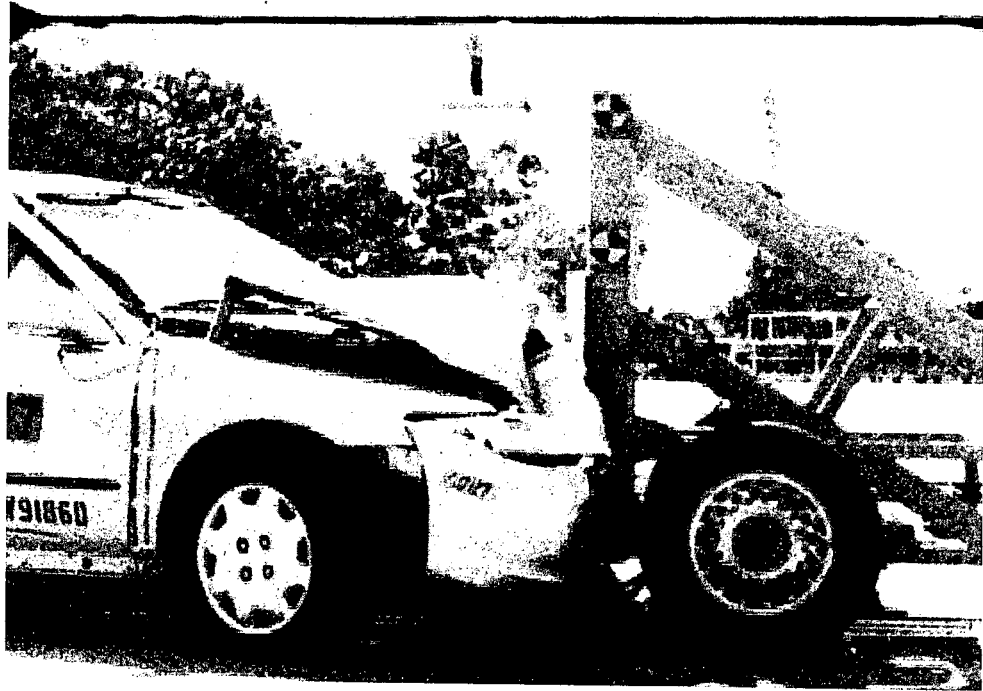
There were two separate but related fires observed during and after the impact in the engine compartment. First, a flame flash was observed above the engine during the impact in the high-speed films. The flash was first observed at about 42 msec after time zero and lasted at least 400 msec. (See Figure 30.) In addition, visible flames were observed in and around the washer solvent reservoir bottle approximately 5 minutes after impact. The fire at the washer solvent bottle was allowed to burn for an additional 5 minutes before it was extinguished.

Figure 30
Consecutive frames from the high-speed film recorded during this test showing the front of the test vehicle at 42 and 44 milliseconds, Test C12127.

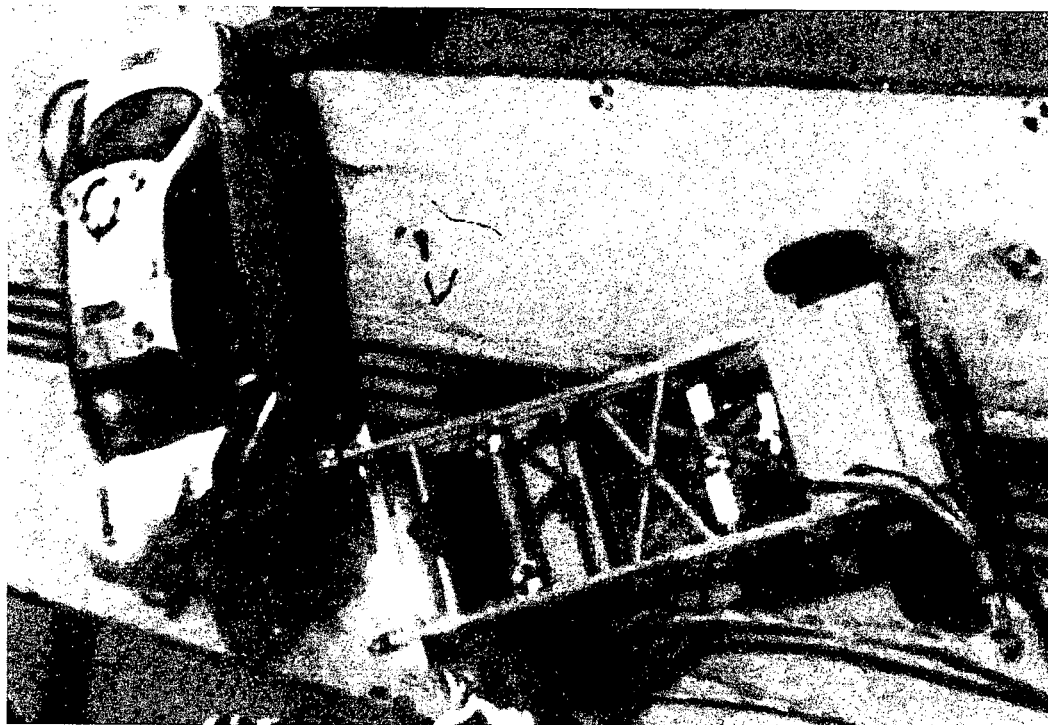
Analysis of the high-speed film from this crash test showed that the burning power steering fluid aerosol moved towards the front of the test vehicle as it translated rearward and rotated away from the barrier (Figure 37). Laboratory tests were conducted to determine (1) if methanol vapor above windshield washer fluid at a temperature greater than its flash point and contained in an exemplar windshield washer fluid reservoir would ignite when exposed to a burning aerosol of power steering fluid, and (2) if flames would spread to the exemplar windshield washer fluid reservoir.

Figure 37
Frame from high-speed film recorded during this test showing the test vehicle and barrier at 464 milliseconds, Test C12127

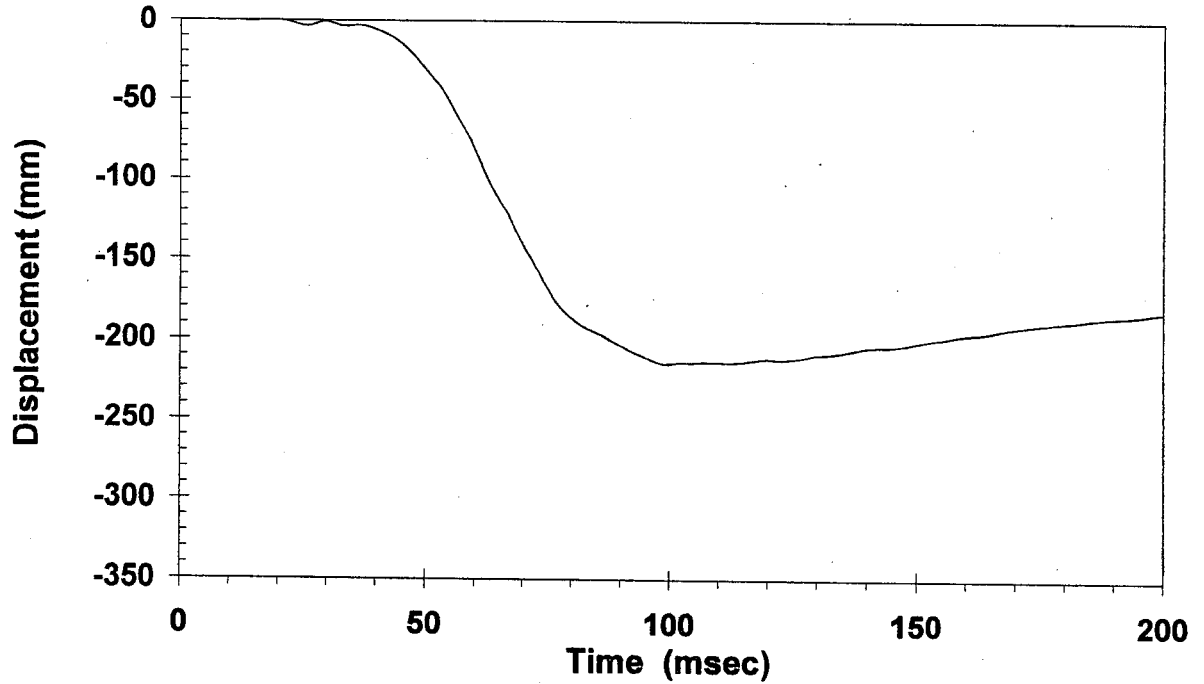
The displacement of the right toe pan, relative to the passenger compartment, was approximately 215 mm and is shown in Figure 45 and also Plot 80, Appendix F.

Figure 45
 Right Toe pan Displacement, Relative to Floorpan
 Test C12174, filtered at SAE class 60 [10]

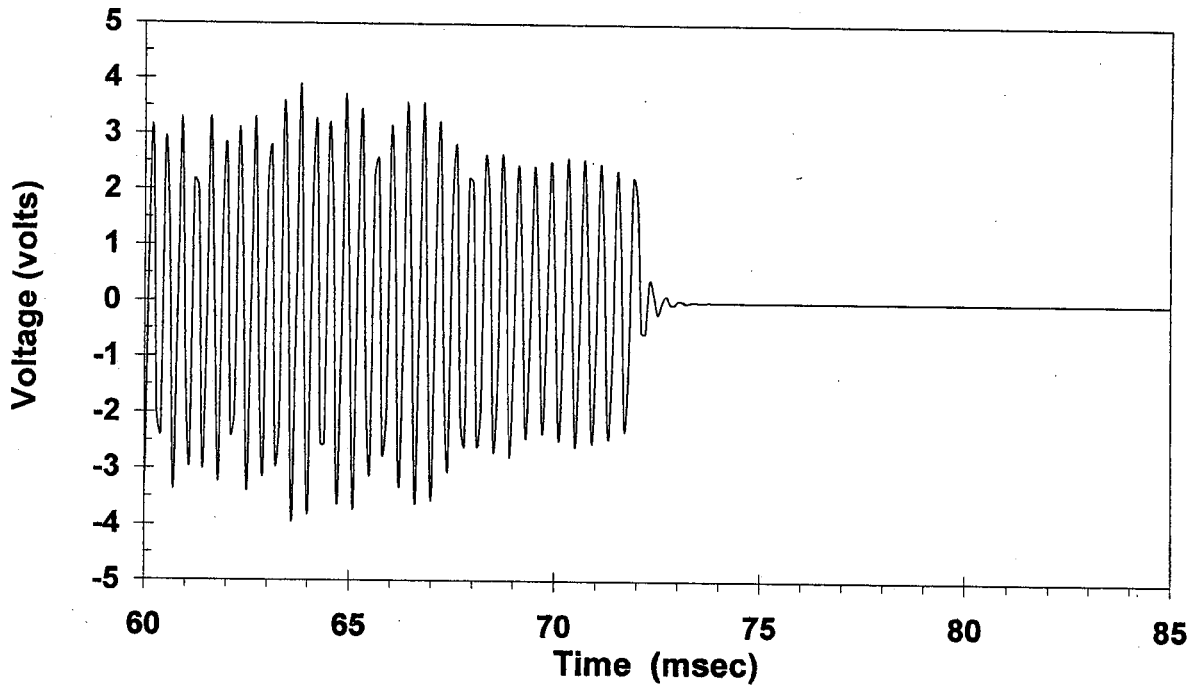
The engine motion stopped at 72 msec after time zero as shown in Figure 46 and Plot 88 in Appendix F. This transducer was mounted such that it outputs a voltage peak each time a flywheel tooth passes by. Thus, the cyclic voltage waveform indicates engine motion and the lack of the cyclic signal indicates engine stoppage. (Note the time scale in Figure 46 has been expanded to show greater time resolution.)

Figure 46
 Engine Motion
 Measured using Auxiliary Magnetic Pickup Transducer, Test C12174

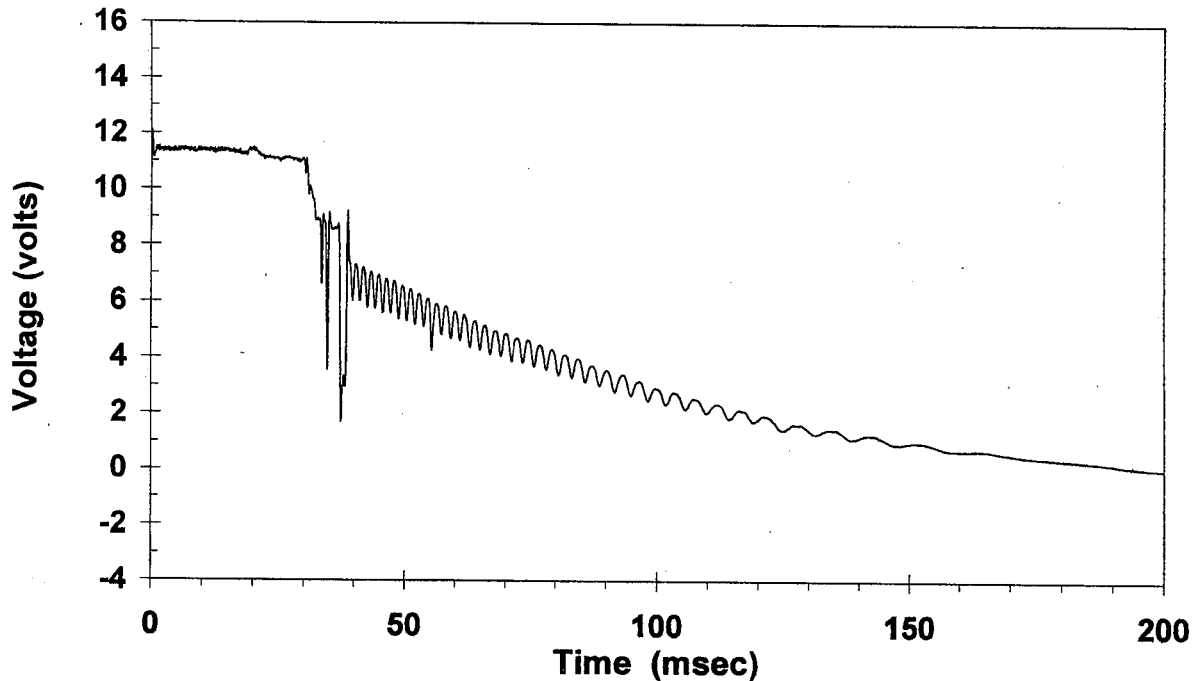
The fuel pump voltage decayed from 12 volts to near zero from about 30 msec to 200 msec as shown in Figure 49 and Plot 84 (Appendix F), consistent with the behavior observed in test C12127.

Figure 49
Fuel Pump Voltage
Test C12174
