**Evaluation of Motor Vehicle Fire Initiation and Propagation
Part 9: Propagation of a Rear-Underbody Gasoline Pool Fire in a
1998 Sport Utility Vehicle**

Jeffrey Santrock
General Motors Corporation

ABSTRACT

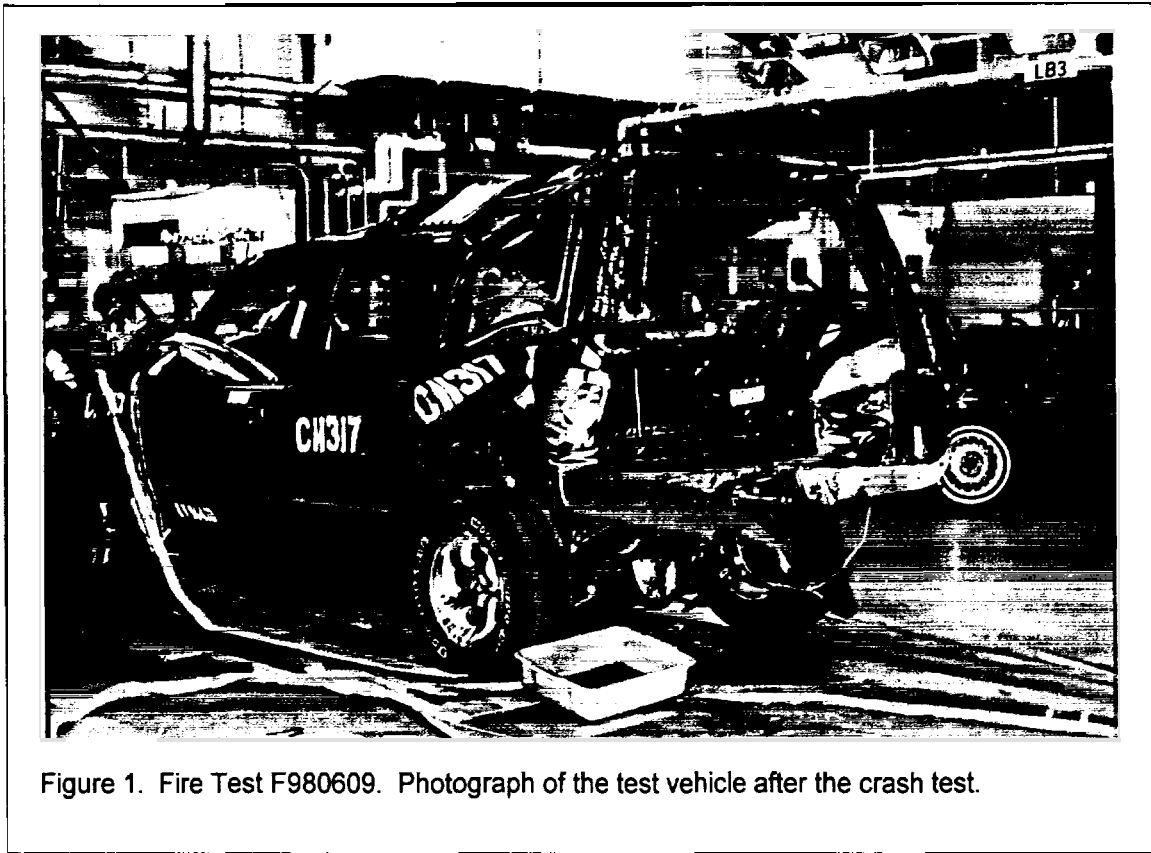
Figure 1. Fire Test F980609. Photograph of the test vehicle after the crash test.

Figure 1 is a photograph of the test vehicle after the crash test. The residual crush to the test vehicle was 550 mm on the left side of the test vehicle and 160 mm on the right side of the test vehicle. The left and right rear quarter glass panes and rear lift gate glass were broken in the crash test (Fig. 1). The right quarter interior trim finishing panel was broken, and the left quarter interior trim finishing panel was broken and dislodged (Fig. 2). The rear compartment floor panel and rear section of the roof were displaced upward relative to the front of the test vehicle (Fig's 1 and 2). The rear lift gate remained latched during and after the crash test (Fig. 1).

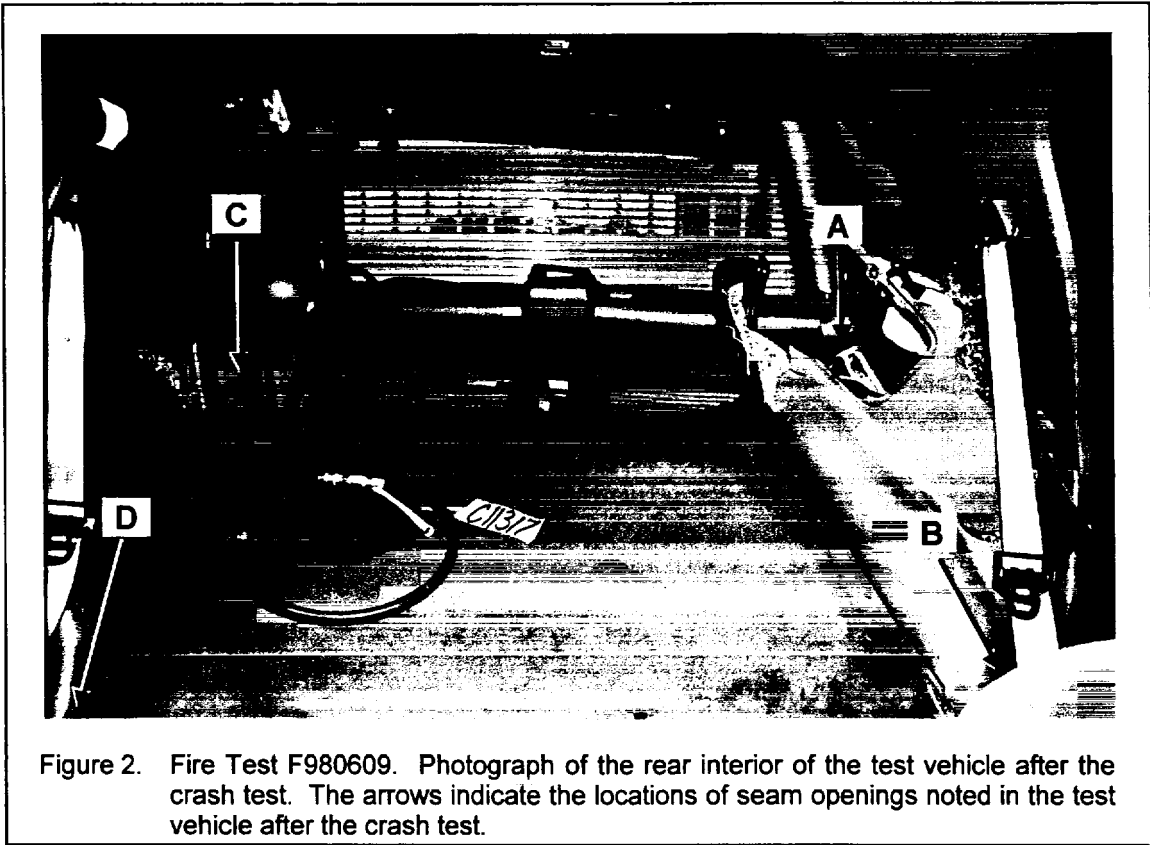
Potential fire paths into the occupant compartment observed during inspection of the test vehicle after the crash test included the window-openings in the left and right quarter panels (Fig. 1), the window opening in the rear lift gate (Fig. 1), gaps around the left rear door and door frame that were the result of deformation to the structure of the test vehicle during the crash test (Fig. 1), and four seam openings around the rear compartment floor panel. Figure 2 is a photograph of the rear compartment of the test vehicle after the crash test. The arrows in Figure 2 indicate the approximate locations of these seam openings: a seam opening between the rear compartment floor panel and the quarter panel behind the left rear wheelhouse (A); a seam opening between

Figure 2. Fire Test F980609. Photograph of the rear interior of the test vehicle after the crash test. The arrows indicate the locations of seam openings noted in the test vehicle after the crash test.

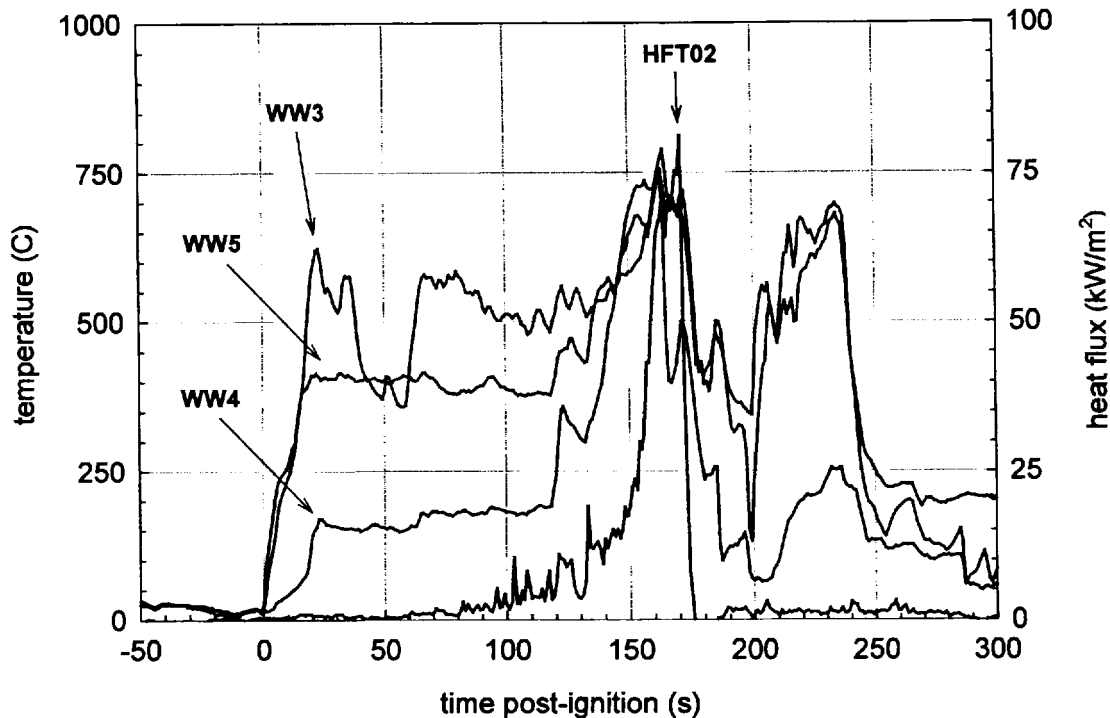
Figure 35. Fire Test F980609. Plots of data recorded from Thermocouples WW3, WW4, and WW5, and from Heat Flux Transducer HFT02.

Temperatures recorded from WW3, WW4, and WW5 started to increase between 120 and 125 seconds post-ignition, reaching maximum temperatures of approximately 790, 650, and 715°C, respectively, between 160 and 165 seconds post-ignition (Fig. 35). The timing of the start of these temperature increases observed in the recorded thermocouple data coincided with the timing of the first appearance of flames in the area above the left rear wheelhouse observed in the video stills from Cameras 1 and 4 (Fig.'s 27 through 33).

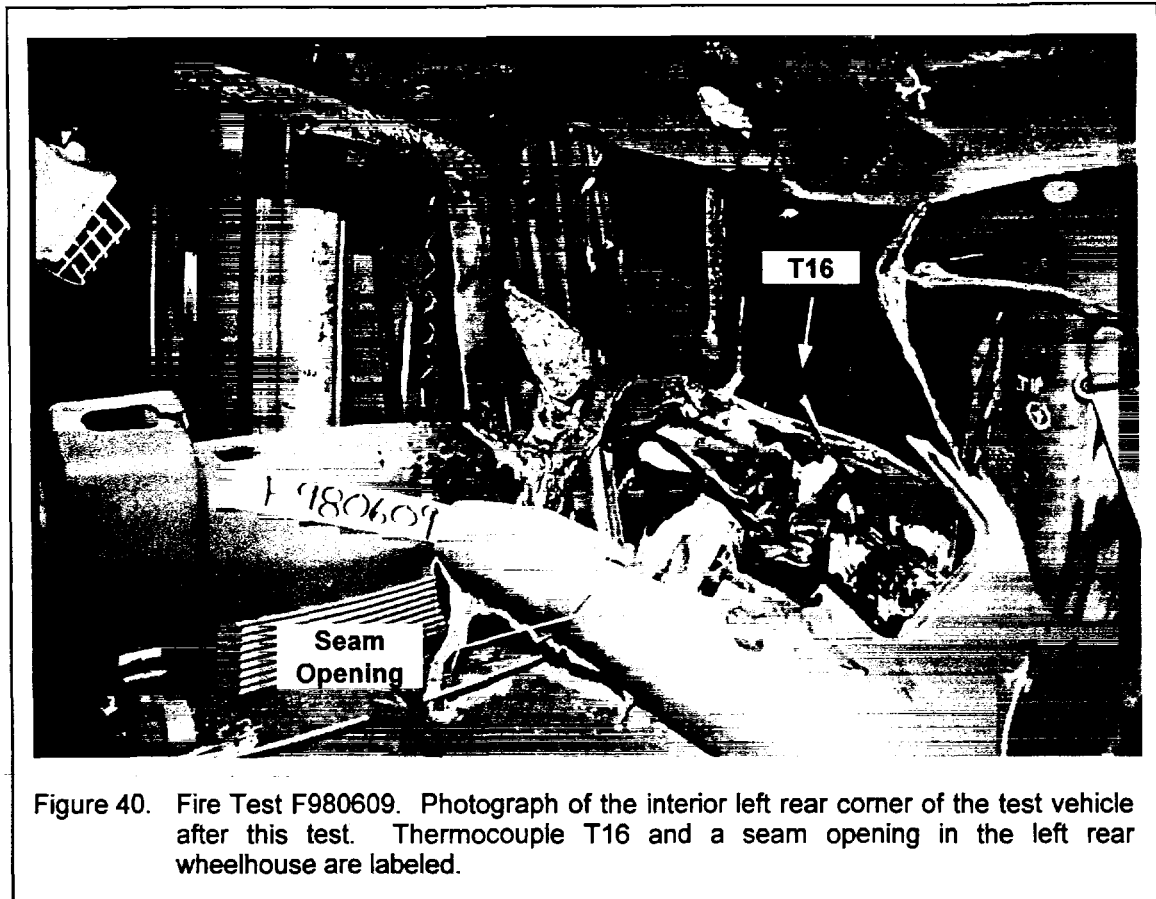
This assessment of areas of the left quarter trim panel that ignited during this test is consistent with the pattern of heat and fire damage observed in the test vehicle after this test. Figure 40 is a photograph of the interior left corner of the test vehicle after this test. Sections of the quarter trim panel adjacent to the lower horizontal and front vertical edges of the quarter glass opening were consumed by fire. Thermocouple T16 is visible in the left quarter glass opening. A section of the quarter trim panel that covered the D-pillar was melted and charred, and had sagged downward. The section of the left quarter trim panel along the header of the quarter glass opening where Thermocouples T21 and T22 were located was consumed by fire. The section of the left quarter trim panel along the header of the quarter glass opening where Thermocouple T20 was located was not burned or charred. The plastic resin on the inner surface (back-side) of a larger section of the broken trim panel that was inboard of this seam opening had melted and started to drip. This section of the quarter trim panel did not appear to have ignited during this test.

Figure 40. Fire Test F980609. Photograph of the interior left rear corner of the test vehicle after this test. Thermocouple T16 and a seam opening in the left rear wheelhouse are labeled.

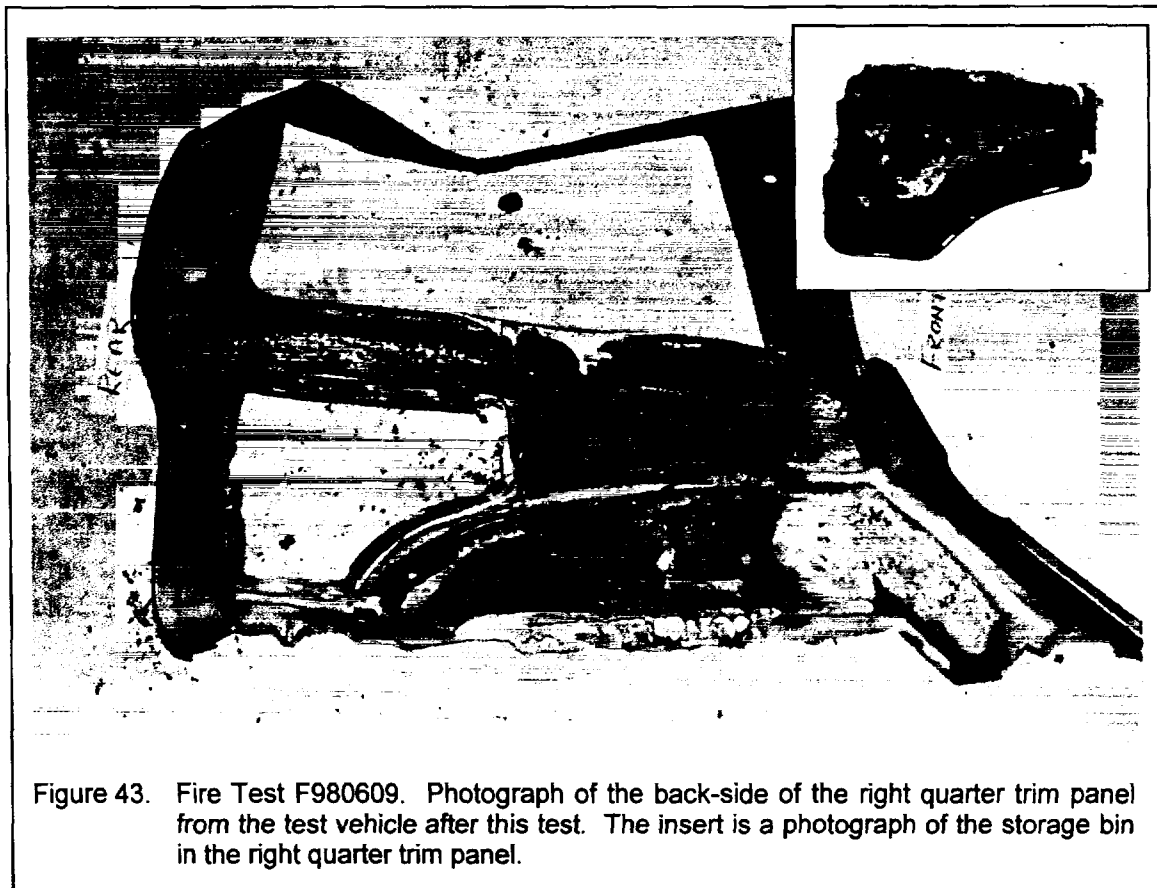
This assessment of flame-spread into the space between the right quarter trim panel and the right quarter panel is generally consistent with the pattern of heat and fire damage observed on the right quarter trim panel after this test. Figure 43 contains photographs of the right quarter trim panel and storage bin from the test vehicle after this test. A felt material was adhered to the inner surfaces of sections of the trim panel and storage bin (Fig. 43). Soot was deposited on the inner surfaces of sections of the trim panel and storage bin (Fig. 43). The fiber mat was burned and charred where the estimated temperatures shown in Figure 41 were greater than approximately 400°C at some time during this test, and was not burned or charred where the estimated temperatures were $<$ about 300°C (Fig. 43). The bottom edge of the trim panel that was in contact with the rear compartment floor panel was melted (Fig. 43). The outer surface of

Figure 43. Fire Test F980609. Photograph of the back-side of the right quarter trim panel from the test vehicle after this test. The insert is a photograph of the storage bin in the right quarter trim panel.

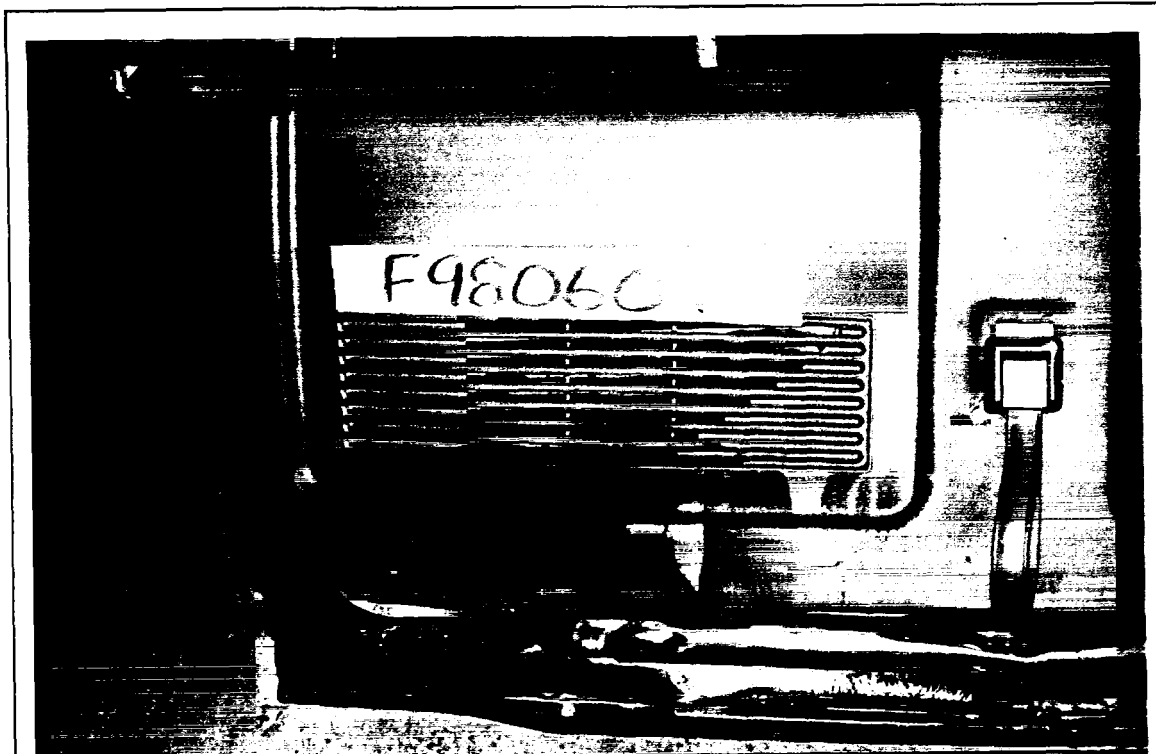
A fire path under the liftgate was discovered during inspection of the test vehicle after this test. Figure 45 is a photograph of the liftgate from the test vehicle after this test. Soot was observed on the lower interior surface of the liftgate trim panel, the lower surfaces of the inner and outer liftgate panels, and the seal along the bottom of the liftgate (Fig. 45). The liftgate trim panel was not burned or charred (Fig. 45).

Figure 45. Fire Test F980609. Photograph of the right-side of the liftgate trim panel from the test vehicle after this test.

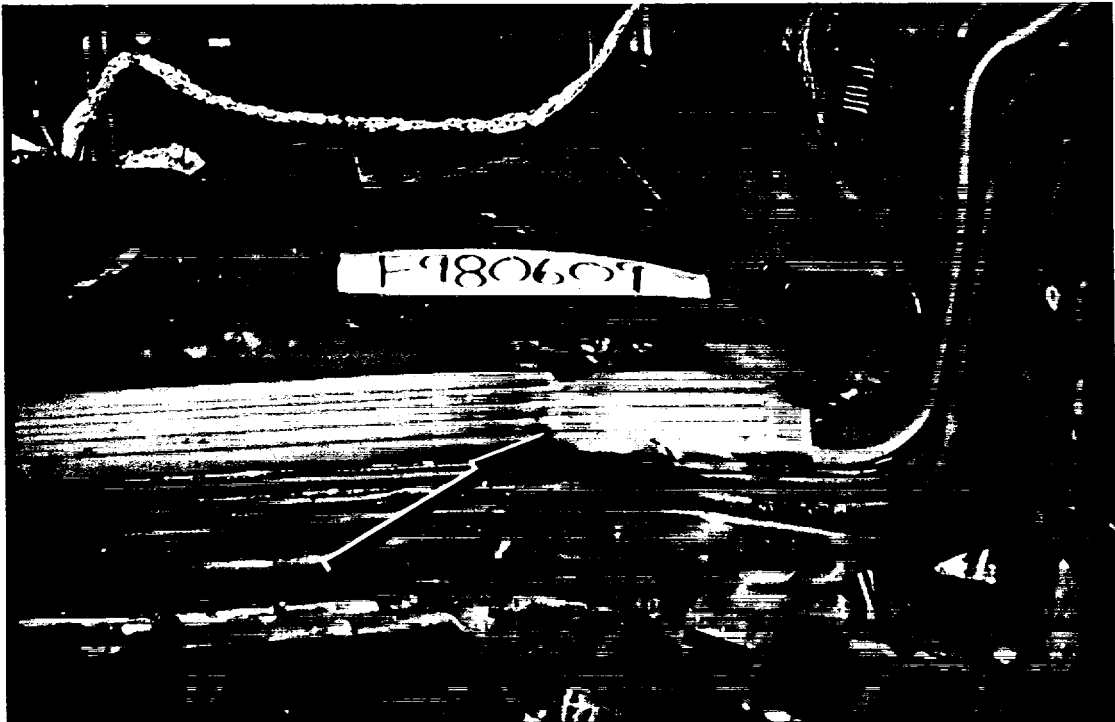
The video stills from Cameras 1 and 4 at 170 seconds post-ignition show a fire plume on the exterior surface of the right side of the liftgate in the area where the scuff plate and rear compartment floor carpet were burned (Fig. 33). Video stills from Cameras 1 and 4 prior to this time show flames sporadically along the lower right edge of the liftgate sporadically throughout this test (Fig.'s 27 through 32). The timing of flame-spread under the liftgate could not be determined precisely because no thermocouples were located in this area.

Figure 46. Fire Test F980609. Photographs of the right side of the rear liftgate sill in the test vehicle after this test. The upper photograph shows the scuff plate in-place. The lower photograph shows the scuff plate has been detached and rotated to its lower surface. The arrows indicate sections of the scuff plate and rear compartment floor carpet where heat and fire damage was observed.

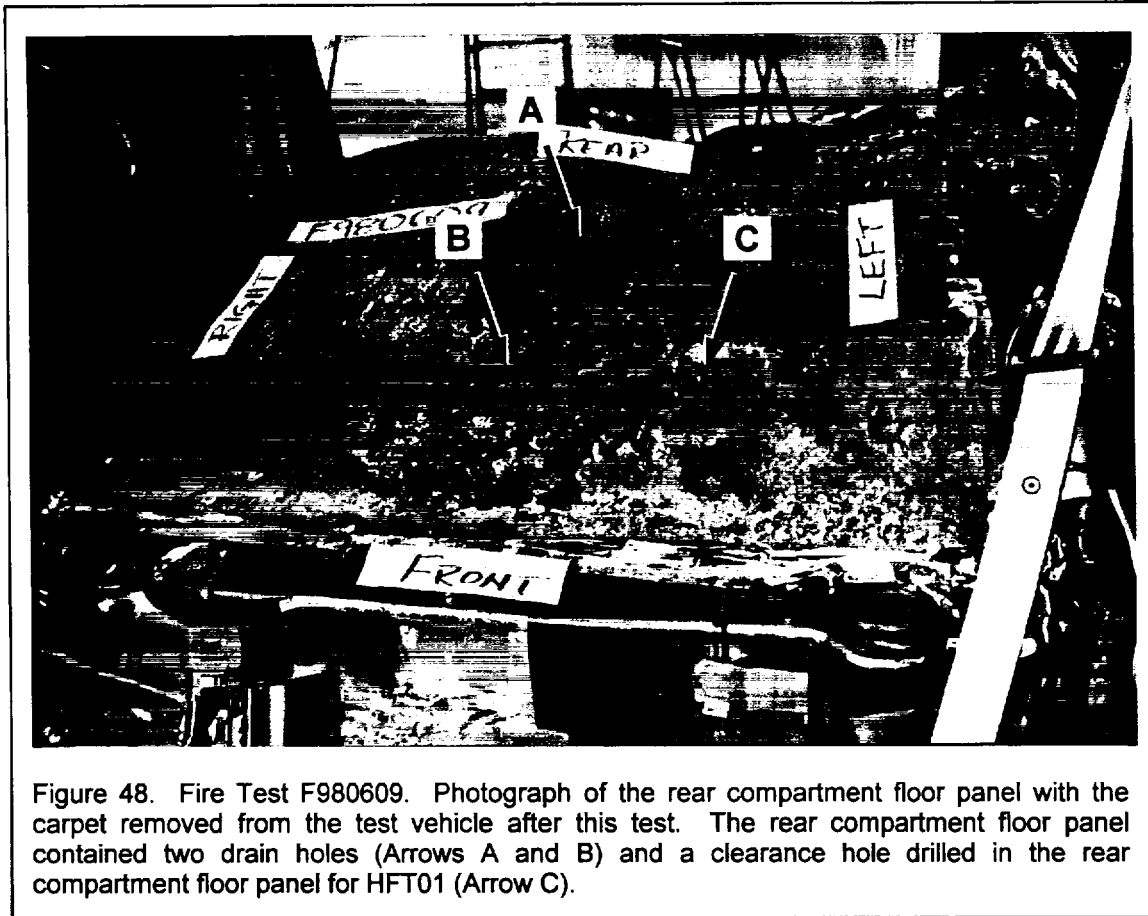
The recorder test data and physical evidence from inspection of the test vehicle after this test indicated that flames burned through both of these drain hole plugs closing the two drain holes located along the longitudinal center-line in the rear compartment floor panel of the test vehicle (see Fig. 27). It was not possible to determine unambiguously to what extent thermal damage to the carpet pad was caused by flame-spread through these openings. For example, Figure 49 is a plot of data recorded from a thermocouple in the center of the upper surface of the rear plug (Arrow A, Fig. 48). The maximum temperature recorded from this thermocouple during this test was $<325^{\circ}\text{C}$ (Fig. 49), which was less than the 600°C threshold used in this report to indicate flames. A section was missing from one end of this plug, and the edges around the missing sections were charred and brittle (insert, Fig. 49). The upper surface of the carpet pad over this drain hole was discolored, but not burned or charred (Arrow A, Fig. 48).

Figure 48. Fire Test F980609. Photograph of the rear compartment floor panel with the carpet removed from the test vehicle after this test. The rear compartment floor panel contained two drain holes (Arrows A and B) and a clearance hole drilled in the rear compartment floor panel for HFT01 (Arrow C).

The carpet pad around the drain hole in the forward section of the rear compartment was charred and burned (Arrow A, Fig. 48). The plug in this drain hole was consumed by fire during this test. No thermocouples were installed on this plug for this test, so it was not possible to determine if flames entered this drain hole during this test.

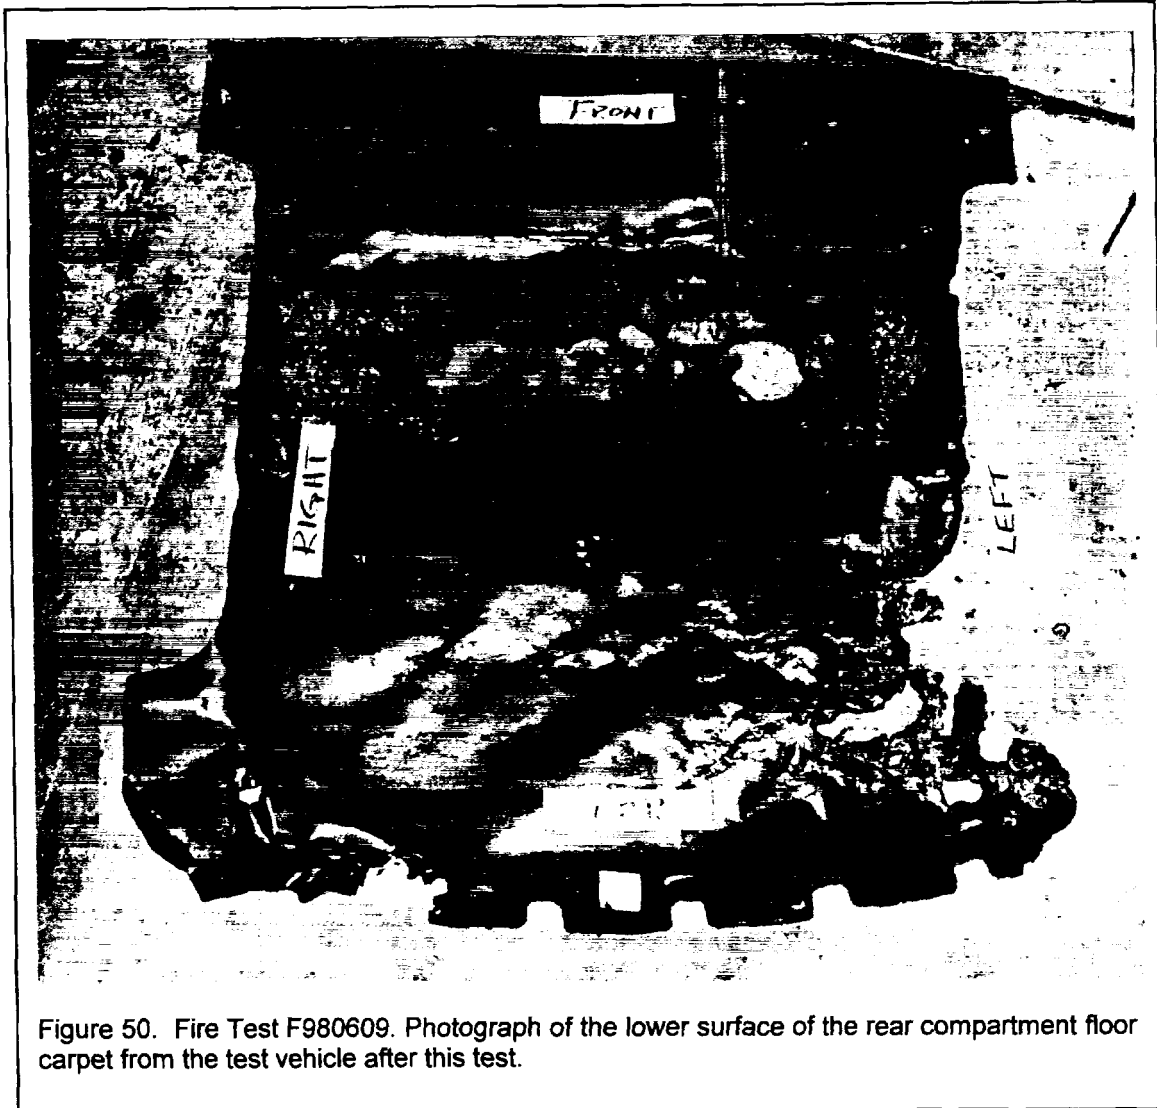
Figure 50 is a photograph of the under side of the carpet from the rear compartment of the test vehicle after this test. The edge of the floor carpet on the left side of the rear compartment was burned and melted where it was adjacent to the left rear wheelhouse (Fig. 48). Pieces of the carpet pad were stuck to the under side of the floor carpet where the backing had melted and re-solidified after the test (Fig. 50). A section of the carpet that was under the right side of the scuff plate, where flames spread under the liftgate, was burned and melted (Fig. 50). The backing of the floor carpet overlaying the forward section of the rear compartment was discolored and contained soot deposits (Fig. 50).

Figure 50. Fire Test F980609. Photograph of the lower surface of the rear compartment floor carpet from the test vehicle after this test.
