Evaluation of Motor Vehicle Fire Initiation and Propagation

Part 2: Crash Tests on a Passenger Van

Jack L. Jensen, Jeffrey Santrock

General Motors Corporation

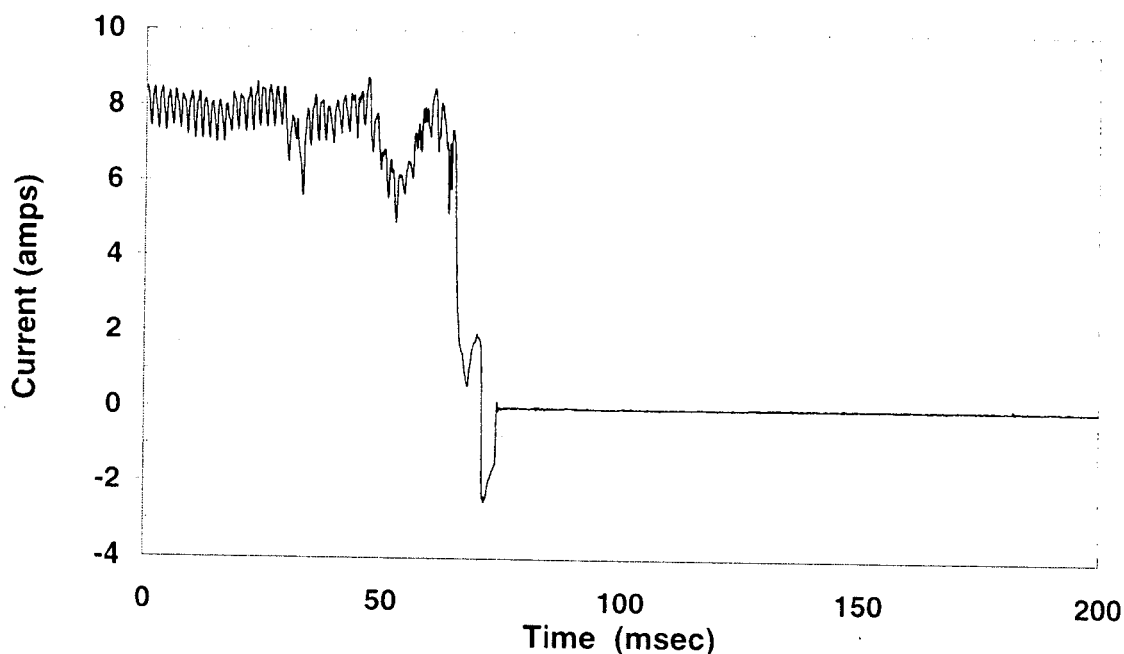
Figure 8
Fuel Pump Current
Test C11108

Figure 8 shows the current measured at the auxiliary fuel pump (the one operating before the impact and supplying gasoline to the engine from the auxiliary fuel tank). The fuel pump drew 8 amps until about 65 msec, when the current dropped to zero. This was due to the loss of the vehicle's electrical power caused by the disconnection of the positive battery cable. Some vehicle fuel pumps are designed to "time out" after a fixed period of engine stoppage (1 or 2 seconds, as an example). Under normal conditions when the engine is turned off, this short period of pump operation pressurizes the fuel systems for the next engine start. However, in the event the engine stops due to a crash, this feature insures that the pump does not continue to operate, possibly supplying a leak with gasoline. For this test, the pump was not required to be "timed-out", instead it shut down early due to the loss of vehicle electrical power.

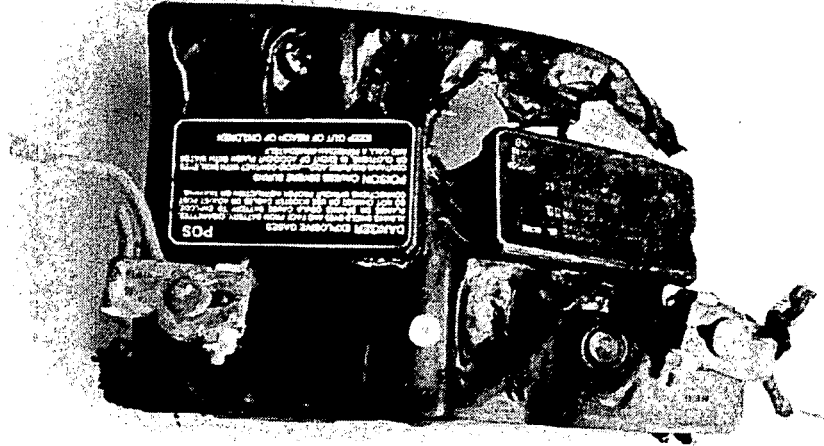
Figure 24

The fire was first observed as blistering paint on the upper radiator tie bar near the front of the deformed battery. Approximately 30 seconds later, flames were then observed near the battery and the fire was allowed to propagate to verify that it was a self-propagating flame front. Approximately five minutes after the first observation of fire (ten minutes after impact) the fire was extinguished using a carbon dioxide fire extinguisher. At that time the damage caused by the fire was limited to the plastic components around the battery compartment including the plastic battery housing, battery top, plastic housing of the power distribution center, miscellaneous electrical connectors and harnesses, and some plastic components of the left front headlight assembly. A photograph of the battery top, removed after the test is shown in Figure 24.

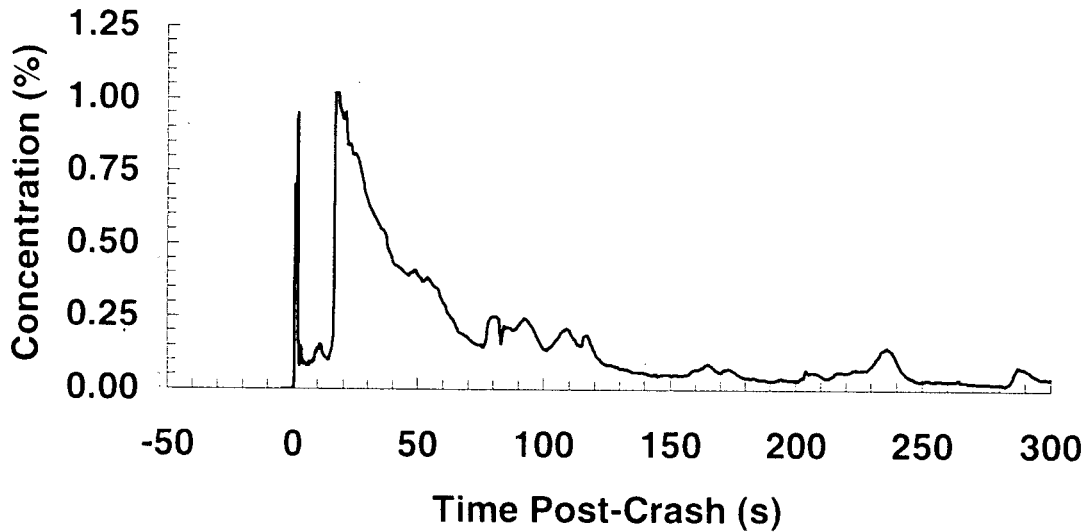
Figure 27

The concentration at the left upper engine (#1) approached 0.3 % concentration from shortly after impact through about 25 seconds as shown in Figure E1, Appendix E. The concentration at this location then decayed to less than 0.1% by 50 seconds after impact. The concentration at the left lower engine (#3) exceeded 1.0 % concentration at approximately 20 seconds after impact and remained above 0.2% through about 100 seconds after impact. The concentration measurement at the left lower engine (#3) is shown in Figure E3 (Appendix E) and is also recreated here as Figure 27. It is possible that these two measurements are simply two different locations in the same cloud of gas, and that the source of the gas could be the same for both measurements. The remaining three locations remained below a concentration of 0.1% for the measurement duration.

Concentration of Hydrocarbon Vapor Measured from Left Lower Engine (Location #3)

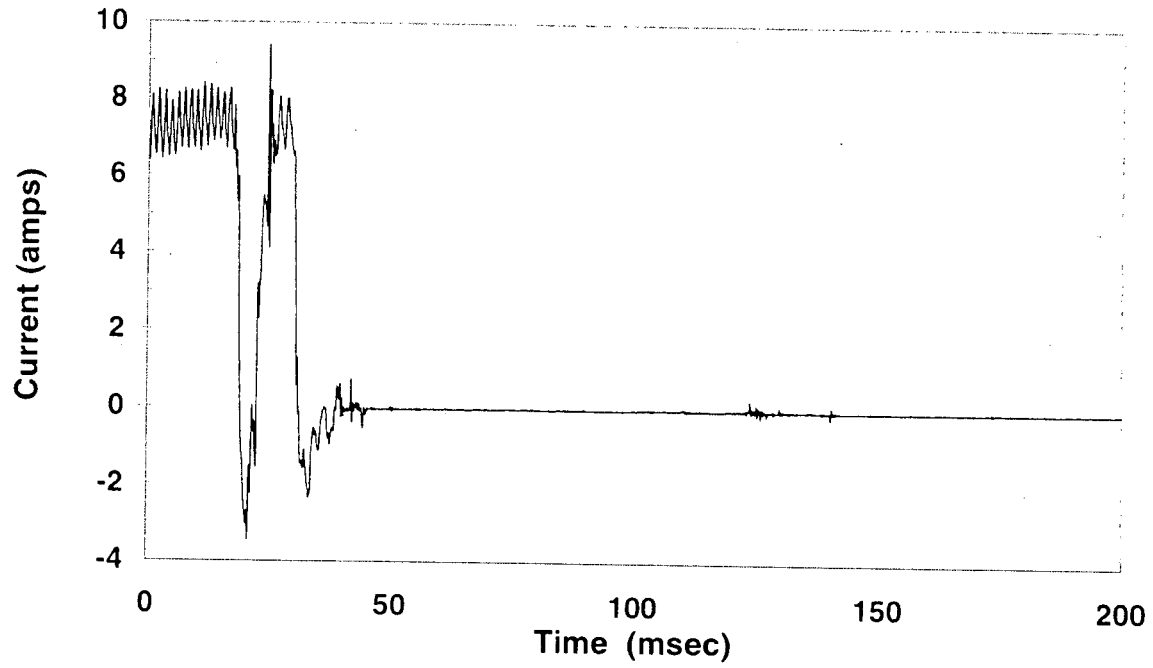
Figure 37
 Fuel Pump Current
 Test C11226

Figure 37 and plot 130 (Appendix F) show the current measurement at the auxiliary fuel pump (the one operating before the impact and supplying gasoline to the engine from the auxiliary fuel tank). The fuel pump drew 7.5 amps until about 20 msec, when the current dropped to zero. It quickly recovered to 7.5 amps before dropping back to zero at about 30 msec. The ignition voltage, which is shown in Figure 38 and plot 120 (Appendix F), also follows a similar waveform. These changes in ignition voltage are the likely cause of the changes in the fuel pump current. Unlike test C11167, the ignition voltage never recovered and remained at or near zero for the duration of the data acquisition period.

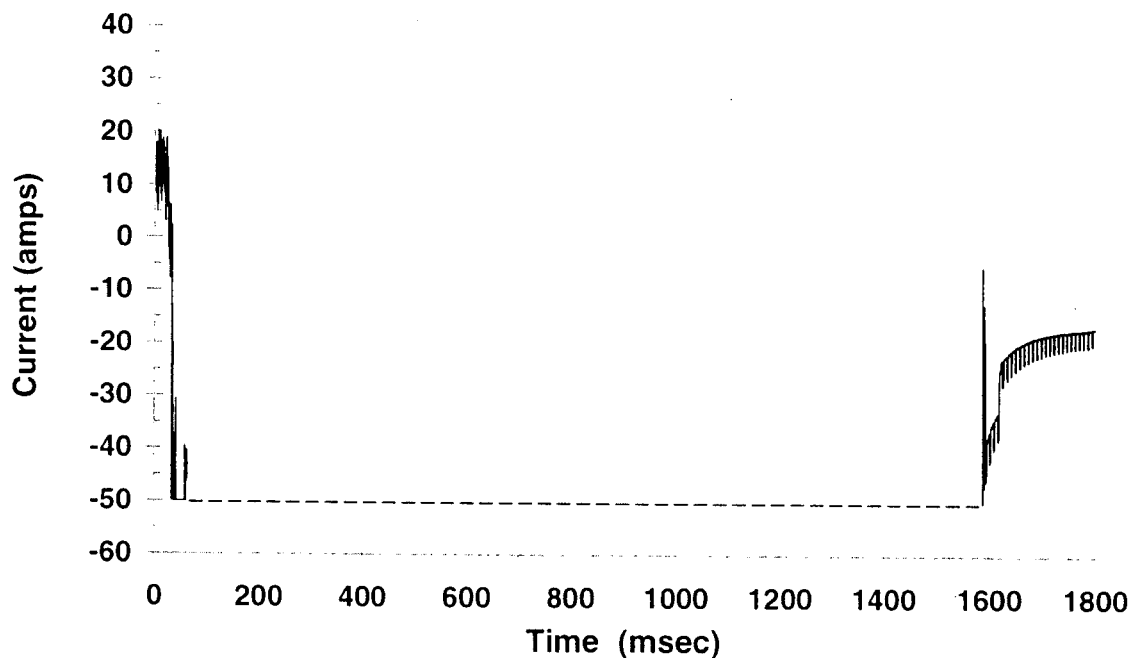
Figure 53

Current flow in the main battery cable (Figure 53) exceeded the full scale range of 50 amps intermittently from 30 msec through 65 msec, and continuously from about 65 msec through 1590 msec. It is possible that a short to chassis, causing significant current flow, caused the battery voltage to be drawn down through 1590 msec. The positive current flow indicated from the time of impact through about 30 msec represents normal current flow when the engine is operating (it is likely the alternator charging the battery). The negative current flow, however, indicates current flowing away from the stored source (battery) to the chassis short.
