**Development of Inspection Technology  
for NGV Fuel Tanks**

## **Development of Inspection Technology for NGV Fuel Tanks**

Failure Analysis Associates, Inc.  
Menlo Park, California

May 1997  
(Revised August 1997)

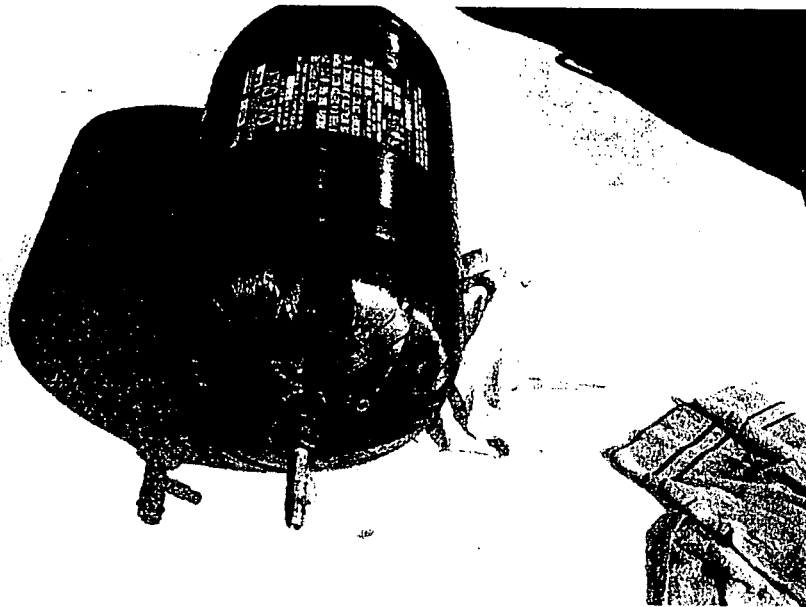
Figure 84. Failed Area on Tank 003

Condition	Significant AE Pressure, psig	Observations
Virgin	6,062	No visible change
Impact 45° Drop c.g., 5 ft above concrete	3,667	No visible change
Fatigue 6,000 cycles - 3,600 psig* 2,146 cycles - 4,000 psig	4,500	Tank failed at impact site after 8,146 cycles
