Enclosed is the final report prepared by EXponent (formerly Failure Analysis Associates) entitled, "Development of Inspection Technology for NGV Fuel Tanks." This report relates to Project B.7 (Development of Criteria and Methodologies for In-Service Inspections of Gaseous Fuel Pressure Vessels).

Exponent Failure Analysis Associates, Inc. (FaAA) is pleased to submit the revised report, Development of Inspection Technology for NGV Fuel Tanks. The report was revised in response to comments received from Southwest Research Institute (SwRI) and Powertech Labs (Powertech) documented in the letter of March 20, 1998, from the National Highway Traffic Safety Administration (NHTSA). The following changes were made:

GM contracted with Failure Analysis Associates, Inc. (FaAA), to evaluate techniques for in-service inspection of natural gas vehicle (NGV) fuel tanks. The fuel tank is typically a composite overwrapped pressure vessel (COPV), which stores the gas at approximately 3,000 psig. The fuel tank consists of an inner liner, made either of metal or plastic, to contain the gas and a composite overwrap, typically filament wound with carbon or glass fibers, to resist the internal pressure.

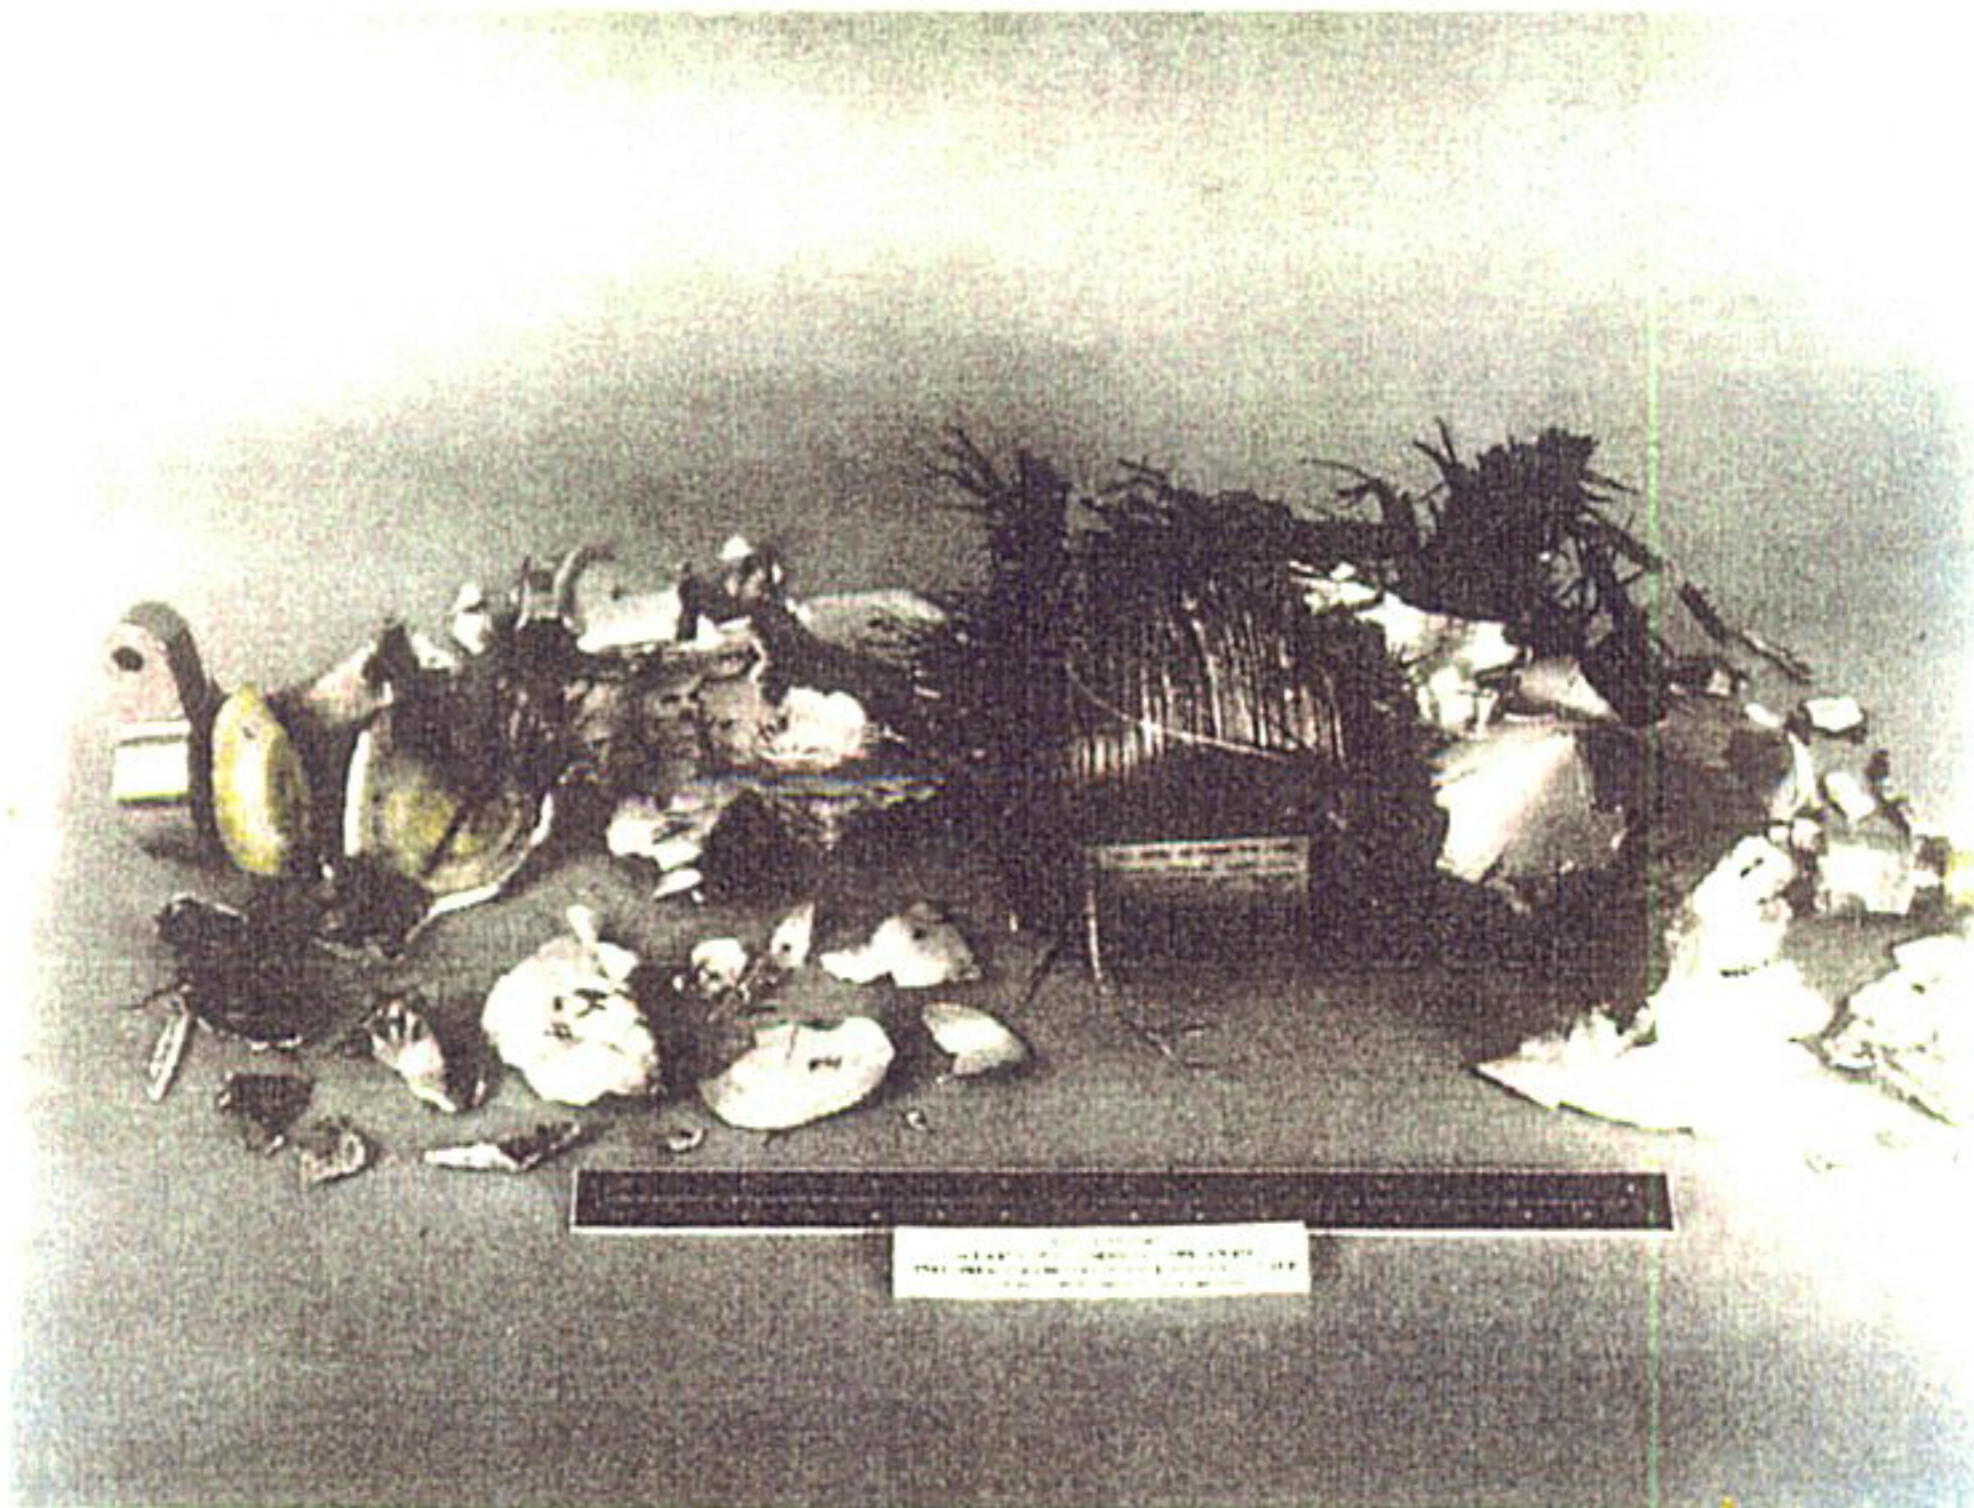
Figure 9. COPV Failed Upon Impact

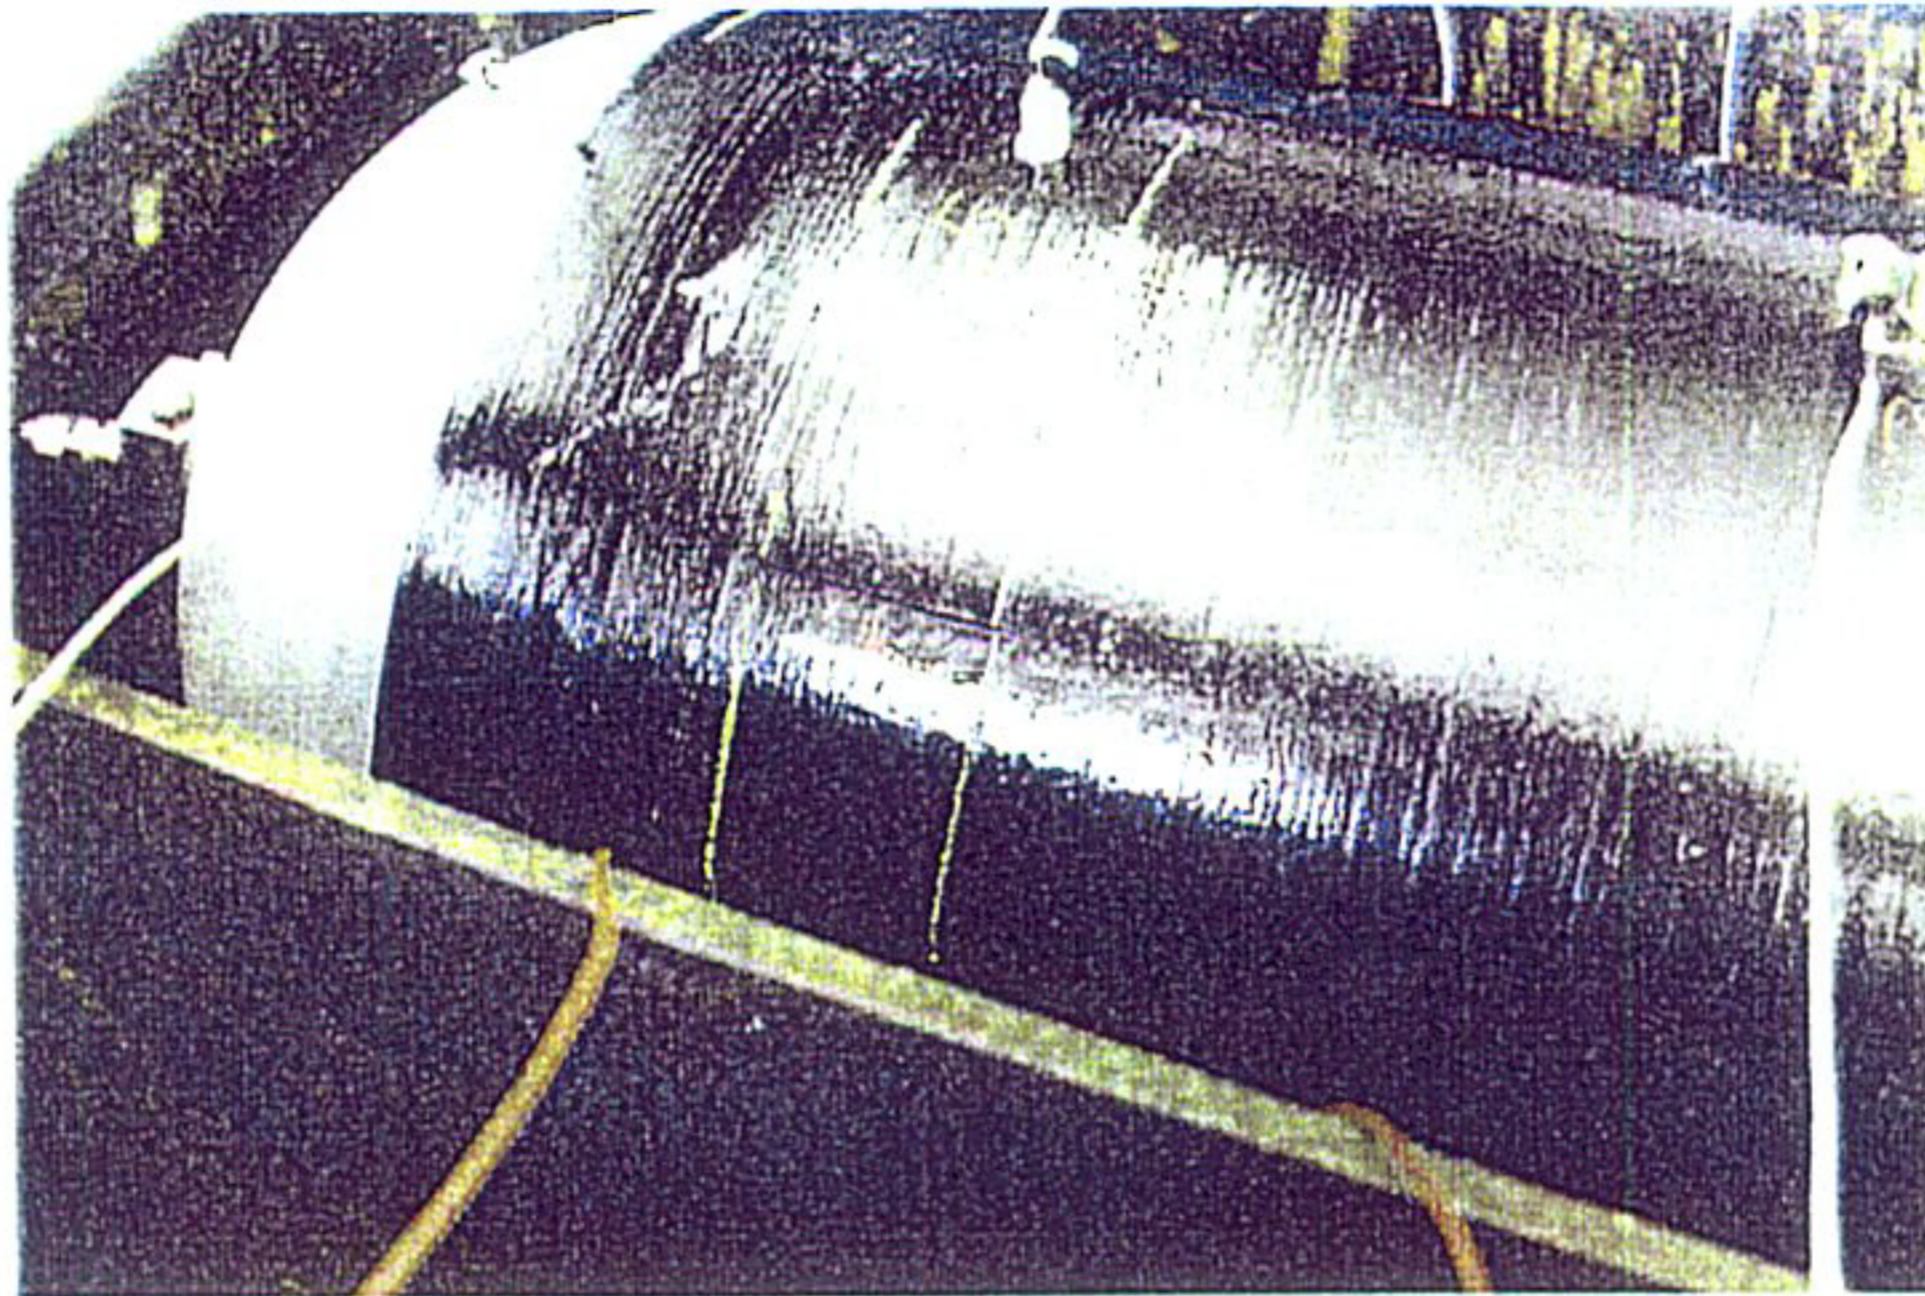
Figure 47. Circumferential Cracks Propagating from the Ends of the 2-inch Slit

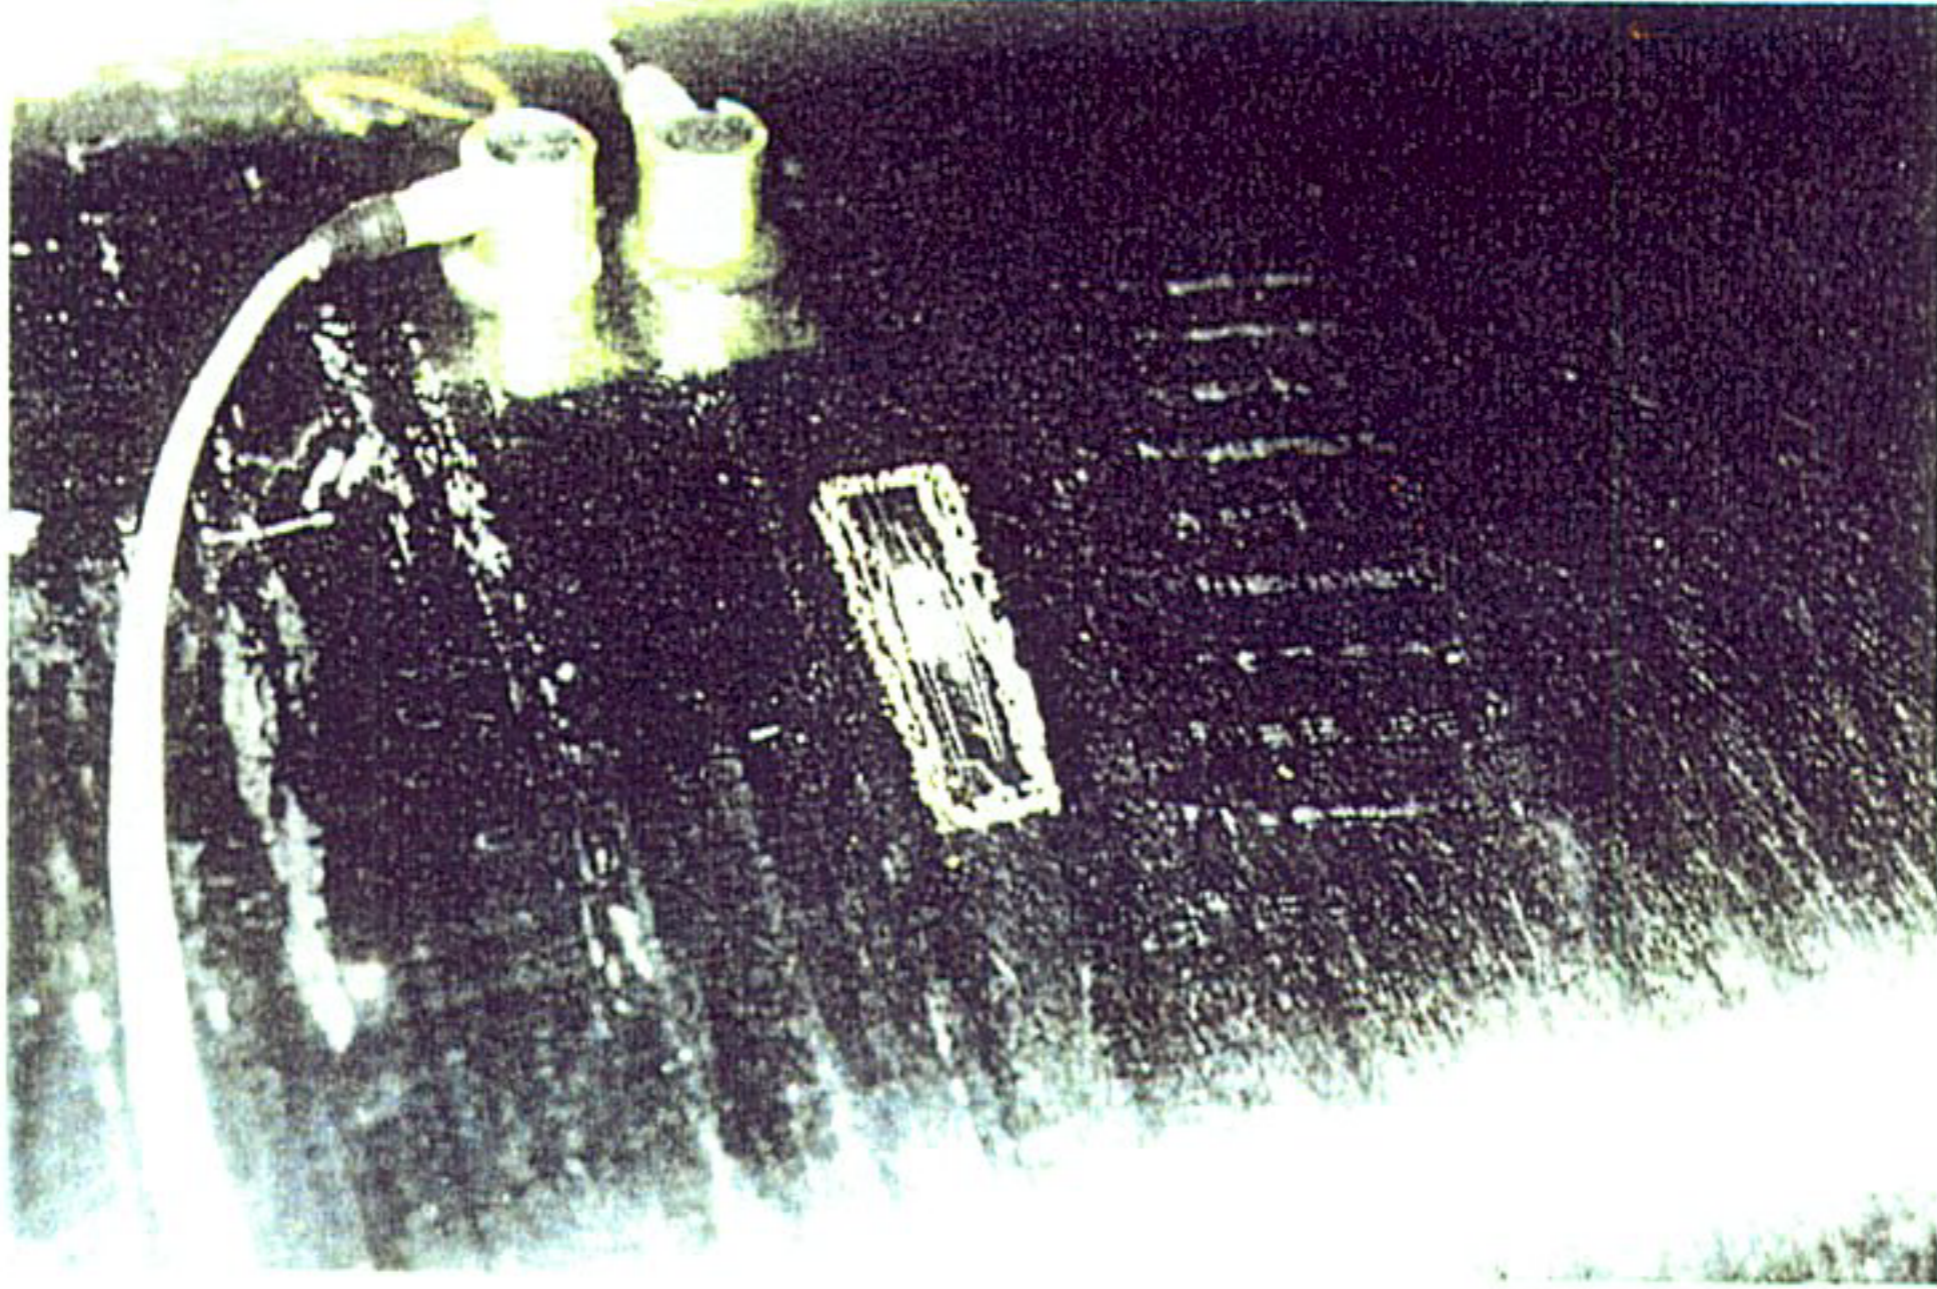
Figure 51. Extent of Damage from 22.1 ft-lbs Impact

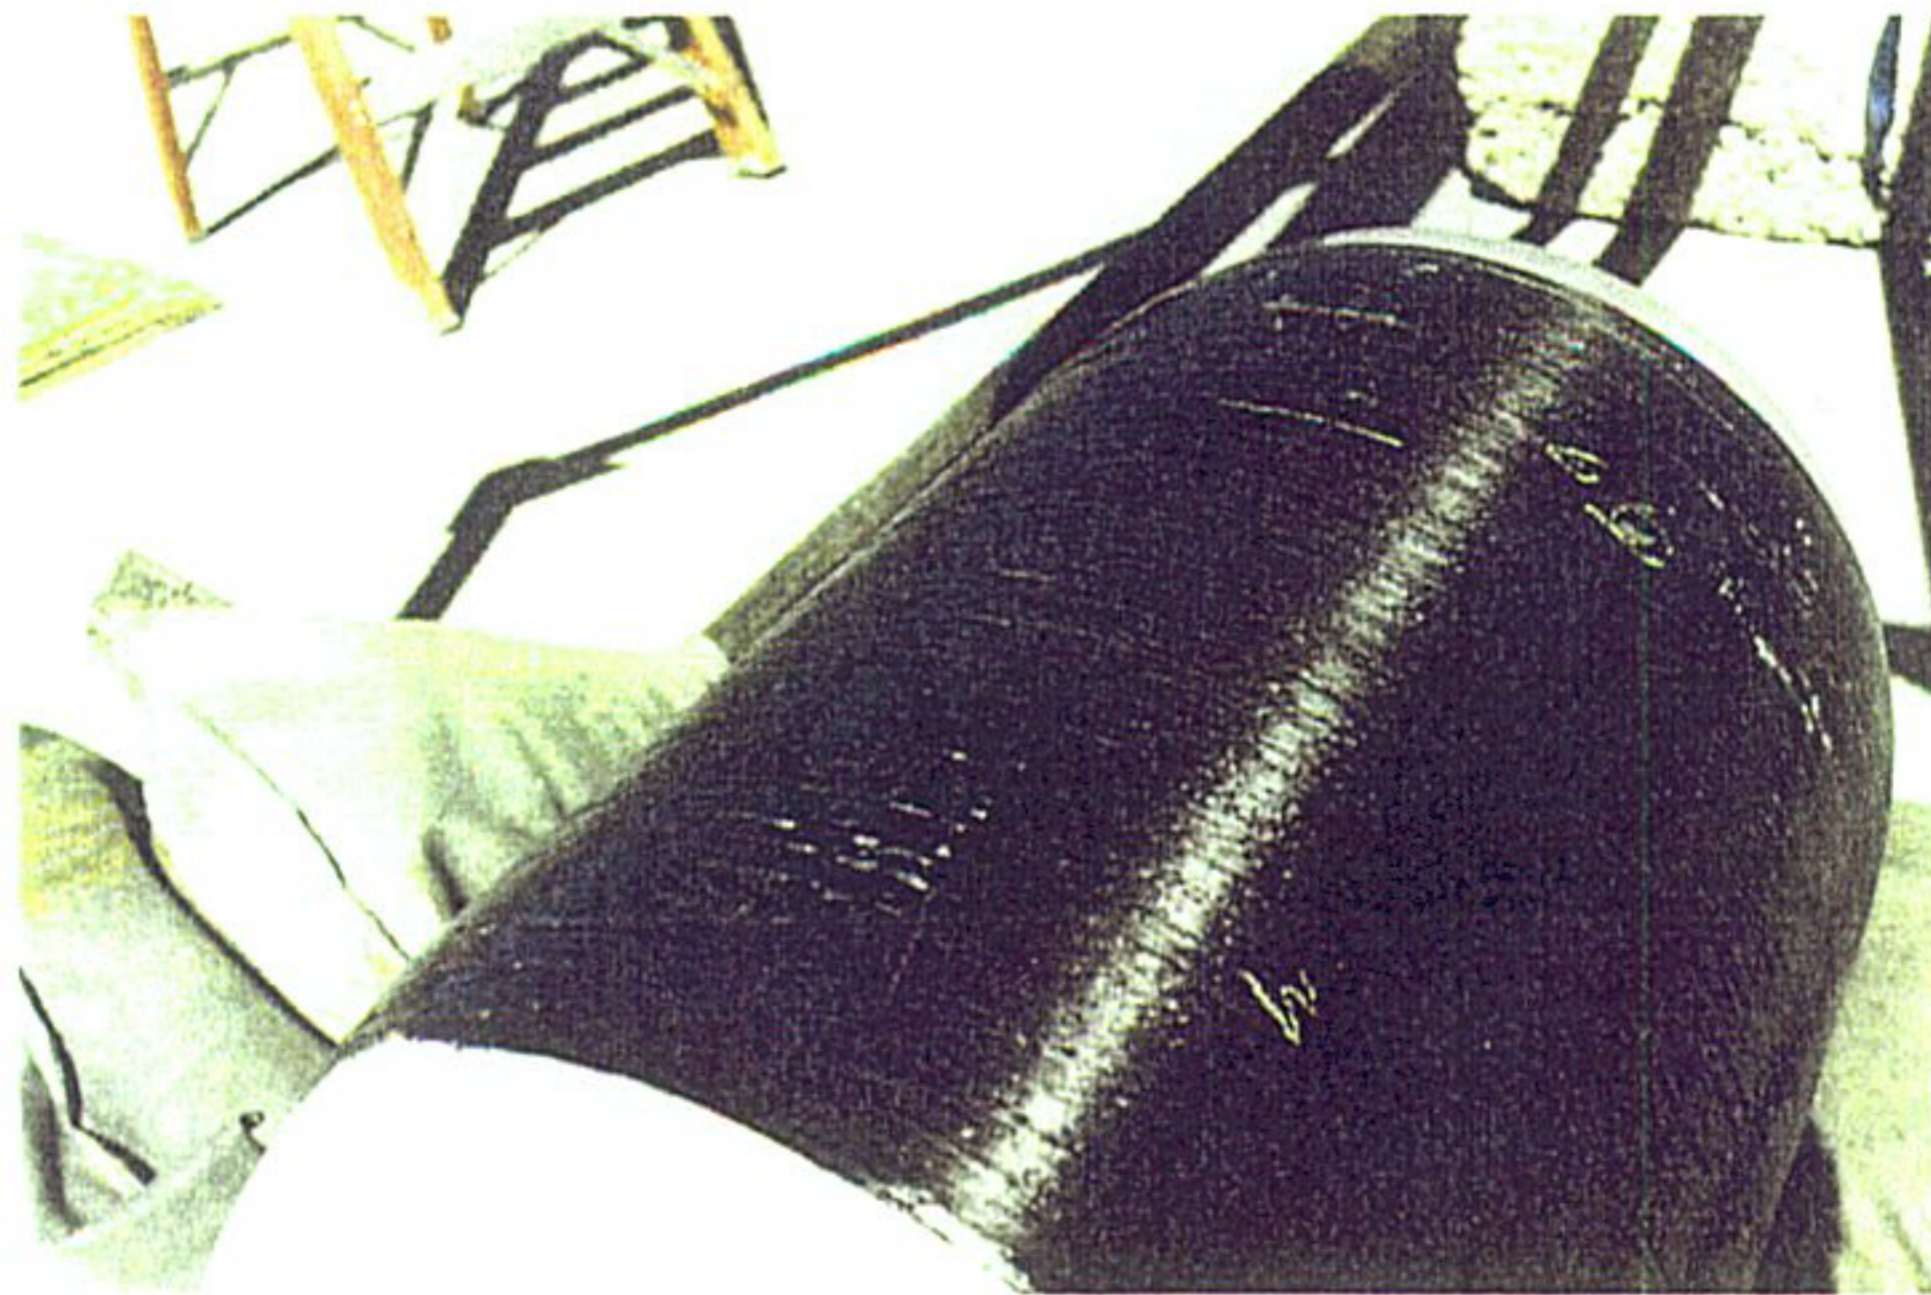
Figure 63. Post-Impact Damage on Tank 018, Overall View

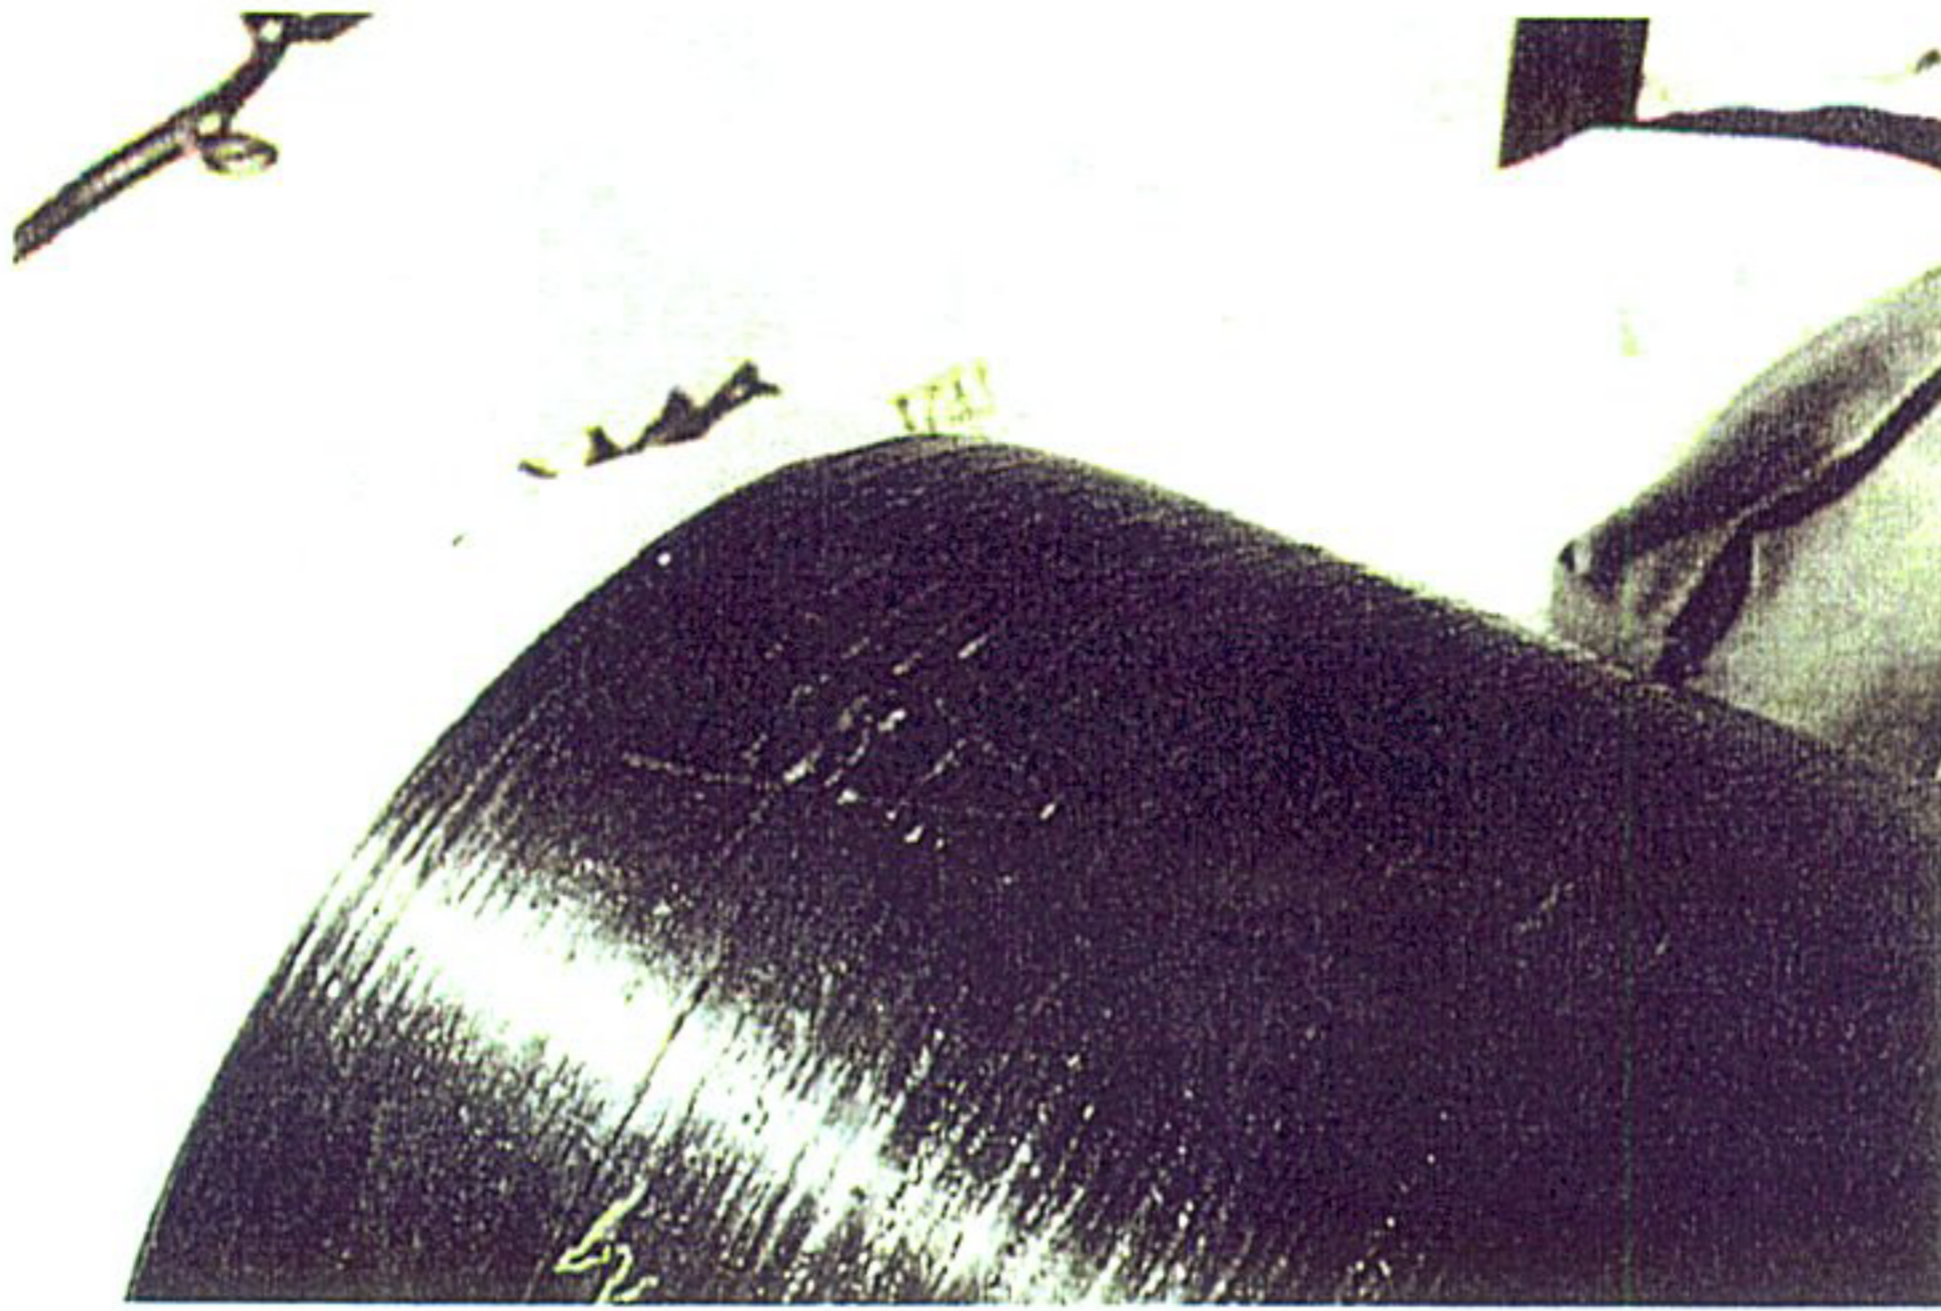
Figure 64. Post-Impact Damage on Tank 018, Close-up

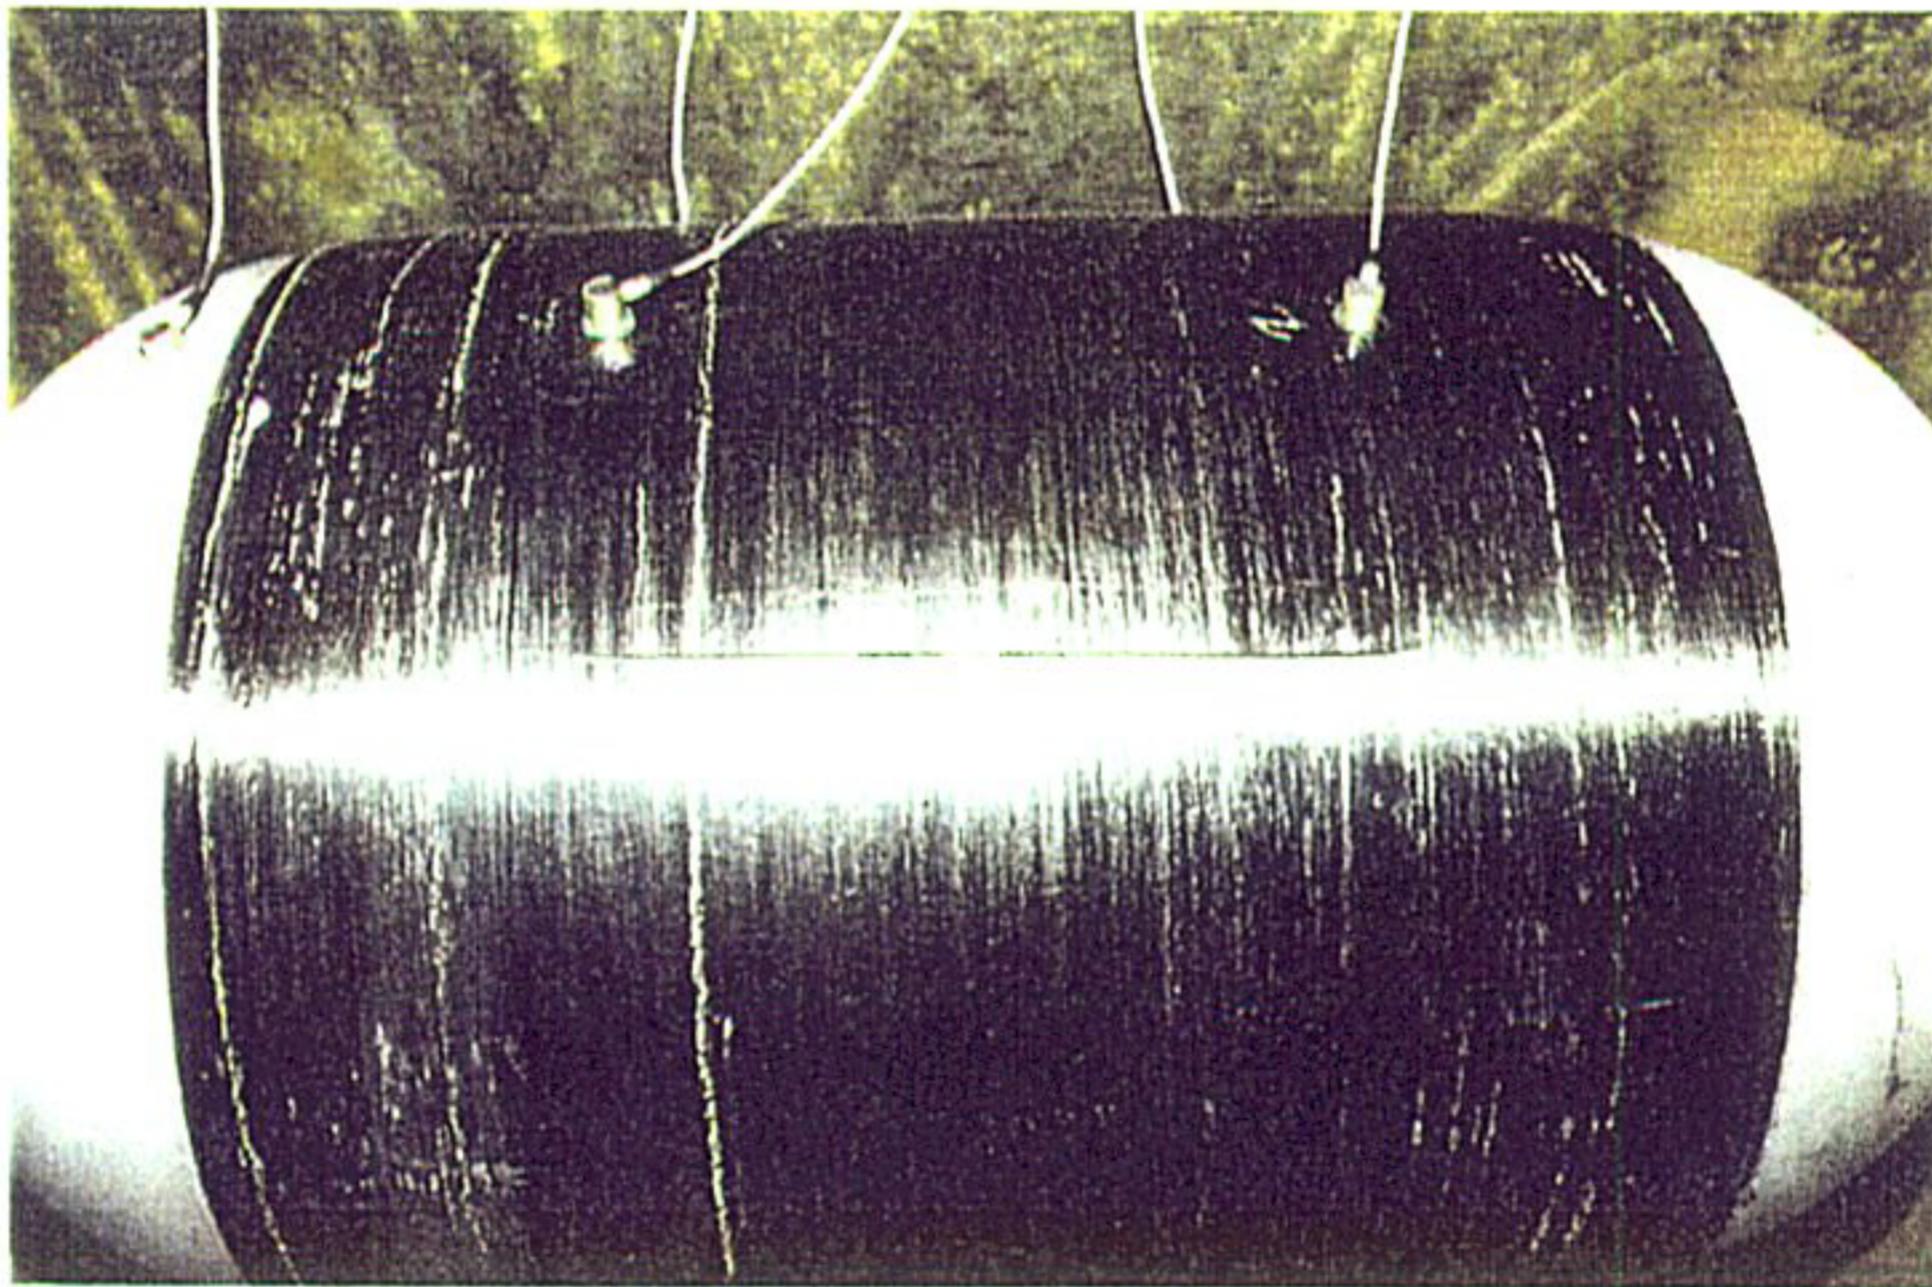
Figure 65. 8-inch Slit Cut in Tank 018

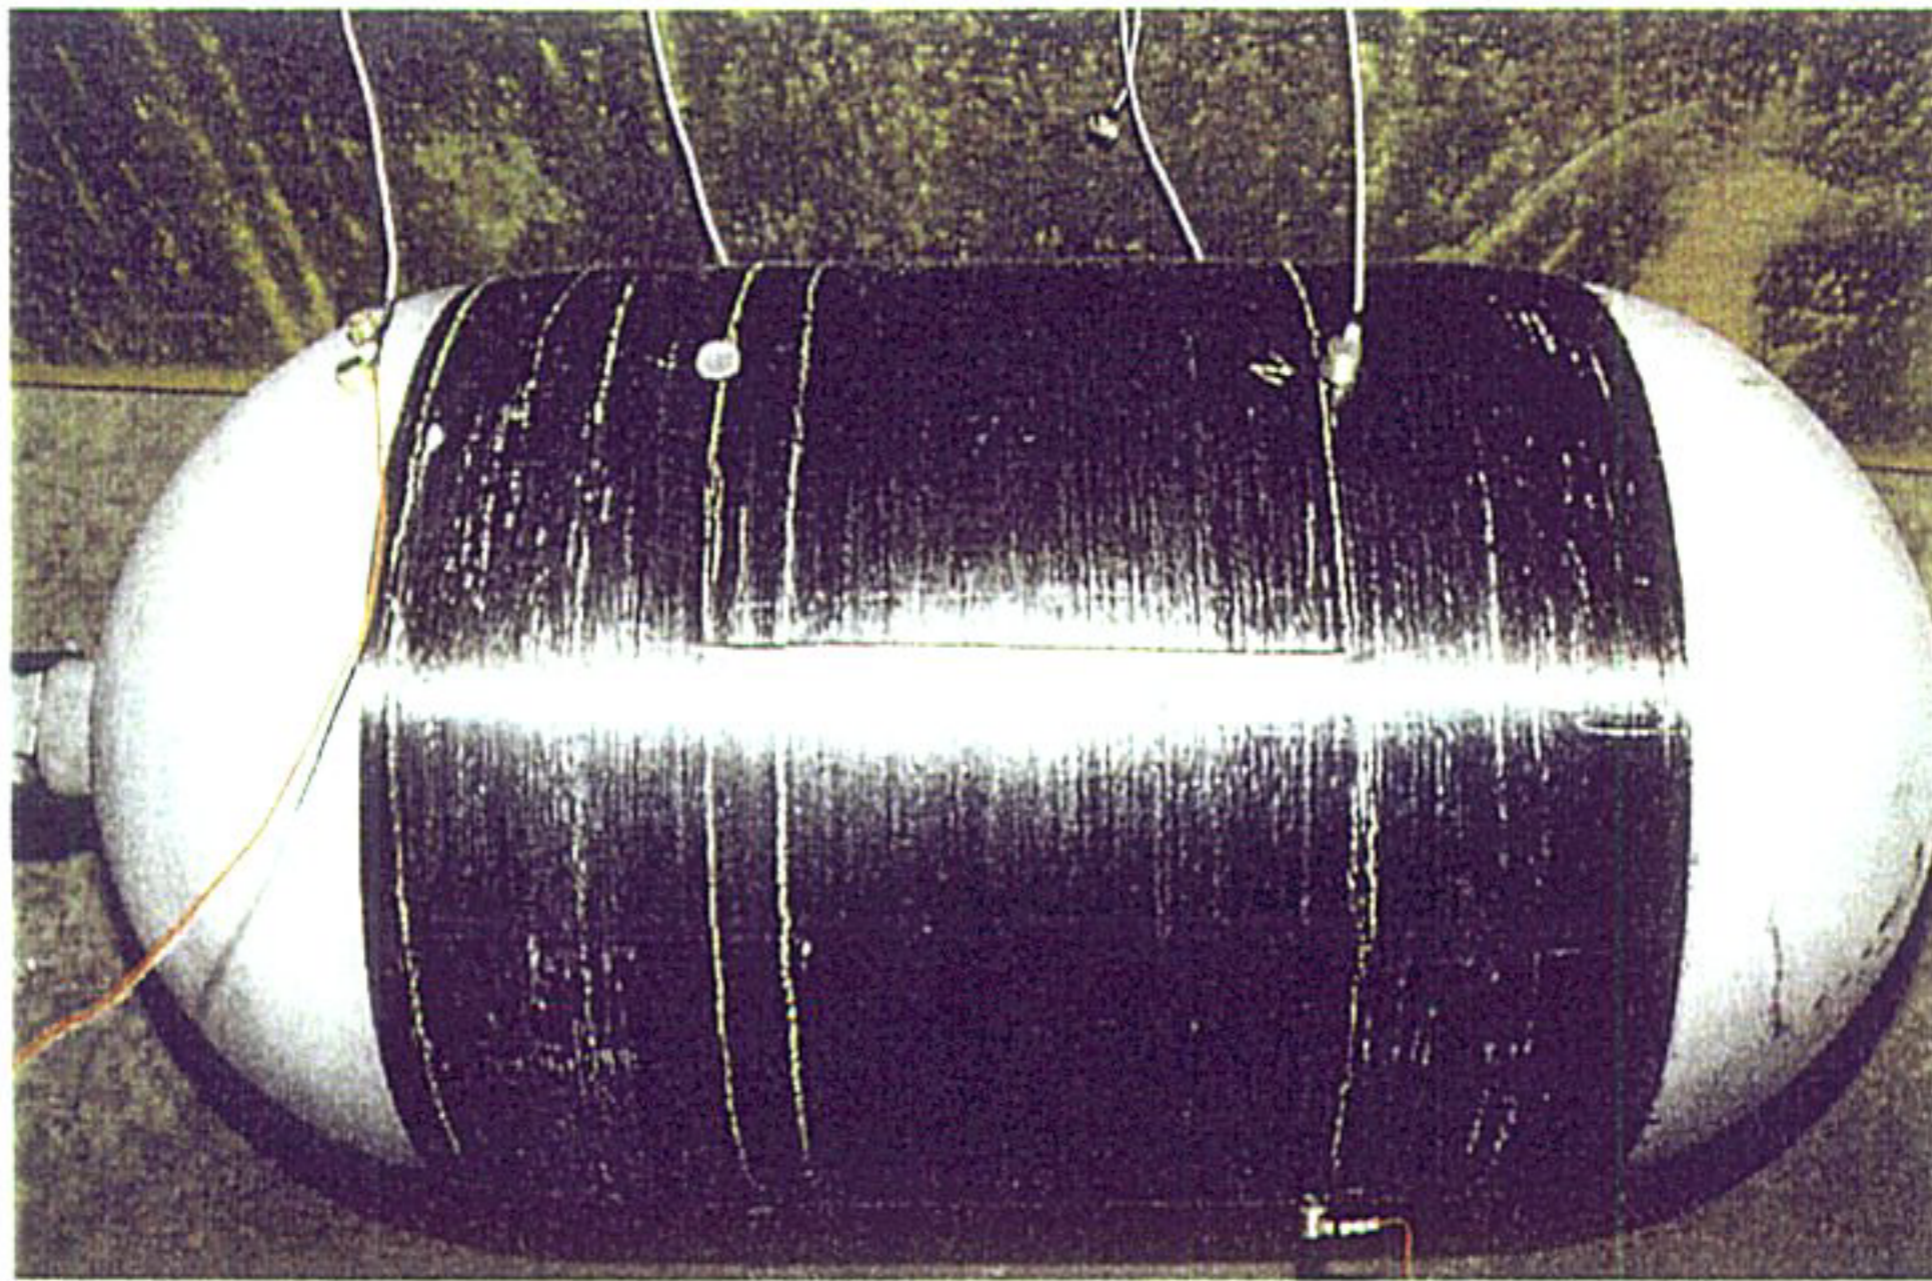
Figure 67. Circumferential Cracks at the Ends of the 8-inch Slit in Tank 018

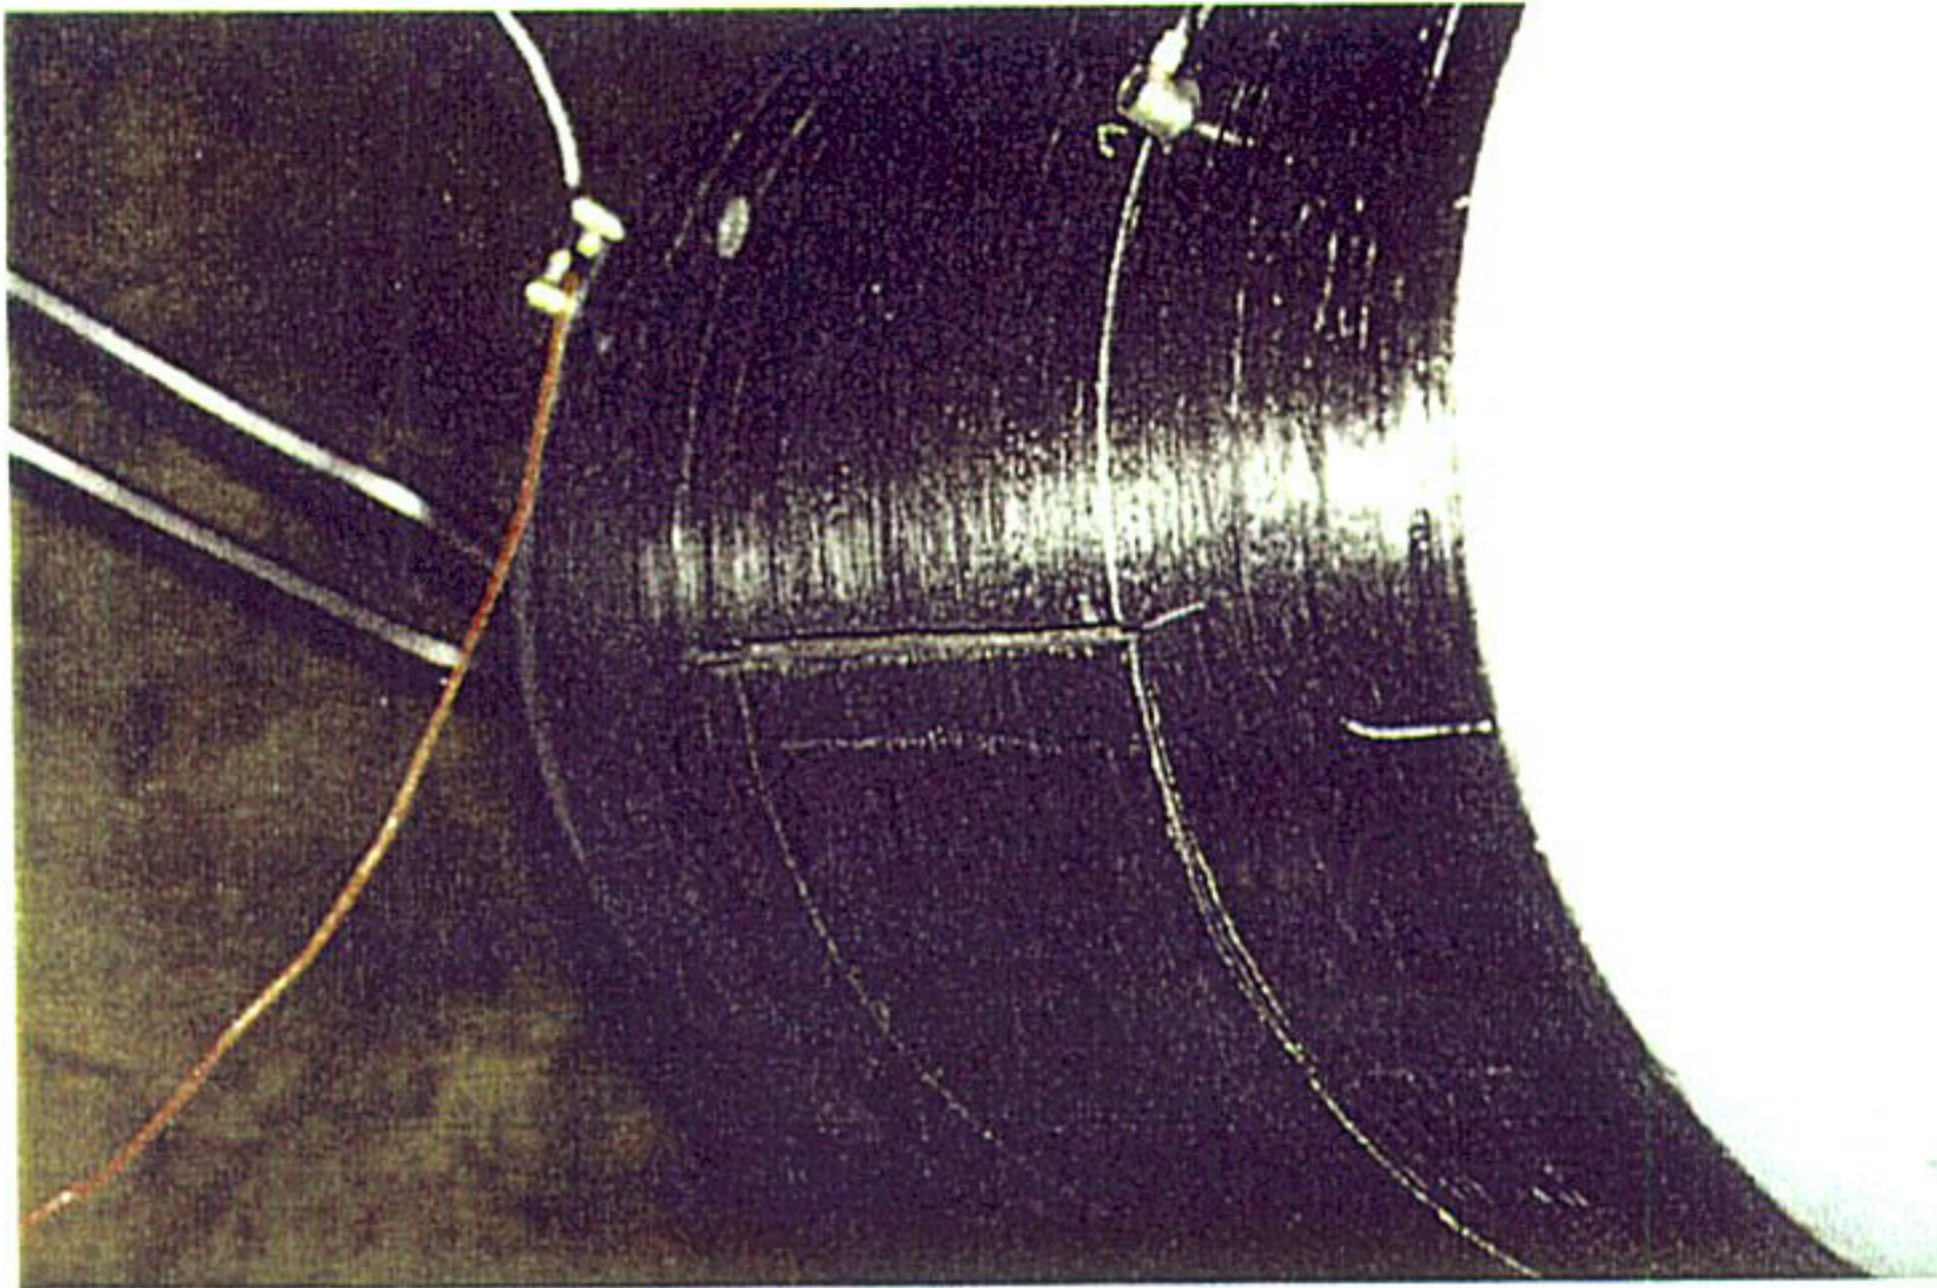
Figure 68. Oblique View of Slit Following Pressurization

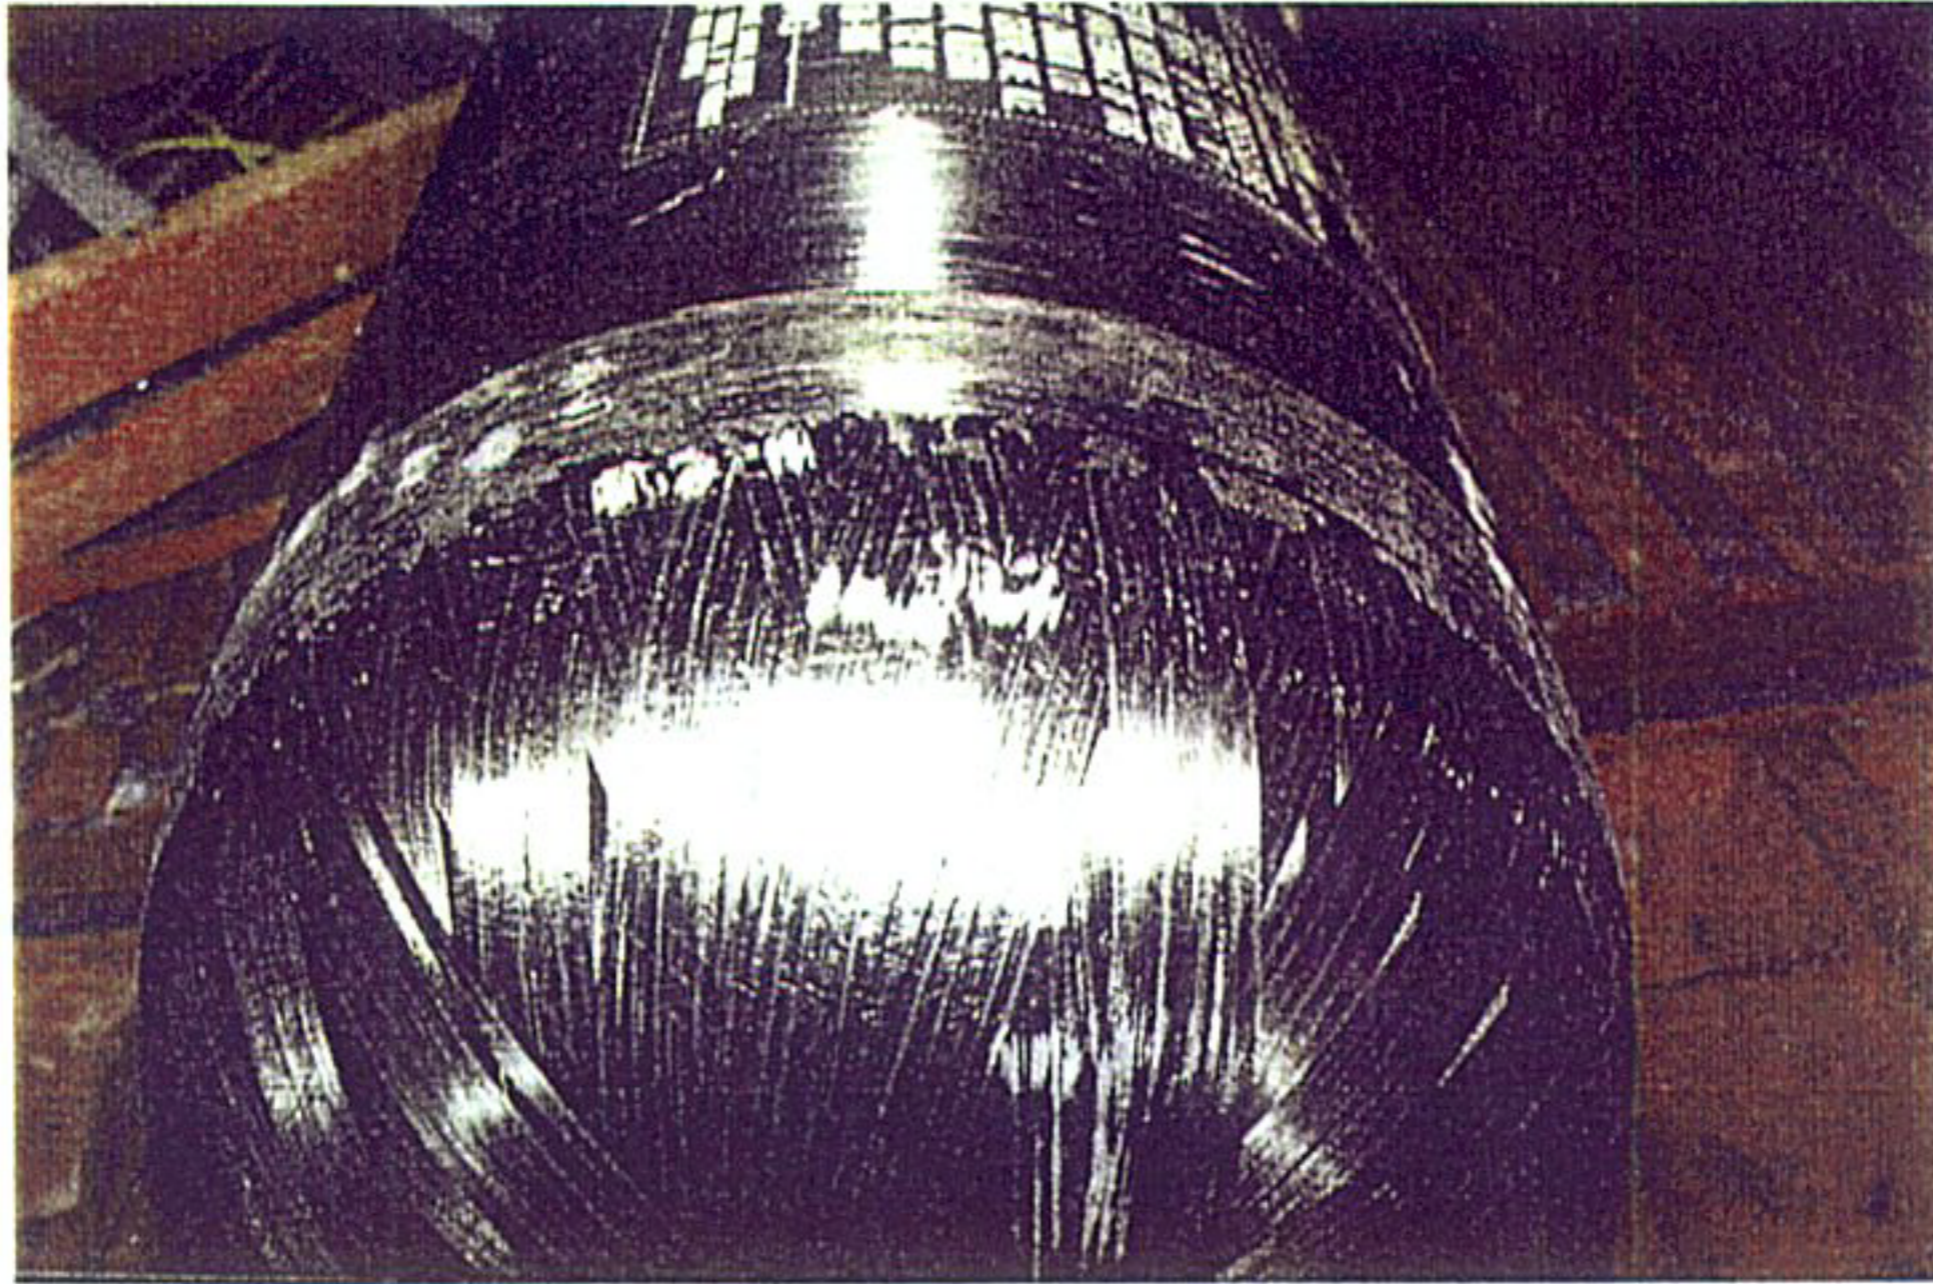
Figure 82. Secondary Damage on Tank 003
