Enclosed is the final report prepared by EXponent (formerly Failure Analysis Associates) entitled, "Development of Inspection Technology for NGV Fuel Tanks." This report relates to Project B.7 (Development of Criteria and Methodologies for In-Service Inspections of Gaseous Fuel Pressure Vessels).

Exponent Failure Analysis Associates, Inc. (FaAA) is pleased to submit the revised report, Development of Inspection Technology for NGV Fuel Tanks. The report was revised in response to comments received from Southwest Research Institute (SwRI) and Powertech Labs (Powertech) documented in the letter of March 20, 1998, from the National Highway Traffic Safety Administration (NHTSA). The following changes were made:

GM contracted with Failure Analysis Associates, Inc. (FaAA), to evaluate techniques for in-service inspection of natural gas vehicle (NGV) fuel tanks. The fuel tank is typically a composite overwrapped pressure vessel (COPV), which stores the gas at approximately 3,000 psig. The fuel tank consists of an inner liner, made either of metal or plastic, to contain the gas and a composite overwrap, typically filament wound with carbon or glass fibers, to resist the internal pressure.

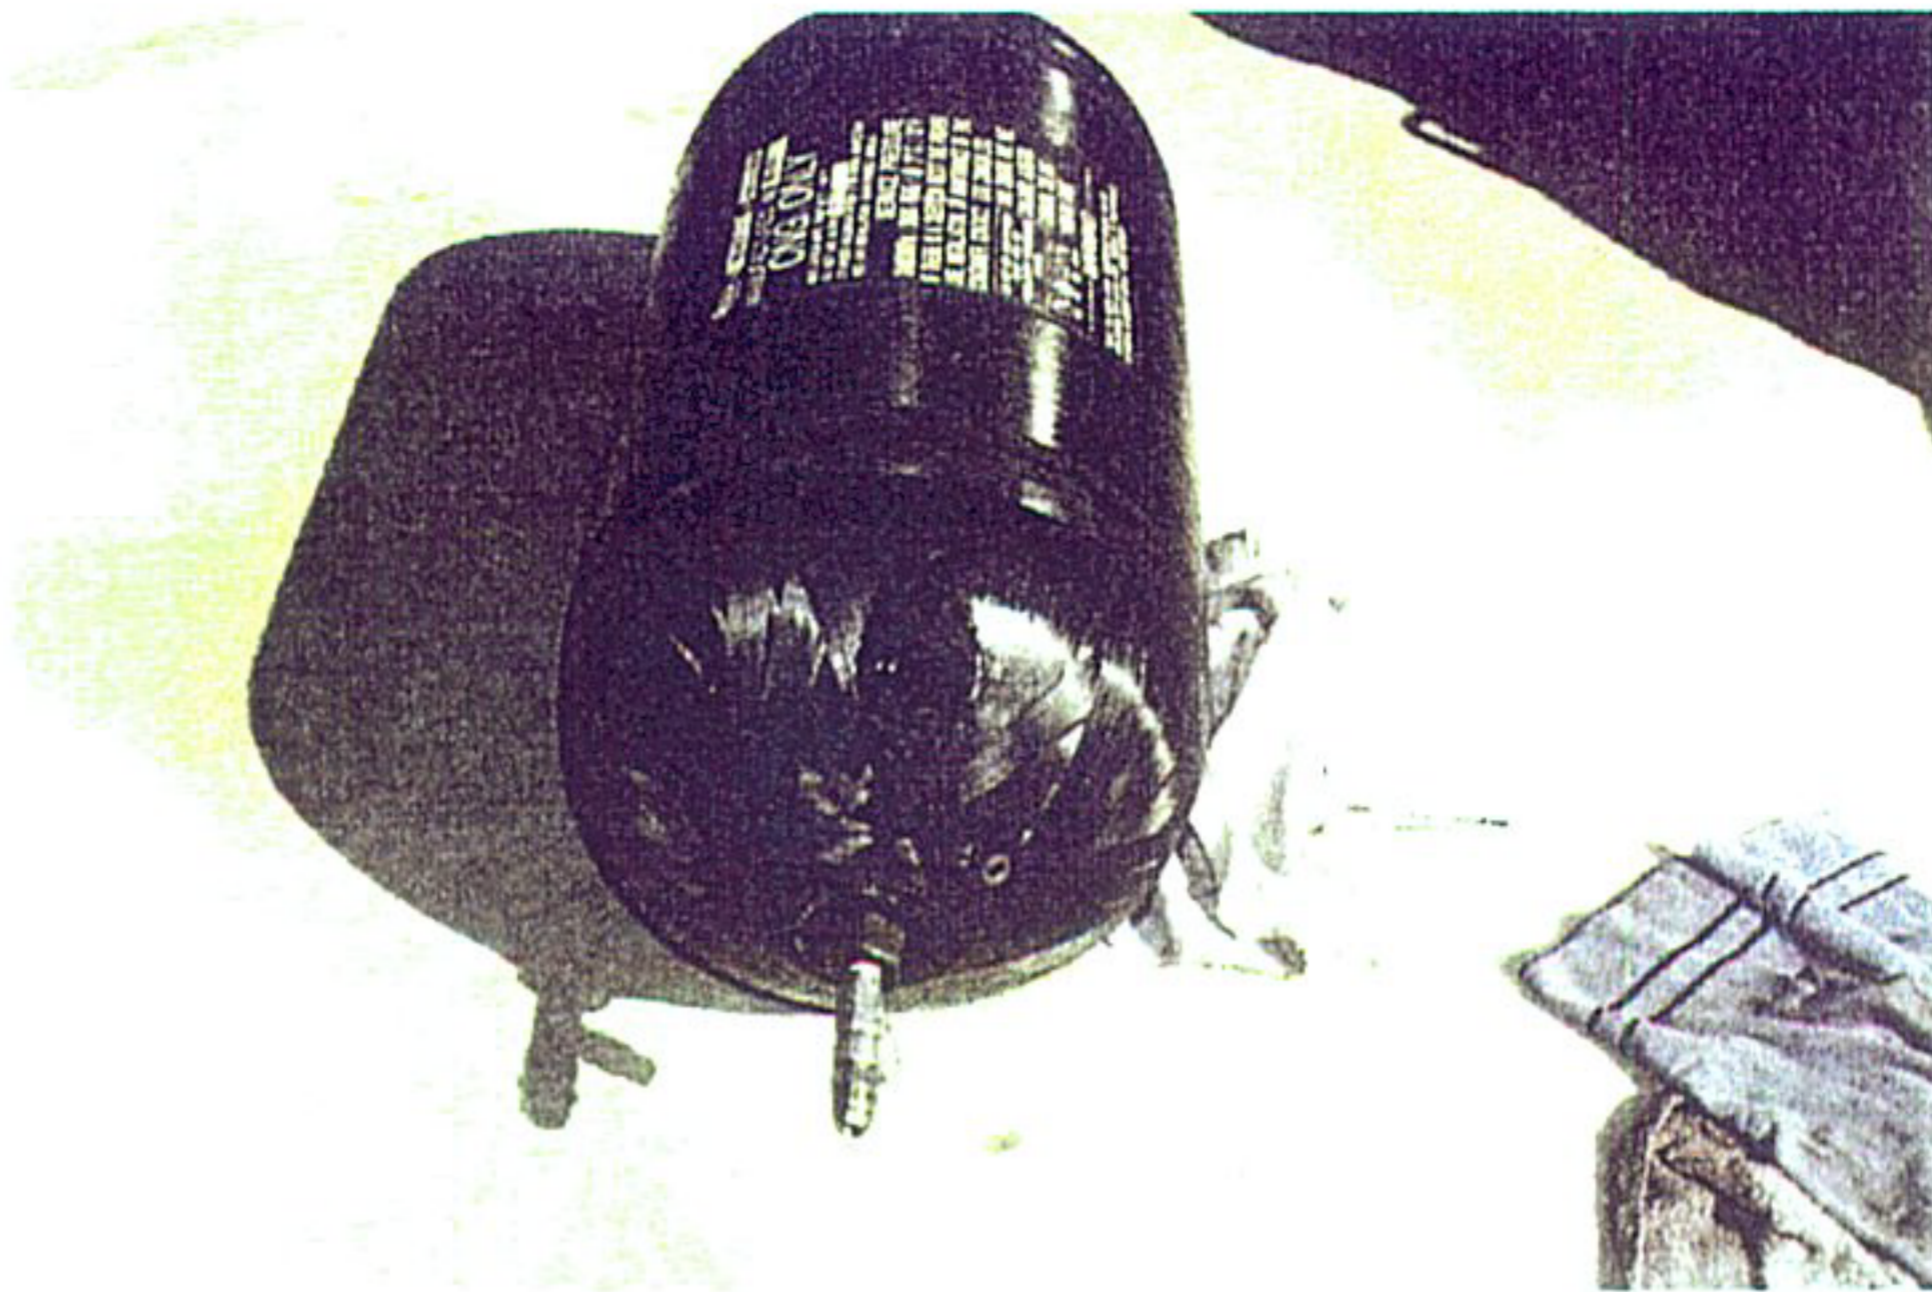
The one Type 4 NGV fuel tank, which sustained damage from a 5-foot drop test, did fail following 8,146 fatigue cycles (54% of the design lifetime). Failure occurred at the impact site in the transition region of the tank. At this location, the acoustic emission inspection detected matrix cracking during pressure cycling and fiber breakage just prior to failure.

Figure 84. Failed Area on Tank 003

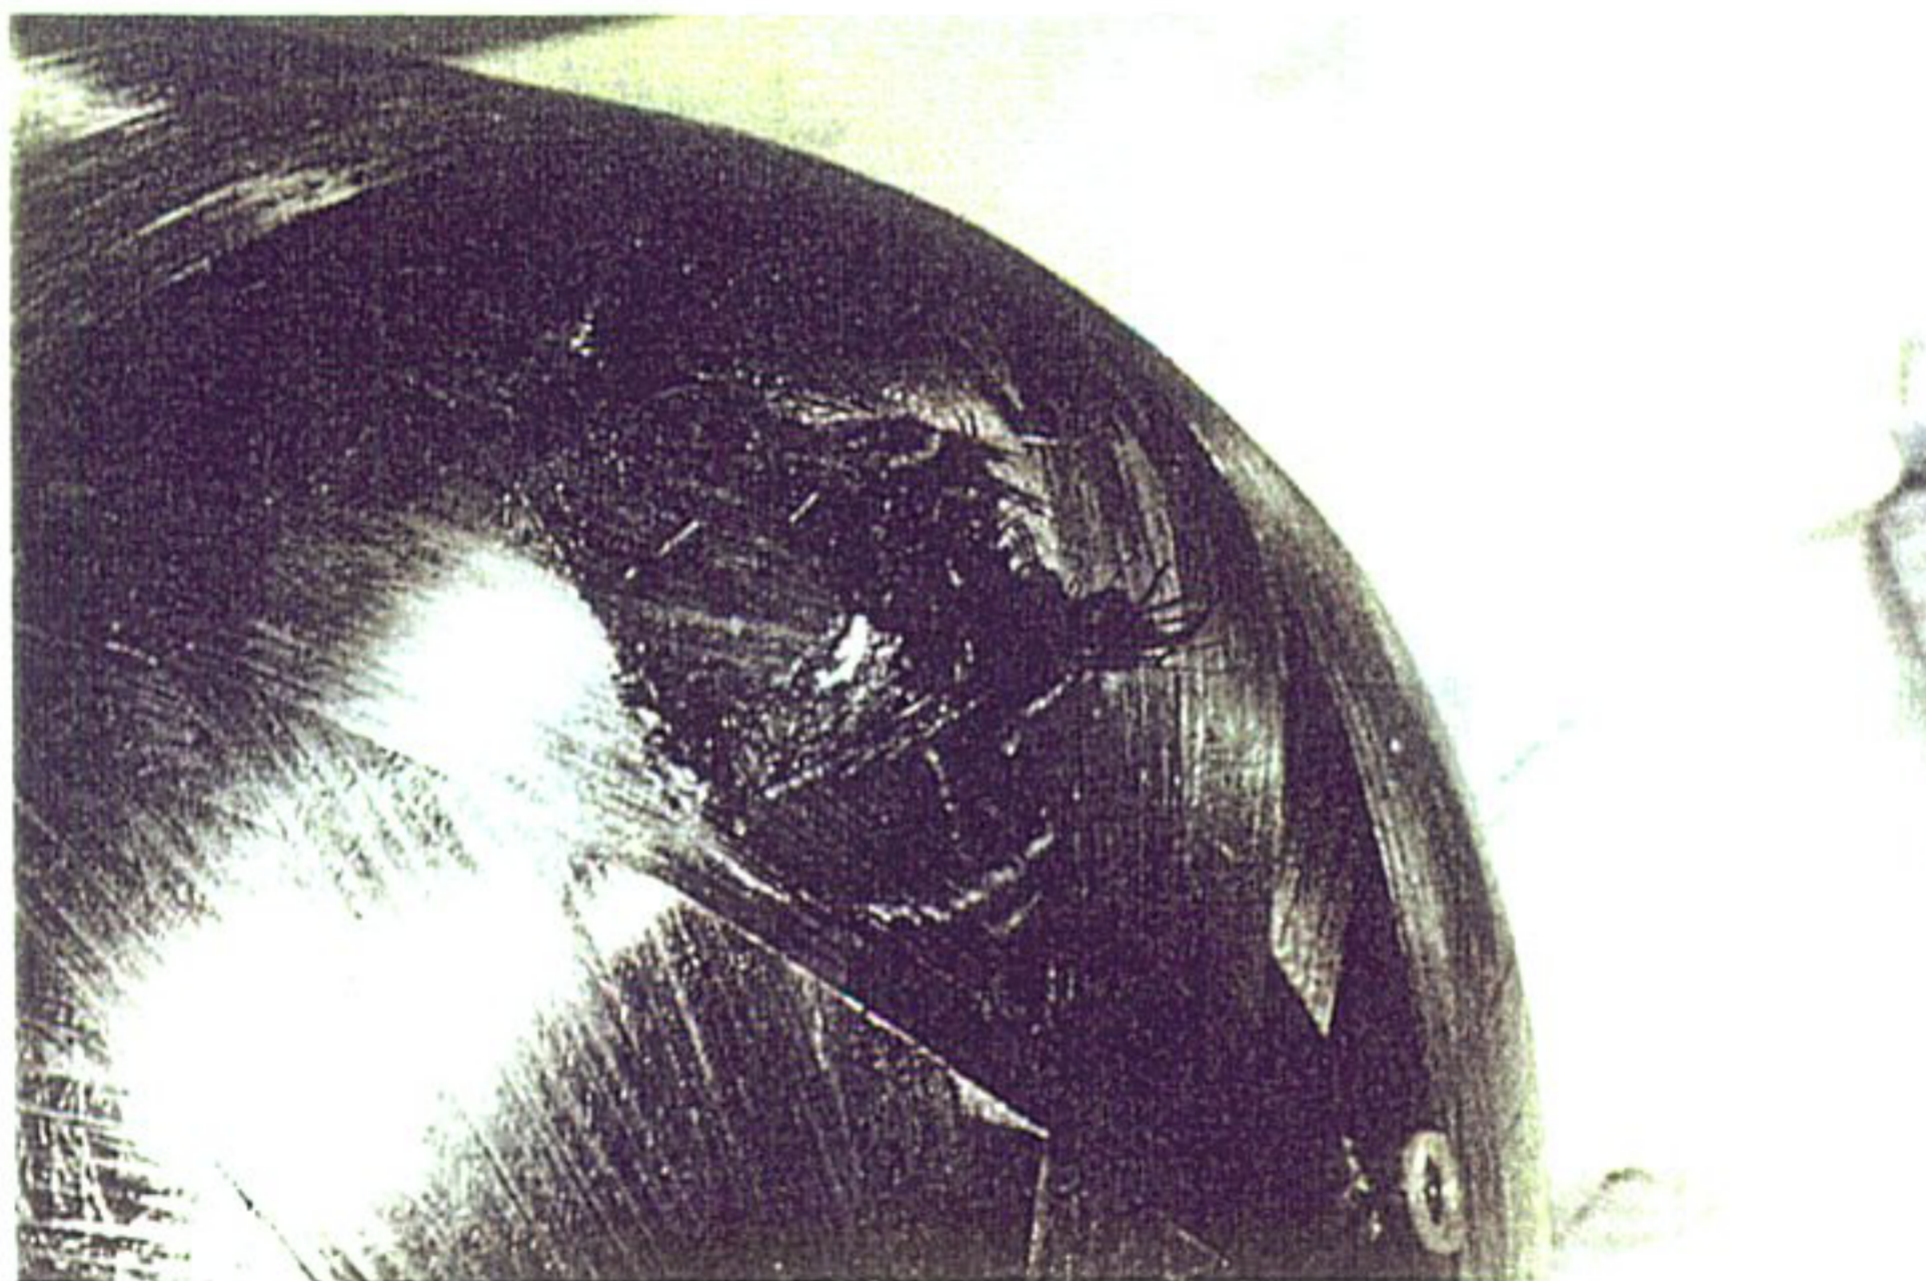
Figure 85. Failed Area on Tank 003, Close-up

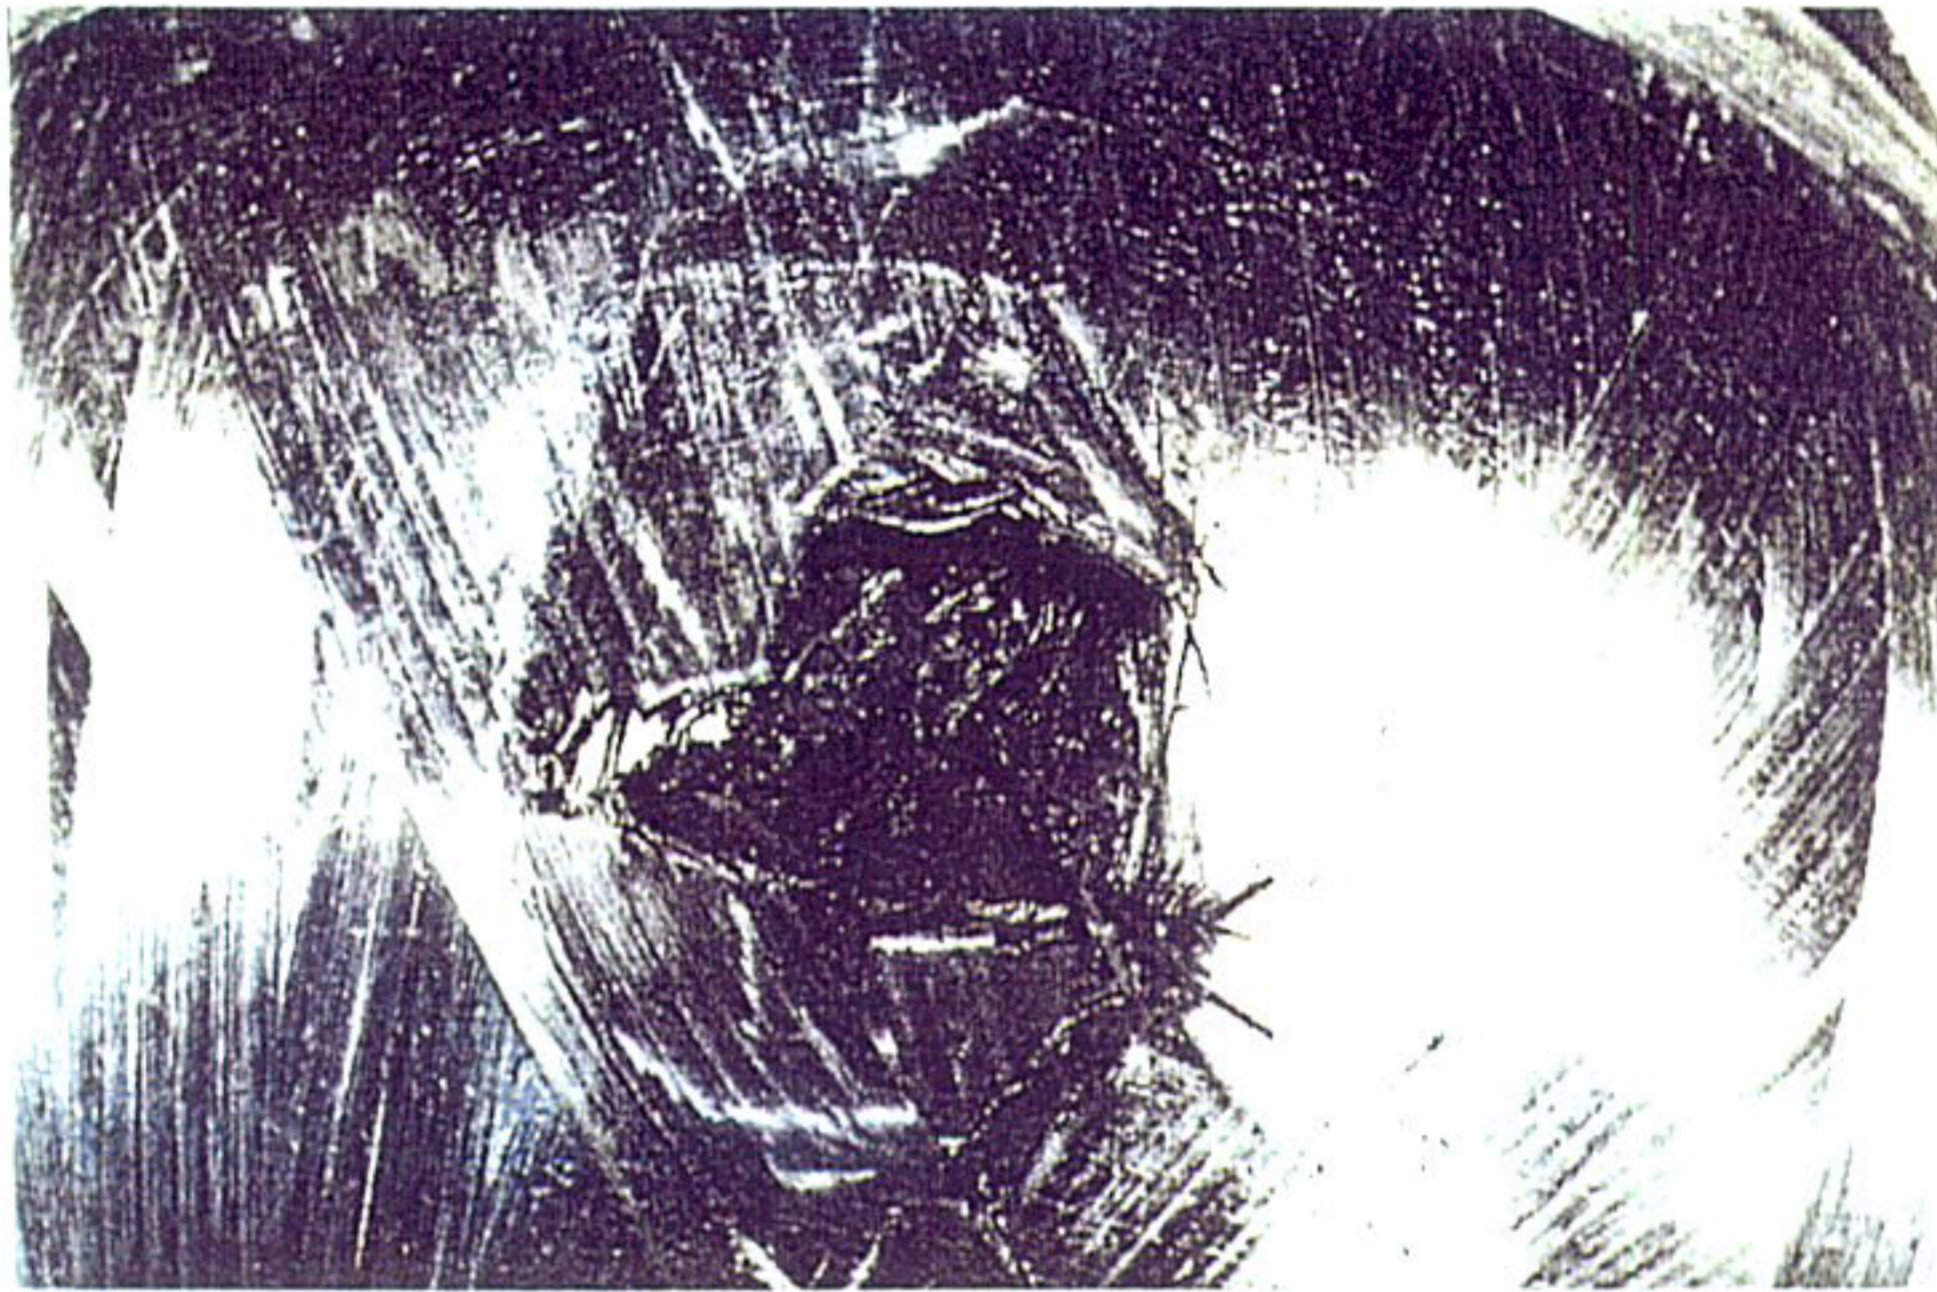
Figure 86. Failed Area on Tank 003, Oblique View
