NHTSA-98-3588-190

Project B.14 – Demonstration of Enhanced Fire Safety Technology – Fire Retardant Materials

Part 1: Full Scale Vehicle Fire Tests of a Control Vehicle and a Test Vehicle Containing an HVAC Module Made from Polymers Containing Flame Retardant Chemicals

**Jeffrey Santrock
General Motors Corporation**

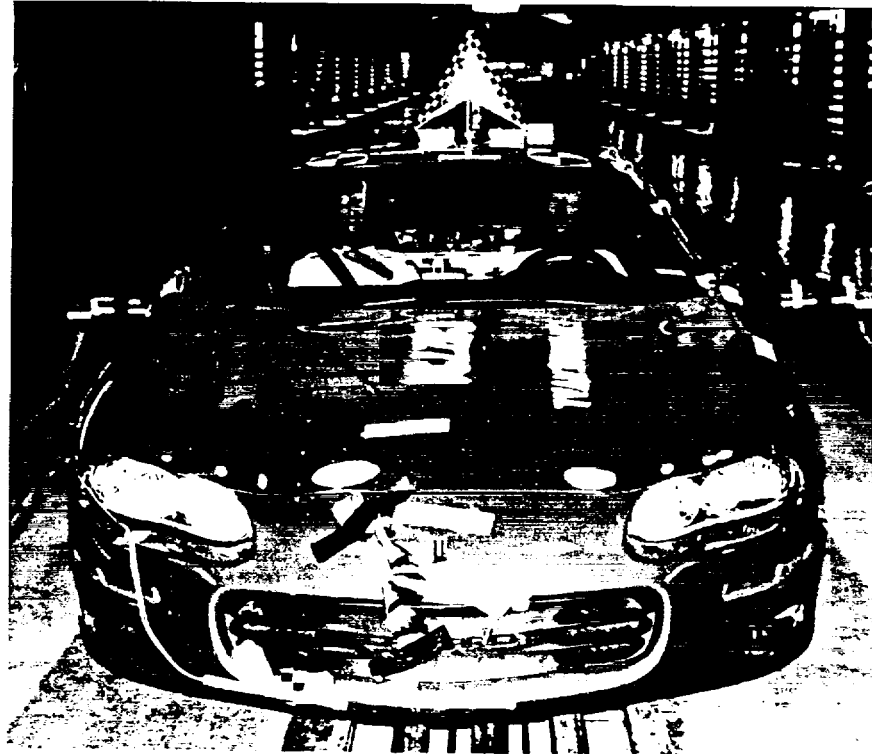
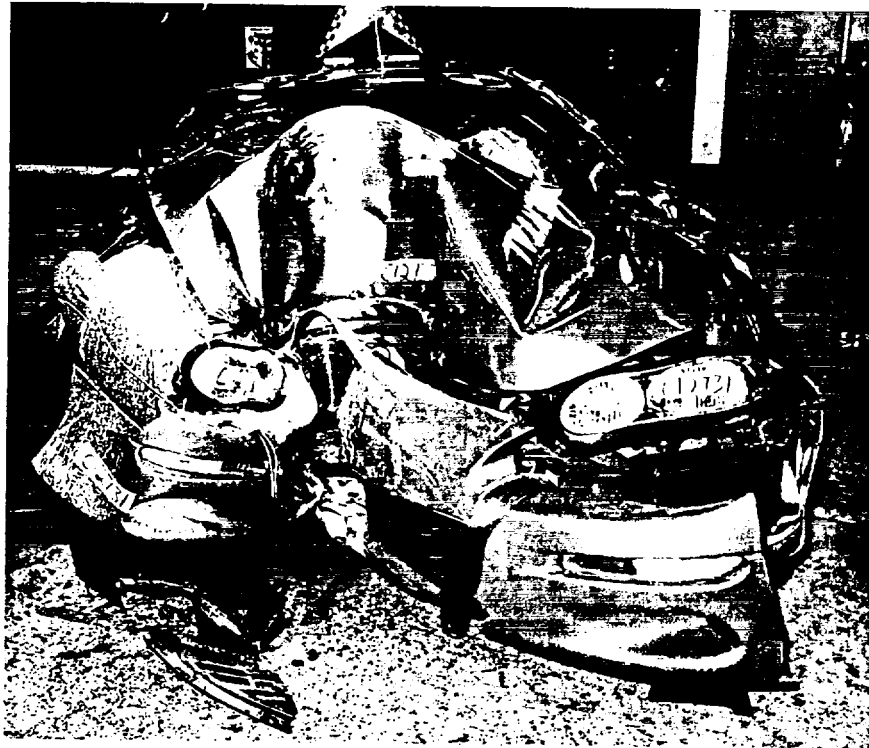
Figure 3. Crash Test C12731. Photographs of the FR Vehicle before (upper) and after (lower) the crash test.

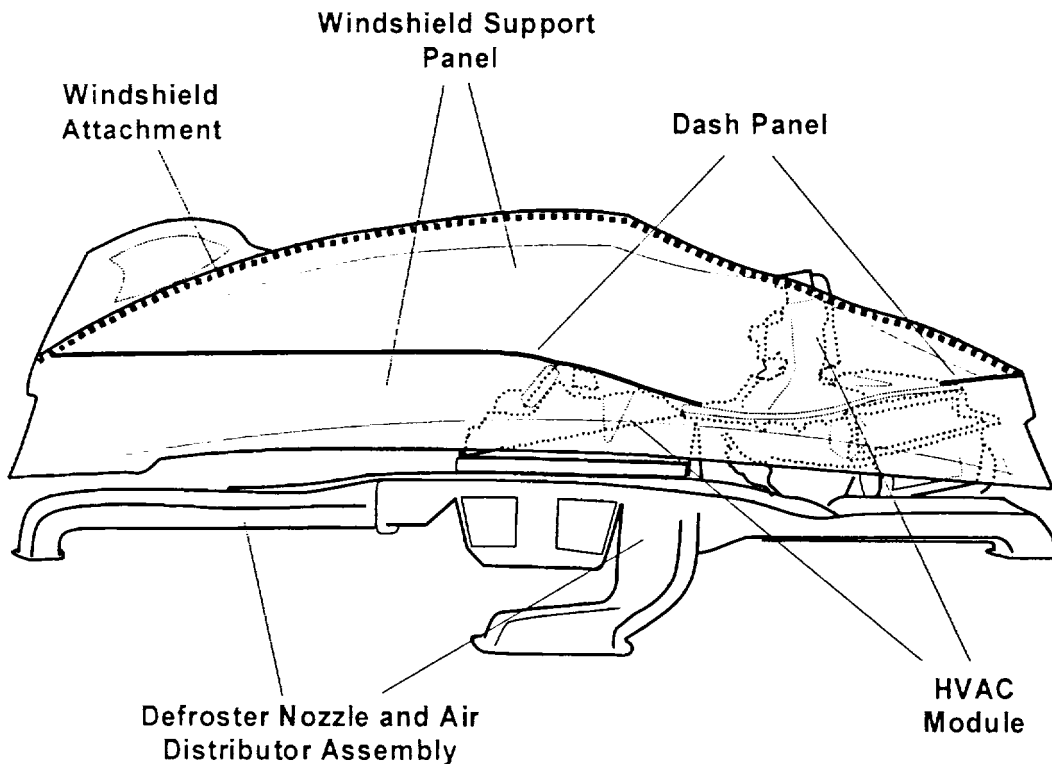
The dashed line indicates where the lower edge of the windshield was attached to the lower windshield support panel. This diagram also shows the approximate locations of the HVAC module, and defroster nozzle and air distributor assembly.

In both test vehicles, the glass outer layers of the windshields⁵ shattered during the crash tests. The right side of the dash panels deformed and were displaced rearward. The right sides of the upper dash extension panels and windshield support panels were deformed, with the broken windshield partially detaching from deformed sections of windshield support panels. The sides and top of the windshields remained attached to the A-pillars and roof. The front section of the broken windshields sagged onto the instrument panel upper trim panel.

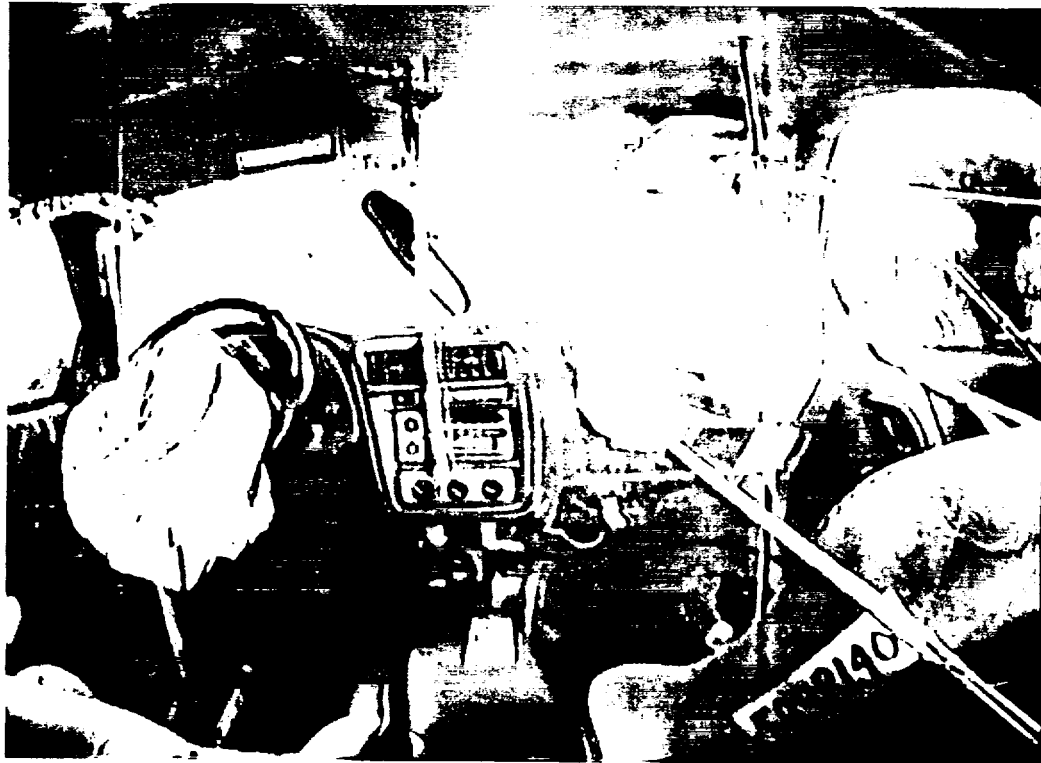
Figures 16 and 17 show video stills from Camera 1 at the time of ignition and at 7 minutes post-ignition in F99B1401 and F99B1402, respectively. The video stills in these figures show that in both test vehicles the windshields had sagged further onto the instrument panel top covers than at the start of these tests. The estimated temperature profiles in Figure 15 indicate that the temperature along the right sides of the windshields was $>100^{\circ}\text{C}$ at 7 minutes post-ignition in both test vehicles. Continued heating of the right sides of the windshields caused the windshield inner layers to soften further. Sections of the right sides of the windshields fell on the instrument panel top covers between 7 and 8 minutes post-ignition. Pieces of windshield had separated and fallen into the passenger compartments of both test vehicles by 8 minutes post ignition (Fig. 18). Pieces of windshield fell onto the instrument panel top cover, the passenger air bag covers, and the deployed passenger air bags (Fig. 19). Flames had spread rearward along the top of the instrument panels to the passenger air bag covers and deployed passenger air bags in both test vehicles by 12:30 min:sec post-ignition (Fig. 20). The lower sections of the right A-Pillar trim panels had ignited and were burning by this time (Fig. 20). Pieces of windshield where the innerlayer had ignited and was burning had fallen onto the right front seat cushion in F99B1401 and onto the deployed passenger air bag in F99B1402. The pieces of burning windshield extinguished before igniting the seat cushion in F99B1401 (upper video still, Fig. 20) and the deployed passenger air bag in F99B1402 (lower video still, Fig. 20).

Figure 16. Fire Test F99B1401. Video Stills from Camera 1 at the time of ignition (upper video still) and at 7 minutes post-ignition. (lower video still).

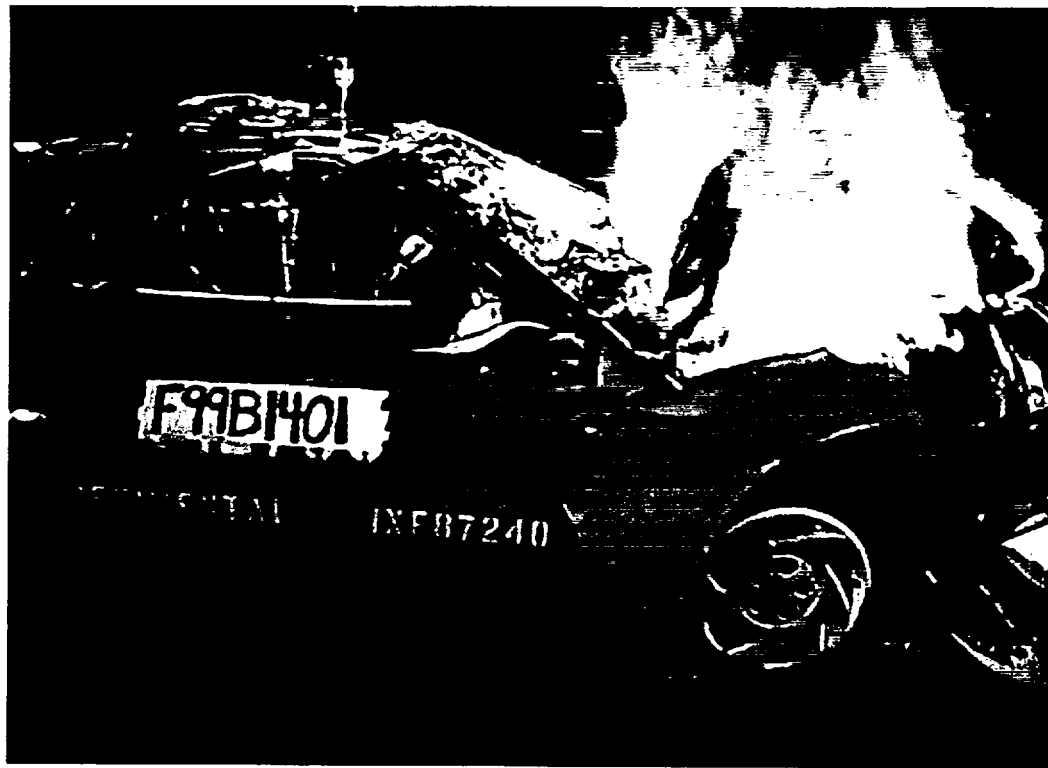
Figure 18. Video Stills from Camera 7 at 8 minutes post-ignition in Fire Test F99B1401 (upper video still) and in Fire Test F99B1402 (lower video still).

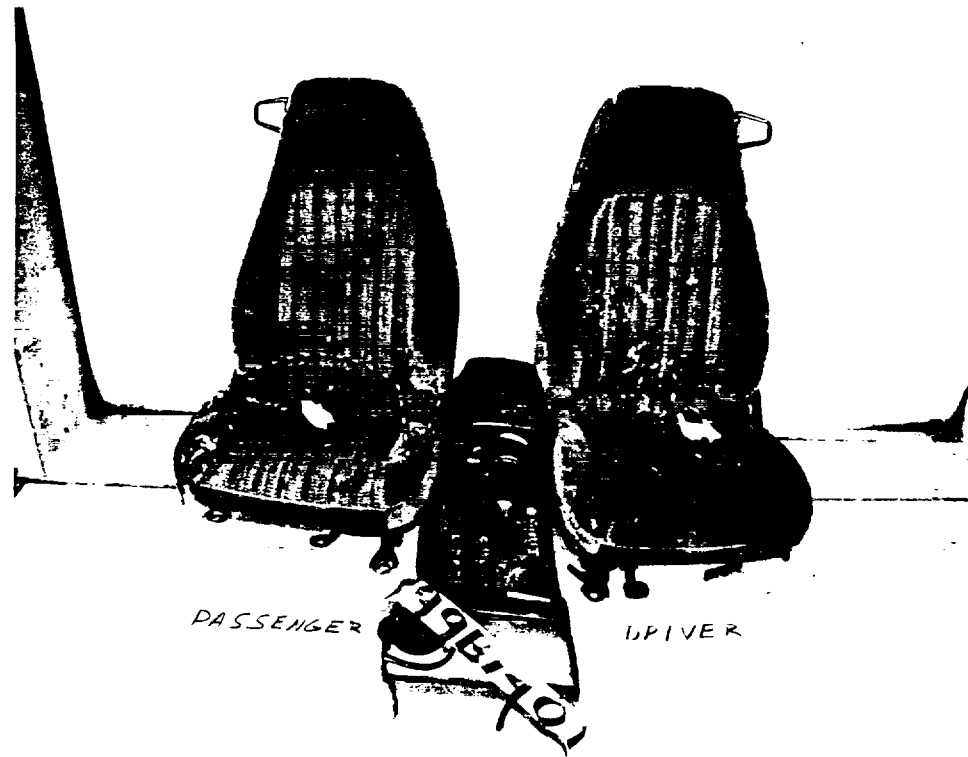
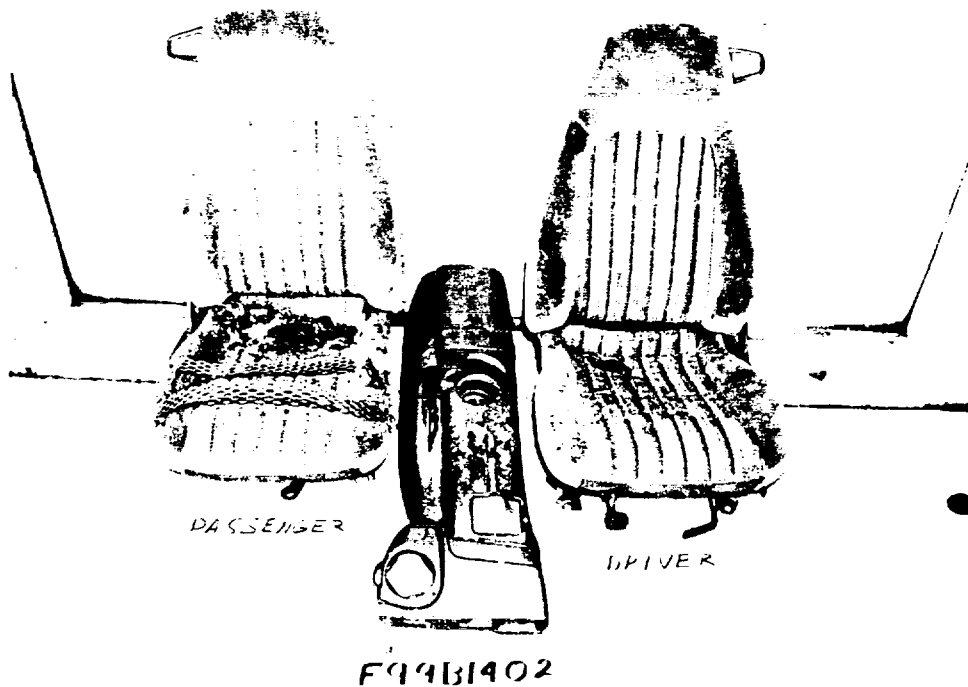
The patterns of fire damage observed in the passenger compartments of the test vehicles after these tests were consistent with flame-spread through the windshield. For example, the center and right of the windshields of both test vehicles had fallen into the passenger compartment (Fig. 21). Pieces of windshield were observed on the instrument panel upper trim panels, the instrument panels, the deployed passenger's airbags, and the front seat cushions (Fig. 21). The instrument panel upper trim panels in both test vehicles were melted and charred (Fig. 21). The inner layer was burned and charred in windshield fragments on the front and right side of the instrument panel upper trim panels, and on the deployed passenger air bags (Fig. 21). Pieces of windshield were observed on both of the front seat cushions in both test vehicles after these tests (Fig. 22). Sections of the right and left front seat cushions in F99B1401 and the right front seat cushion in F99B1402 were burned and charred.

Figure 22. Photographs of the front seats and center console removed from F99B1401 (upper photograph) and F99B1402 (lower photograph) after the fire tests.
