ESCAPE WORTHINESS OF VEHICLES FOR OCCUPANCY SURVIVALS AND CRASHES. SECOND PART: APPENDICES

OKLAHOMA UNIV. RESEARCH INST., NORMAN

DOT HS-800 737

Second Part: Appendices

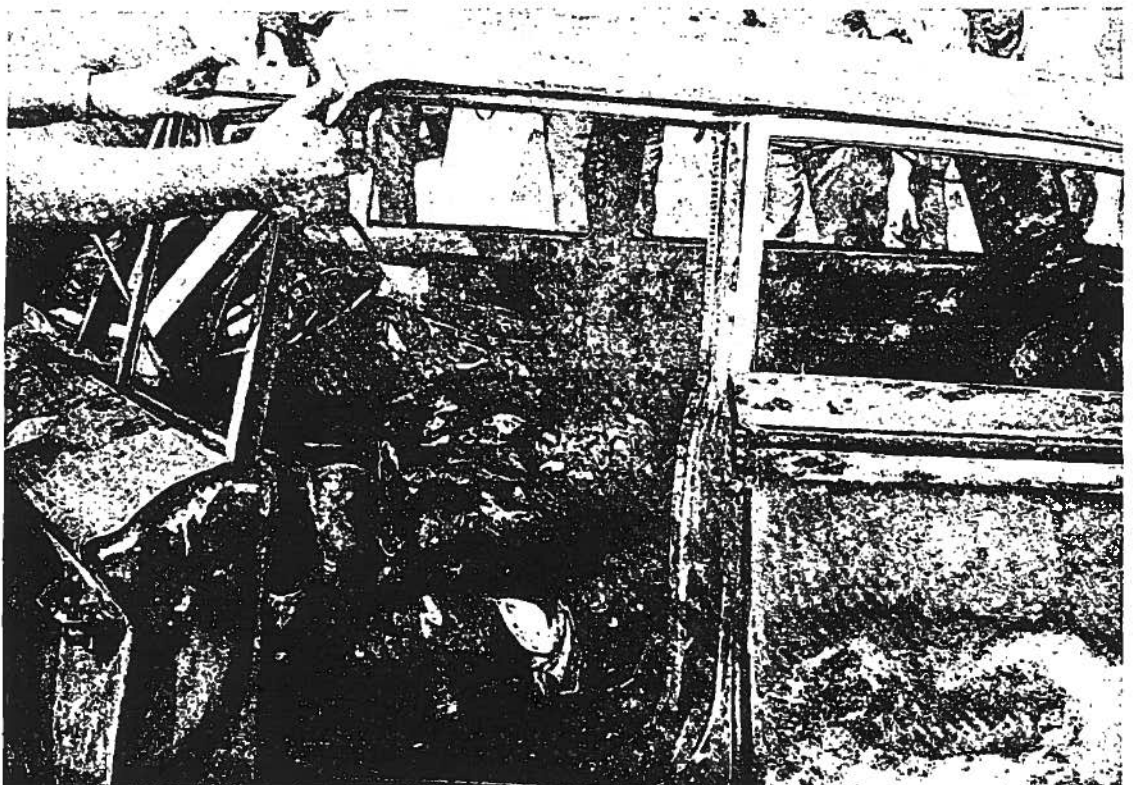
Figure 4. Fire damage, Vehicle #2, as door is pulled open after fire.

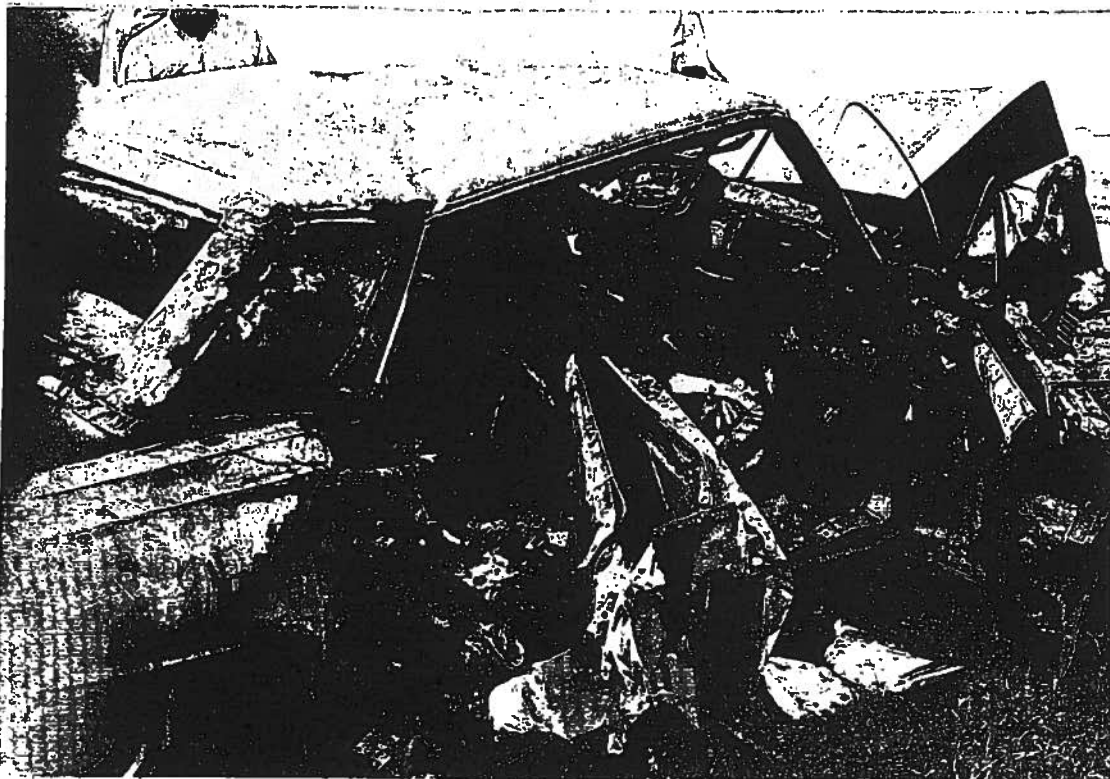
Figure 6. Vehicle #1, fire damage, immediately after doors were pulled open.

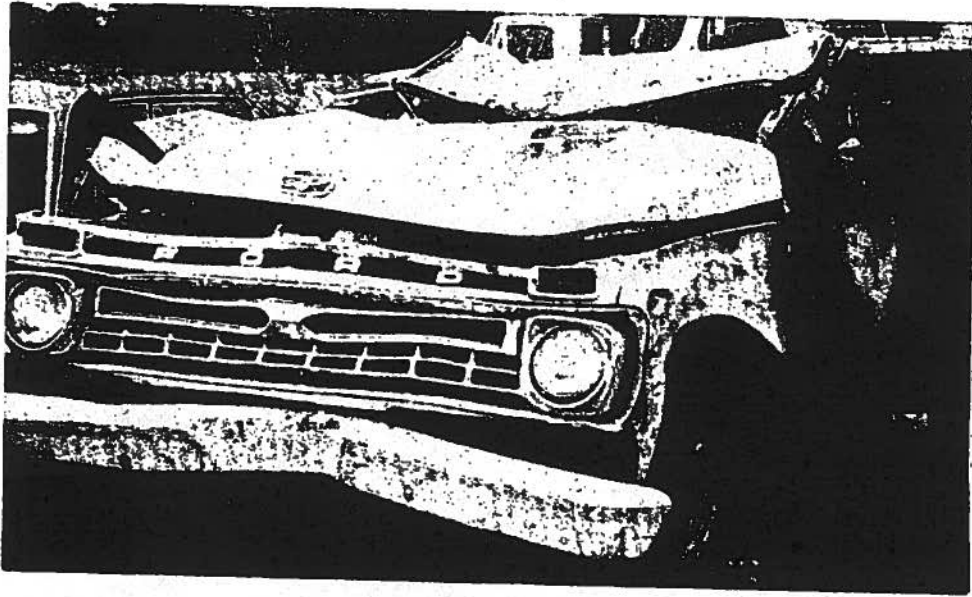
Figure 4. Front of submerged 1965 Ford pickup. Note damage to cab.

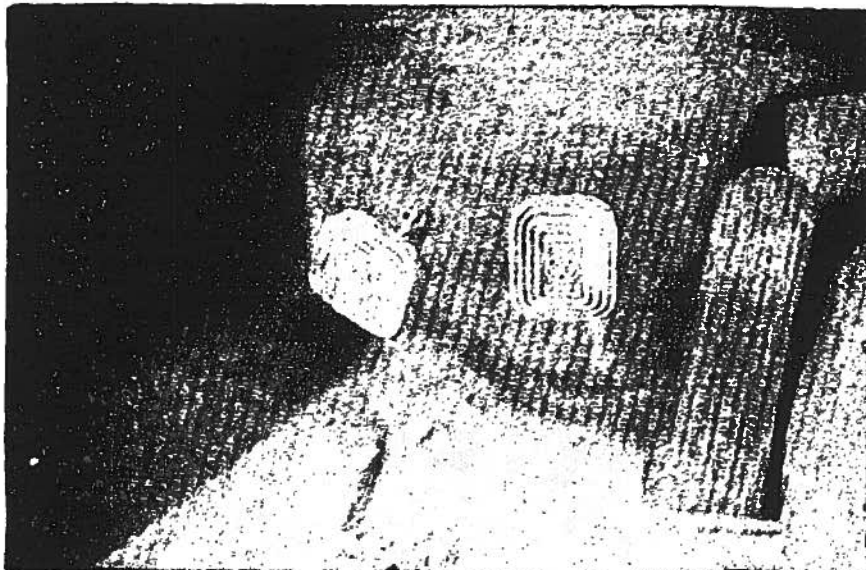
Figure 5. Interior, left side, showing impact area under the glove box and broken steering wheel.

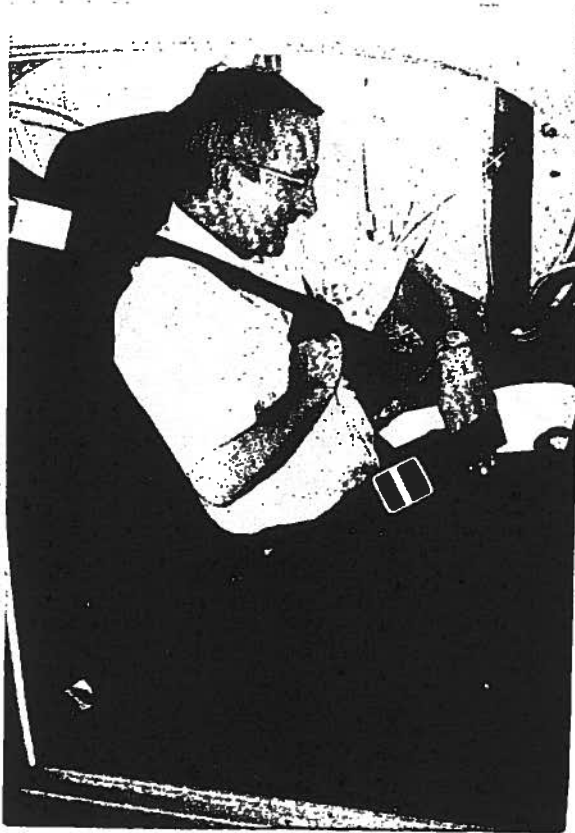
Figure 7. Seat belt on passenger side. Note loose adjustment. Subject in seat is 5'4", 140 pounds.

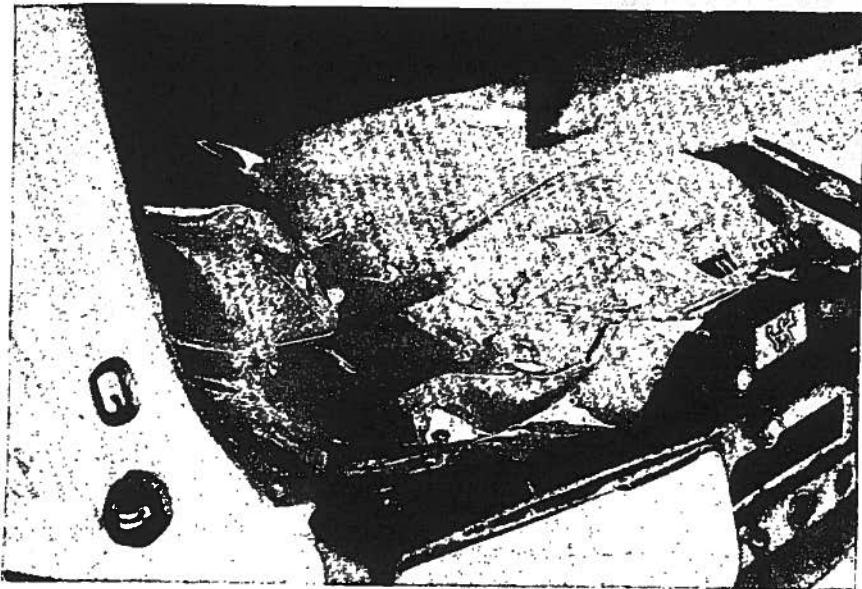
Figure 8. Impact area under glove box.

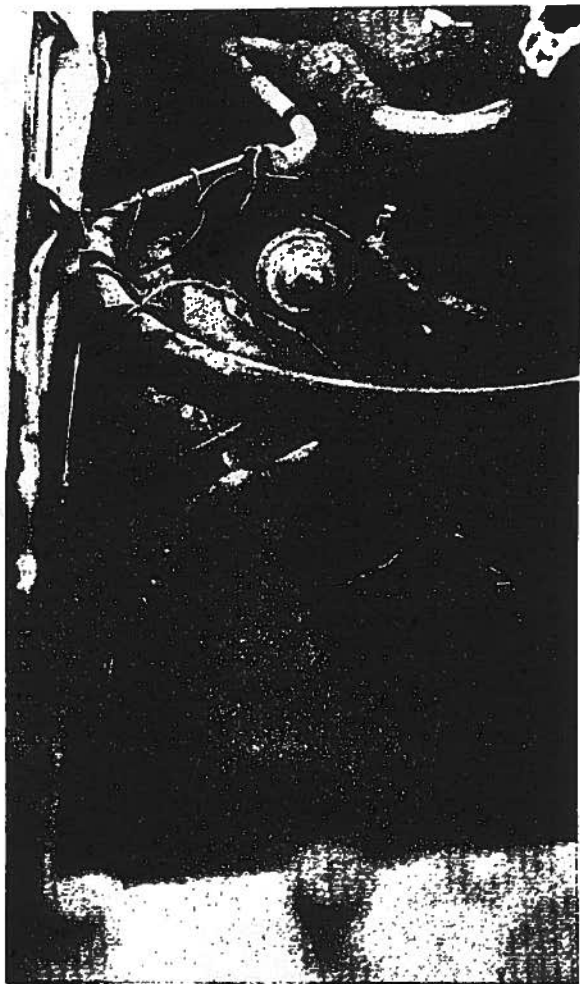
Figure 6. Bare wire from clamp to hose, and running back towards aluminum tubing.

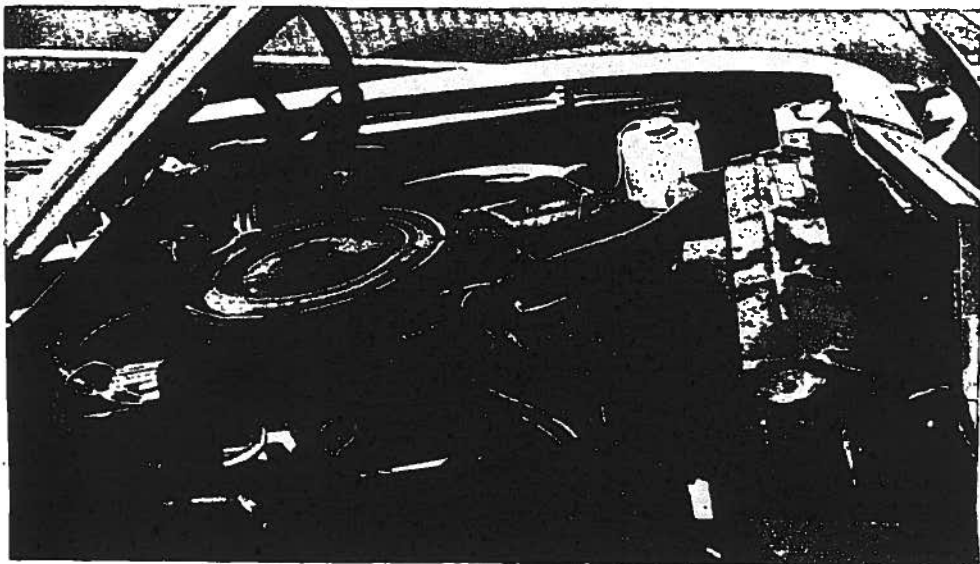
Figure 7. Note lack of burning in engine compartment.

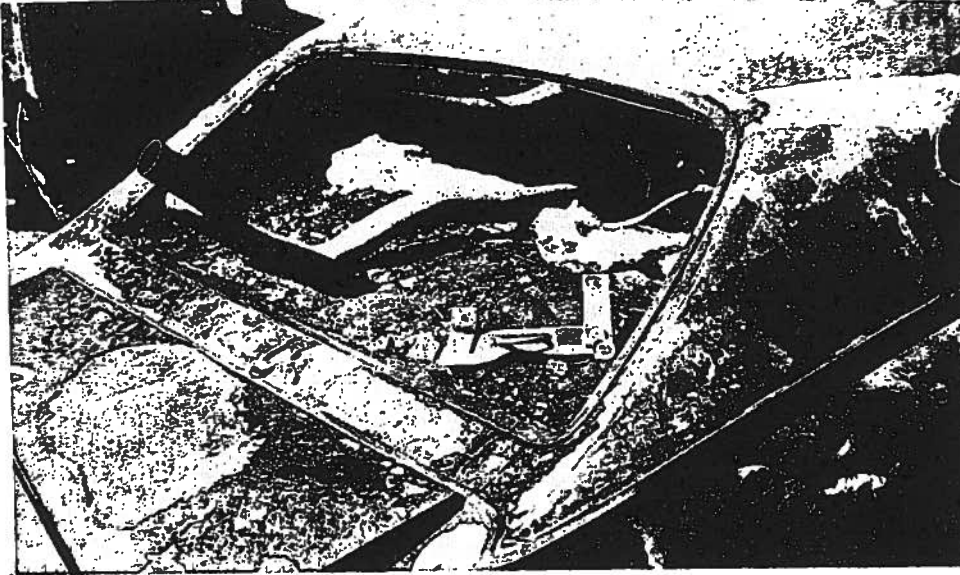
Figure 9. Note rear window glass lying on package shelf, body solder melted from roof joint.

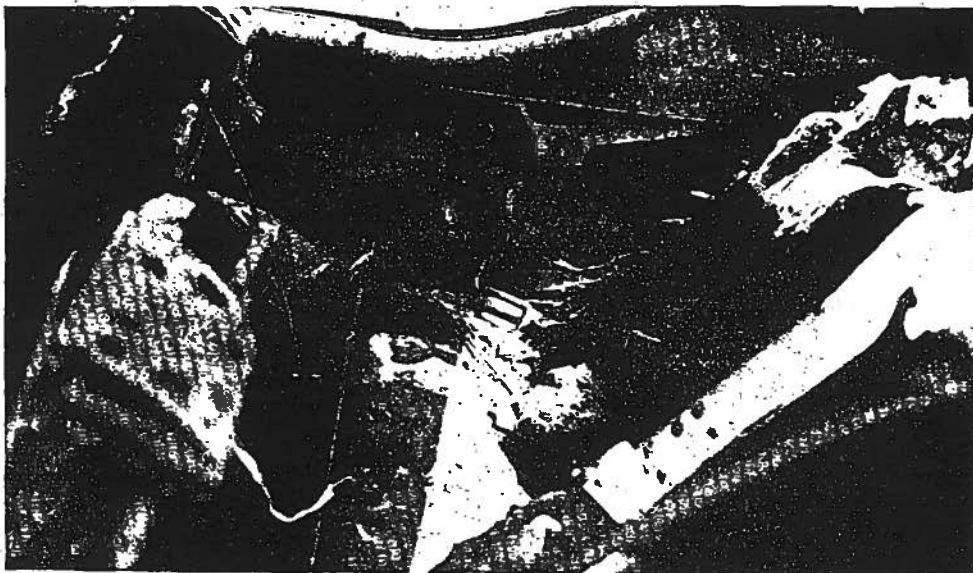
Figure 14. Rear seat area fire damage.

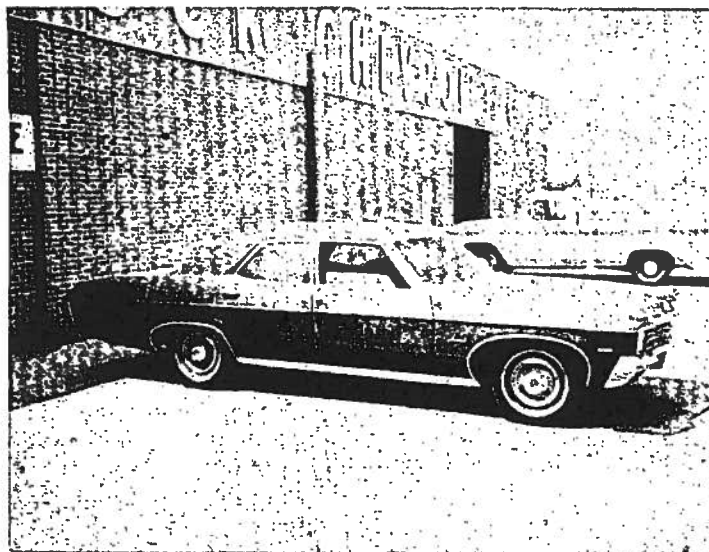
Figure 1. Over-all view of 1970 Chevrolet Impala with interior essentially destroyed by fire.

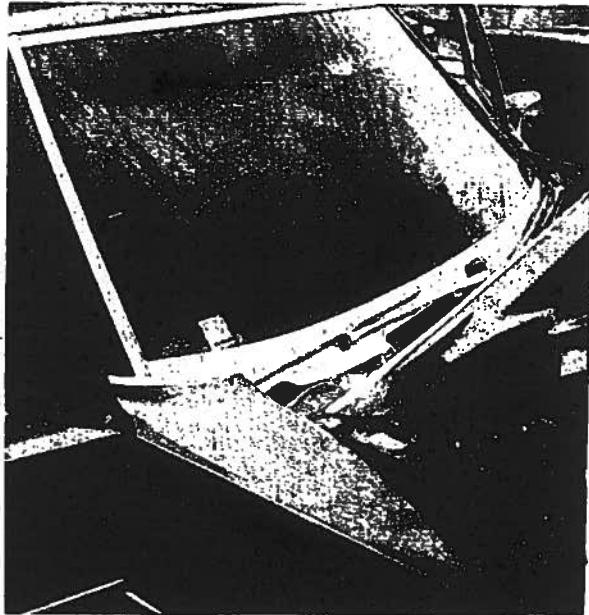
Figure 12. View of paper match cover with unlighted match inside found in place after the fire. Cover slightly scorched, vinyl crash pad covering in the immediate area totally destroyed.

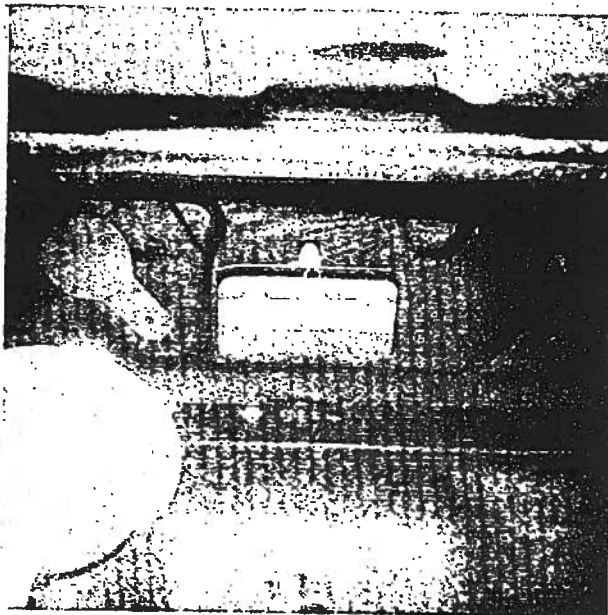
Figure 13. View of trunk interior. Note undamaged rear seat backing.

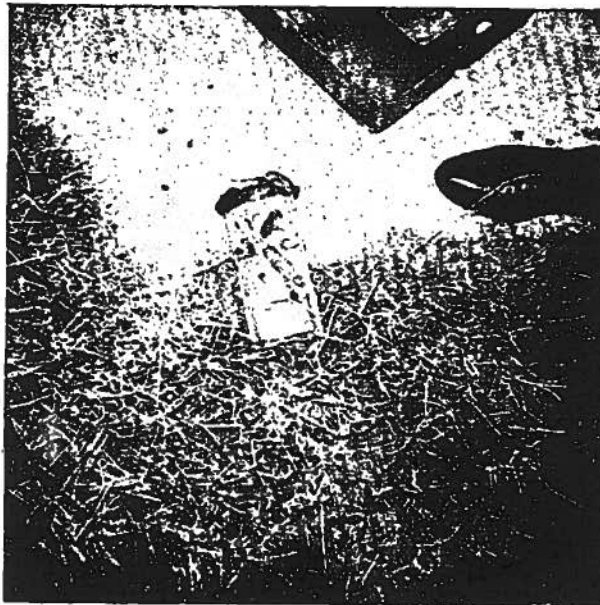
Figure 14. View of ash tray. Tray extended about one-half way. Note the unscorched condition of contents.

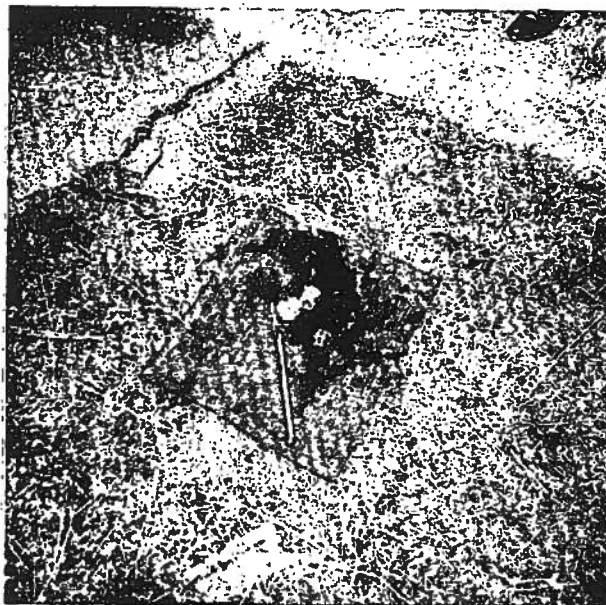
Figure 15. View of driver's rubber floor mat. Note undamaged condition. Debris is melted remains of plastic litter container.

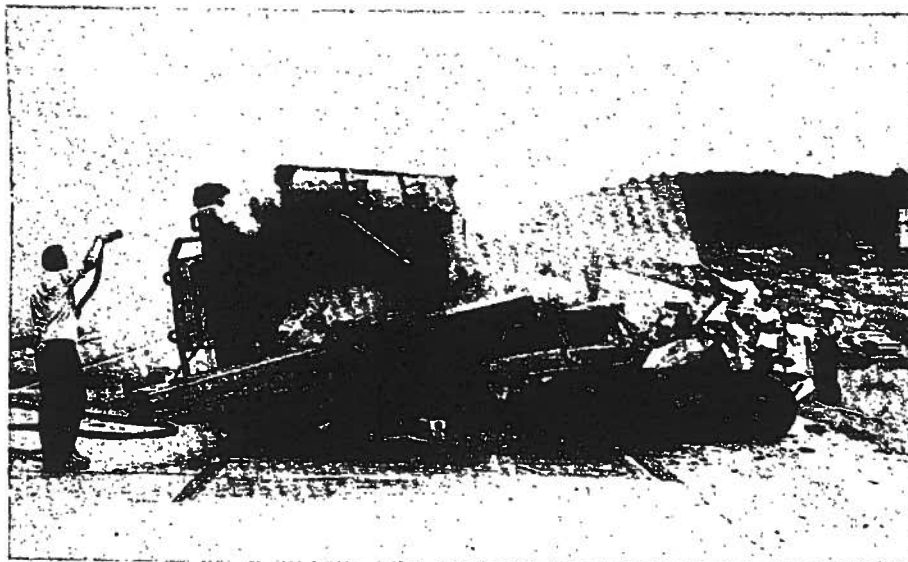
Figure 1. Collision scene showing truck overturned on passenger car, looking in the car's direction of travel.

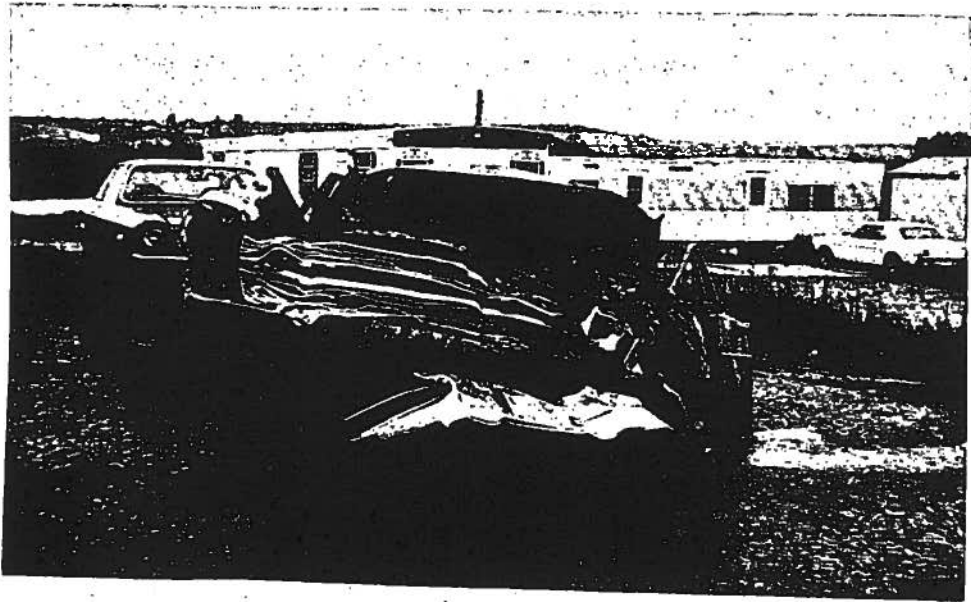
Figure 3. Vehicle 1. Front view of damage.

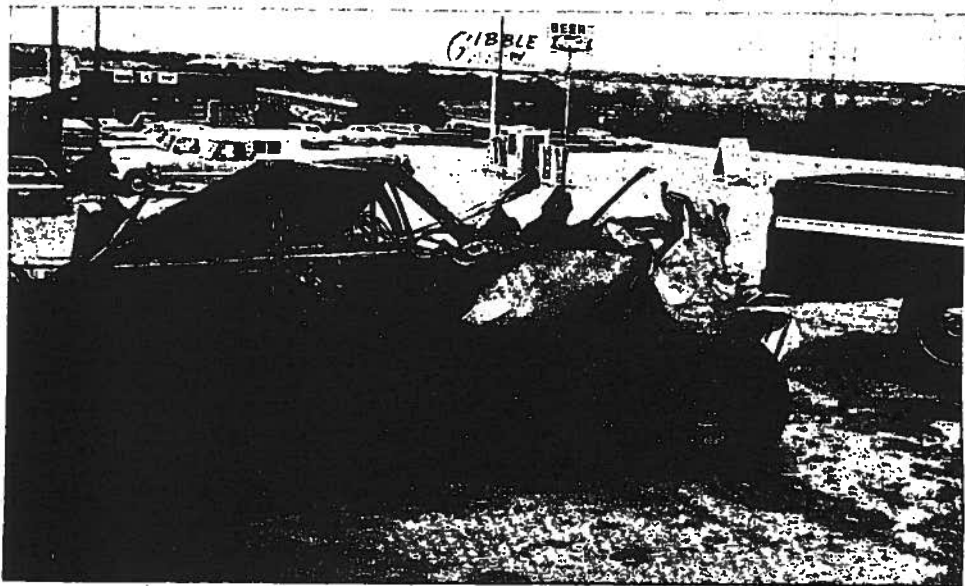
Figure 4. Vehicle 1. Side view of collision damage.

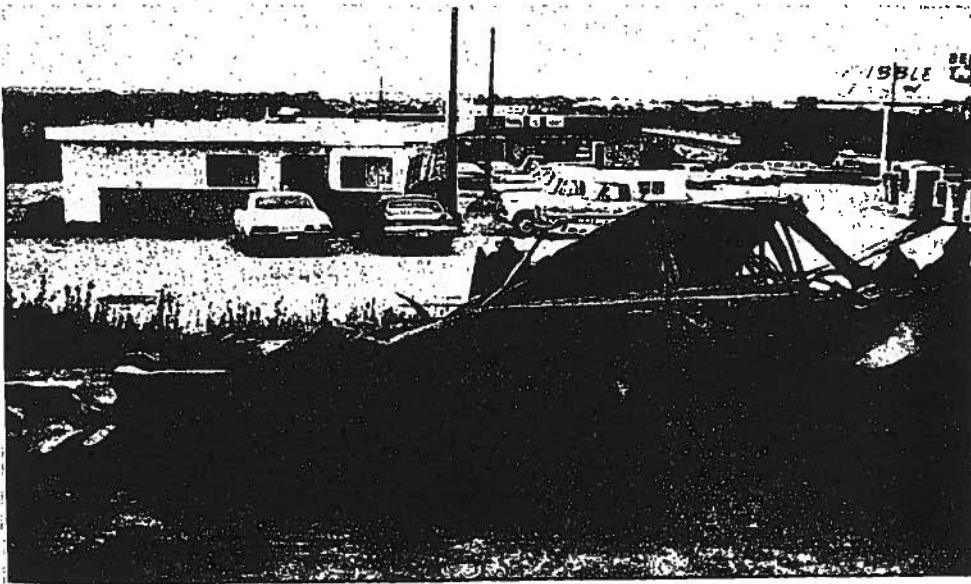
Figure 5. Vehicle 1. Side view showing extent of collapse caused by overturned truck.

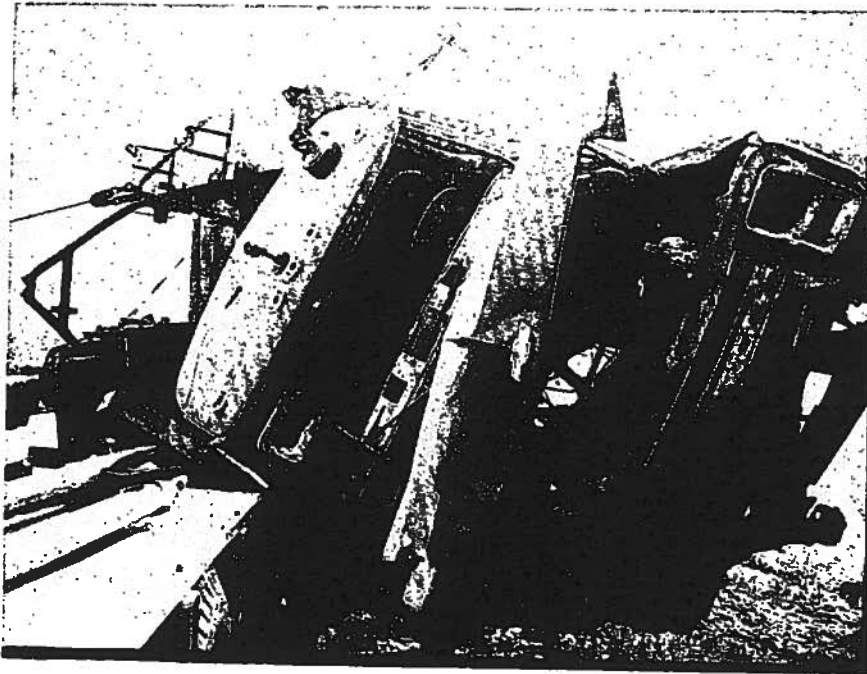
Figure 7. Vehicle 2. Front view of collision damage.

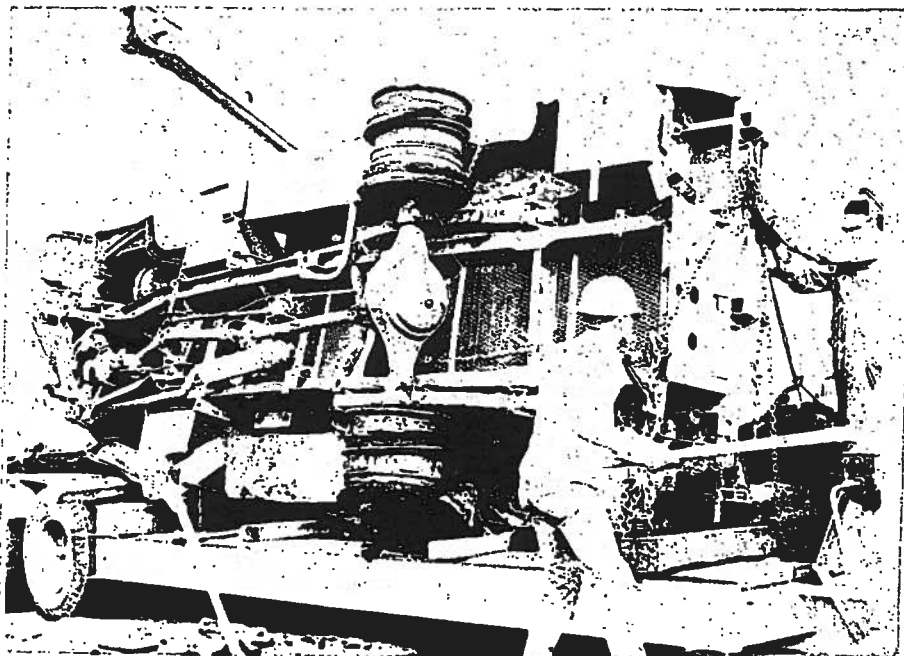
Figure 8. Vehicle 2. Note missing front axle.

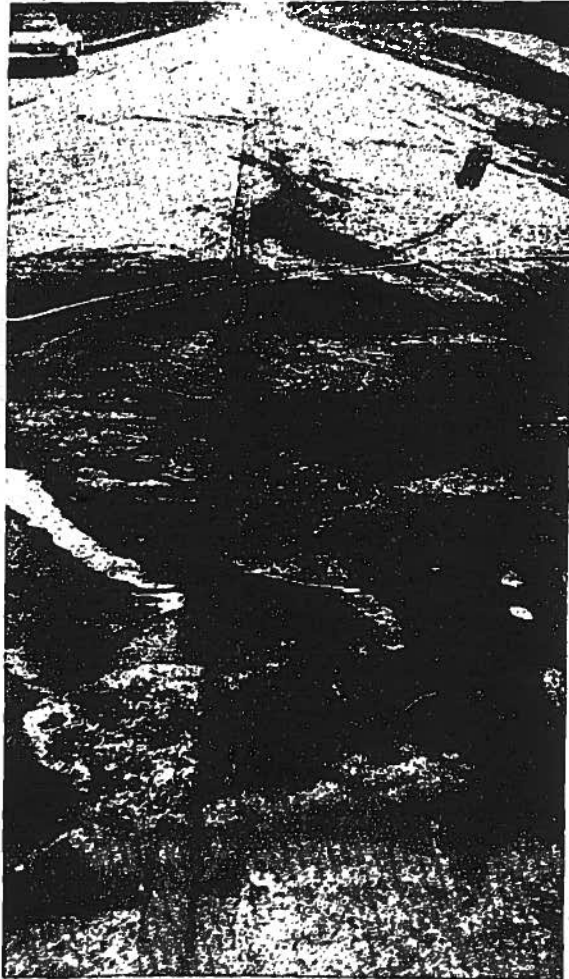
Figure 9. Both vehicles came to rest at this point. Note extensive spalling of concrete from intense heat.

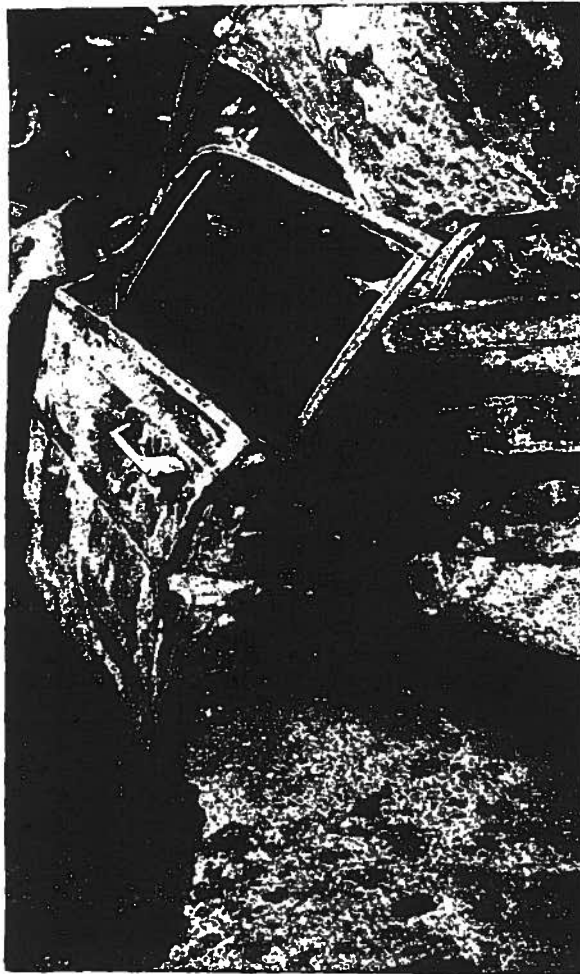
Figure 12. Vehicle 1, driver's door. Despite bending shown here, door still closed, mating with the B-post.
