# **FUEL TANK PROTECTION**

## **FINAL REPORT**

FHR 3771  
30 June 1969

An Investigation of Fuel, Exhaust and  
Electrical Systems as Related to Post  
Crash Fire Safety

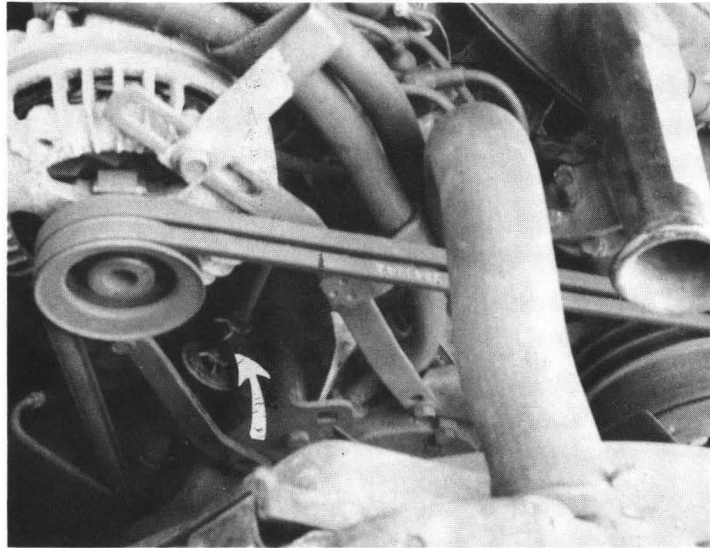
Figure 3-16. 1968 Chrysler New Yorker Fuel Filter

Figure 3-16 shows a fuel filter connection sleeve touching an alternator support member. Abrasive deterioration during normal operation and failure from crash impact may result.

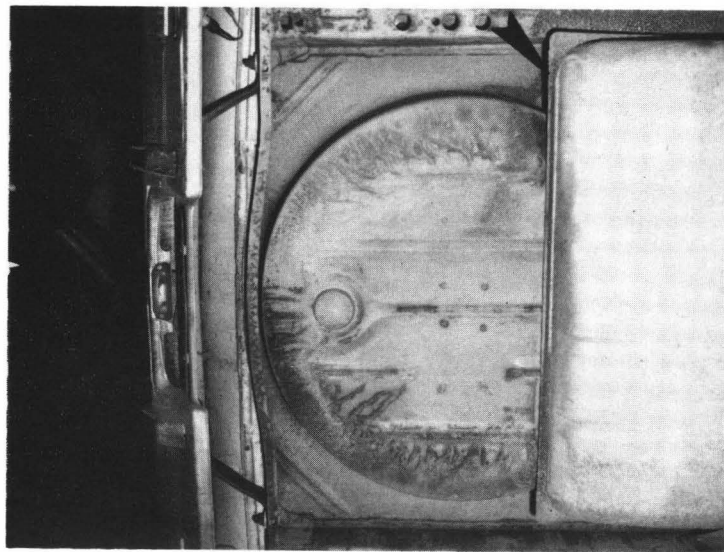
Figure 3-23. 1967 Dodge Dart Fuel Tank Location

Figures 3-23 and 3-24 show how the fuel tank partially encloses the spare wheel well at the rear portion of the floor pan. Impacts, whether from side or rear, that are sufficient to deform the floor pan, could cause damage to the fuel tank since the crush spaces are small.

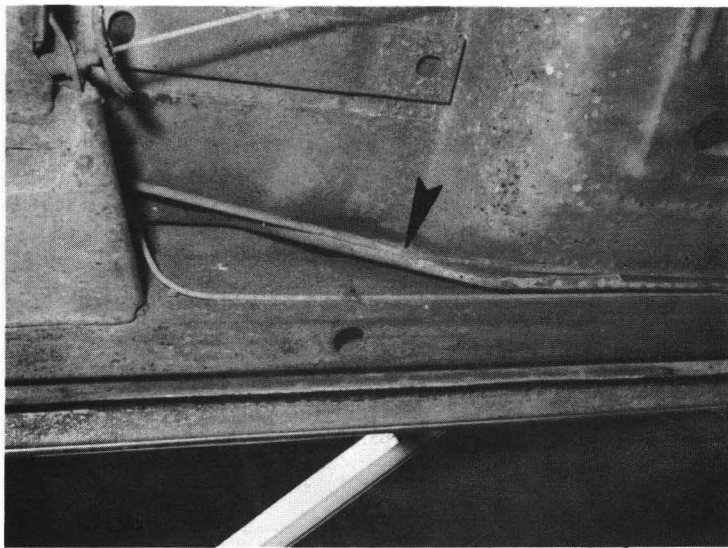
Figure 3-41. 1966 Mercury Monterey Fuel Line Routing

Operational vibration or side impact deformation could cause fuel line abrasion or leakage. A minor change in the fuel line routing would prevent the contact.

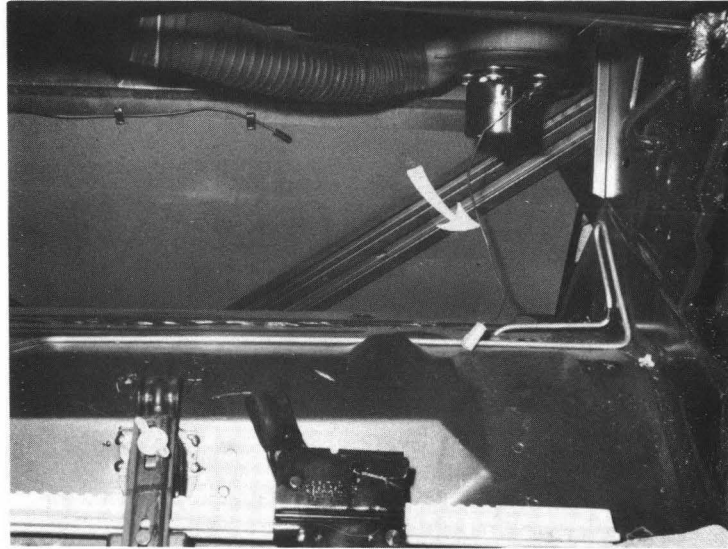
Figure 3-90. 1968 Dodge Coronet 440 Luggage Compartment Wiring

A view of the forward end of the trunk compartment shows the rear window defogger motor connected by a loose wire rising from the floor. Another wire (not connected to any light or accessory in this vehicle) is firmly clipped to the rear fire wall. Desirable and undesirable wiring methods are contrasted in this illustration (Figure 3-90).

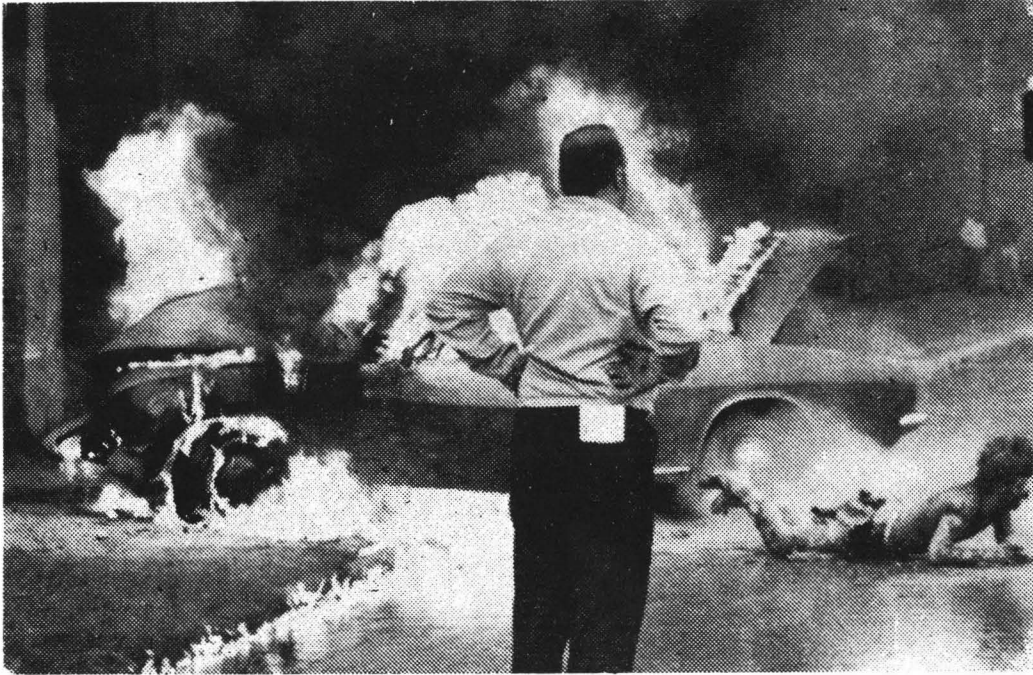
Figure 6-3. 1966 Corvair after Impacting a Wall

The accident shown in Figure 6-3 occurred on July 7, 1969 and was reported in the New York Daily News of July 8, 1969. A 1966 Corvair impacted a wall while traveling on the New England Thruway. Detailed information concerning this accident was unavailable at press-time of this report.

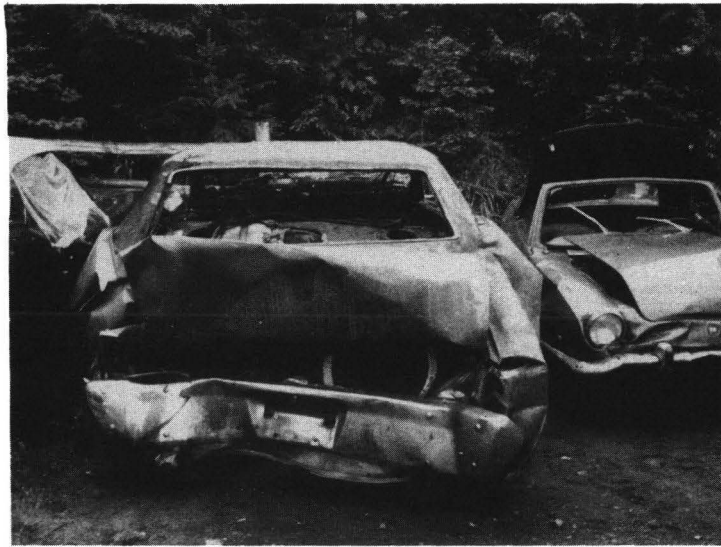
Figure 6-11. Rear View of 1968 Mercury

THE ACCIDENT: The Pontiac, traveling east at approximately 60-70 mph, collided with the rear of the Mercury (Figure 6-11), which was stopped in the right traffic lane. Investigation indicated that the driver of the Pontiac, which was traveling in left lane, applied his brakes just before the impact, thus causing his vehicle to swerve into the left rear of the Mercury. As a result of the collision, the Mercury caught fire.
