# CNG Vehicle Tank Burst During Filling

Motor Vehicle Fire Research Institute

On 26 May 2007 an airport shuttle van driver was killed when his CNG tank burst during filling.

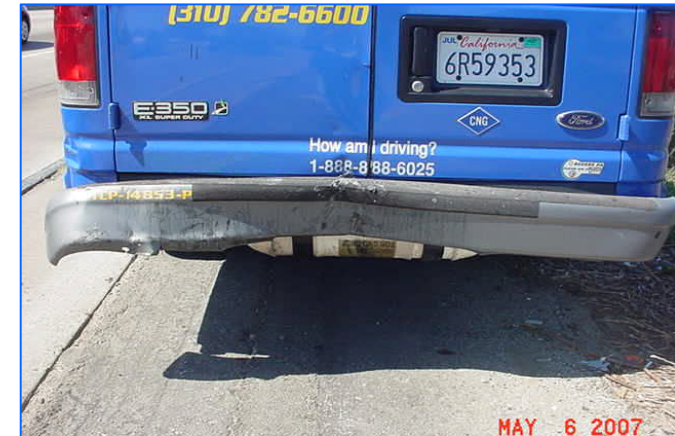
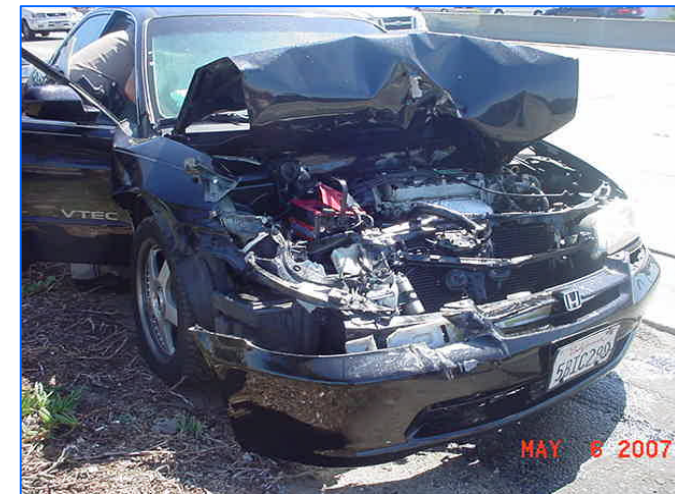
# Rear End Accident

**6 May 2007 the van was involved in a rear impact accident.**

- Van was hit from behind by a Honda Accord
- Damage to van minor
  - ≡ Rear bumper bent a few inches
  - ≡ Minor body work
- Extensive damage to Honda
  - ≡ Under-rode the Van – both vehicles braking
  - ≡ Van's rear wheels off the ground when at rest
  - ≡ Extensive frontal damage
  - ≡ Hood crumpled
  - ≡ Battery acid spilled on rear of Van

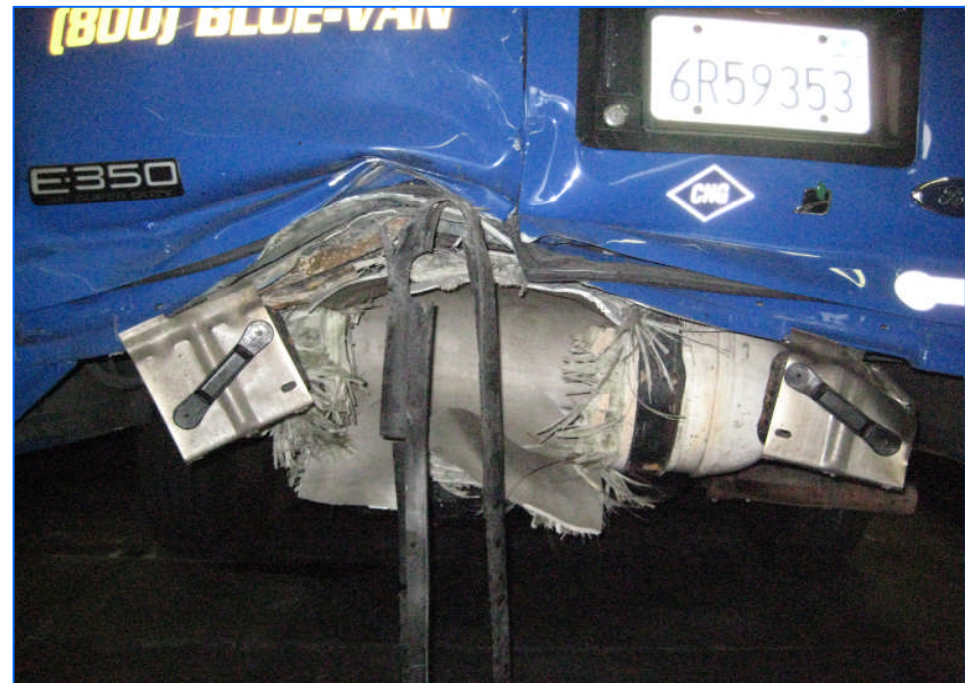
# Vehicle Damage

- Two rear and one side window broken
- Bumper blown off and twisted up
- Tank has “fish mouth” shaped rupture
- Al liner torn open in several pieces

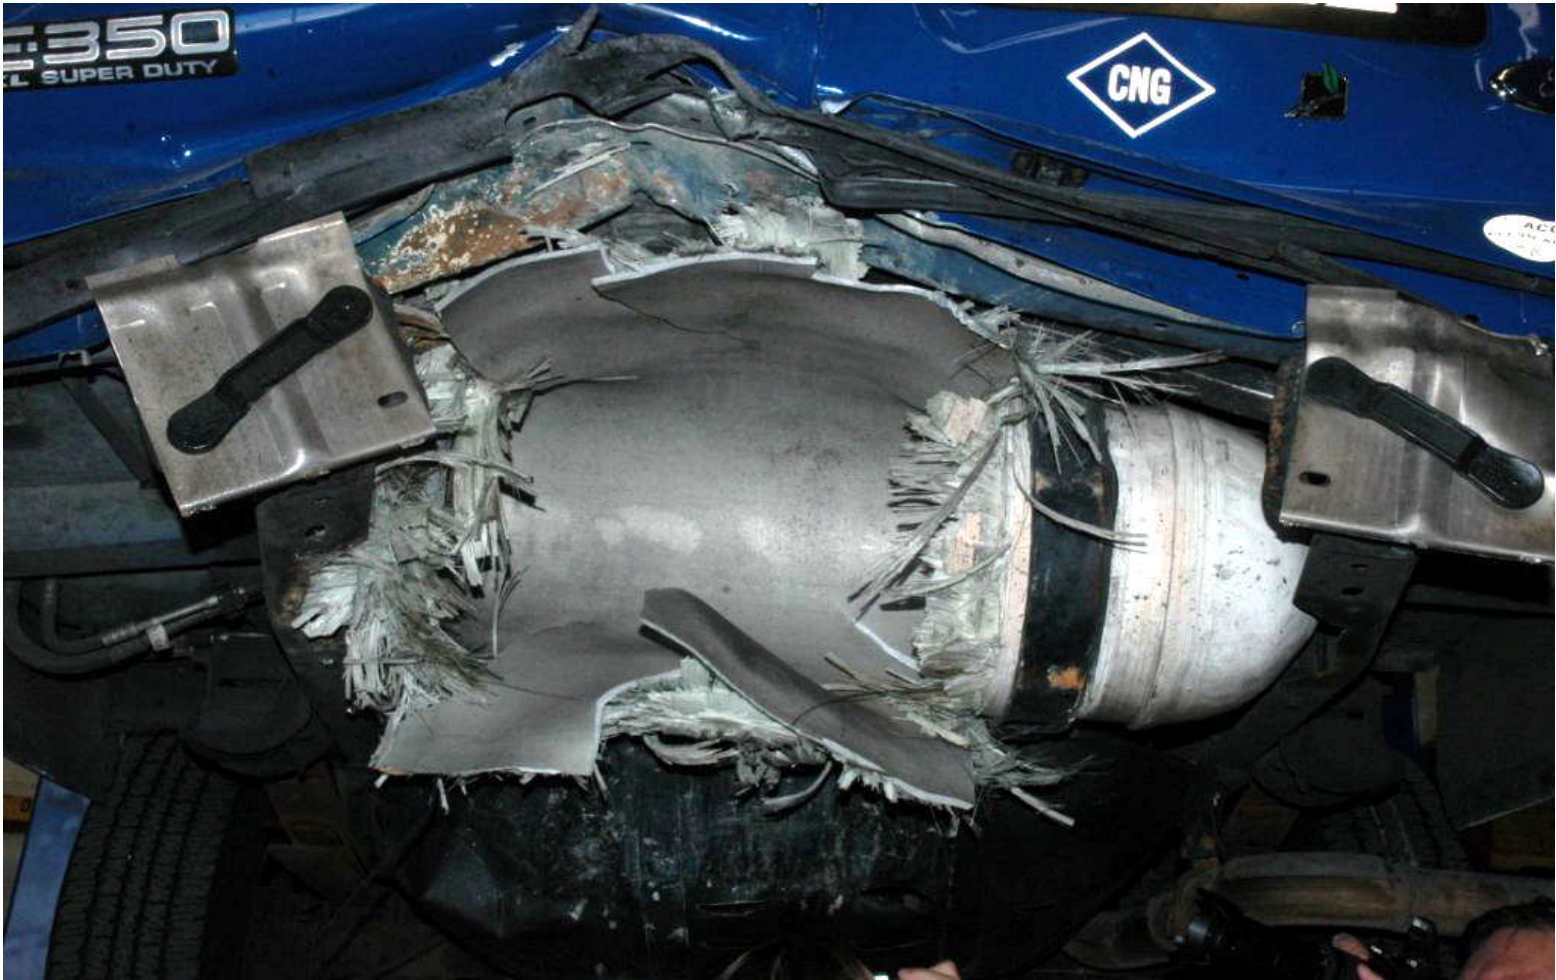
# Rear View of Van

- Visual inspection of tanks and plumbing
- Frame rails had been torched to provide room for tank end domes
- OEM tanks were still pressurized – 2650 psi
- Burst tank and shut-off valve removed
- Aftermarket tank that did not burst was rated at 3000 psi and had exceeded its lifetime (2006)

- ⌘ 3000 psi tanks should not be installed in a 3600 psi system
- ⌘ Expired tank was not removed
- ⌘ Tanks should not be right behind rear bumper
- ⌘ Rear frame rails should not be torched to accommodate tank

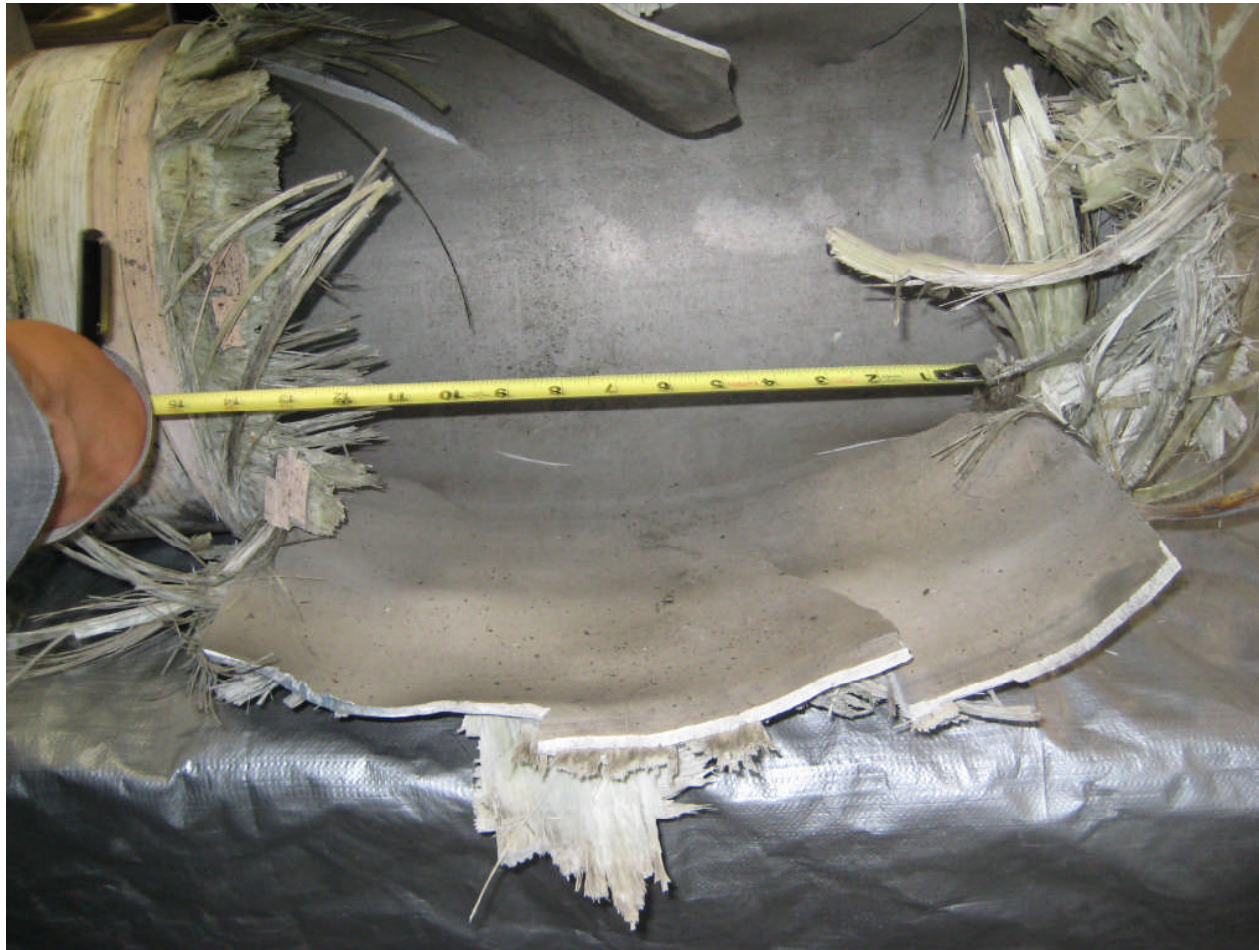
# Tank after Removal

- Performed at SEAL Laboratories, Torrance, CA
  - ≡ Visual inspection and photographs
  - ≡ Tank end-of-life 2009
  - ≡ Wall samples cut out
  - ≡ Inspection by microscopy, SEM, EDX, FTIR, TGA, & DSC
- Some mechanical damage – not in area of burst
- Light brown stain on tank
- Extensive cracking of surface fibers

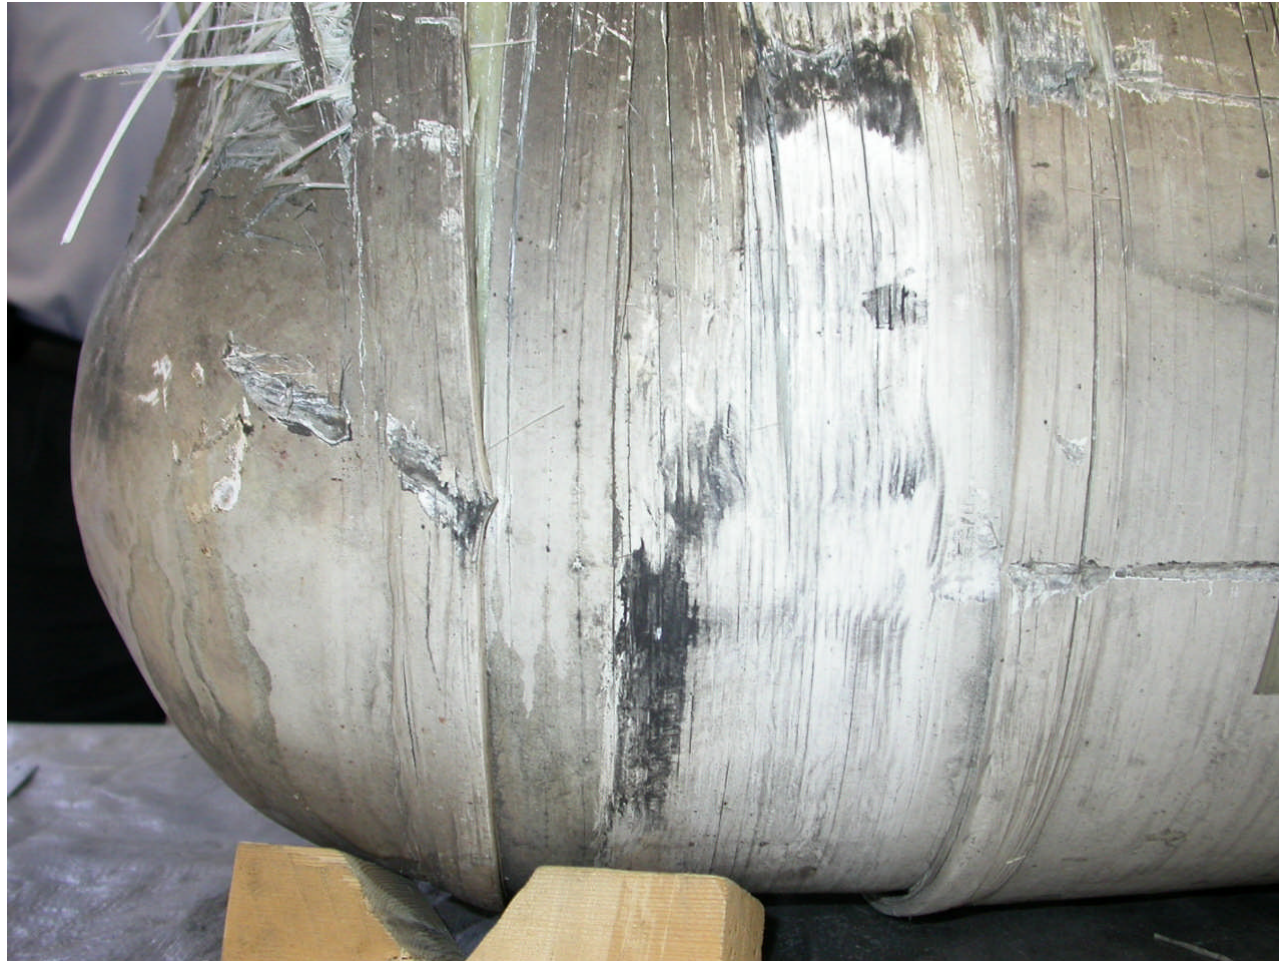
# Light Brown Stain on Tank

Tank lost strength due to Stress Corrosion Cracking (SCC)

- ⌘ Caused by battery acid spilled on tank
- ⌘ Brown stain was replicated – with heat to dry it
