## **MVFRI RESEARCH SUMMARY**

**Kennerly H. Digges, R. Rhoads Stephenson**

### **Research in Fire Safety for Hydrogen-Fueled Vehicles**

Based on contracts with:  
Southwest Research Institute  
Bob Zalosh (FIREXPLO)

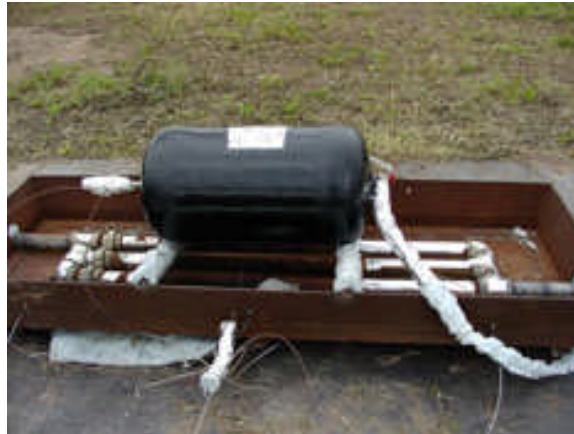
**Figure 1. Hydrogen fuel tank in bonfire test fixture**

The test setup for the bonfire test is shown in Figure 1. The hydrogen tank was supported by two insulated chains approximately 24 in. (61 cm) apart. A propane burner provided the heat source below the tank. The line burner was approximately 12 in. (30 cm) wide and had an effective length of 33-in. (84-cm). The burner length was shorter than the 65 in. (165 cm) required by the standard. This was done to determine the effect of a concentrated bonfire on the hydrogen tank. The propane burner was protected from wind with a 32 x 90 x 8-in. deep (81 x 230 x 20cm) pan.

The composite material on the surface of the tank ignited approximately 45 seconds after the start of the bonfire exposure. After 6 minutes and 27 seconds, the cylinder failed catastrophically through the bottom, launching the 30.9 lb. (14.0 kg) main portion 270 ft. (82 m) from the test location. Blast pressures were 43 psig (300 KPa) at 6.3ft. (190 cm.) and 6 psig (41 kPa) at 21.3 ft. (650 cm.). The pressures measured did not include any effect of reflected waves that might be associated with surrounding rigid and semi-rigid surfaces. The data from the test was recorded in a report to MVFRI and a published paper. (Weyandt 2005, Zalosh 2005).

The internal temperature and pressure of the hydrogen at the time of failure was 103°F (39°C) and 5,180 psig (35.7 MPa), respectively. It is necessary to locate pressure relief devices (PRD's) such they experience the same, or worse, fire as the tank. Redundancy may be prudent also.

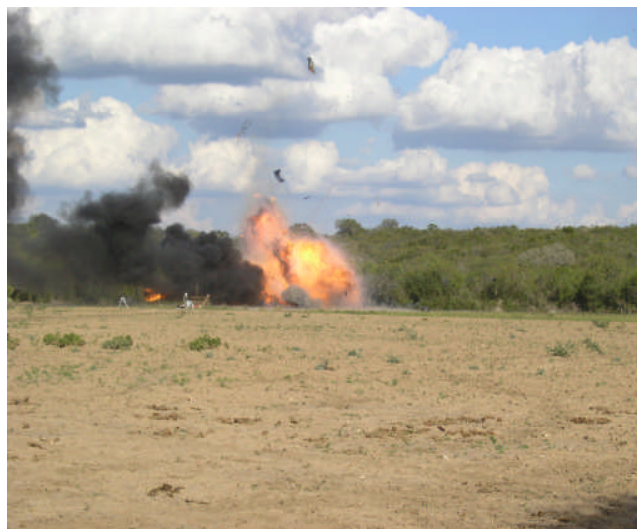
**Figure 3. Fireball from tank burst**

The fire was initiated and portions of the vehicle became involved (plastic body panels, tires, and then the interior). The temperatures on the underside of the cylinder quickly rose in excess of 1200 °F (650 °C). Measurements inside the vehicle showed that the driver's position space became untenable (CO > 1% and temperature > 200C°) in about 4 minutes. The internal tank pressure remained fairly constant during the first 9 minutes, at which time the pressure transducer failed. The fire continued and grew and the hydrogen tank burst after 12 minutes. The fireball is shown in Figure 3.

The mechanical impulse from the tank burst did extensive damage to the vehicle, and parts of the vehicle were scattered as far as 350 feet. A large portion of the tank landed 135 feet away. Overpressures of 2 psi were measured at 32 feet, and thus the exclusion radius for no overpressure damage (0.3 psi) is about 150 feet.

Based on analysis of the video and thermocouple data, it is very likely that a PRD mounted at either end of the tank in this test would have been thermally actuated and prevented the tank from bursting.

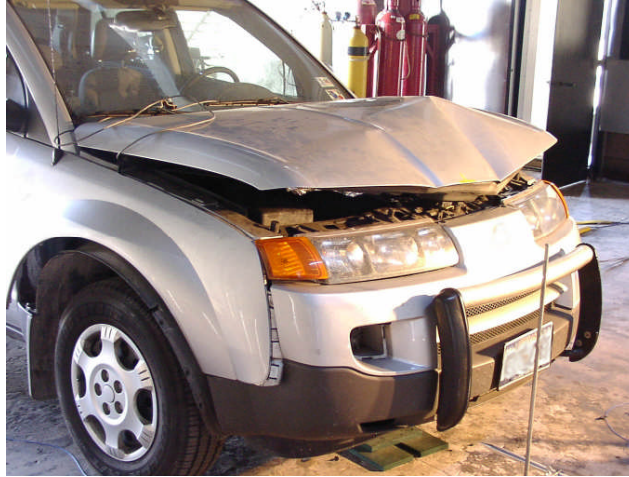
Blast wave pressures were significantly higher in Series 2 tests than in Series 1. The highest pressures were consistently obtained inside the engine compartment. Engine compartment overpressures ranged from 0.14-psig (2-sec duration) to 3.2-psig (64-sec duration) at this location. The next highest pressures were obtained at the front of the vehicle (up to 2.08 psig) followed by the passenger and driver sides, and finally the rear of the vehicle. Most tests resulted in little to no damage to the vehicle. The overpressure during the 64-sec duration leak caused deformation of the hood and loosening of the passenger side fender. The damage is shown in Figure 4. Several pressures in excess of 1 psig were recorded for releases of 8 sec or greater duration.

**Figure 4. Damage to vehicle during series 2 leakage tests**

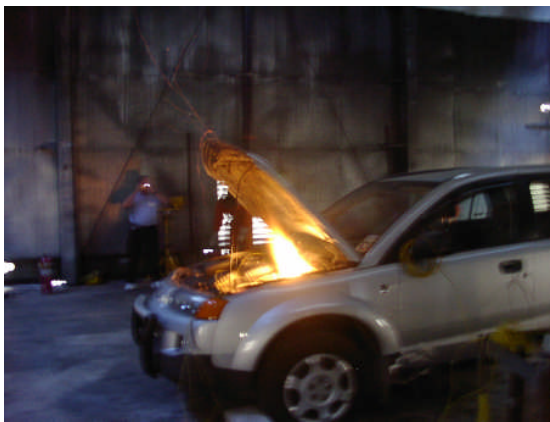
The 48-g/min hydrogen jet-fires in Series 4 impinged directly on the underside of the hood of the engine compartment in all but the first test. The thermocouple in the direct path of the jet-fire recorded a temperature above 2200°F in each test. Temperatures on the underside of the vehicle did not increase appreciably. In a test with the hood open, the visible jet fire appeared to reach 16 in. outside of the engine compartment, for a total length of approximately 32 in. from the nozzle. A test with hood open is shown in Figure 5 and with hood closed is shown in Figure 6.

**Figure 5: Fuel line leakage – hood open**

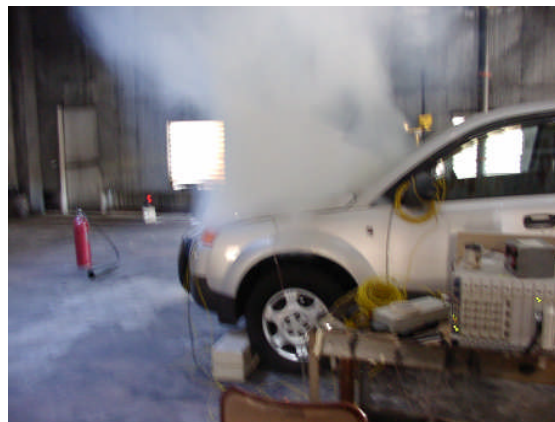
**Figure 6: Fuel line leakage – hood closed**

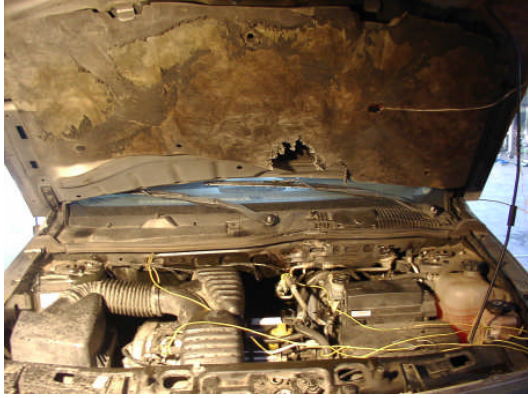
After a jet fire of 5.2 sec, the liner on the underside of the hood ignited. After the 9.8-sec duration jet fire, a plastic harness showed obvious deterioration, there was a hole in the hood liner, and the exterior of the hood showed slight warping and paint bubbling. After a 17.8-sec duration burn, the plastic harness was completely consumed, copper wires were severed, and the exterior of the hood was discolored with more warping and paint bubbling. See Figures 7 and 8.

**Figure 7: Hood damage – underside**

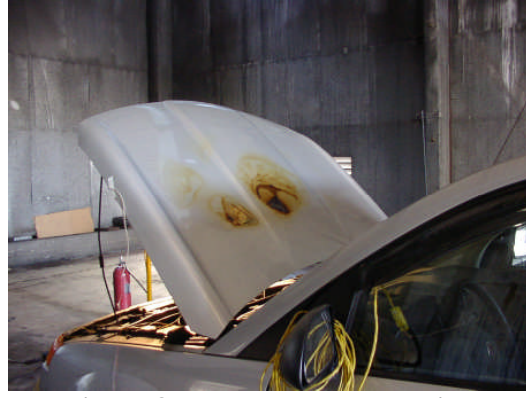
**Figure 8: Hood damage - outside**

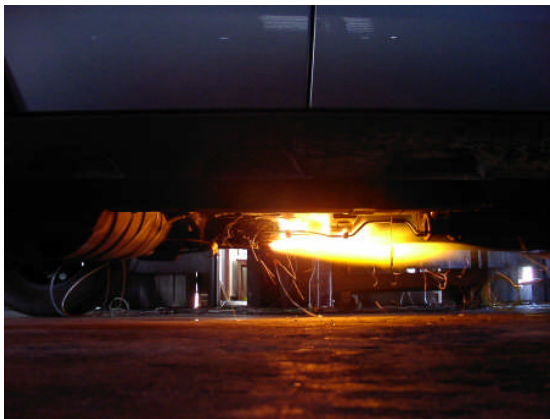
The 48-g/min jet-fires in Series 5 tests impinged along the frame, fuel lines, and into plastic support components as shown in Figure 9. Minimal damage occurred to the vehicle in this series. The jet-fire quickly destroyed the delicate combination Thermocouple/heat flux sensor in its direct path and it only intermittently measured the jet-fire temperature of about 2200°F.

**Figure 9: Leakage flame during test**

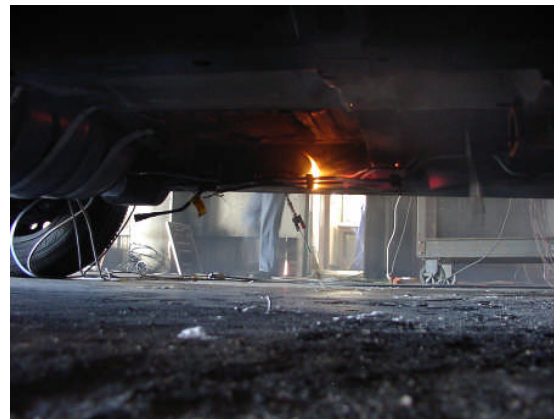
**Figure 10: Residual flame after test**

Even in the shortest duration test, the fuel lines were red hot and the plastic support brackets continued to burn following the test as shown in Figure 10. For longer jet-fire durations, the fuel lines remained red hot for a longer period. After the final duration of 33 sec, the plastic bracket had been mostly consumed, but no other damage around the vehicle was evident. Peak heat fluxes measured in Series 5 tests were about 3600 Btu/ft<sup>2</sup>hr (11 kW/m<sup>2</sup>).
