## Summary Report: Expansion of the Vehicle Fuel System Database and Overview of Pickup Truck History

Report No.:  
R04-02 – v02

Date:  
2004 – 05 - 10

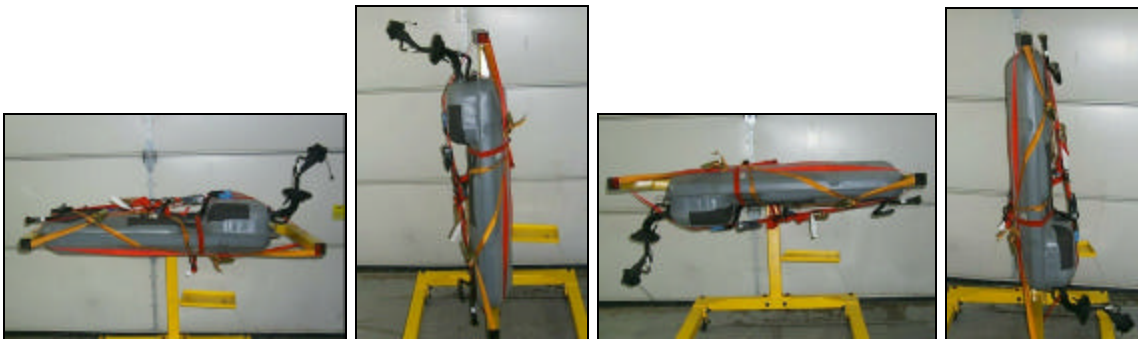
Figure 10: Typical test set-up for a leak test showing inversion of a tank system.

Rudimentary leak testing of these tank systems was performed to determine if the tank would leak if inverted as in a rollover and to determine which hose would result in a fuel leak if severed.

The testing comprised filling the tanks to capacity and rotating them about an axis that, for a tank installed in a vehicle, would be parallel to the longitudinal axis of the vehicle. For safety and environmental reasons, the tanks were filled with water instead of gasoline or Stoddard which is typically used in automotive testing. It was understood that the properties of these liquids are different, however, any leakage encountered solely because of the difference between the liquids would be negligible. Nevertheless, liquid soap was added to the water to reduce surface tension and promote capillary flow as much as possible.

In each tank orientation the hoses connected to the tank were disconnected one at a time and the leakage rate was observed and measured. Excessive leaks were plugged and the leakage rate was not measured.
