NHTSA-98-3588-202

Project B.14 – Demonstration of Enhanced Fire Safety Technology – Fire Suppression Systems

Part 2A: Evaluation of Fire Suppression Systems in a Full Scale Vehicle Fire Test and Static Vehicle Fire Tests

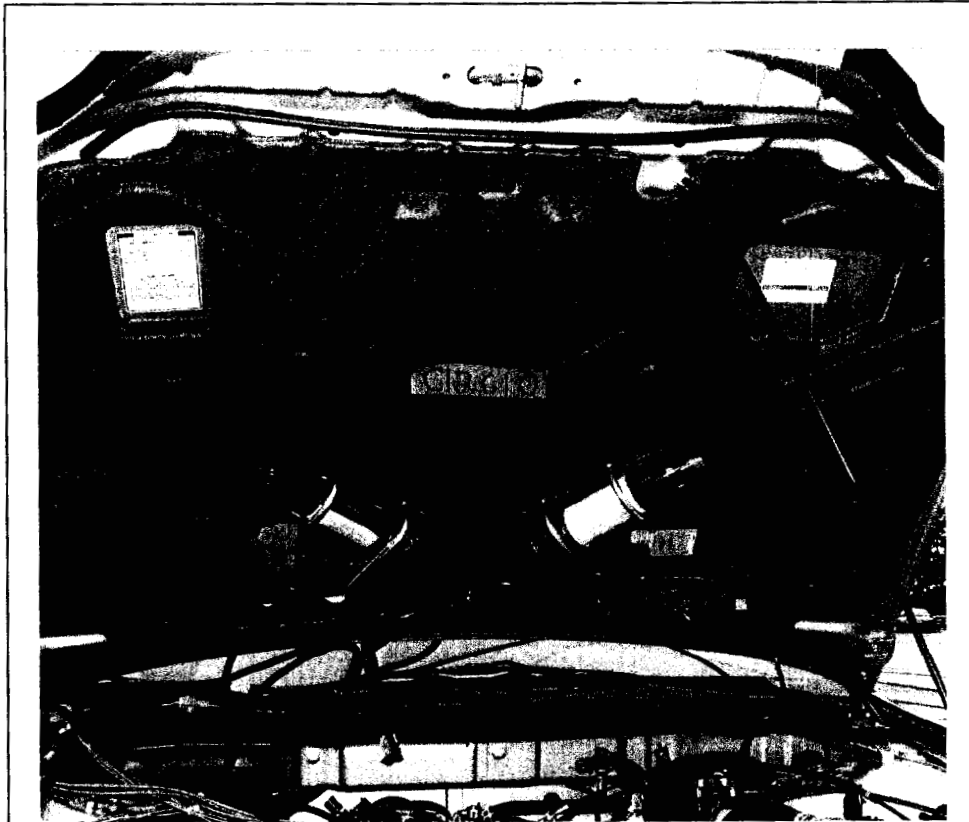
The SPGG units automatically discharged during this crash test. Figure 4 shows close-up views of the optical detectors and SPGG units on the hood before and after this crash test.

Figure 4. Crash Test C12610. Photographs of the optical detectors and SPGG units on the hood before (upper) and after (lower) this crash test.

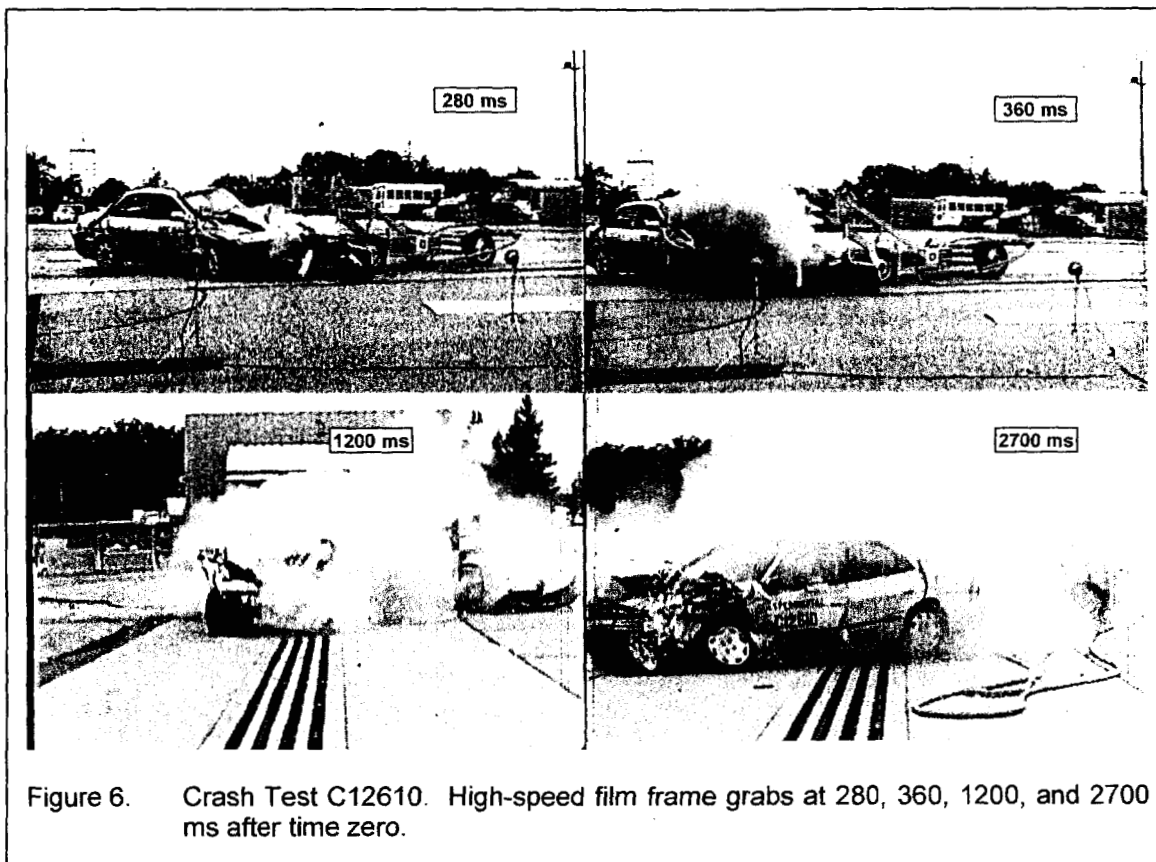
The fire suppression system failed to extinguish the fire. The result was that the fire was, at most, briefly knocked down. The fire in the engine compartment continued to burn after the suppression system discharged. The fire was extinguished manually using a deluge gun on a pumper truck present for this test.

Figure 6 shows a series of high-speed film frame grabs at 280, 360, 1200, and 2700 ms after time zero. Close inspection of the frame grab at 280 ms after time zero shows flames visible in the front of the engine compartment in the approximate location of the exhaust manifold (Fig. 6). The frame grab at 380 and 1200 ms after time zero show the effluent from the SPPG units venting

Figure 6. Crash Test C12610. High-speed film frame grabs at 280, 360, 1200, and 2700 ms after time zero.

The failure of the automatic extinguishers to significantly suppress or extinguish the fire was probably due to the effects of vehicle deformation and motion during the crash test, which re-directed and altered the discharge pattern of suppression agent from the SPGG units. The hood remained latched and the center of the hood deformed upward as the barrier crushed the front of the test vehicle, creating gaps between the sides of the hood and the front fenders and between the rear of the hood and the cowl. Vehicle rotation combined with wind (3 to 5 mph steady with 8 to 10 mph gusts out of the West) effectively cleared the suppression agent from the engine compartment through these gaps before the vehicle came to rest. This led to a reduction in the amount of suppression agent distributed to the flames because a large fraction of the effluent from the SPGG units was not contained within the engine compartment and dispersed outside of the engine compartment, without attacking the fire.

Another factor contributing to the failure of the fire suppression system to extinguish the fire in this test appears to be ineffective distribution of agent into the lower portion of the engine compartment because of crush to the front of the test vehicle. The optical detectors and SPGG units were located on the hood to minimize the possibility of physical damage to the fire suppression system during the crash test. Previous testing indicated that fire detectors located on the hood of a vehicle involved in a frontal crash test were less likely to fail because of direct impact or crushing damage than fire detectors located elsewhere in the engine compartment [1, 10 - 12]. With the SPGG units located on the hood, effective flame suppression requires distribution of the agent downward into the engine compartment. Inspection of the test vehicle after this crash test indicated that crush of the front of the test vehicle reduced the volume of airspaces between objects and created restricted voids in the engine compartment that were not present in the un-crashed vehicle. Lack of containment within the engine compartment caused by rapid dispersion of agent out of the engine compartment during this crash test appears to have resulted in distribution of insufficient amounts of agent for fire suppression into the air spaces in the lower part of the engine compartment, as evidenced by observations of flames in the lower engine compartment while the test vehicle was rebounding from the barrier and after it came to rest (Fig. 6).

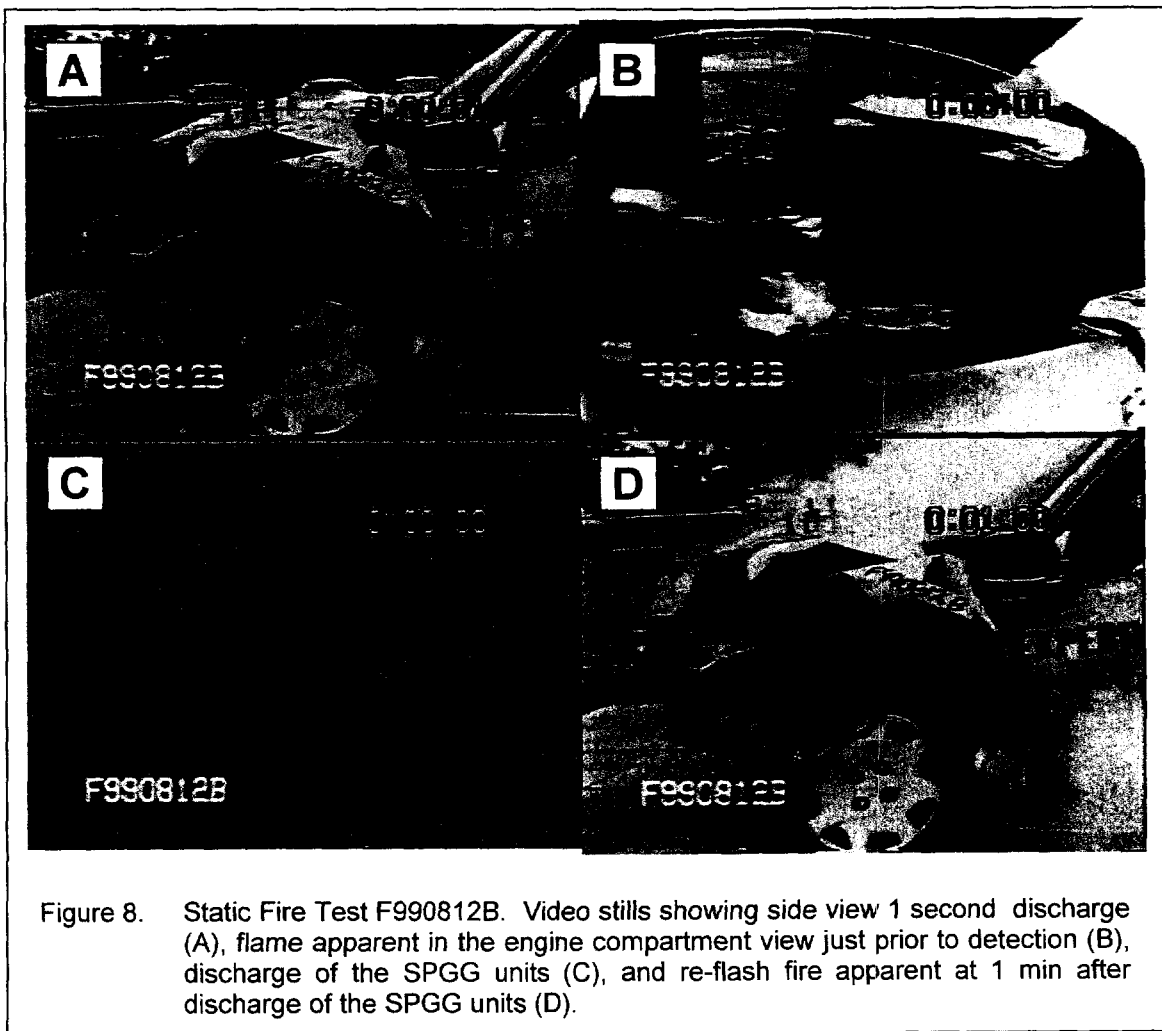
An electrical igniter was placed under the cover of the power distribution box. The damaged hood liner was removed and a new hood liner was installed in the test vehicle. The spent SPGG units were removed and two charged SPGG units installed on the hood of the test vehicle. One of the optical flame detectors was not functioning within specifications, and was removed from the circuit. To start the test, electrical current was applied to the igniter, which resulted in flaming ignition of plastic materials in the power distribution box in approximately 90 seconds. The optical flame detector triggered discharge of the SPGG units shortly after flames were first visible. The discharge from the fire suppression system initially extinguished the flames. The igniter remained energized and a fire re-ignited in the area of the igniter within a few seconds (approximately 18 seconds after ignition). The sequence is shown in Figure 8. Safety personnel present for this test extinguished the fire using hand-held fire extinguishers (carbon dioxide).

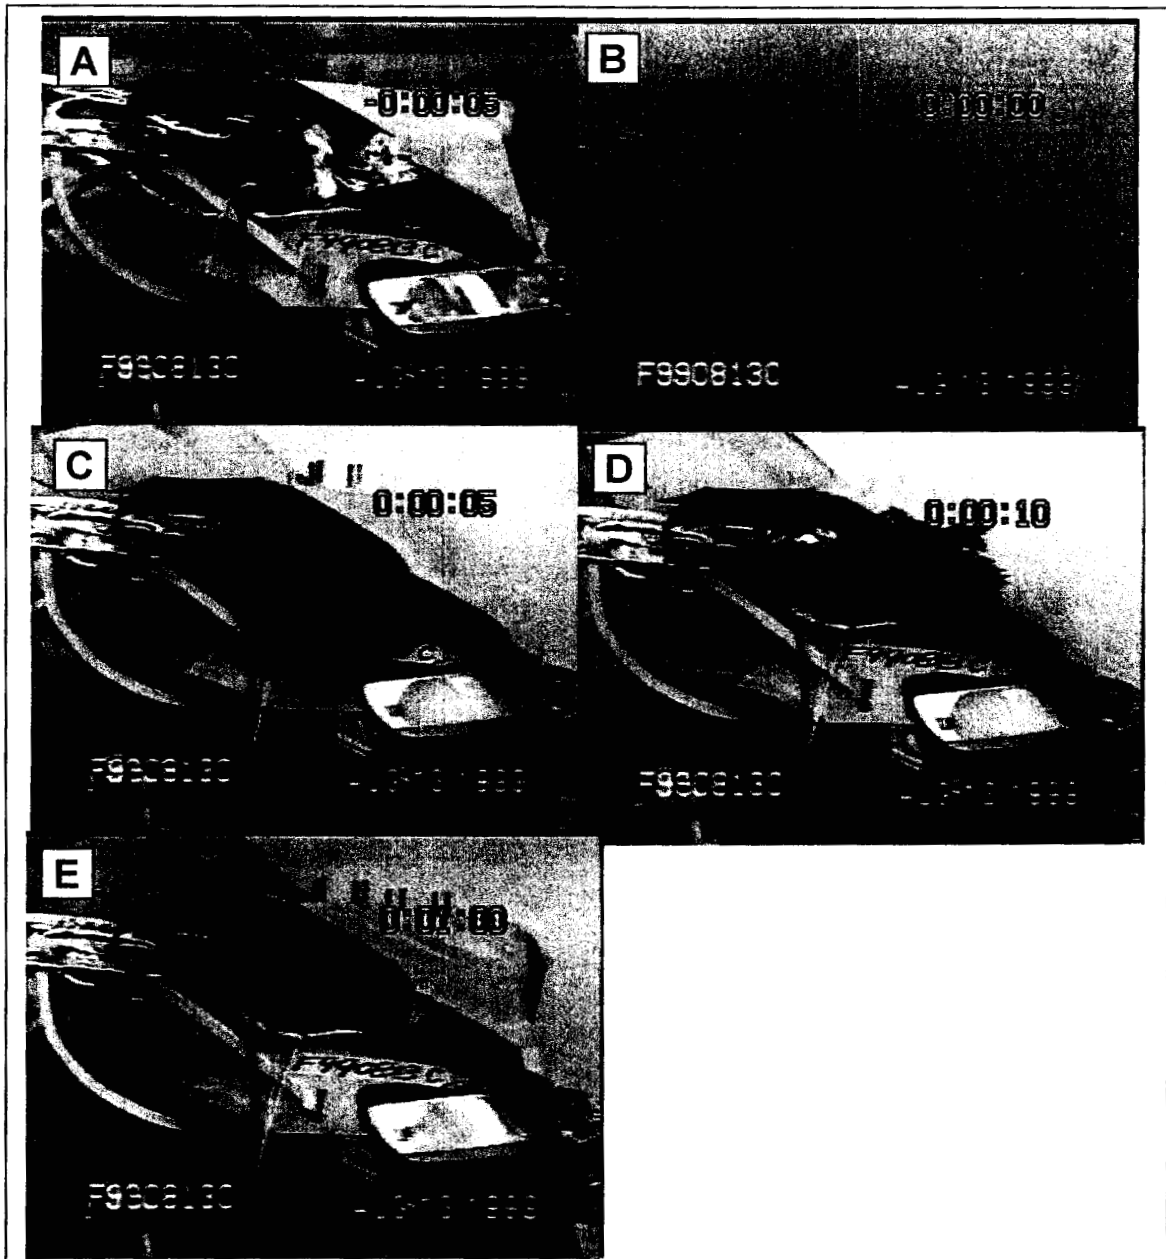
Autoignition of the power steering fluid on the heated metal plat was finally achieved by placing a barrier along one side of the metal plant to shield it from wind blowing through the engine compartment. The optical flame detector triggered discharge of the SPGG units shortly after flames were first observed in the engine compartment. The flames were extinguished, but re-ignition of residual power steering fluid on the metal plate occurred shortly after the discharge from the units had ceased, approximately 37 seconds after the first fire was detected. The sequence is shown in Figure 9. Safety personnel present for this test extinguished the fire using hand-held fire extinguishers (carbon dioxide).

Figure 9. Static Fire Test F990813C. Video stills showing flames in engine compartment 5 seconds before SPGG discharge (A), automatic discharge of the SGG units (B), knock-down of the flame at 5 seconds after discharge (C), a re-flash fire on the hood liner 10 sec after discharge of the SPGG units (D), and flames from re-ignition of residual power steering fluid on the heated plat 1 minute after discharge of the SPGG units (E).

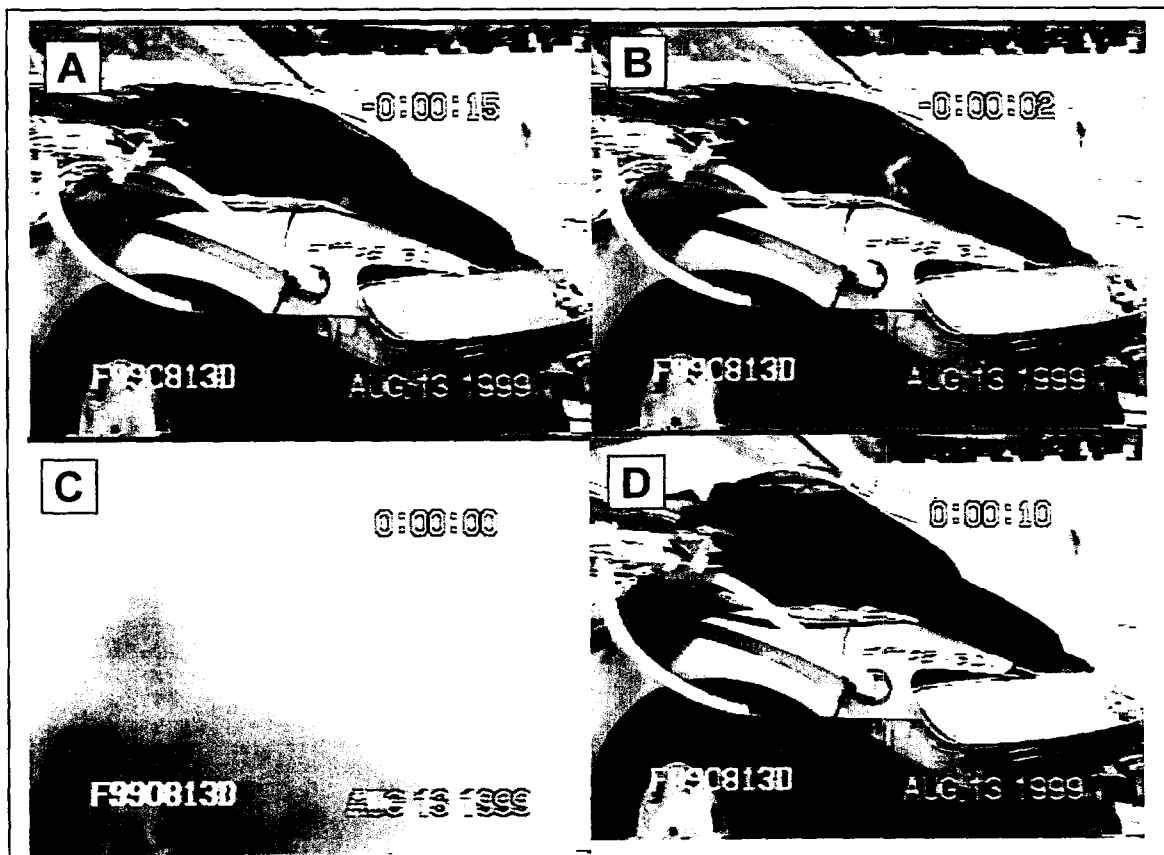
An electrical igniter was placed on top of the battery. The spent SPGG units were removed and two charged SPGG units installed on the hood of the test vehicle. To start the test, electrical current was applied to the igniter. Flaming ignition of the plastic materials in the igniter was observed in approximately 90 sec. Electrical power to the igniter was shut-off as soon as flaming ignition was observed. Although the optical fire detector functioned properly before and after this test, the optical fire detector failed to activate the fire suppression system. The SPGG units were activated using a remote manual trigger connected to an external power supply. The flames were extinguished by the discharge from the SPGG units. Re-ignition did not occur. The optical flame sensor was tested after this test and determined to be functioning within specifications. Figure 10 shows the flame and SPGG discharge.

Figure 10. Static Fire Test F990813D. Video stills showing flames under hood 15 sec before discharge of the SPGG units (A), flames in the engine compartment 2 seconds before discharge of the SPGG units (B), manual discharge of the SPGG units (C), and complete extinguishment of flames in the engine compartment 10 sec after discharge of the SPGG units (D).

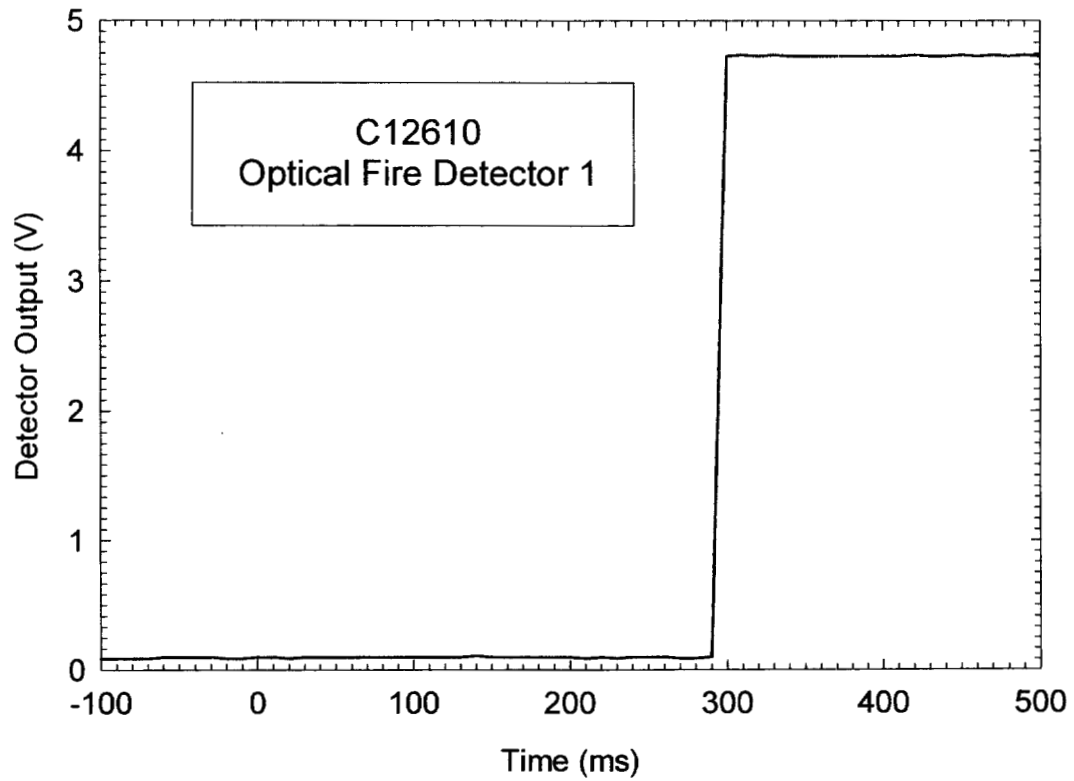
Data recorded from the fire suppression system indicates that Detector 1 output a firing signal at 298 milliseconds. Detector 2 did not output a firing signal at any time during this test. The system was configured so that an alarm from either of the two detectors caused the two gas generator extinguishers to discharge (see Appendix E). Thus, the firing signal from Detector 1 caused both SPGG units to discharge.

Plot E1. Crash Test C12620. Output from Optical Flame Detector 1.

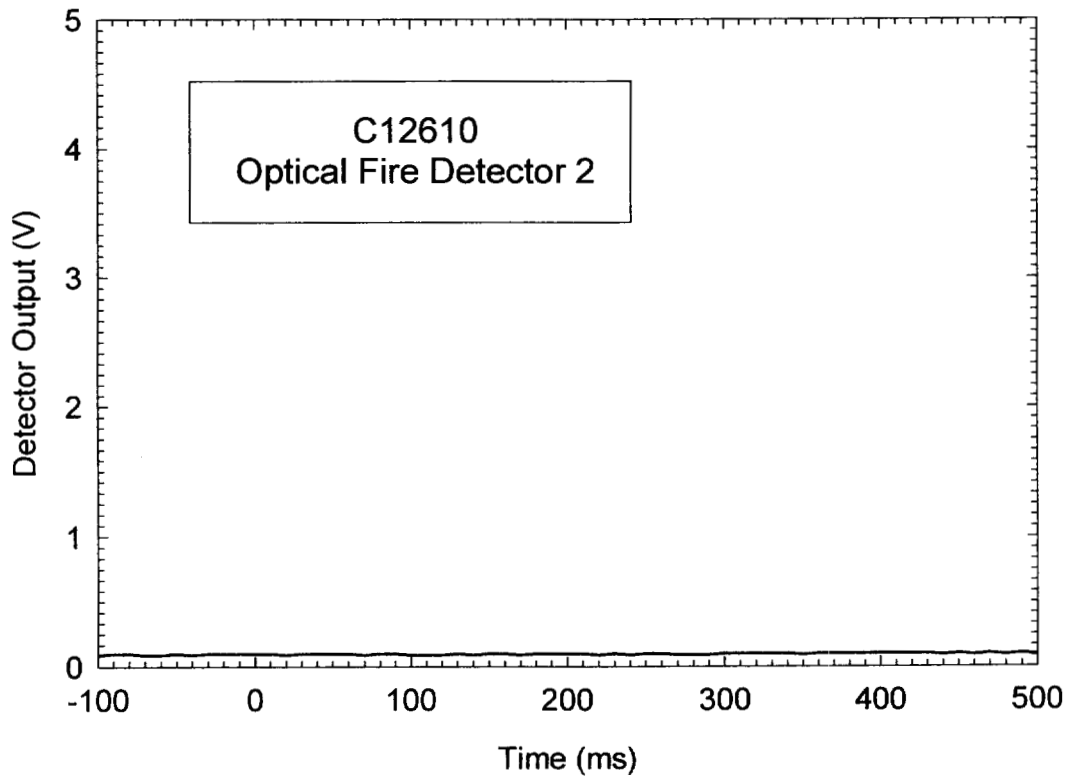
The fact that, initially, only detector 1 alarmed, is consistent with the physical location of the fire which ignited on the left side of the engine compartment. It is therefore reasonable that Detector 2 did not alarm initially. Detector 2 may not have alarmed to the subsequent re-flash³ fire due to crash effects including: a) damage to this detector sustained in the crash and b) re-orientation of the detector so that the sensing element did not "see" radiation from the flames.

Plot E2. Crash Test C12610. Output from Optical Flame Detector 2.
