NHTSA - 98 - 3588 - 205

Project B.14 – Demonstration of Enhanced Fire Safety Technology – Fire Suppression Systems

Part 2B: Evaluation of a Fire Suppression System in a Full Scale Vehicle Crash Test and Static Vehicle Fire Tests – Underbody Gasoline Fires

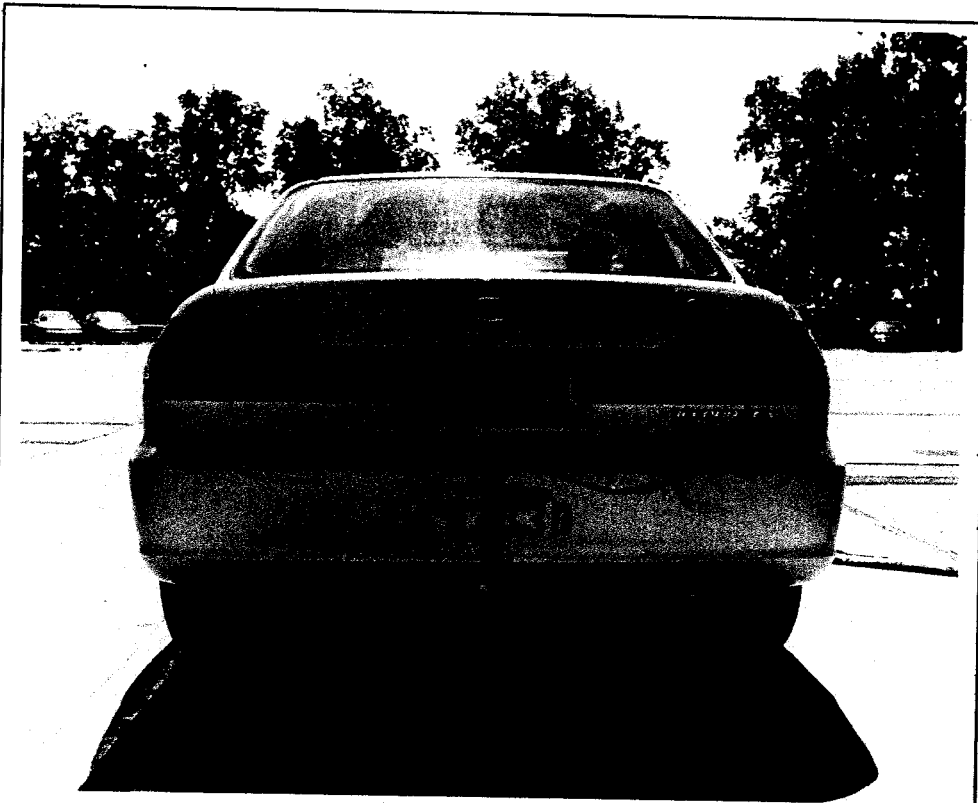
Crash Test C12611 did not result in a fuel leak in the test vehicle and no fire was observed during this crash test. Neither SPGG units activated during this crash test. Figure 4 shows close-up views of the optical detectors and SPGG units on the underbody of the test vehicle after this crash test.

Figure 3. Crash Test C12611. Photographs of the test vehicle before (upper) and after (lower) this crash test.

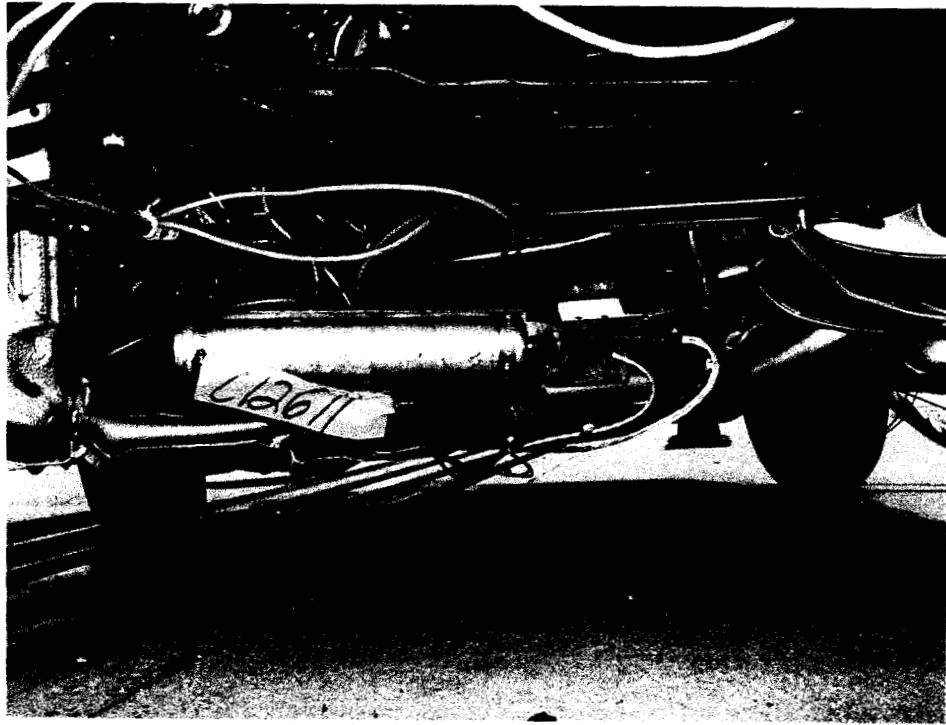
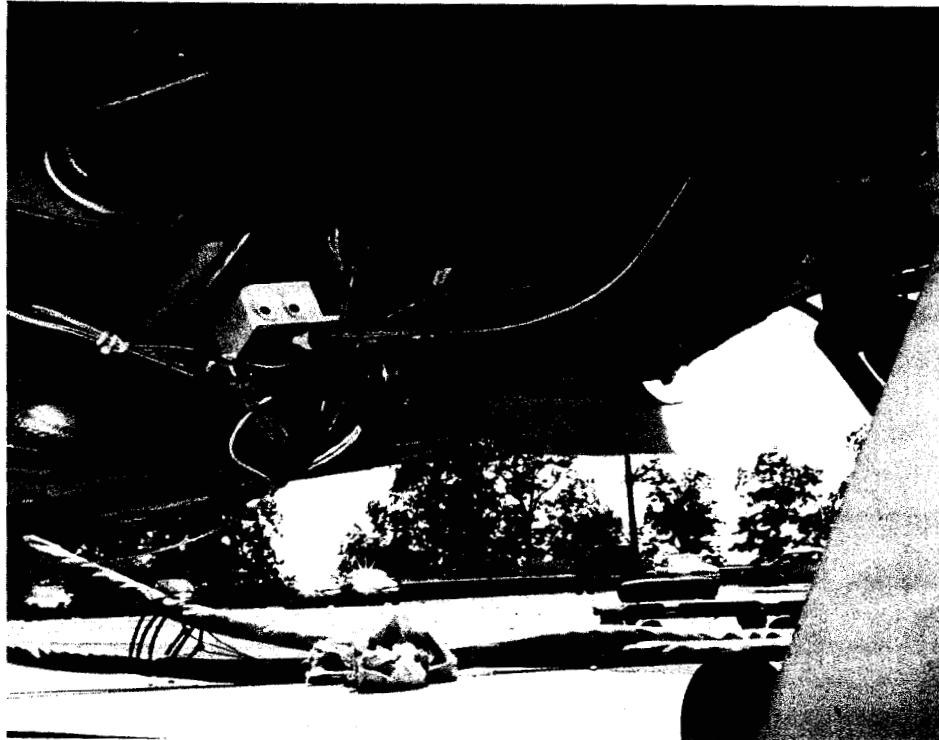
Figure 4. Crash Test C12611. Photographs of the optical detectors and SPGG units mounted on the underbody of the test vehicle after this crash test.

Deformation of the test vehicle in this crash test caused the orientation of the optical detectors and SPGG units to change (see Fig. 4). Both optical detectors were tilted upward, with the optical detector on the left side of the test vehicle tilted upward approximately 60°.

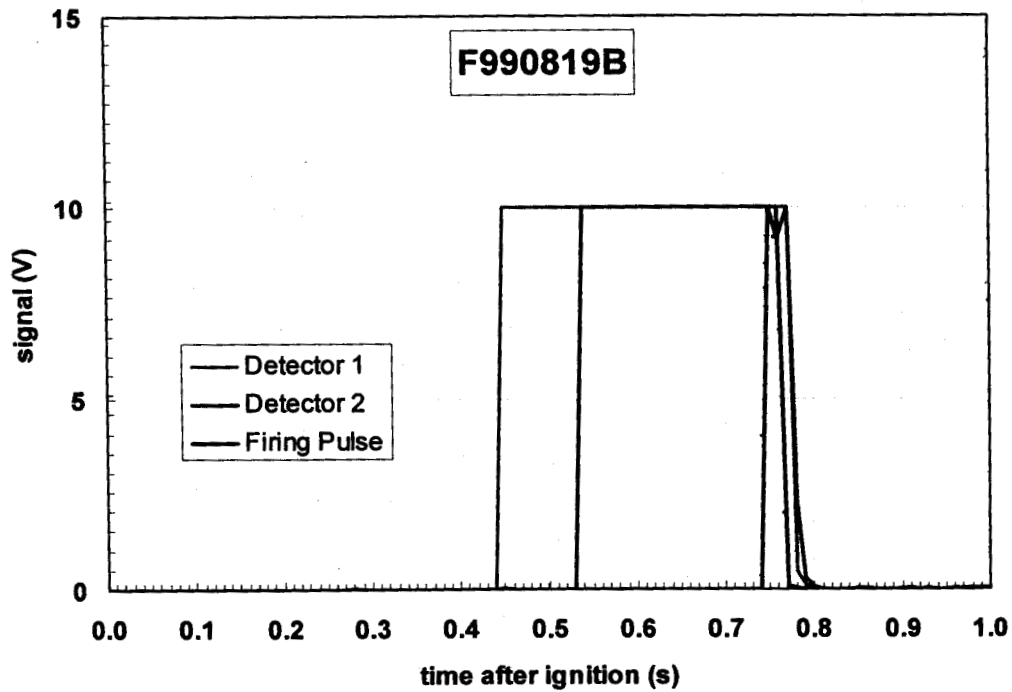
Detector 1 output a detection signal to the fire suppression system controller approximately 450 ms after ignition. Detector 2 output a detection signal to the fire suppression system controller approximately 540 ms after ignition. The fire suppression system controller output a firing pulse to the SPGG units approximately 750 ms after ignition. Figure 6 shows a sequence of video stills from this test at 200 ms before ignition, 500 ms after ignition, 800 ms after ignition, and 25 s after ignition. This series of video stills shows that the effluent from the SPGG units extinguished the flames without re-ignition.

Figure 5. Static Fire Test F990819B. Plots of the output signals from Detectors 1 and 2 to the fire suppression system controller and the firing pulse from the fire suppression system controller to the SPGG units.

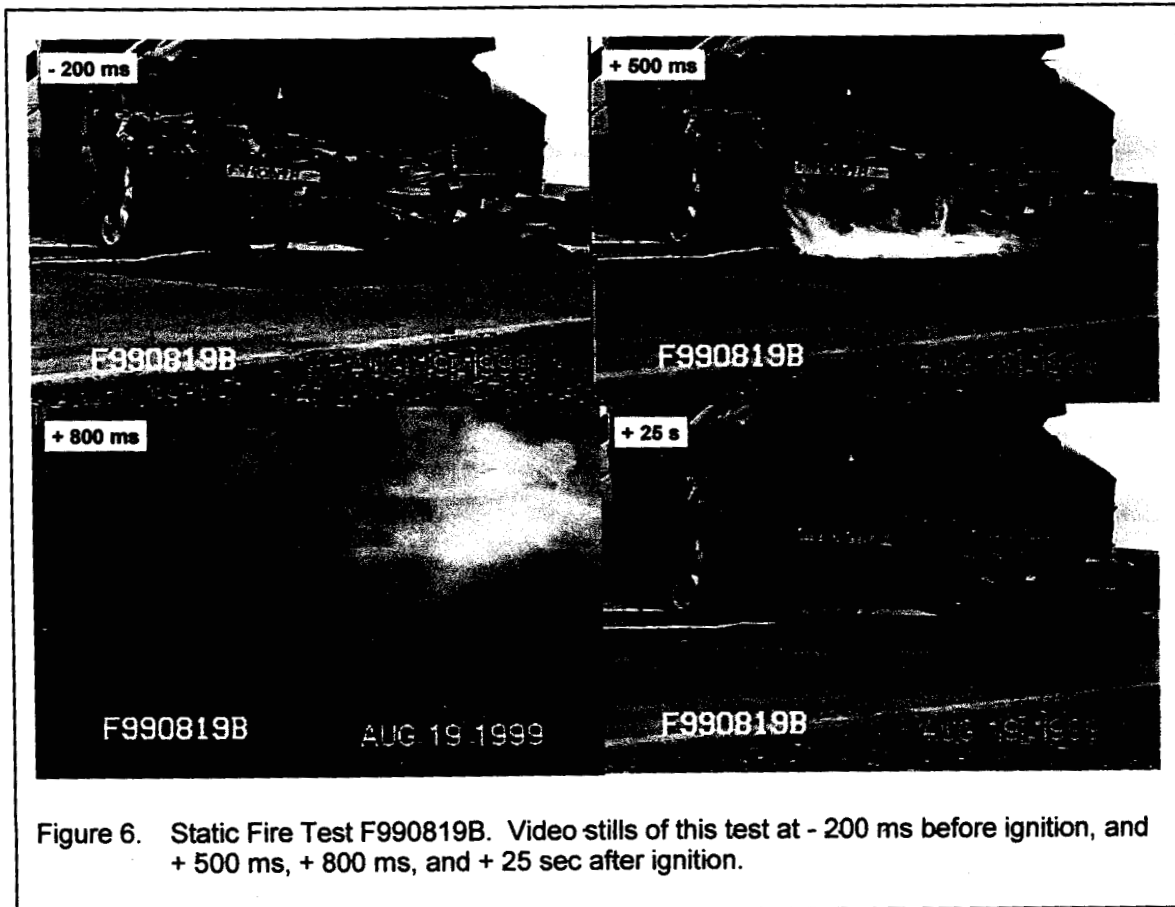
Figure 6. Static Fire Test F990819B. Video stills of this test at - 200 ms before ignition, and + 500 ms, + 800 ms, and + 25 sec after ignition.

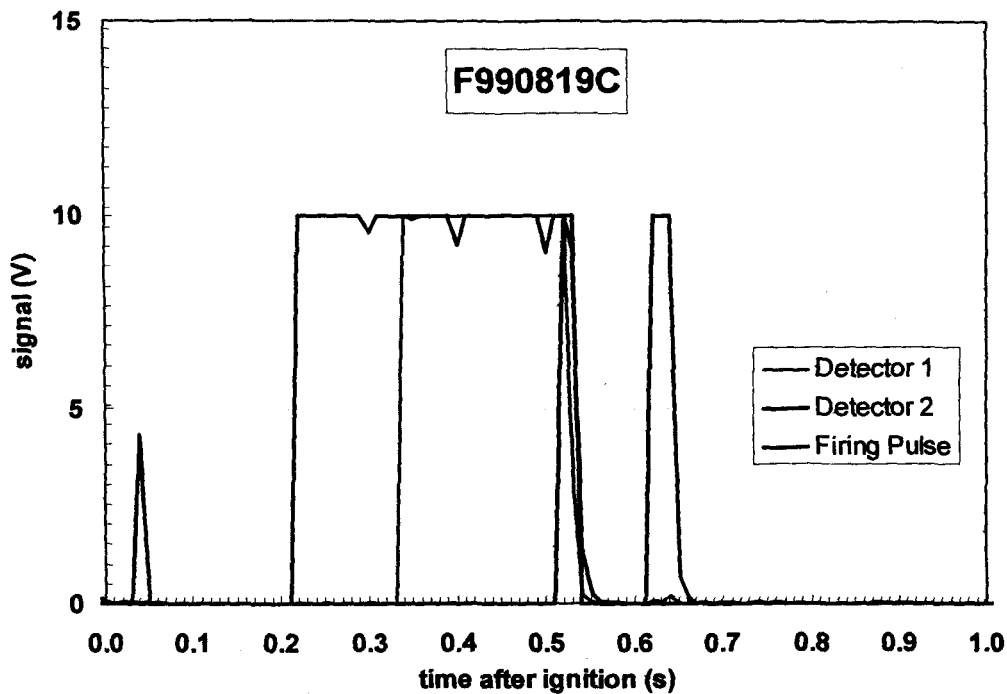
The flow rate of gasoline was approximately 2 L/min. Approximately 500 mL of liquid gasoline was poured onto the ground beyond (outboard) the left rear wheel of the test vehicle. Vapor above liquid gasoline ignited approximately 35 s after the start of gasoline flow onto the ground under the test vehicle. Figure 7 shows plots of the output signals from Detector 1 and Detector 2 to the fire suppression system controller, and the fire pulse from the fire suppression system controller to the SPGG units during this test.

Figure 7. Static Fire Test F990819C. Plots of the output signals from Detectors 1 and 2 to the fire suppression system controller and the firing pulse from the fire suppression system controller to the SPGG units.

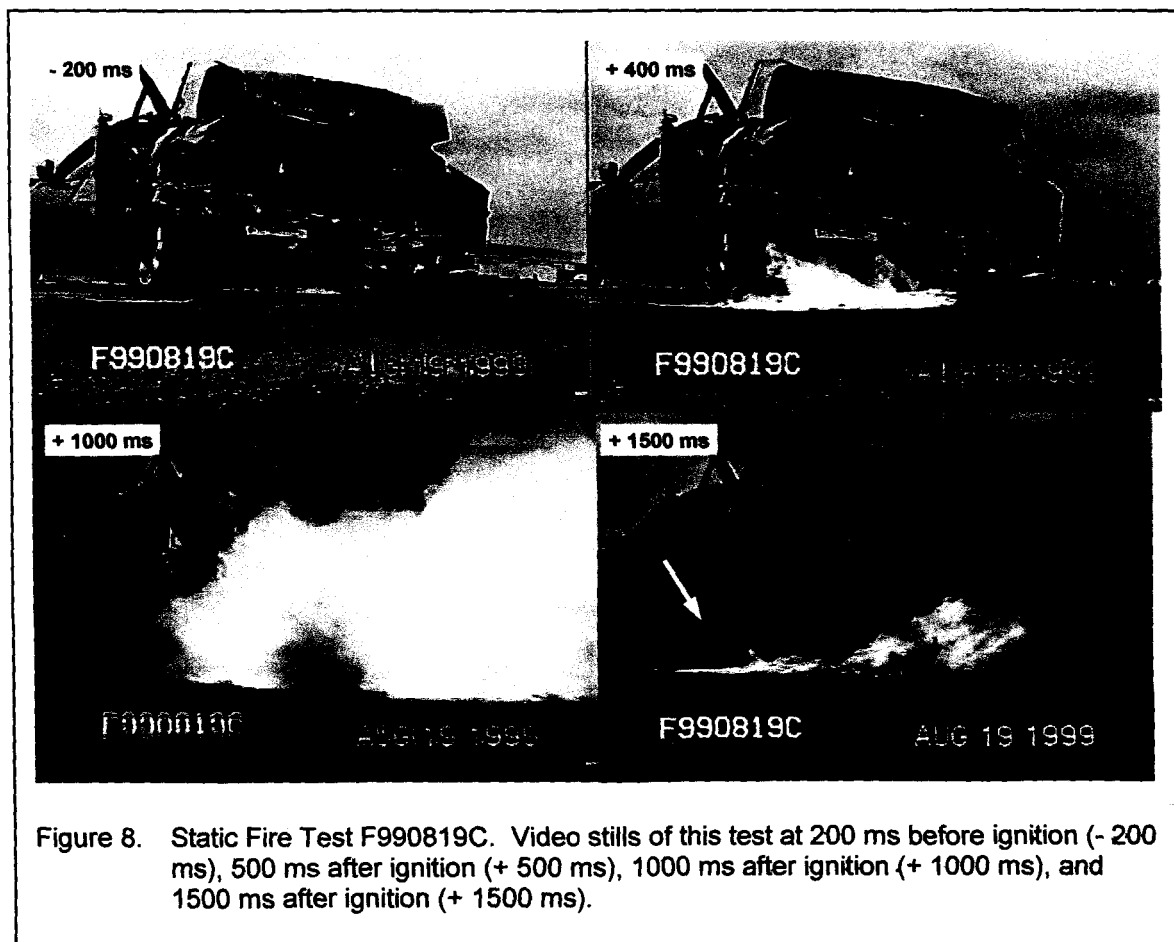
agent and continued to burn (arrow in Fig. 8), re-igniting liquid gasoline on the ground under the test vehicle after the SPGG discharge had ceased and airborne suppression agent was blown away from under the test vehicle. Safety personnel present for this test extinguished the fire using hand-held fire extinguishers (carbon dioxide).

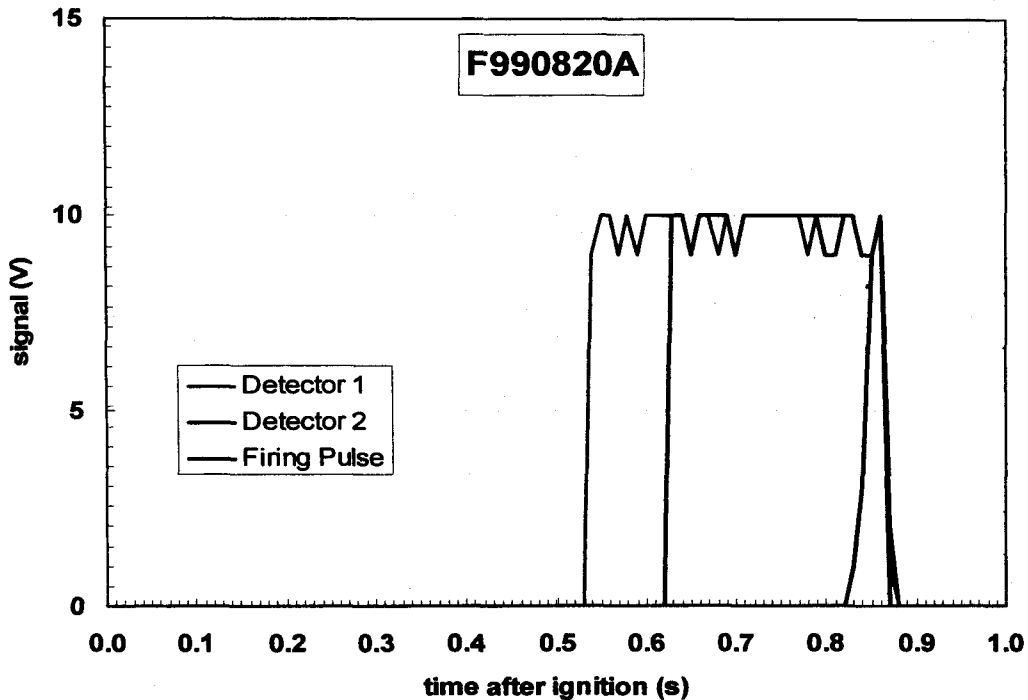
Detector 1 output a detection signal to the fire suppression system controller approximately 540 ms after ignition. Detector 2 output a detection signal to the fire suppression system controller approximately 630 ms after ignition. The fire suppression system controller output firing pulse to the SPGG units approximately 830 ms after ignition.

Figure 9. Static Fire Test F990820A. Plots of the output signals from Detectors 1 and 2 to the fire suppression system controller and the firing pulse from the fire suppression system controller to the SPGG units.

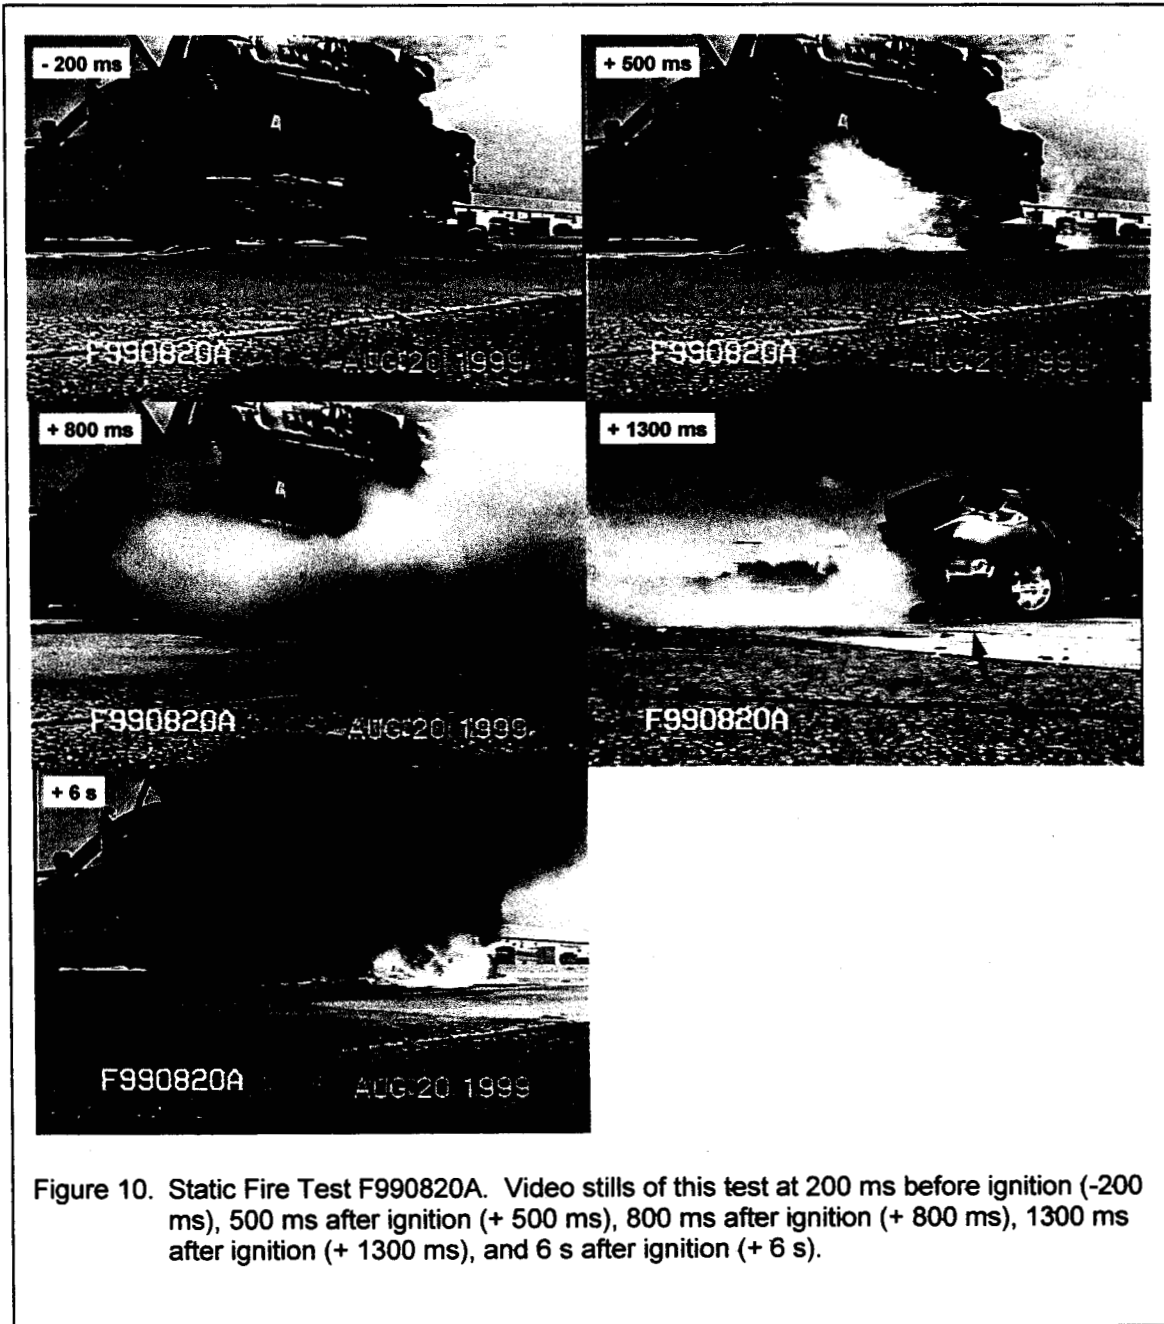
Figure 10 shows a sequence of video stills from this test at 200 ms before ignition, 500 ms after ignition, 800 ms after ignition, 1300 ms after ignition, and 6 s after ignition. This sequence of video stills shows that the discharge from the SPGG units did not extinguish the fire. Gasoline outboard of the muffler and exhaust pipes was shielded from the suppression agent and continued to burn after the SPGG discharge had ceased and airborne suppression agent cleared from under this section of the test vehicle (arrow in + 1300 ms video still in Fig. 10). Flames propagated from the shielded, unextinguished flame to gasoline on the ground under the under the test vehicle. Safety personnel present for this test extinguished the fire using hand-held fire extinguishers (carbon dioxide).

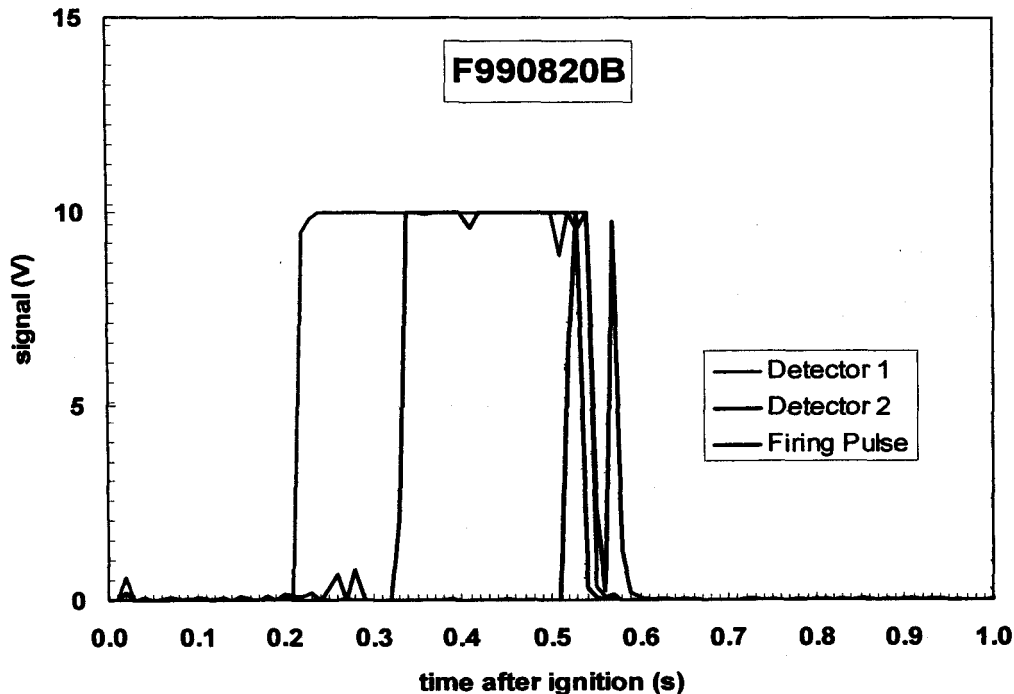
the test vehicle. Figure 11 shows plots of the output signals from Detector 1 and Detector 2 to the fire suppression system controller, and the fire pulse from the fire suppression system controller to the SPGG units during this test.

Figure 11. Static Fire Test F990820B. Plots of the output signals from Detectors 1 and 2 to the fire suppression system controller and the firing pulse from the fire suppression system controller to the SPGG units.

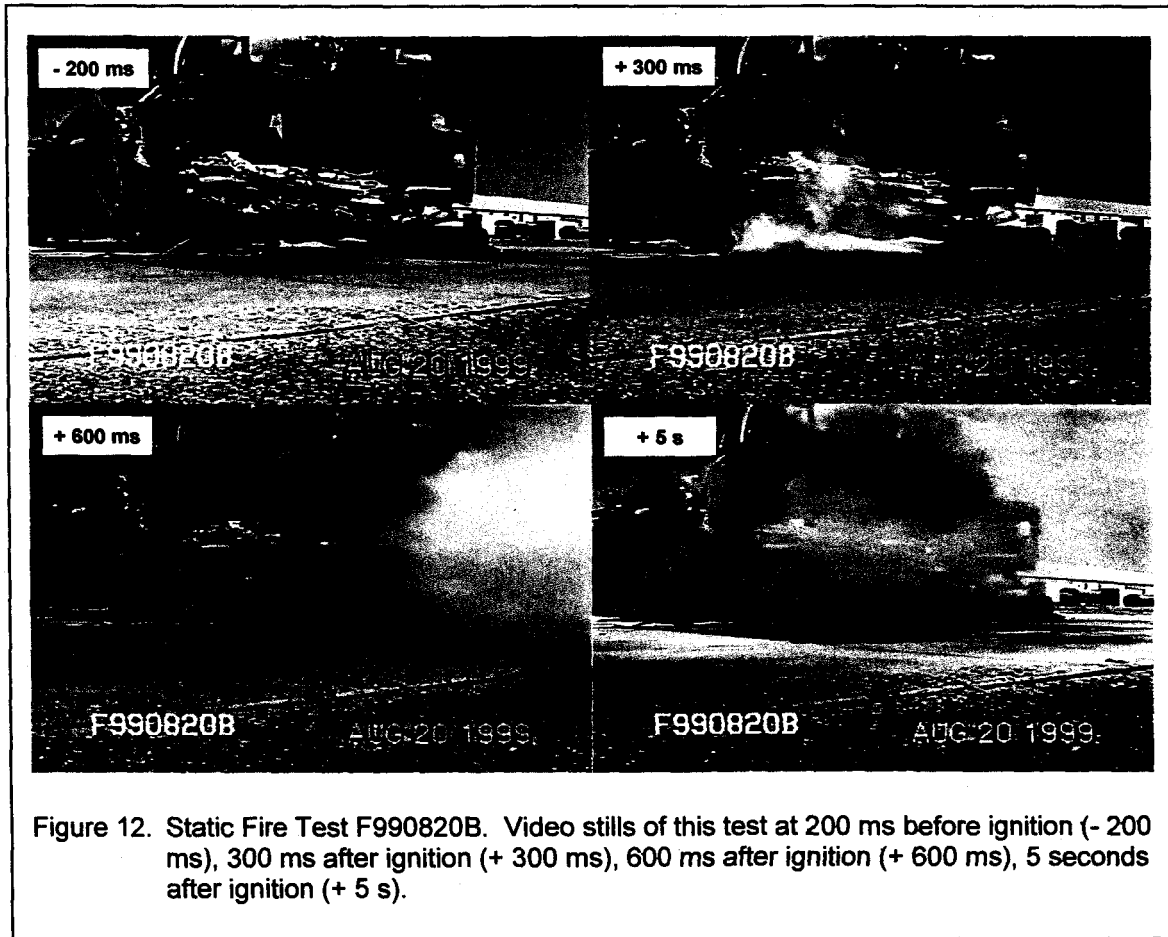
Detector 1 output a detection signal to the fire suppression system controller approximately 220 ms after ignition. Detector 2 output a detection signal to the fire suppression system controller approximately 320 ms after ignition. The fire suppression system controller output a firing pulse to the SPGG units approximately 530 ms after ignition. Figure 12 shows a sequence of video stills from this test at 200 ms before ignition, 300 ms after ignition, 600 ms after ignition, and 5 s after ignition. This series of video stills shows that the effluent from the SPGG units extinguished the flames without re-ignition.

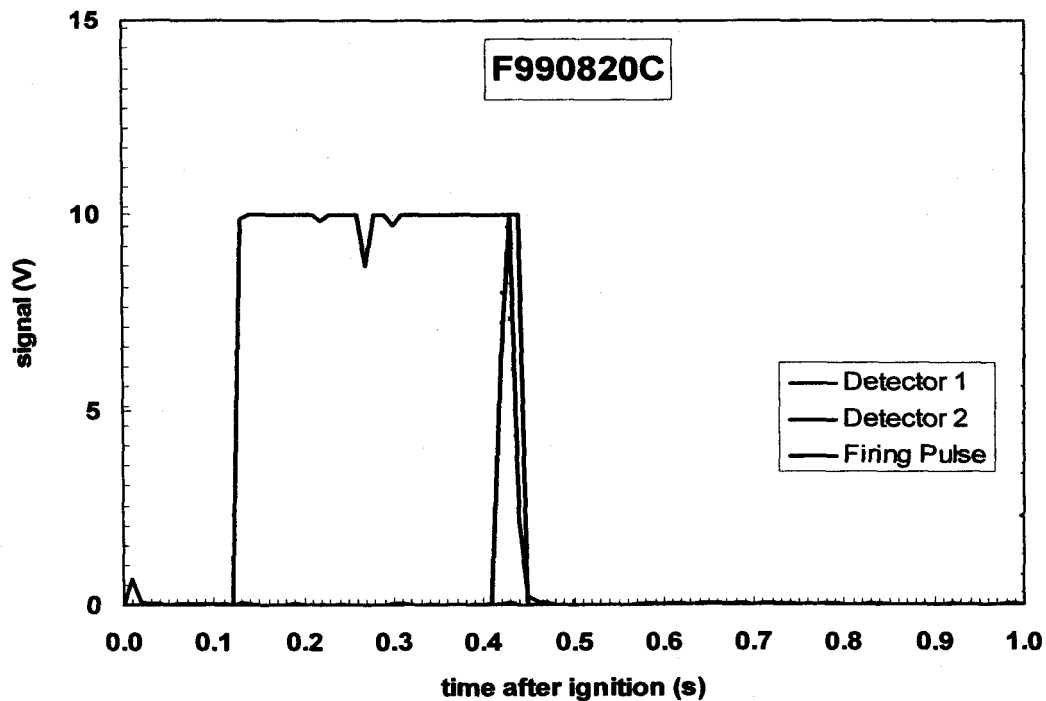
Detector 1 did not output a detection signal to the fire suppression system during this test. Detector 2 output a detection signal to the fire suppression system controller approximately 130 ms after ignition. The fire suppression system controller output firing pulse to the SPGG units approximately 430 ms after ignition.

Figure 13. Static Fire Test F990820C. Plots of the output signals from Detectors 1 and 2 to the fire suppression system controller and the firing pulse from the fire suppression system controller to the SPGG units.
