AUTOMOTIVE FUEL TANK EVALUATION

COMPARATIVE EVALUATION OF AUTOMOTIVE FUEL TANKS IN GENERAL ACCORDANCE WITH THE ECE R34.01, ANNEX 5 SECTION 5.0 "RESISTANCE TO FIRE;" AND SECTION 1.0 "IMPACT RESISTANCE;" THE US DEPARTMENT OF TRANSPORTATION 49 CFR 393.67, SECTION E "DROP TEST;" AND ASTM D 638-00, "STANDARD TEST METHOD FOR TENSILE PROPERTIES OF PLASTICS"

FINAL REPORT Consisting of 228 Pages SwRI® Project No. 01.06081.01.001 August 2003

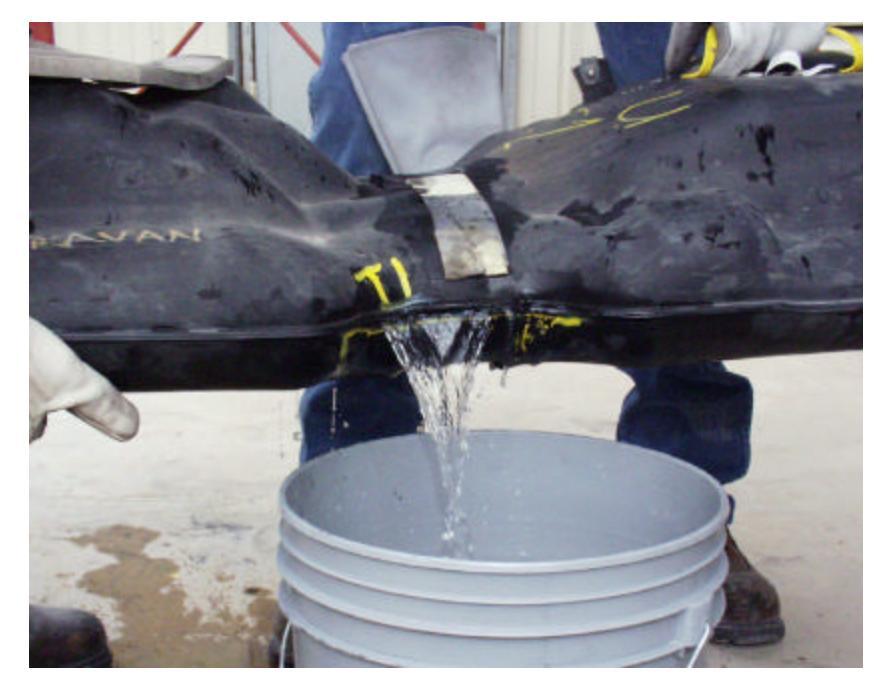
Figure A-30. Leakage of New Plymouth Plastic Fuel Tank After Impact.

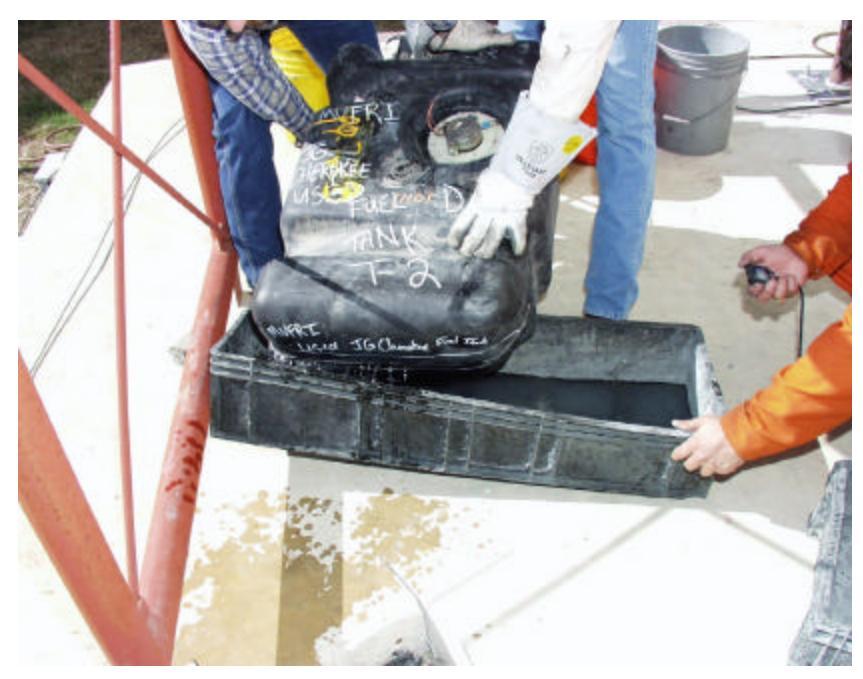
Figure A-31. Leakage of Conditioned Plymouth Plastic Fuel Tank After Impact.

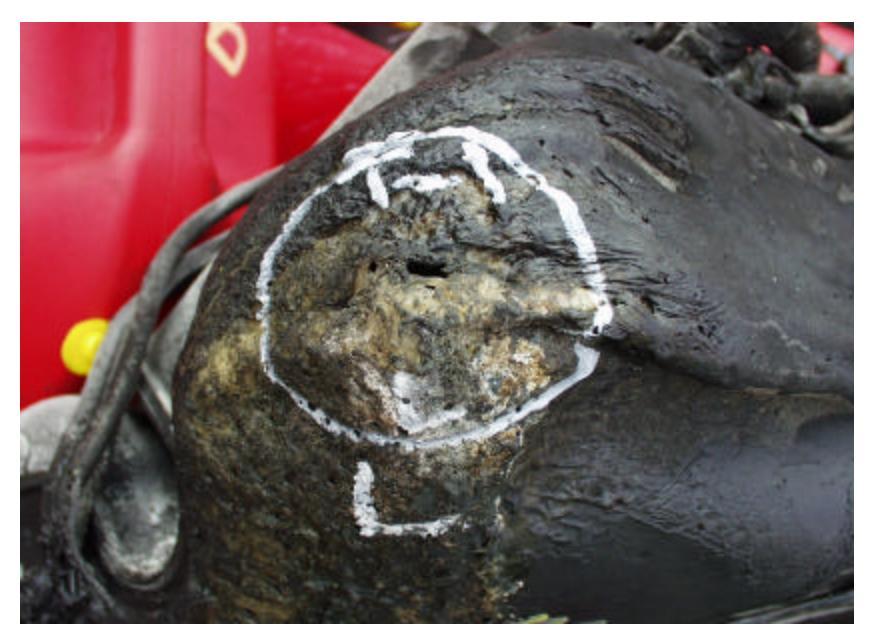
On December 18, 2002, Test SCP1 was conducted on the conditioned 1998 Saturn Twin Cam 4-Door fuel tank utilizing the original Saturn test buck. Test SCP1 demonstrated no leaks during the 2min ECE R34.01 fire exposure period. At 3 min 39 sec from the start of fuel tank fire exposure (or 1 min 39 sec into the extended fire exposure), the fuel tank leaked at the rear left side bottom corner of the fuel tank. Figure 8 provides a photograph of the fuel tank after the fire exposure. For additional photographs see Figures A-42 through A-51 in Appendix A.

Figure A-51. Test No. 1, Fire Exposure Hole at Rear Left Side Bottom Corner of Conditioned 1998 Saturn Twin Cam 4-Door Fuel Tank.

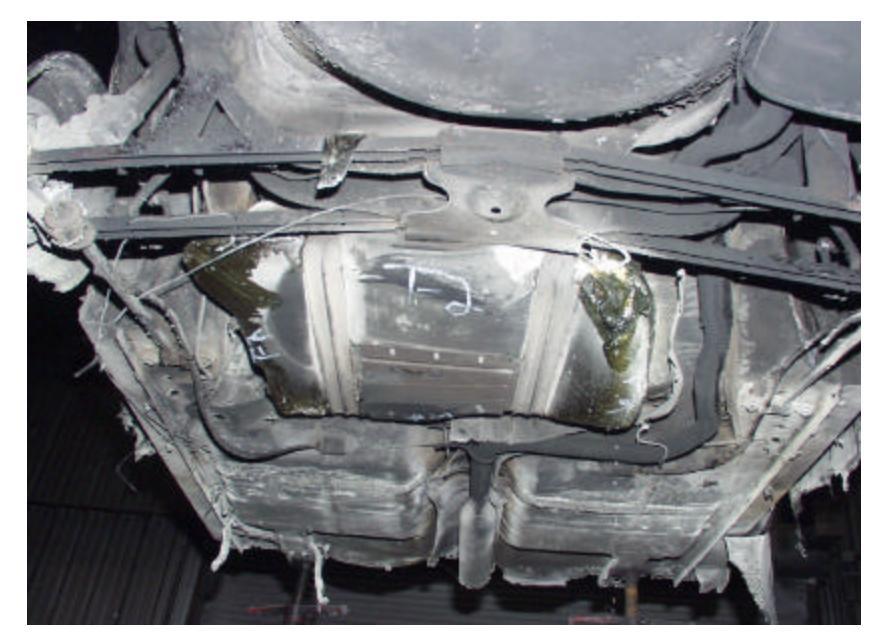
Figure A-72. Test No. 2, Repeatability Evaluation on a New Twin Cam 4-Door Fuel Tank Immediately After Fire Exposure with a Leak on Rear Passenger Side Corner of Fuel Tank.

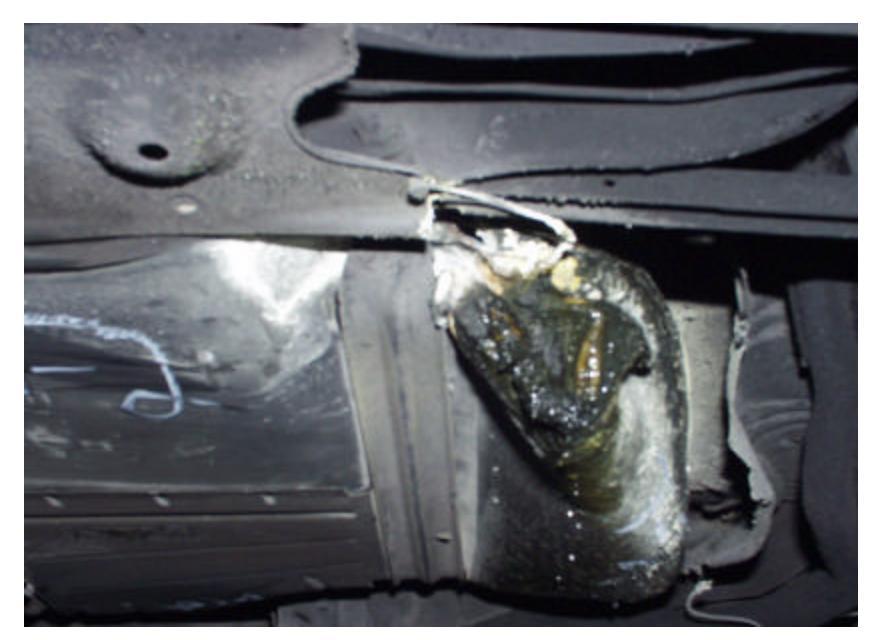
Figure A-74. Test No. 2, Repeatability Evaluation on a New 1998 Saturn Twin Cam 4-Door Fuel Tank Immediately After Fire Exposure with Leak on Rear Passenger Side Corner of Fuel Tank.

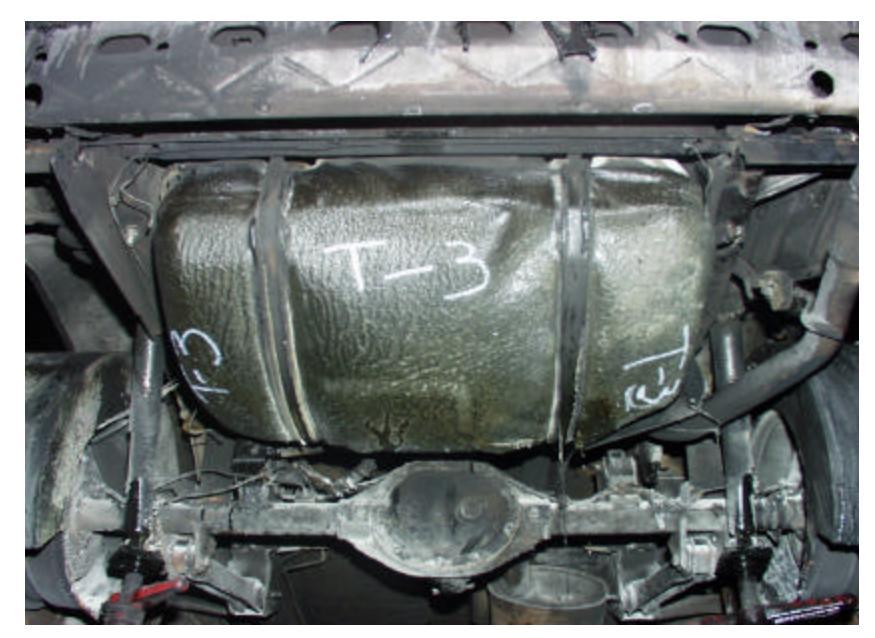
Figure A-96. Test No. 3, Conditioned 1998 Jeep Grand Cherokee Fuel Tank Immediately After Fire Exposure with Leak at Front Right Side Along Outboard Side of Strap.

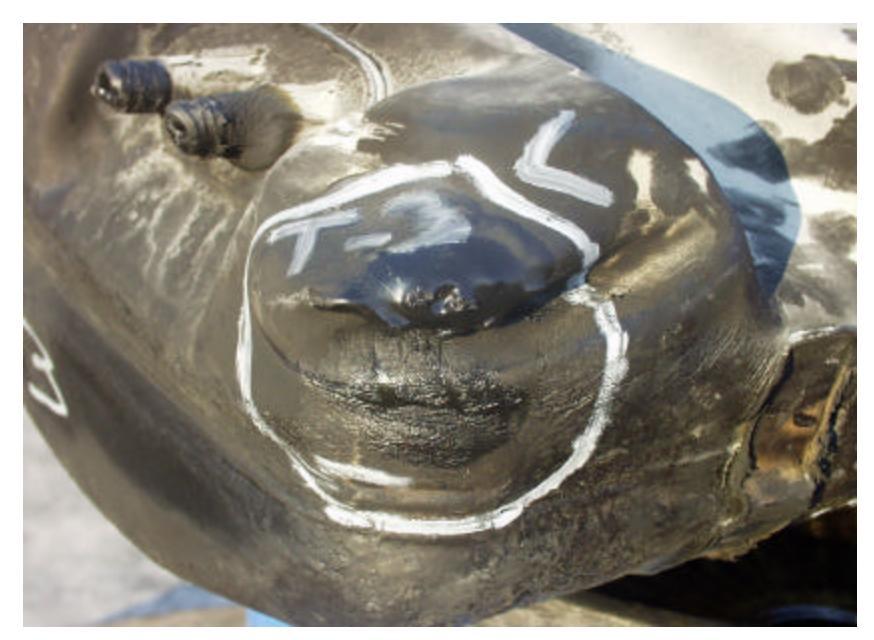
Figure A-100. Test No. 3, Fire Exposure Hole at Front Right Side Top Corner of Conditioned 1998 Jeep Grand Cherokee Fuel Tank.

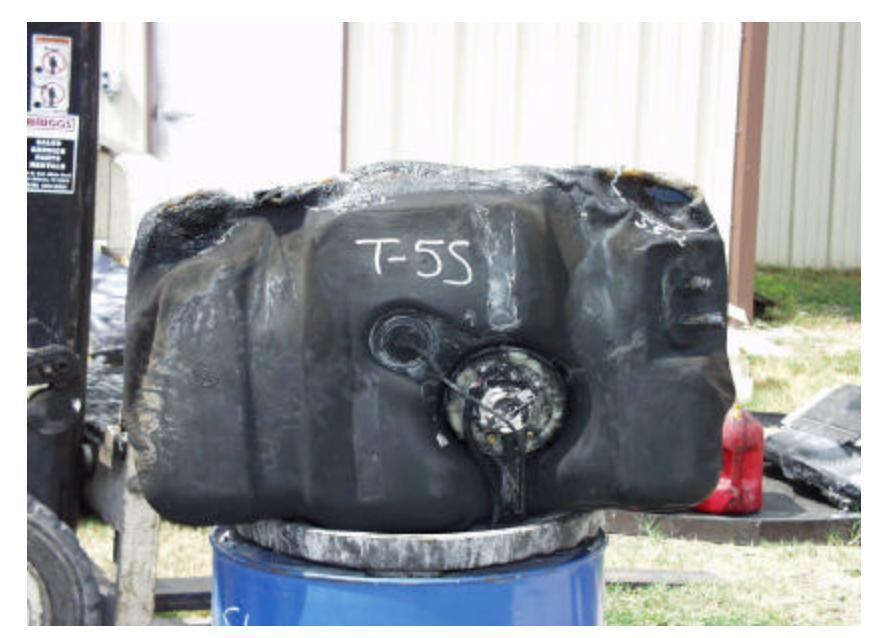
Figure A-126. Test No. 5S, Top View of New 1998 Jeep Grand Cherokee Fuel Tank After Fire Exposure.

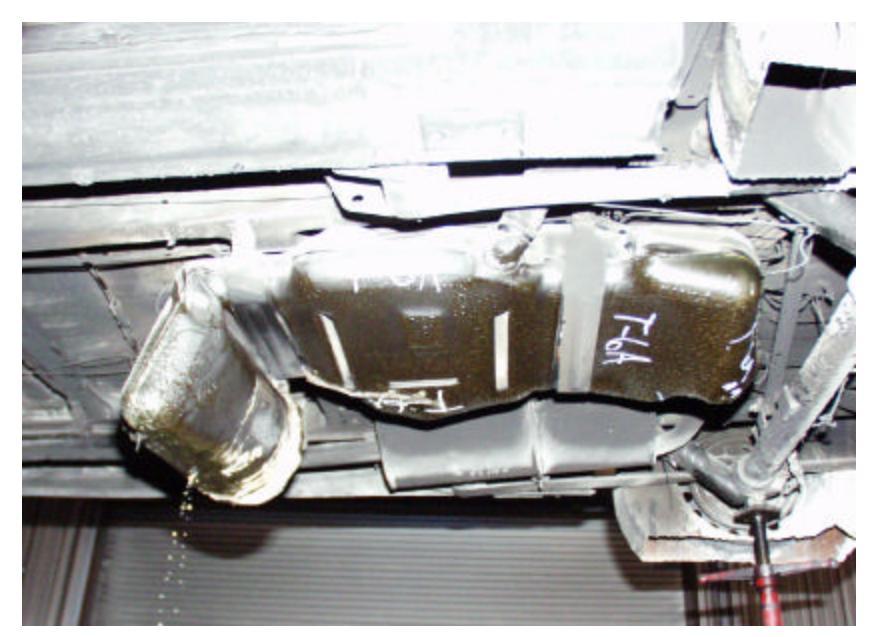
Figure A-148. Test No. 6A, New 1998 Plymouth Grand Voyager Fuel Tank Immediately After Fire Exposure with Leak at Front Strap and Front Top Side of Fuel Tank.

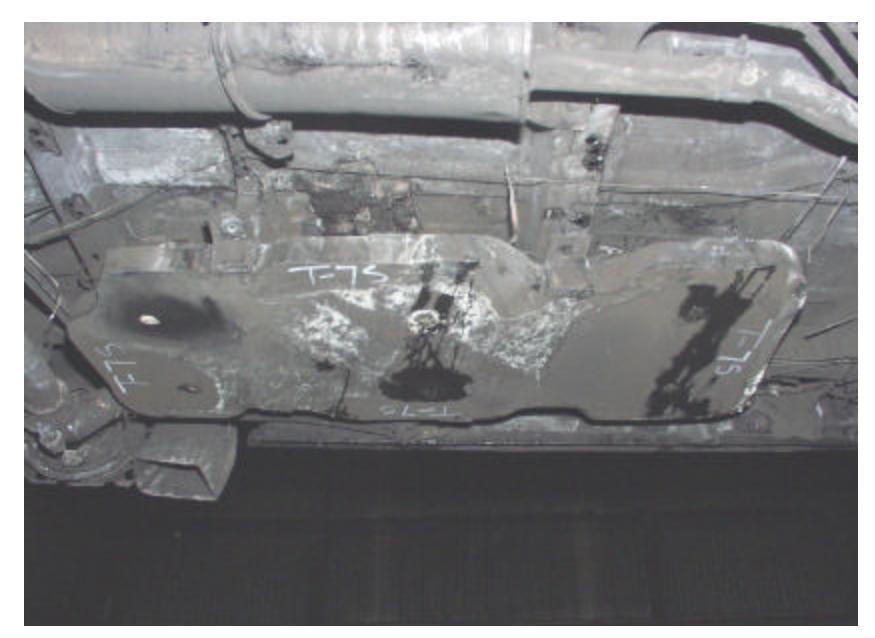
Figure A-167. Test No. 7S, Bottom View of New 1998 Plymouth Grand Voyager Fuel Tank With Heat Shield After Fire Exposure With Leak Location at Front Side and Middle Drain Holes.

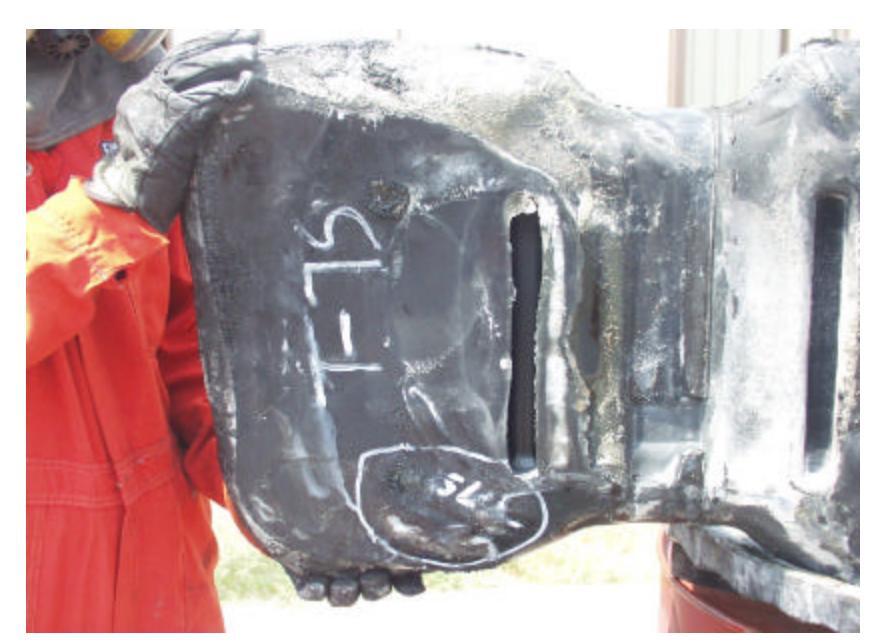
Figure A-179. Test No. 7S, Bottom View of New 1998 Plymouth Grand Voyager Fuel Tank After Fire Exposure With Leak Location at Front Bottom Passenger Side of Fuel Tank.

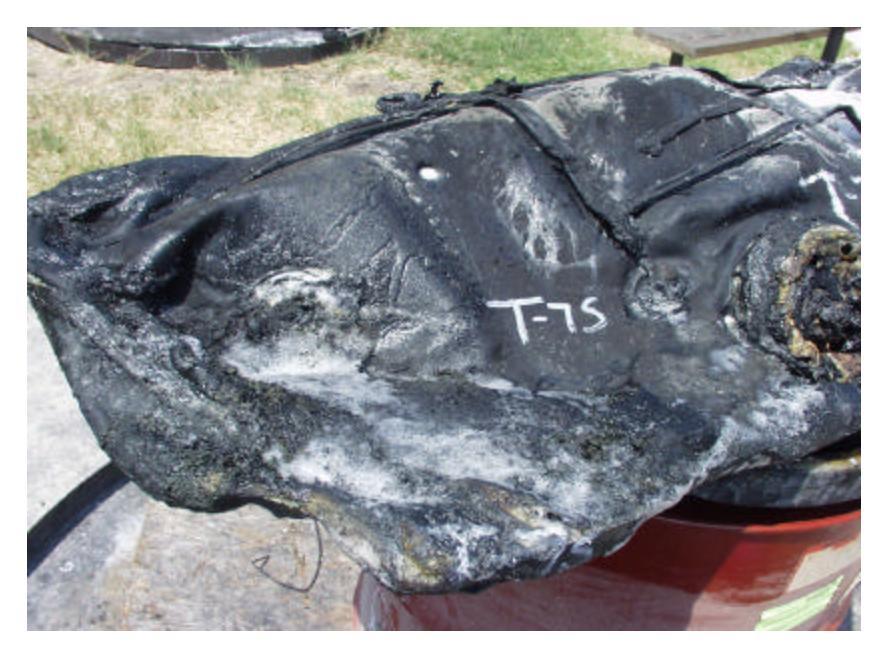
Figure A-183. Test No. 7S, Top View of New 1998 Plymouth Grand Voyager Fuel Tank After Fire Exposure With Leak Location at Rear Corner Passenger Side of Fuel Tank.

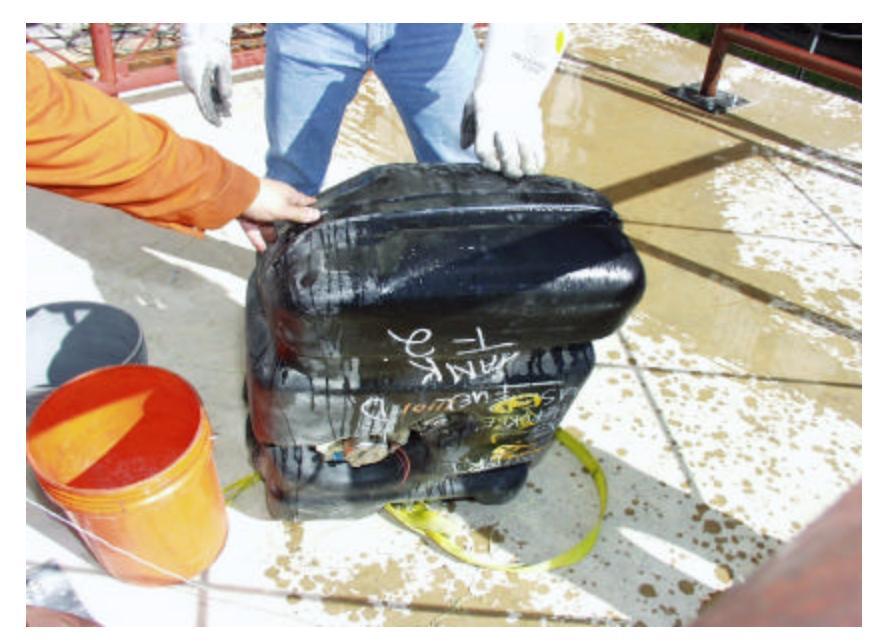
Since the drop tests indicated there could possibly be an issue of bond strength weakness at the pinch-off locations of the failed tanks previously mentioned, tensile tests were conducted in general accordance with ASTM D 638-00, "Standard Test Method for Tensile Properties of Plastics." Specimen coupons for these tests were extracted from the new and conditioned Plymouth Grand Voyager fuel tanks and the new and conditioned Jeep Grand Cherokee fuel tanks that underwent the previously mentioned drop test. The pinch-off locations of these coupons were perpendicular to the long-axis of the specimen. Failure for all specimen coupons was attributed to elongation in the long-axis of the specimen's parent material and not from the bond at the pinch-off location. Alternative test methods should be considered or developed to evaluate the bond strength at the pinch-off location under conditions more representative of the dynamics of the drop test, for example to evaluate the effect of shear stresses.

Figure A-242. Leak Due to Pinch-Off Separation of the Conditioned 1998 Jeep Grand Cherokee Fuel Tank After the 30-ft Drop Test.
