Enclosed is a final report prepared by Jeffrey Santrock of General Motors Corporation, entitled, "Evaluation of Motor Vehicle Fire Initiation and Propagation/Part 7: Propagation of an Engine Fire in a 1997 Rear Wheel Drive Passenger Car."

This report relates to Project B.3 (Fire Initiation and Propagation Tests).

# **Evaluation of Motor Vehicle Fire Initiation and Propagation Part 7: Propagation of an Engine Compartment Fire in a 1997 Rear Wheel Drive Passenger Car**

Jeffrey Santrock  
General Motors Corporation

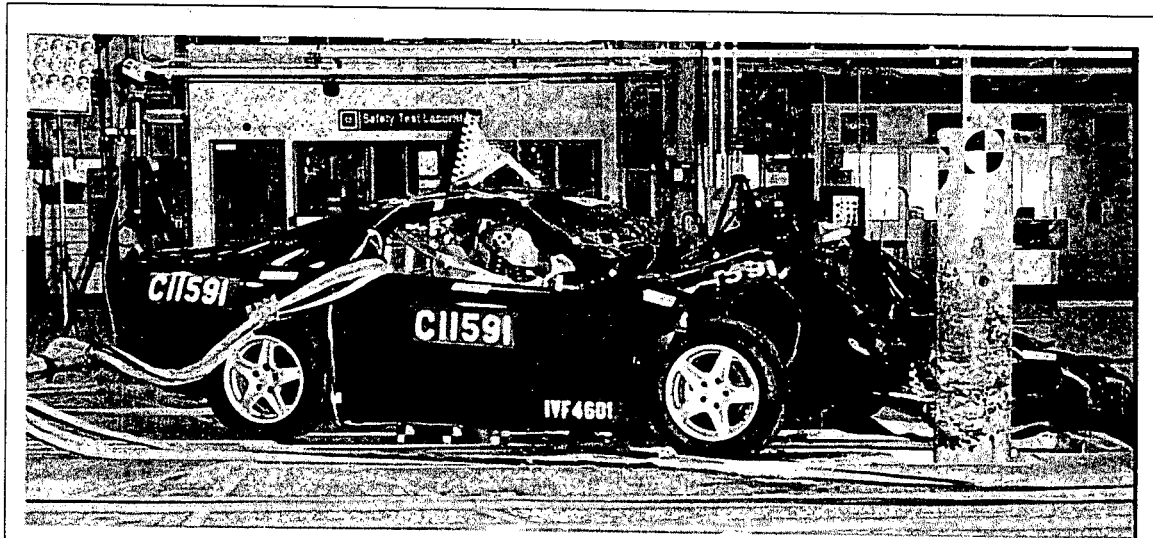
Figure 1 is a photograph of the test vehicle after the crash test. The maximum penetration of the pole into the test vehicle (dynamic crush) during the crash test was approximately 1255 mm and occurred at 118 milliseconds. The residual crush was not determined. The hood and right fender were crushed. The windshield and window in the right door were broken. The left side of the front bumper fascia was detached from the test vehicle.

Figure 1. Fire Test F971003. Photograph of the test vehicle after the crash test.

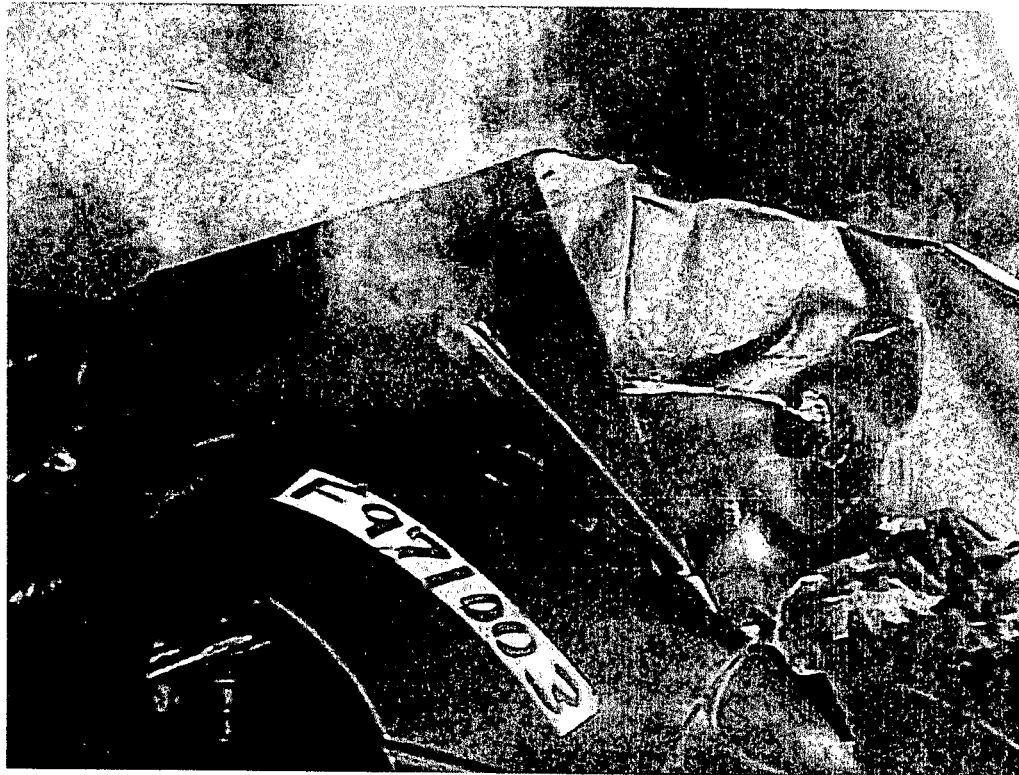
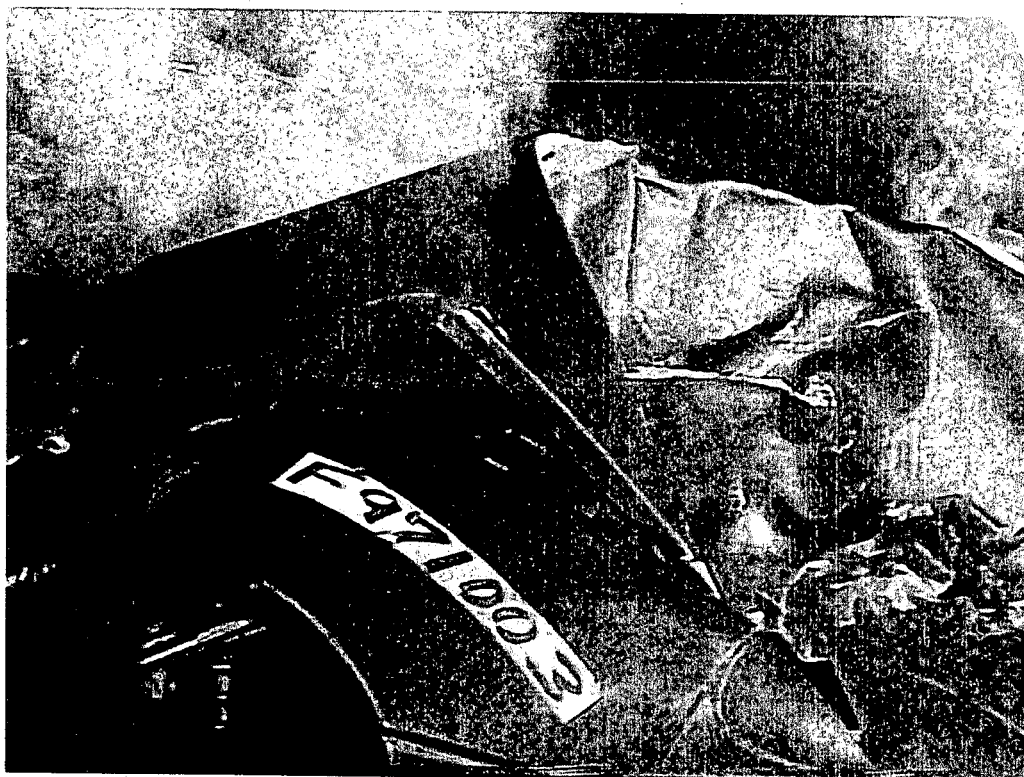
Figure 8. Fire Test F971003. Video stills from Camera 9 at 120 and 150 seconds post-ignition.

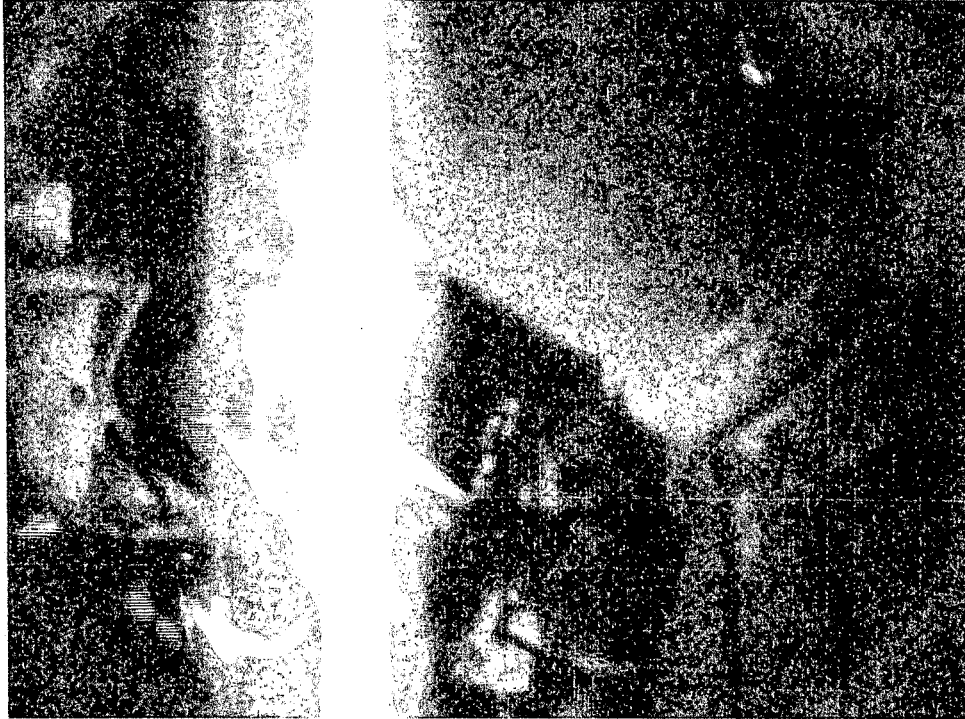
Figure 15. Fire Test F971003. Video still from Camera 7 at 5 minutes post-ignition.

Burning polymer melt was observed dripping periodically onto the inboard section of the HVAC upper case, right exhaust manifold heat shield, and right valve cover starting between 1½ and 3 minutes post-ignition. Initially, it was not possible to determine the source of this material as it appeared to originate from above and left, out of the field-of-view of Camera 7. By 3 minutes post-ignition, a section of the HVAC upper case<sup>5</sup> near one of the heater hoses was burning, and pools of burning polymer melt were observed on the right exhaust manifold heat shield (Fig.13). The burning polymer melt on the right exhaust manifold heat shield self-extinguished by 5 minutes post-ignition (Fig.'s 14 and 15). Flames spread lower on the HVAC module as burning polymer melt flowed downward on the upper case between 3 and 6 minutes post-ignition (Fig.'s 13 through 16).

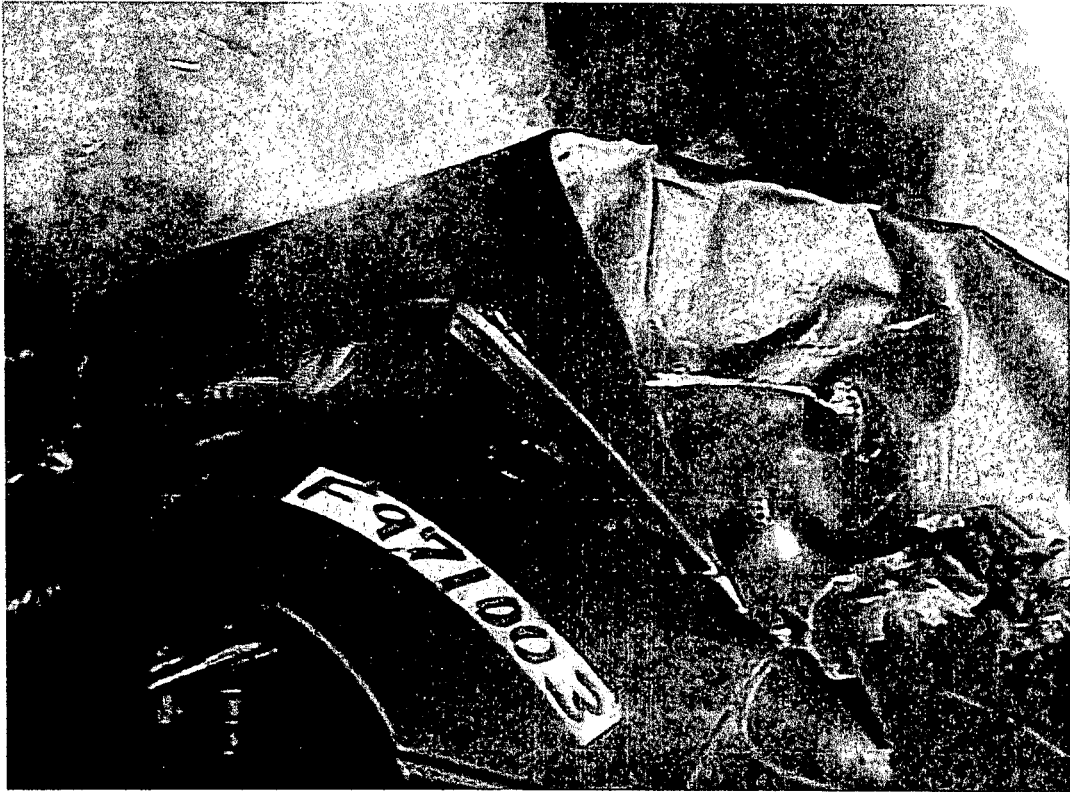
Figure 18. Fire Test F971003. Video still from Cameras 9 and 4 at 3½ minutes post-ignition.

Figure 17 shows estimated isothermal contours in the upper part of the engine compartment of the test vehicle at 2, 3, 4, 5, 6, 7, 8, 9, 10, 11, 12, 13, 14, 15 and 16 minutes post-ignition. These estimated isothermal contour plots suggest that flames emerged from under the upper dash extension panel above the area where the propane torch was located between 3 and 4 minutes post-ignition<sup>6</sup> (Fig. 17). The video records from Cameras 4 and 9 show that flames reached the air inlet screen at the base of the windshield in the area above the propane torch about 3½ minutes post-ignition (Fig. 18). For example, a view into the engine compartment under the right side of the deformed hood shows a fire plume emerging from under the dash upper extension panel, extending under and in front of the right air inlet screen at this time (upper video still, Fig. 18). An overall view of the front of the test vehicle from above shows flames emerging from the front and rear around the right air inlet screen at this time (lower video still, Fig. 18). The timing of flame-spread to the right air inlet screen estimated from the isothermal contour plots (Fig. 17) is consistent with the timing of flame-spread to this area observed in the videos from Cameras 4 and 9 (Fig. 18).

Flames began to contact the windshield between 3 and 4 minutes post-ignition, when flames emerged from the engine compartment along the rear edge of the deformed hood (see Fig. 18). Figures 24 through 33 show a series of video stills from Cameras 4 and 6 at 4, 5, 6, 7, 8, 9, 10, 11, and 12 minutes post-ignition. The isothermal contour plots overlaid on the video stills from Camera 4 are estimated temperature profiles at the exterior surface of the windshield.<sup>11</sup> The thermocouples used to measure the temperature data used in the calculation of these isothermal contours were located approximately 5 mm away from (in front of) the exterior surface of the windshield or below the air inlet screen just above the leading edge of the windshield. These thermocouples were heated by convection and radiation from hot gases and flames venting from the engine compartment along the rear edge of the deformed hood. Thus, the estimated temperature profiles shown in Figures 24 through 33 indicate the approximate distribution of heated gases and flames along the exterior surface of the windshield. This analysis cannot be used to estimate the temperature of the exterior surface of the windshield because the thermocouples used to acquire the data for these calculations were not in contact with the windshield.

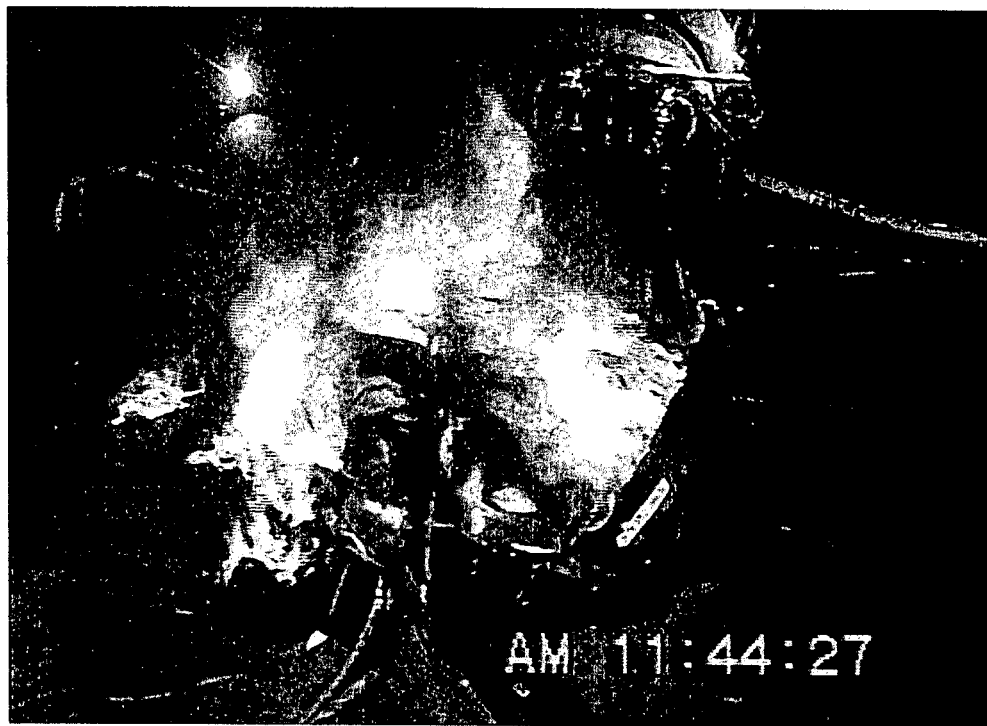
Figure 21. Fire Test F971003. Video still from Camera 4 at 15½ minutes post-ignition.

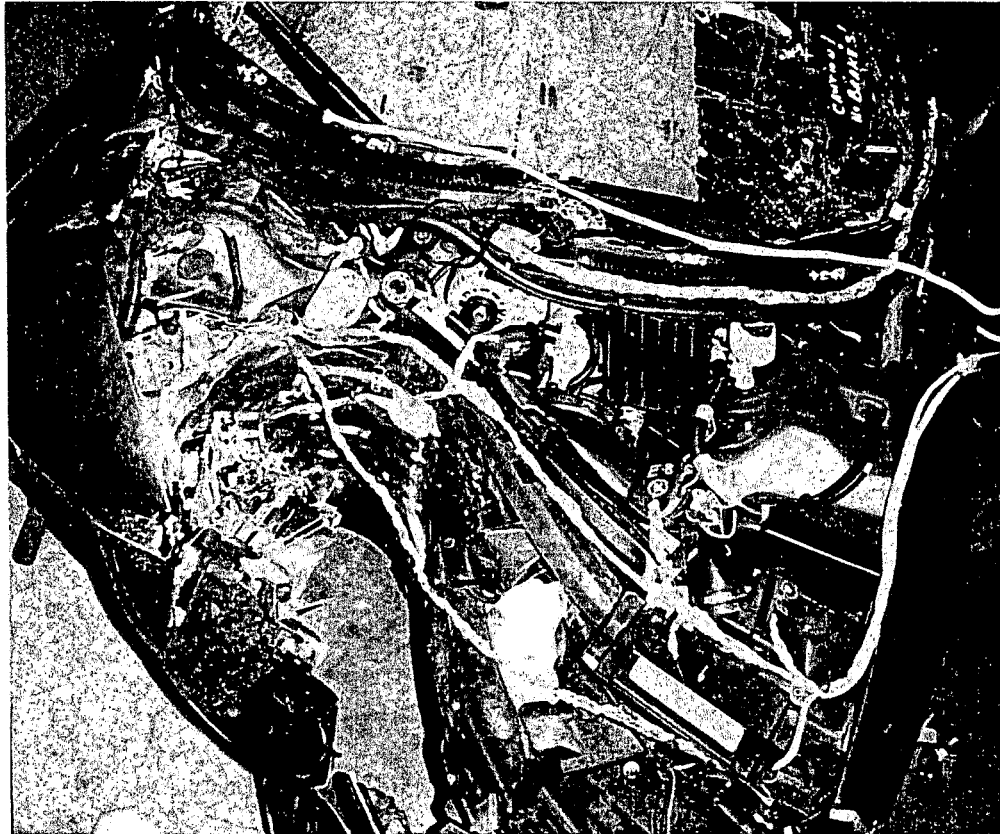
Figure 22. Fire Test F971003. Photographs of the front of the test vehicle before (upper) and after (lower) this test.

The pattern of fire damage to components in the engine compartment of the test vehicle after this test (Fig. 22) is consistent with the extent of flame-spread in the engine compartment inferred from the estimated isothermal contour plots of temperatures in the upper engine compartment at 16 minutes post-ignition (Fig. 17). For example, the air inlet screen at the rear of the engine compartment, and the engine air intake duct and engine air cleaner housing along the upper radiator support cross-member were in areas where the estimated temperature was at least 600°C (Fig. 17). Burned and charred residue from these components was present in the engine compartment after this test (Fig. 22). Components forward of the upper radiator support cross-member on the left side of the test vehicle such as the windshield washer fluid reservoir showed no evidence of melting or igniting (Fig. 22).

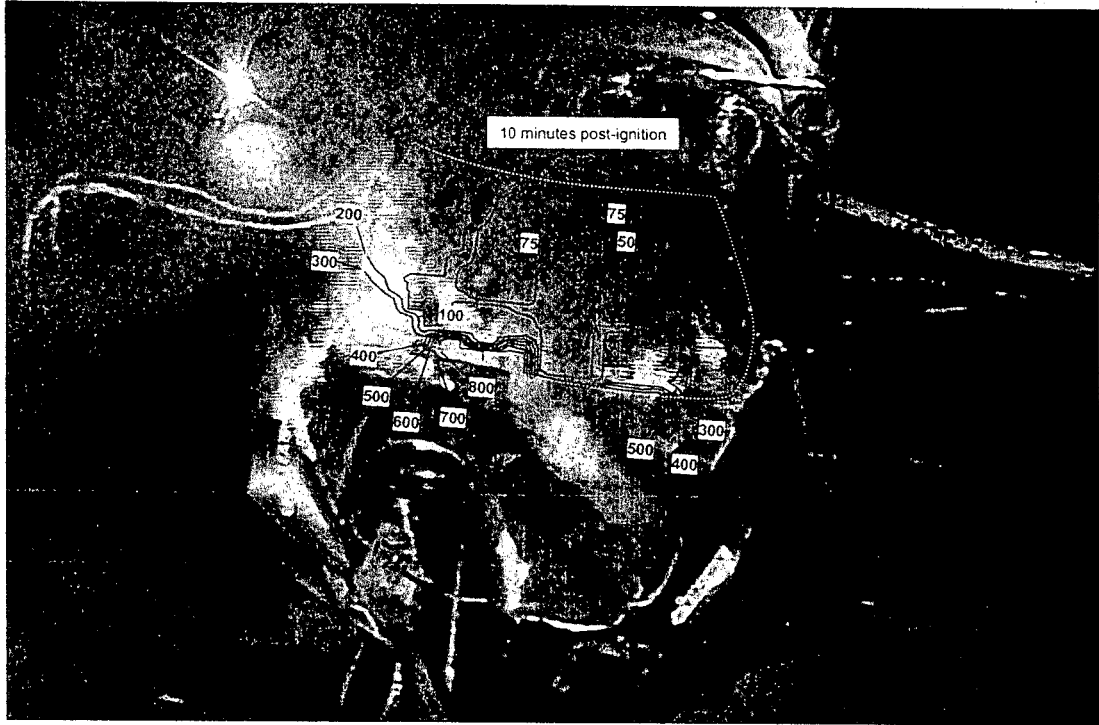
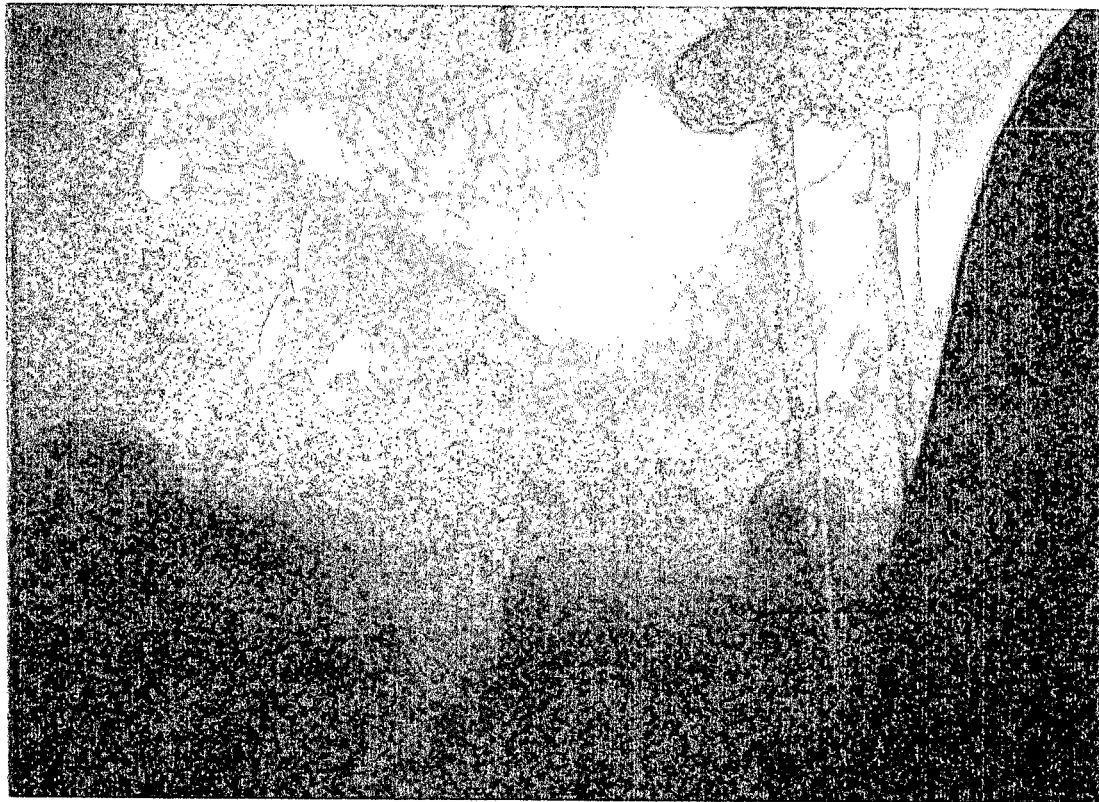
Figure 31. Fire Test F971003. Video Stills from Camera 4 with estimated isothermal contour plots of temperatures on the windshield and Camera 6 at 10 minutes post-ignition.

The recorded temperature data indicates that two areas at the exterior surface of the windshield were exposed to flames from 4 through 12 minutes post-ignition. These are the areas where  $t > 600^{\circ}\text{C}$  in Figures 24 through 33, which were located along the lower (forward) edge of the windshield below the air inlet screen, and initially were exposed to flames venting from the engine compartment at the rear of the hood (see **SECTION 4**). Flames emerging from under the upper dash extension panel were channeled between the air inlet screen and the windshield (see Fig. 18). Flames attached to the lower surface of the air inlet screen also were channeled between the air inlet screen and the windshield, igniting the forward edge of the instrument panel upper trim panel and the inner layer where the windshield had separated from the windshield support panel. Neither the video record nor the recorded temperature give a clear indication of when the instrument panel upper trim panel and the windshield inner layer ignited in these areas.

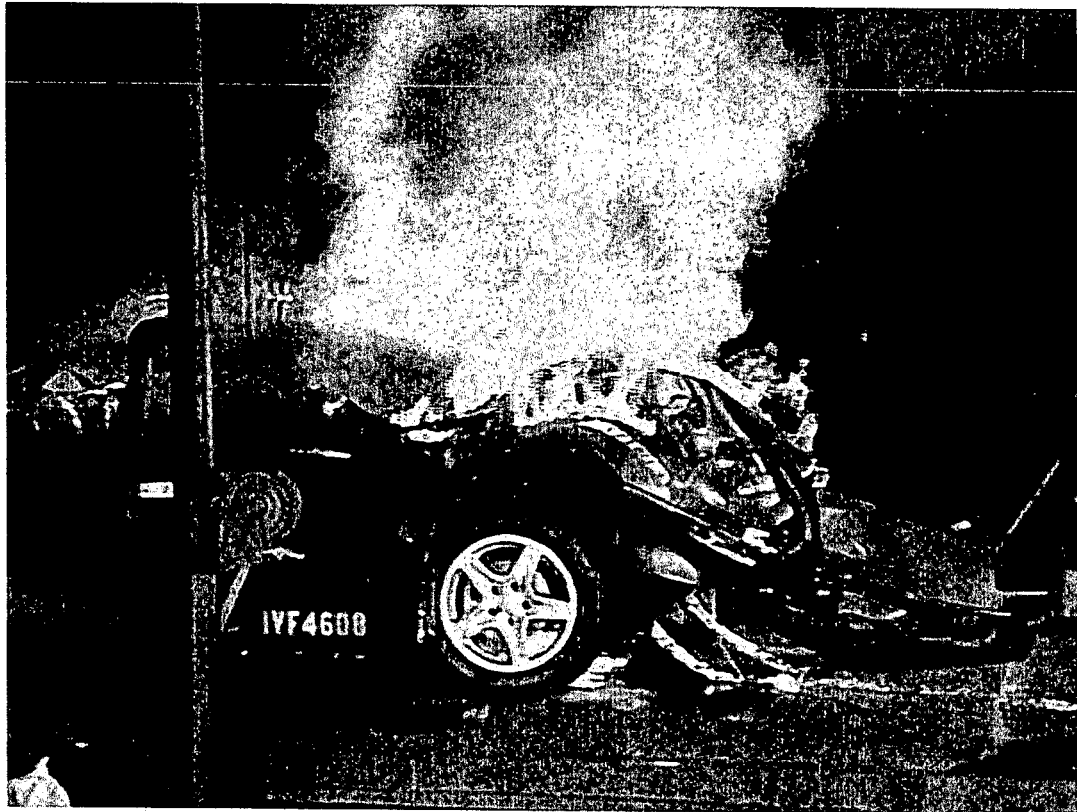
Figure 34. Fire Test F971003. Video still from Cameras 2 at 10 minutes post-ignition.

The heat release-rate of the fire was approximately 240 kW at 10 minutes post-ignition (plot H1, **APPENDIX H**). The velocity of the vent flow along the rear of the engine compartment was insufficient to force the flames against the sagged windshield (Fig. 34). The natural buoyancy of the flames predominated, causing the fire plumes to rise almost straight up from the rear edge of the hood. Although these fire plumes did not contact the windshield, convection and radiation from flames along the rear edge of the hood heated the exterior glass outer layer causing the inner layer to soften and stretch (Fig.'s 24 through 32). The video stills from Camera 6 show that the windshield inner layer started to soften and stretch along the cracks in the glass outer layers of the attached glass between 8 and 9 minutes post-ignition (Fig.'s 29 and 30). A section of the windshield fell on top of the instrument panel between 11:05 and 11:10 minutes:seconds post-ignition (Fig. 35).

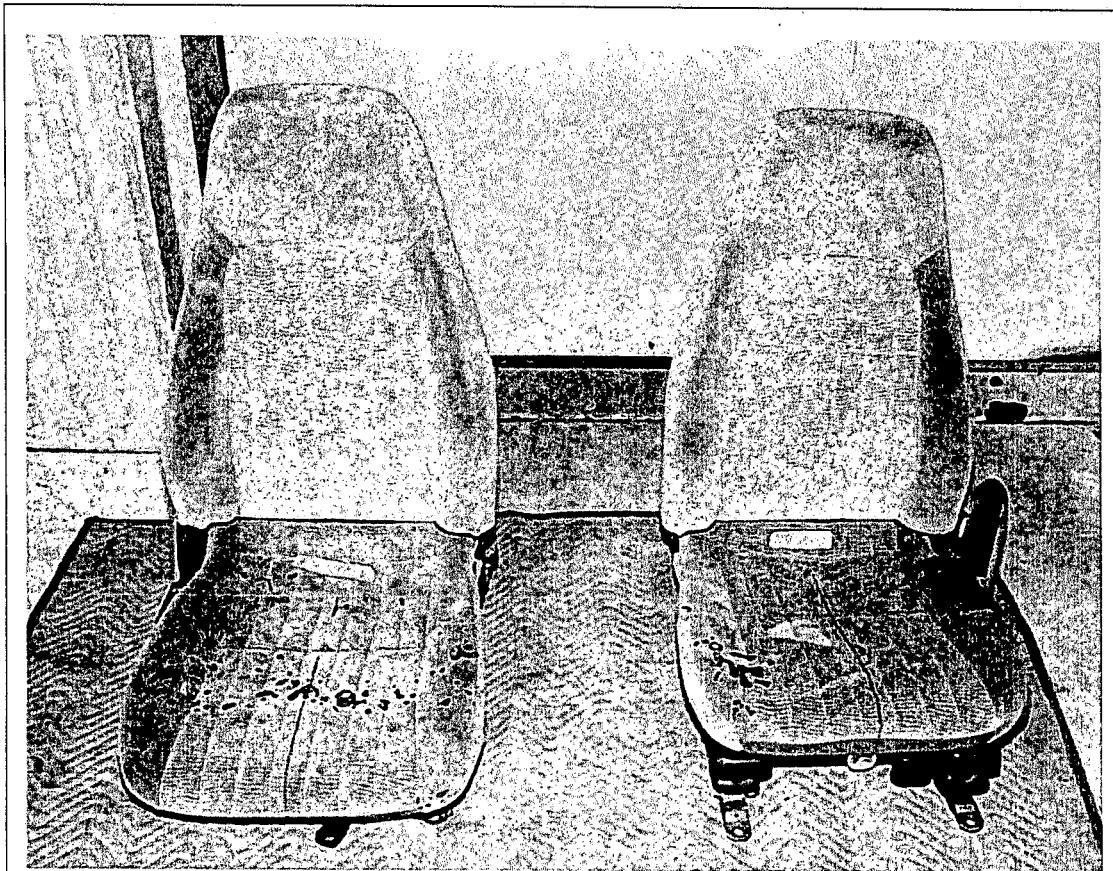
Figure 57. Fire Test F971003. Photograph of the front seats from the test vehicle after this test.

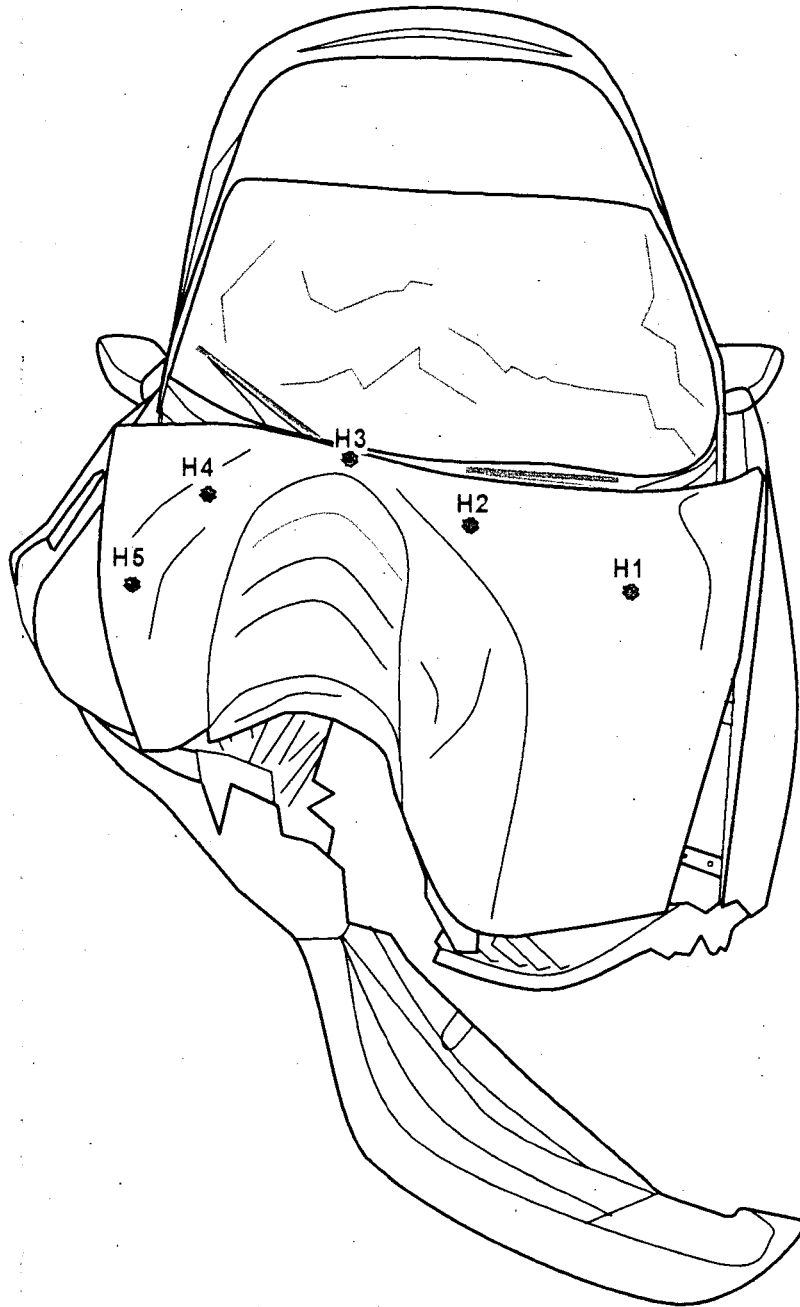
Figure C3. Fire Test F97.1003. Diagram showing the approximate locations of thermocouples on the hood of the test vehicle. Thermocouples H1 through H5 were located approximately 1 cm below the lower surface of the hood liner on the under-side of the hood.

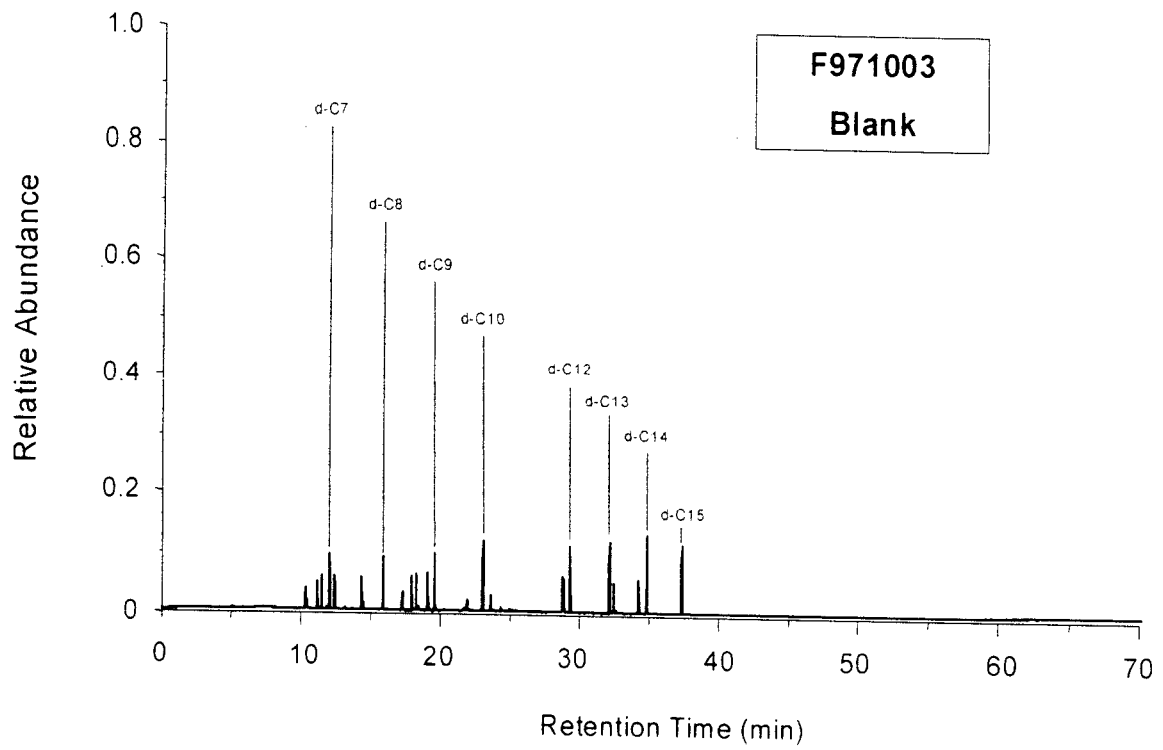
Plot J1. Fire Test F971003. Mass chromatogram from GC/MS analysis of a blank acquired for 10 minutes before the start of the test.
