**Evaluation of Motor Vehicle Fire Initiation and Propagation  
Part 10: Propagation of a Mid-Underbody Gasoline Pool Fire in a  
1998 Sport Utility Vehicle**

Jeffrey Santrock  
General Motors Corporation

NHTSA-98-3588-189

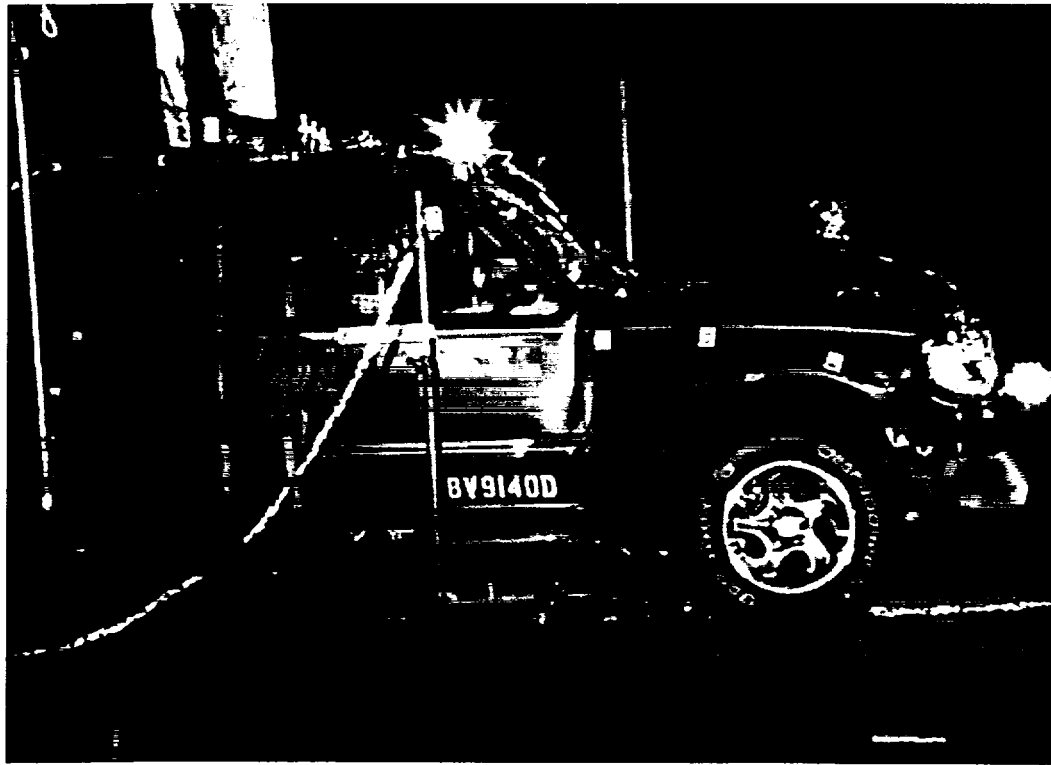
Figure 9. Fire Test F980611. Video stills from Camera 2 at 2 seconds before ignition (upper) and approximately ½ second after ignition (lower).

Gasoline flowed into the fuel tank skid plate and onto the cement board surface under the test vehicle. A propane torch was used to ignite gasoline vapor above the liquid gasoline pool under the test vehicle approximately 28 seconds after the start of gasoline flow. Figures 8 through 11 show a series of video stills from Cameras 1 through 4 at 2 seconds before ignition and about ½ second after ignition. Ignition occurred under the front of the fuel tank near the left side of the test vehicle (lower video stills, Fig.'s 8 through 11). Blue flames (Fig.'s 5 through 8) spread concentrically from the point of ignition through gasoline vapor retained in the bottom of the fluid containment pan<sup>2</sup> after it had vaporized. Flames were observed in the fuel tank skid plate after ignition.

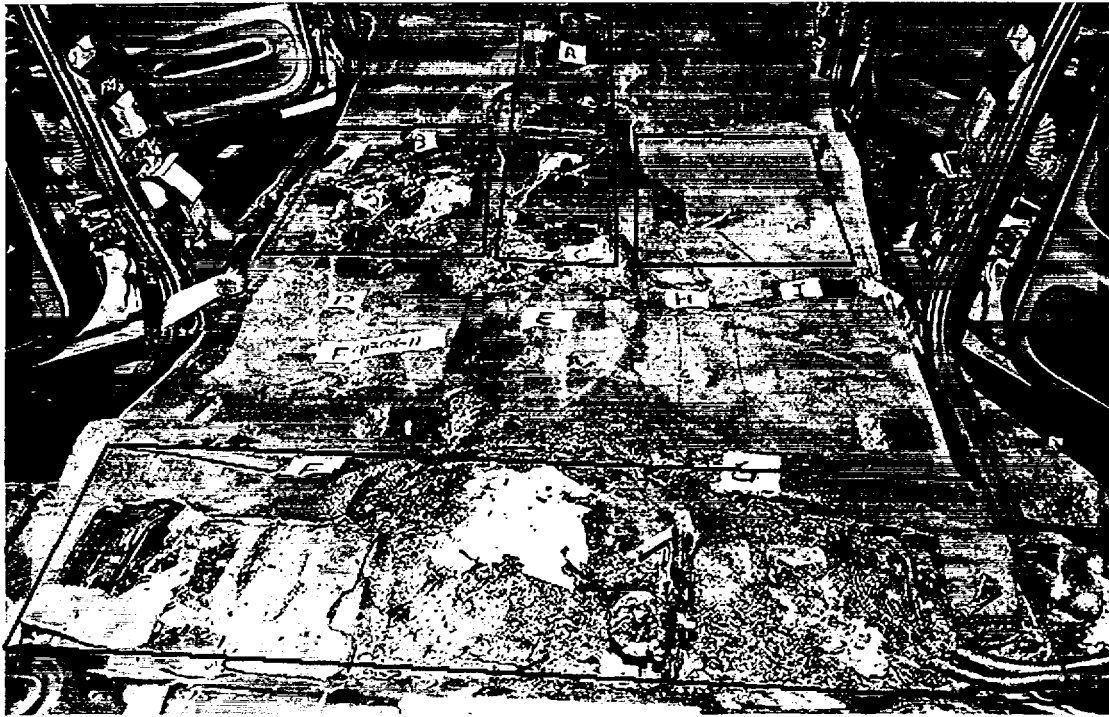
Heat and fire damage to the floor panel and floor carpet observed during inspection of the test vehicle after this test indicated that flames spread into the passenger compartment through a number of openings in the floor panel. Figure 24 shows photographs of the floor carpet and floor panel in the test vehicle after this test. The instrument panel, center console, seats, and interior trim panels were removed from the test vehicle after this fire test and before the photographs in Figure 24 were taken. The outlines in these photographs indicate the approximate foot-prints of the front seats, center console, and rear bench. The labels in both photographs indicate the following openings in the floor panel: crash-induced gaps around the shift lever pass-through cover plate (A); electrical pass-through openings under the left front seat (B); drain openings in the panel (C through I).

Photographs in Figure 24 show three areas of heat and fire damage to the floor carpet and floor panel caused by flame-spread through the electrical pass-through openings in the floor panel under the left front seat, where the carpet was over the drive train tunnel, and along the rear of the front compartment under the right side of the rear seat. Conduction through the floor panel also appears to have resulted in heat damage to the carpet in these areas. The timing of flame-spread through the electrical pass-through openings under the left front seat was determined by analysis of data recorded from thermocouples and heat flux transducers in the test vehicle, and by examination of the video record. The timing of flame-spread through drain holes in the floor panel could not be determined accurately from the thermocouple data recorded during this test. Temperature data recorded from Thermocouples F13, F14, F16, F17, and F18 indicate that flames did not spread into the passenger compartment through the gaps around the floor panel and the shift lever pass-through cover plate (see APPENDIX C).

An area of the floor carpet that was under the left front seat was burned and charred, and consumed by fire. Electrical pass-through openings are visible in the exposed floor panel (B, Fig. 24). Figure 25 contains diagrams showing the approximate locations of Thermocouples C1, C2, F9, F10, P5, P6, P7, S18, S19, and S20, and HFT2 in the test vehicle. Thermocouple F9 was located approximately ½ in. below the lower surface of the floor panel (Diagram A, Fig. 25). Thermocouple F10 was attached to the upper surface of the floor panel using a thermally conductive adhesive (Diagram A, Fig. 25). HFT2 was located in a clearance hole drilled in the floor panel such that the transducer element was facing downward and flush with the lower surface of the floor panel (Diagram A, Fig. 25). Thermocouples P6 and P7 were located in the

Figure 24. Fire Test F980611. Photograph of the floor carpet (upper) and floor panel (lower) in the test vehicle after this test.

The floor carpet over the drive train tunnel that was under the rear of the center console was burned and charred, and consumed by fire (Fig. 24). A drain hole opening is visible in the exposed section of floor panel (C, Fig. 24). An area of the floor carpet that was under the rear bench seat was burned and charred, and consumed by fire. A drain hole opening is visible at the edge of the carpet (G, Fig. 24). When the floor carpet was removed from the test vehicle after this test, a number of other drain hole openings were observed in the floor panel (Fig. 24). Grommets were in place in all of these drain hole openings before this fire test, and appeared to have been partially or completely consumed by fire during this test.

vehicle after this test revealed that the grommets in 5 of 7 drain holes in the floor panel in the front compartment of the test vehicle were partially or completely consumed by fire (Fig. 24). Heat and fire damage to the floor carpet (Fig. 24), rear section of the center console (Fig. 37), and rear panels in the front seat back covers (Fig. 41) indicate that flames spread into the passenger compartment through the drain hole labeled C in Figure 24. Heat and fire damage to the floor carpet (Fig. 24) and rear seats (Fig. 42) indicate that flames spread into the passenger compartment

Sections of the floor carpet that were over the drive train tunnel, under the left front seat, and under the rear seat on the right side of the vehicle and that did not contain carpet pad ignited and burned during this test. Residue from the floor carpet that had melted during the fire and solidified when the fire was extinguished was adhered to the floor panel in these areas after the floor carpet was removed from the test vehicle (Fig. 24).
