NHTSA-98-3588-201

**Evaluation of Motor Vehicle Fire Initiation and Propagation  
Part 12: Propagation of an Underbody Gasoline Pool Fire in a  
1998 Front-Wheel Drive Passenger Vehicle**

Jeffrey Santrock  
General Motors Corporation

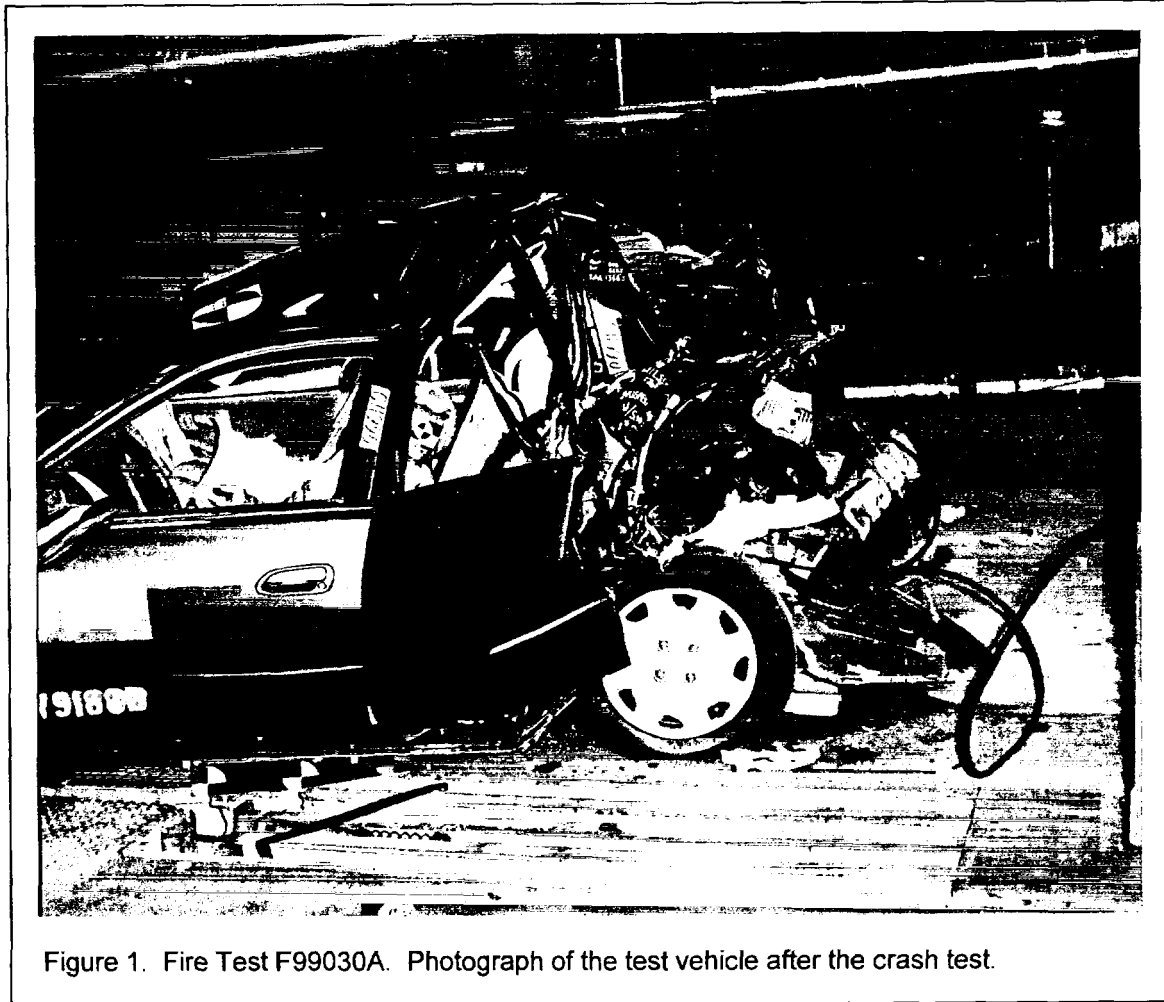
Figure 1. Fire Test F99030A. Photograph of the test vehicle after the crash test.

Figure 1 is a photograph of the test vehicle after the crash test. Numerical analysis of high speed film of this crash test indicated that the longitudinal displacement on the right side of the test vehicle relative to a target on the moving barrier was approximately 1299 mm [2]. Longitudinal displacement on the left side of the test vehicle was not measured because the target on the left side of the test vehicle became obscured during this crash test [2]. The rear window glass, and the glass in the right and left rear doors was broken in the crash test (Fig. 1). The left rear door bent and was displaced outward from the door frame, creating gaps between the rear and lower edges of the door and the door frame (Fig. 1). The left rear door remained latched during this crash test. The roof was displaced upward in this crash test (Fig. 1).

occupant compartment observed during inspection of the test vehicle after the crash test included the rear window opening (Fig. 1), the window-openings in the left and right rear doors (Fig. 1), seam openings between the floor panel and the left and right wheel house panels (Fig. 2), and gaps around the left rear door and door frame that were the result of deformation to the structure of the test vehicle during the crash test (Fig. 3). The test vehicle was instrumented with thermocouples and heat flux transducers to measure flame spread from the under-body gasoline pool fire into the passenger compartment.

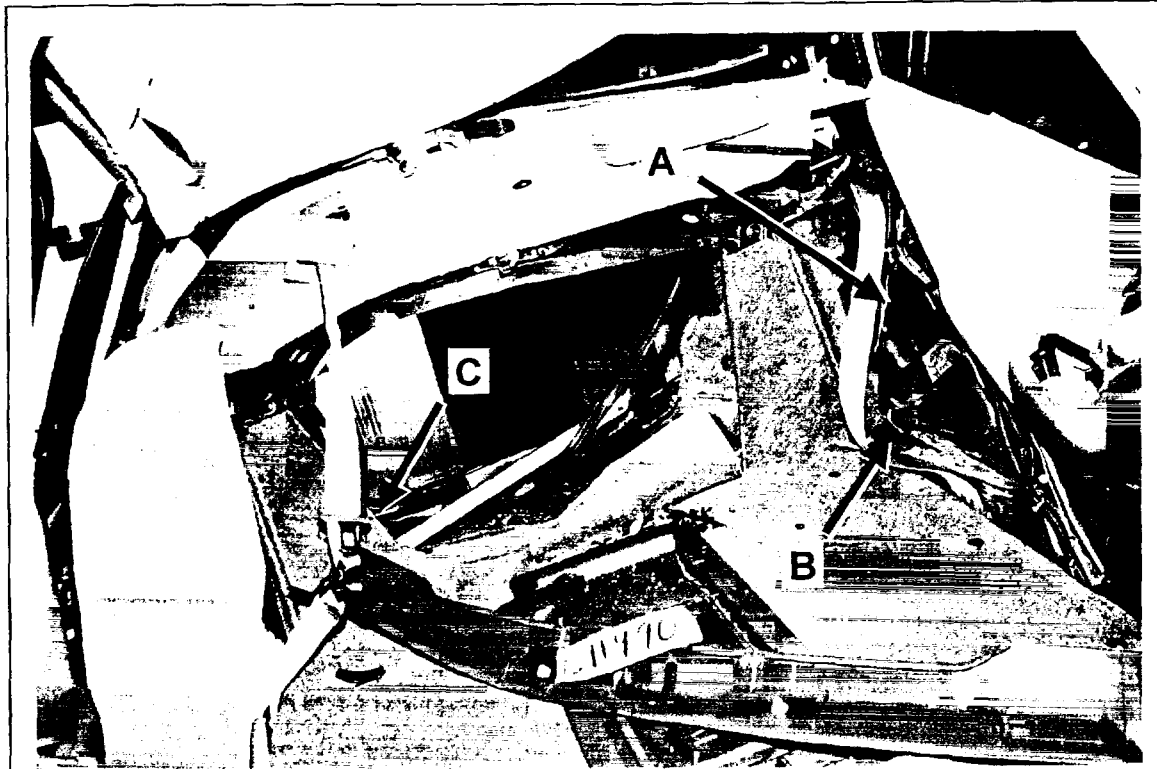
Figure 2. Fire Test F99030A. Photograph of the rear interior of the test vehicle after the crash test. The arrows indicate the approximate locations of crash-induced seam openings observed in the test vehicle after the crash test.

locations of crash-induced seam openings observed in the test vehicle after the crash test. Arrow A indicates a crash-induced seam opening between the left wheelhouse panel and inner quarter panel. Arrow B indicates a crash-induced seam opening between the left wheelhouse panel and floor panel. Arrow C indicates a crash-induced seam opening between the right wheelhouse panel and inner quarter panel which is not visible in this photograph.

Figure 2 is a photograph of the rear interior of the test vehicle after the crash test. The rear seat back had been folded down and the left seat wing had been removed when this photograph was taken. The trim on the rear package shelf was dislodged in the crash test and was laying on top of the folded down seat back in this photograph. The arrows in Figure 2 indicate the approximate

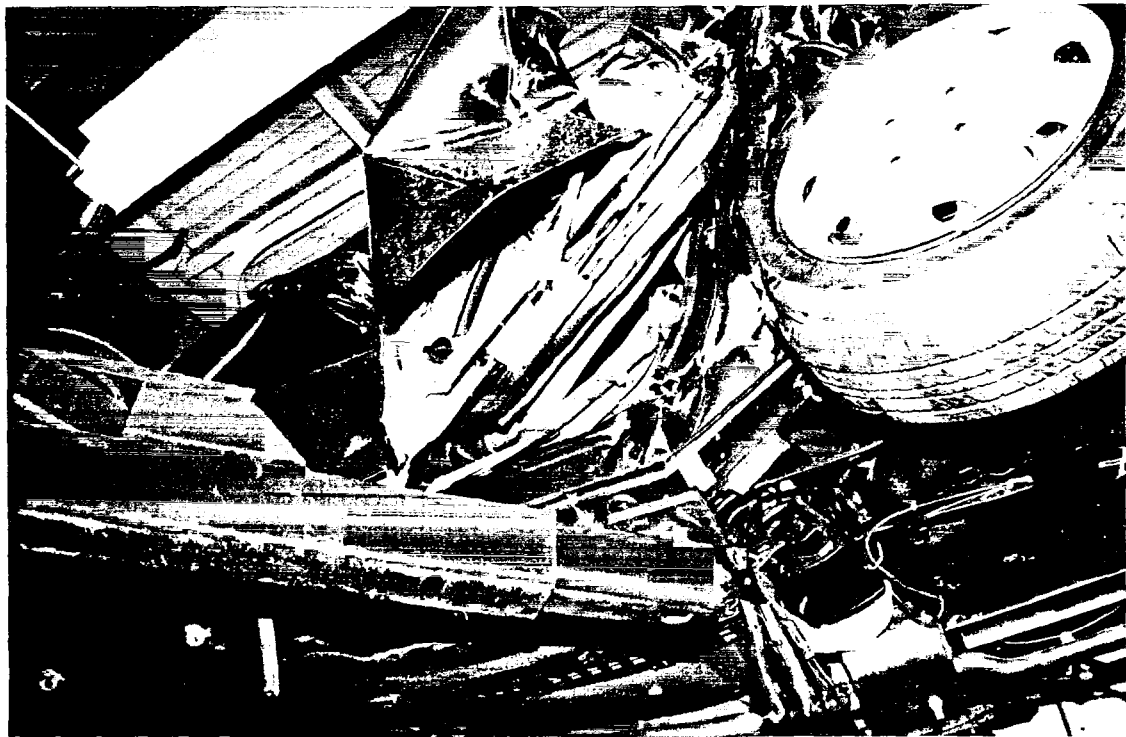
Figure 3. Fire Test F99030A. Photograph of the left rear door and left rear wheel of the test vehicle after the crash test. The test vehicle was on a vehicle hoist for this photograph.

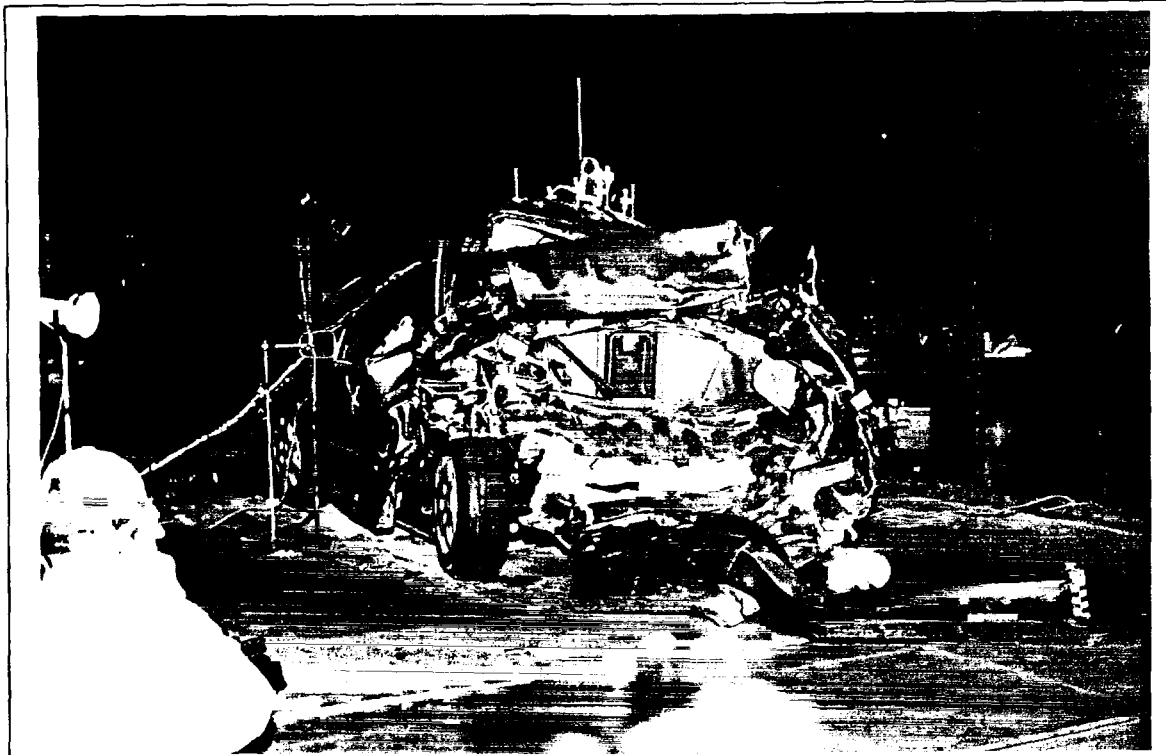
Figure 4. Fire Test F99030A. Photograph of the test vehicle in the fluid containment pan before the fire test.

The test vehicle was placed in the center of the pan (Fig. 4). All doors were closed, and the window glasses in both front doors were raised to their fully closed position. The glass in the rear window, and the left and right rear doors, which were broken in the crash test, were not replaced for the fire test.

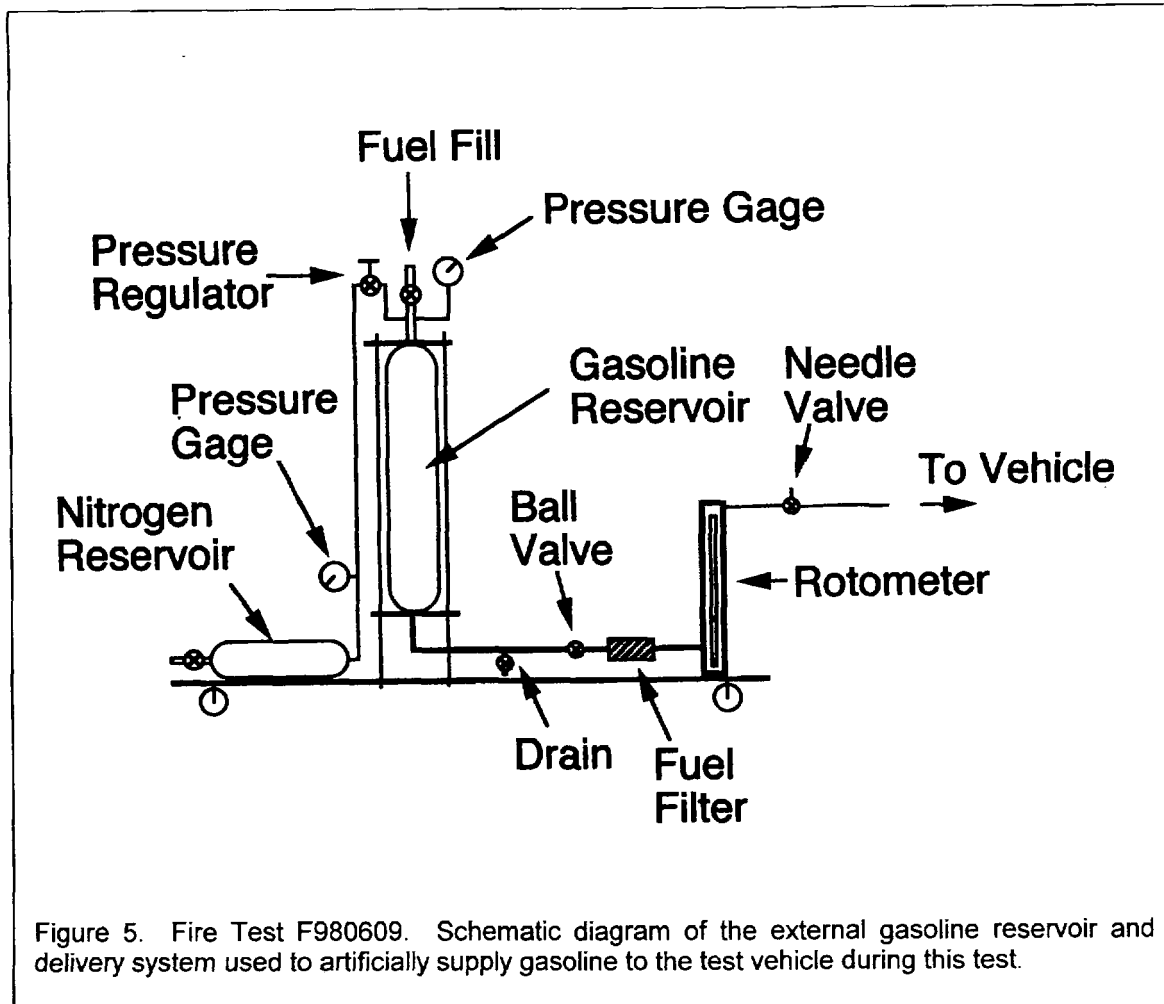
Figure 5. Fire Test F980609. Schematic diagram of the external gasoline reservoir and delivery system used to artificially supply gasoline to the test vehicle during this test.

system used in this test. Figure 5 shows a schematic diagram of the gasoline delivery system used in this test. This system consisted of two stainless steel cylinders. One cylinder functioned as a fluid reservoir and had a capacity of 4 L, while the other cylinder functioned as a gas reservoir and had a capacity of 2 L. A pressure regulator in the line connecting the gas reservoir to the fluid reservoir controlled the head pressure in the fluid reservoir. The outlet line of the fluid reservoir contained a ball valve that was used to turn on and off the flow of gasoline during the test, a rotometer to indicate the flow of gasoline during the test, and a needle valve to control the flow of gasoline.

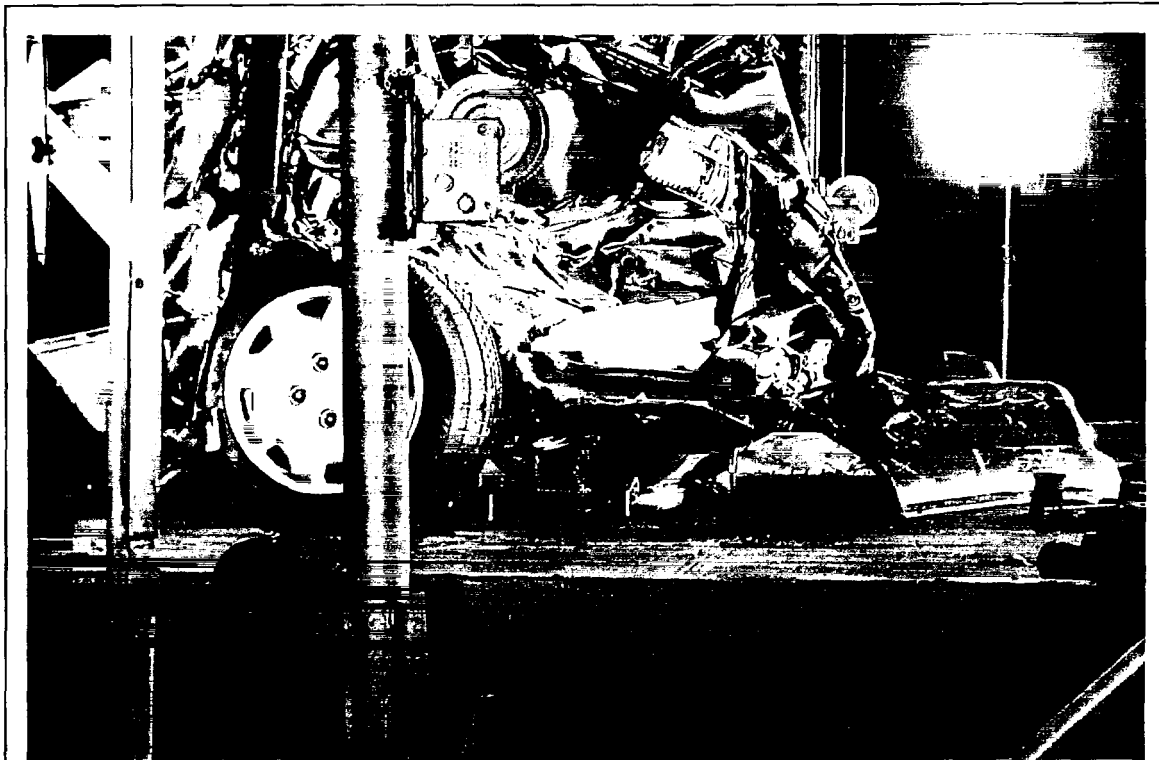
Figure 6. Fire Test F99030A. Photograph of the rear of the test vehicle and fluid containment pan approximately 30 seconds after the start of gasoline flow.

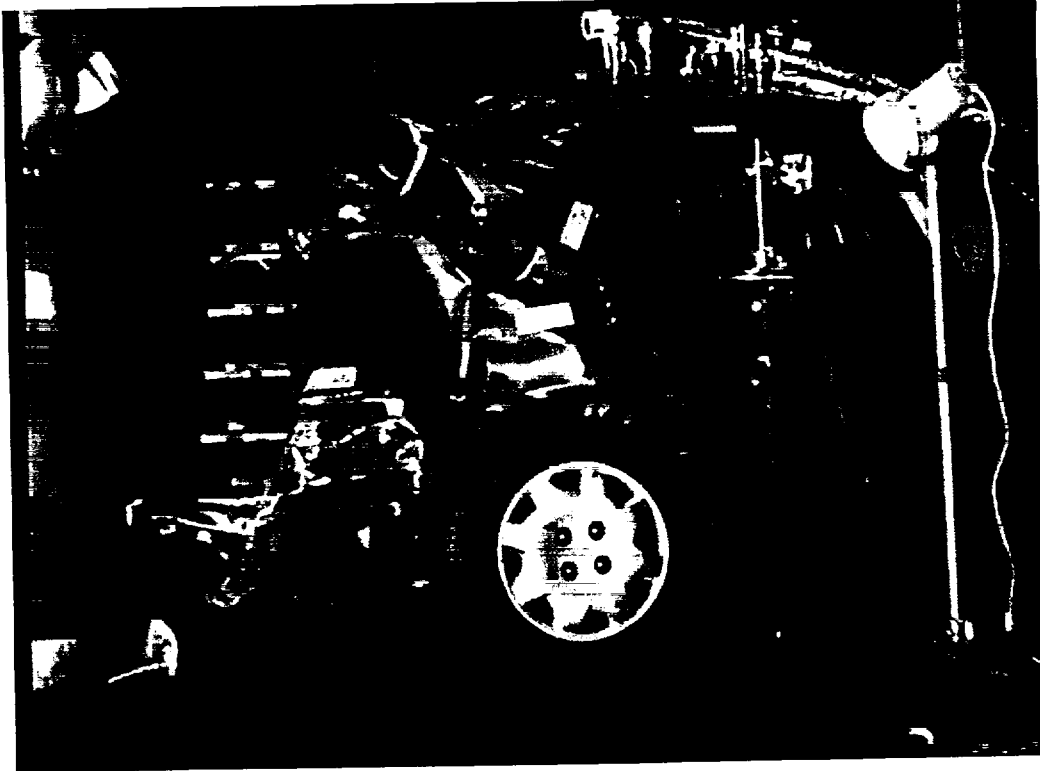
Figure 8. Fire Test F99030A. Video stills from Camera 2 at 5 seconds before ignition (upper) and approximately  $\frac{1}{2}$  second after ignition (lower).

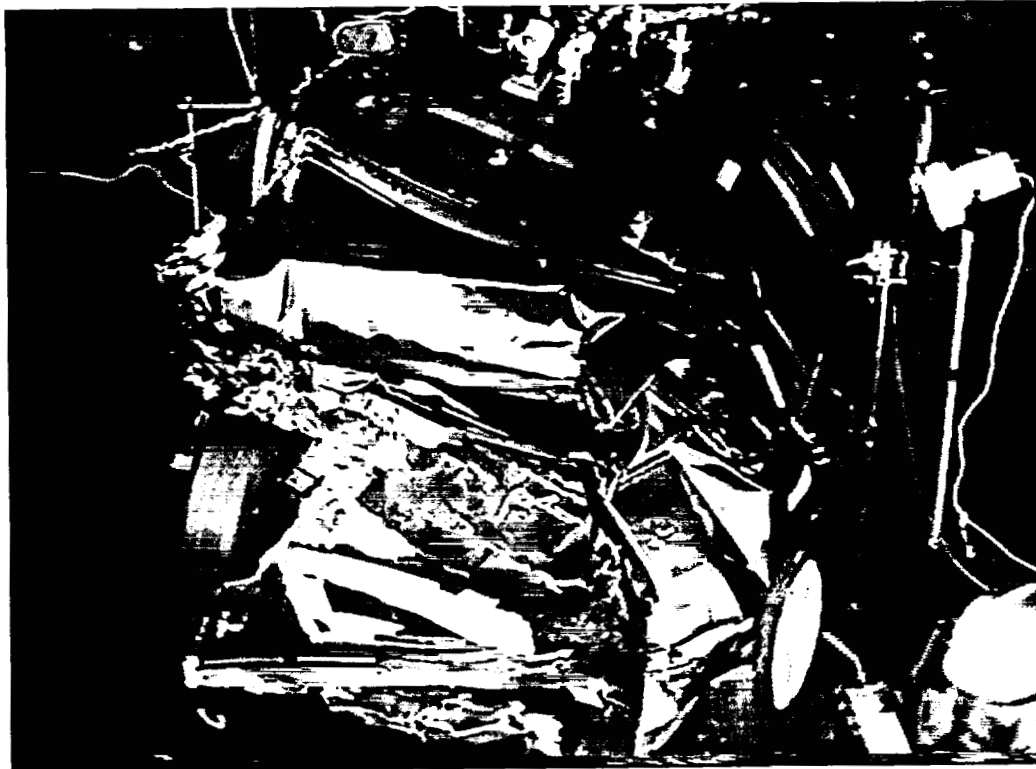
Figure 9. Fire Test F99030A. Video stills from Camera 3 at 5 seconds before ignition (upper) and approximately 1/2 second after ignition (lower).

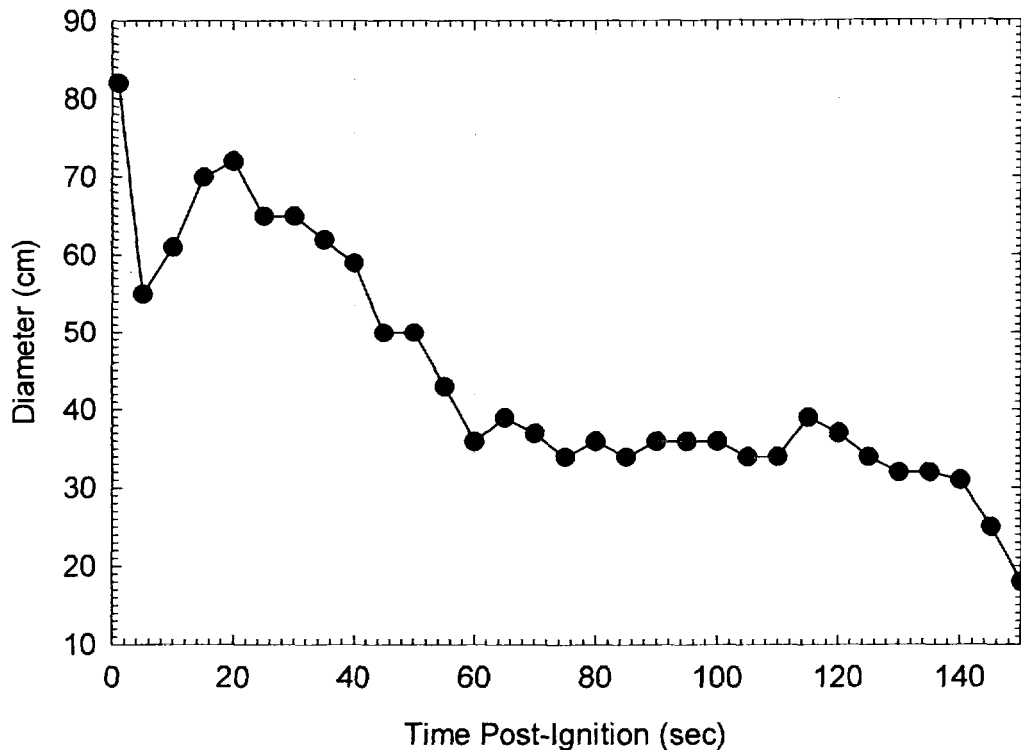
Figure 12. Fire Test F99030A. Estimated diameter of flames at the cement board surface under the test vehicle at five-second intervals from 0 through 150 seconds post-ignition obtained by analysis of the video from Camera 5.

The flow rate of gasoline was maintained at approximately at 400 cm<sup>3</sup>/min throughout the test. After ignition, the diameter of the burning gasoline pool was estimated from the video from Camera 5. Two bolts placed on the cement-board surface under the rear of the test vehicle were used to determine distances. These bolts are visible in Figure 6. The distance between these bolts measured perpendicular to the line-of-sight of Camera 5 was approximately 30 cm. The resonator, muffler, and the section of exhaust pipe between the resonator and muffler partially obscured the right hand edge of the flames, making a precise measurement of pool diameter difficult. The uncertainty in the estimated pool size was  $\pm 10$  cm.

The decrease in the estimated flame diameter at the surface of the cement board from approximately 82 to 36 cm between the time of ignition and 60 seconds post-ignition was attributed to an increase in the burning rate of liquid gasoline flowing downward on underbody components in the test vehicle. After ignition, liquid gasoline in contact with the fuel tank and rear suspension sub-frame would have been heated by the fire, increasing the vaporization rate from liquid gasoline on underbody components in the test vehicle. An increased vaporization rate would have resulted in a decrease in the volume flow rate of liquid gasoline onto the cement board surface and, consistent with the decrease in the diameter of flames on the cement board surface observed in Figure 12, a decrease in the size of the gasoline pool under the test vehicle as this test progressed. An increased vaporization rate from liquid gasoline in contact with underbody components also would have resulted in an increase in the volume of flames in spaces along the test vehicle underbody as this test progressed, which is evident in the video stills from Camera 5 in Figures 13 through 22.

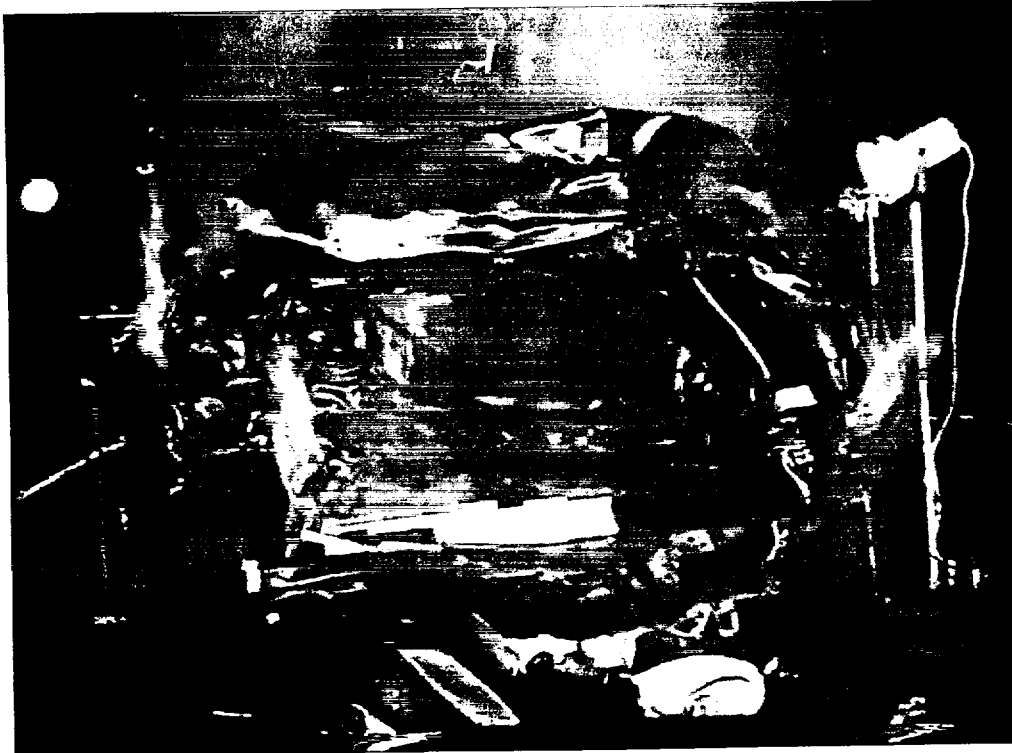
Figure 30. Fire Test F99030A. Video still from Video Camera 1 (upper) and Infrared thermogram from IR8 (lower) at 90 seconds post-ignition.

Figures 23 through 32 show a series of video stills from Camera 1 and Infrared thermograms from IR8 at 0, 10, 15, 30, 45, 60, 75, 90, 120, and 153 seconds post-ignition. This sequence of video stills shows the approximate timing of flame-spread to the area around the rear wheelhouses and into the passenger compartment. Although a temperature scale for these thermograms from IR8 is not available, the Infrared thermograms in Figures 23 through 32 show the areas in the test vehicle that were exposed to heated gases and flames. For example, smoke (video still, Fig. 24) and heated gases (Infrared thermogram, Fig. 24) had started to vent from both wheelhouses by 10 seconds post-ignition. Smoke and heated gases were also observed behind the rear surface of the rear seat back at this time (Fig. 24). Flames were visible in the area between the left side of the floor panel in the trunk and the inboard side of the left rear tire by 15 seconds post-ignition (Fig. 25). The height of this fire plume increased between 15 and 60 seconds post-ignition (Fig.'s 25 through 28). The Infrared thermograms in Figures 25 through 28 show that, although this fire plume did not contact the trunk lid directly during this time, it did heat the left rear area of the deformed trunk lid. Flames had begun to vent from the right rear wheelhouse by 75 seconds post-ignition (Fig. 29) and from the left rear wheelhouse by 90 seconds post-ignition (Fig. 30). The height of the fire plumes venting from the rear wheelhouses increased until the fire was extinguished starting at about 155 seconds post-ignition (Fig.'s 29 through 32).

Flames also began to contact the rear surface of the left side of the rear seat back between 75 and 90 seconds post-ignition (Fig.'s 29 and 30). Flames were visible on the lower surface of the roof trim panel through the upper left corner of the rear window opening by 120 seconds post-ignition (Fig. 31) and venting from the passenger compartment along the rear edge of the roof by 153 seconds post-ignition (Fig. 32).

This assessment of flame-spread in the left rear area of the passenger compartment and left front area of the trunk is consistent with the video and infrared camera record and the pattern of heat and fire damage observed on the right quarter trim panel after this test. For example, smoke and heated gases were in an area behind the left side of the rear seat back by 10 seconds post-ignition (Fig. 24) and flames were in this area by 90 seconds post-ignition (Fig. 30).

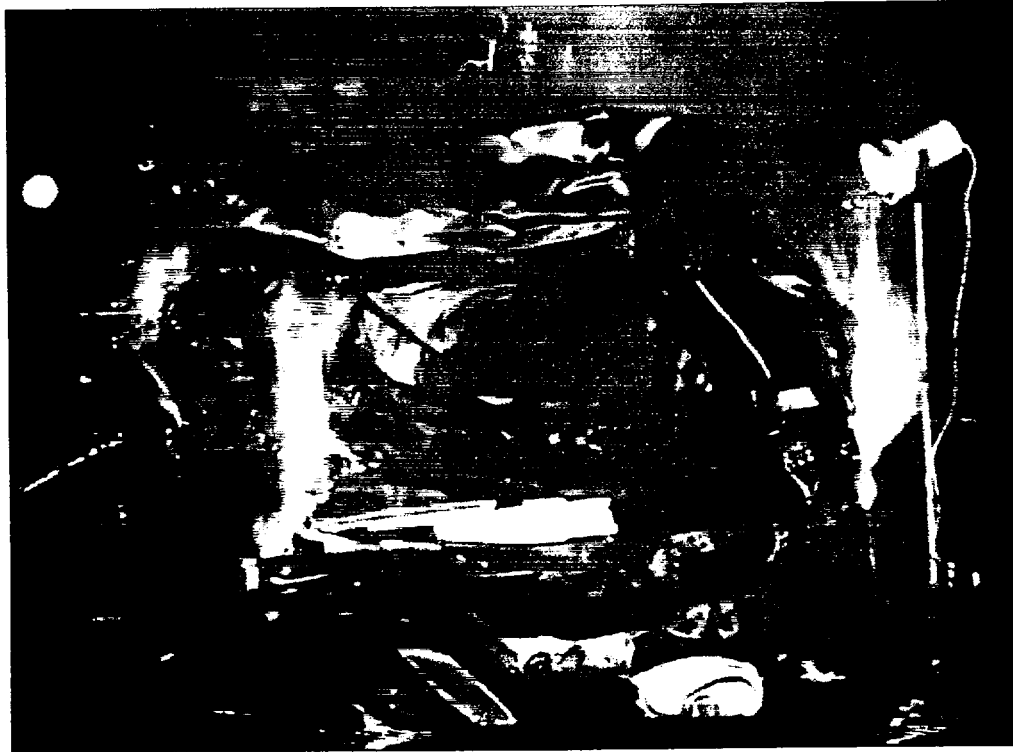
Figure 31. Fire Test F99030A. Video still from Video Camera 1 (upper) and Infrared thermogram from IR8 (lower) at 120 seconds post-ignition.

15 seconds post-ignition (Fig. 25), with flames visible on the upper right corner of the rear seat back by 120 seconds post-ignition (Fig. 31).

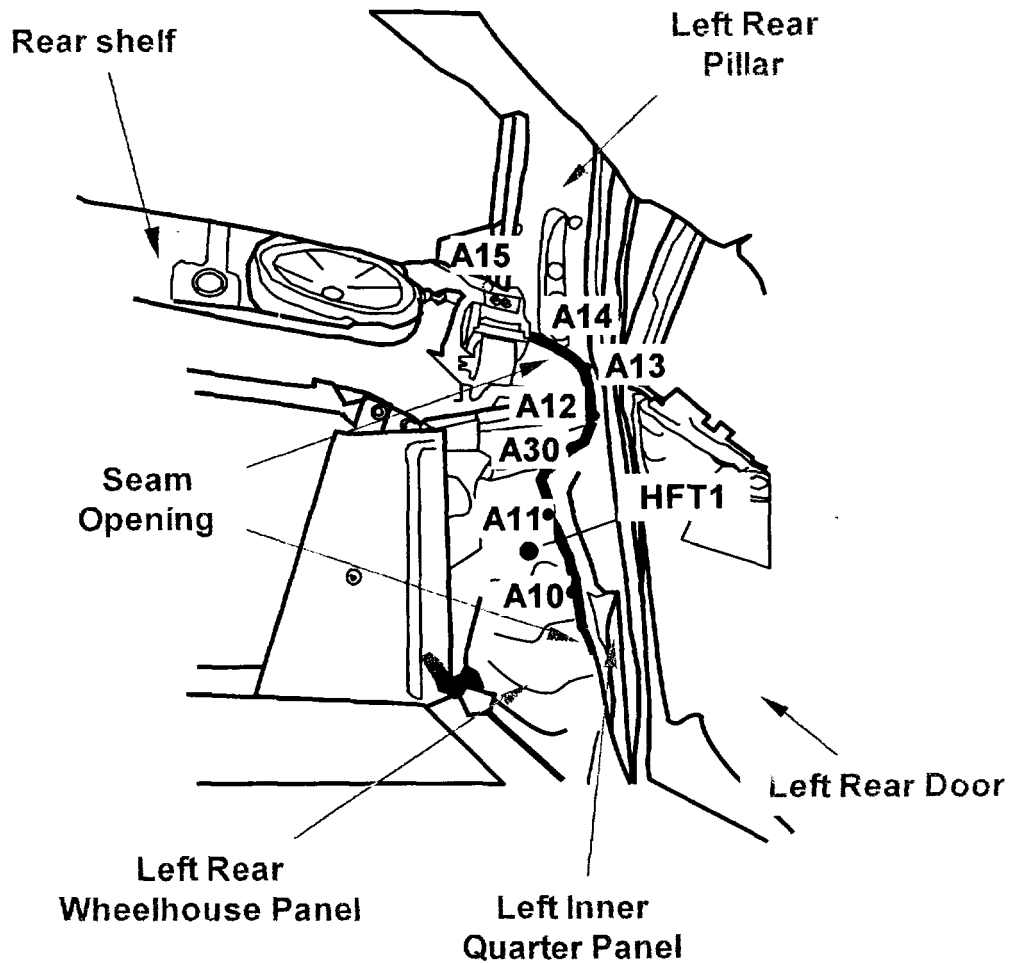
Figure 33. Diagram showing the approximate locations of thermocouples in a crash-induced seam opening between the left rear wheelhouse panel and the left inner quarter panel and a heat flux transducer in the left rear wheelhouse panel.

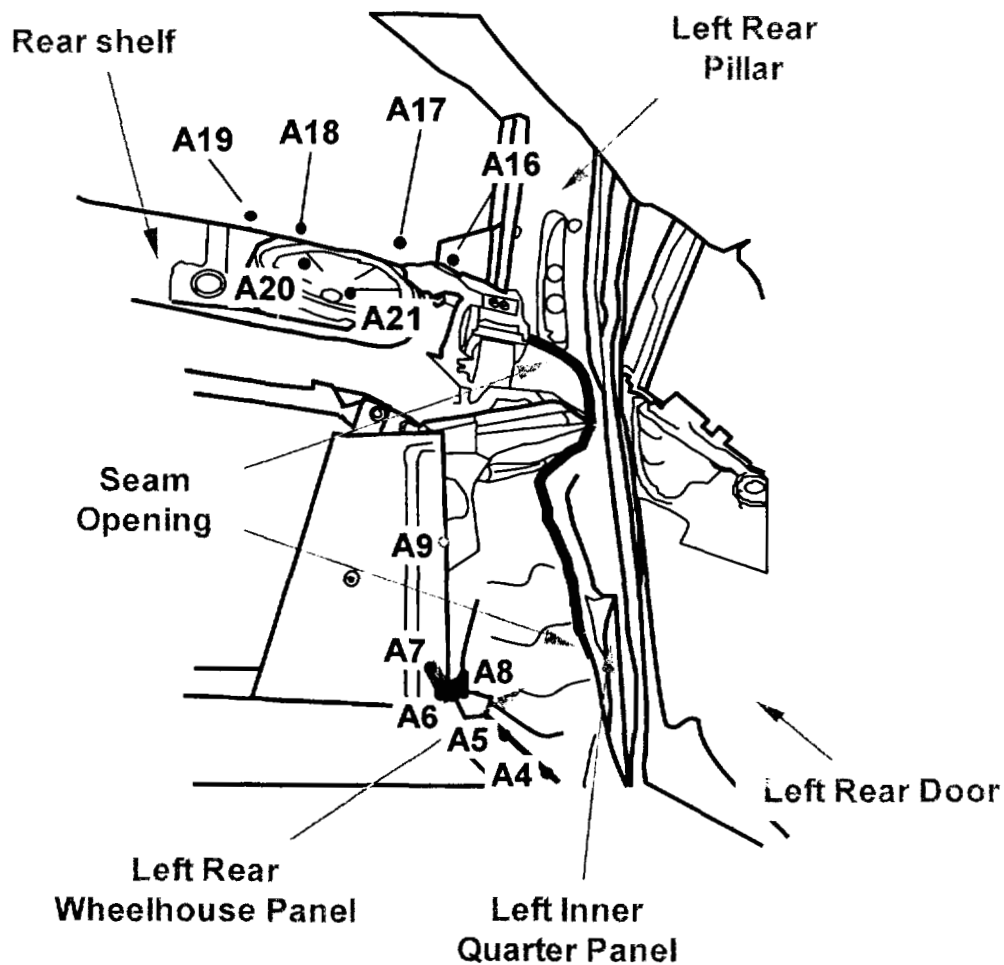
Figure 37. Fire Test F99030A. Diagram showing the approximate locations of thermocouples in a crash-induced seam opening between the left rear wheelhouse panel, the floor panel, above the rear edge of the rear shelf, and, above the left speaker in the rear shelf.

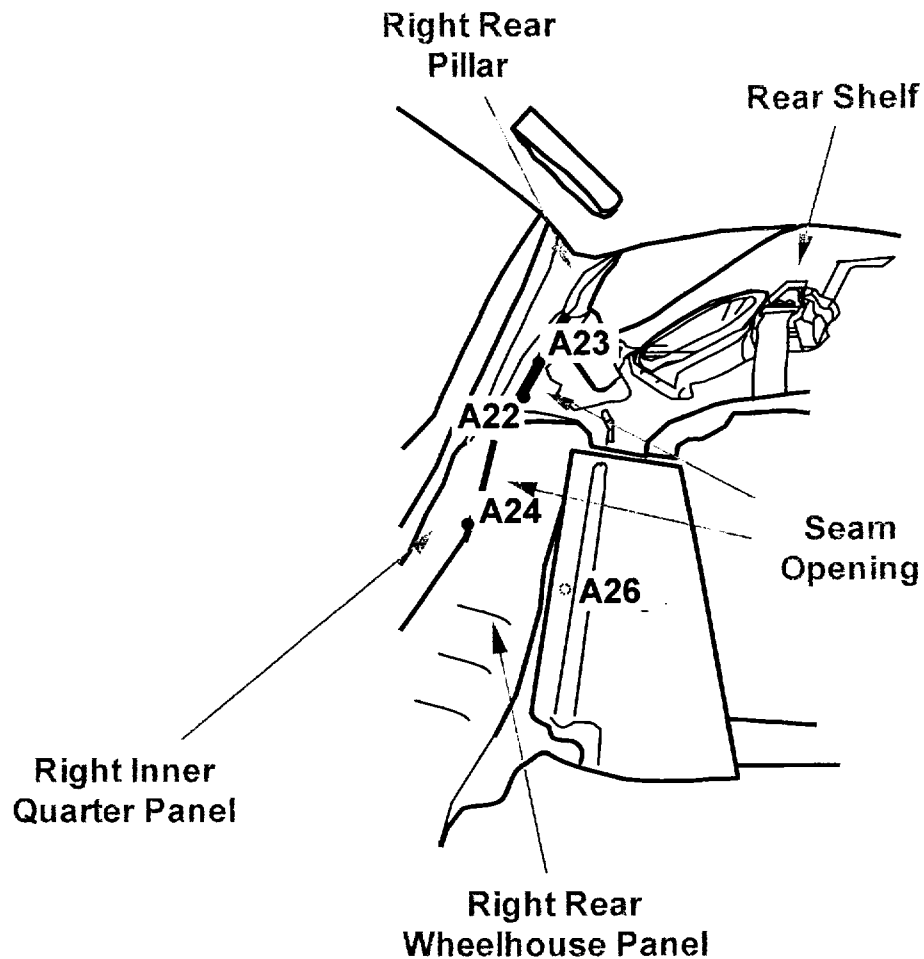
Figure 49. Diagram showing the approximate locations of thermocouples in a crash-induced seam opening between the left rear wheelhouse panel and the left inner quarter panel and a heat flux transducer in the left rear wheelhouse panel.

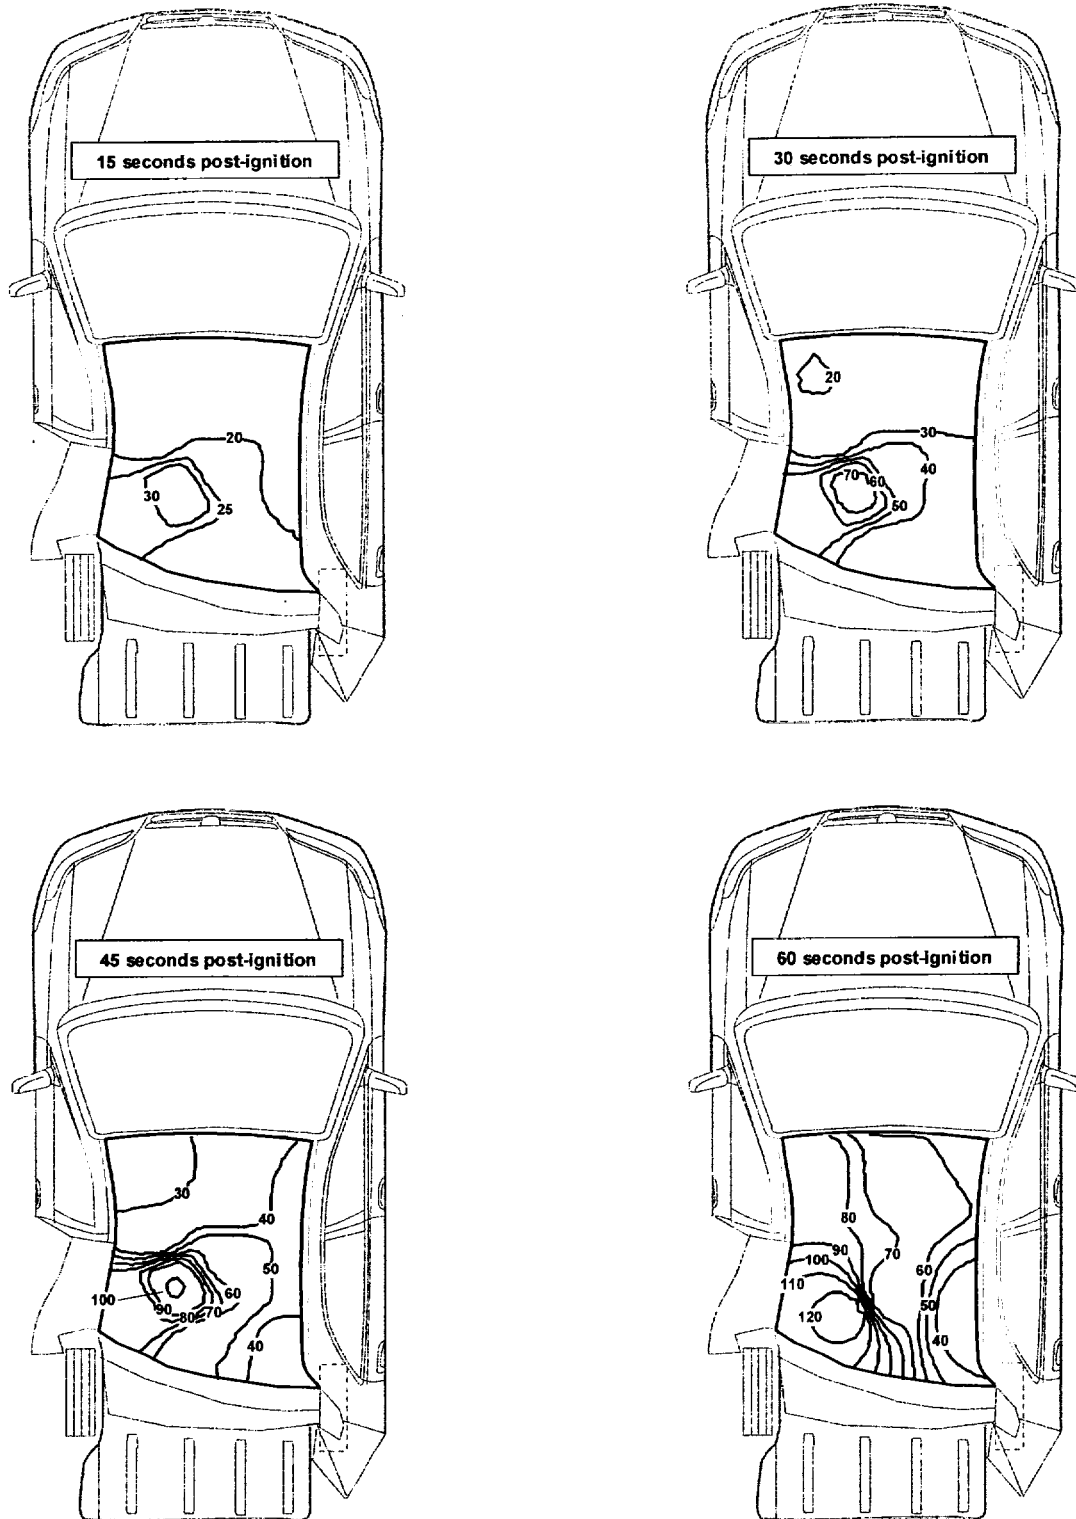
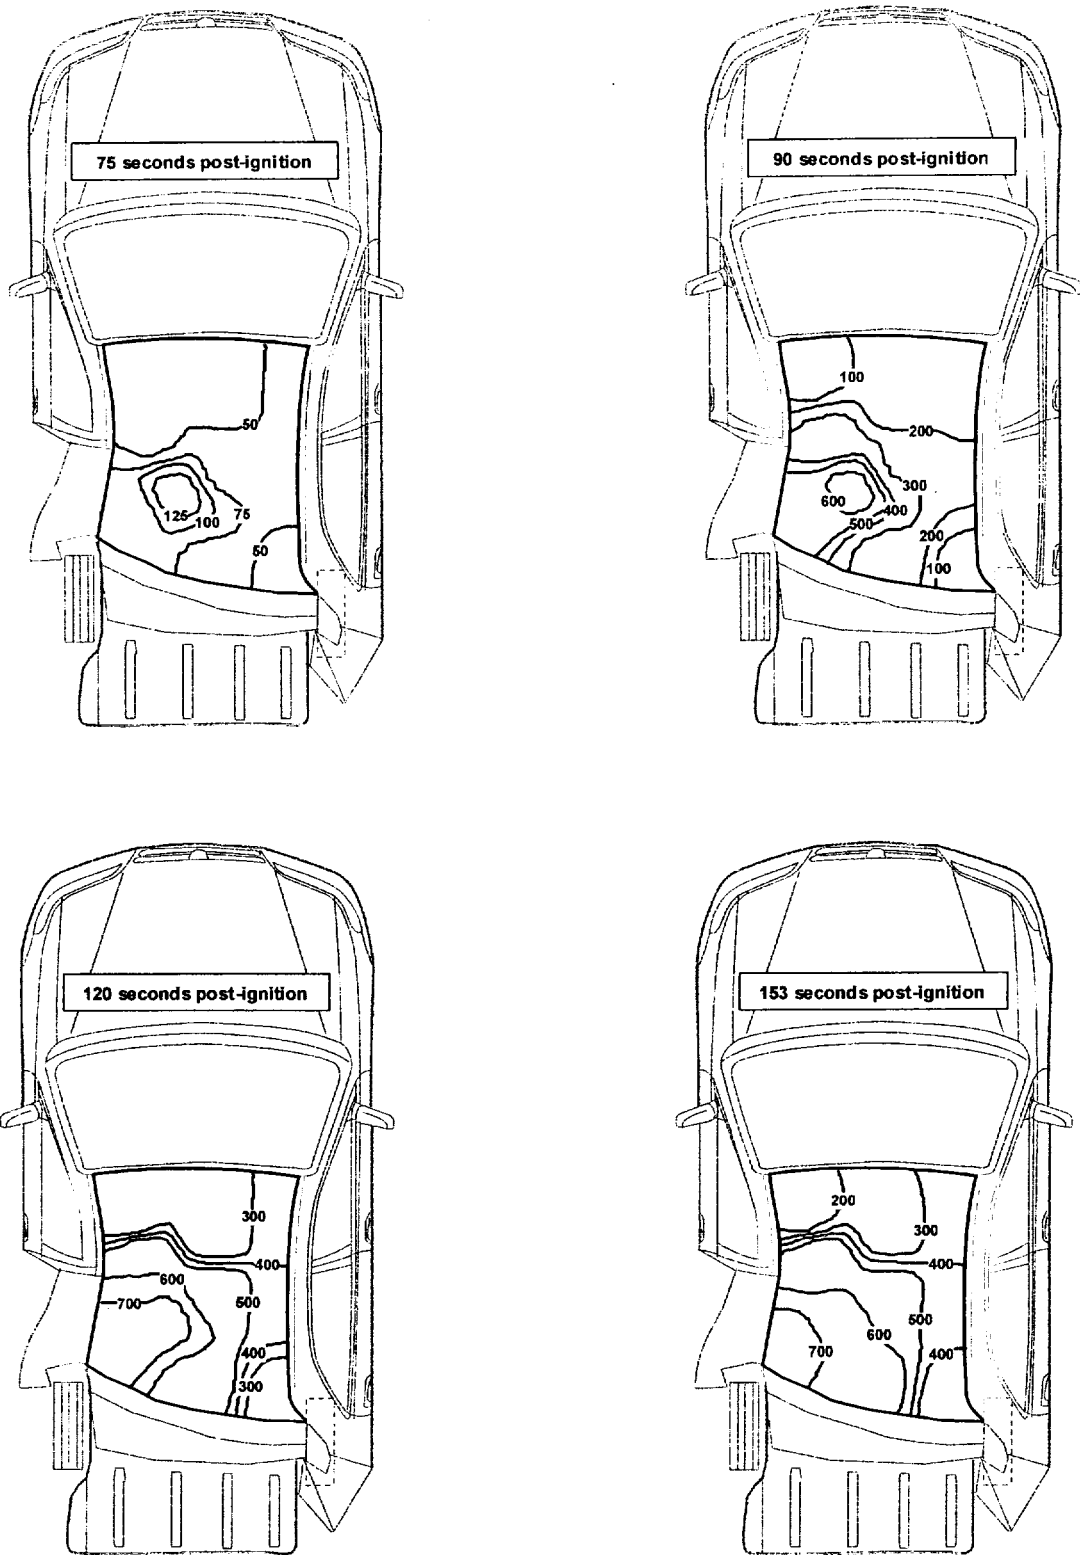
Figure 53, continued. Fire Test F99030A. Diagrams showing isothermal contour plots of estimated temperature along the lower surface of the roof trim panel at 0, 10, 15, 30, 45, 60, 75, 90, 120, 153 seconds post-ignition.

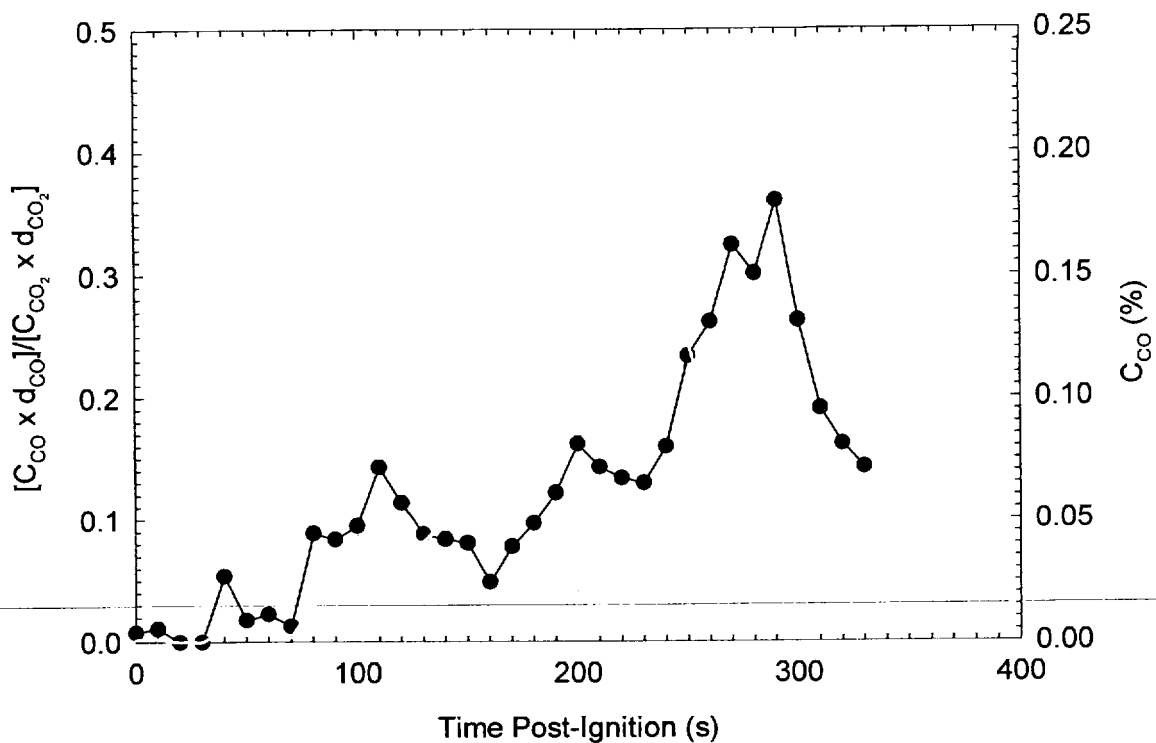
Figure 55. Fire Test F99030A. Plots of  $[C_{CO} \times d_{CO}] / [C_{CO_2} \times d_{CO_2}]$  (—●—, left axis) and the concentration of carbon monoxide (—, right axis) in the passenger compartment.

An analysis of combustion conditions based on air temperature and gas concentration data from the passenger compartment is shown in Figures 55 through 59. Air temperature and gas concentration data from the passenger compartment were used to determine  $[C_{CO} \times d_{CO}]/[C_{CO_2} \times d_{CO_2}]$ ,  $[C_{HC} \times d_{HC}]/[C_{CO_2} \times d_{CO_2}]$ ,  $[C_{CO_2} \times d_{CO_2}]/[t_{air} \times C_p]$ ,  $[C_{CO} \times d_{CO}]/[t_{air} \times C_p]$ , and  $[C_{HC} \times d_{HC}]/[t_{air} \times C_p]$ . In these formulas,  $C_j$  is the gas-phase concentration of species  $j$ ,  $d_j$  is the density of species  $j$ ,  $t_{air}$  is the air temperature, and  $C_p$  is the heat capacity of air. The product  $[C_j \times d_j]$  equals the mass-concentration of species  $j$  in passenger compartment. The concentrations of the gaseous combustion products ( $C_j$ ) were determined by Fourier Transform Infrared Spectrometry (**APPENDIX I**). Air temperature data from the aspirated thermocouple assemblies in the passenger compartment (**APPENDIX D**) was used to determine  $t_{air}$ . The ratios  $[C_{CO} \times d_{CO}]/[C_{CO_2} \times d_{CO_2}]$ ,  $[C_{HC} \times d_{HC}]/[C_{CO_2} \times d_{CO_2}]$ ,  $[C_{CO_2} \times d_{CO_2}]/[t_{air} \times C_p]$ ,  $[C_{CO} \times d_{CO}]/[t_{air} \times C_p]$ , and  $[C_{HC} \times d_{HC}]/[t_{air} \times C_p]$  are equivalent to  $Y(CO)/Y(CO_2)$ ,  $Y(HC)/Y(CO_2)$ ,  $Y(CO_2)/\Delta H_{CON}$ ,  $Y(CO)/\Delta H_{CON}$ , and  $Y(HC)/\Delta H_{CON}$ , respectively, in Table 2.

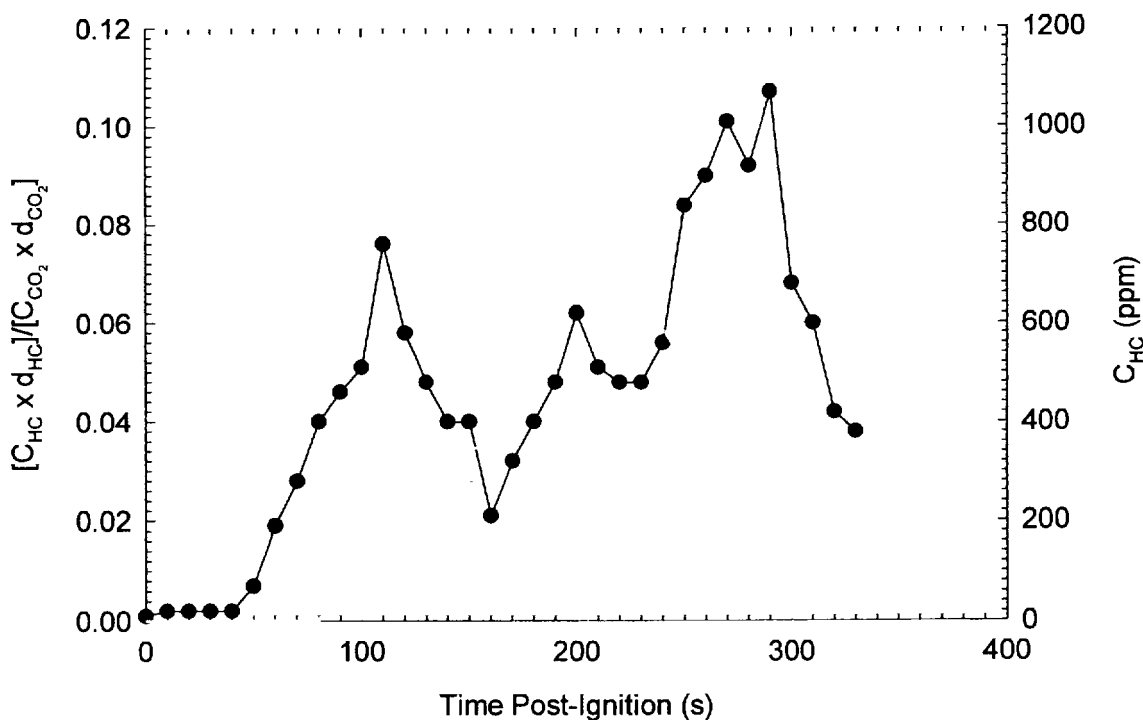
Figure 56. Fire Test F99030A. Plots of  $[C_{HC} \times d_{HC}] / [C_{CO_2} \times d_{CO_2}]$  (—●—, left axis) and the concentration of total hydrocarbons (—, right axis) in the passenger compartment.

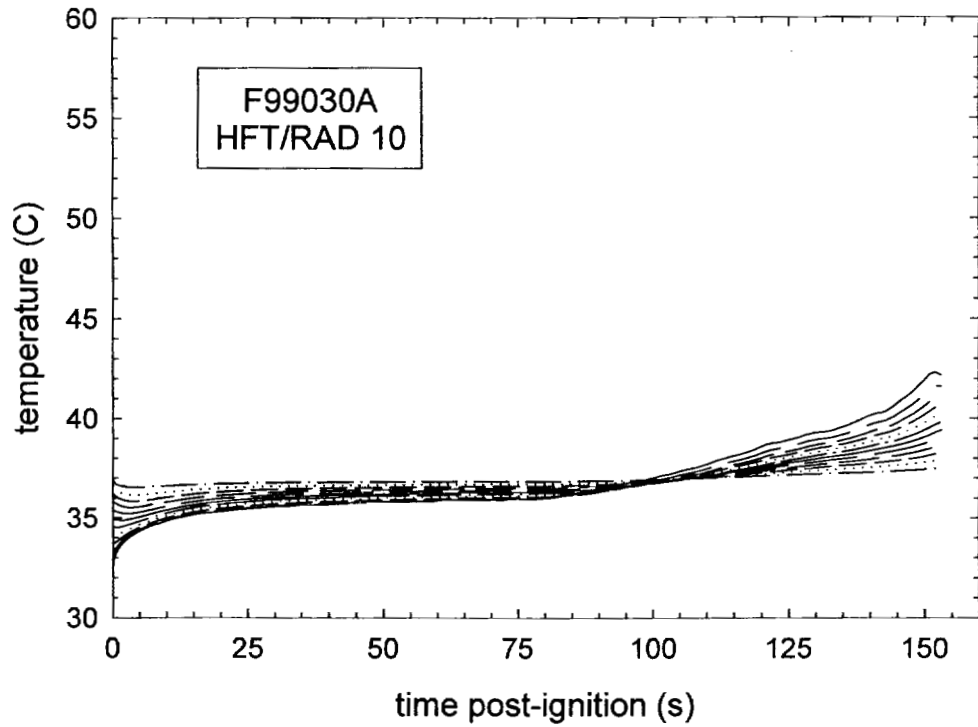
Figure 60. Fire Test F99030A. Skin temperature profiles estimated from heat flux data recorded from HFT/RAD Assembly 10 (APPENDIX E, Plots E3 and E4).

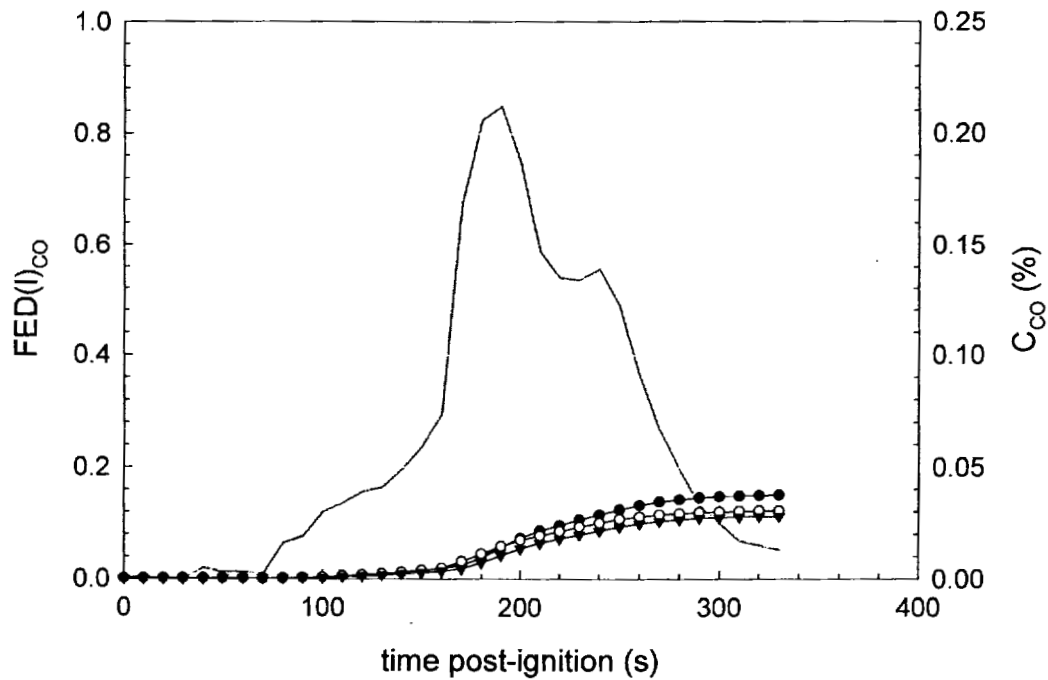
Figure 67. Fire Test F99030A. Plots of estimates of  $FED(I)_{CO}$  versus time post-ignition computed using the FAA Combined Hazard Survival Model (—○—), the Purser model with a respiratory minute volume of 8.5 L/min (—▼—), and the Purser model with a respiratory minute volume of 25 L/min (—●—). A plot of  $C_{CO}$  (—) is shown for reference.
