NHTSA-98-3588-201

**Evaluation of Motor Vehicle Fire Initiation and Propagation  
Part 12: Propagation of an Underbody Gasoline Pool Fire in a  
1998 Front-Wheel Drive Passenger Vehicle**

Jeffrey Santrock  
General Motors Corporation

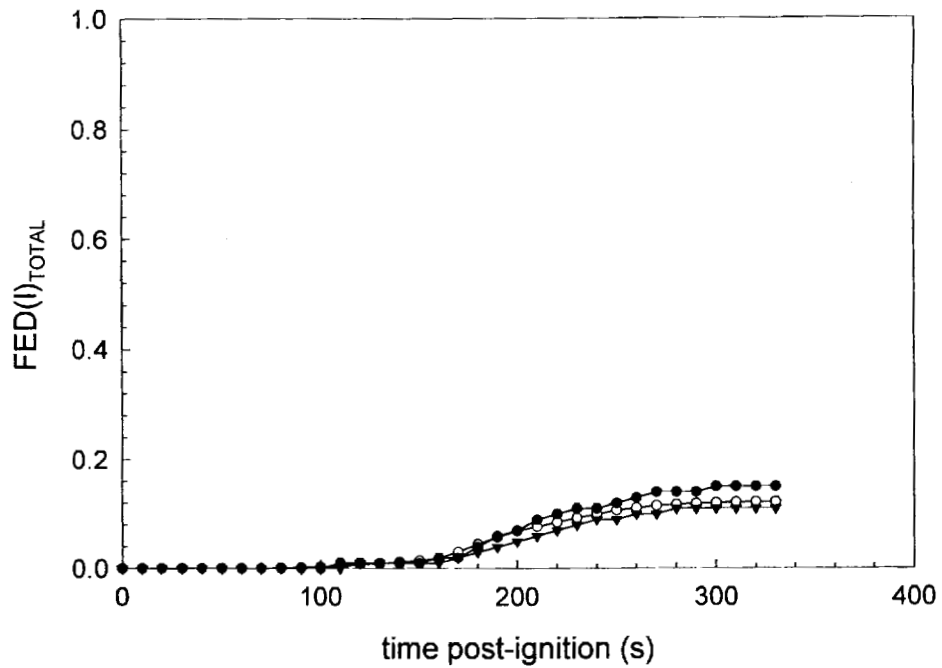
Figure 70. Fire Test F99030A. Plots of  $FED(I)_{TOTAL}$  versus time post-ignition: FAA Combined Hazard Survival Model (—O—); Purser's model with  $RMV = 8.5$  L/min (—▼—); and Purser's model with  $RMV = 25$  L/min (—●—).

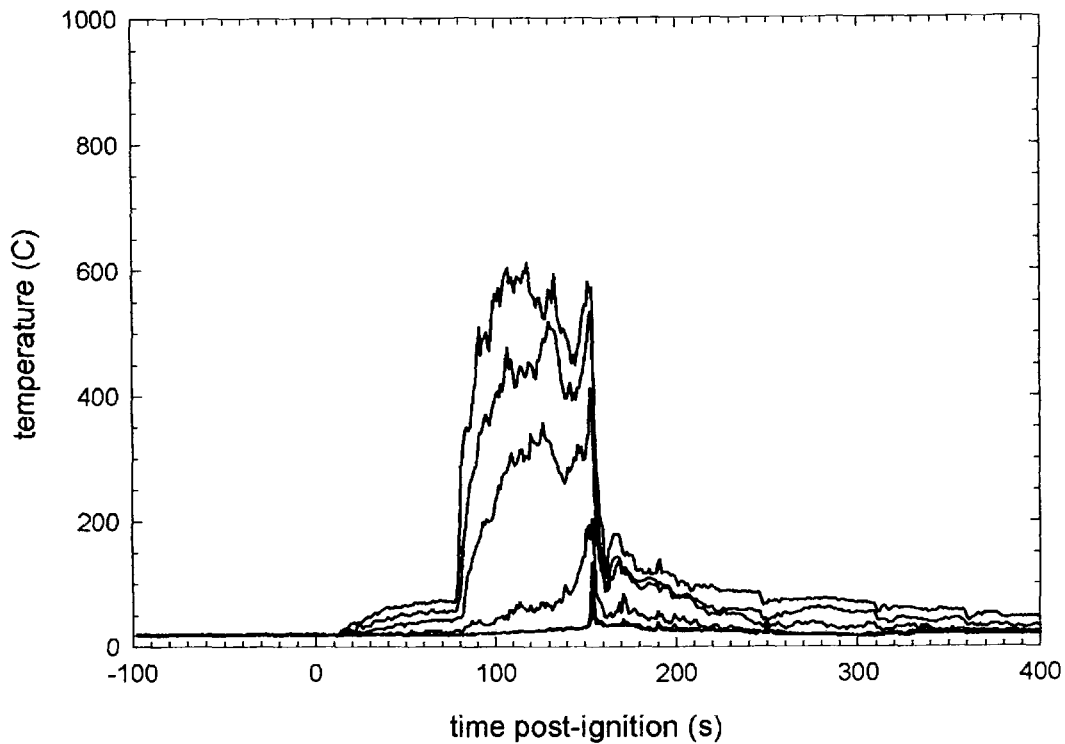
Figure 72. Fire Test F99030A. Plots of temperature data recorded from the aspirated thermocouples in the passenger compartment of the test vehicle.

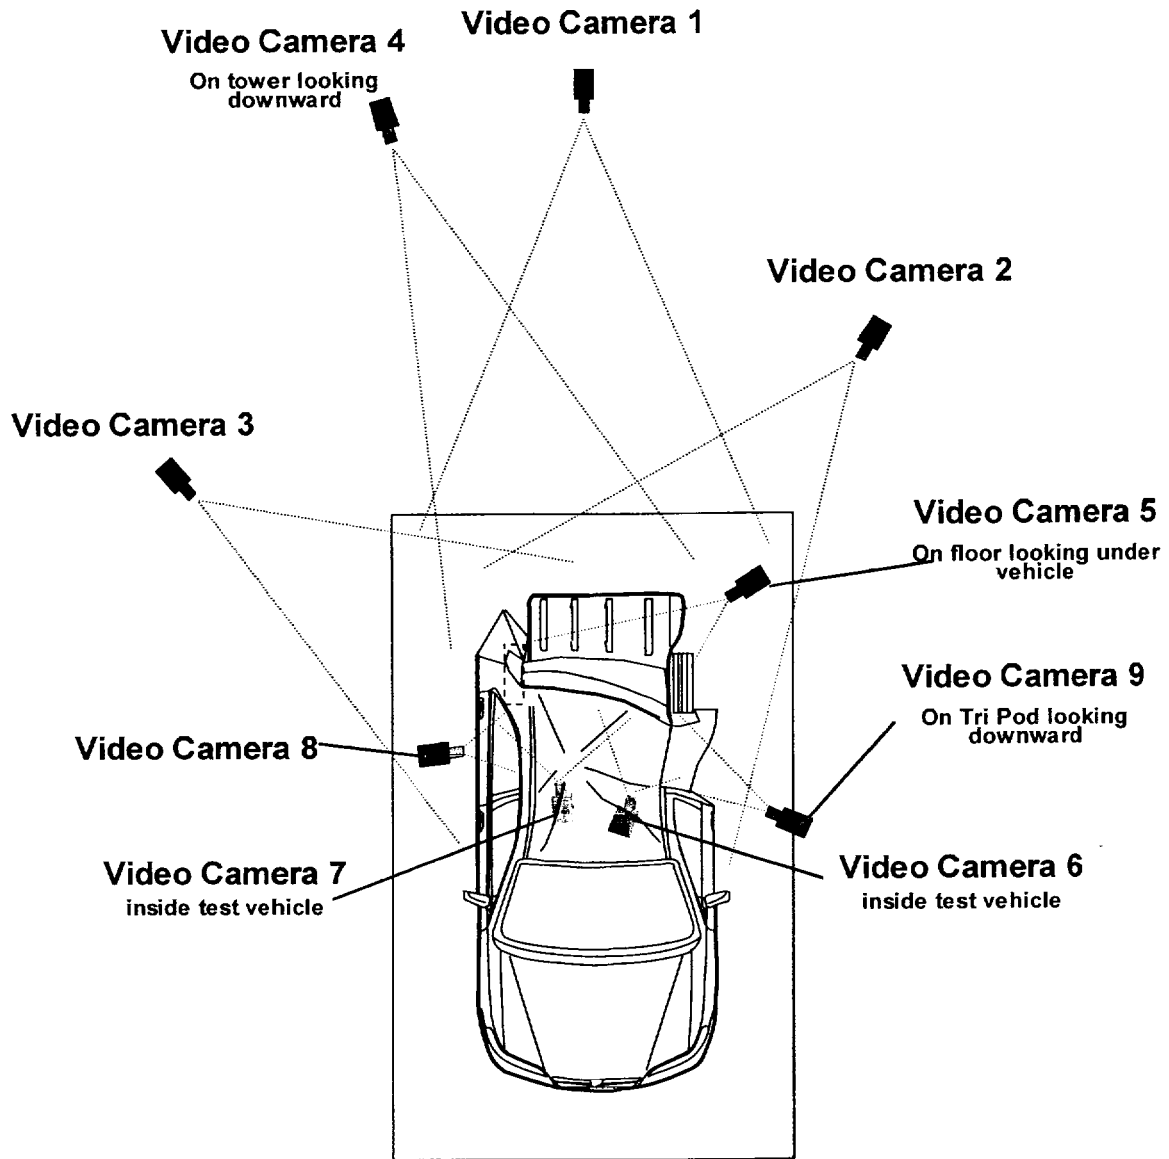
Figure A1. Fire Test F99030A. Diagram showing the approximate locations of the video cameras during this test. Distances in this figure are not to scale in this diagram.

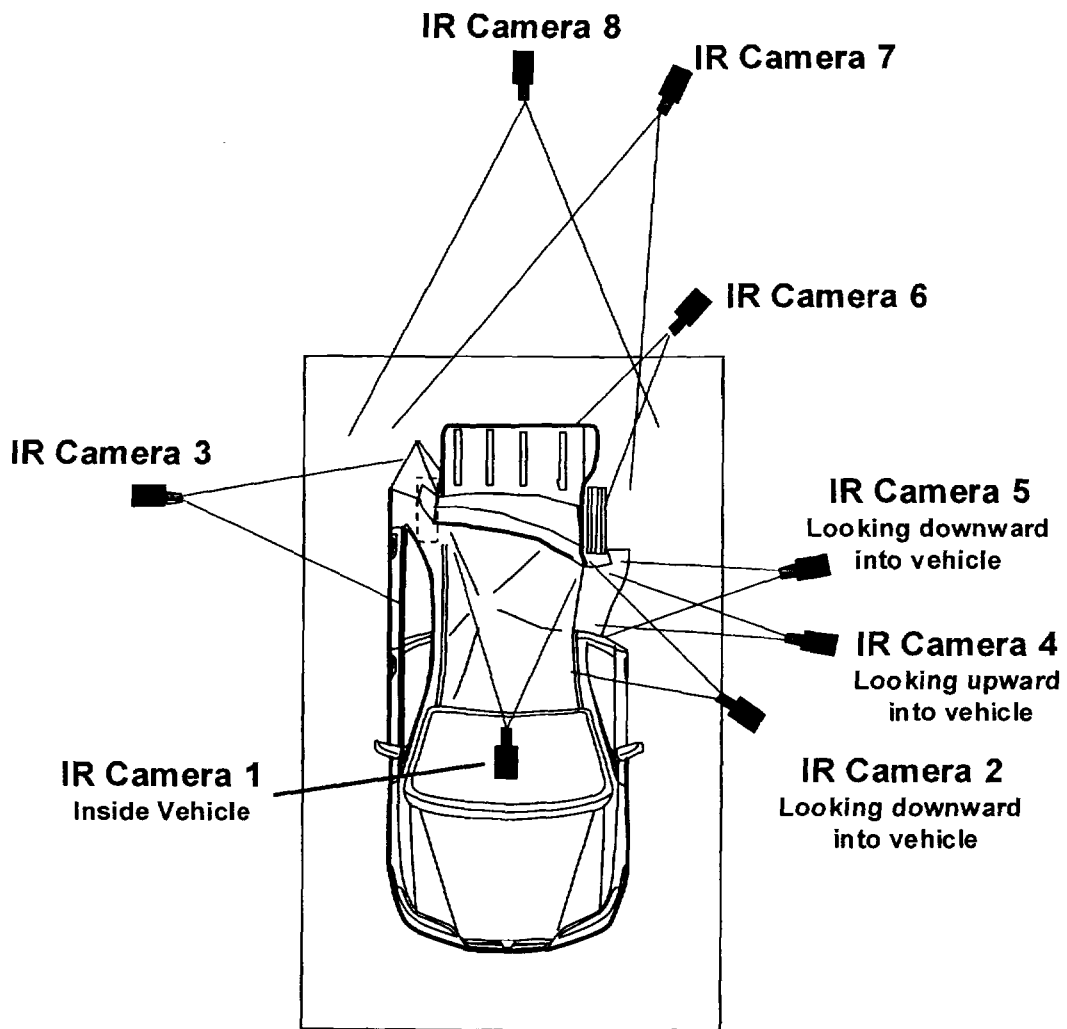
Figure B1. Fire Test F980609. Diagram showing the approximate locations of infrared cameras around the test vehicle during this test. This diagram is approximate and not drawn to scale in this diagram.

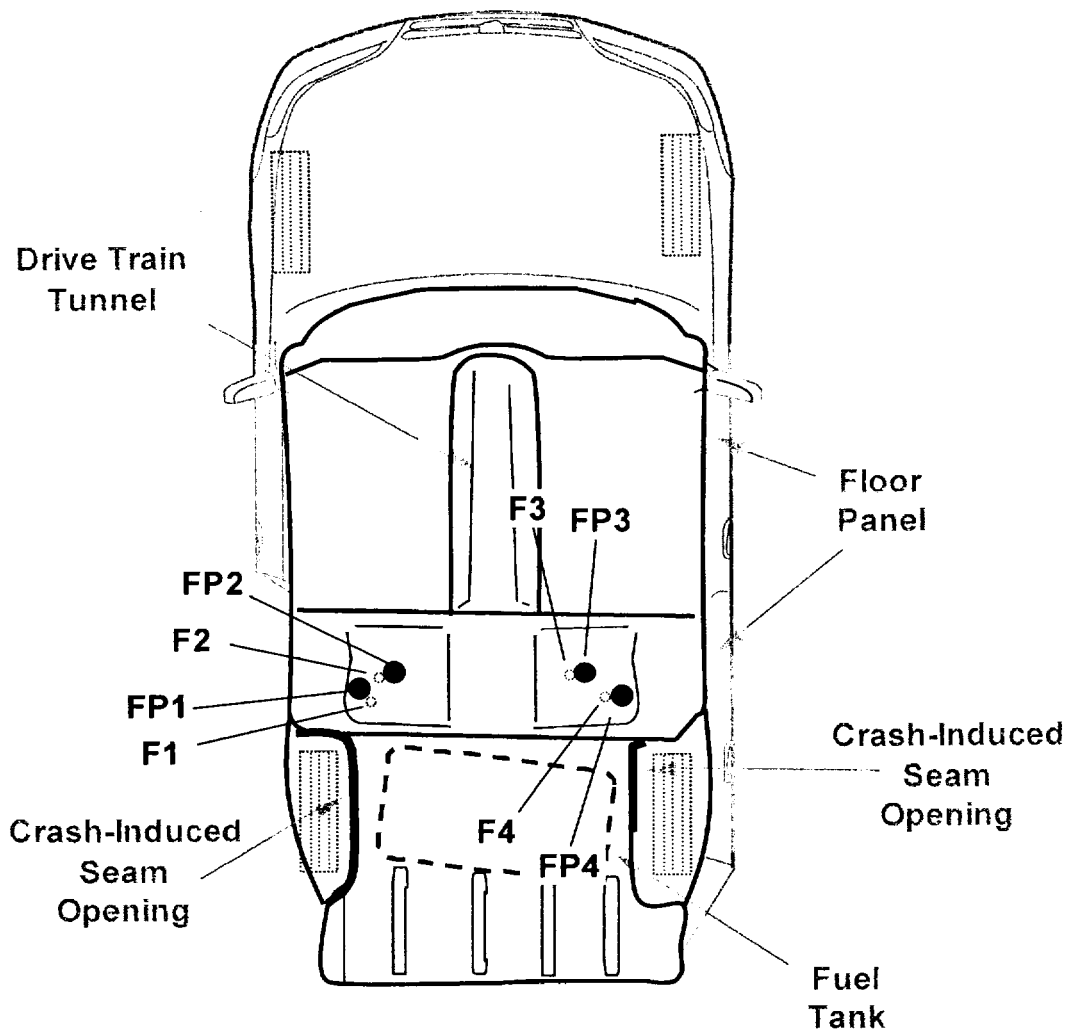
Figure C2. Fire Test F99030A. Diagram showing the approximate locations of thermocouples F1 through F4 and Thermocouples FP1 through FP4. Thermocouples F1, F2, F3, and F4 were located approximately 1 cm below the lower surface of the floor panel. Thermocouple FP1 was located on the upper surface of an electrical pass through in the floor panel under the left side of the rear seat cushion. Thermocouples FP2, FP3, and FP4 were located on the upper surfaces of drain hole plugs in the floor panel under the rear seat cushion.

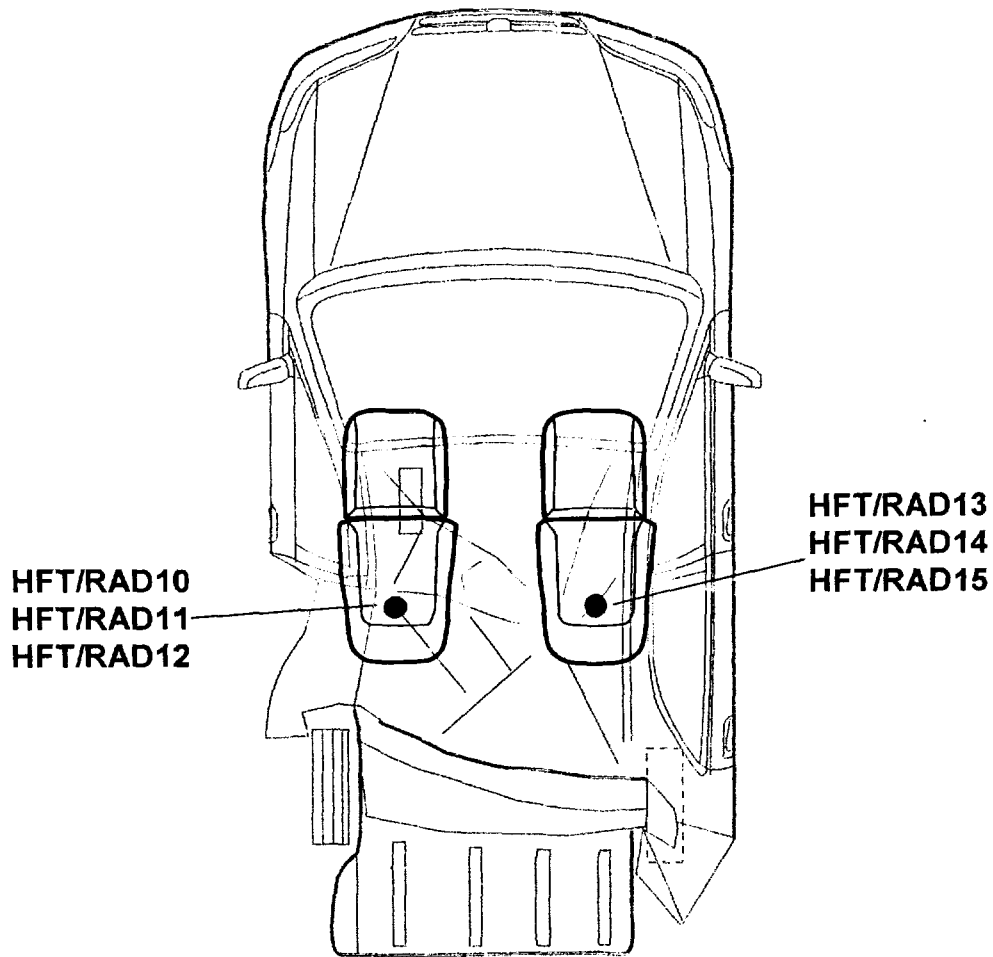
Figure E2. Fire Test F99030A. Top view of the test vehicle showing the approximate locations of heat flux transducer/radiometer (HFT/RAD) assemblies mounted in the test vehicle. HFT/RAD10 was located above the left front seat back facing the right rear corner of the test vehicle. HFT/RAD11 was located above the left front seat back facing upward. HFT/RAD12 was located above the left front seat back facing the left rear corner of the test vehicle. HFT/RAD13 was located above the right front seat back facing the right rear corner of the test vehicle. HFT/RAD14 was located above the right front seat back facing upward. HFT/RAD15 was located above the right front seat back facing the left rear corner of the test vehicle.

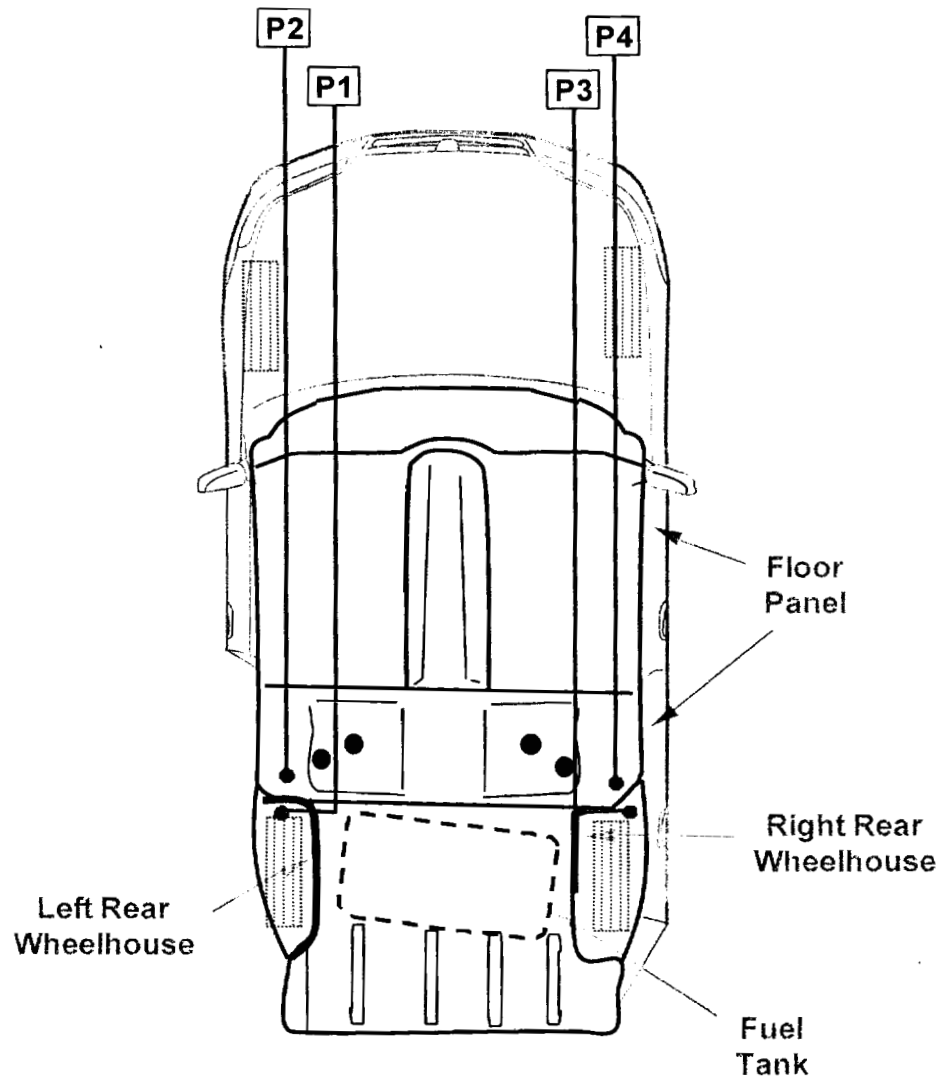
Figure F1. Fire Test F99030A. Top view showing the approximate locations of pressure taps around the rear wheelhouses of the test vehicle.

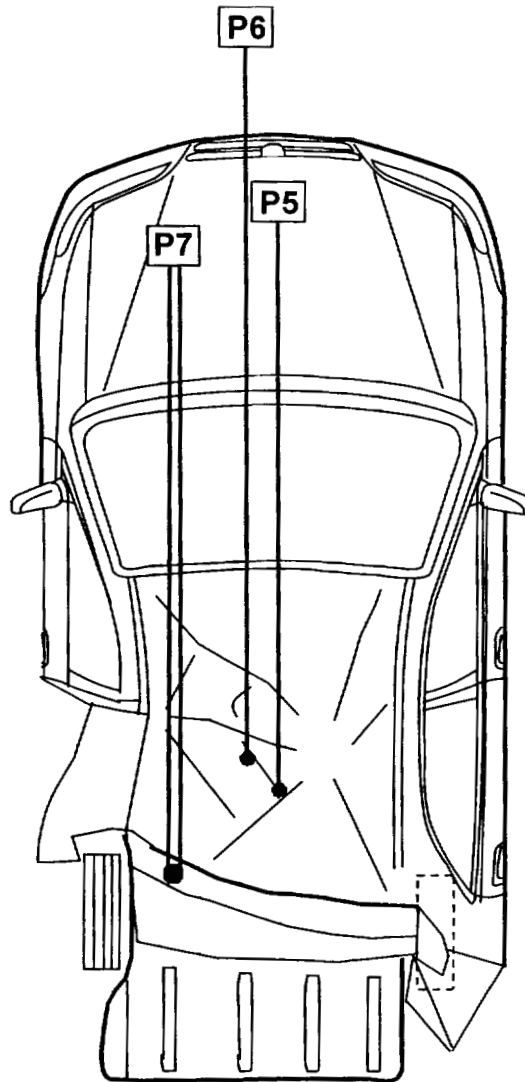
Figure F2. Fire Test F99030A. Top view showing the approximate locations of pressure taps at the roof and floor of the test vehicle, and of a bi-directional flow probe above the left side of the rear package shelf.

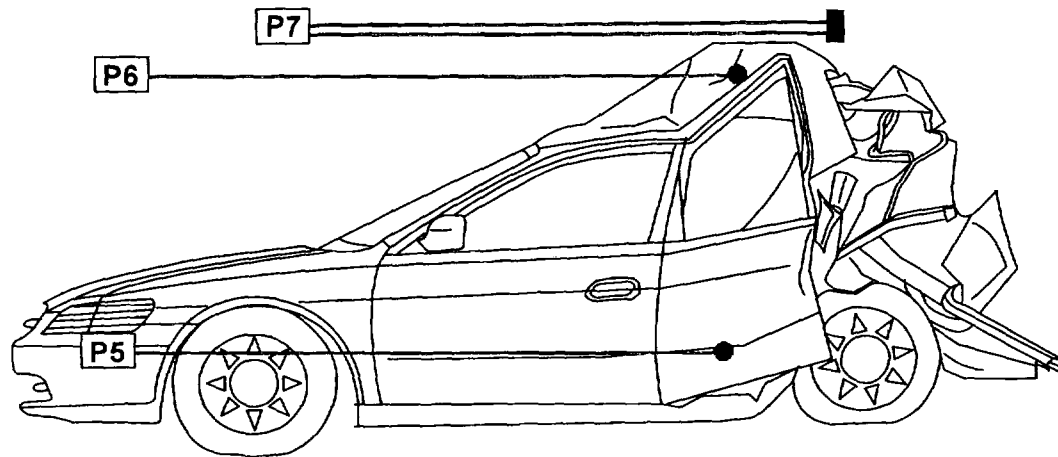
Figure F3. Fire Test F99030A. Side view showing the approximate locations of pressure taps at the roof and floor of the test vehicle, and of a bi-directional flow probe above the left side of the rear package shelf.

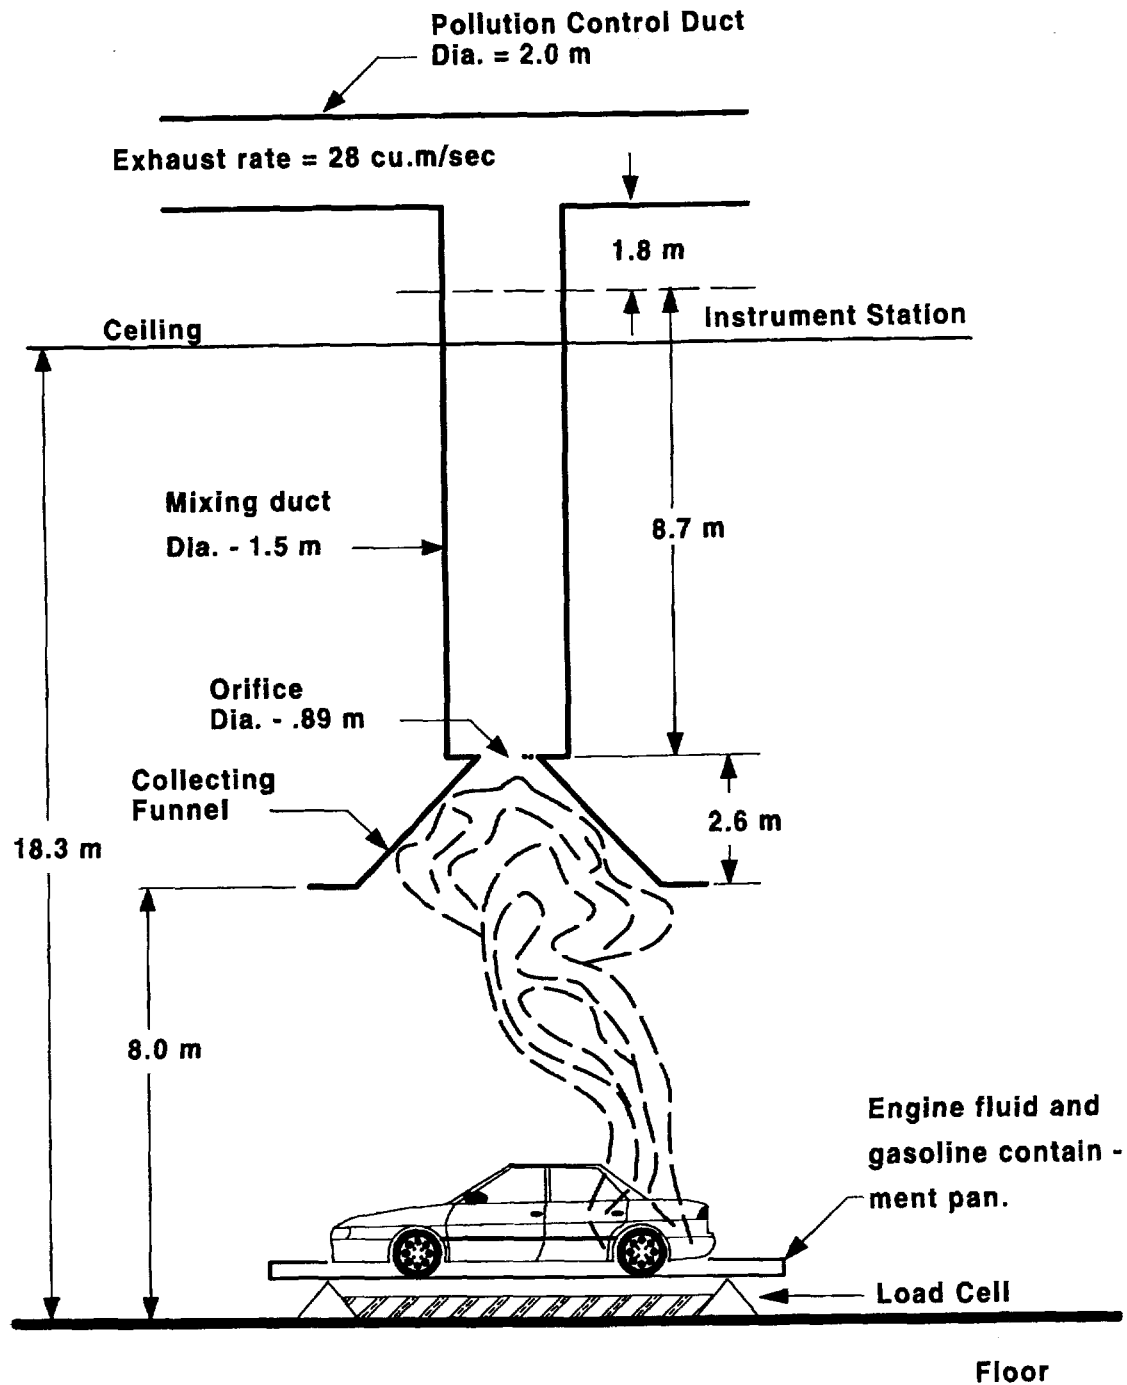
Figure G1. Fire Test F99030A. Diagram of the test vehicle under the fire products collector at the Factory Mutual Test Center.

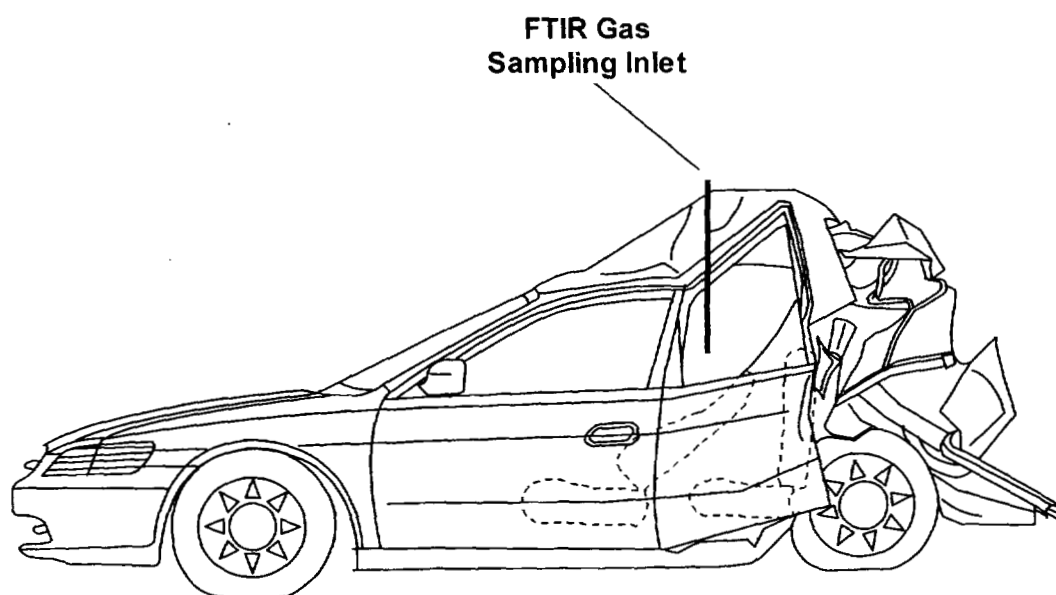
Figure H1. Fire Test F99030A. Side-view of the test vehicle show the approximate location of the FTIR gas sampling inlet in the passenger compartment.

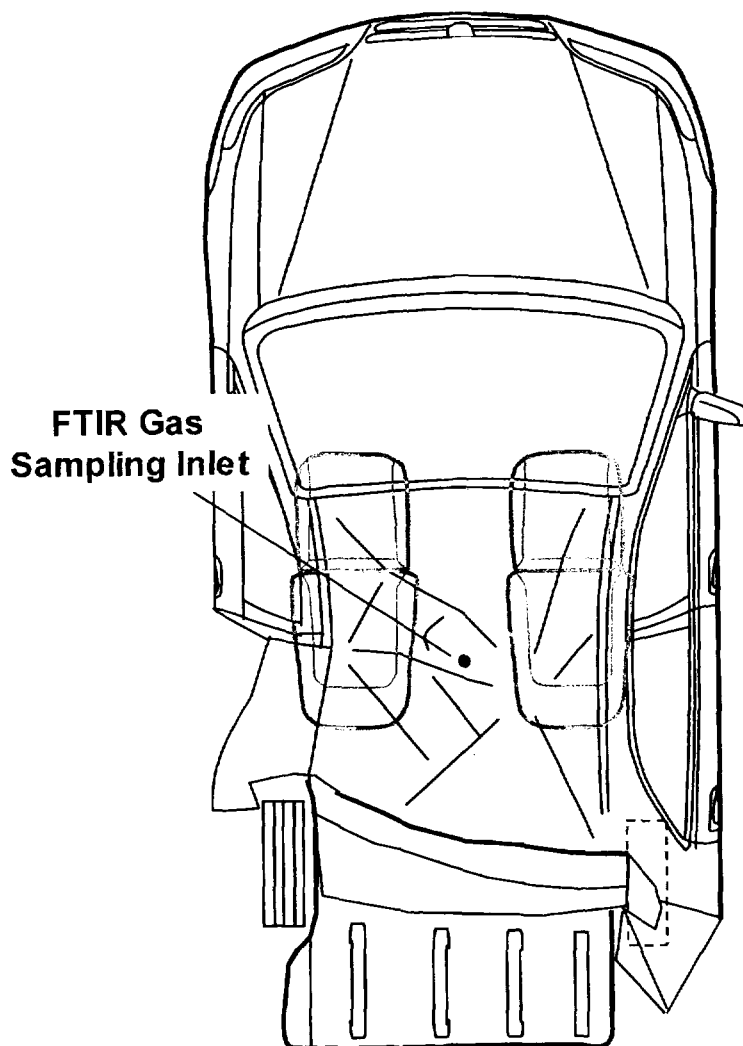
Figure H2. Fire Test F99030A. Top view of the test vehicle showing the approximate location of the FTIR gas sampling inlet in the passenger compartment.

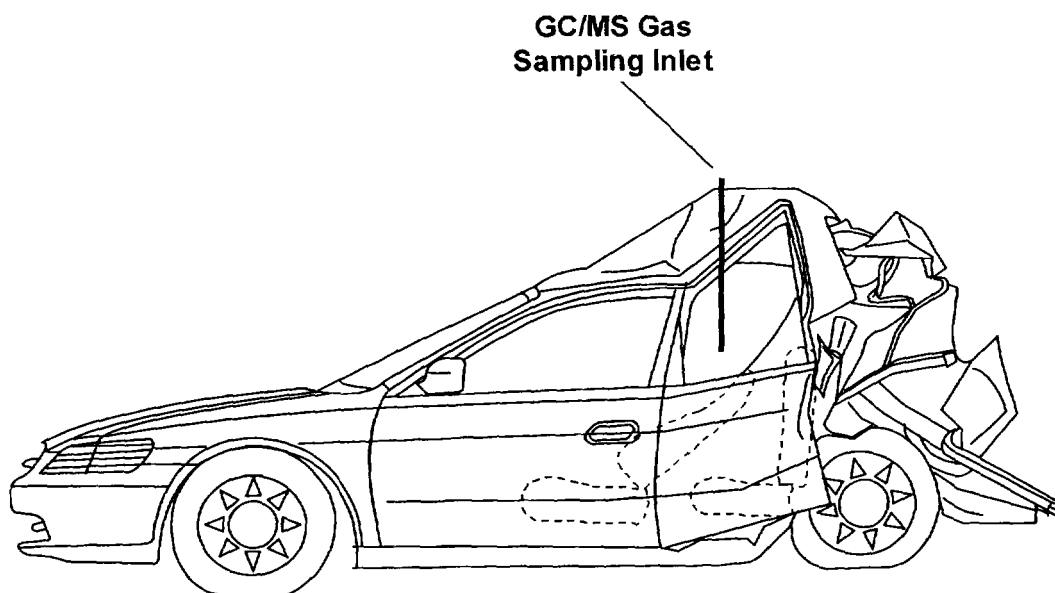
Figure I1. Fire Test F99030A. Side-view of the test vehicle show the approximate locations of the GC/MS gas sampling inlets in the passenger compartment.

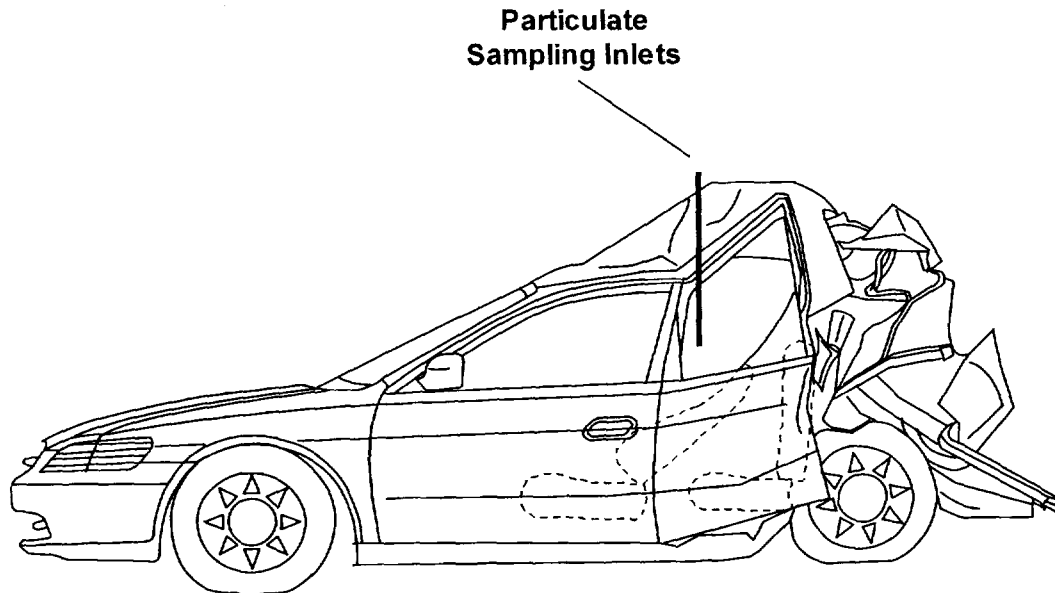
Figure J1. Fire Test F99030A. Side-view of the test vehicle showing the approximate locations of the particulate sampling inlets in the passenger compartment.
