NHTSA-98-3588

**Evaluation of Motor Vehicle Fire Initiation and Propagation  
Part 13: Propagation of an Engine Compartment Fire in a  
1998 Front-Wheel Drive Passenger Vehicle**

Jeffrey Santrock  
General Motors Corporation

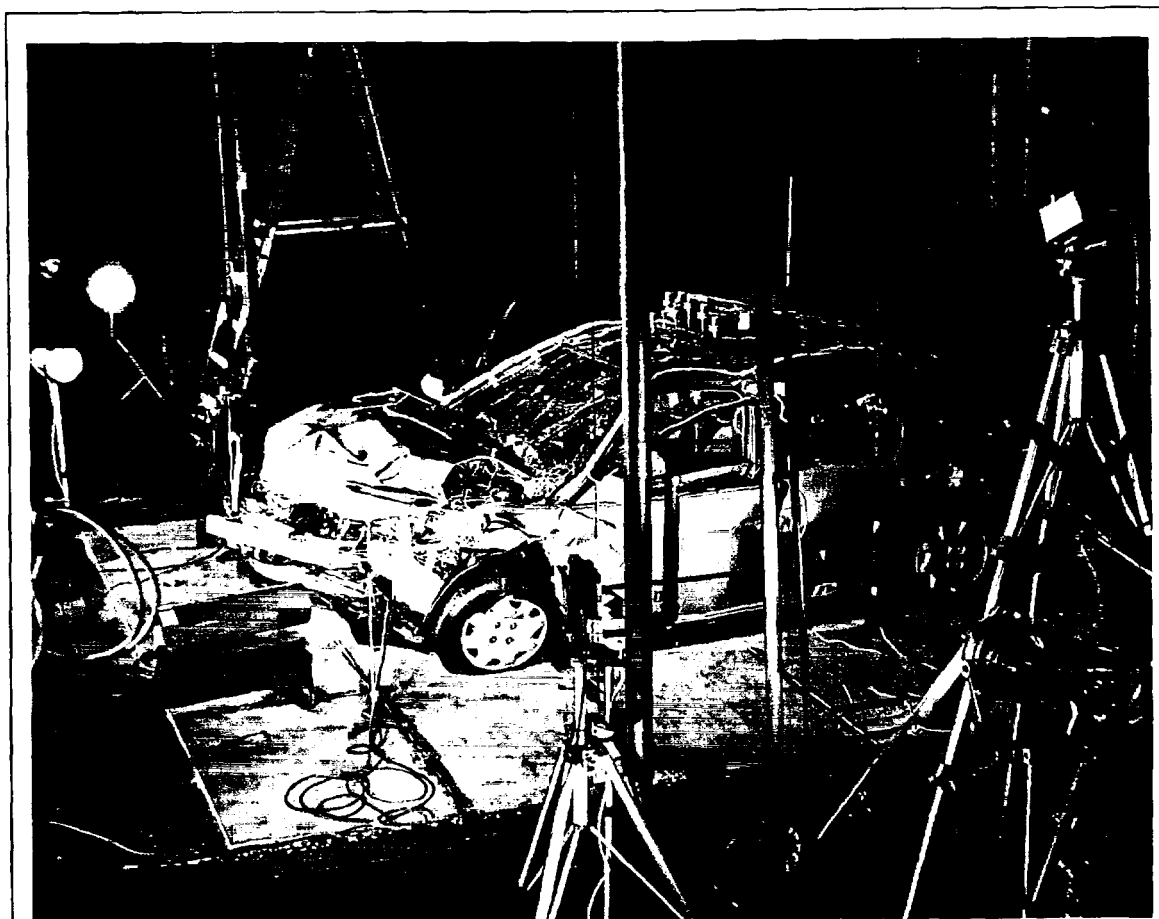
Figure 3. Fire Test F99030B. Photograph of the test vehicle before the start of this test showing a propane "torpedo" heater used to heat the windshield washer fluid reservoir.

The test vehicle was placed in the center of the pan (Fig. 3). All doors were closed. The windshield and the glass in the left front door were broken in the crash test, and were not replaced for the fire test.

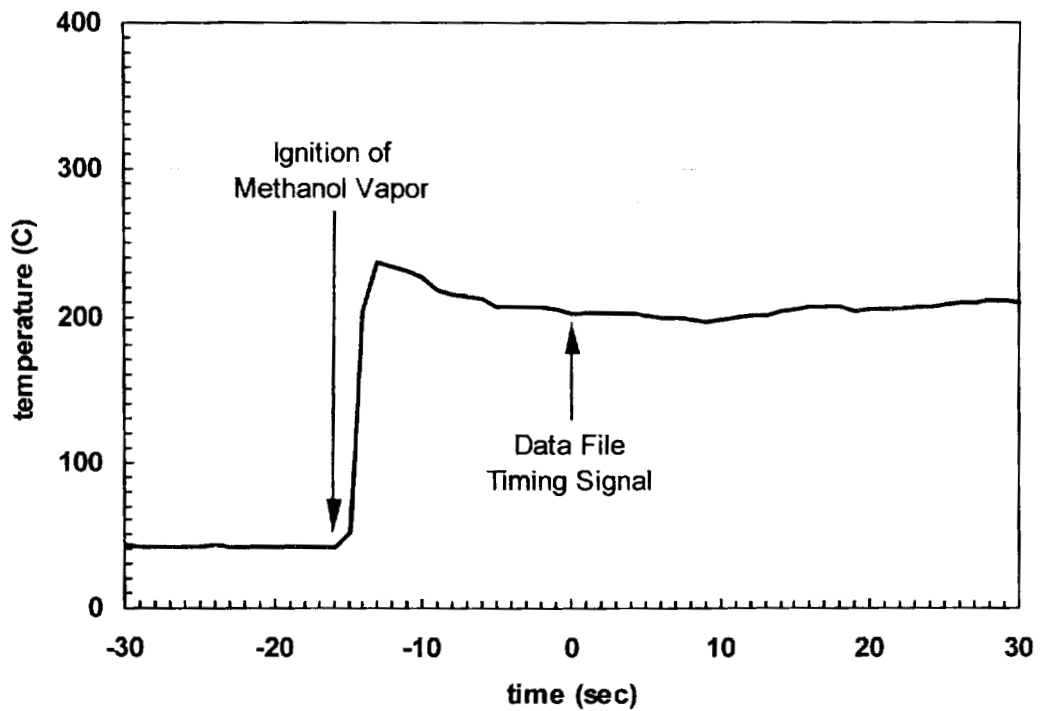
Figure 7. Fire Test F99030B. Plot of temperature data recorded from Thermocouple A4.

Figure 7 shows plots of temperature data recorded from Thermocouple A4, located in the windshield washer fluid reservoir. The origin of the abscissa in this plot was determined from the timing of the first air horn signal. The plot in Figure 7 shows temperature data recorded from 30 seconds before to 30 seconds after the first sounding of the air horn (- 30 to + 30 sec). Analysis of video from Camera 3 indicated a 14 second delay from the time burning power steering fluid aerosol entered the windshield washer fluid reservoir to the first sounding of the air horn audible in this video. Temperature data recorded from Thermocouple A7 started to increase from ambient levels between 15 and 16 seconds before the timing signal (Fig. 7)

The 16-second interval between ignition of methanol vapor in the windshield fluid reservoir and the timing signal in the data file is consistent with a 14 second time interval from entry of burning power steering fluid aerosol into the windshield washer fluid reservoir to the first sound of the air horn and an estimated 1 to 2 seconds delay for manually depressing the timing switch on the thermocouple data acquisition system after hearing the air horn. All discussions of the timing of flame-spread in this report are relative to the time of ignition of methanol vapor in the windshield washer fluid reservoir, which occurred approximately 16 seconds prior to the timing signal in the data files.

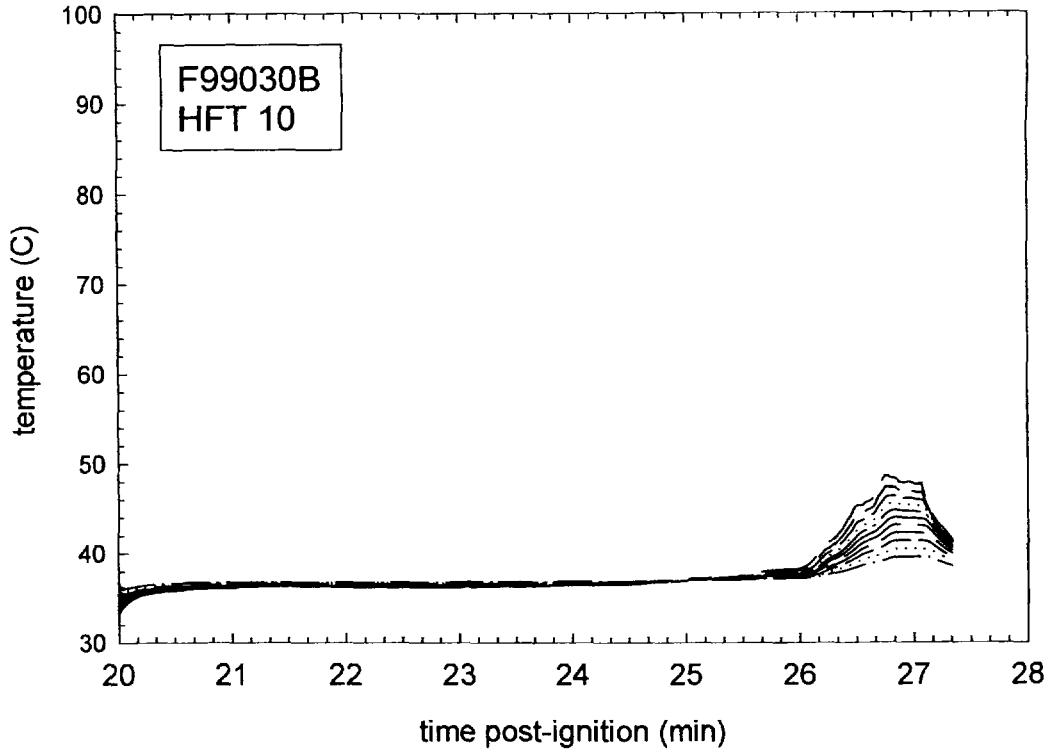
Figure 57. Fire Test F99030B. Skin temperature profiles estimated from heat flux data recorded from HFT/RAD Assembly 10 (APPENDIX E, Plots E2 and E3).

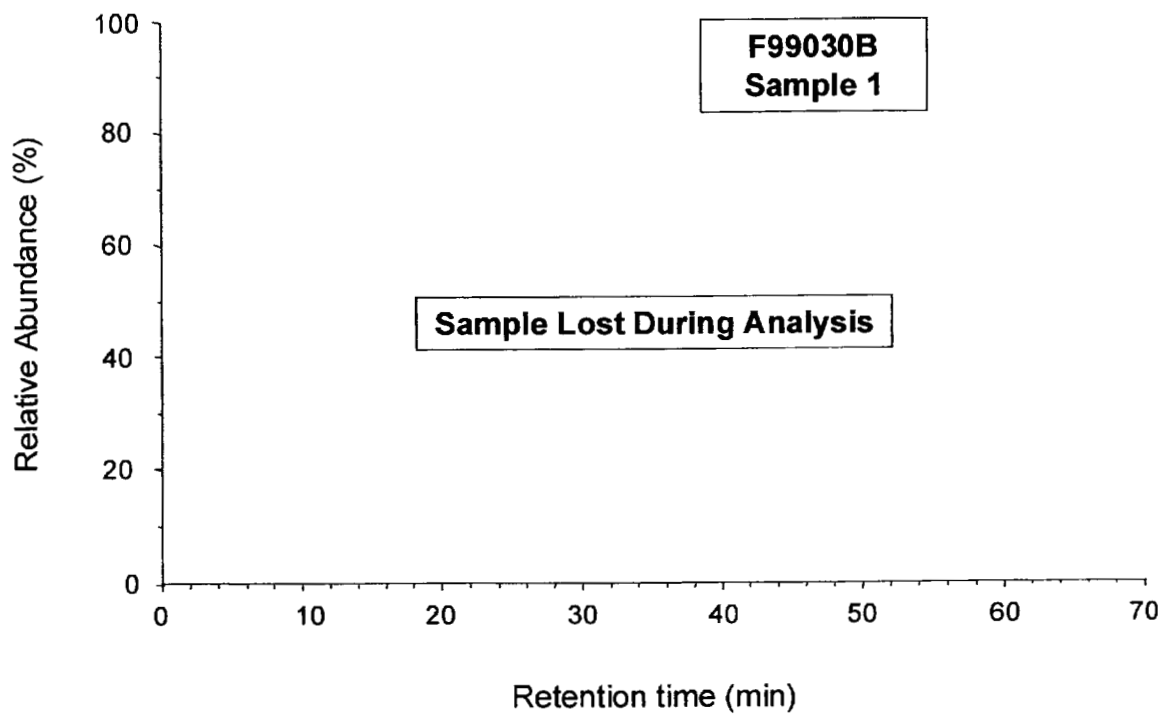
Plot I3. Fire Test F99030B. Mass Chromatogram of Sample 1 acquired from +00:00 to +22:30 min:sec post-ignition.
