Re: **Settlement Agreement**
Section B. Fire Safety Research

Overview of FMVSS 301 Upgrade Testing at GM

**SAE Government / Industry Meeting
Post Crash: Fire Safety Research Session
Washington, DC
April 21, 1998**

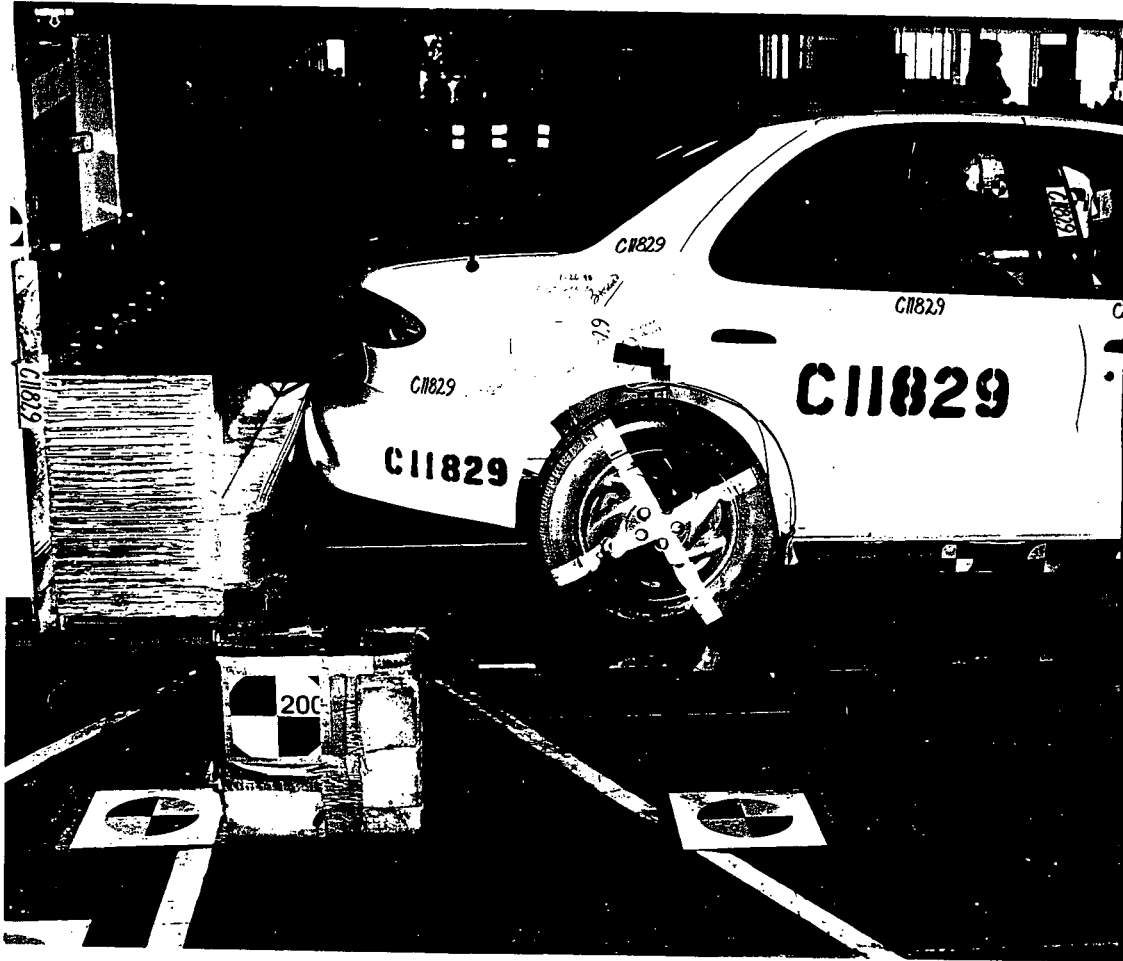
The tests were completed in December 1997 and January 1998, and this slide shows a pre-test view of one of the tests. NEXT SLIDE

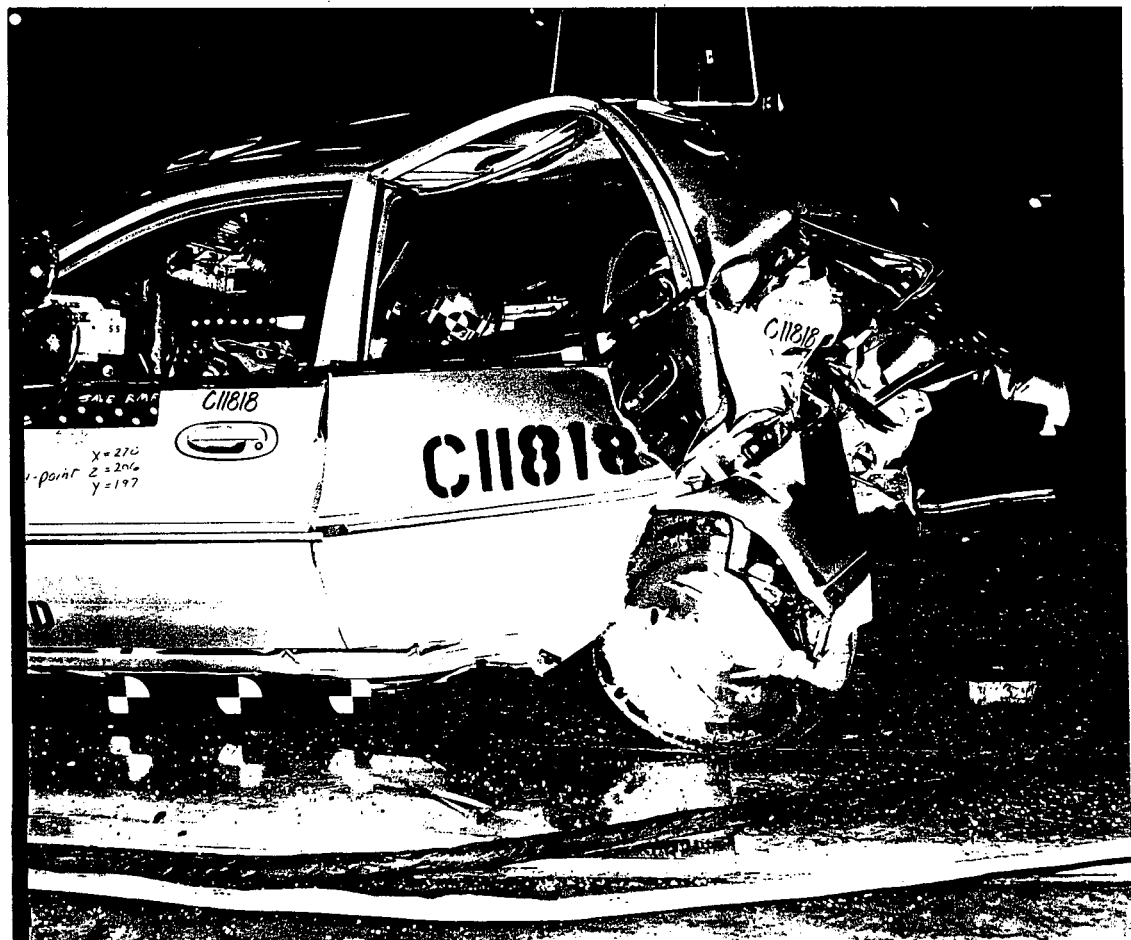
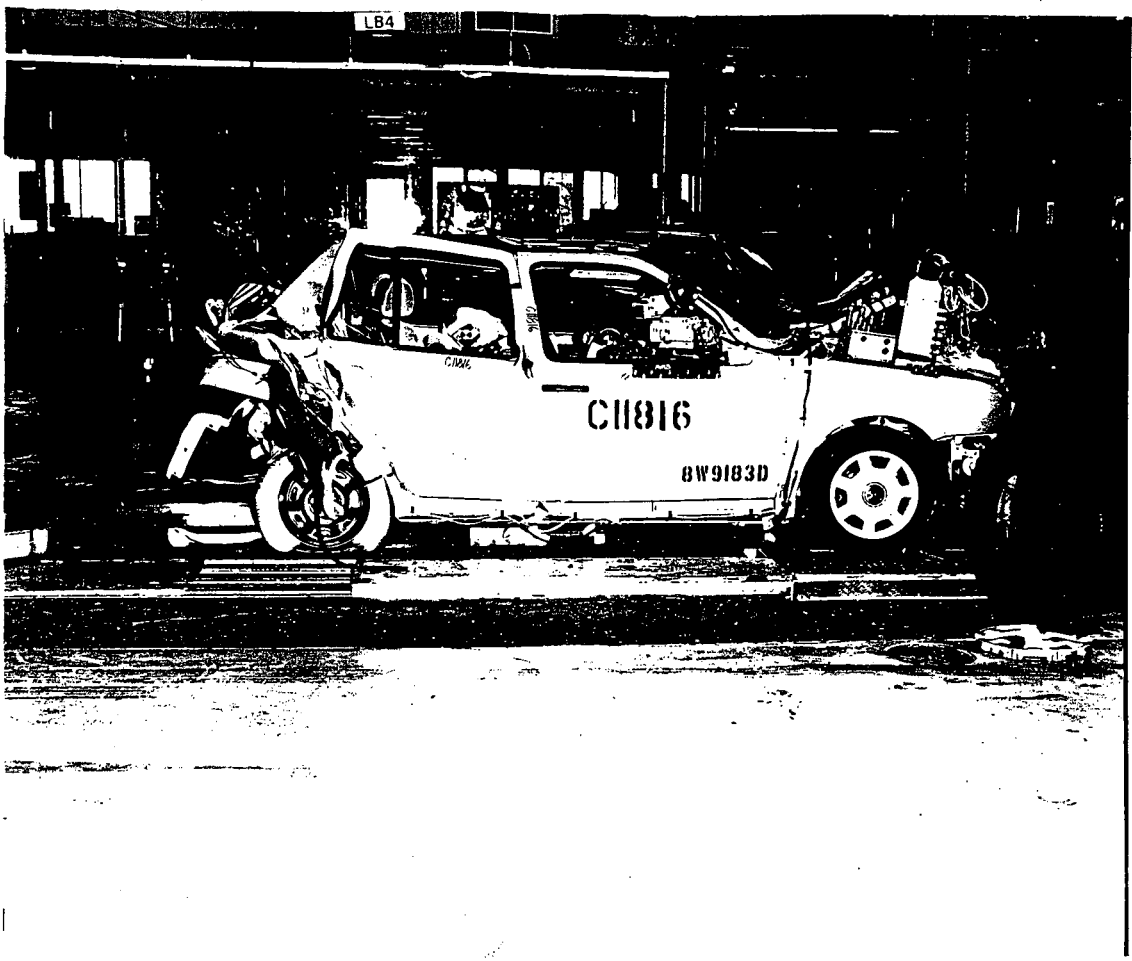
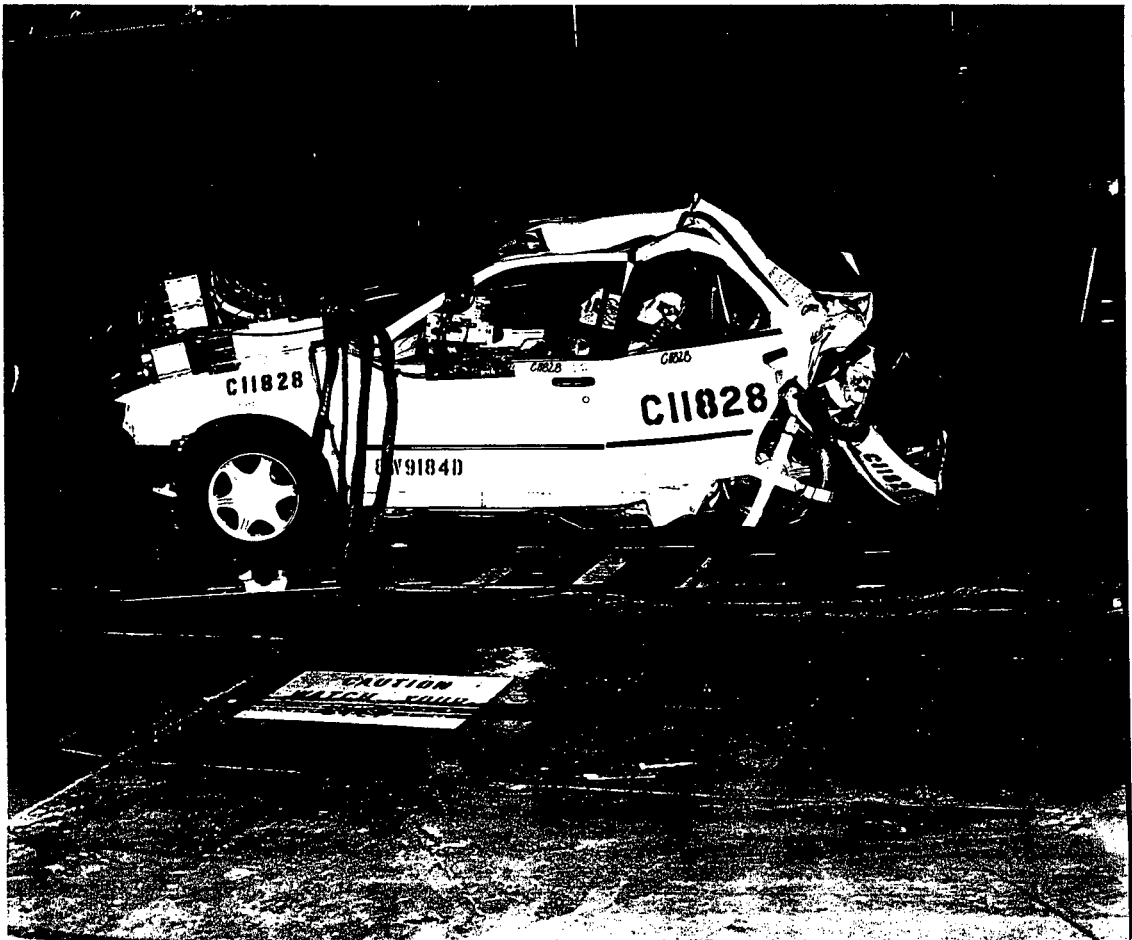
This slide and the next two, showing a post-impact view of each car, will give you pretty good idea of the high energy nature of this test condition. For example, based on visual inspection, there was a substantial reduction in rear seat occupant space in each of the tests.

First, this is a severe test, based on the evident high levels of car deformation.

Finally, the substantially reduced rear seat occupant space observed in the tests, and front seat test dummy injury criteria data in some of the tests, indicate that possibly serious to fatal impact-induced occupant injuries could occur under this crash condition. Accordingly, even if motor vehicles, especially small cars, could be developed to meet fuel system performance requirements repeatably in this test, further consideration seems appropriate regarding whether occupants will survive the crash forces. That concludes my presentation.
