Project B.14 – Demonstration of Enhanced Fire Safety Technology

Part 3: Full Scale Vehicle Fire Tests of a Control Vehicle and a Test Vehicle Containing an Intumescent Paint on its Underbody

**Jeffrey Santrock and Douglas E. LaDue III
General Motors Corporation**

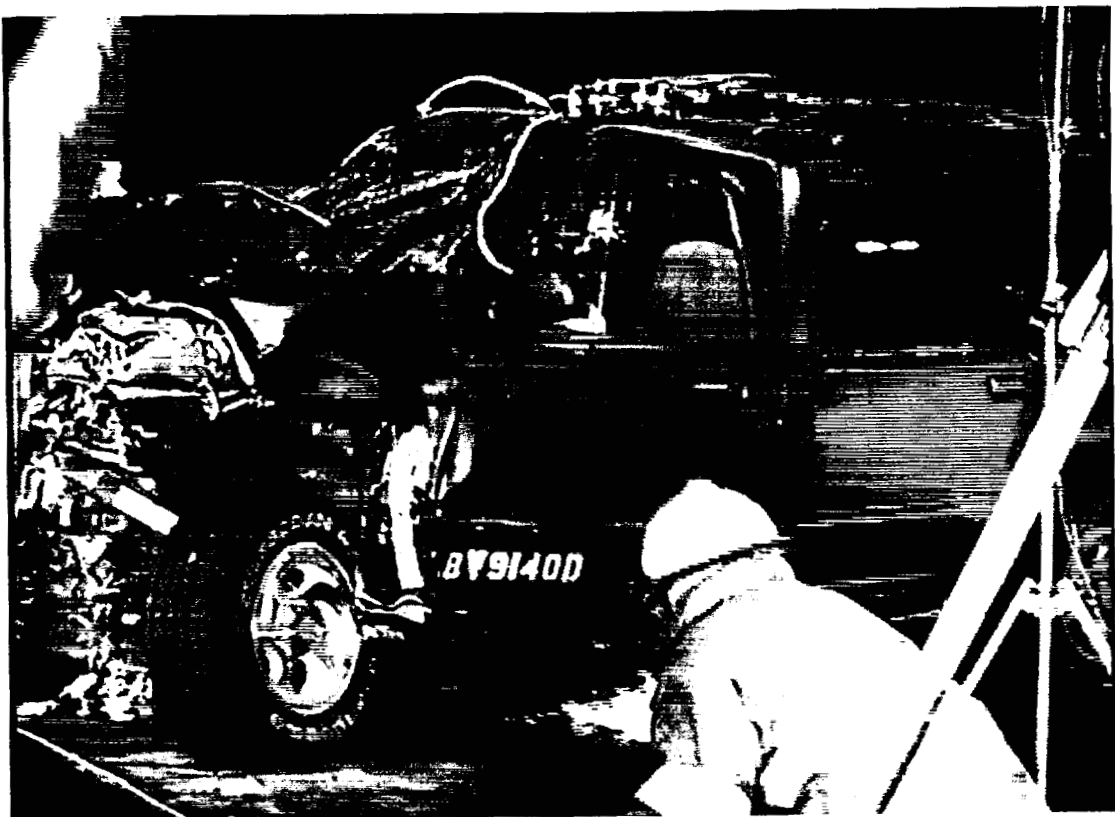
Figure 6. Video stills from F980611 Camera 3 (upper) and F99B1403 Camera 7 (lower) at the time of ignition.

Liquid gasoline flowed from the outlet of the stainless steel tubing installed in the fuel tank into the fuel tank skid plate and onto the cement board surface below the forward section of the fuel tank. After ignition, flames were observed on the cement board surface and in the fuel tank skid plates in both test vehicles. Figures 7 through 16 show a series of video stills from F980611 Camera 3 (upper) and F99B1403 Camera 7 at 15, 30, 60, 90, 120, 150, 180, 210, 240, and 243/245 seconds post-ignition. In both tests, the flames attached to the gasoline pool on the cement board appeared to be between 10 and 15 inches wide¹ from the time of ignition through about 30 seconds post-ignition (video stills, Fig.'s 7 through 8). The amount of gasoline flowing from the fuel tank skid plate onto the cement board surface decreased as this test progressed, resulting in a decrease in the width of flames on the cement board surface (Fig.'s 8 through 16). This observed behavior suggests that the rate of consumption by fire of liquid gasoline in the fuel tank skid plate was greater than the flow rate of liquid gasoline onto the skid plate, resulting in a decrease in the flow of liquid gasoline out of the fuel tank skid plate onto the cement board surface under the test vehicle. By 210 seconds post-ignition in F980611 (upper video still, Fig. 14) and 150 seconds post-ignition in F99B1403 (lower video still, Fig. 12), the size of the burning gasoline pool on the cement board surface had decreased substantially and flames from the cement board surface did not appear to reach the lower surface of the fuel tank skid plate. Flames from burning gasoline in the fuel tank skid plate could be seen spreading along the underbodies of the test vehicles inboard of the left rocker panel.

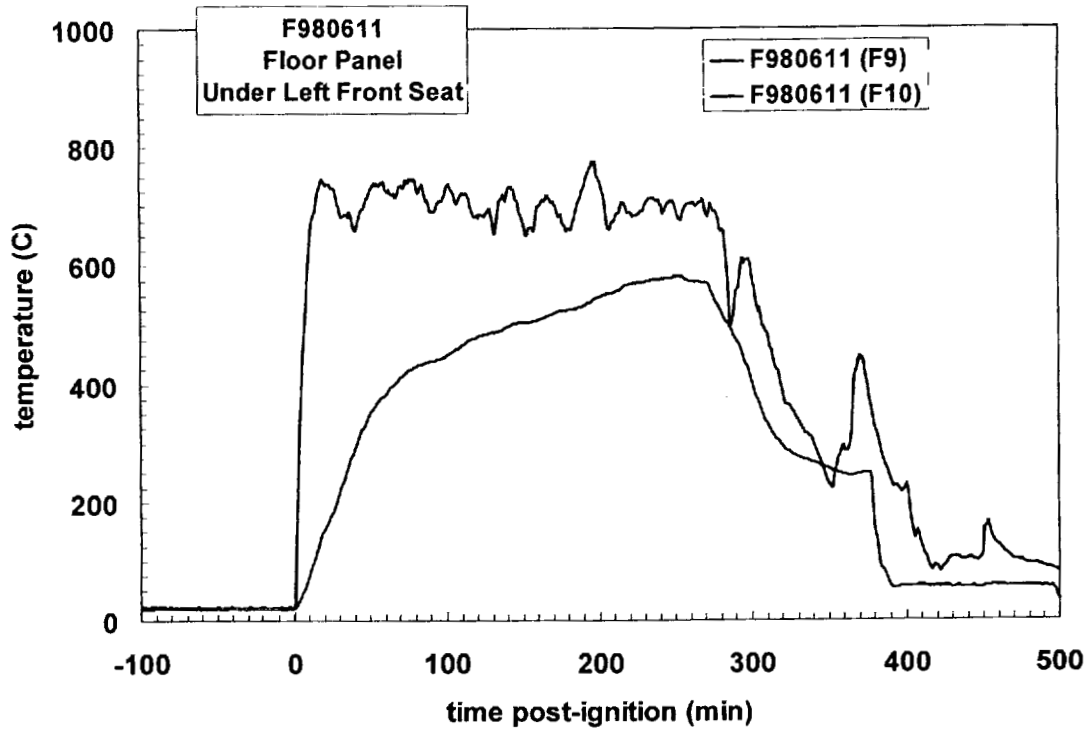
Figure 19. Fire Test F980611. Plots of temperature data recorded from Thermocouples F9 and F10.

Temperature data recorded from thermocouples located below the floor panel indicated that this area of the floor panel was exposed to flames within 15 seconds post-ignition (Fig.'s 19 and 20). Temperatures below the floor panel were between 650 and 750°C from 15 through 280 seconds post-ignition in F980611 (Fig. 19) and between 500 and 600°C from 15 through 380 seconds post-ignition in F99B1403 (Fig. 20).

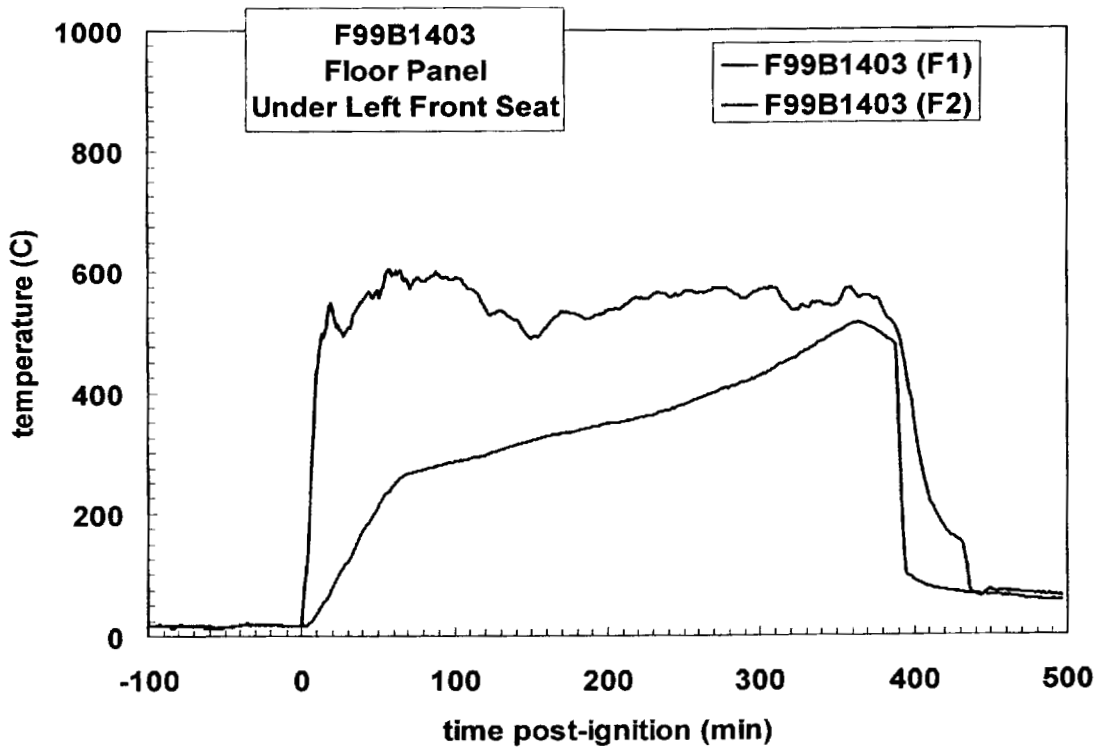
Figure 20. Fire Test F99B1403. Plots of temperature data recorded from Thermocouples F1 and F2.

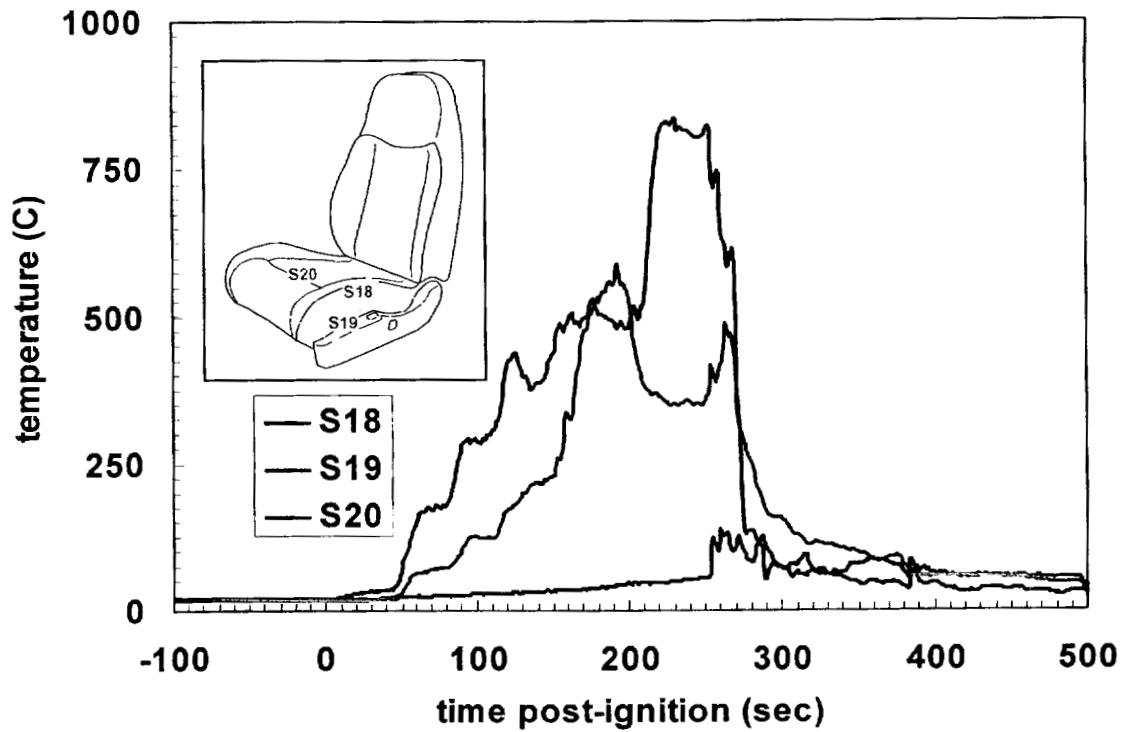
Figure 21. Fire Test F980611. Plots of temperature data recorded from Thermocouples S18, S19, and S20.

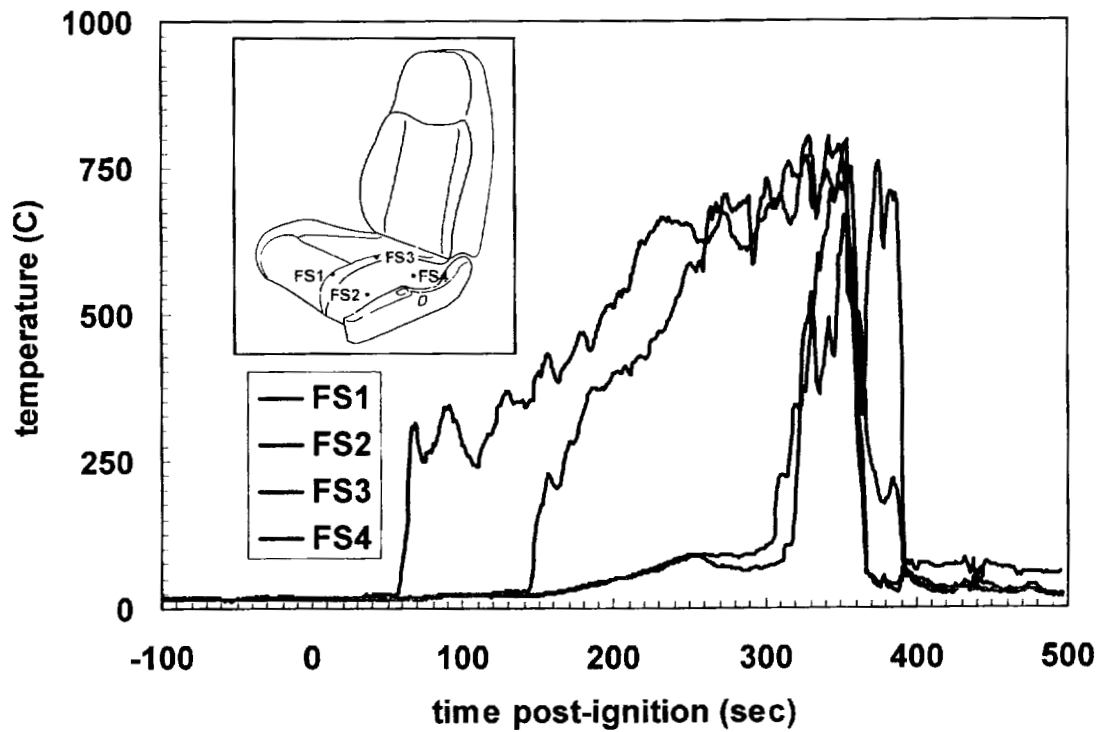
Figure 22. Fire Test F99B1403. Plots of temperature data recorded from Thermocouples FS1, FS2, FS3, and FS4.
