DOT HS 813 282

June 2022

Firewall Design in Buses To Mitigate the Propagation of Engine Fires

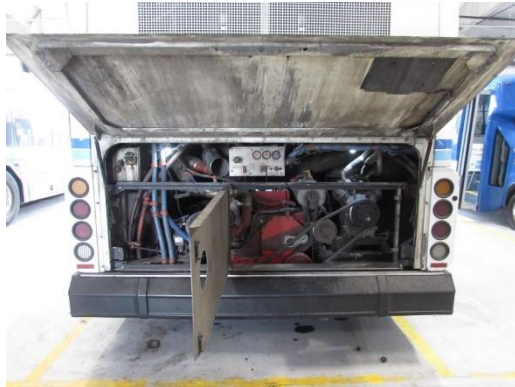
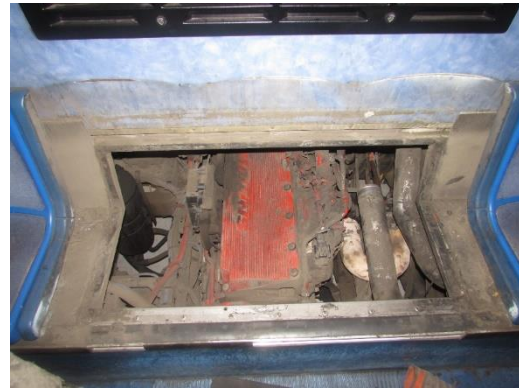
Figure 4 shows selected photographs from one of the surveyed transit buses (Gillig Diesel) and Table 5 shows a summary of the observed penetrations areas.

Rear view of engine compartment

Engine access panel

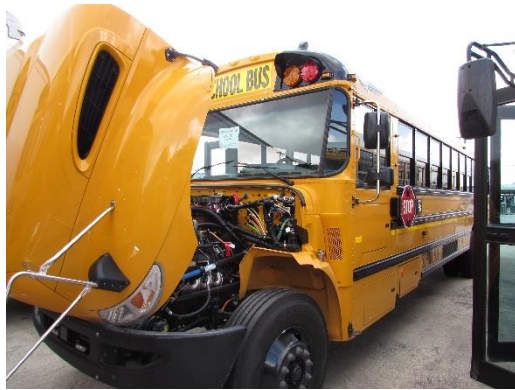
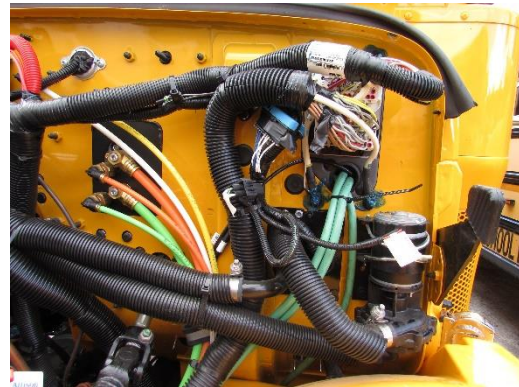
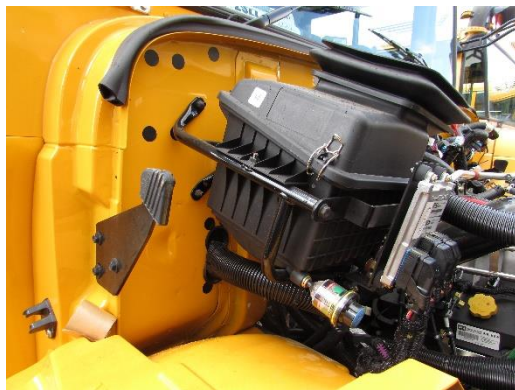
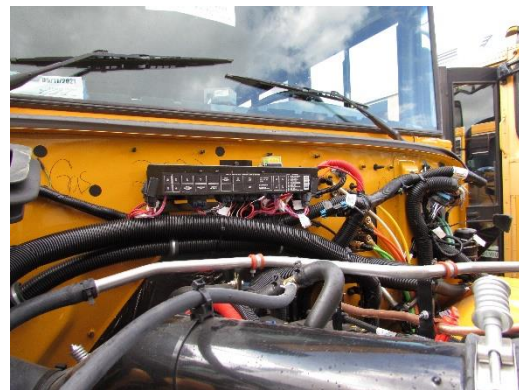
Figure 5 shows selected photographs from one of the surveyed school buses (2021 IC School Bus – Full-Length) and Table 7 shows a summary of the observed penetrations areas.

Overall view of school bus

Driver (right) side of firewall

Passenger (left) side of firewall

Center of firewall

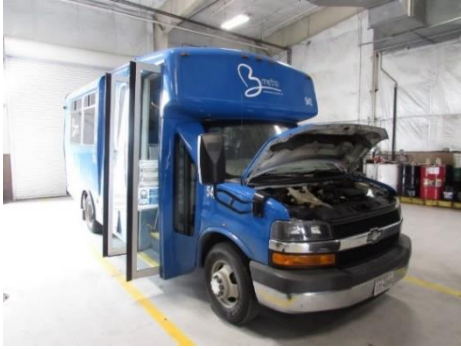
Figure 6 shows a photograph array of the Champion/GM Cutaway medium-size bus engine compartment surveyed at the Brownsville facility. This bus was very similar to the other medium-size buses surveyed at IDIADA. However, it was possible to observe a few new things for this bus that were not observed for the previous medium-size buses. This had to do with the specific configuration and location of the HVAC ductwork and the engine block cover. Figure 7 shows another photograph array for this bus but focusing on those parts. **Error! Reference source not found.** provides a summary of the observed firewall penetration findings.

Overall view of bus

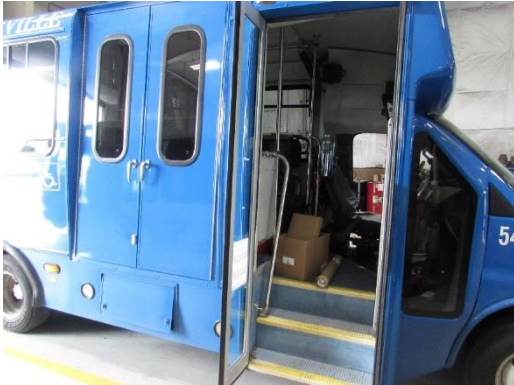
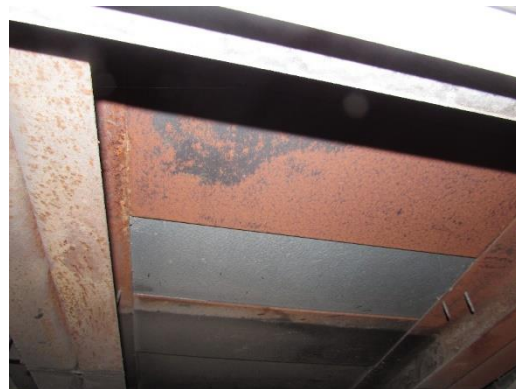
The last newly observed propagation pathway for this type of bus was the supplemental battery compartment, which was located just rear of the main doorway. Figure 8 shows a photograph array of this area. Per the site visit host, this additional battery compartment is quite common in newer medium-size buses and in the event of an electrical short of the main battery in the engine compartment, it is possible to also short out these supplemental batteries and provide a more direct path for fire and smoke into the passenger compartment.

Overall view with battery compartment under wheelchair access door

View of bus floor directly above batteries

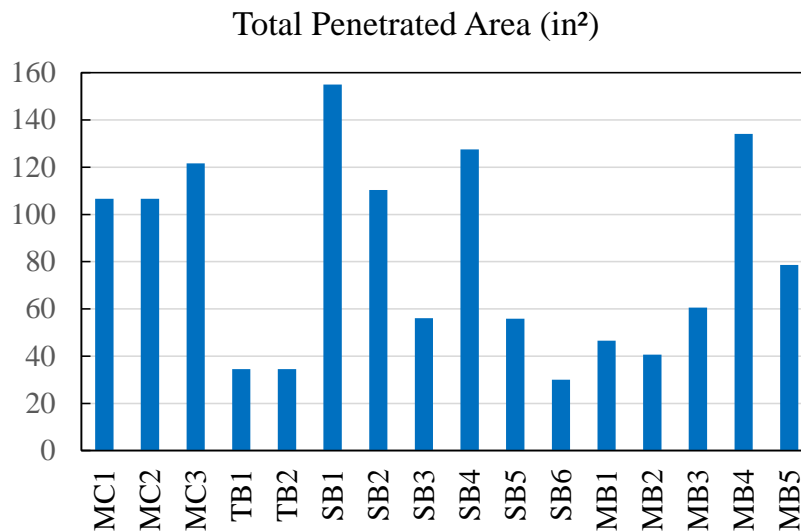
Figure 10. Total penetrated area for the 16 firewalls documented

The following four figures provide a comparison of the firewall area and total area and number of penetrations for the 16 buses that were surveyed in Task 2. Figure 9 indicates that the firewalls in motorcoaches, and up to a lesser extent transit buses, are much larger than the firewalls in school buses and medium-size buses. This can be explained by the fact that vehicles and engine size are larger in motorcoaches and transit buses. However, as discussed in more detail in the next few sections, the negative effect of the larger firewall size is offset by the fact that firewalls in motorcoaches are not in direct contact with the passenger compartment but separate the engine from an intermediate space, which acts as a buffer. Figure 10 indicates that the total penetrated area in motorcoaches is comparable to that in the full-size school buses. However, Figure 12 clearly shows that the number of penetrations is much smaller in motorcoaches, which implies that they are much larger and therefore easier to seal. This is consistent with the fact that the total penetrated area is much smaller for motorcoaches compared to the other buses, as shown in Figure 11.

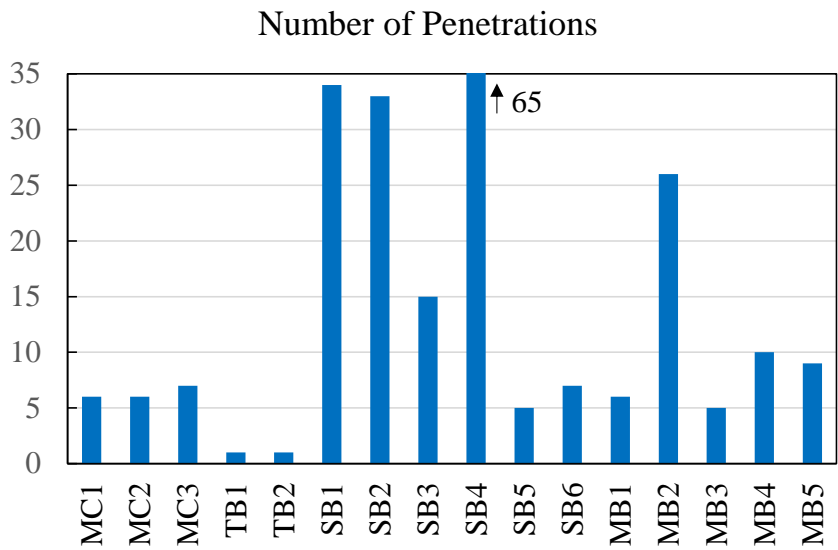
Figure 12. Number of penetrations for the 16 firewalls documented

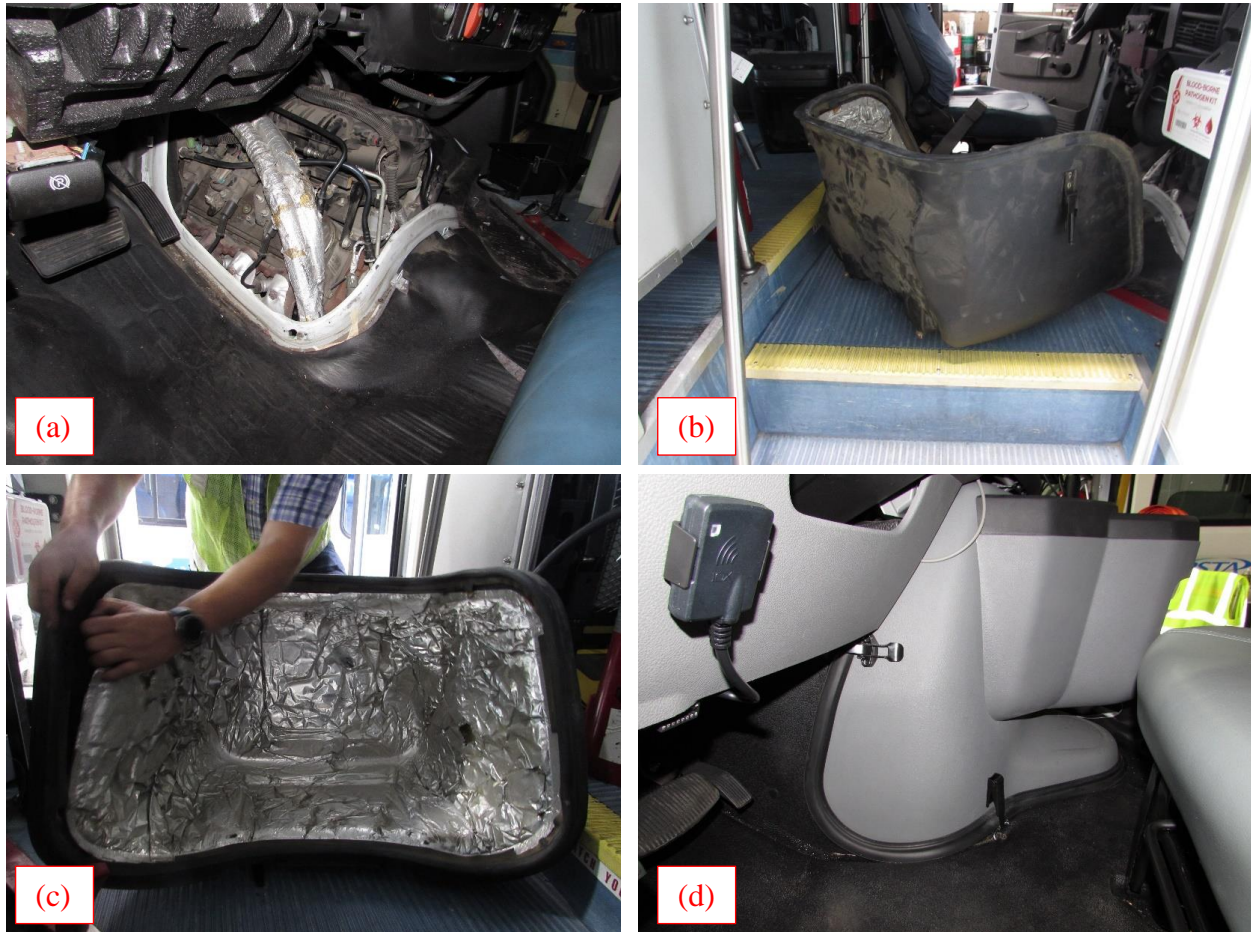
Figure 16. Pictures of engine extension and cowling in MB1 (a-c) and MB5 (d)

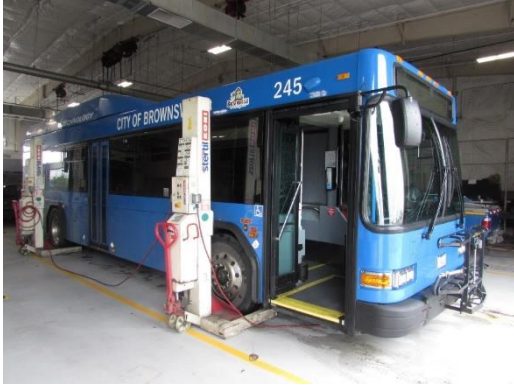
Figure A-1 shows a photograph array of the Gillig-Hybrid engine compartment surveyed at the Brownsville, Texas, facility. Table A-1 provides a summary of the observed firewall penetration findings. There were no visible penetrations. However, there is a hatch that makes some type of connection between compartments and the estimated penetration listed in Table A-1 assumes a ¼-in gap forming around the perimeter of this hatch area in the event of a fire.

Overall view

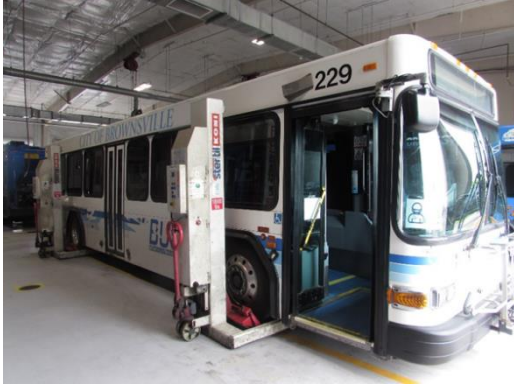
Figure B-1 shows a photograph array of the Gillig-Diesel engine compartment surveyed at the Brownsville, Texas, facility. Table B-1 provides a summary of the observed firewall penetration findings. There were no visible penetrations. However, there is a hatch that makes some type of connection between compartments and the estimated penetration listed in B-1 assumes a ¼-in gap forming around the perimeter of this hatch area in the event of a fire.

Overall view

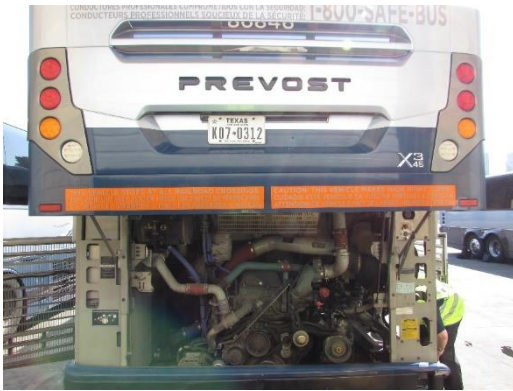
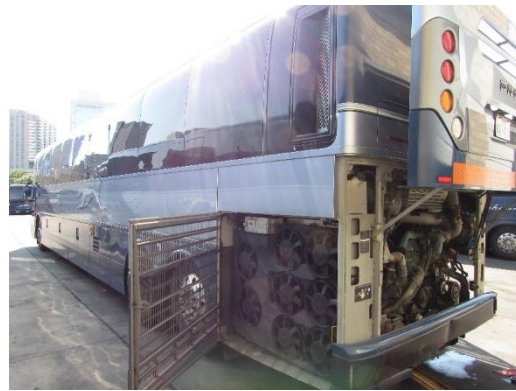
Figure E-1 shows a photograph array of the Prevost motorcoach engine compartment surveyed at the Greyhound facility. Table E-1 provides a summary of the observed firewall penetration findings. The only visible penetrations are related to the lavatory connections. However, there are also two hatches that make some type of connection between compartments and the estimated penetration listed in Table 4 assumes a ¼-in gap forming around the perimeter of this hatch area in the event of a fire. This is likely a conservative assumption for a flame spread path. If these leakage perimeter areas are taken away, then the penetration area is reduced from 1.5 percent to 0.69 percent of the area of the firewall.

Overall view

Left rear side with fan compartment

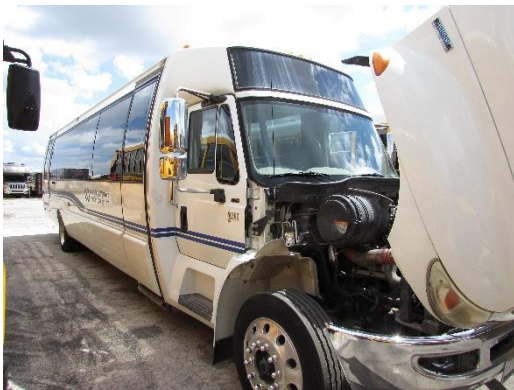
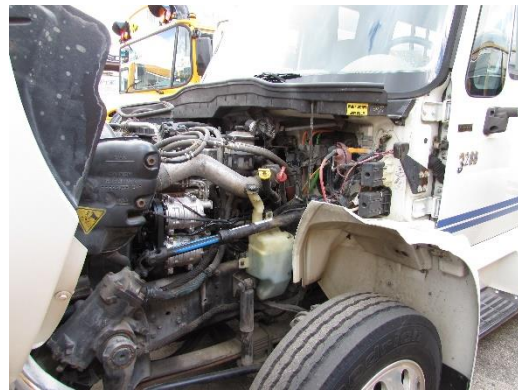
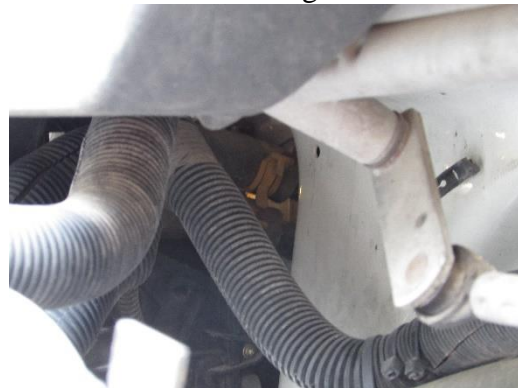
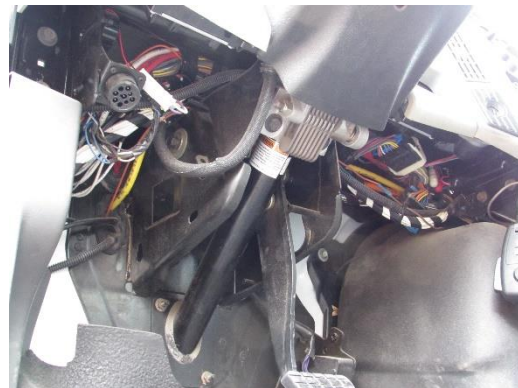
Figure F-1 shows a photograph array of the IC commercial bus engine compartment surveyed at Navistar/IC Bus. Table F-1 provides a summary of the observed firewall penetration findings. Figure F-2 shows a schematic of the observed penetrations.

Overall view

Firewall on right side

Penetrations on left side

Interior – View from below steering wheel

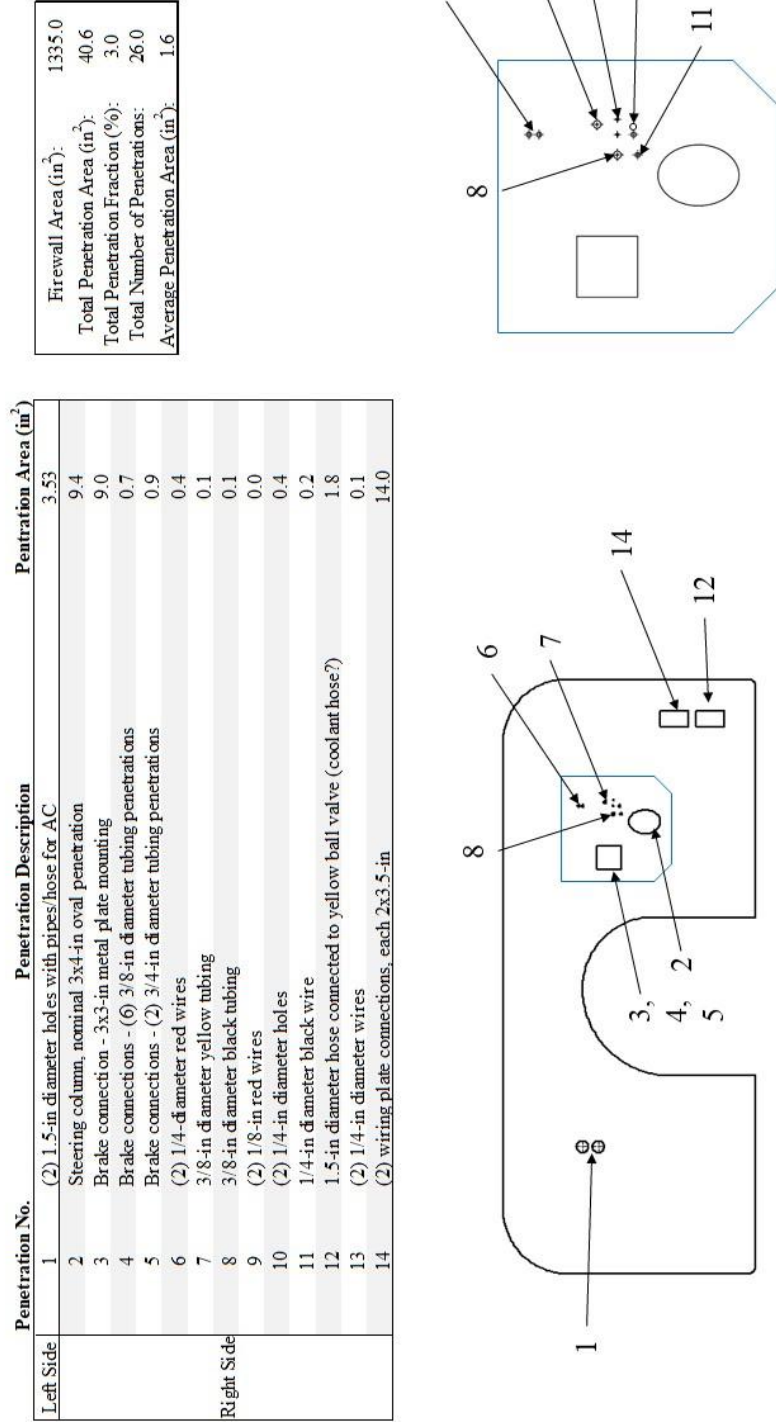
Firewall Area (in ²):	1335.0
Total Penetration Area (in ²):	40.6
Total Penetration Fraction (%):	3.0
Total Number of Penetrations:	26.0
Average Penetration Area (in ²):	1.6

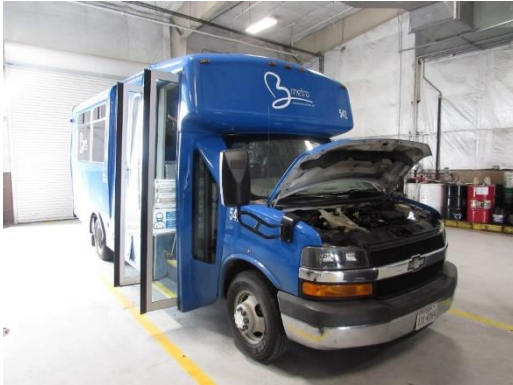
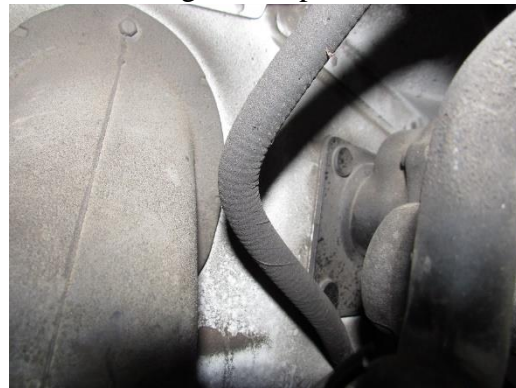
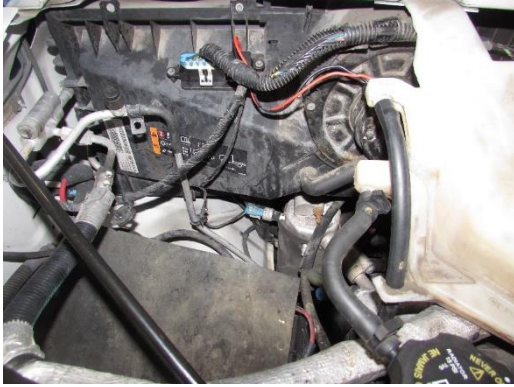
Figure G-1 shows a photographic array of the Champion/GM Cutaway bus engine compartment surveyed at the Brownsville, Texas, facility. This bus was very similar to the other medium-size buses surveyed at IDIADA. However, it was possible to observe a few new things for this bus that were not observed for the previous medium-size buses. This had to do with the specific configuration and location of the HVAC ductwork and the engine block cover. Figure G-2 shows another photograph array for this bus, but focusing on those parts. Table G-1 provides a summary of the observed firewall penetration findings.

Overall view of bus

Right side view of firewall

View of steering and brake penetrations

Because the interior section of dashboard had been removed by the site visit hosts, the potential propagation path was more readily observable. According to the site visit host, a common fire event scenario for these buses in their fleet is an electrical short of the battery, which can then ignite the HVAC housing, which is plastic (likely ABS or PP), and can then fail and easily propagate a fire into the passenger compartment. Before a more catastrophic failure occurs, it may still be possible to transmit products of combustion from an engine compartment fire into the passenger compartment through the existing ductwork outlet (shown in lower left image in Figure G-2).

Left side of engine compartment – HVAC

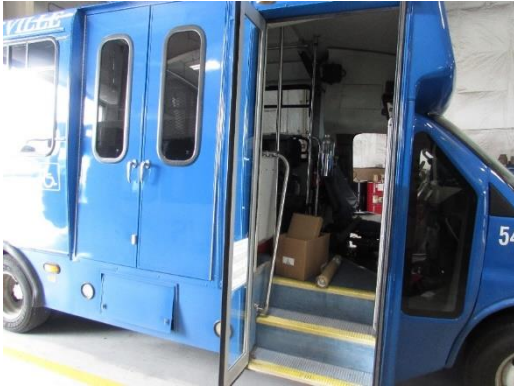
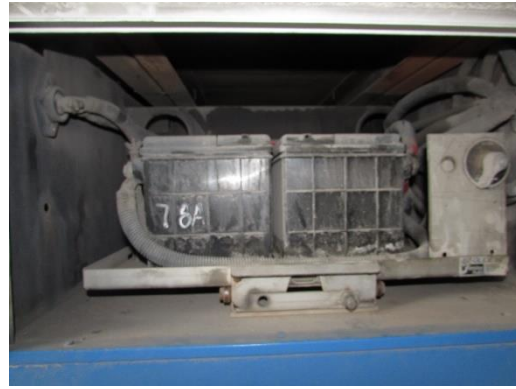
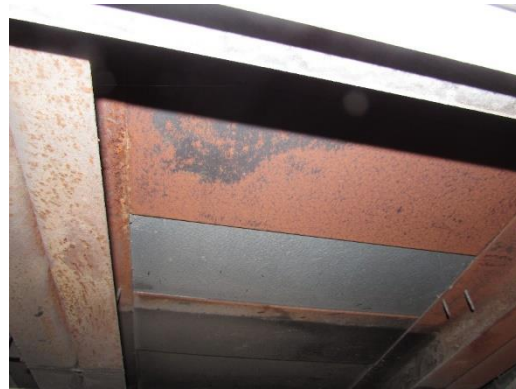
The last newly observed propagation pathway for this type of bus was the supplemental battery compartment, which was located just rear of the main doorway. Figure G-3 shows a photograph array of this area. Per the site visit host, this additional battery compartment is quite common in newer medium-size buses and in the event of an electrical short of the main battery in the engine compartment, it is possible to also short out these supplemental batteries and provide a more direct path for fire and smoke into the passenger compartment.

Overall view with battery compartment under wheelchair access Door

Close-up view of supplemental batteries and associated Cabling

View of bus floor directly above batteries

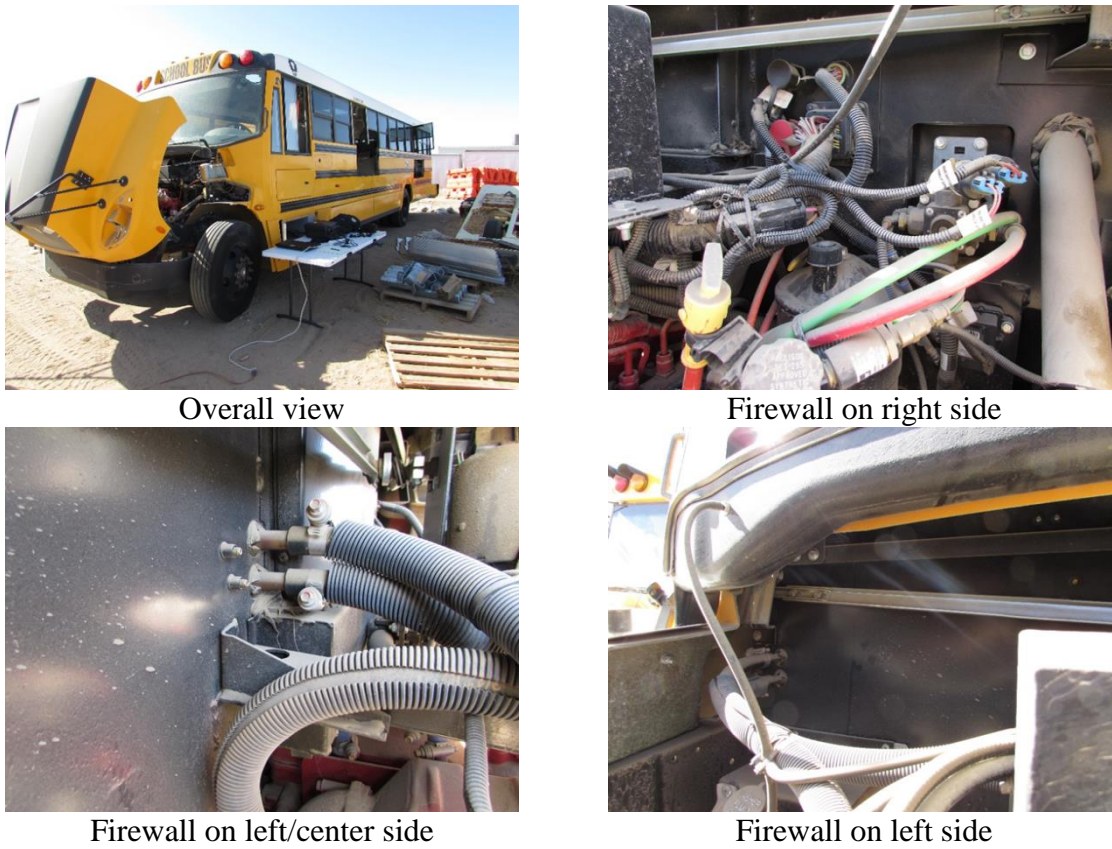
Figure I-1 shows a photograph array of the Lion bus engine compartment surveyed at IDIADA. Table I-1 provides a summary of the observed firewall penetration findings. Figure I-2 shows a sketch of the observed penetrations documented at the site visit.

Overall view

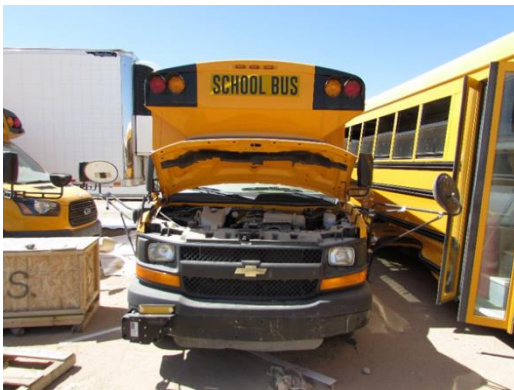
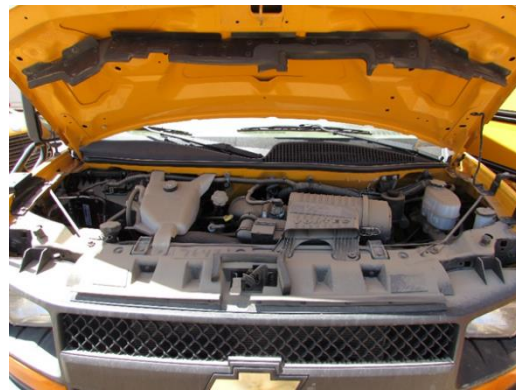
Figure J-1 shows a photograph array of the Van Con bus engine compartment surveyed at IDIADA. Table J-1 provides a summary of the observed firewall penetration findings. Figure J-2 shows a schematic of the observed penetrations.

Overall view

Overall view (close-up)

Firewall on right side

Firewall on right side (steering penetration)

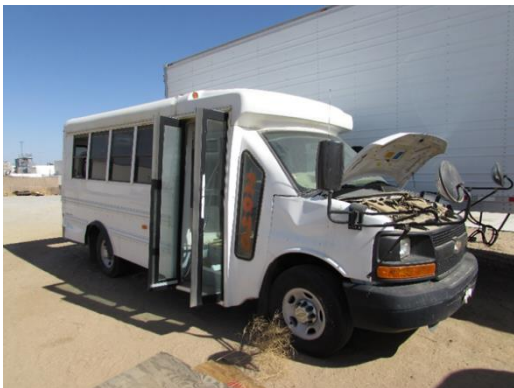
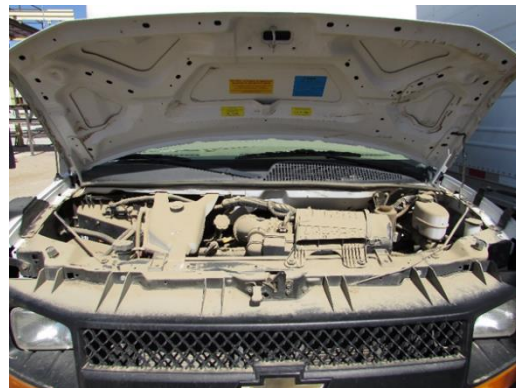
Figure K-1 shows a photograph array of the Starcraft bus engine compartment surveyed at IDIADA. Table K-1 provides a summary of the observed firewall penetration findings. Figure K-2 shows a sketch of the observed penetrations during the site visit.

Overall view

Overall view (close-up)

Firewall on right side

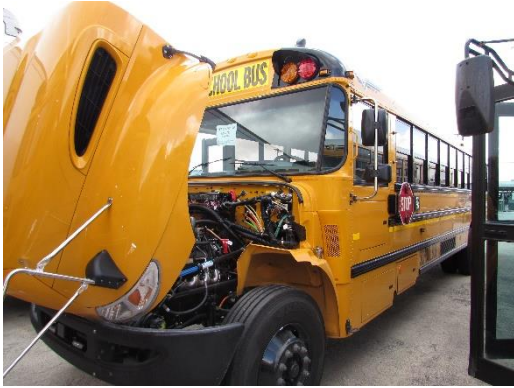
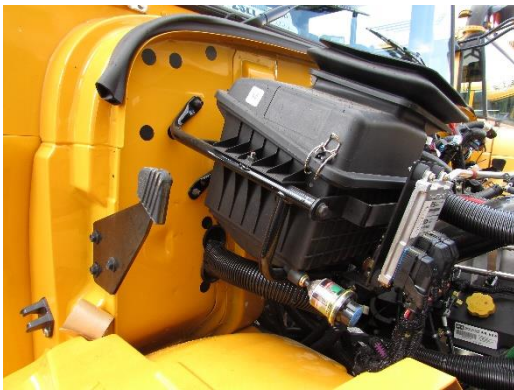
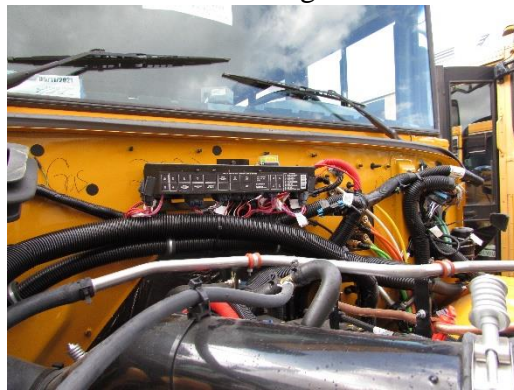
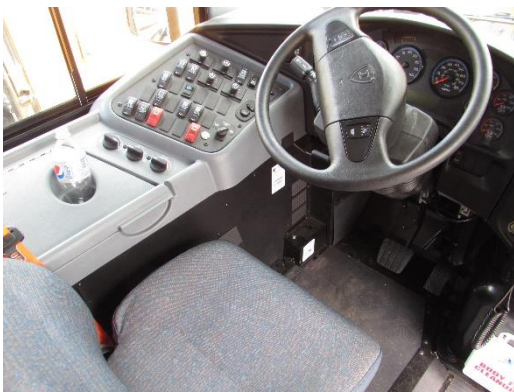
Figure L-1 shows a photograph array of the IC school bus engine compartment. Table L-1 provides a summary of the observed firewall penetration findings. The school bus surveyed looked very similar to the one surveyed at VRTC. Figure L-2 shows a schematic of the penetrations observed during the site visit.

Overall view

Firewall on left side

Firewall in center section

Driver's location – Interior

Interior – View from below steering wheel

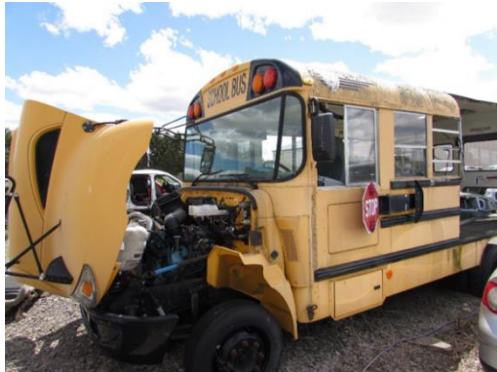
Figure M-1 shows a photograph array of the IC (short bus) engine compartment surveyed at VRTC. Table M-1 provides a summary of the observed firewall penetration findings. Figure M-2 shows a schematic of the observed penetrations during the site visit.

Overall view

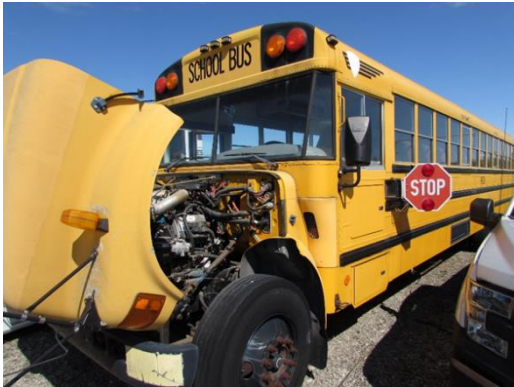
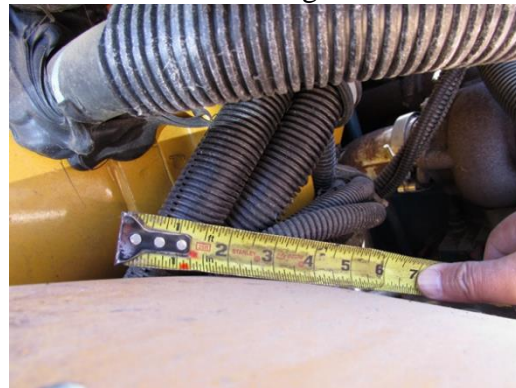
Figure N-1 shows a photograph array of the IC (long bus) engine compartment surveyed at VRTC. Table N-1 provides a summary of the observed firewall penetration findings. Figure N-2 shows a schematic of the observed penetrations during the site visit.

Overall view

Firewall on left side (close-up view)

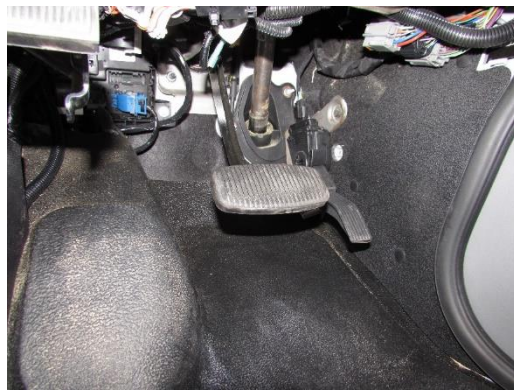
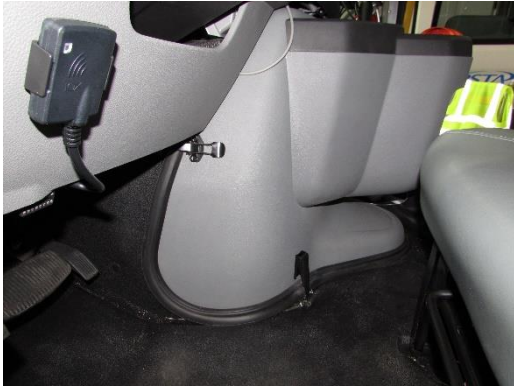
Right side firewall view

Interior view on driver's side

The newly observed feature on this bus is the battery disconnect switch located under the driver's seat. This can be seen in the top right image of Figure O-2. The purpose of this switch is to disconnect power to the engine compartment, while keeping power in the passenger compartment for the purposes of egress. The site visit host is having these switches installed on all new buses that allow this option. Table O-1 shows a summary of the observed penetrations through the firewall. Figure O-3 shows a schematic of the penetrations.

View of Plastic engine cover

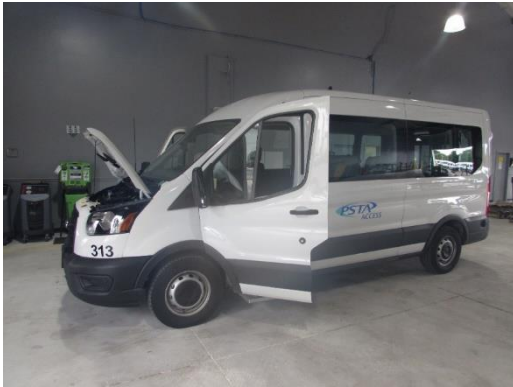
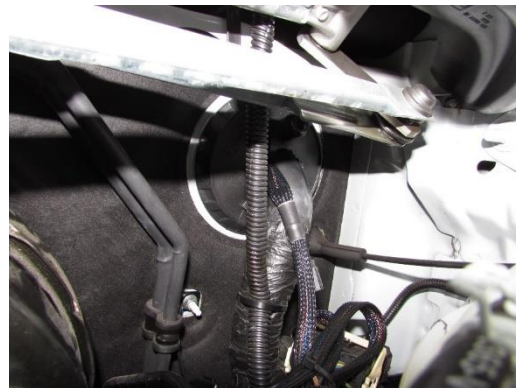
Figure P-1 shows a photograph array of the Ford Paratransit van engine compartment surveyed at the Tampa facility. The engine compartment for this van was very similar to the other medium-size buses surveyed at other sites. An interesting feature of this van design is the location of the battery, which is located under the driver's seat. In the engine compartment there is a distribution module for routing of these battery cables. The bottom two images in Figure P-1 shows the battery arrangement. Table P-1 shows a summary of the observed firewall penetrations.

Overall view of van

Center view of firewall

Right side firewall view
