FIREFIGHTER NEAR MISS

Auto Fire with
Compressed Natural Gas
(CNG) Fuel Tank Explosion

Prepared By Operations Division

Incident #26564, March 26, 2007

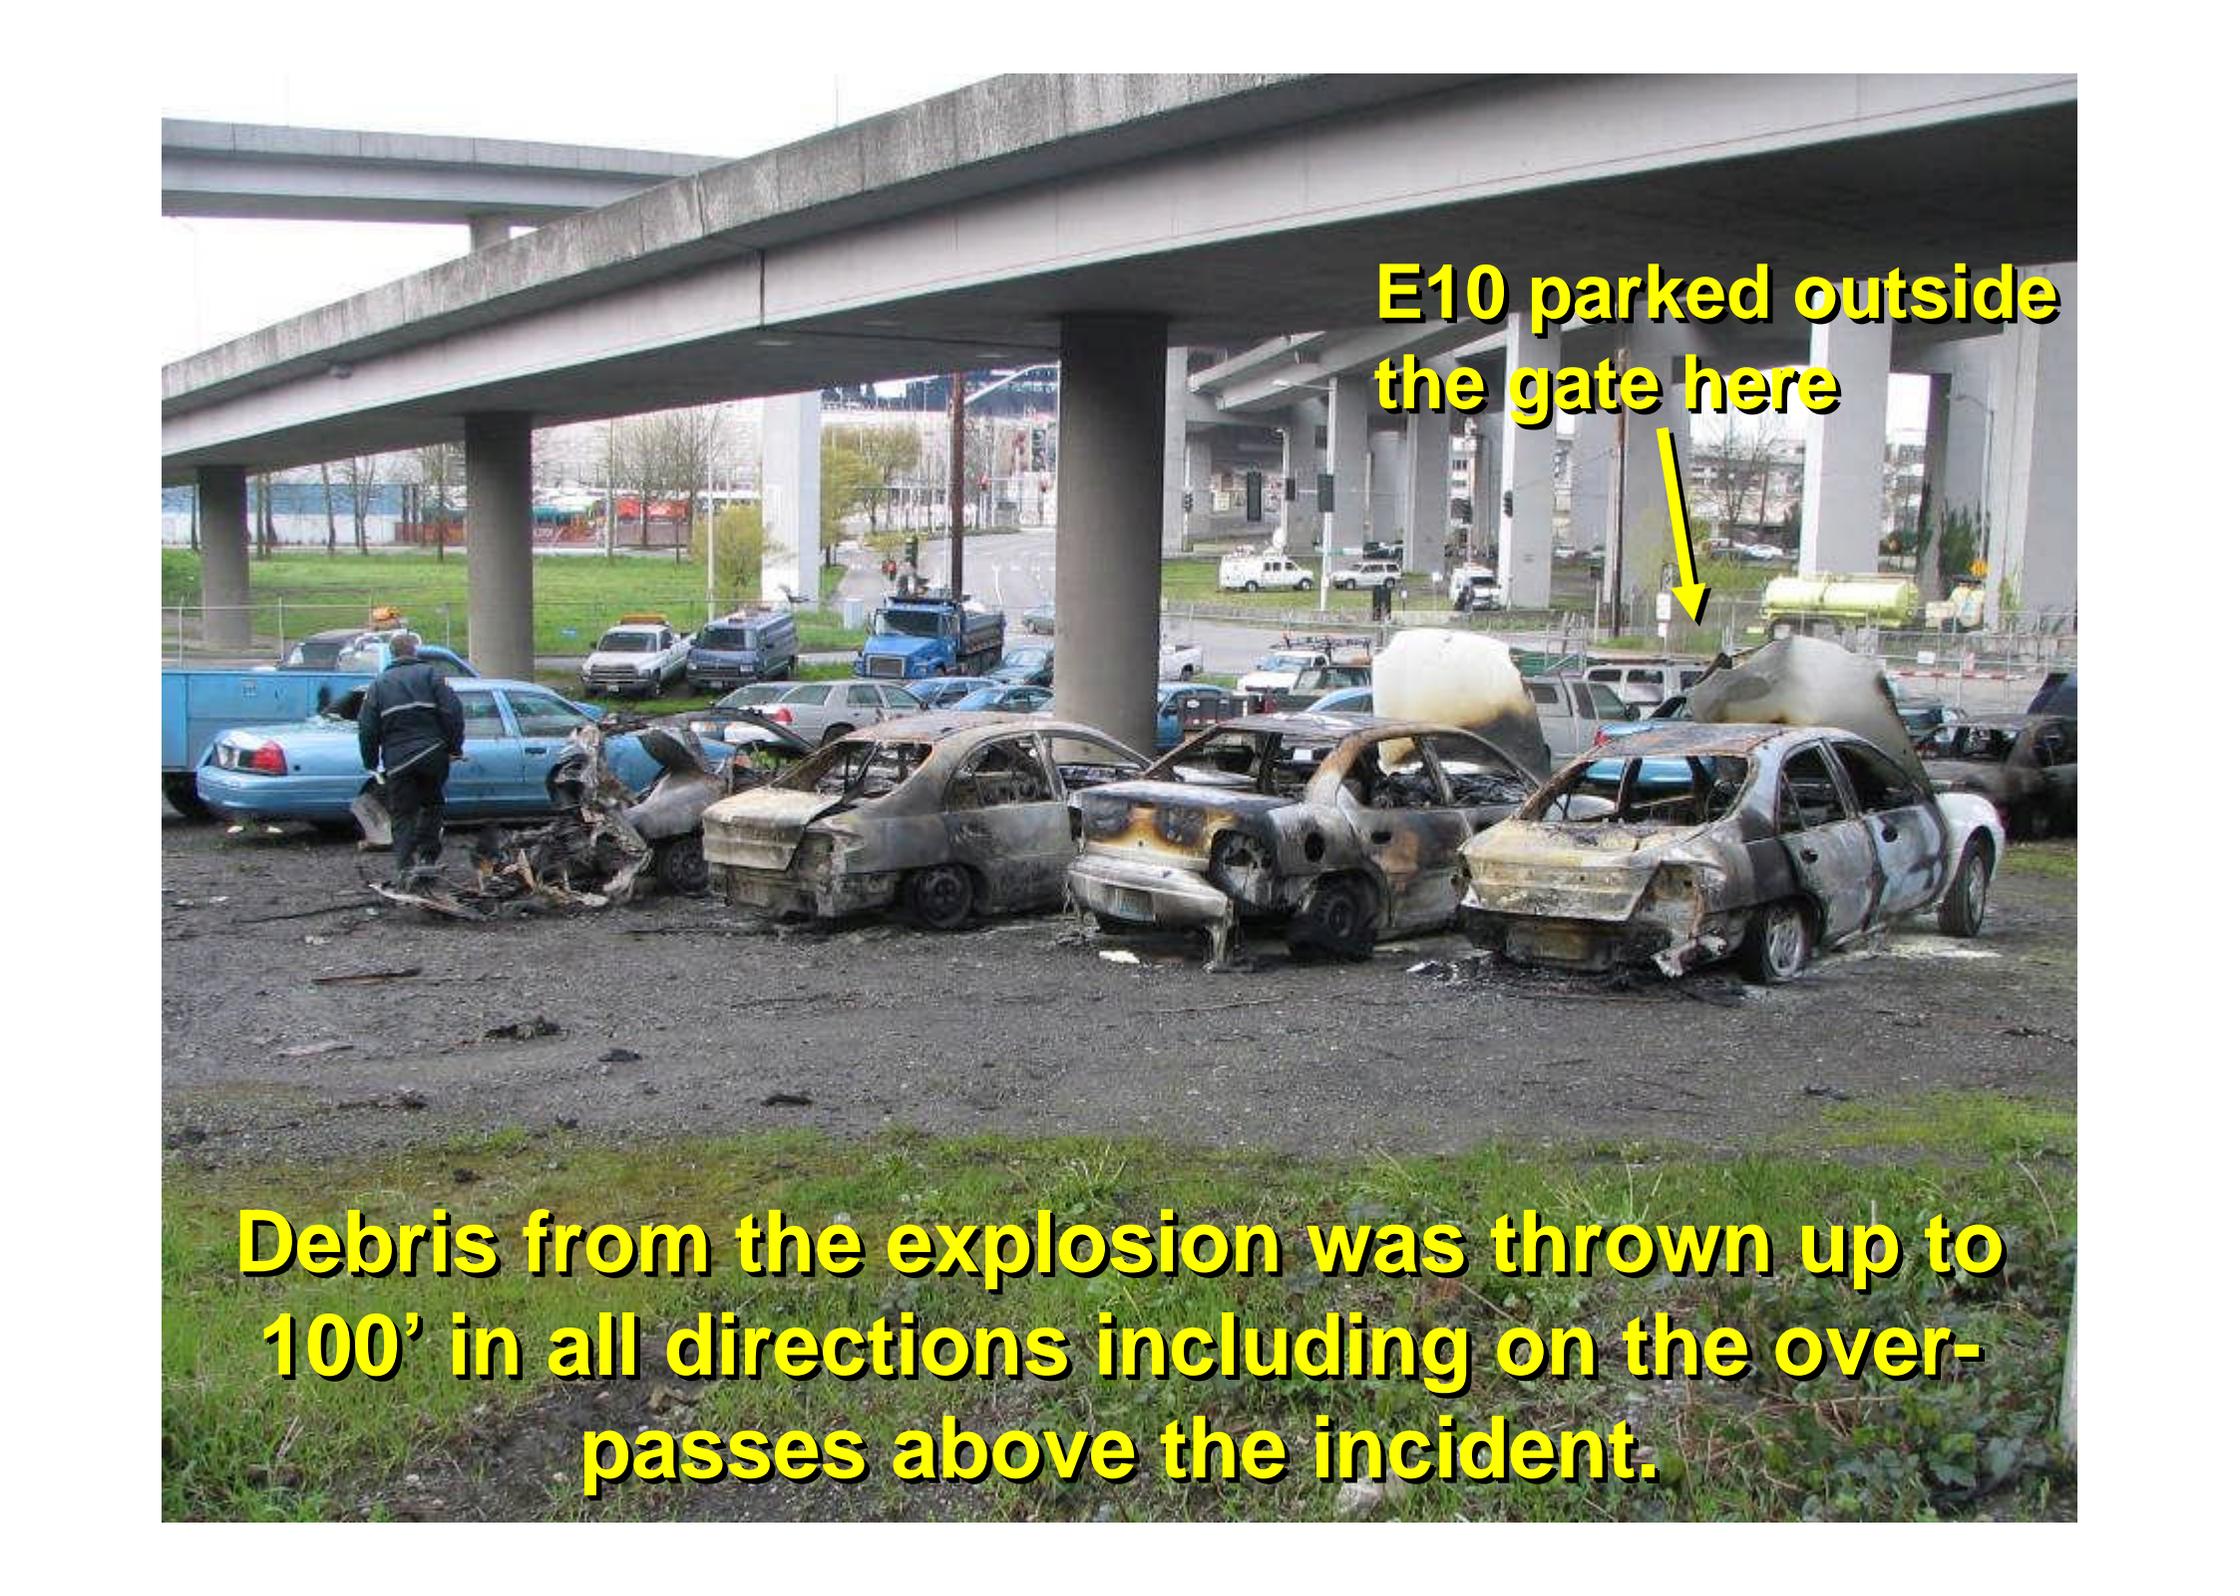
**E10 parked outside
the gate here**

A photograph showing the aftermath of an explosion in a parking lot. Several cars are severely damaged, with their metal bodies crumpled and charred. In the background, there is a concrete overpass structure supported by pillars. A yellow arrow points from the text above to a specific car in the middle ground.

**Debris from the explosion was thrown up to
100' in all directions including on the over-
passes above the incident.**

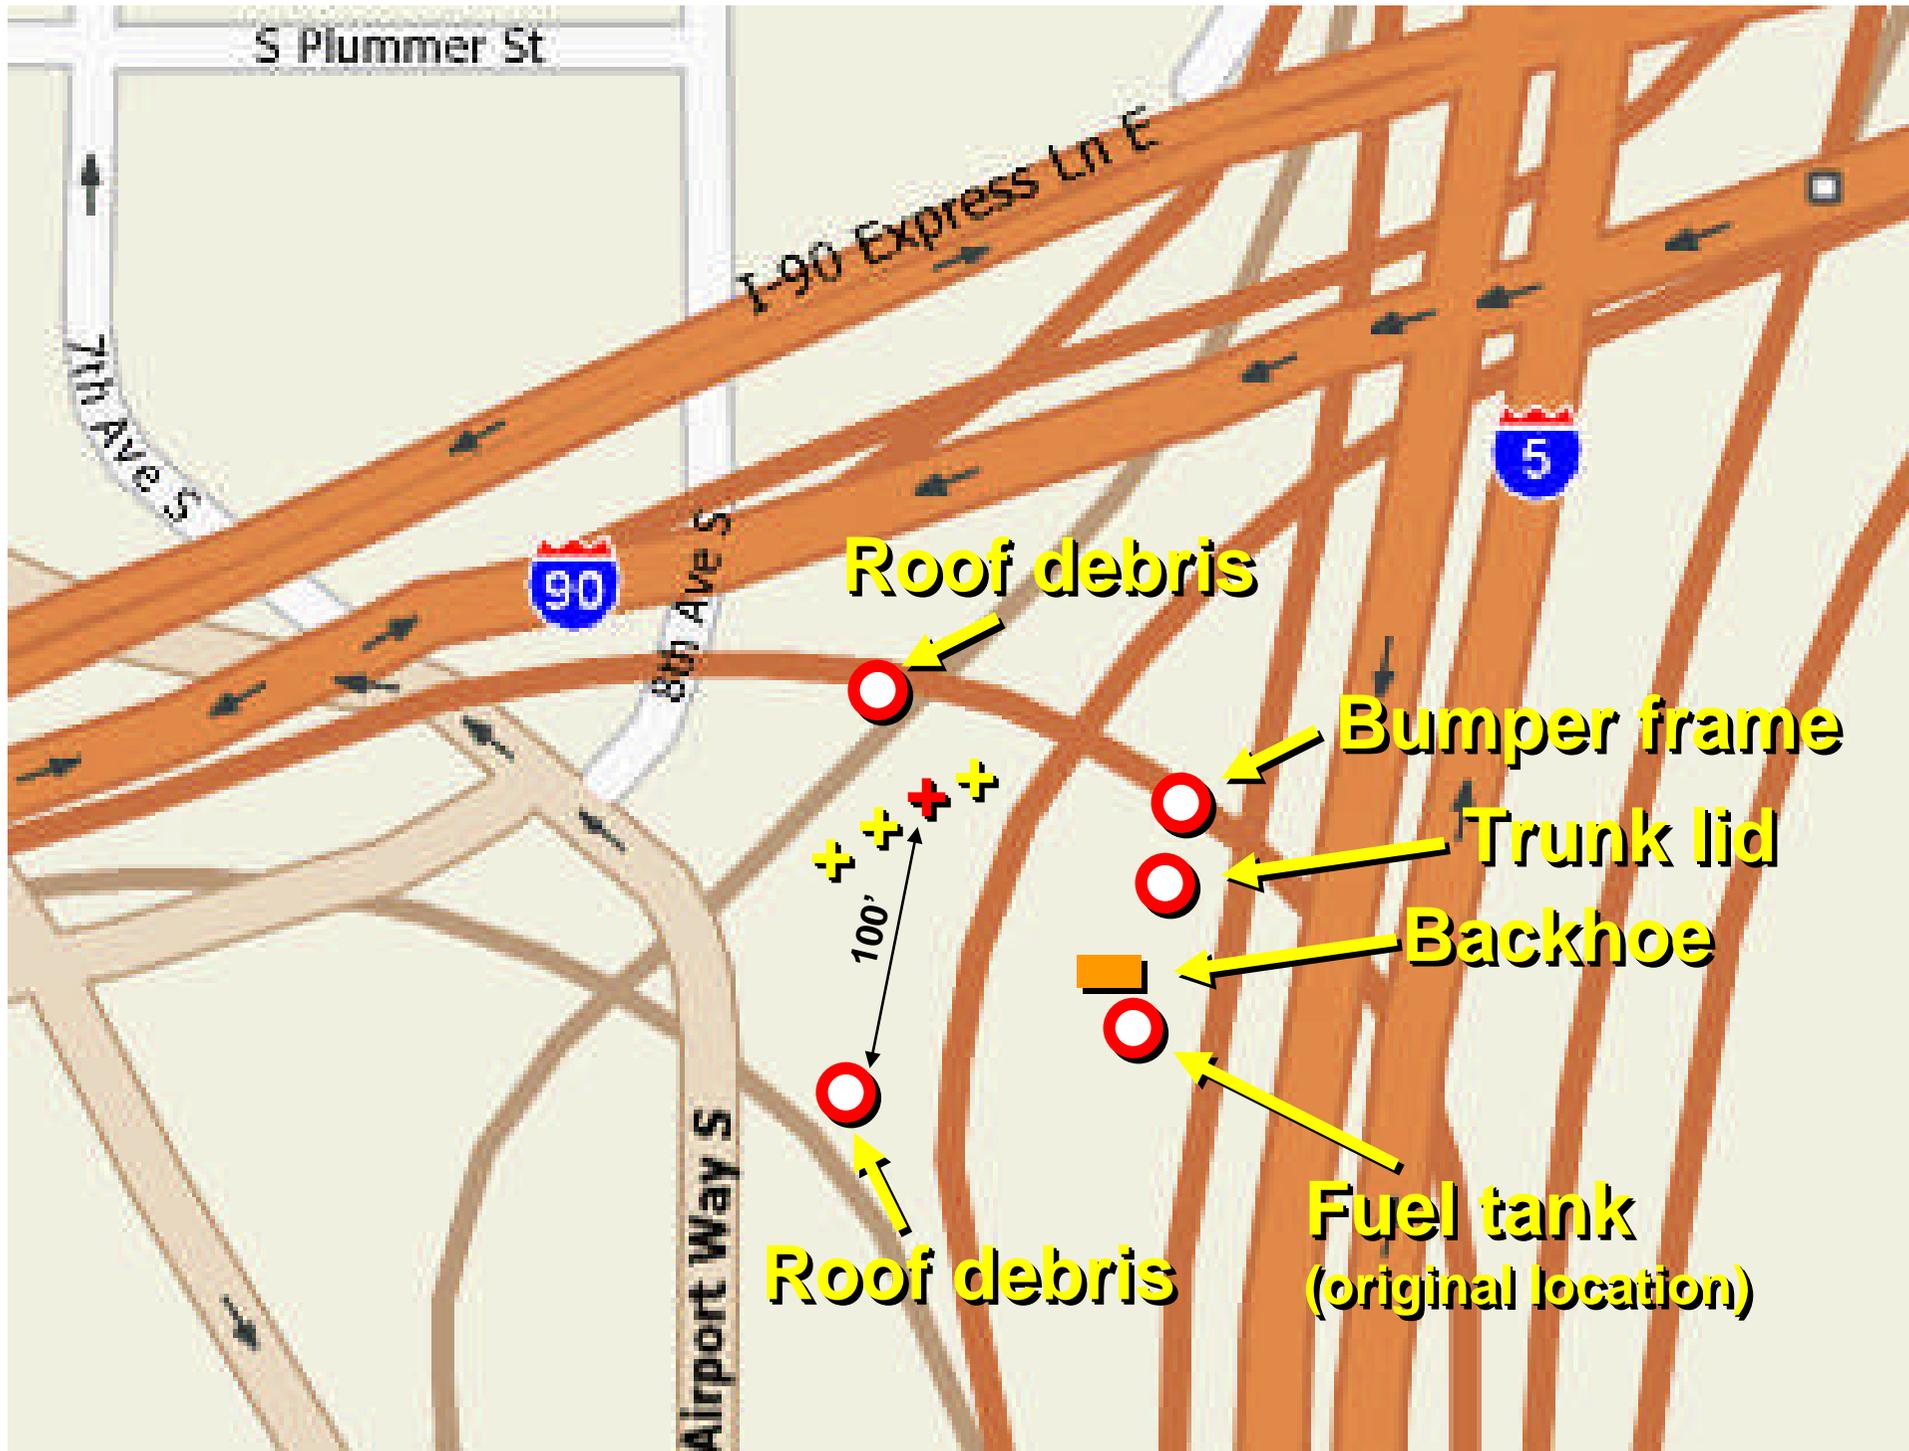
Roof debris

Bumper frame

Trunk lid

100'

Fuel tank
(original location)

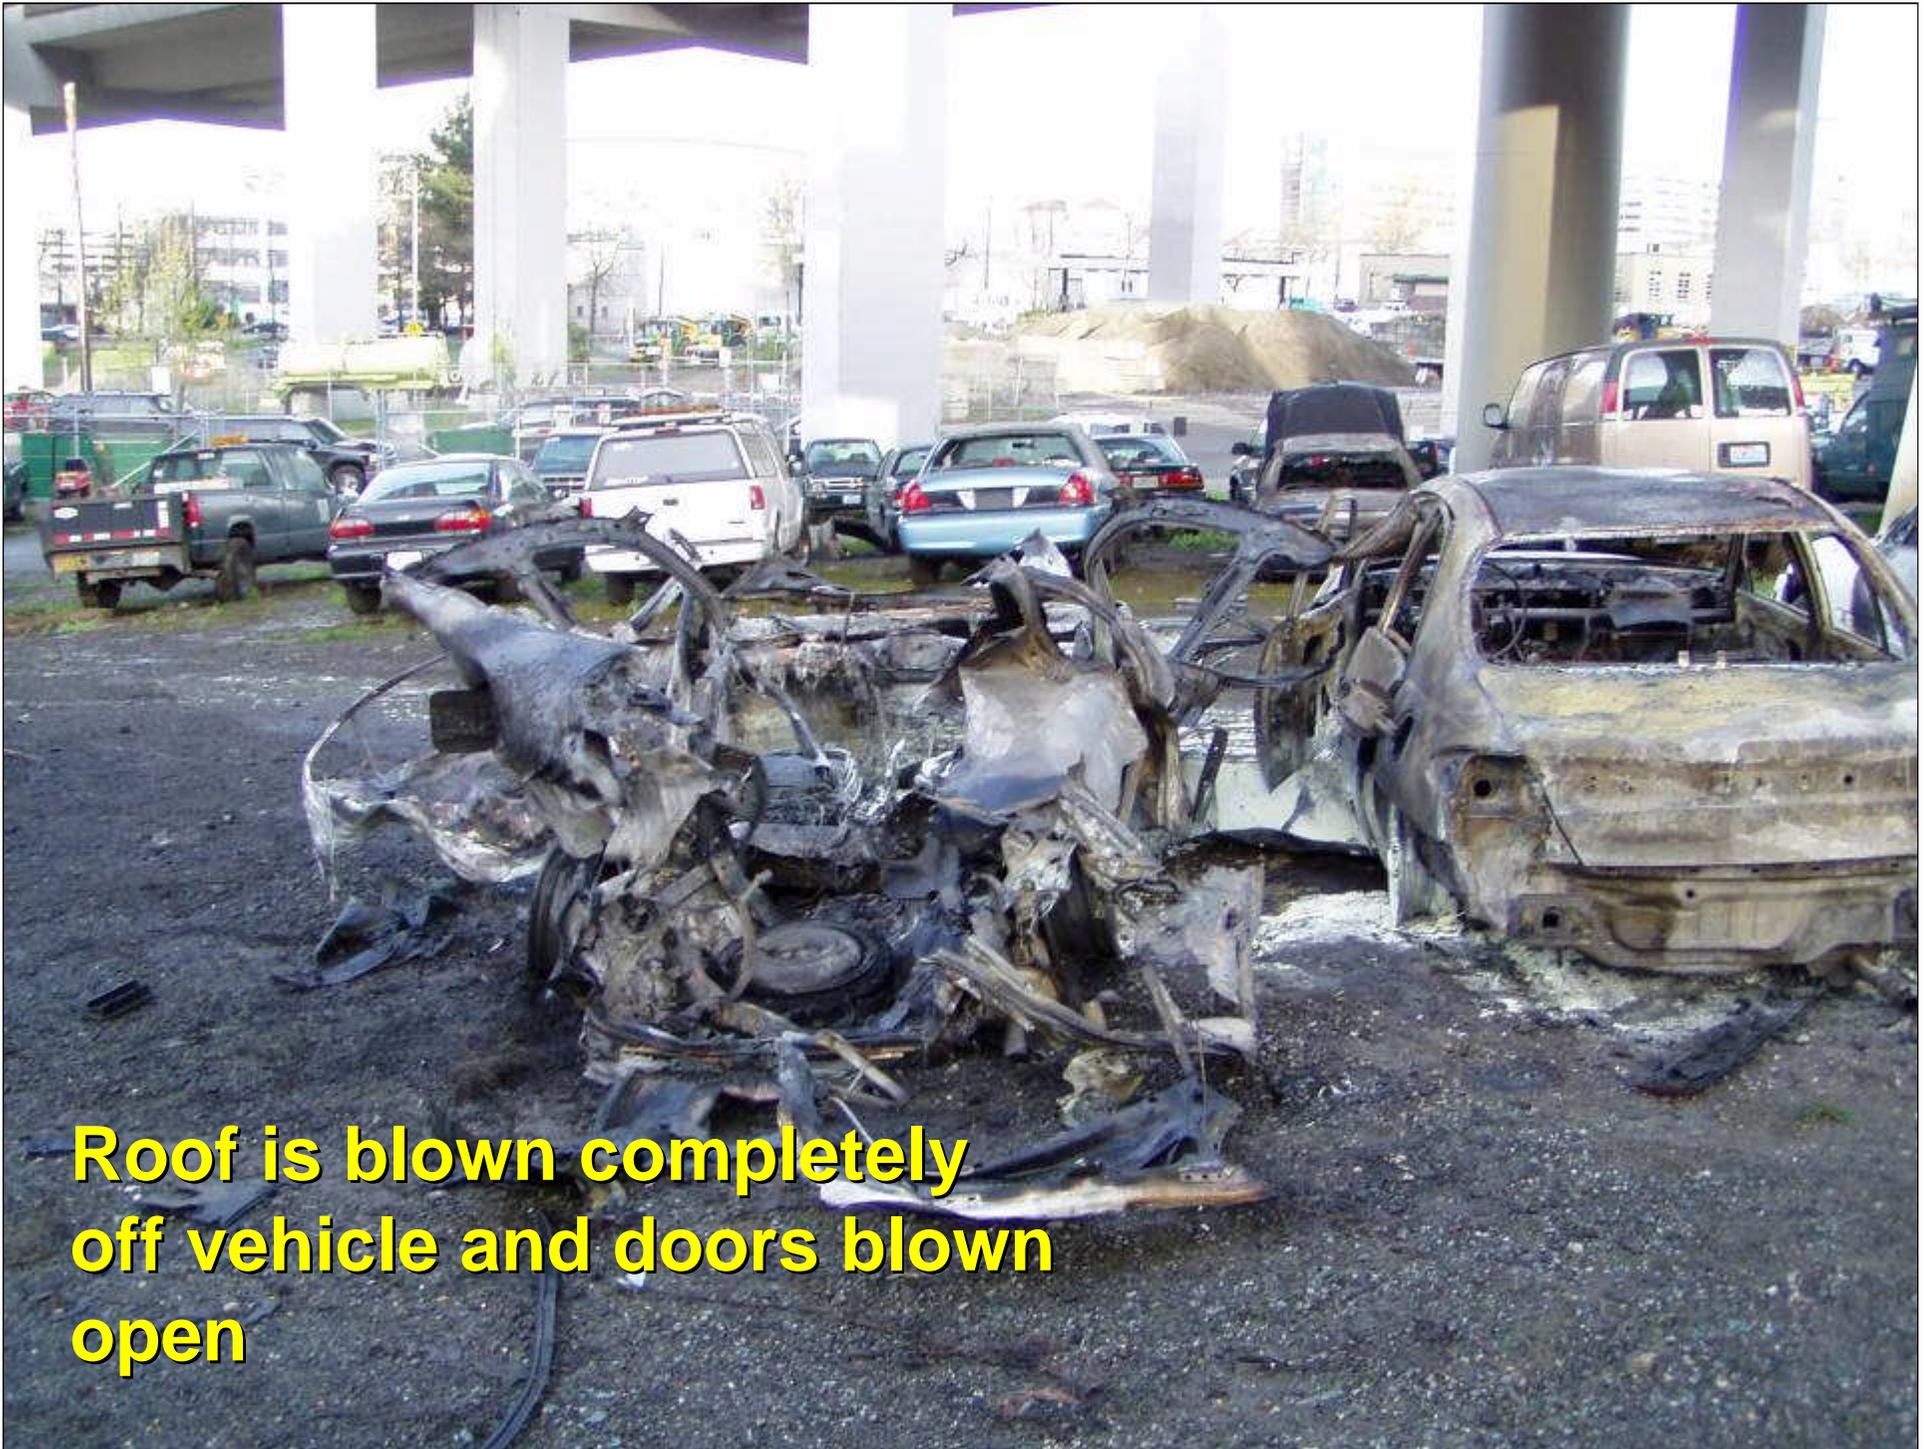
**Roof is blown completely
off vehicle and doors blown
open**

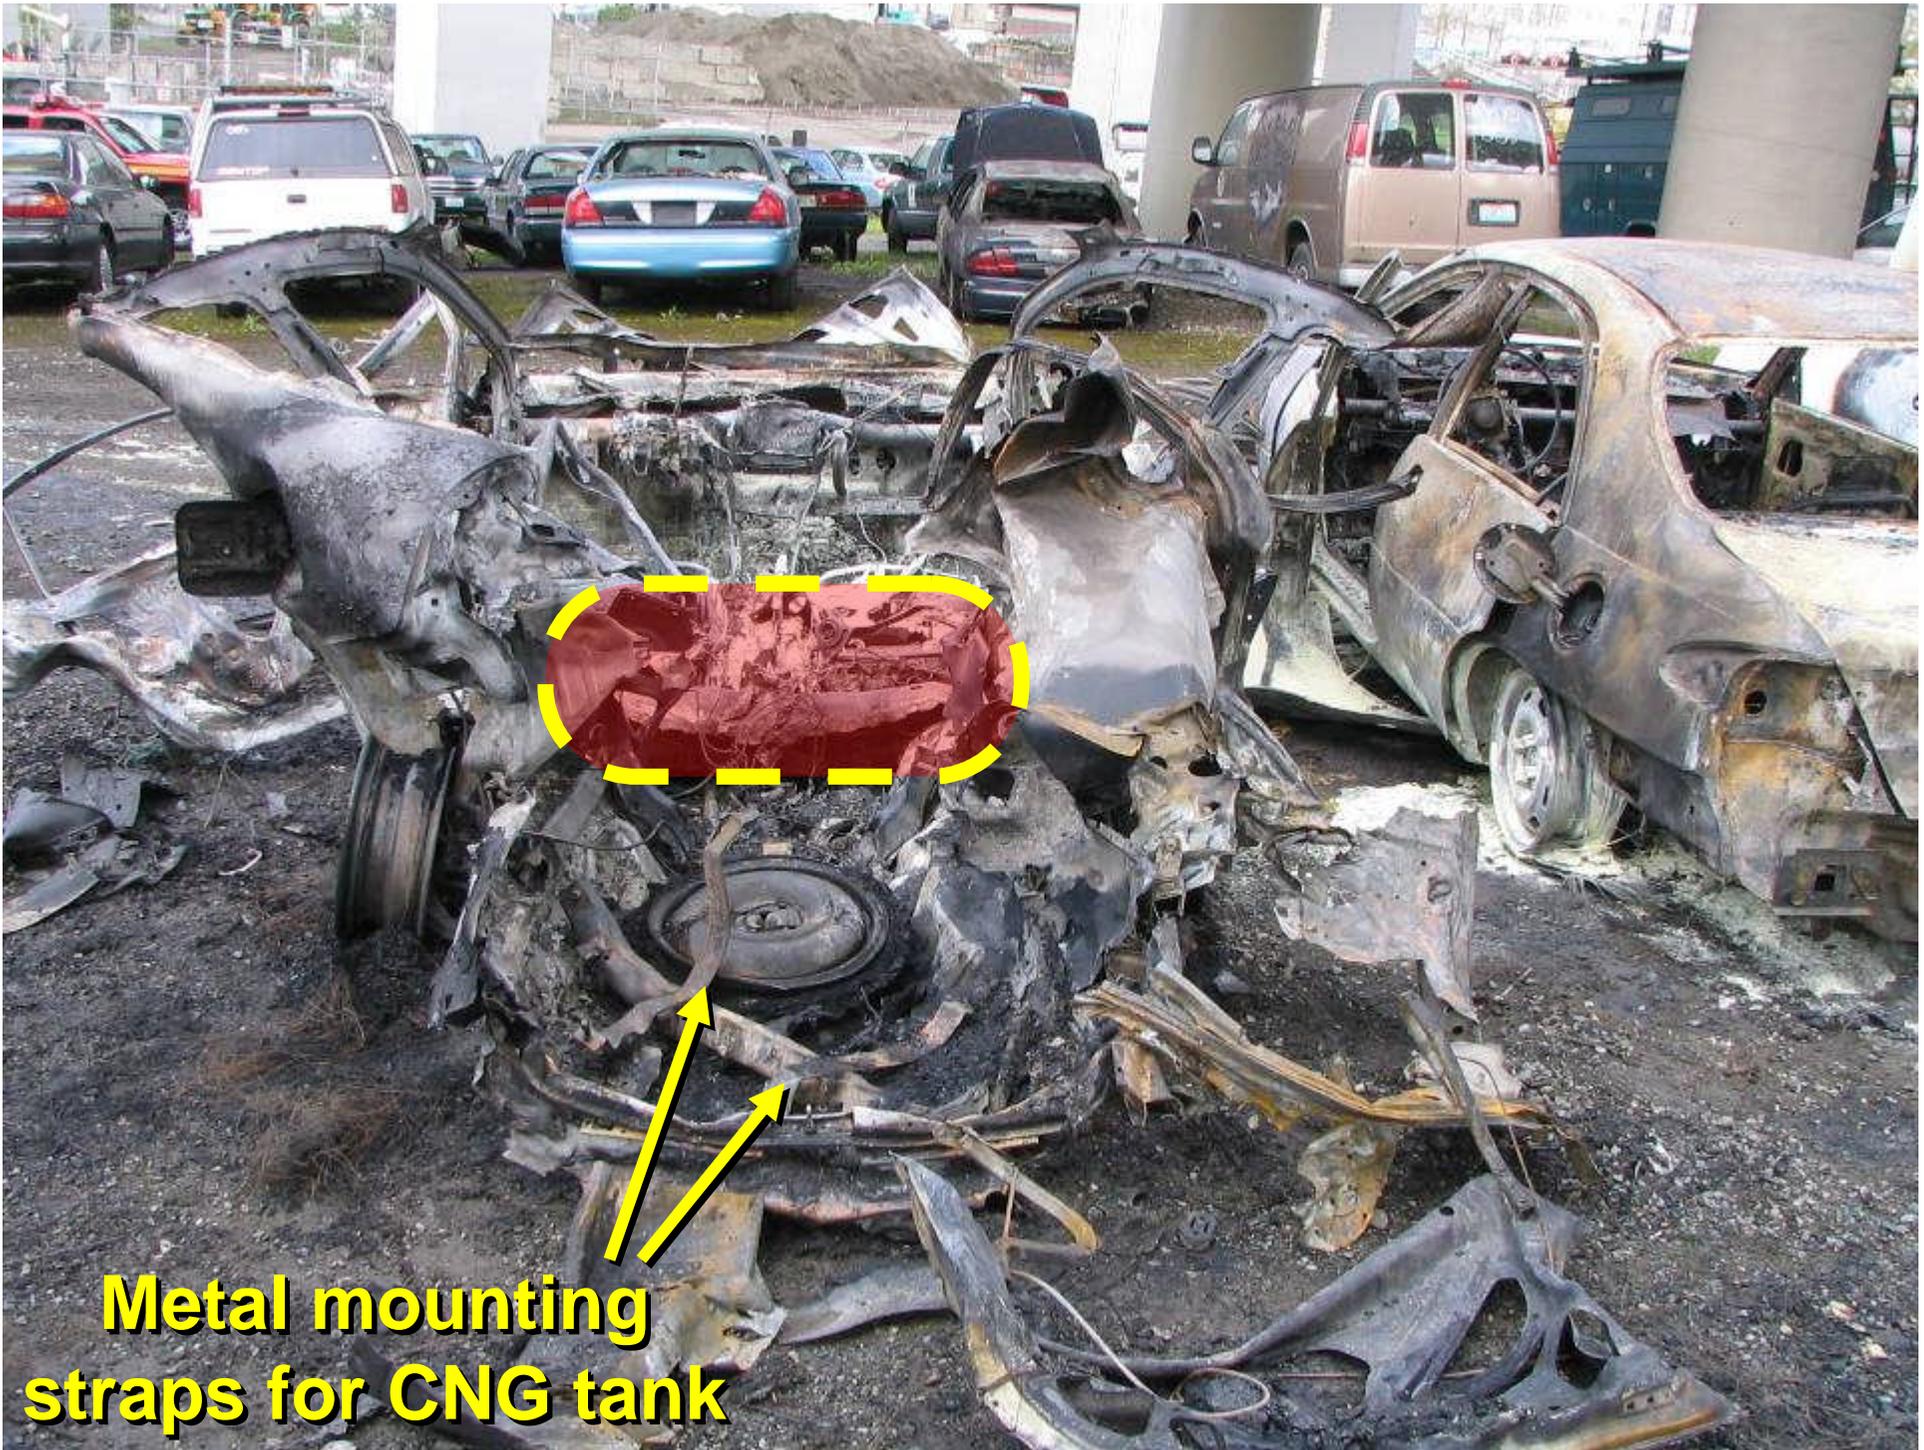
**Metal mounting
straps for CNG tank**

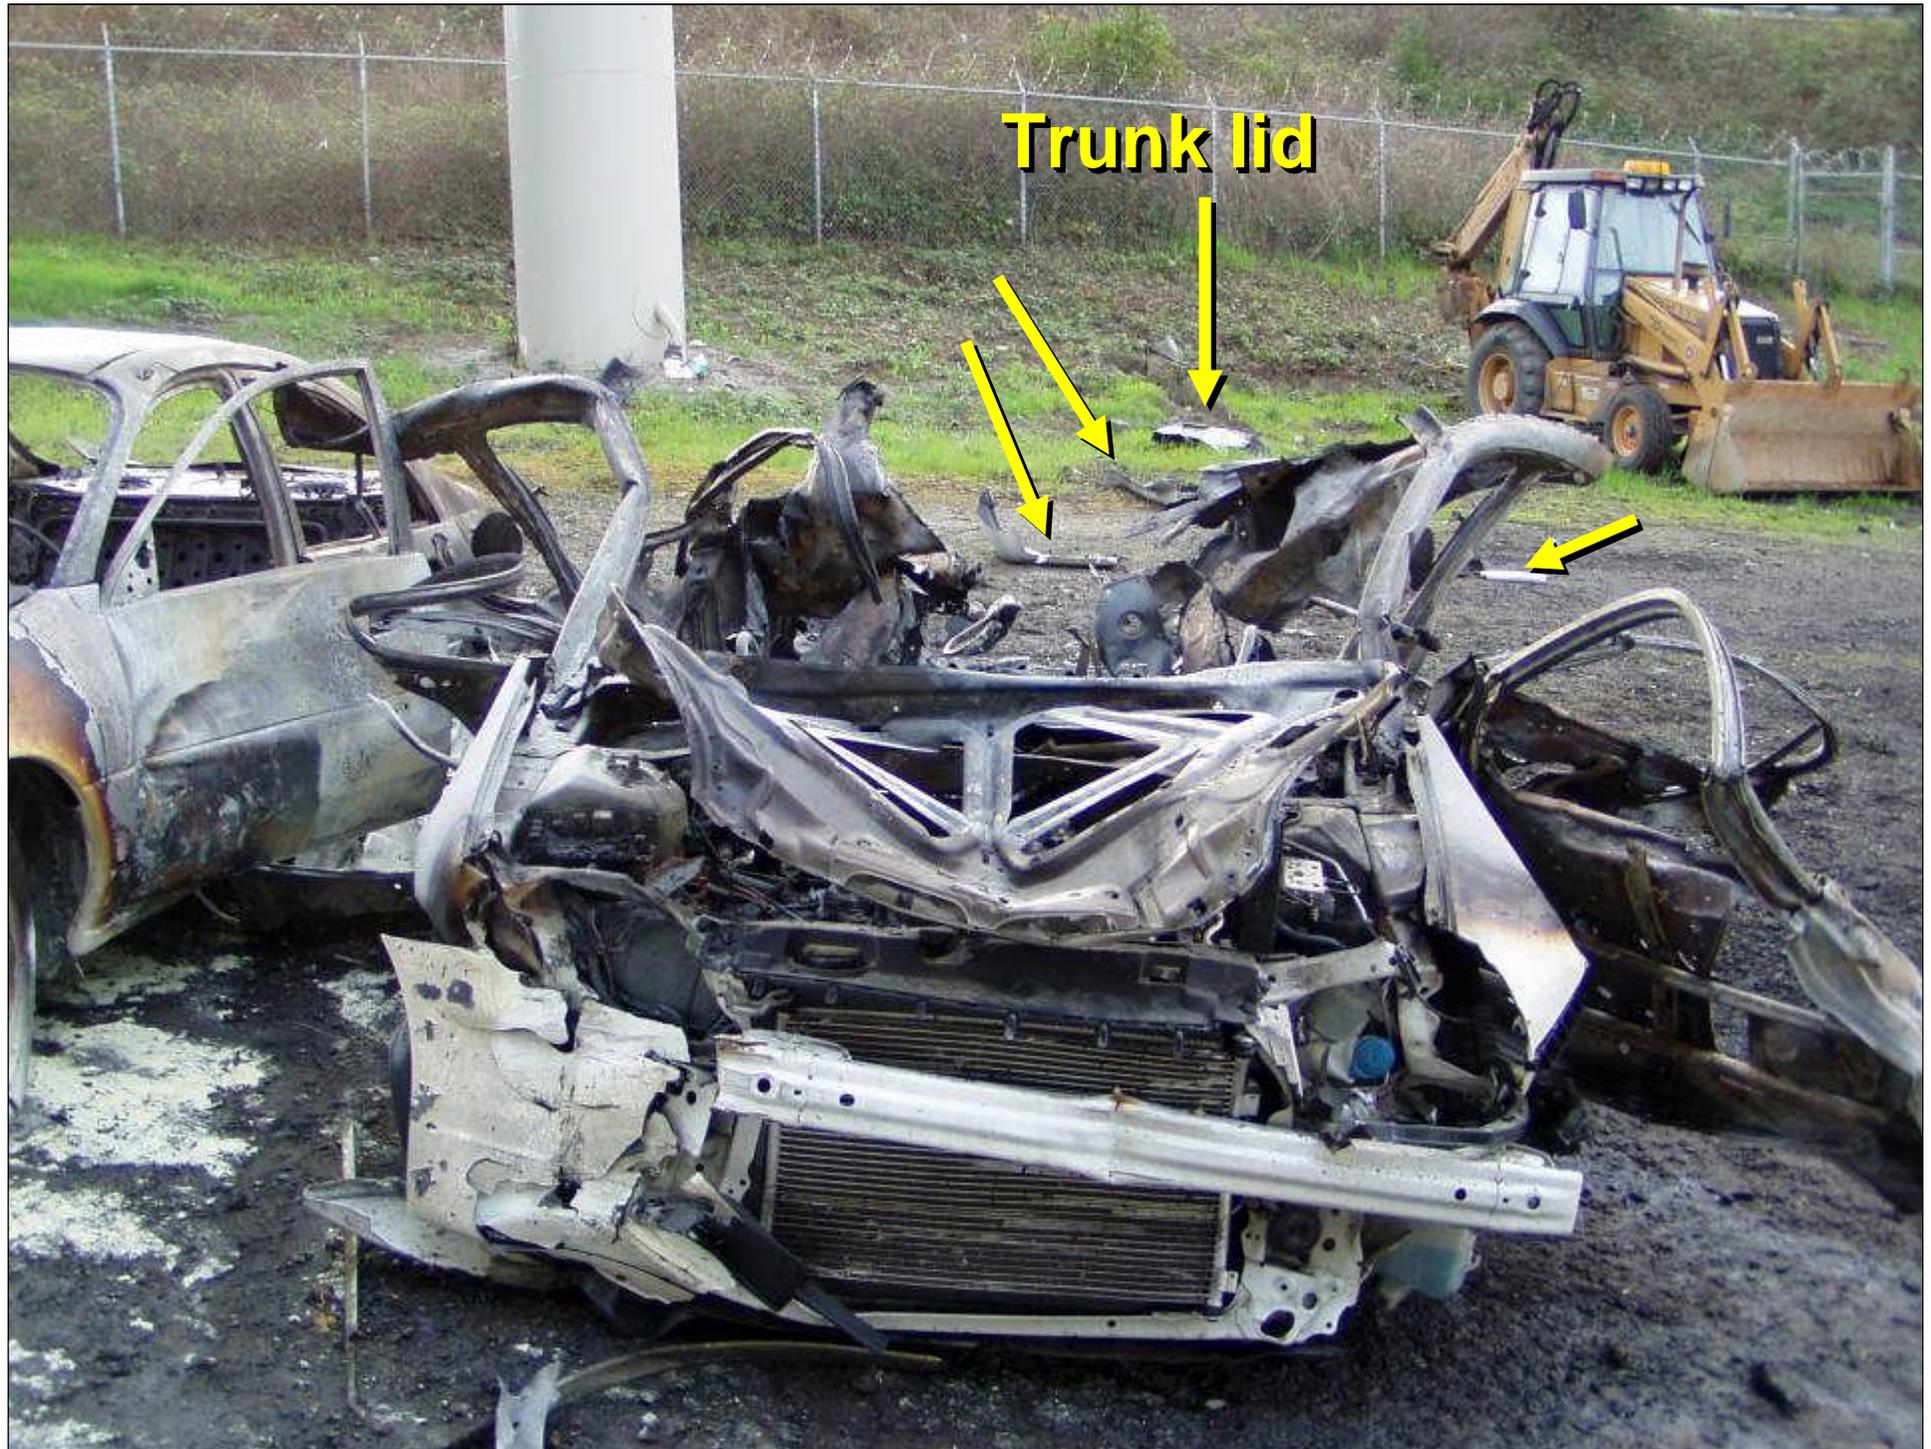
Trunk lid

Tank initially landed here, about 100' away

...then was moved down the hill for extinguishment.

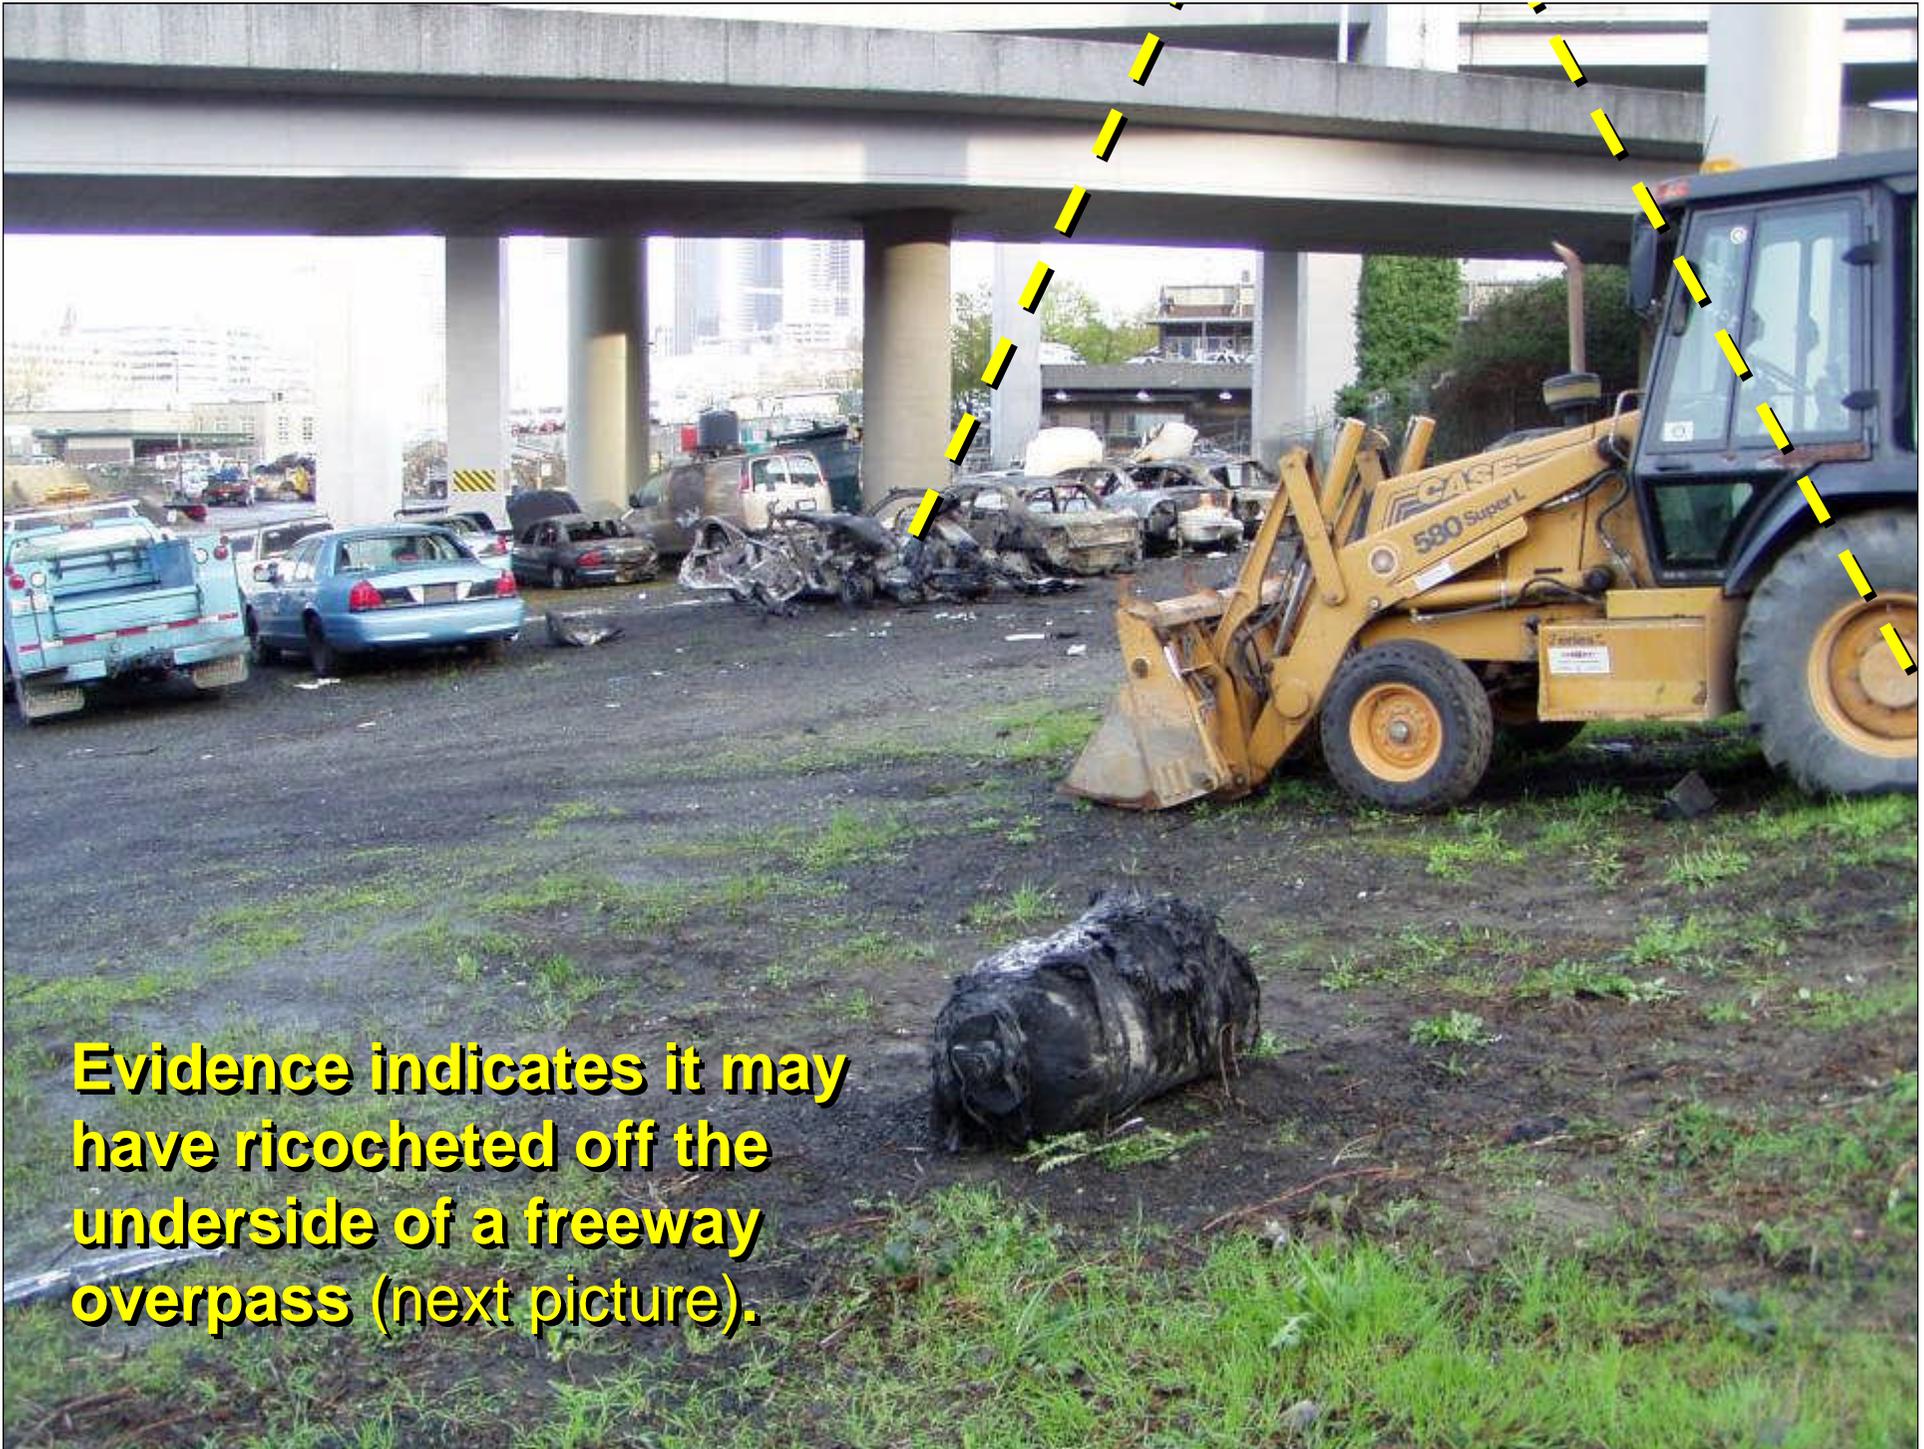
Evidence indicates it may have ricocheted off the underside of a freeway overpass (next picture).

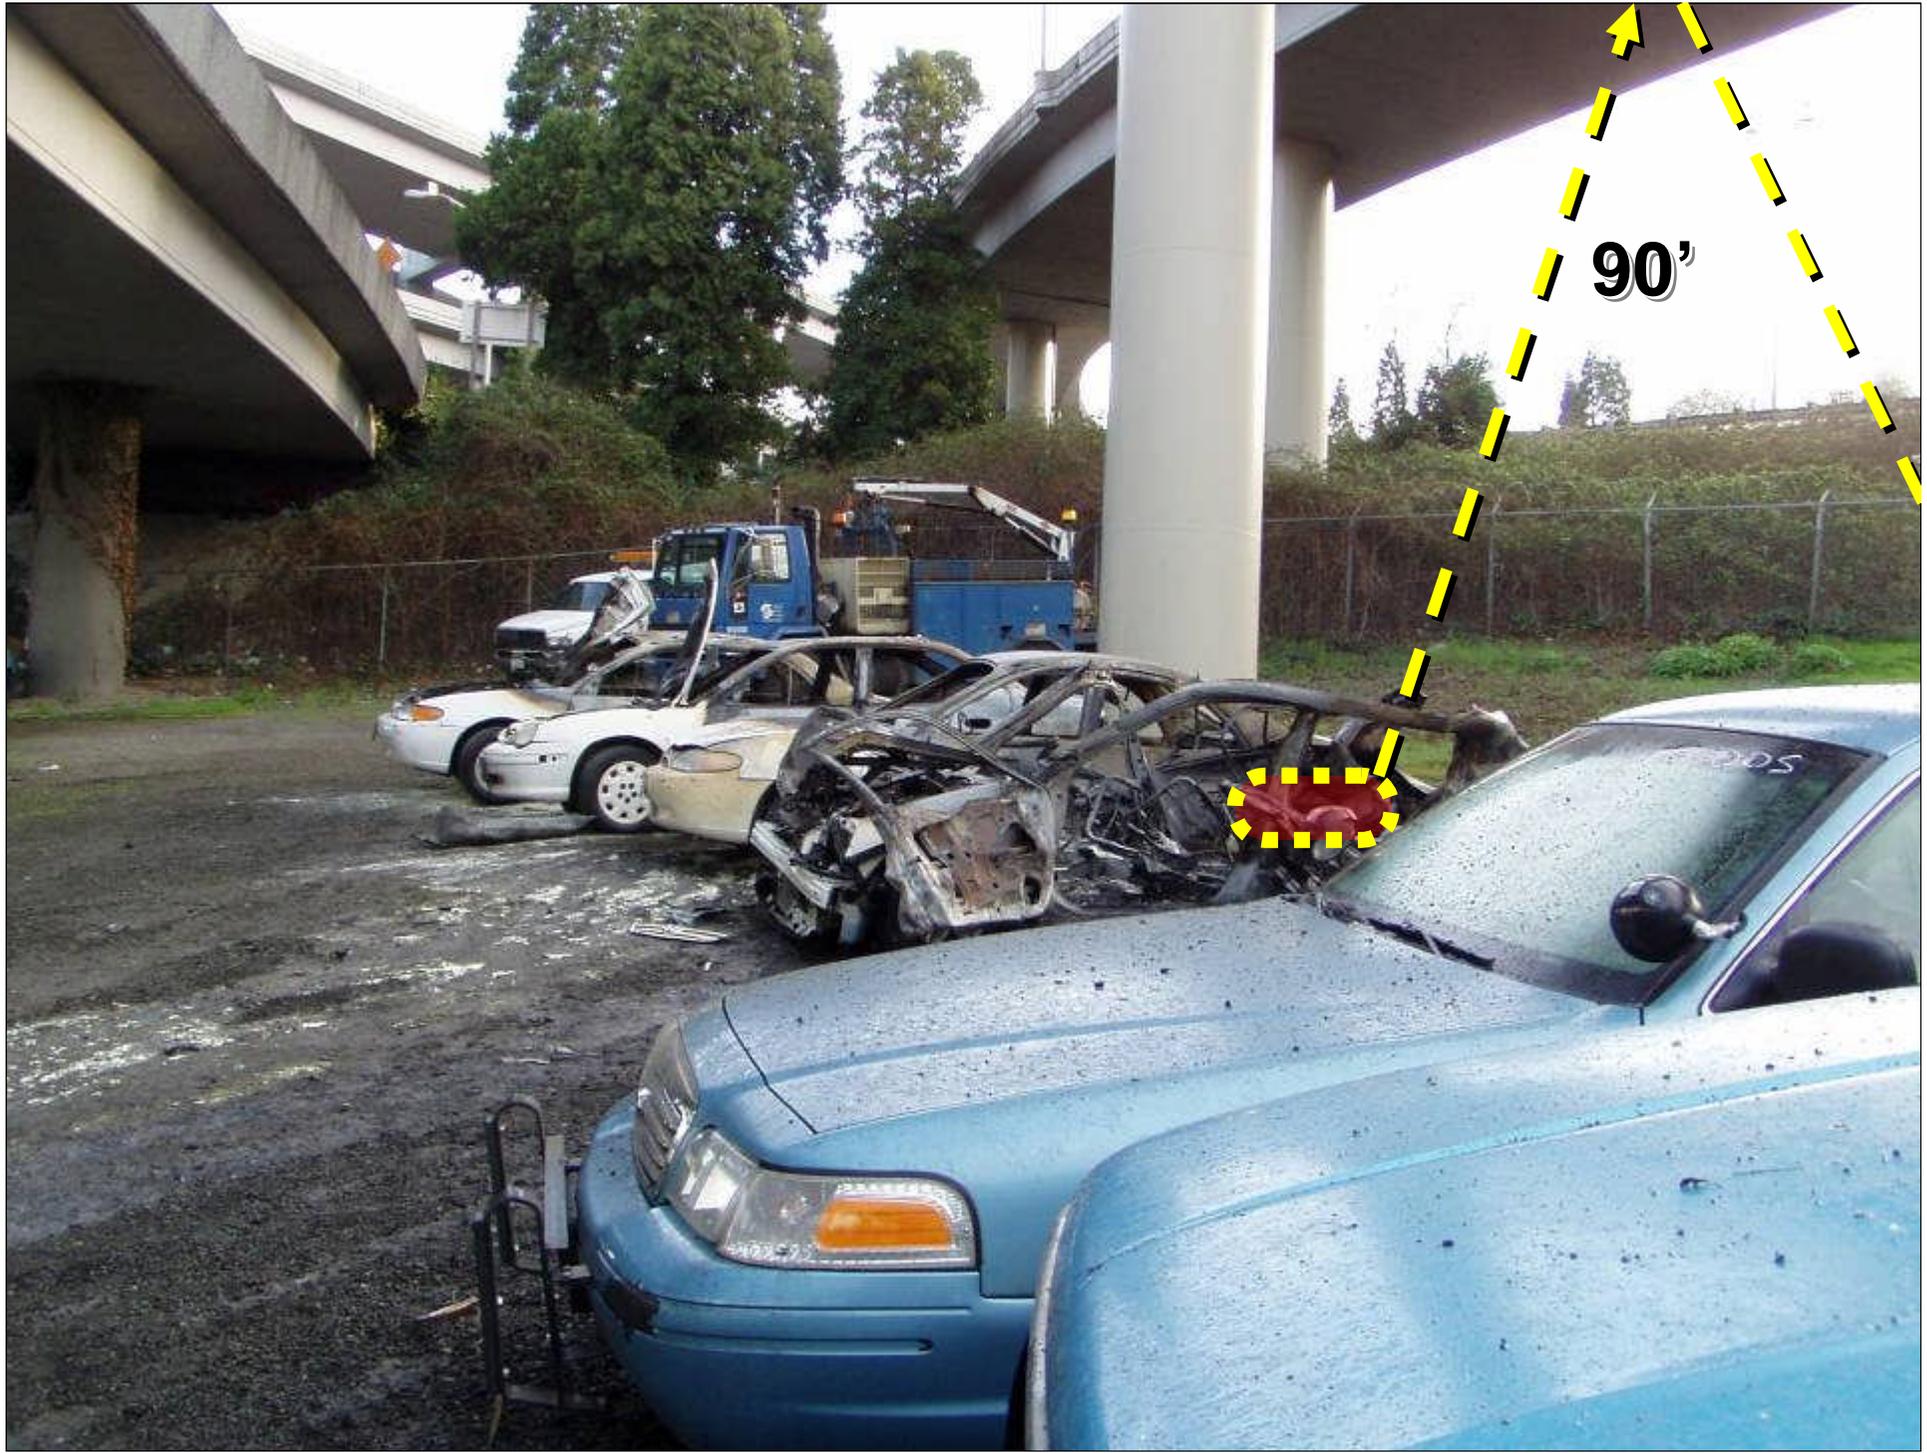
Rear bumper frame 90'+ away

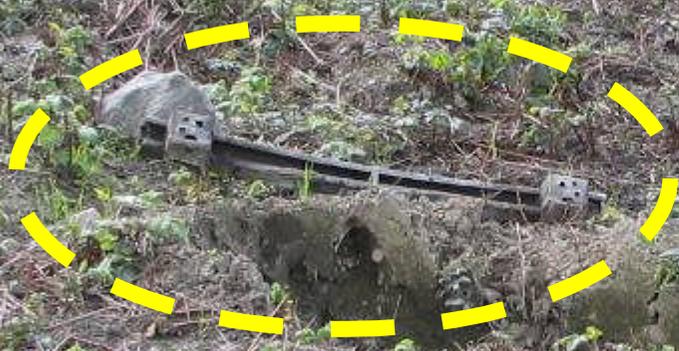
**Bumper shrapnel
(note burn marks on
ground)**
