FIREFIGHTER NEAR MISS

Auto Fire with
Compressed Natural Gas
(CNG) Fuel Tank Explosion

Prepared By Operations Division

Incident #26564, March 26, 2007

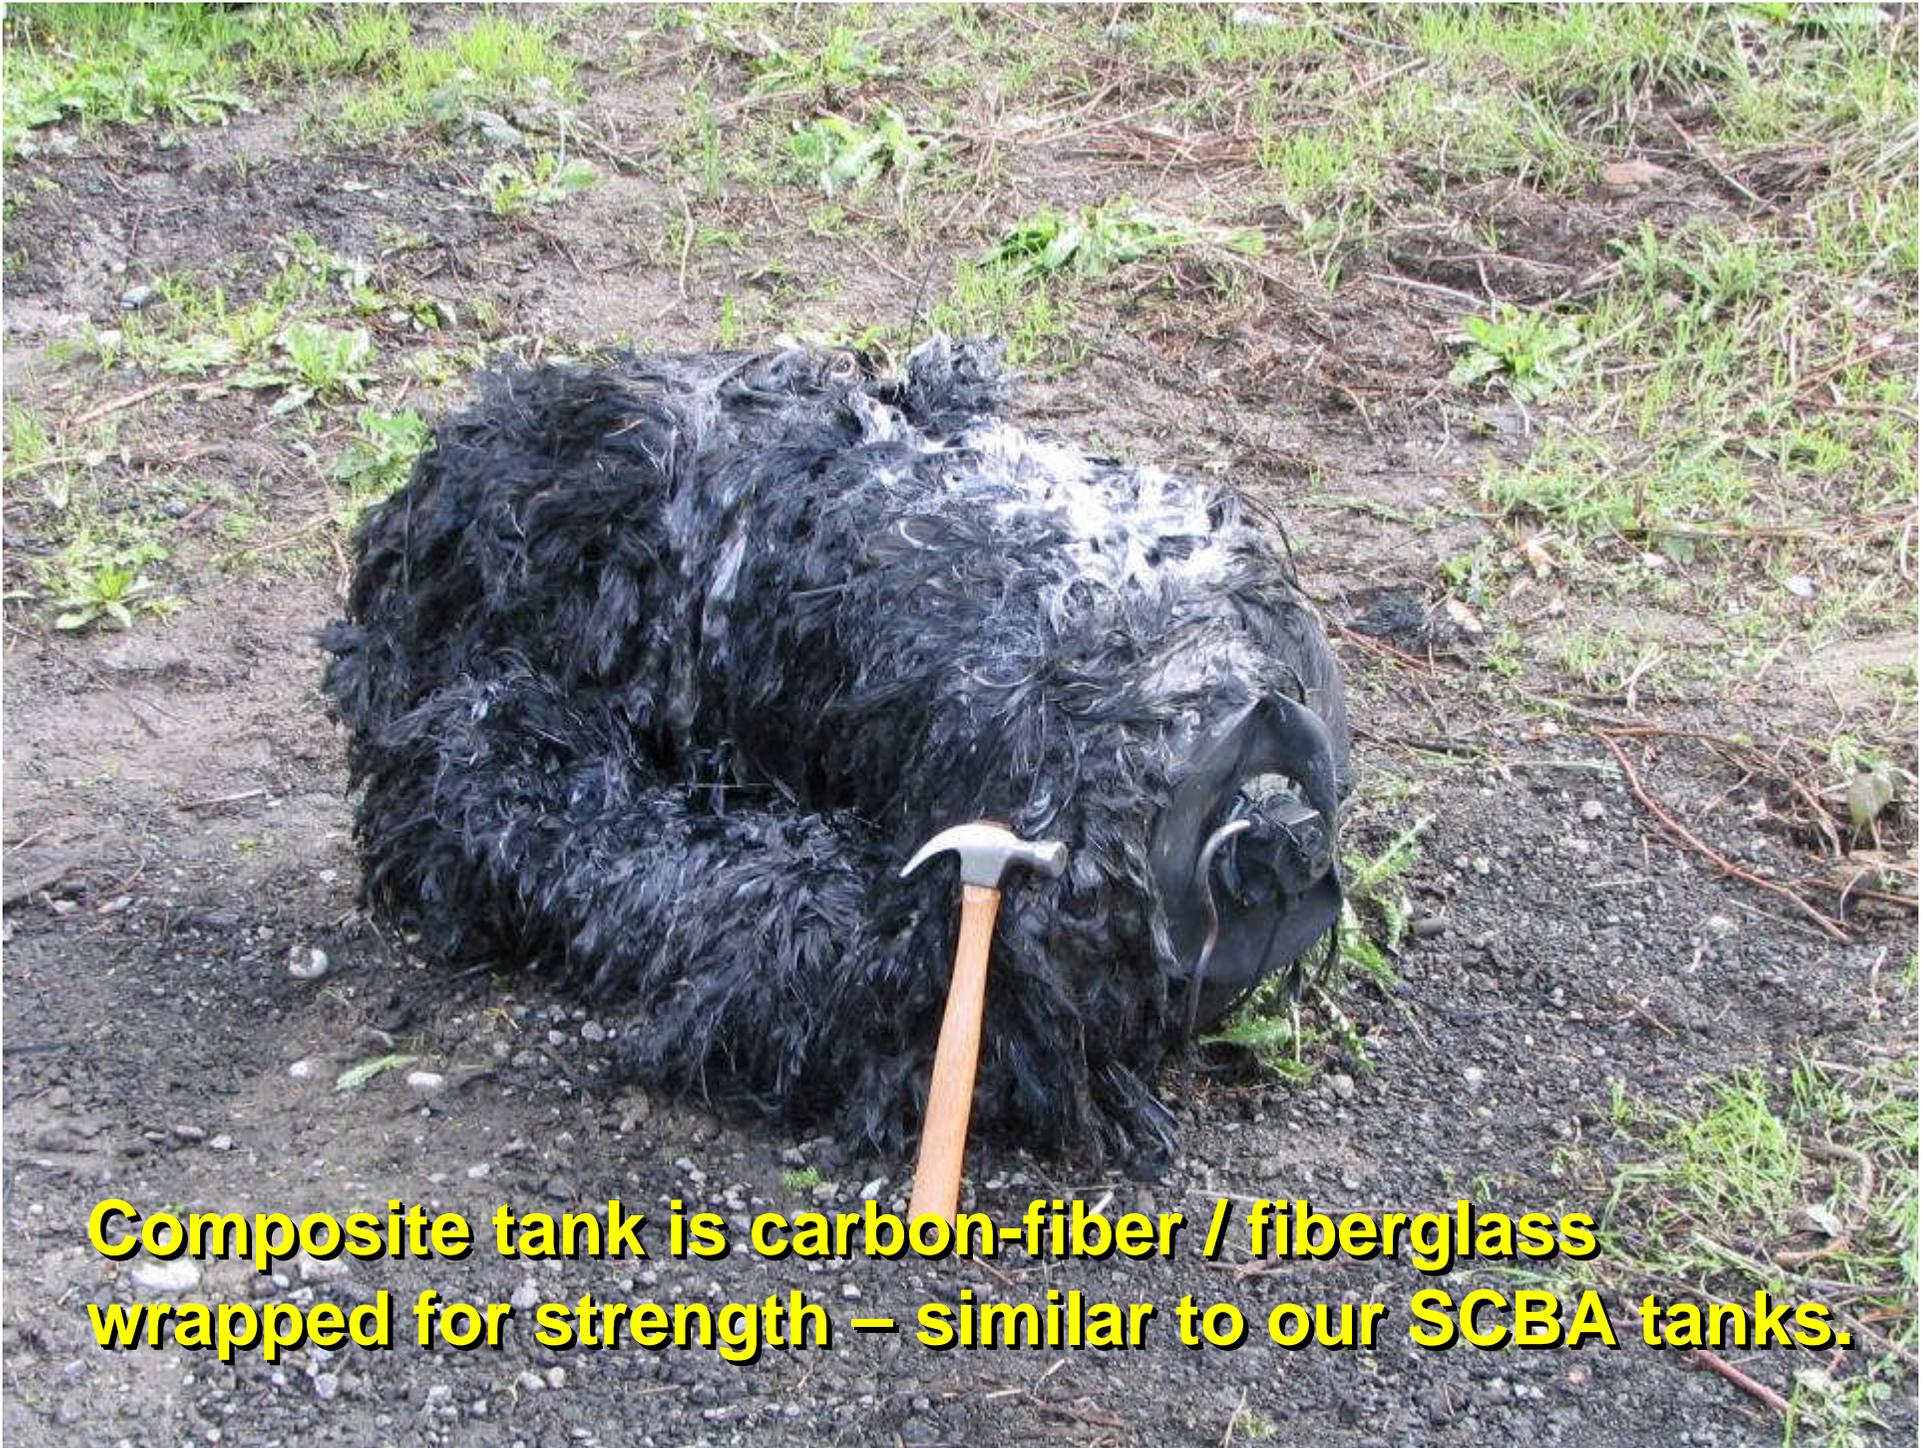
Composite tank is carbon-fiber / fiberglass wrapped for strength – similar to our SCBA tanks.

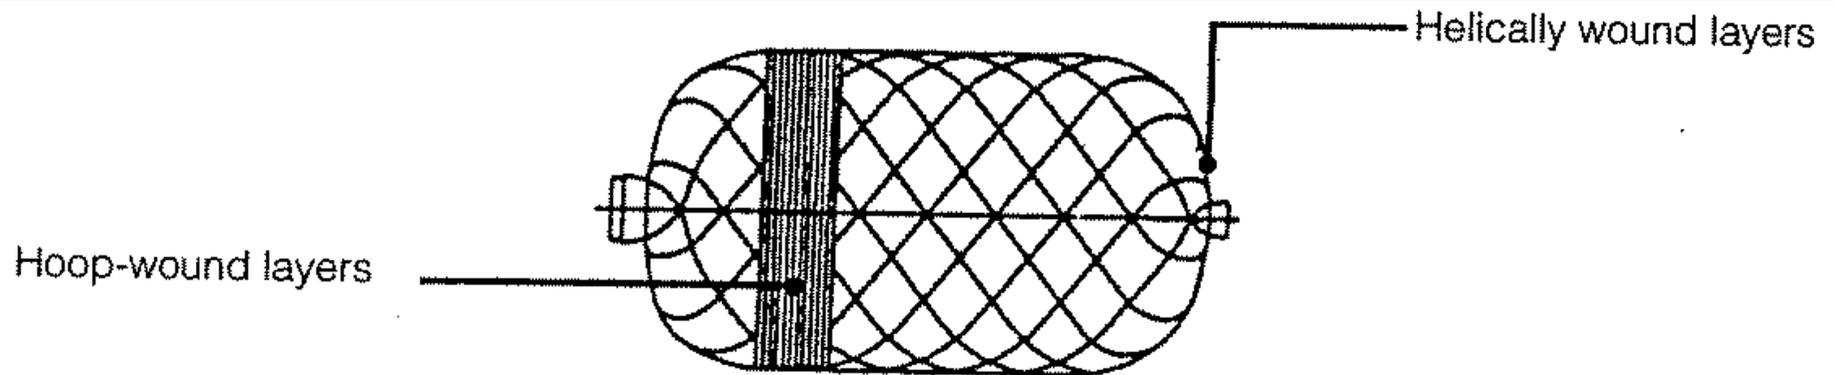
Honda Civic Tank Design

Filament Winding Pattern

Note: The pressure relief device (PRD) activates similar to a fusible link – it fails versus resealing like a spring-assisted pressure reducing valve (PRV). The gas is vented out the vent tube until the tank is empty. Discharge time depends on fuel level.

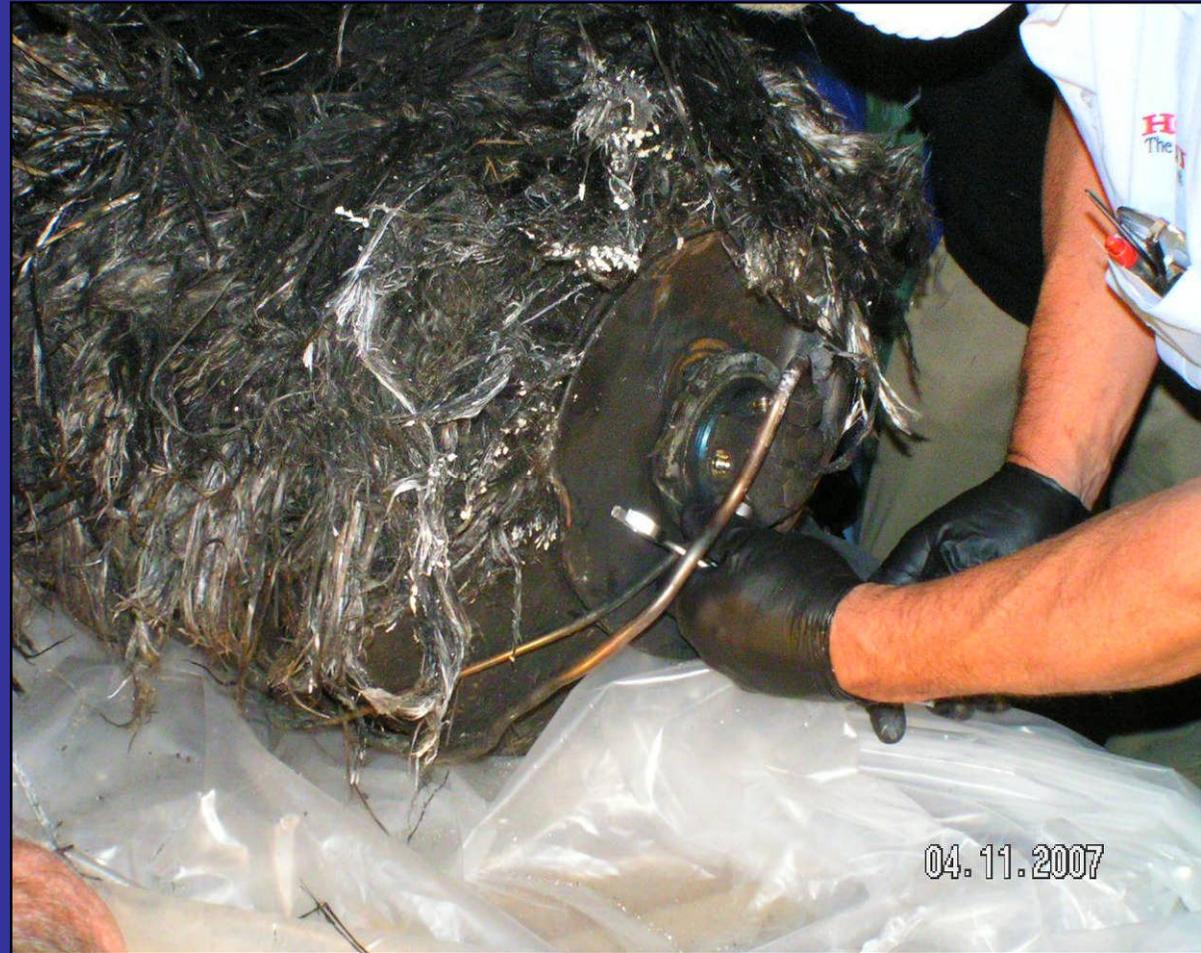
The tank was wrapped and secured at the FD Commissary for subsequent investigation by engineers from the various component manufacturers.

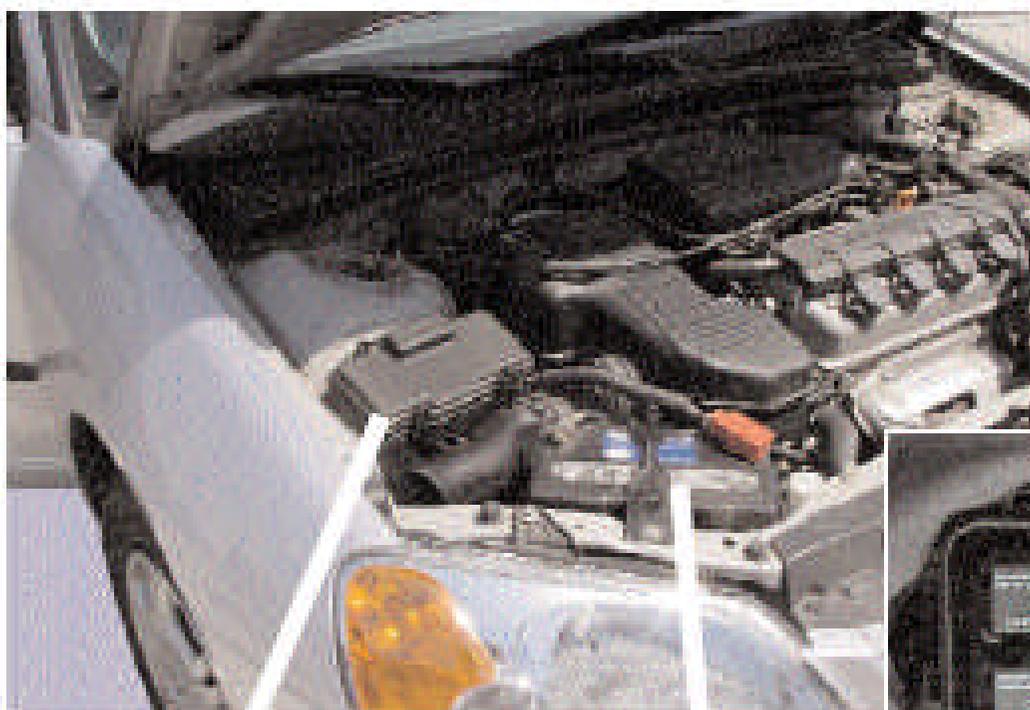
Under-Hood
Fuse Box

Battery

Remove the main fuse, and disconnect the battery negative cable.

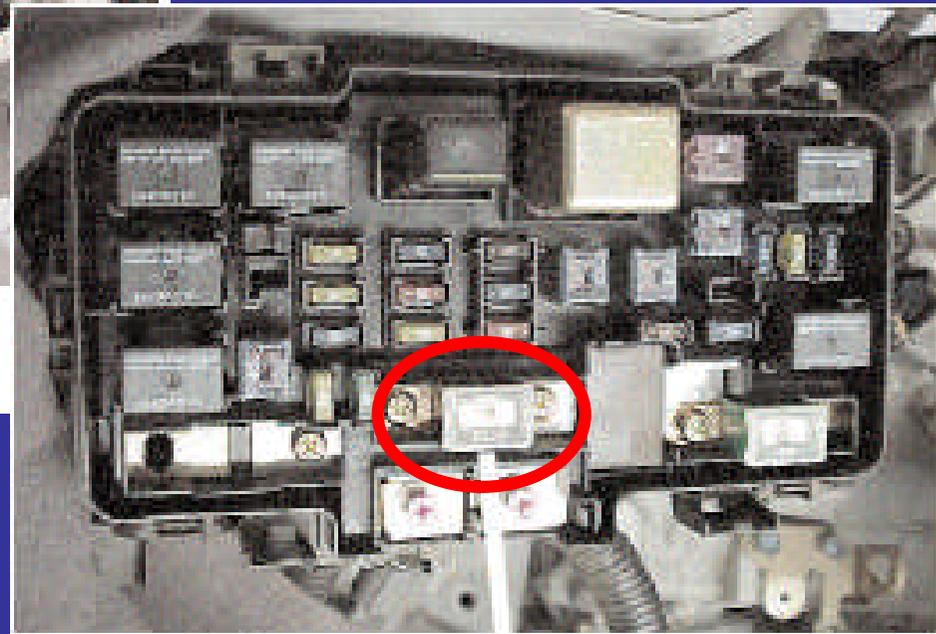
Main Fuse

Removing the main fuse shuts off the flow of CNG from the fuel tank and turns off the engine. Disconnecting the battery negative cable cuts power to the airbags and the seat belt tensioners within 3 minutes. It also prevents the engine from being restarted.

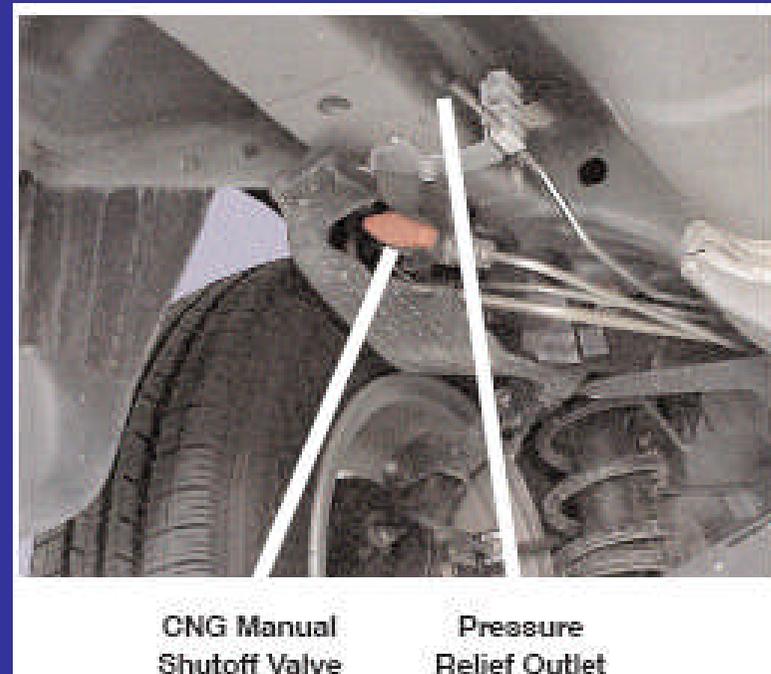
CNG Manual Shutoff Valve

The Civic GX has a CNG manual shutoff valve to stop the flow of CNG from the fuel tank. The red handle of the valve is on the bottom of the car, near the left rear tire and the splash guard.

Turn off the CNG manual shutoff valve.

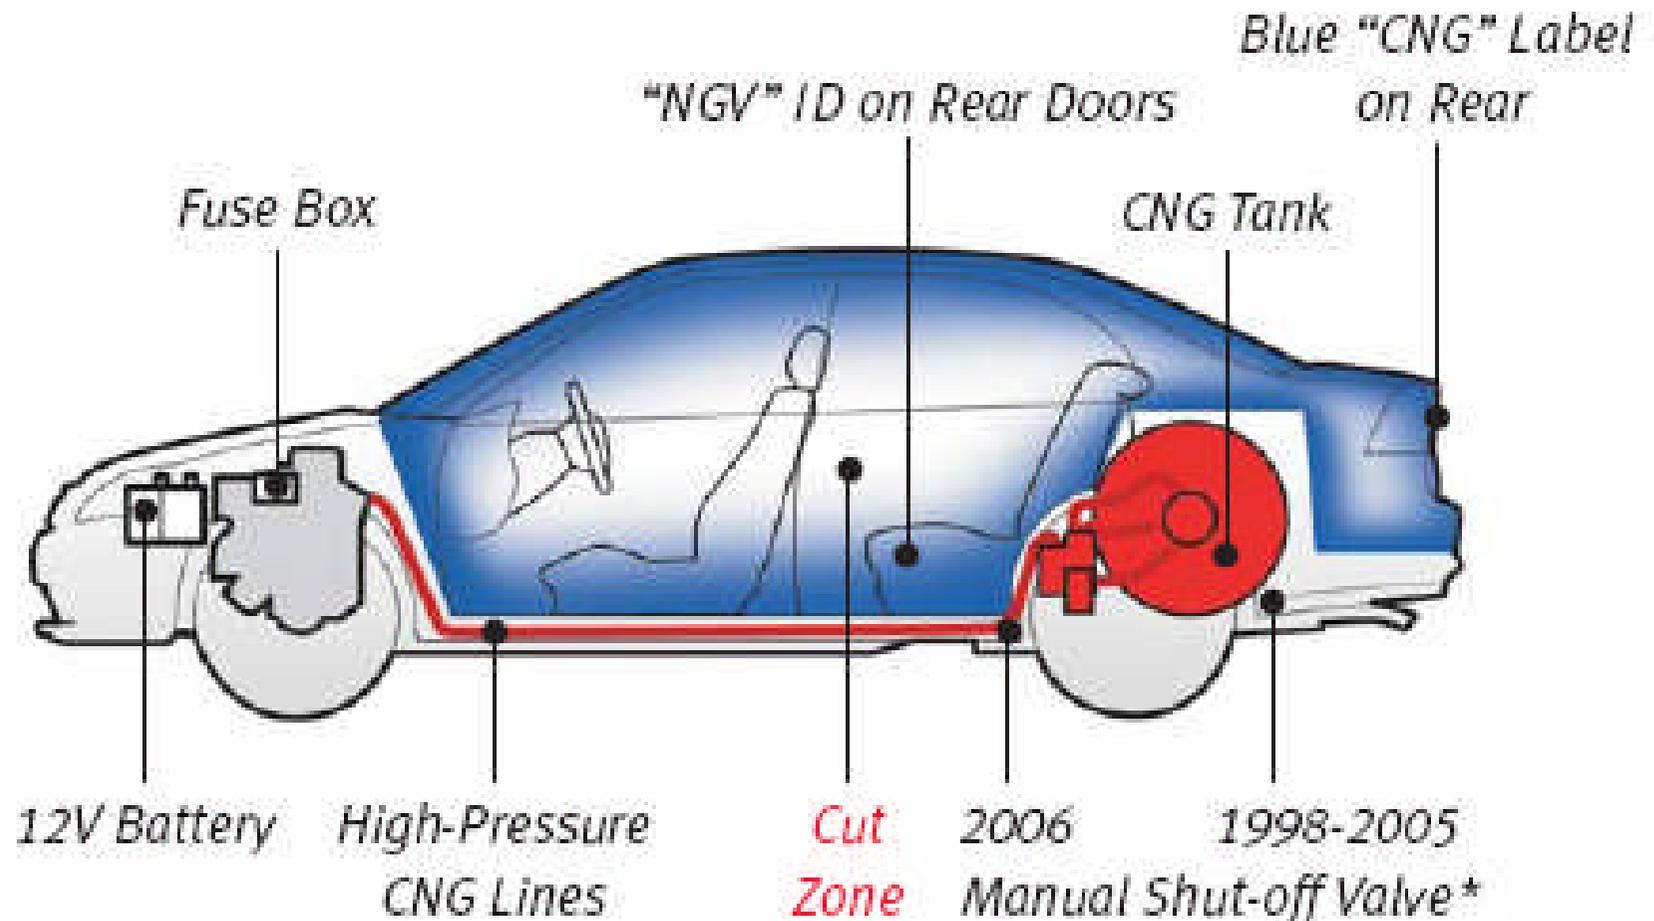
Civic GX (1998-2006)

*On driver's side. Turn one-quarter turn clockwise to shut off CNG.

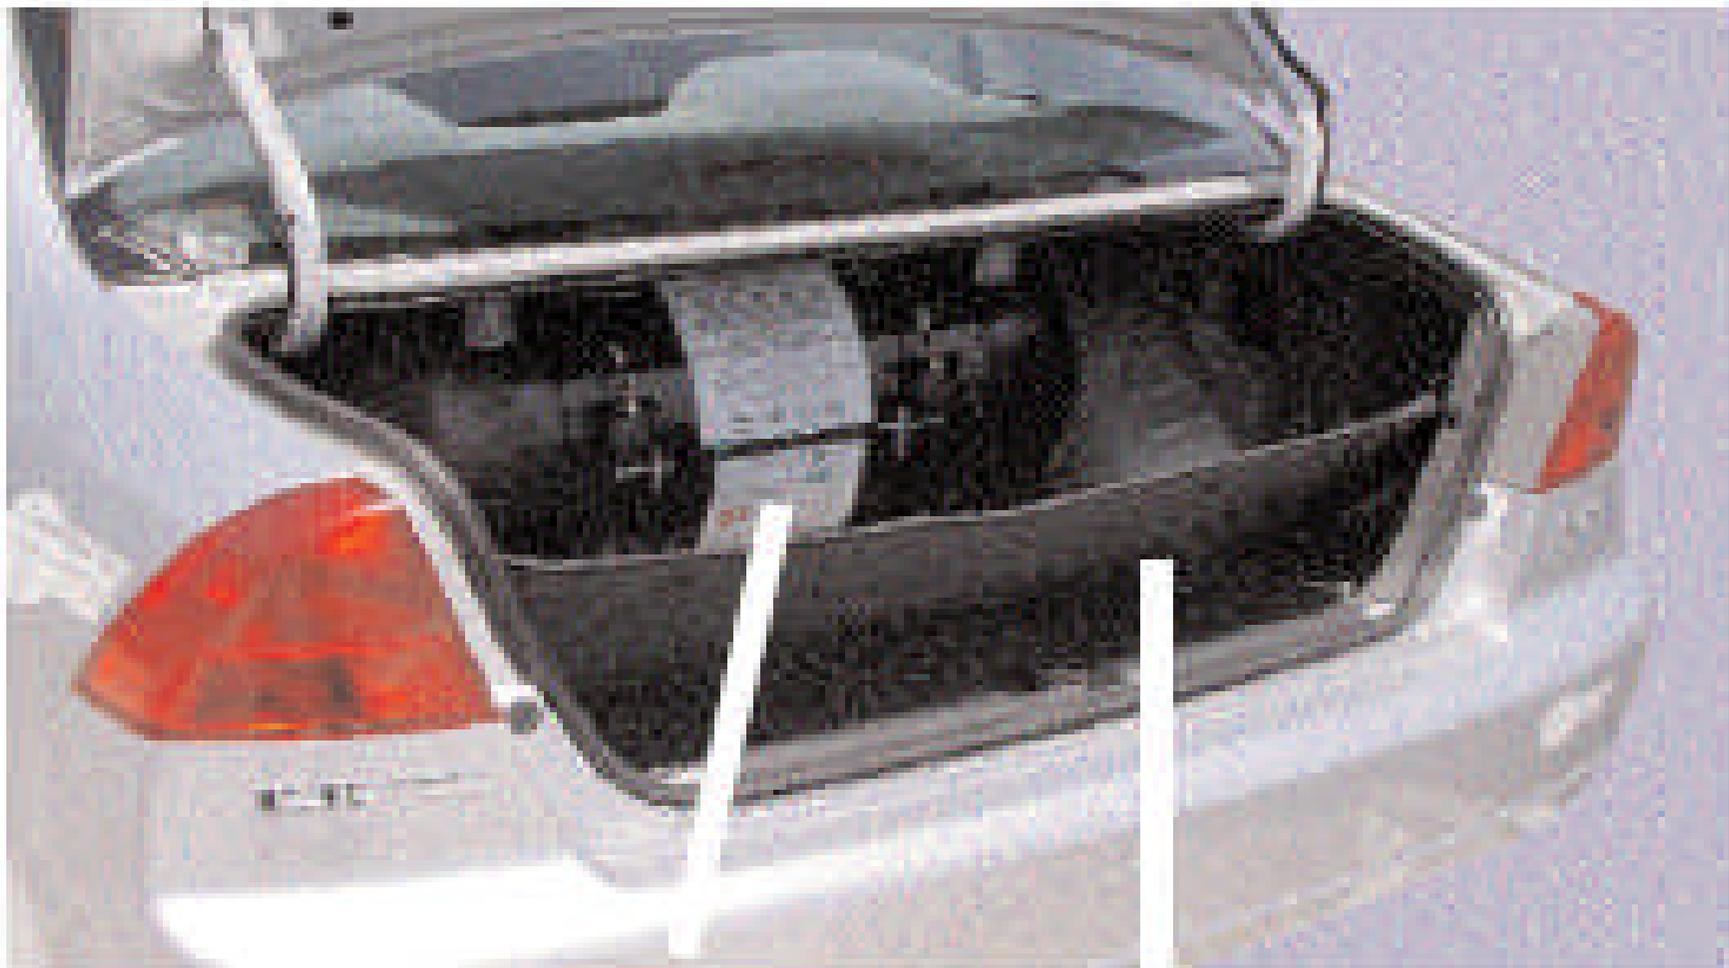
Fuel Tank

Removable
Divider
