Crash Reports

Prepared by Ken Digges

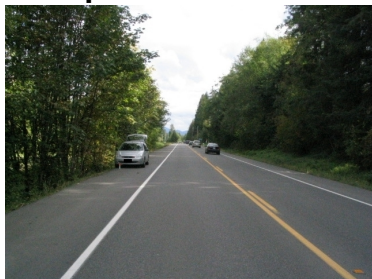
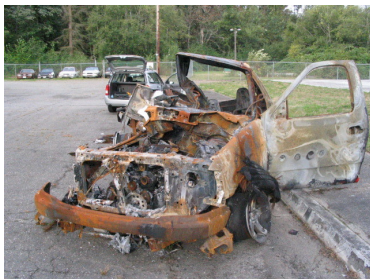
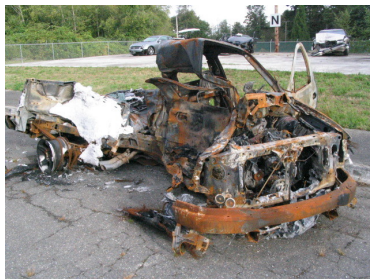
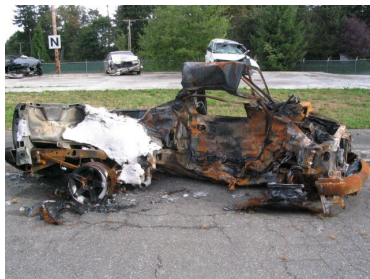
Occupant: 2005-81-63-1-1

Fire Information

| Fire Occurrence | Major fire |
| Location of Fuel Leakage | Unknown |
| Fuel Tank Damage | Unknown |

| Damage (C1-C6) | 27 78 93 139 155 86 |

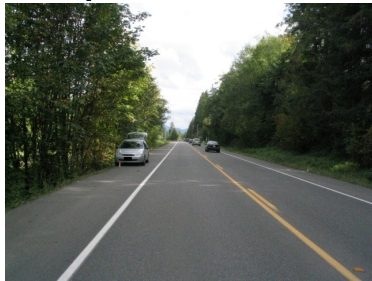
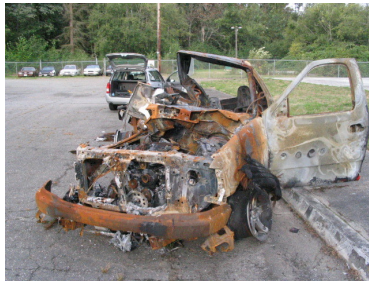
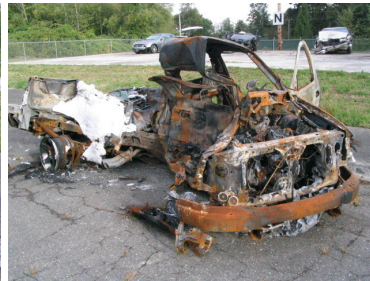
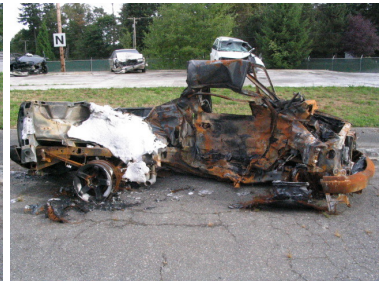
Occupant: 2005-81-63-1-2

Fire Information

| Fire Occurrence | Major fire |
| Location of Fuel Leakage | Unknown |
| Fuel Tank Damage | Unknown |

| Damage (C1-C6) | 27 78 93 139 155 86 |

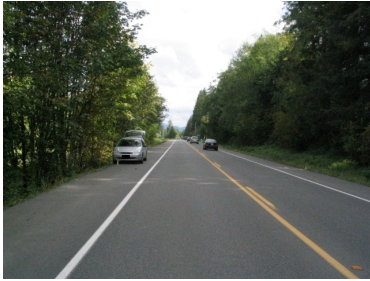
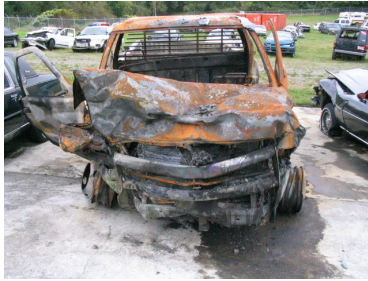
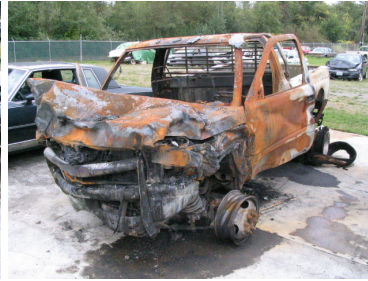
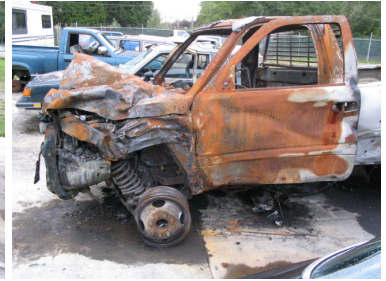
Occupant: 2005-81-63-2-1

Fire Information

| Fire Occurrence | Major fire |
| Location of Fuel Leakage | Unknown |
| Fuel Tank Damage | Unknown |

| Damage (C1-C6) | 57 34 29 38 56 76 |

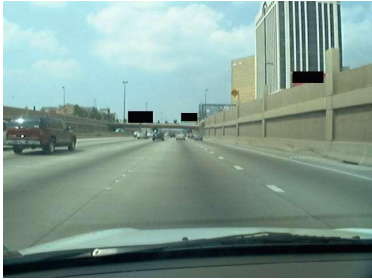
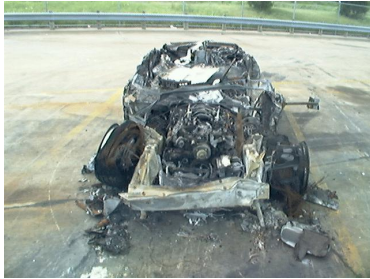
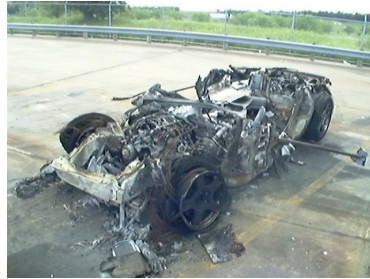
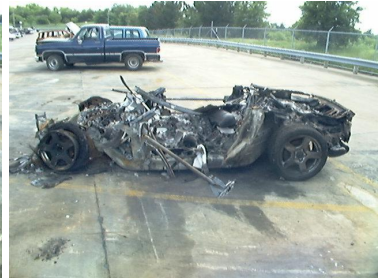
Occupant: 2002-49-61-1-1

Fire Information

| Fire Occurrence | Major fire |
| Location of Fuel Leakage | Unknown |
| Fuel Tank Damage | Unknown |

| Damage (C1-C6) | 0 0 0 0 0 0 |

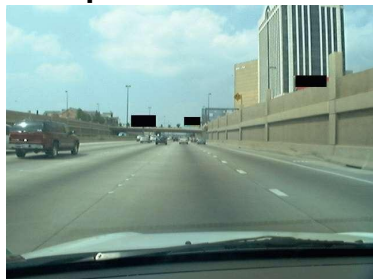
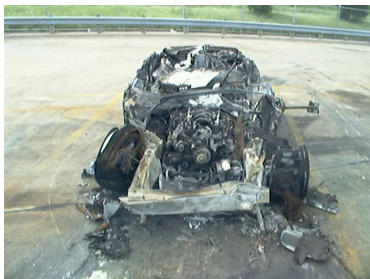
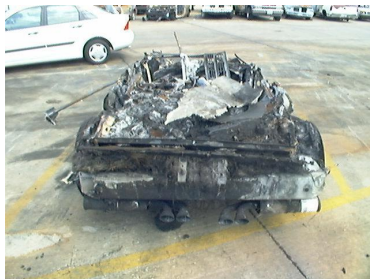
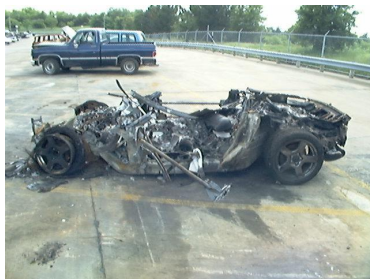
Occupant: 2002-49-61-1-2

Fire Information

| Fire Occurrence | Major fire |
| Location of Fuel Leakage | Unknown |
| Fuel Tank Damage | Unknown |

| Damage (C1-C6) | 0 0 0 0 0 0 |

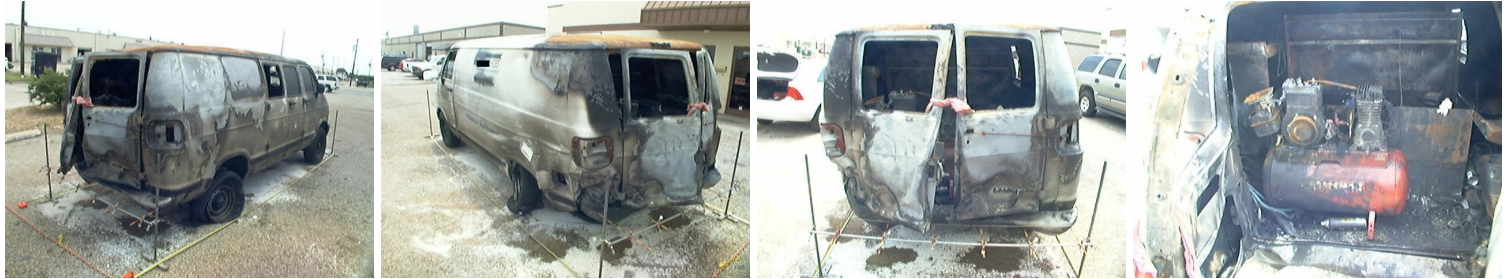
Occupant: 2002-49-61-2-1

Fire Information

| Fire Occurrence | Major fire |
| Location of Fuel Leakage | Unknown |
| Fuel Tank Damage | Unknown |

| Damage (C1-C6) | 0 0 0 0 0 0 |
