## COMPARATIVE ABUSE TESTING OF 36V AND 12V BATTERY DESIGNS IN GENERAL ACCORDANCE WITH SAE J2464

**FINAL REPORT**  
Consisting of 45 Pages  
SwRI® Project No. 01.06939.01.002  
May 2005

**Motor Vehicle Fire Research Institute**  
1334 Pendleton Court  
Charlottesville, VA 22901

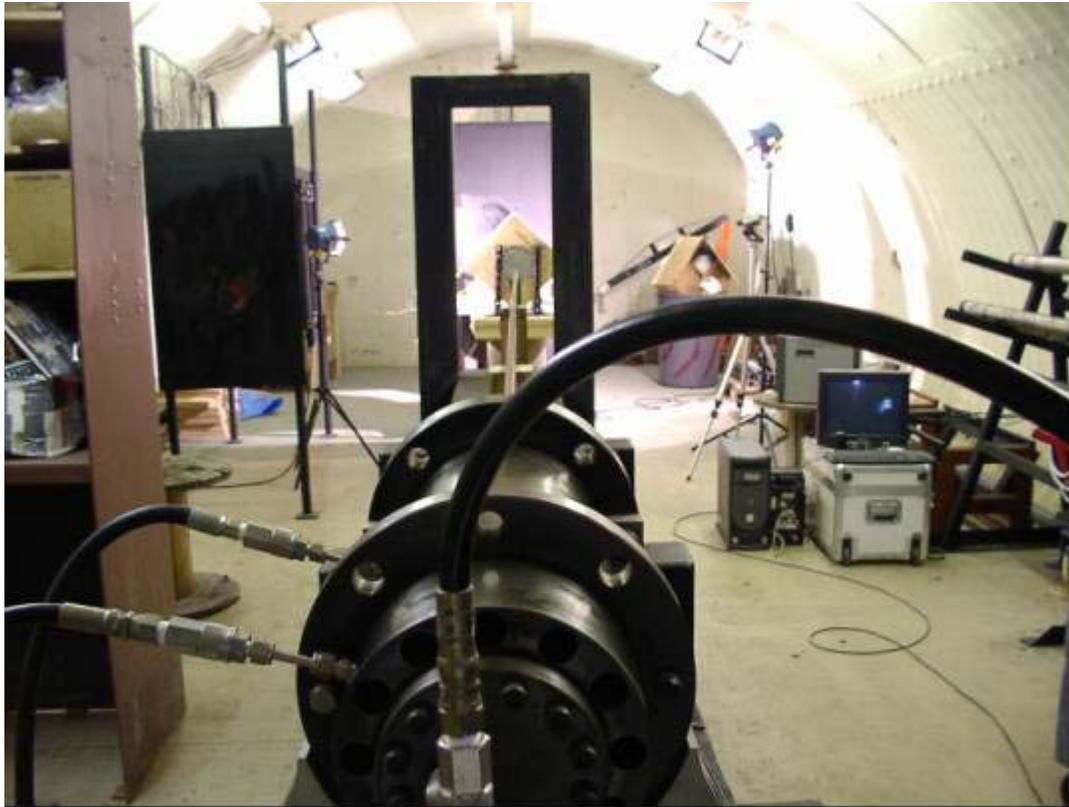
**Figure B-1. Penetration Test Setup.**

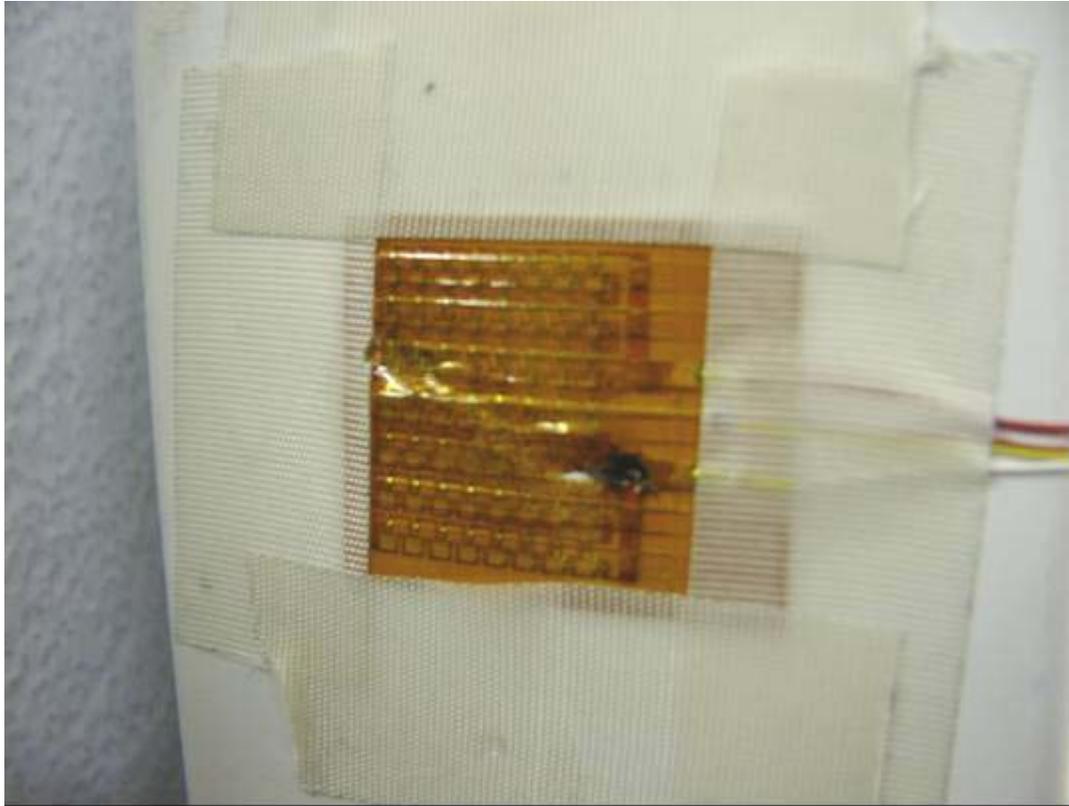
**Figure B-3. Penetration Hole in 12V Battery (Through Heat Flux Sensor).**

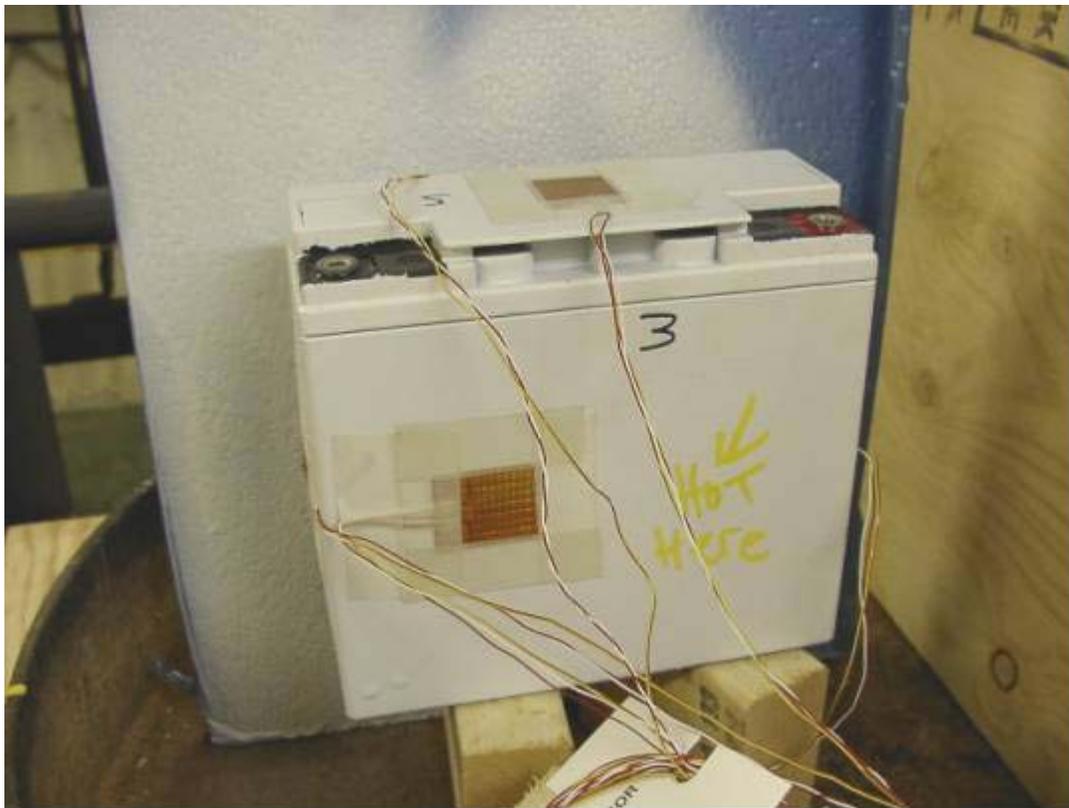
**Figure B-4. Hot Spot Indicated on 12 V Battery Following Test.**

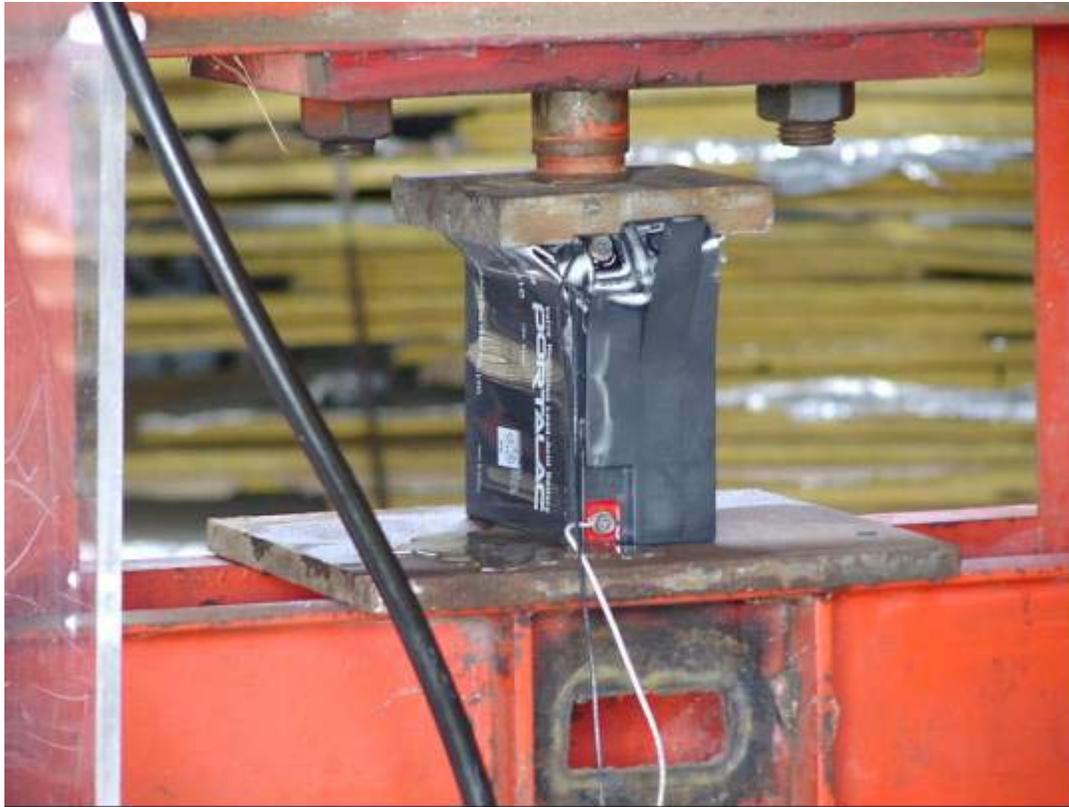
**Figure B-9. X-Axis Crushing of 12V Battery.**

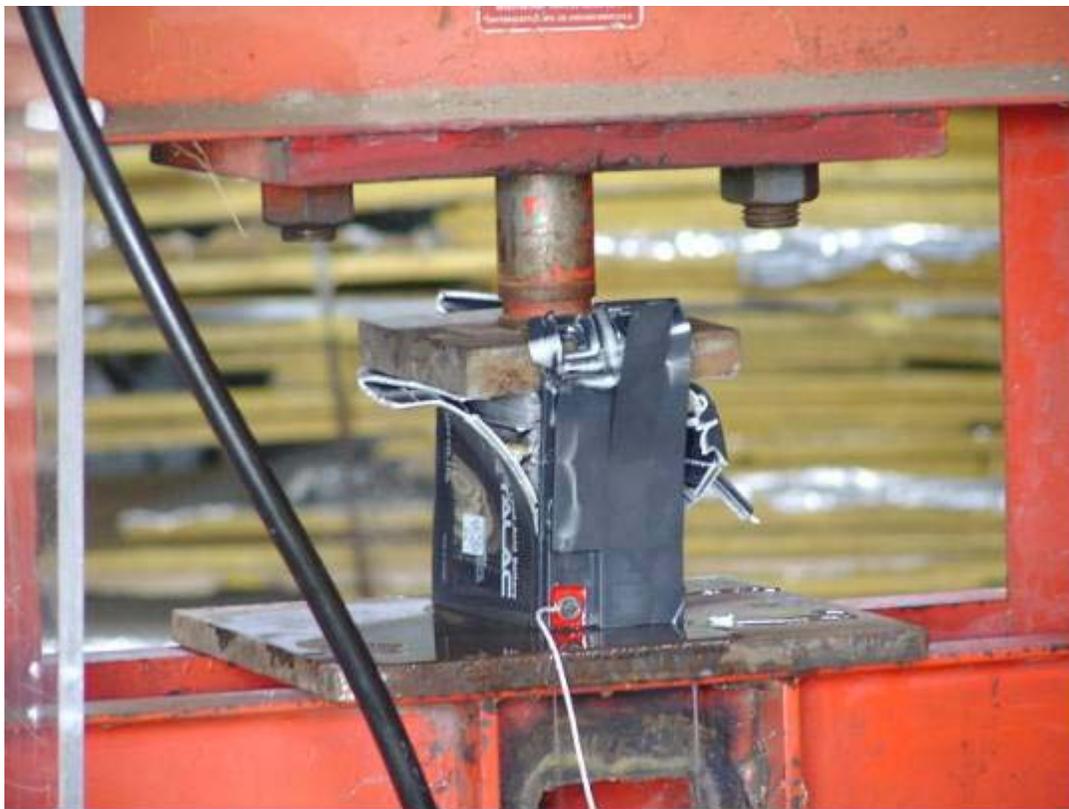
**Figure B-10. X-Axis Crushing of 12V Battery.**

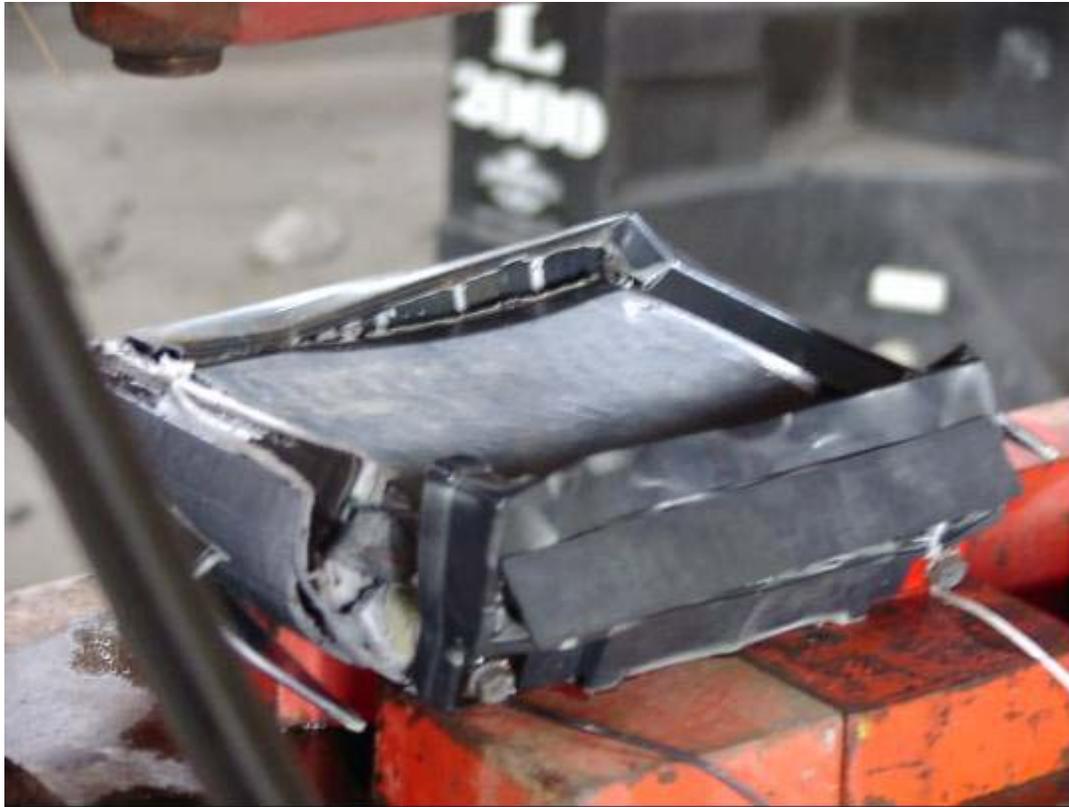
**Figure B-11. 12V Battery Following Y-Axis Crushing.**

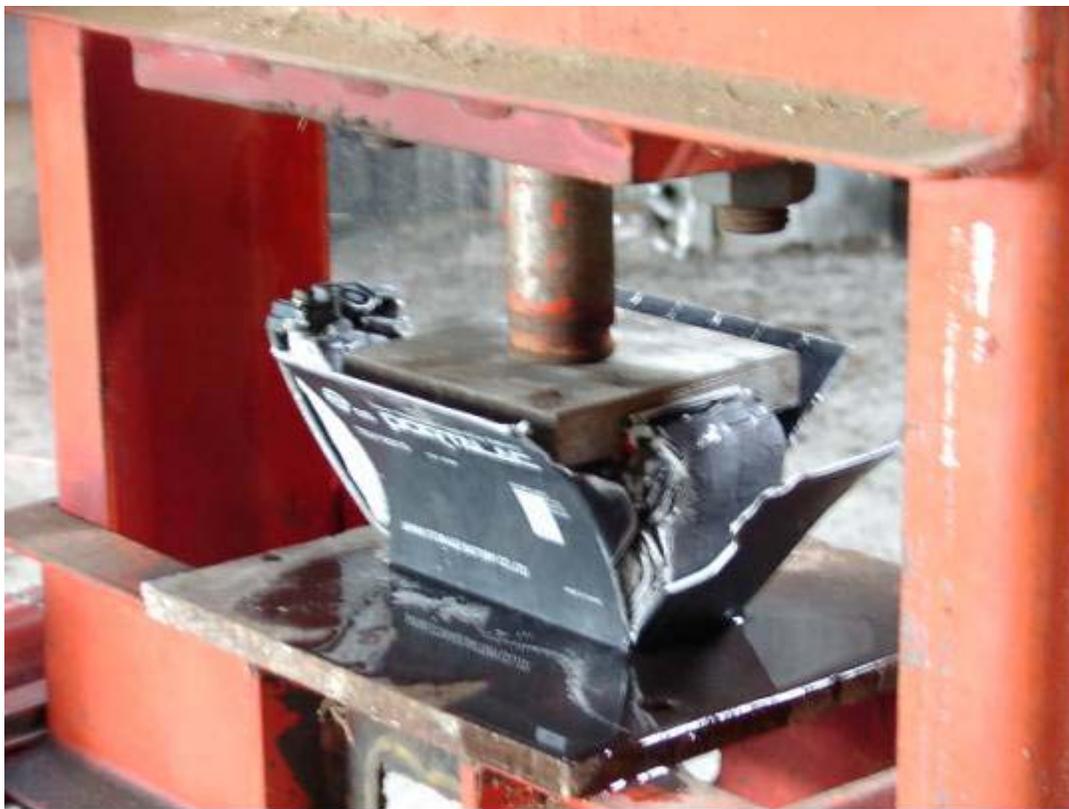
**Figure B-12. Z-Axis Crushing of 12V Battery.**

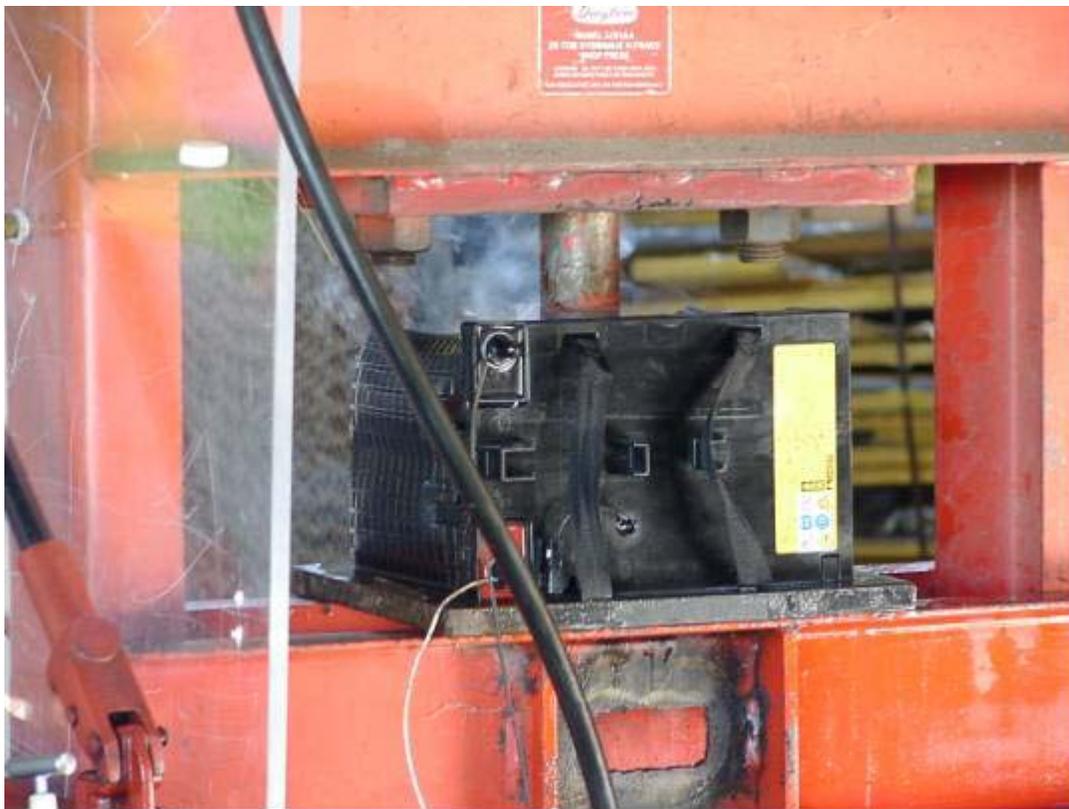
**Figure B-14. Y-Axis Crushing of 36V Battery.**

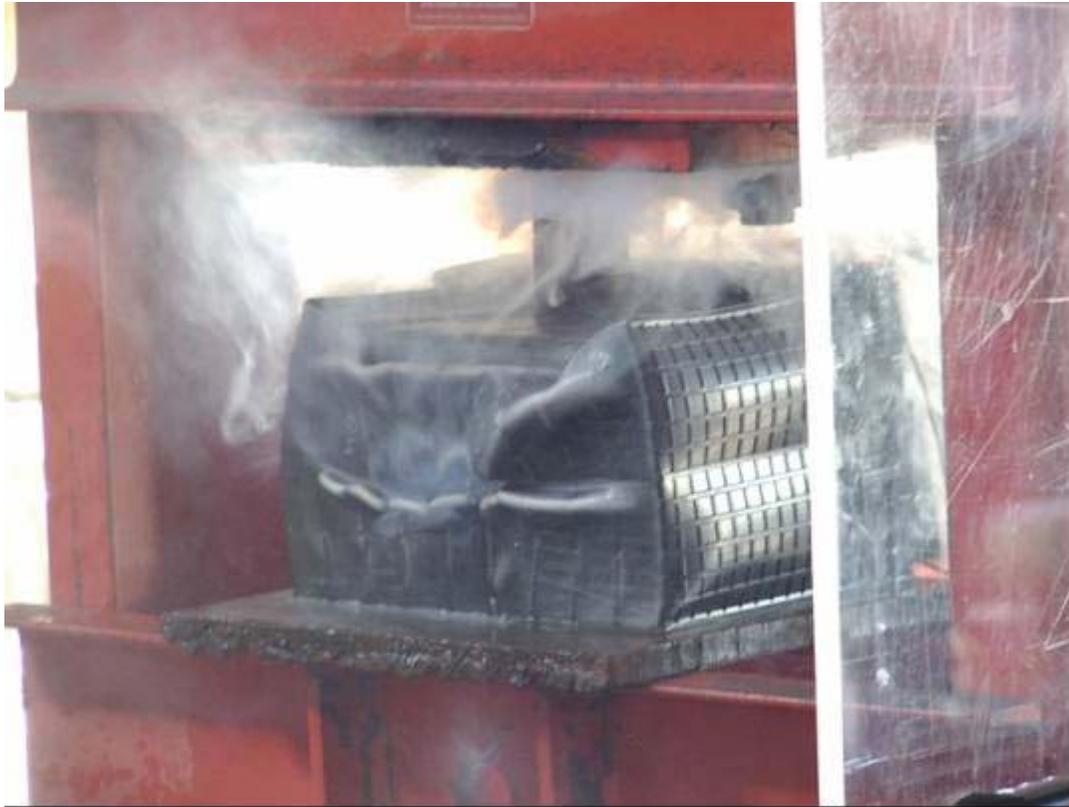
**Figure B-15. Sulfuric Acid Vapors Emitting from 36V Battery During Y-Axis Crush Test No. 1.**

Surface temperature of the 12V batteries rose to a maximum on the order of 200°F during the crush tests as indicated by the thermal imaging camera. Surface temperature of the 36V batteries rose to a maximum on the order of 180°F during the crush tests. During the y-axis crush test of one of the 36V batteries, the surface temperature rose to approximately 180°F. Acid vapors were emitted from a hole formed in the battery for approximately 8 min, substantially longer than in any other test. This condition was not reproduced in the second y-axis crush test of a 36V battery.

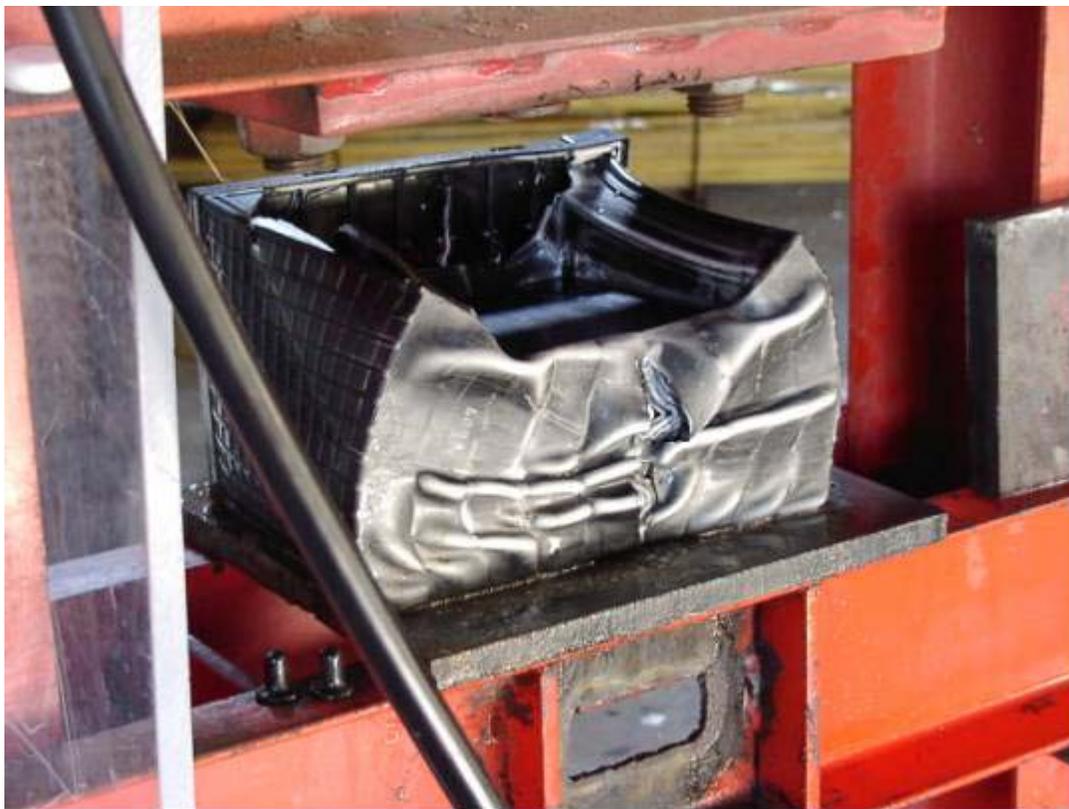
**Figure B-16. 36V Battery Following Crush Test.**

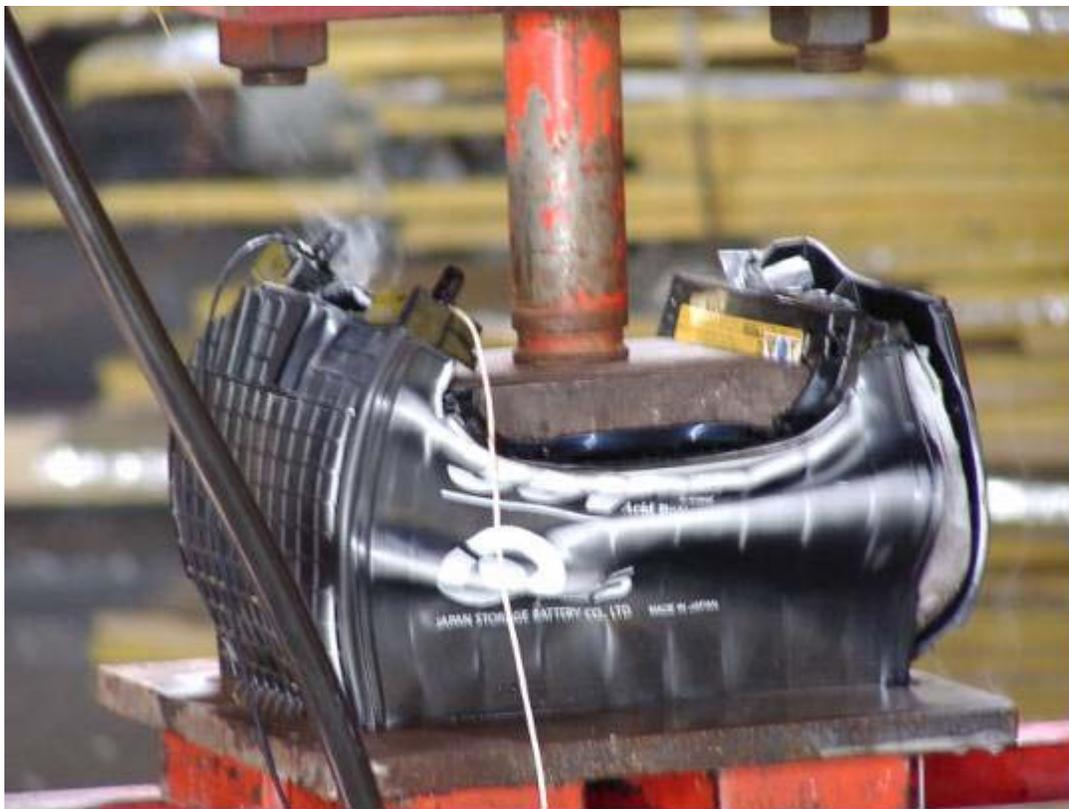
**Figure B-18. 36V Battery During Z-Axis Crush. Note Arcing to Crush Plate.**

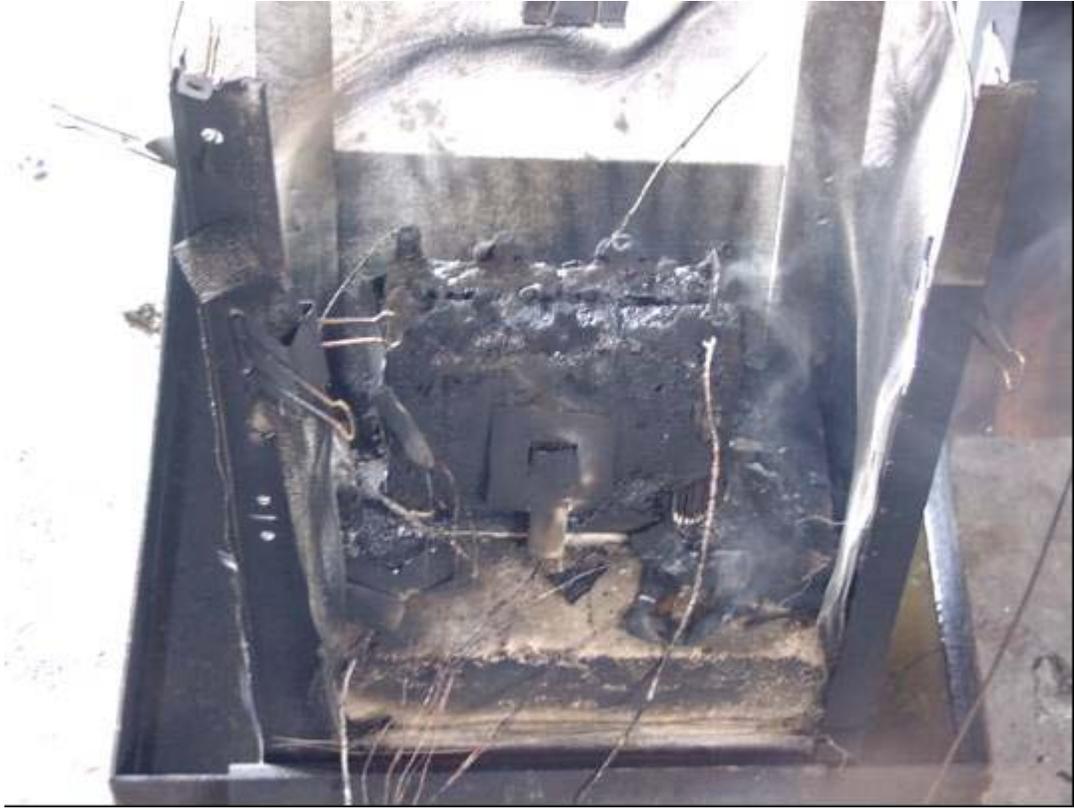
**Figure B-21. 12V Battery Following Radiant Exposure Test.**

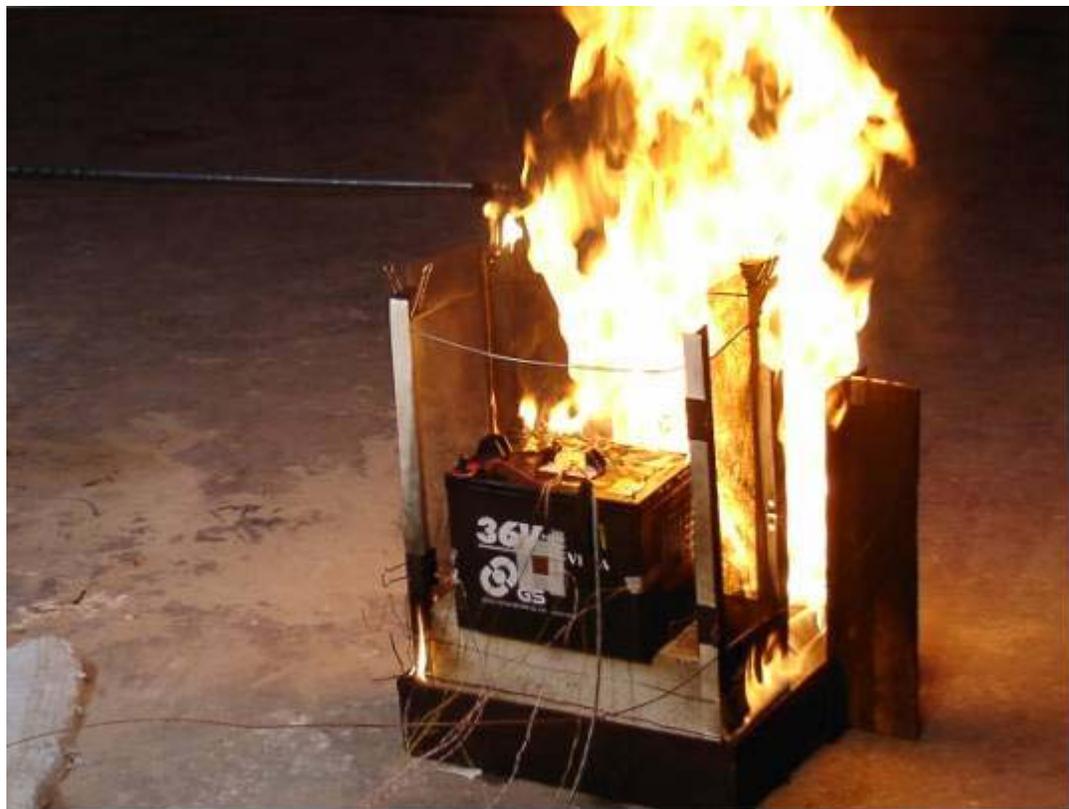
**Figure B-24. Ignition of 36V Battery During Radiant Exposure Test.**

The heptane pool fire reached flame temperatures between 1600°F and 1700°F during the tests. One 36V battery was exposed to the heat source for a period of 5 min. Ignition of the battery material had occurred after 45 sec and the voltage dropped to 0 Volts after approximately 130 sec of exposure. The 12V battery and second 36V battery were exposed to the heat source for a period of 10 min. Ignition of both the 12V and 36V battery exteriors occurred after 40 sec of exposure. Voltage in the 12V battery began dropping after 400 sec of exposure, and voltage in the 36V battery began dropping after 280 sec of exposure.

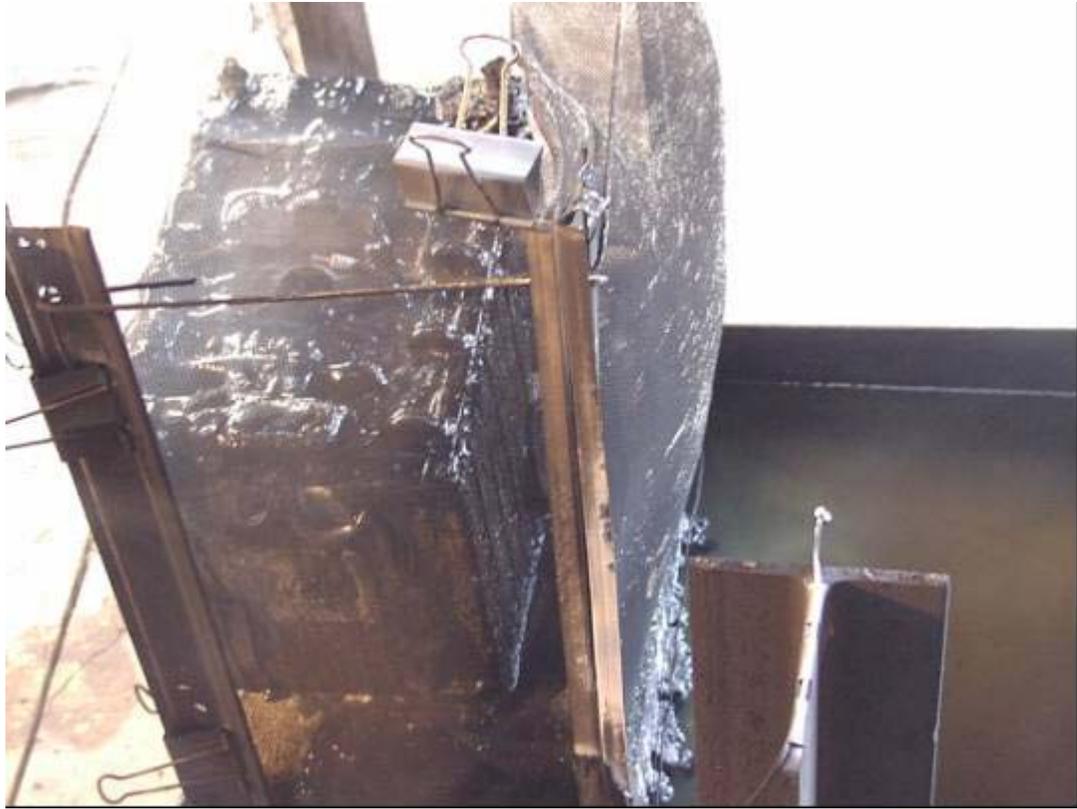
**Figure B-25. 36V Battery Following Radiant Exposure Test No. 1.**

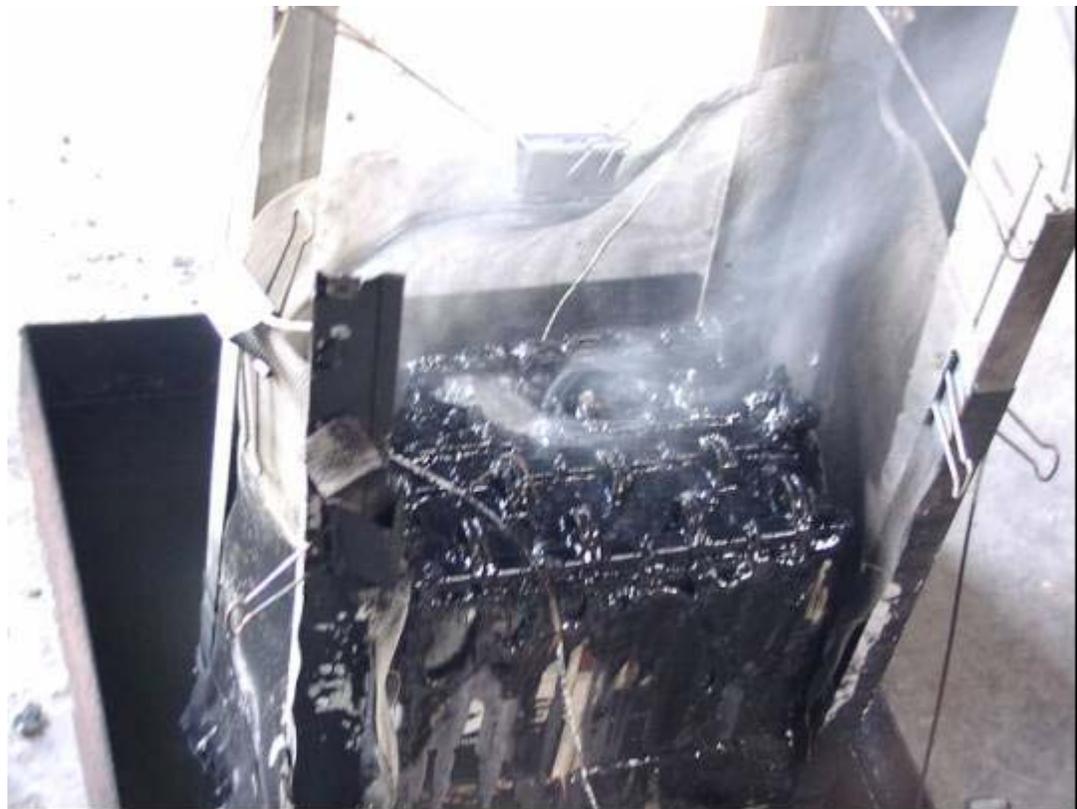
**Figure B-26. 36V Battery Following Radiant Exposure Test No. 2.**

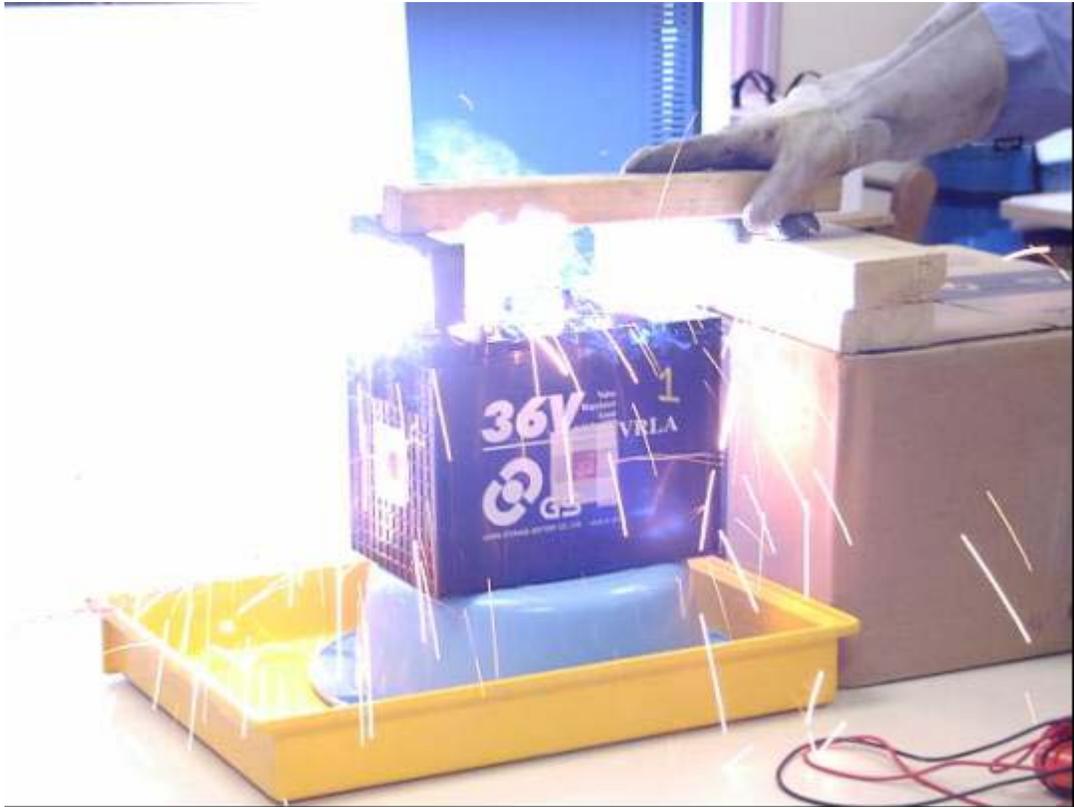
**Figure B-29. Application of Hard Short to 36V Battery.**

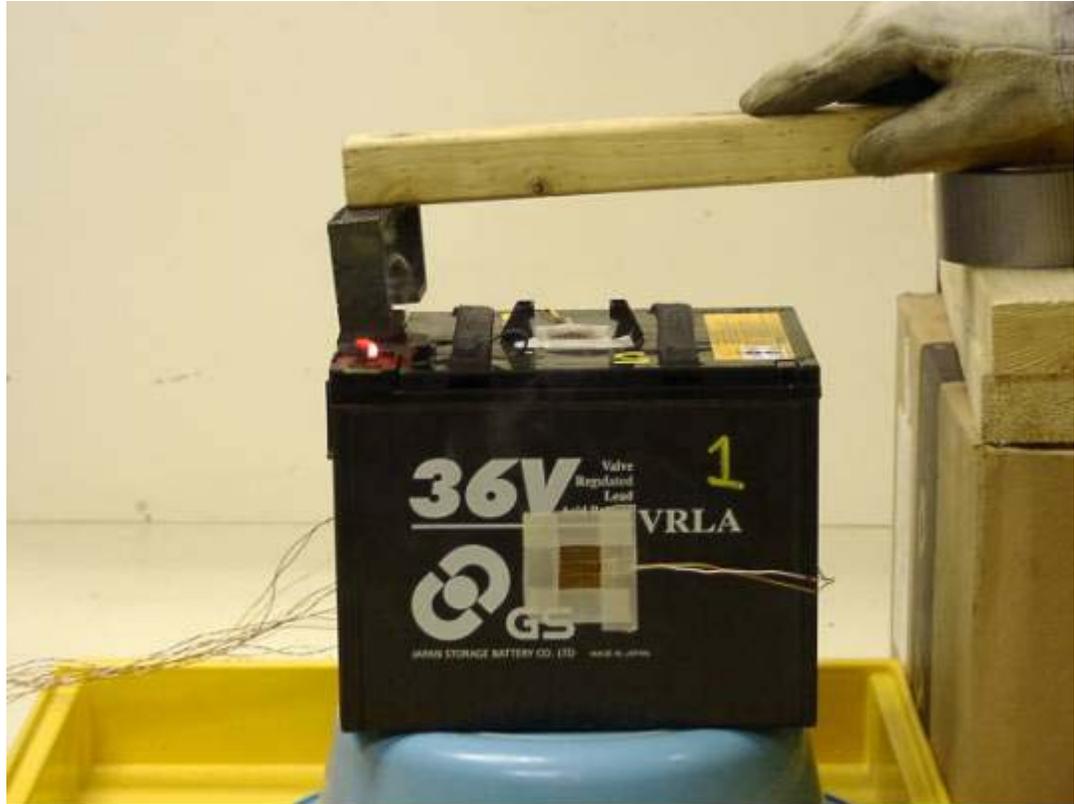
**Figure B-30. Red-Hot Peg Shown after Application of Hard Short to 36V Battery.**

Arcing occurred immediately upon the shorting of all three batteries, which stopped once a strong connection was made. Heat produced by the arcing and voltage discharge was sufficient to weld the conductive metal used to create the hard short. Thermal imaging showed a high rate of heating of the metal for a brief period of time; the metal would then show signs of cooling, signifying an internal short of the battery. For the 12V battery, the metal was removed at 150 sec, and the voltage was verified as 0 Volts. The metal short material could not be easily removed from either of the two 36V batteries, but Tests 1 and 2 showed signs of cooling at 10 and 5 min, respectively. Ambient temperature prior to testing was approximately 72°F. The maximum temperature and estimated maximum heat flux (time-weighted average) can be found in the following table:
