## Automotive Fuel System Anti-siphoning and Leak Prevention Technology Review

Report No.:  
R06-20

Authors:  
Tim Bayne  
Ed Fournier

Biokinetics and Associates Ltd.  
2470 Don Reid Drive  
Ottawa, Ontario, K1H 1E1  
Canada

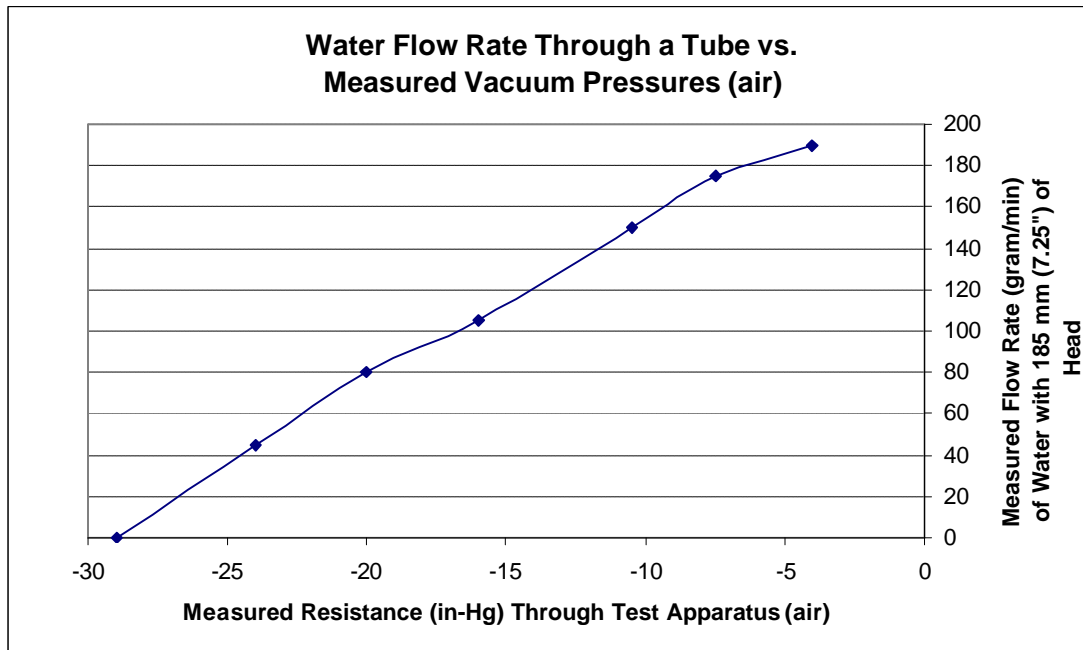
Figure 2: Graph of Volumetric Flow Rate vs. Vacuum Generated .

performed to establish the amount of flow for a given amount of vacuum. The test apparatus consisted of a flexible tube with a ball valve installed mid length. With the valve set to different closure levels the vacuum pressure created by tube was measured. For each valve setting the tube and valve assembly was primed and one end was placed in a tank of water<sup>4</sup>. The other end of the tube was placed in a graduated cylinder at a fixed distance below the surface level of the water in the tank. The volume of flow that occurred in one minute was measured. Measured flow in relation to the measured pressure is plotted in Figure 2.

To put the leakage rates presented in Figure 2 into perspective, the Federal Motor Vehicle Safety Standard 301 (FMVSS 301) requires that a tank system cannot exceed a leakage rate of 28 grams/minute. This rate equates to a vacuum pressure of approximately -26 inches of mercury (in-Hg) in the flow tests conducted. Note that these tests measured the flow through a hollow tube using a ball valve to vary the flow restriction.

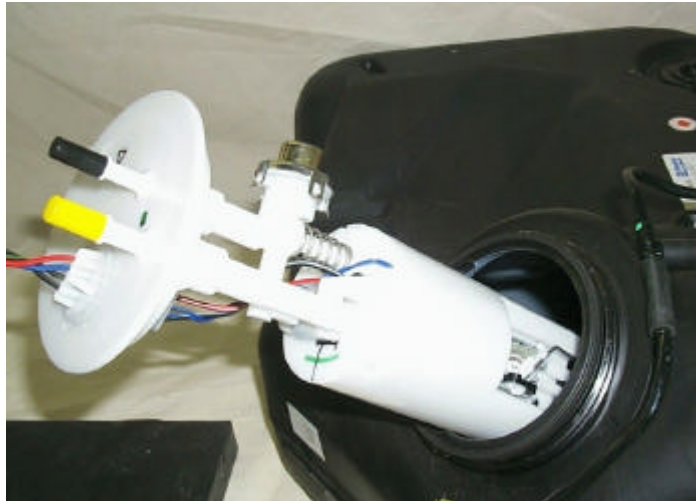
Figure 18: Chrysler Cirrus sending unit.

Two fuel lines exit the top of the sending unit, shown in Figure 18. They include the fuel delivery and fuel return lines. As shown previously in Table 2, a partial vacuum (-8 in-Hg) was generated on the fuel delivery line. The only source of resistance to fuel flow in the fuel delivery line is the fuel pump which is shown in a disassembled state in Figure 19.

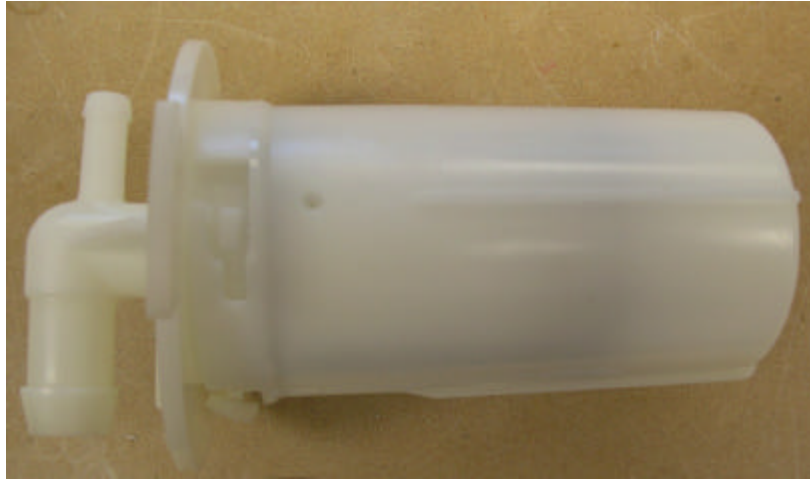
Figure 22: Chrysler Cirrus fuel vapour port valve.

There are two vapour ports on the tank, both of which are located at the top of the tank. The valve connected to the first port is shown in Figure 22. The disassembled valve is shown in Figure 23 and Figure 24. A buoyant plunger<sup>6</sup> seal, supported by a light force compression spring translates in the vertical

direction. When the fuel level is full, the buoyant<sup>7</sup> plunger with the assistance of the compression spring pushes up against the sealing surface, preventing fuel loss through the vapour line due to siphoning.

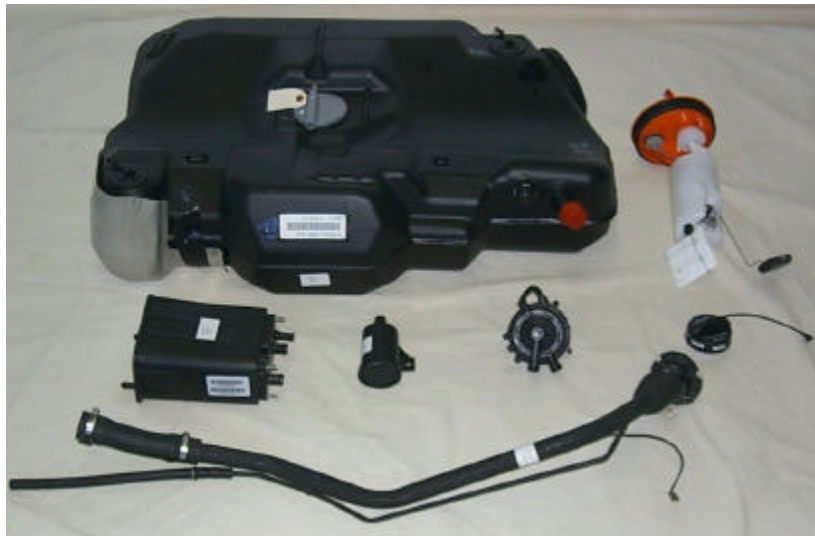
Figure 27: Dodge Neon tank system.

The complete Dodge Neon tank system is shown in Figure 27. The Neon has five openings to the tank: filler tube, sending unit and three fuel vapour ports, two of which are identical.

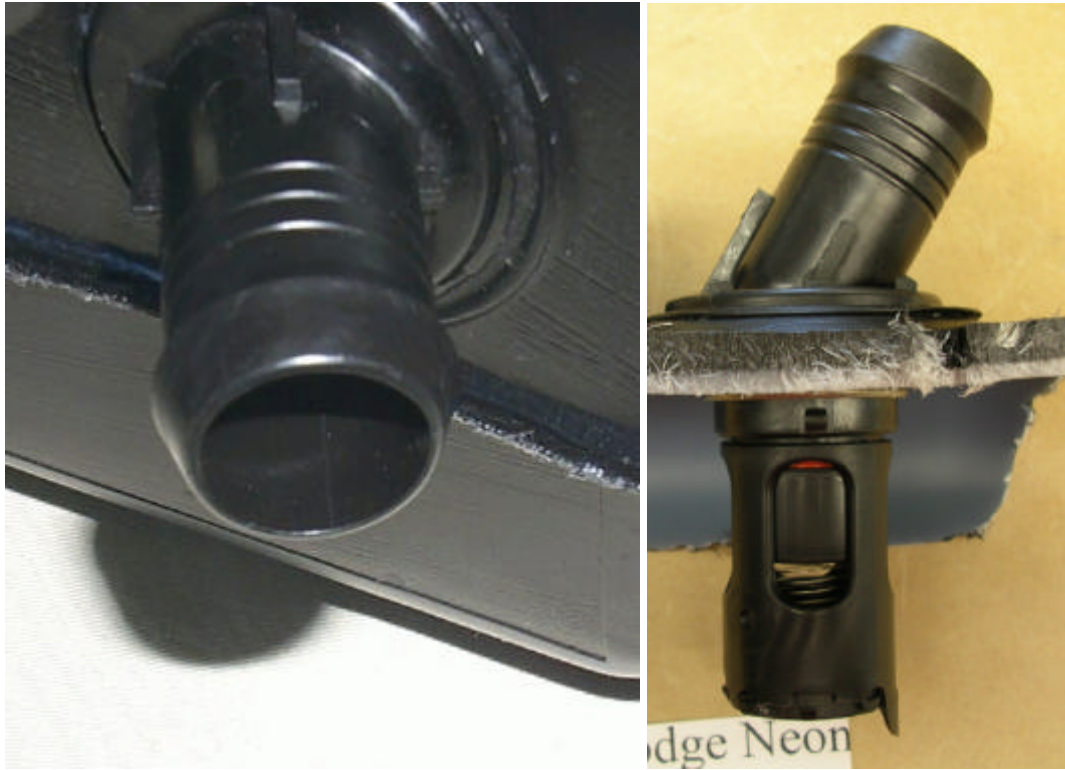
Figure 28: Dodge Neon filler tube spout and valve.

The filler hose is fastened to a spout that is integral to the tank. On the inside of the spout is a normally closed, plunger valve, see Figure 28. A disassembled view of the valve is shown in Figure 29. The normally closed valve is displaced as fuel enters the tank from the filler tube, once the fuel has stopped flowing into the tank, the valve closes thus preventing fuel and/or vapour from leaving the tank.

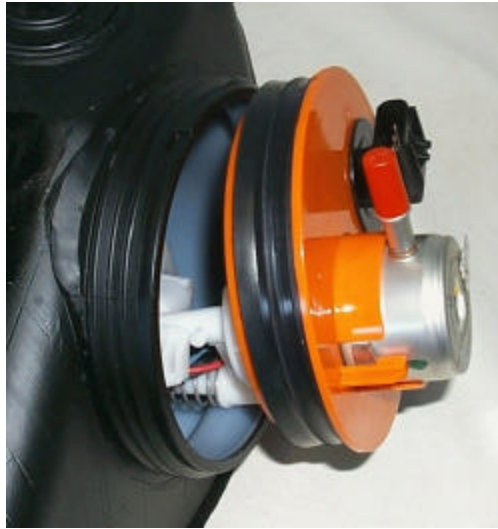
Figure 30: Dodge Neon sending unit.

The sending unit, shown in Figure 30 is a returnless fuel system and therefore has only the fuel delivery line connected to it. As documented in Table 2, only a partial vacuum (-10 in-Hg) was generated on the fuel delivery line. The fuel pump provided the resistance to fuel flow in the line. The fuel pump is shown in Figure 31<sup>8</sup>. A detailed picture of the internal gear pump is shown in Figure 32.

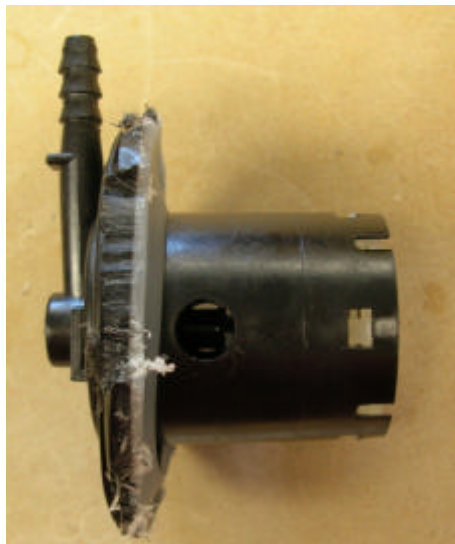
Figure 36: Dodge Neon second fuel vapour valve.

The second vapour valve, of which there are two installed in the tank is identical to that used in the Chrysler Cirrus and is shown in Figure 36 and Figure 37, they are both located at the top of the tank. The valve is equipped with a buoyant plunger and a compression spring. With a full tank, the plunger is sealed, preventing fuel or vapour from escaping. Because the fuel vapour line exits at the top of the tank, siphoning can not be initiated with the vehicle in the upright position.

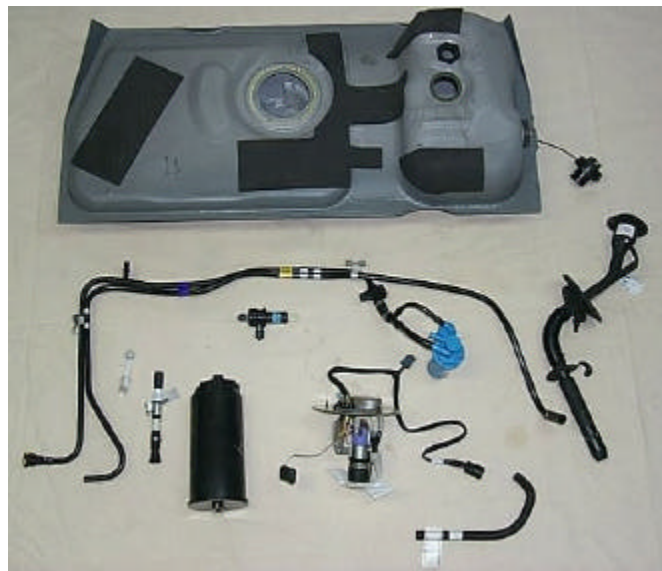
Figure 38: Ford Mustang tank system.

All the components of the Ford Mustang tank system are shown in Figure 38. The Mustang has four openings to the tank: filler tube, sending unit and two fuel vapour ports.

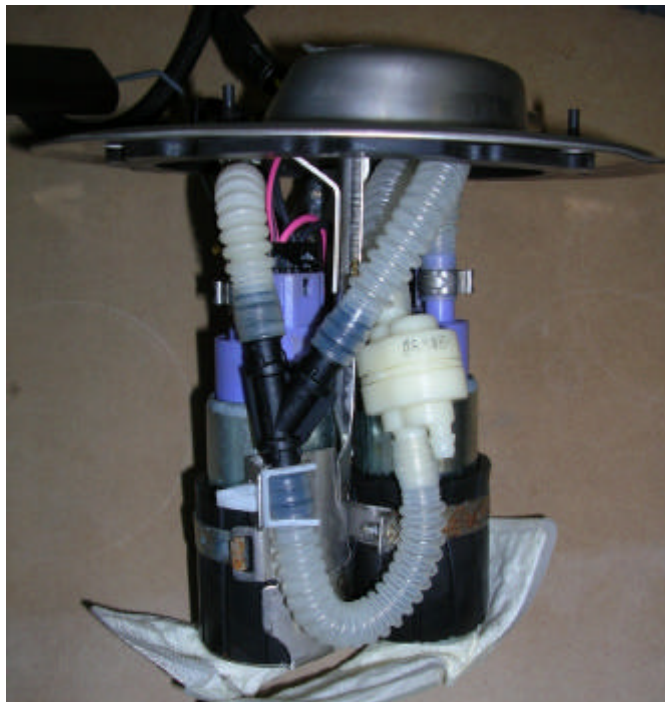
Figure 41: Ford Mustang sending unit.

The sending unit, shown in Figure 41 is a returnless system and therefore it only has a fuel delivery line. The Mustang's sending unit is unique in that it contains two fuel pumps that are mounted in parallel. As documented in Table 2, a full vacuum was generated on the fuel delivery line for this vehicle. The resistance to fuel flow in the fuel delivery line stems from a valve assembly located just downstream of both fuel pumps, see Figure 42. The valve comprises two spring loaded plungers which seal against a brass fitting. The first plunger prevents fuel from draining back into the tank once the pumps have shut off keeping the line primed. This valve also provides the full vacuum generated on the fuel delivery line during the vacuum test to assess siphoning. The second plunger appears to function as an overflow valve such that, if the fuel pressure in the line exceeds that required by the engine, fuel is diverted back into the tank. This valve assembly would prevent siphoning.

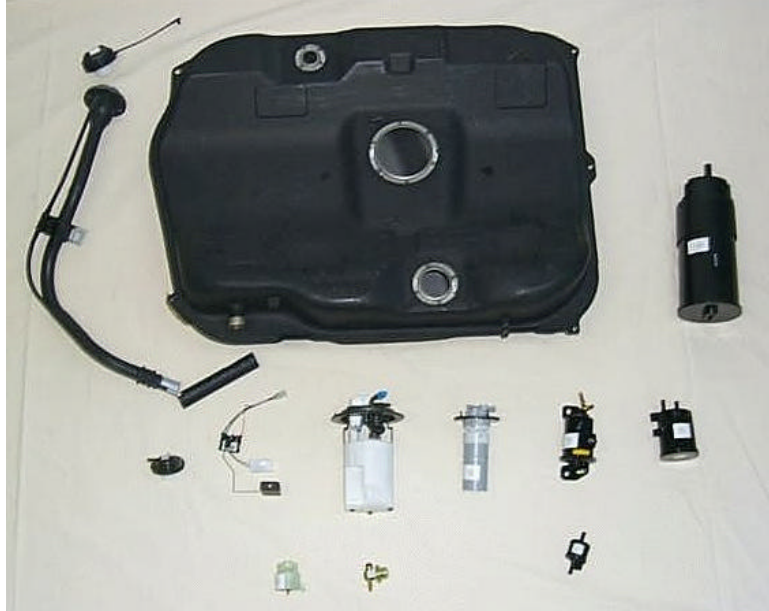
Figure 50: Kia Spectra tank system.

The components for the Kia Spectra tank system are shown in Figure 50. The Spectra has four openings to the tank that include the filler tube, sending unit and two fuel vapour ports.

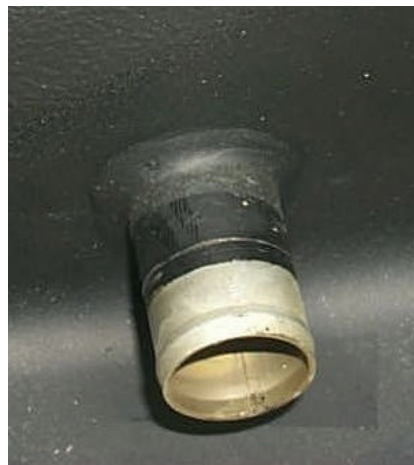
Figure 51: Kia Spectra filler tube spout.

The filler hose is fastened to a spout that is welded to the tank, see Figure 51. On the inside of the tank, the filler spout is terminated with a normally closed, spring loaded flapper valve, as seen in Figure 52. The valve uses a rubber disk to enhance the seal when closed. The normally closed flapper valve is displaced as fuel enters the tank and closes to prevent reverse flow of fuel and/or vapour once filling is stopped.

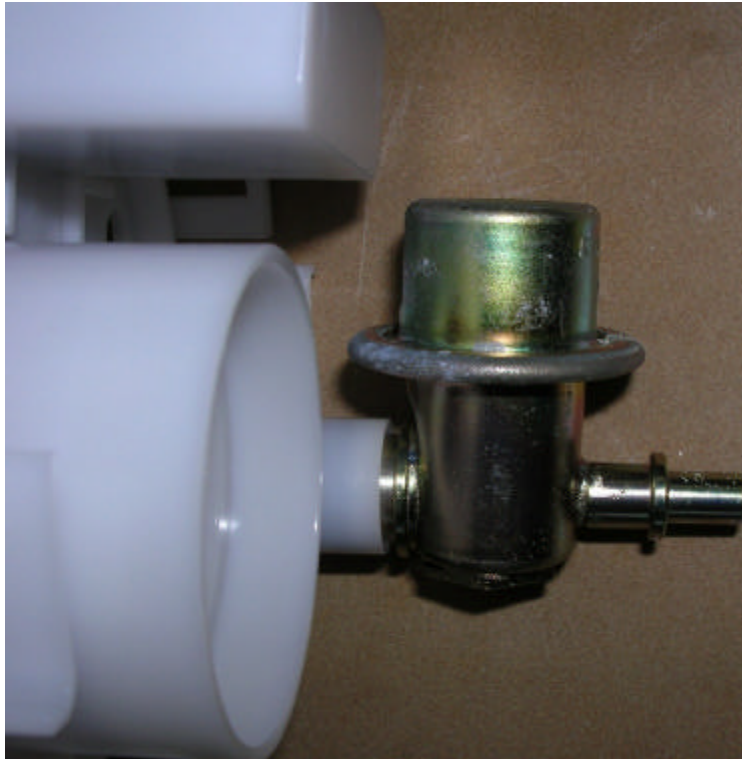
Figure 55: Kia Spectra fuel return valve.

The fuel return line is fitted with a normally closed valve located at the very bottom of the sending unit, as shown in Figure 55. This valve is identical to the valve used in the Grand Voyager's and the Chrysler Cirrus' sending units. The valve mechanism was shown previously in Figure 10.

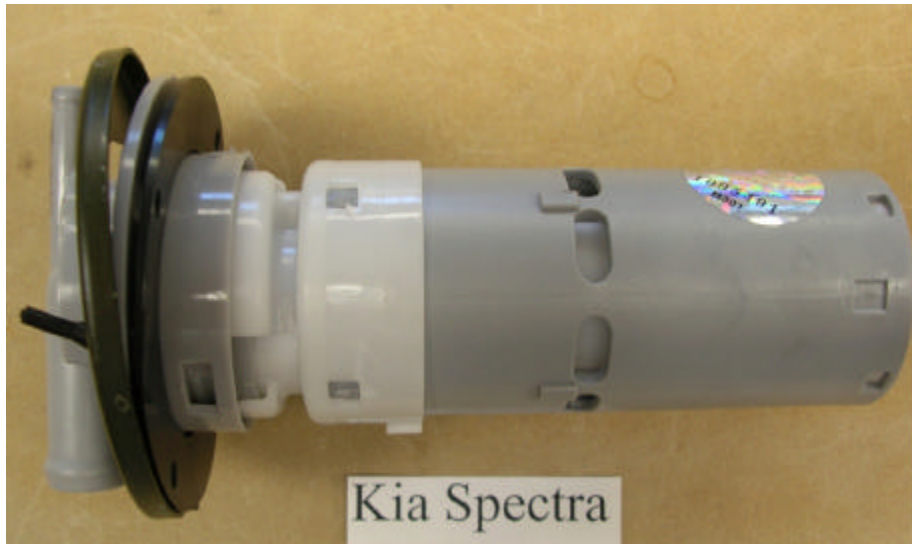
Figure 56: Kia Spectra fuel vapour valve.

There are two vapour ports on the Kia tank, both are located on the top of the tank. The first is shown in Figure 56. The vapour port is comprised of a sealed float that is attached to a sprung flapper valve. The components of this valve are shown in Figure 57 through Figure 59.

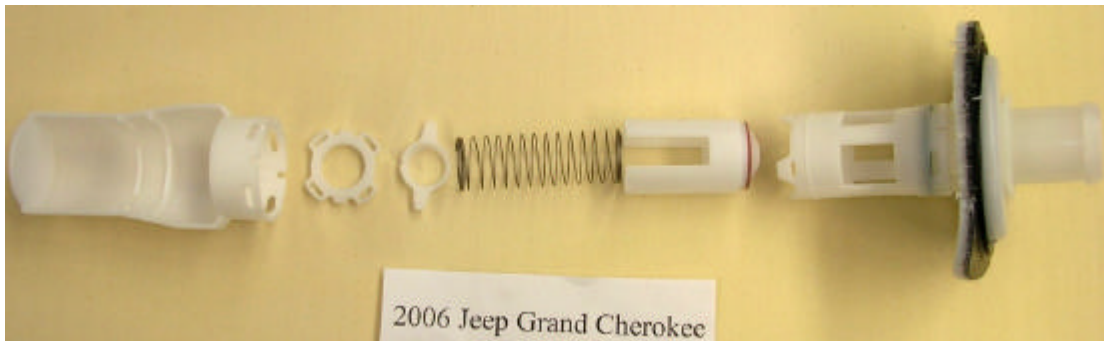
Figure 67: Jeep Grand Cherokee Filler Port and Check Valve.

The filler neck is fitted with a check valve on the inside of the tank. The valve is shown in a disassembled state in Figure 67. The valve comprises a normally closed spring plunger design. The pressure of the fuel entering the tank displaces the valve allowing fuel to enter the tank. The seal is such that no fuel and/or vapour could leak from the tank under any circumstances, including siphoning.

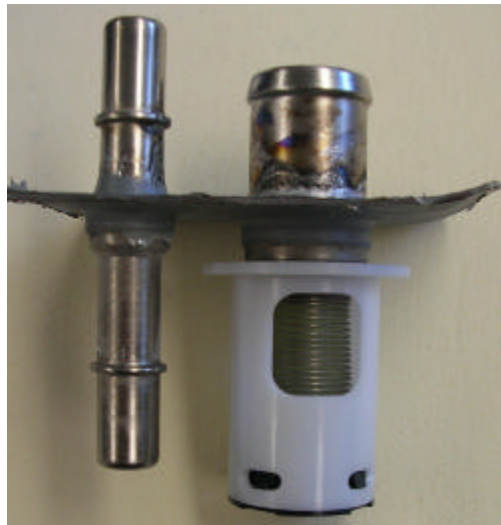
Figure 73: Ford Fusion Filler and Vent Ports.

Figure 73 shows the filler and vent port cut out from the tank. A normally closed spring plunger valve is connected to the filler spout on the inside of the tank. An exploded view of the spring plunger valve is shown in Figure 74.

The fuel vent tube, shown in Figure 73 is connected to two check valves mounted on the inside top surface of the fuel tank. Neither of the valve assemblies generates a vacuum and therefore does not exhibit any anti-siphoning abilities. The two check valves mounted to the inside of the tank are shown in Figure 76.

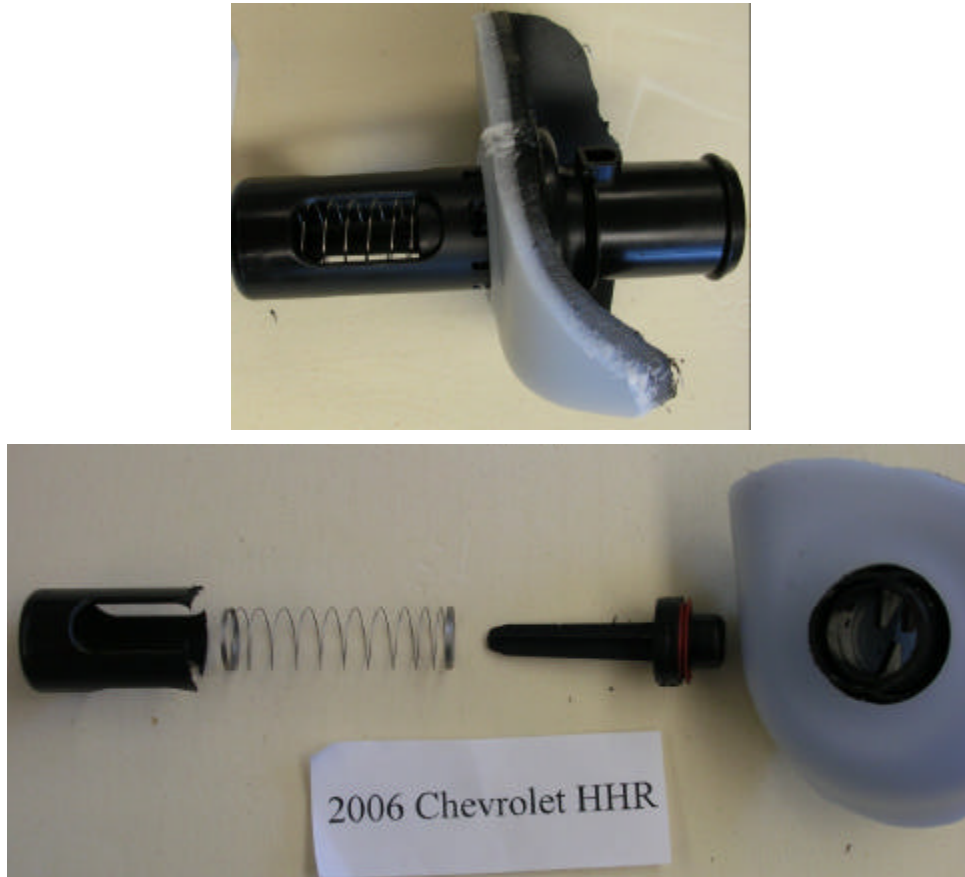
Figure 80: Chevrolet HHR Filler Port.

An exploded view of the filler neck, cut from the tank, is shown in Figure 80 and Figure 81. A normally closed spring plunger valve is connected to the filler neck on the inside of the tank. The pressure of the fuel entering the tank displaces the valve allowing fuel to enter the tank. The seal is such that no fuel and/or vapour could leak from the tank under any circumstances, including siphoning.
