## ANALYSIS OF INDUCED CATASTROPHIC FAILURE OF A 5000 PSIG TYPE IV HYDROGEN CYLINDER

**FINAL REPORT**  
**Consisting of 28 Pages**  
**SwRI® Project No. 01.06939.01.001**  
**February 2005**

**Motor Vehicle Fire Research Institute**  
**1334 Pendleton Court**  
**Charlottesville, VA 22901**

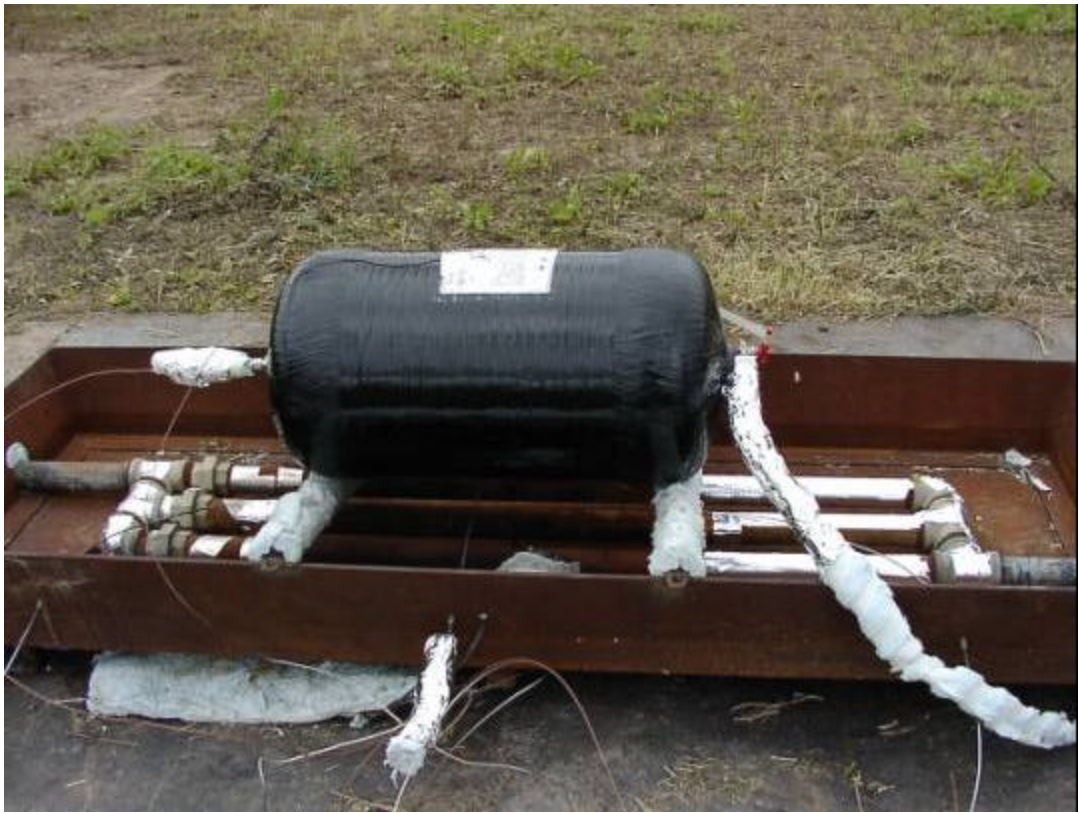
**Figure B-1. Type -IV Hydrogen Cylinder Located on Bonfire Source.**

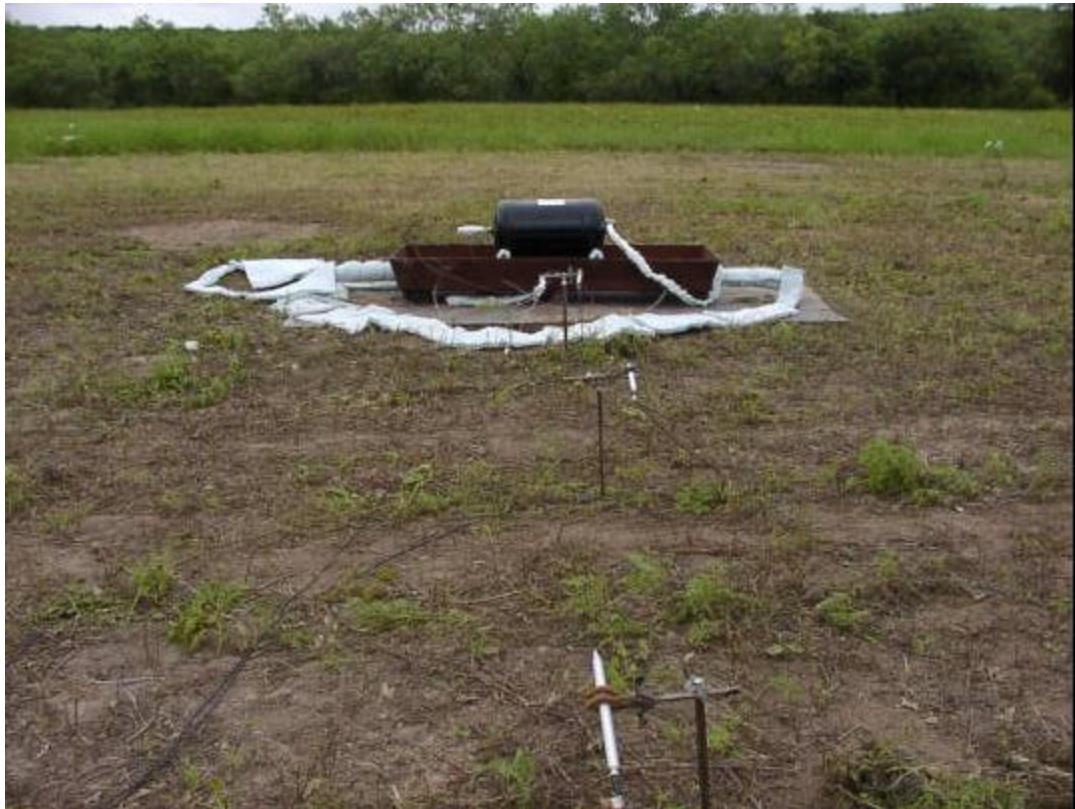
**Figure B-2. View of Blast-Wave Pressure Transducers on West Side of Cylinder.**

Blast-wave pressures were measured with four blast-pressure pencil probes. The two probes nearest the cylinder had a range of 0-500 psig (3.4 MPa), and the two probes farther from the cylinder had a range of 0-50 psig (340 kPa). One of the 0-500 psig probes was located perpendicular to the axis of the cylinder, approximately 76 in. (190 cm) from the center of the tank. The two 50 psig probes were located in a straight line with this probe, perpendicular to the cylinder, spaced 90 in. (230 cm) apart, placing them 166 in. (420 cm) and 256 in. (650 cm) from the center of the cylinder, respectively. The remaining 500-psig probe was located just off the axis of the cylinder, approximately 166 in. (420 mm) from the center of the cylinder, placing it equidistant from the cylinder with the second perpendicular probe.

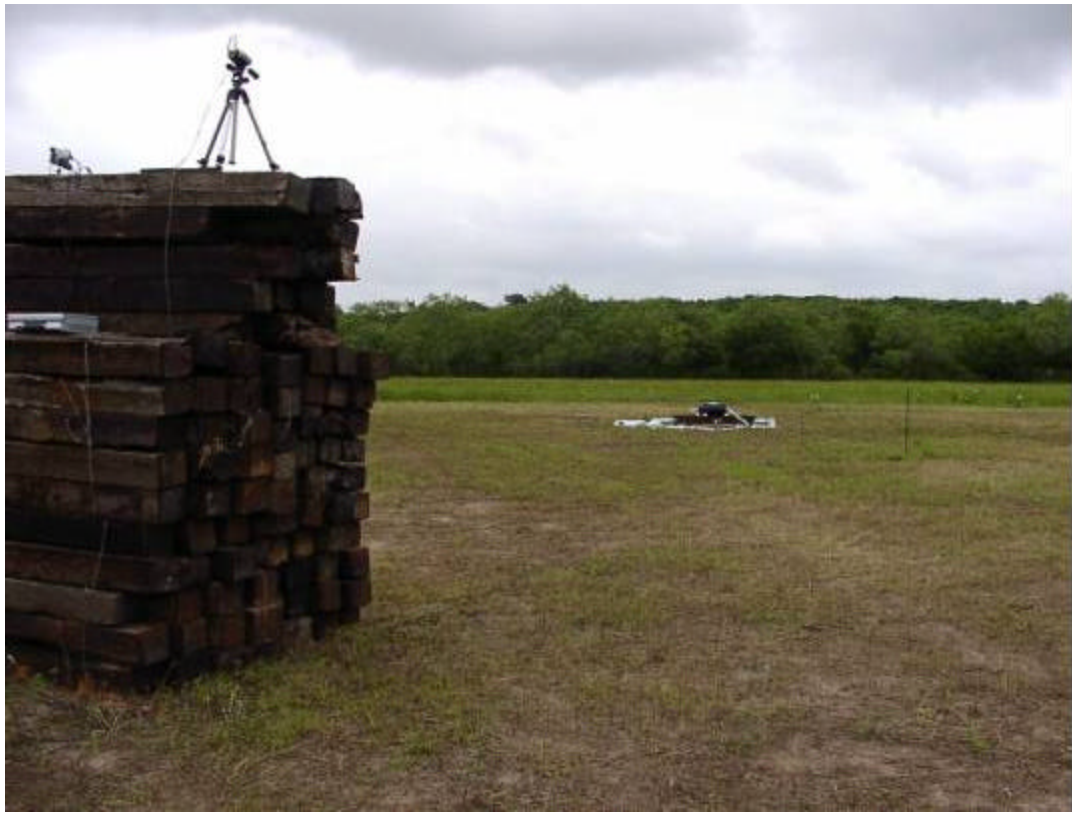
**Figure B-3. Camera Setup.**

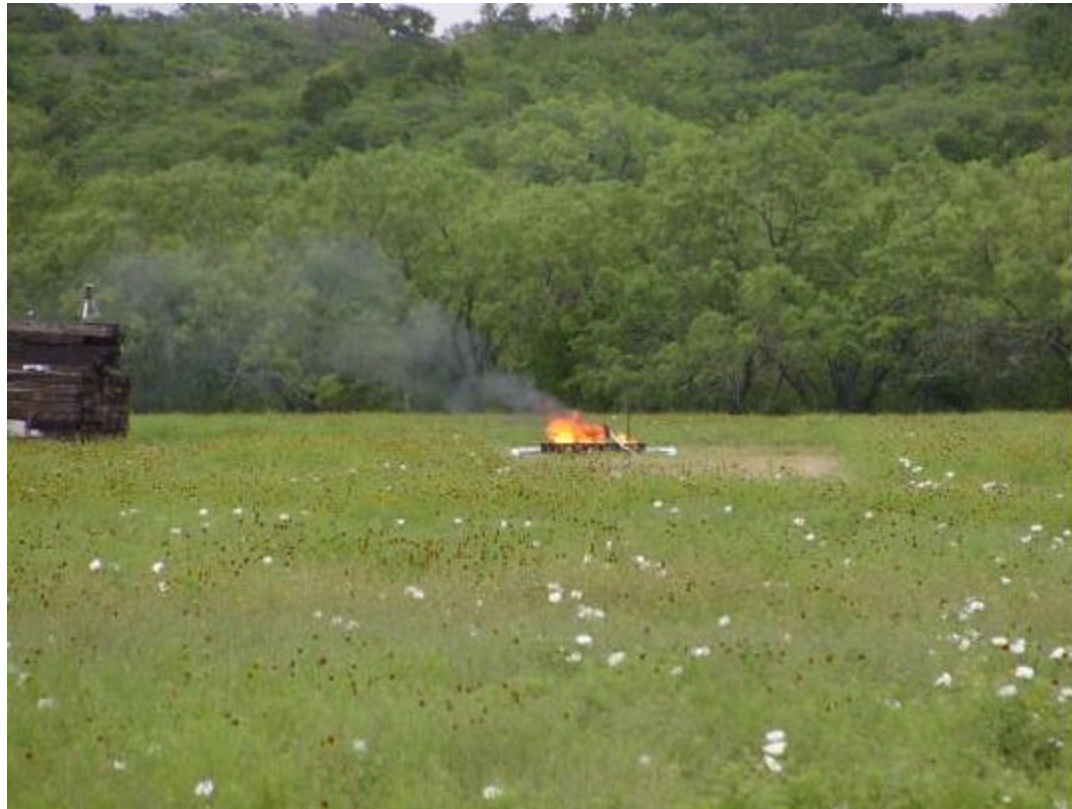
**Figure B-4. Cylinder Under Bonfire. Note soot from combustion of cylinder materials.**

Composite material on the surface of the tank ignited approximately 45 sec into the test, as evidenced by the appearance of black soot. The internal cylinder temperature and pressure slowly increased during the exposure. The cylinder was exposed to the fire for 6 min 27 sec when it lost its integrity and failed catastrophically. The internal temperature and pressure at this time had risen to 103°F (39°C) and 5,180 psig (35.7 MPa), respectively. The temperature and pressure rise correlated within 0.1% of expected values from the Redlich/Kwong correlation.

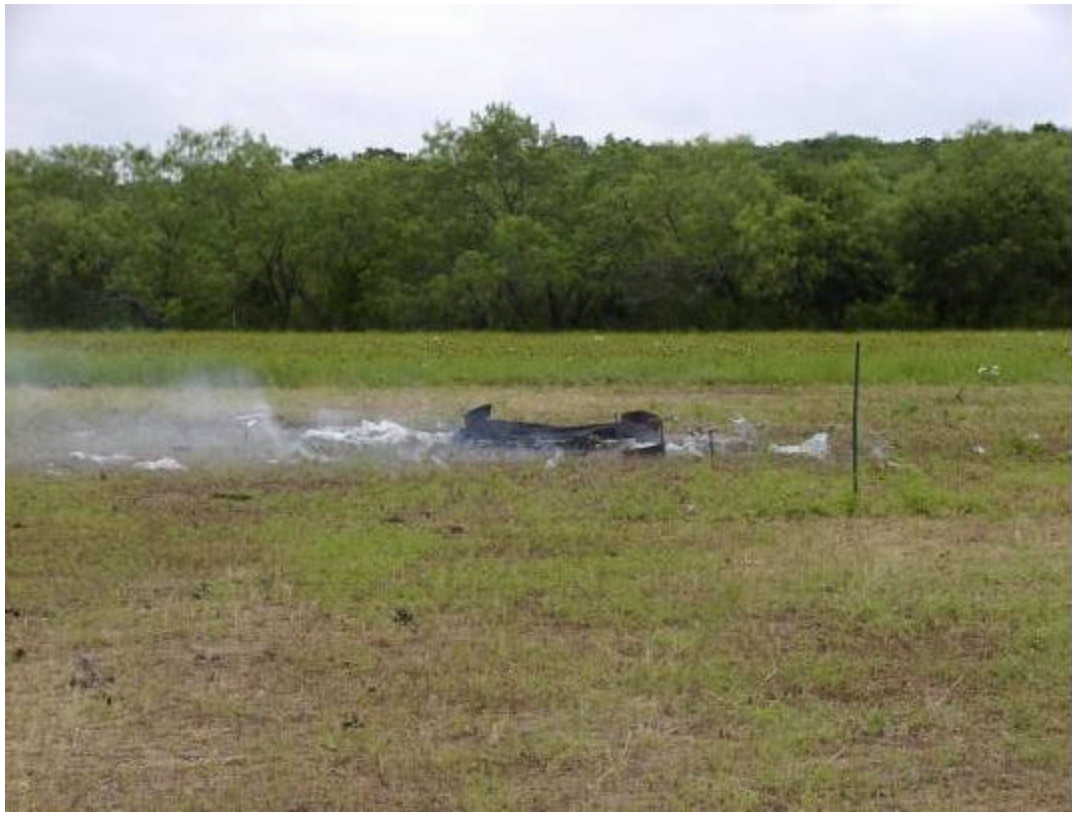
**Figure B-5. Test Site After Cylinder Failure.**

The cylinder failed through the bottom, destroying the burn shield and launching the 30.9-lb (14.0-kg) main portion 270 ft (82 m) east of the test location. The main portion included the aluminum end fitting to which the manifold and ball valve were still attached. The opposite aluminum end fitting was not attached, nor was it located.

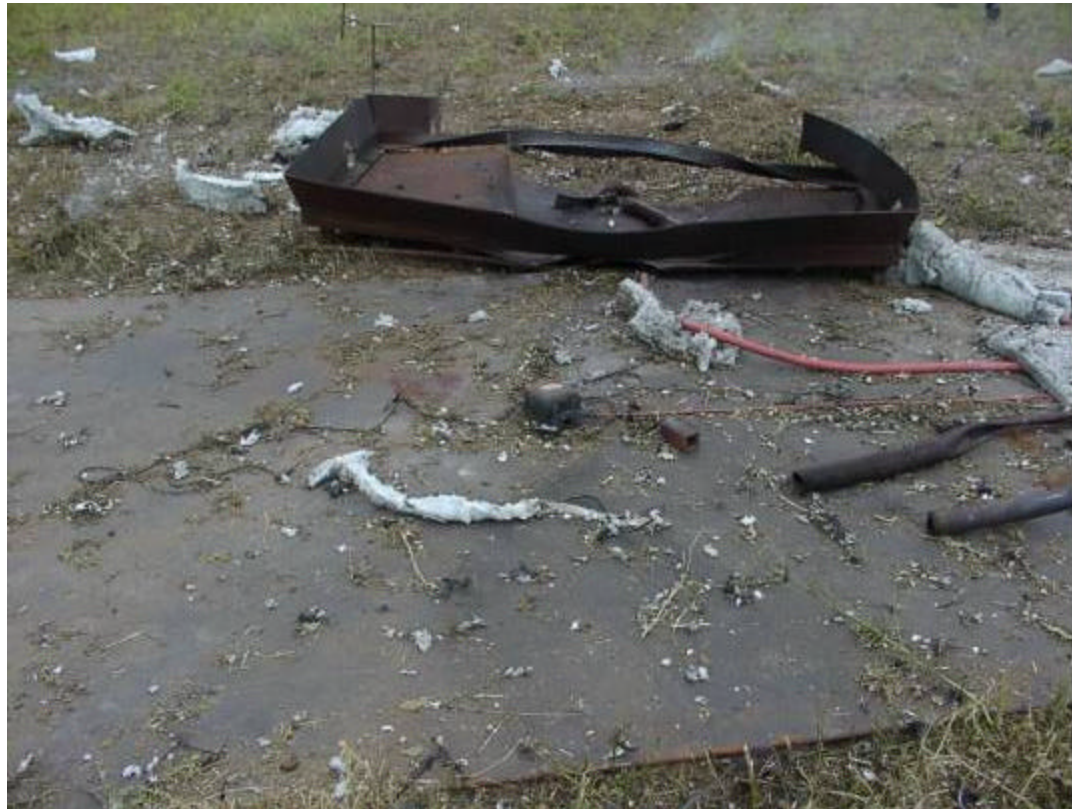
**Figure B-6. Remains of Bonfire Source and Shield.**

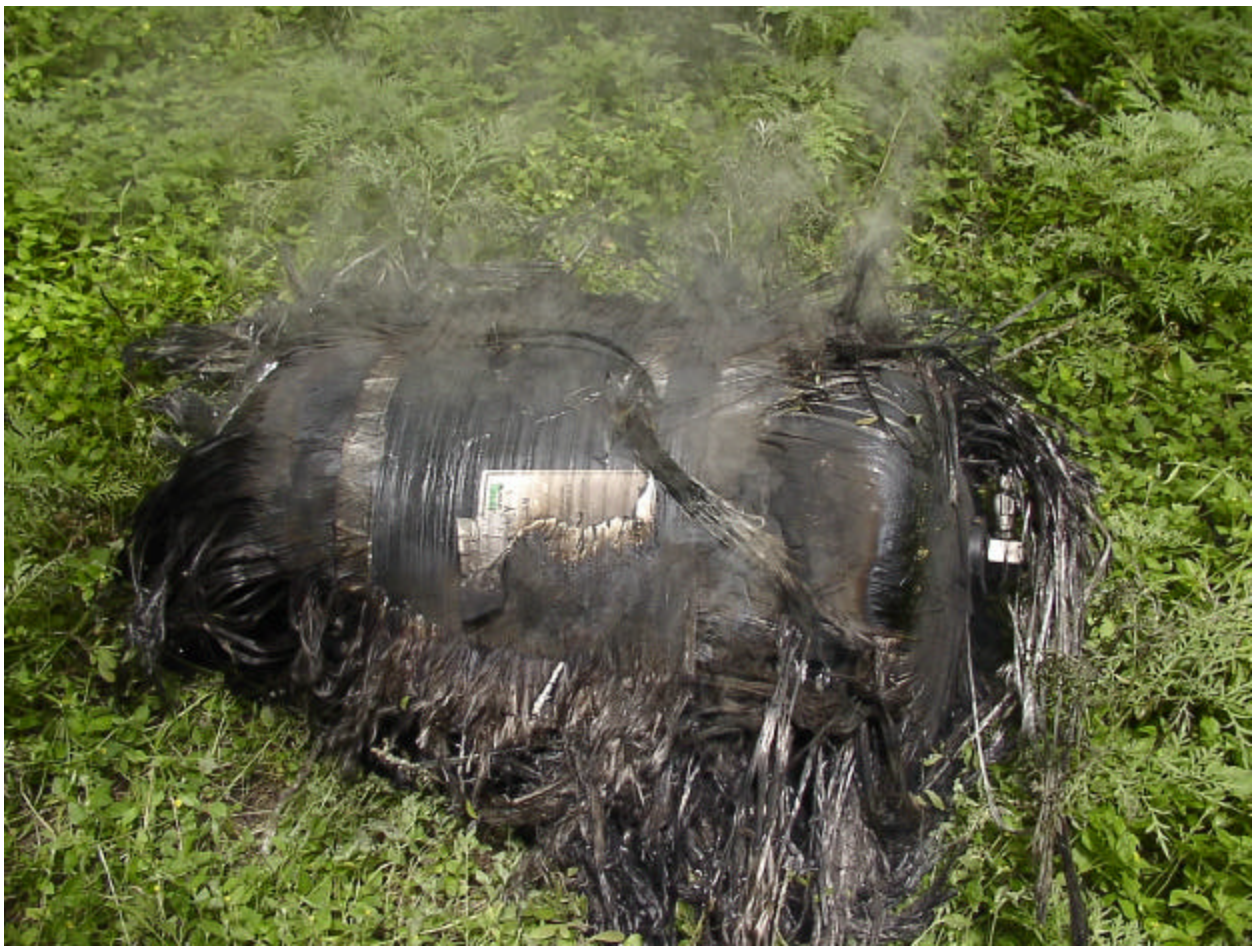
**Figure B-7. Main Portion of Cylinder Remains.**

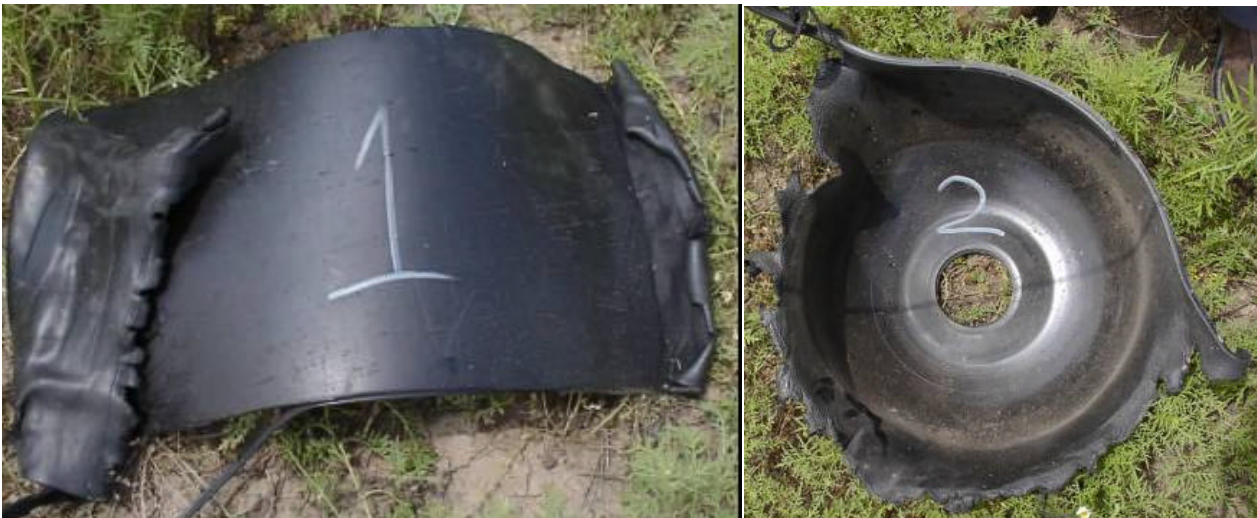
**Figure B-8. Main Cylinder and Dome of Polyethylene Liner.**

The remainder of the polyethylene liner was expelled through the bottom of the cylinder as it arced through the air. Three main pieces of the liner were found: a 3.6-lb (1.6-kg) split cylinder

approximately 74 ft (22 m) east of the test location, and two 4.3-lb (2.0-kg) domes approximately 157 and 163 ft (48 and 50 m) northeast of the test location; it is assumed that the domes' location north of the cylinder's eastward trajectory is due to wind.
