IGNITED HYDROGEN RELEASES FROM A SIMULATED AUTOMOTIVE FUEL LINE LEAK

FINAL REPORT
Consisting of 121 Pages

SwRI® Project No. 01.06939.01.004
Final Test Date: September 11, 2006
Report Date: December 1, 2006

Motor Vehicle Fire Research Institute
1334 Pendleton Court
Charlottesville, VA 22901

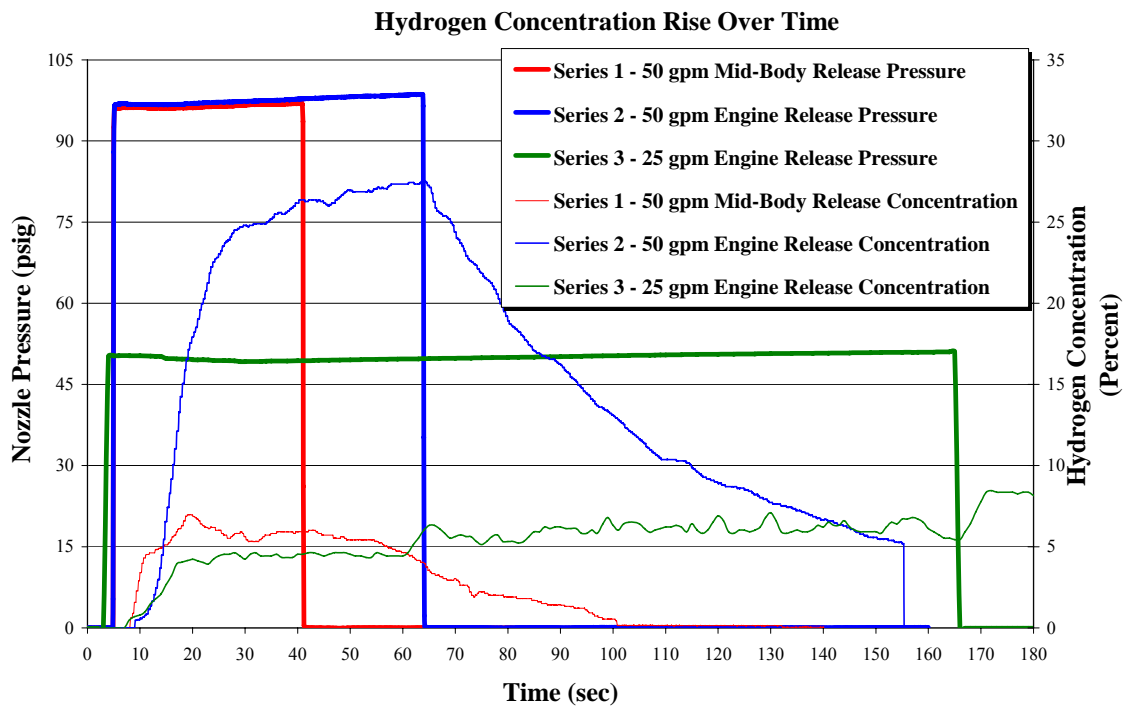
Figure 2. Engine Compartment Hydrogen Concentration Rise to Steady-State Values.

Follow-up tests were performed to the Series 1, 2 and 3 test parameters. Instrumentation was reduced with the intent of gathering pressure data only. Prior to performing the follow-up tests, the rise of hydrogen concentration to a steady-state value was measured inside the engine compartment under the conditions of Series 1, 2 and 3. Hydrogen release was begun and continued until data indicated that a steady-state value had been reached. At that point, the hydrogen flow was stopped without attempting ignition. Figure 2 shows the rise in hydrogen concentration over time under Series 1, 2 and 3 conditions.

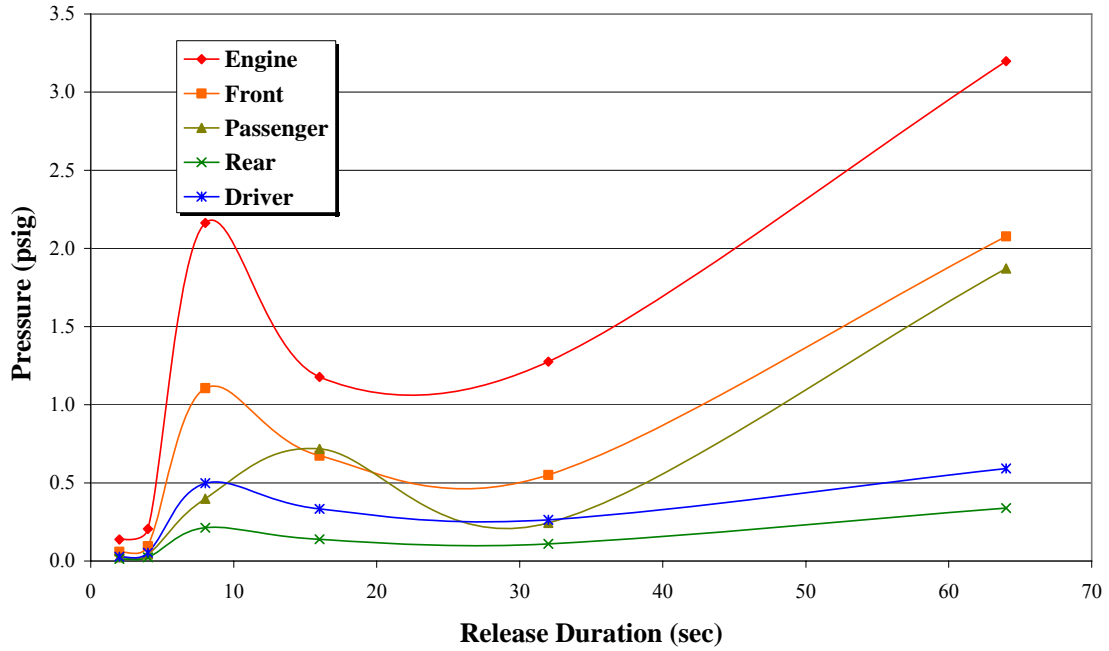
Figure 5. Maximum Pressures Obtained During Series 2 Tests.

Blast wave pressures were significantly higher in Series 2 than in Series 1. The highest pressures were consistently obtained inside the engine compartment. Engine compartment overpressures ranged from 0.14-psig (2-sec duration) to 3.2-psig (64-sec duration) at this location. The next highest pressures were obtained at the front of the vehicle (up to 2.08 psig) followed by the passenger and driver sides, and finally the rear of the vehicle. Most tests resulted in little to no damage to the vehicle. The pressure rise time in the 64-sec duration test was about 10 ms. Pressure rise times between 15 and 20 ms were recorded in the tests with lower peak pressures. The overpressure during the 64-sec duration leak caused severe deformation of the hood and loosening of the passenger side fender. This is contrary to the results of the 64-sec duration leak from the original Series 2 tests in which no significant damage occurred. Furthermore, several pressures in excess of 1 psig were recorded for releases of 8 sec or greater duration during the follow-up tests.

Figure 5 shows the blast wave pressures measured with respect to hydrogen-release duration for the Series 2 tests. Figure 6 depicts the damage that occurred to the hood during the 64-sec release test.

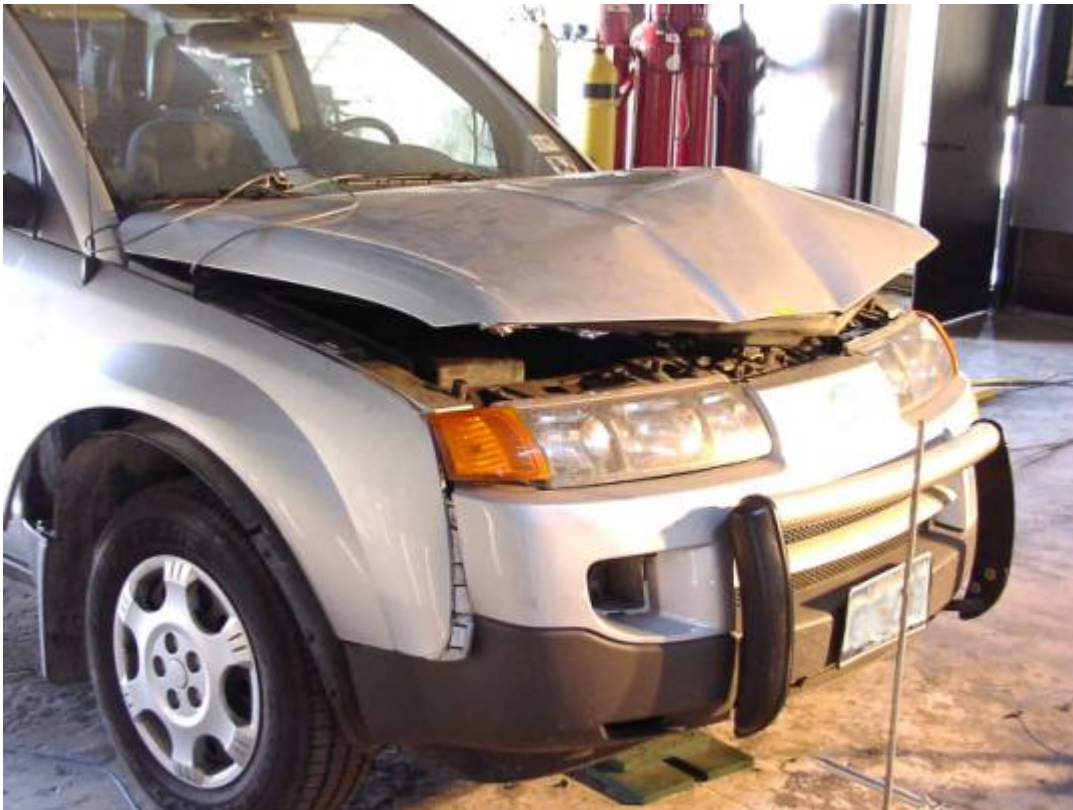
Figure 6. 64-Sec Duration Test – Damage to Hood Following Series 2 Tests.

Significant physical damage only occurred to the vehicle during the 64-sec duration 48-g/min engine-compartment hydrogen release during the follow-up tests. It appeared as though the majority of pressures measured in the follow-up Test Series 2 were higher than the initial Test Series 2, as they

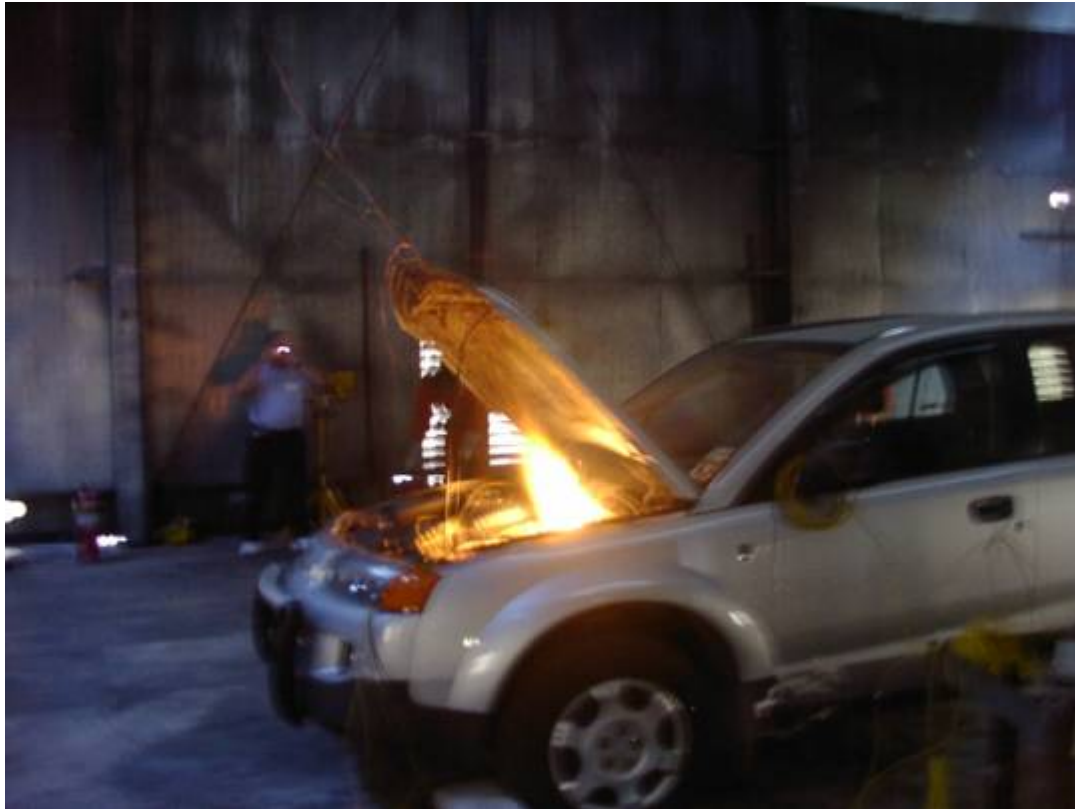
Figure F-7. Jet-Fire Length During Open Hood Test.

In Test No. 1, the visible jet fire appeared to reach 16 in. outside of the engine compartment, for a total length of approximately 32 in. from the nozzle. After a jet fire of 5.2 sec, the liner on the underside of the hood ignited. After the 9.8-sec duration jet fire, a plastic harness showed obvious deterioration, there was a hole in the hood liner, and the exterior of the hood showed slight warping and paint bubbling. After a 17.8-sec duration, the plastic harness was completely consumed, copper wires were severed, and the exterior of the hood was discolored with more warping and paint bubbling.

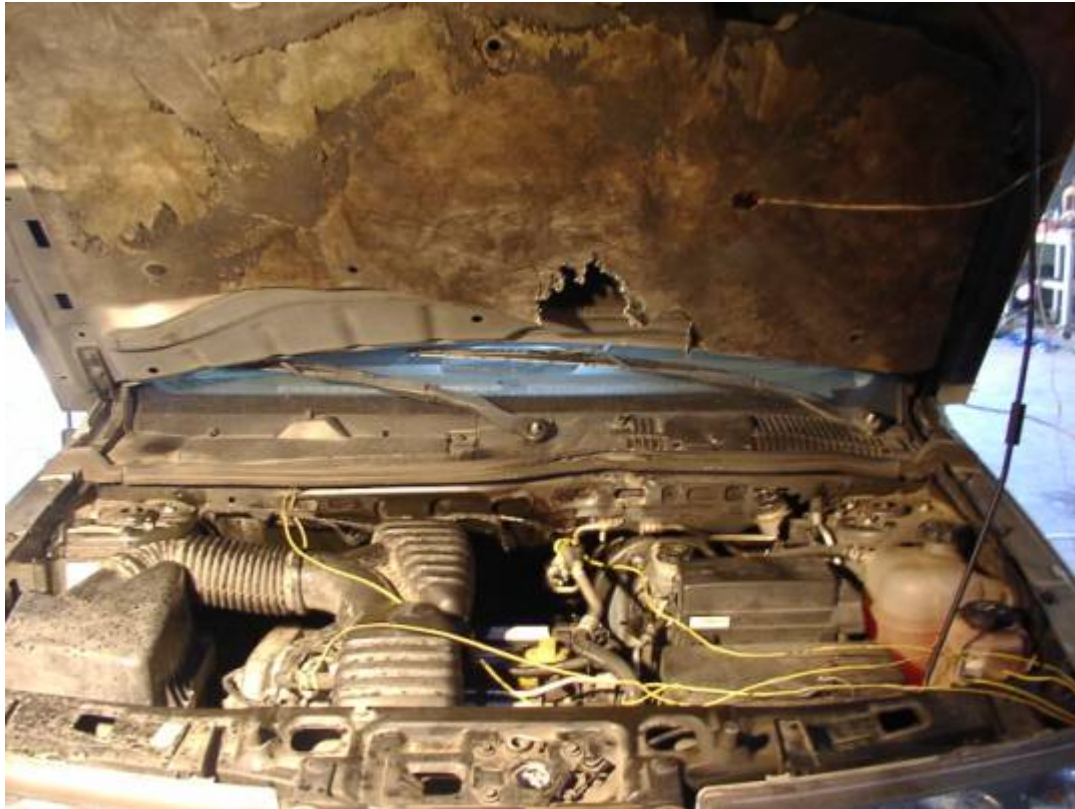
Figure F-9. Damage to Underside of Hood Liner Following Series 4 Tests.

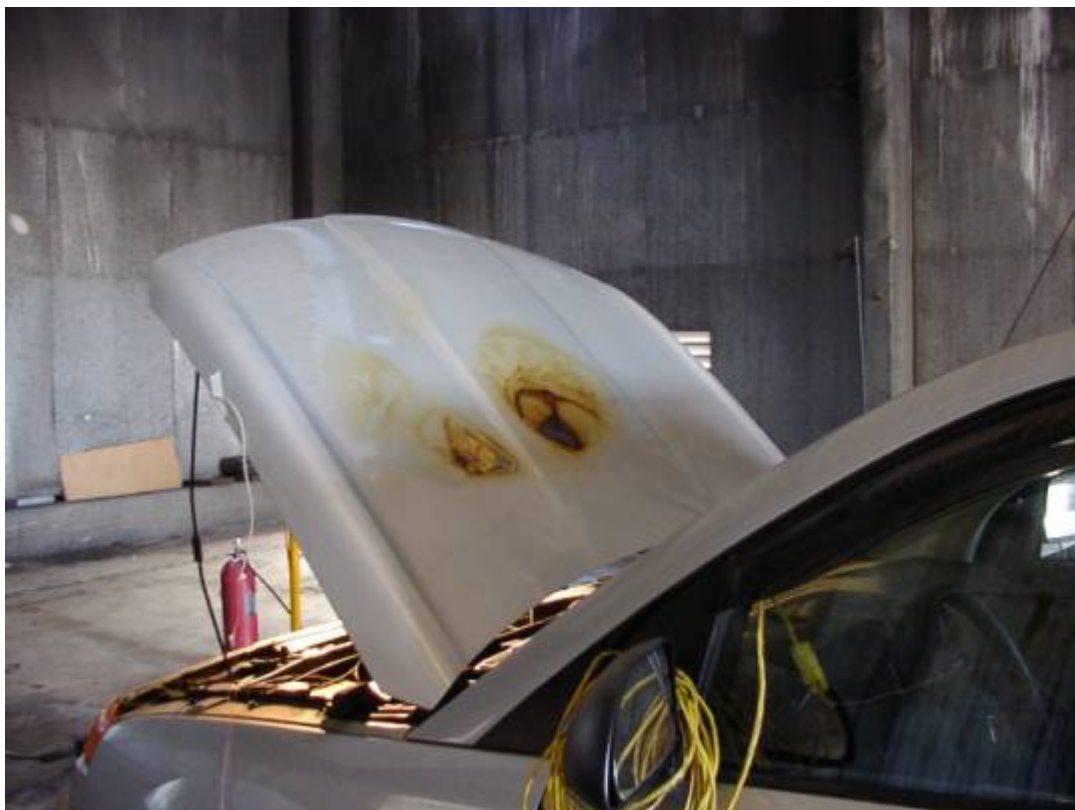
Figure F-10. Damage to Topside of Hood Following Series 4 Tests.

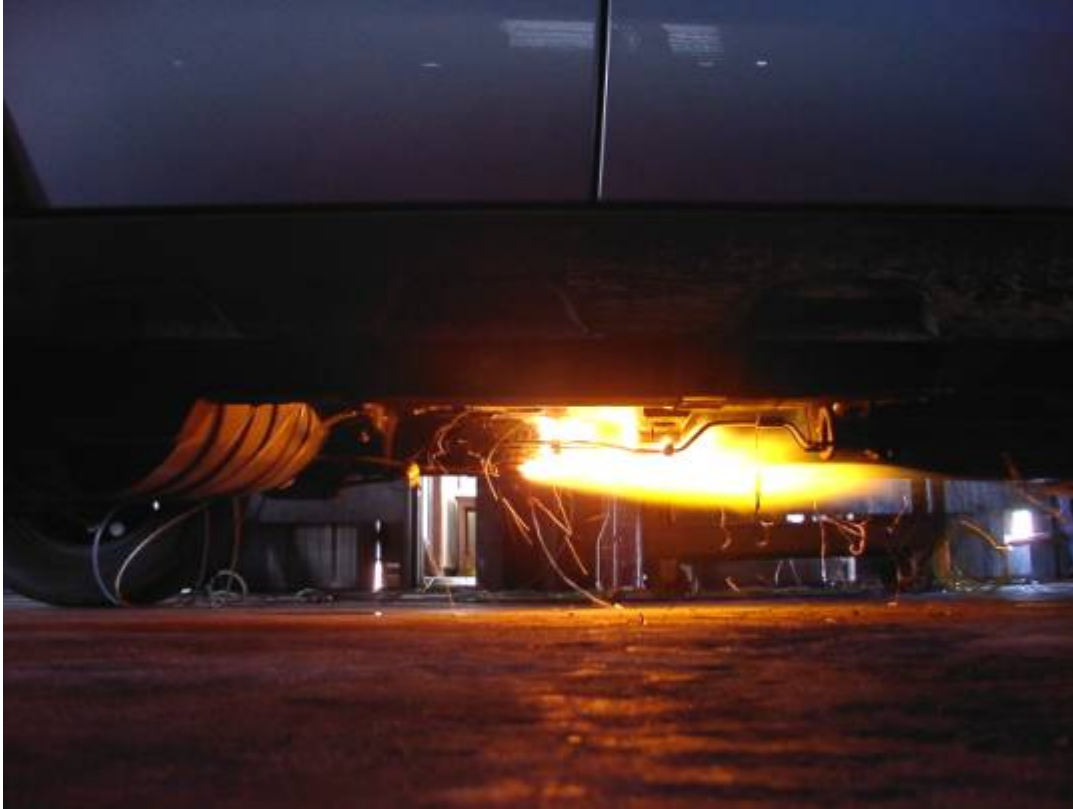
Figure F-11. View of Jet-Fire on Underside of Vehicle.

Even in the shortest duration test, the fuel lines were red hot and the plastic support brackets continued to burn following the test. For longer jet-fire durations, the fuel lines remained red hot for a longer period. After the final duration of 33 sec, the plastic bracket had been mostly consumed, but no other damage around the vehicle was evident. Peak heat fluxes measured in Series 5 tests were about 3600 Btu/ft²hr (11 kW/m²) as indicated in Table 1.
