Re: **Settlement Agreement**
Section B. Fire Safety Research

Field Investigation of Motor Vehicle Collision-Fires

Robert R. Scheibe
Golder Associates Inc.

ABSTRACT

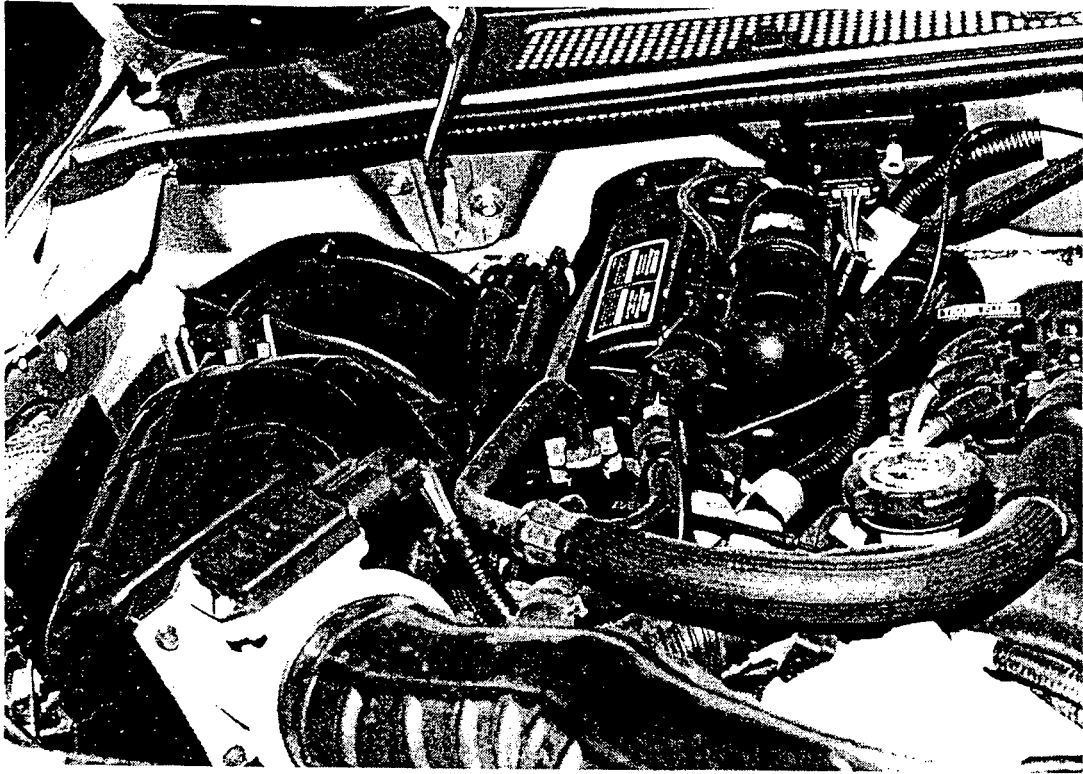
There was static crush distortion to the bulkhead in the blower housing mount location (Figure 4). Leftward dynamic crush likely caused contact between the blower housing and the cooling hose connection at the bulkhead because of the close proximity of these components (Figure 5). This could possibly have caused rupture of the cooling hose connection near the bulkhead, though physical evidence was destroyed in the fire. Figures 4 and 5 show the right rear of the engine compartment in incident and exemplar vehicles, respectively. Substantial impact damage to the right front wheel suggests that the right front brake hose may have ruptured but there was likely no brake fluid leakage communicated to the engine compartment beyond the fender skirt. The fender skirt was totally consumed in the subsequent fire and was not evident at the time of inspection. There were no other liquid fuels routed in or near the impact area of the engine compartment.

Figure 5. Investigation 2 exemplar SUV, looking rearward, showing passenger side of engine compartment
