**Evaluation of Motor Vehicle Fire Initiation and Propagation  
Part 3: Propagation of an Engine Compartment Fire in a 1996 Passenger  
Van**

Jeffrey Santrock  
General Motors Corporation

**ABSTRACT**

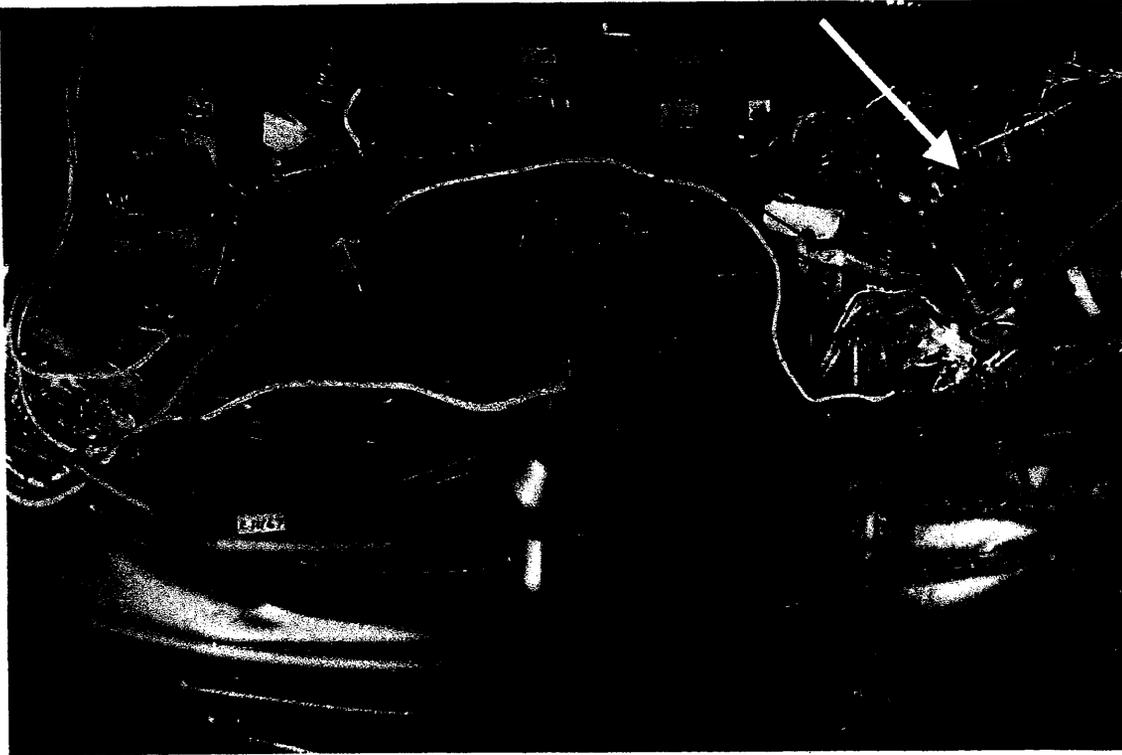
The igniter was placed between the battery and PDC, close to where flames were first observed during the crash test.

Figure 5. Fire Test F961115. Photograph of the igniter (arrow) inserted between the battery and power distribution center before the fire test. The hood was removed for this picture, and was replaced before the fire test was started.

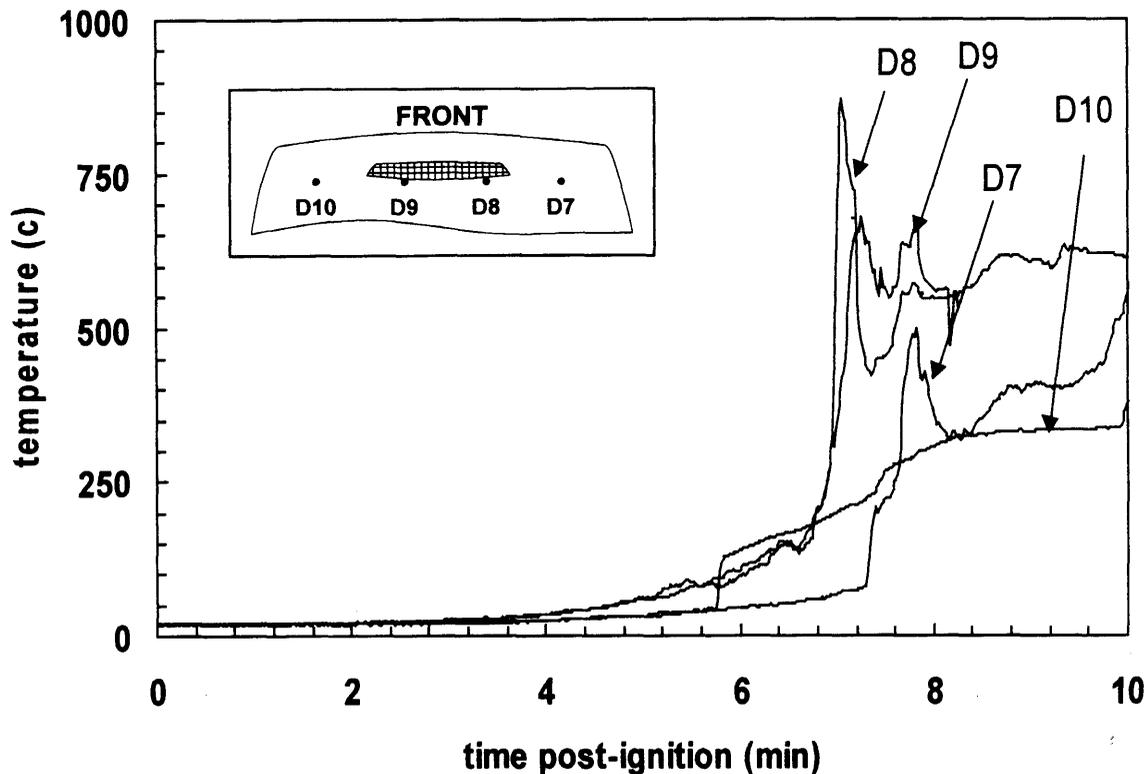
over the next two minutes. At first, the pieces of glass appear to have shielded the instrument panel from the flames. A combination of radiation from the flames in front of the windshield and pieces of burning windshield falling inward ignited the instrument panel top cover between 6 and 7 minutes post-ignition (see thermocouples D8 and D9, Fig. 33). Flames then spread laterally toward the left and right, and downward into the underlying defroster duct assembly over the next few minutes.

Figure 33. Fire Test F961115. Plots of temperatures recorded by thermocouples on the instrument panel top cover. The thermocouple junction of D9 failed shortly after 8 minutes post-ignition. The inset shows the locations of the thermocouples on the instrument panel top cover. See Figures A9 through A11 in **APPENDIX C** for the locations of the D thermocouples.

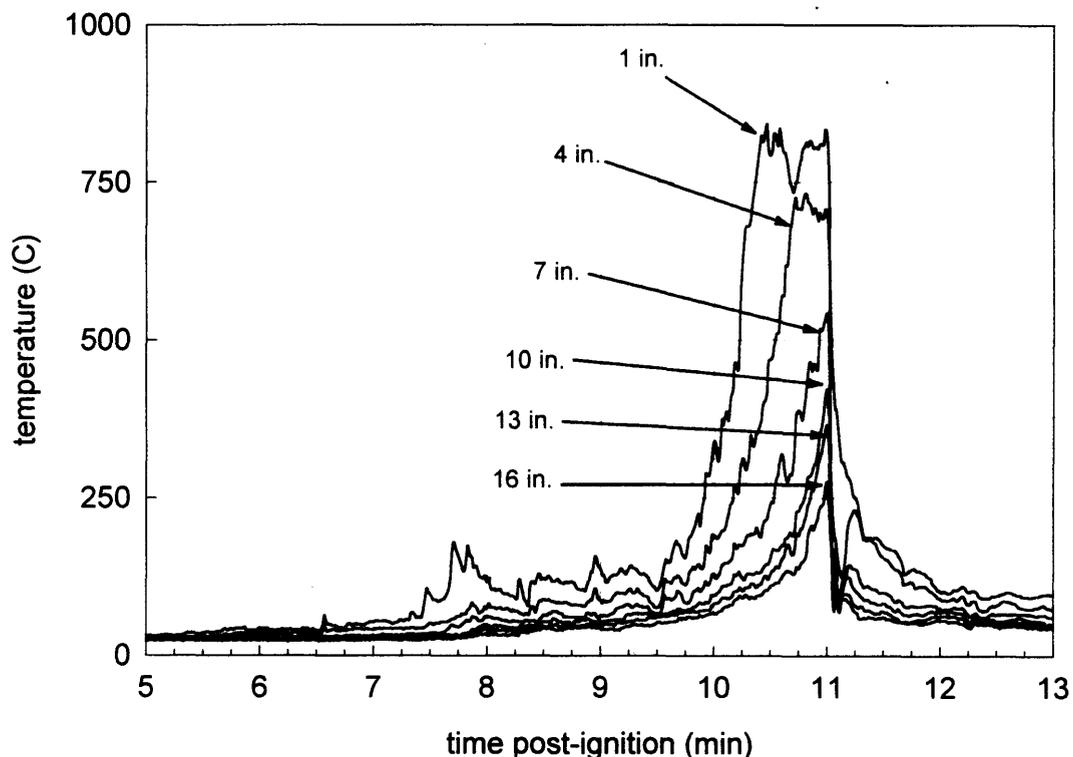
Figure 36 shows plots of air temperature at six heights in the passenger compartment: 1, 4, 7, 10, 13, and 16 inches below the lower surface of the headliner. The temperature of the layer of air just below the headliner (1 inch, Fig. 36) increased from about 50°C to greater than 100°C

between 7 and 8 minutes post-ignition. The air temperature 16 inches below the headliner was only 32°C. The concentrations of the measured combustion gases (measured 6 inches below the headliner) also started to accumulate in the passenger compartment between 7 and 8 minutes post-ignition (see **SECTION 8** and **APPENDIX I**).

A layer of heated combustible gasses produced by thermal decomposition of materials in the instrument panel, the deployed air bags, the interior trim panels, the front seats, and the carpet accumulated below the headliner of the test vehicle, and ignited between 9 and 10 ½ minutes post-ignition. The temperature recorded from the thermocouple closest to the headliner increased from approximately 150 to > 800°C between 9 and 10½ minutes post-ignition.

Figure 36. Fire Test F961115. Plots of air temperature in the passenger compartment measured 1, 4, 7, 10, 13, and 16 inches below the lower surface of the headlining.

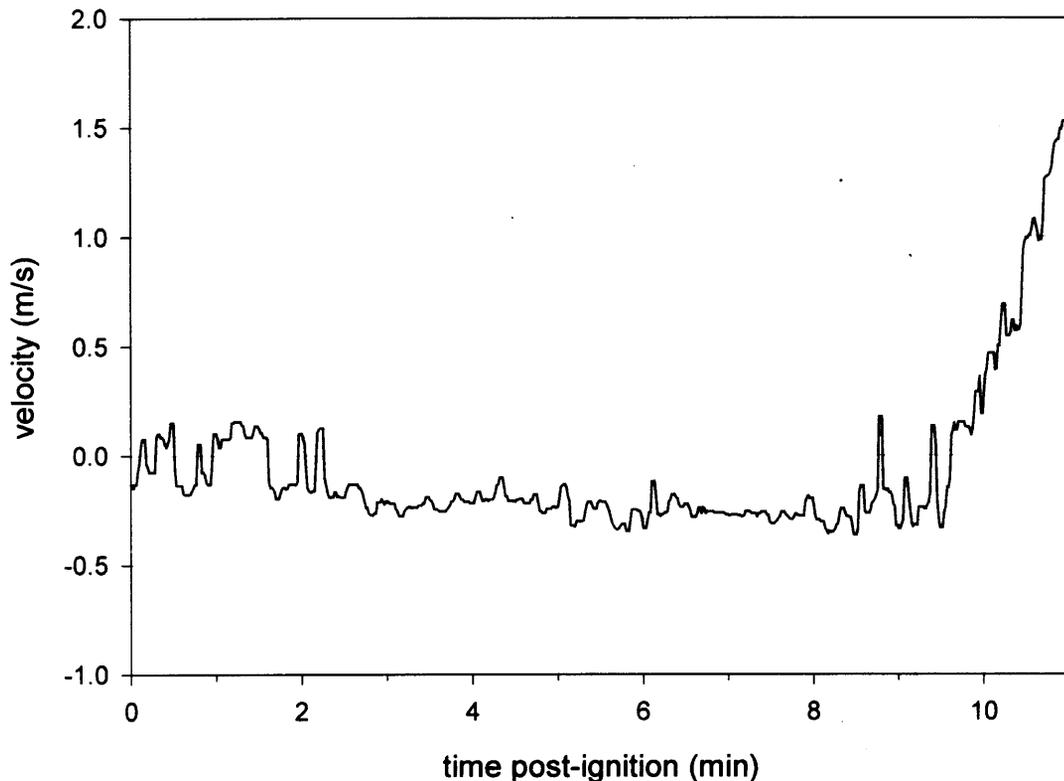
smoke being drawn out through the windshield (see Fig. 34). The linear velocity of airflow during this time varied between -0.15 and -0.25 m/s. The direction of airflow reversed and the velocity of airflow through the window opening increased at 9½ minutes post-ignition (Fig. 37). The measured airflow through the top of the driver's window was -0.25 m/s at 9½ minutes post-ignition (before ignition of the upper layer) and +1.5 m/s – net outflow of air from the passenger compartment – at 11 minutes post-ignition.

Figure 37. Fire Test F961115. Plot of airflow through the window in the driver's door. Velocity was measured using a bi-directional probe located at the top of the window opening in the driver's door. A positive velocity indicated net outflow and a negative velocity indicated net inflow.

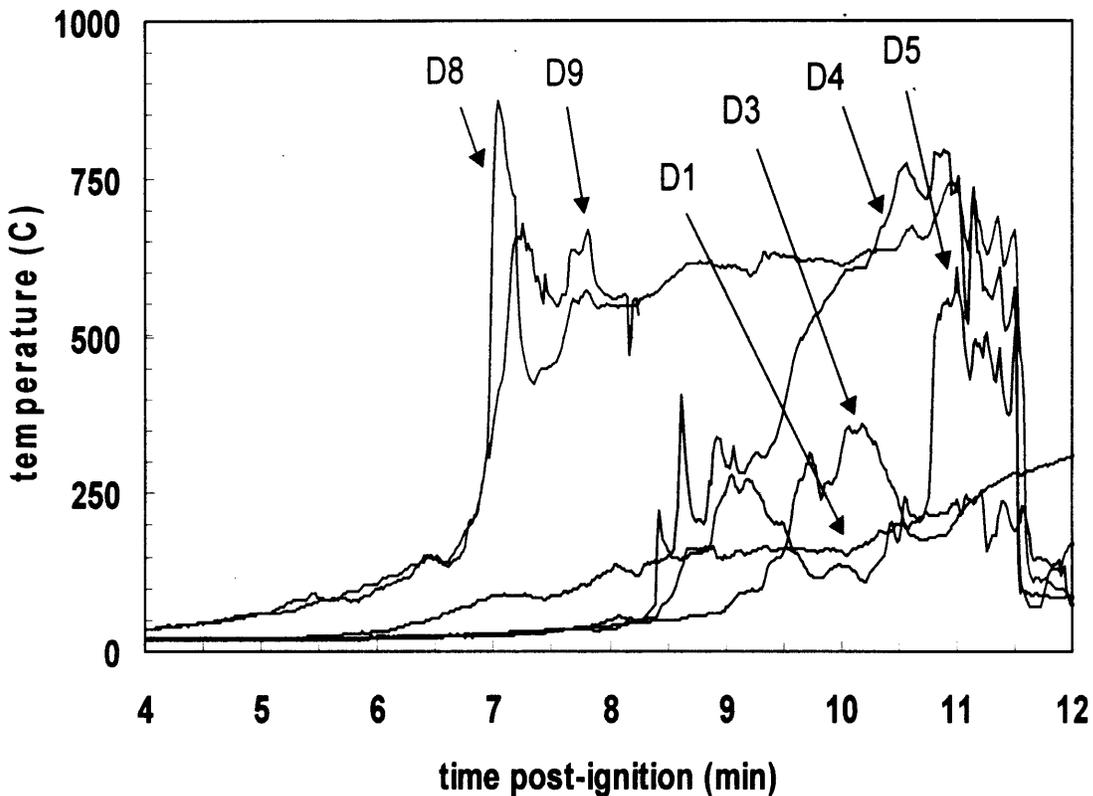
The thermocouple data and physical evidence obtained during inspection of the vehicle after the test indicated that flames spread from the instrument panel top cover downward into the HVAC demister and distribution ducts, and partially into the HVAC distribution housing. The center of the instrument panel top cover ignited about 7 minutes post-ignition (thermocouples D8 and D9, Fig. 38).

Figure 38. Fire Test F961115. Plots of temperatures recorded by thermocouples on the center of the instrument panel top cover (D8 and D9), in the left (D5), center (D4), and right (D3) of the distribution ducts, and in the upper section of the distribution housing (D1). See Figures C3 through C5 in **APPENDIX C** for the approximate locations of the D thermocouples in the test vehicle.

Hot gas and flames started to penetrate the center of the distribution duct assembly between 8 and 9 minutes post-ignition (Thermocouple D4, Fig. 38), which was burning by 10 minutes post-ignition. The distribution ducts extending to the left and right were not fully in flames when the

instrument panel was extinguished about 11½ minutes post-ignition (Thermocouples D3 and D5, Fig. 38). The temperature in the top of the distribution housing remained below 250°C throughout the test (Thermocouple D1, Fig. 38), indicating that the fire was extinguished before flames had spread to the bottom of the distribution housing. If there had been fire damage to the lower exterior surfaces of the distribution duct assembly and to the lower section of the distribution housing, it would have been nearly impossible to determine the direction of flame-spread in the center of the instrument panel. The absence of flame damage to the lower section of the distribution housing allowed unambiguous determination of flame-spread through the dash panel into the HVAC module (see **SECTION 6**).

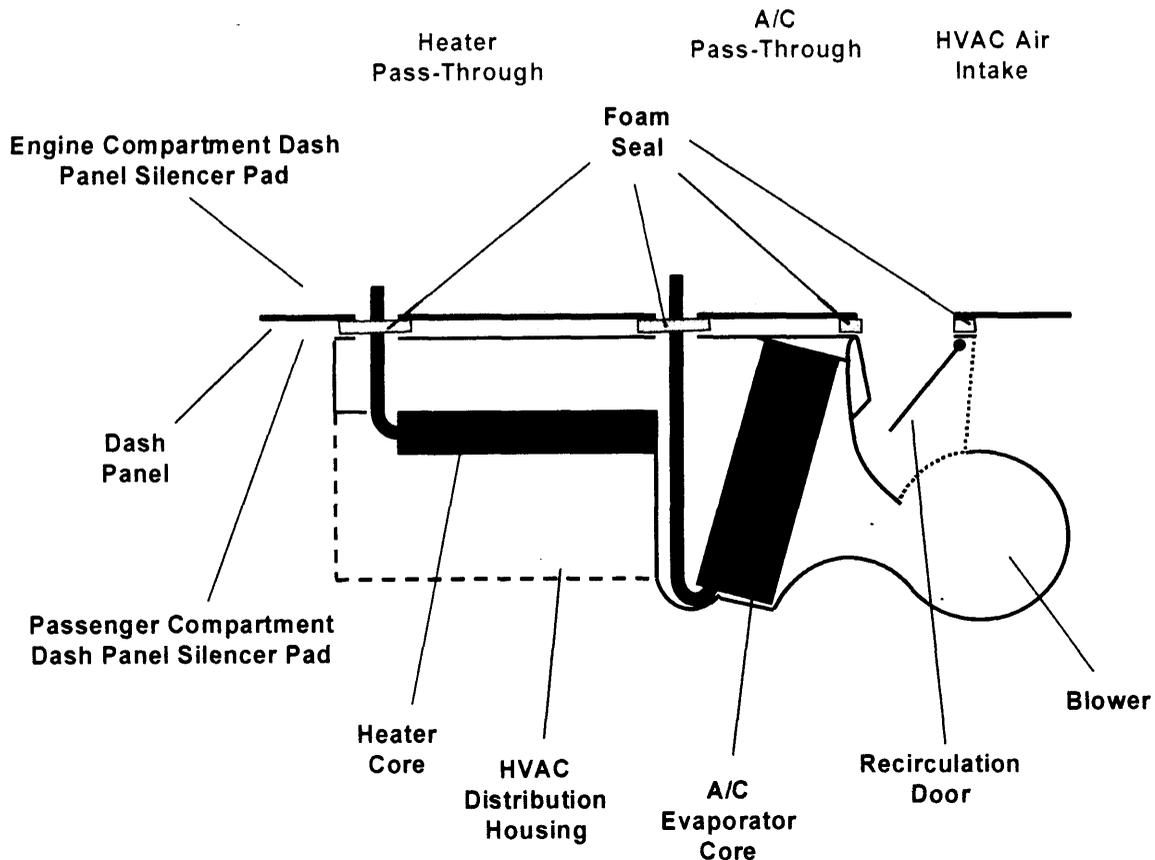
As stated in the **INTRODUCTION**, the residual crush to the front left corner of the test vehicle was 585 mm. The engine was displaced to the right and rearward against the dash panel, causing the right side of the dash panel to buckle inward where it was loaded by the displaced engine. The master cylinder power booster was crushed against the dash panel, blocking the brake-linkage pass-through. The steering-column pass-through was low in the dash panel and covered by a rubber boot, which remained intact after the crash test. The heater pass-through, the A/C pass-through, the condensate drain pass-through, and the HVAC air intake open into the HVAC module, which mounts to the interior face of the dash panel. The diagram below shows a top-view of the HVAC module mounted to the dash panel as it appeared in the test vehicle before the crash test. As a result of the deformation to the right side of the dash panel, the HVAC module broke in several places, and was dislodged rearward from its mounts to the dash panel.

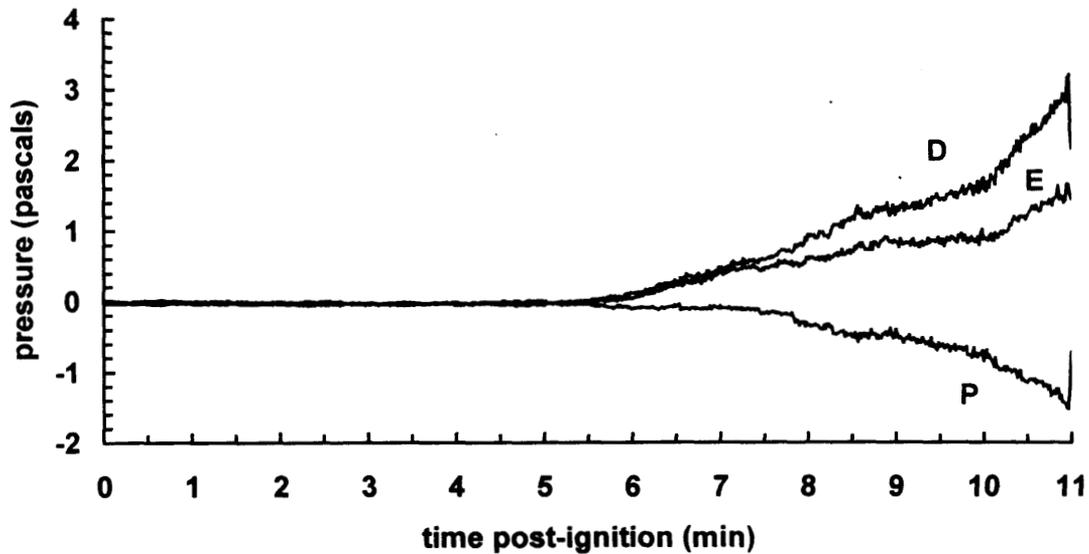
Pressure measurements at the exterior and the interior faces of the dash panel in the area of the heater and A/C pass-throughs indicated that there was no difference in pressure until about 5½ minutes post-ignition (Fig. 45).

Figure 45. Fire Test F961115. Plots of pressures measured at the dash panel. Pressure taps were located in the approximate center of the dash panel. Curve P is the pressure in the passenger compartment relative to atmosphere; Curve E is the pressure in the engine compartment relative to atmosphere; and Curve D is the differential pressure across the dash panel ( $P_D = P_E - P_P$ ). A positive value indicates the pressure was greater in the engine compartment than in the passenger compartment.

post-ignition to about 20 kW/m<sup>2</sup> at this time (HFT2, Fig. 47). These results indicate that flames were contacting the exterior surface of the silencer pad above the heater pass-through between 6 and 7 minutes post-ignition. The timing of flame-contact with the silencer pad in this location was coincident with the development of a pressure gradient of approximately 1 Pa across the dash panel (Fig. 45).

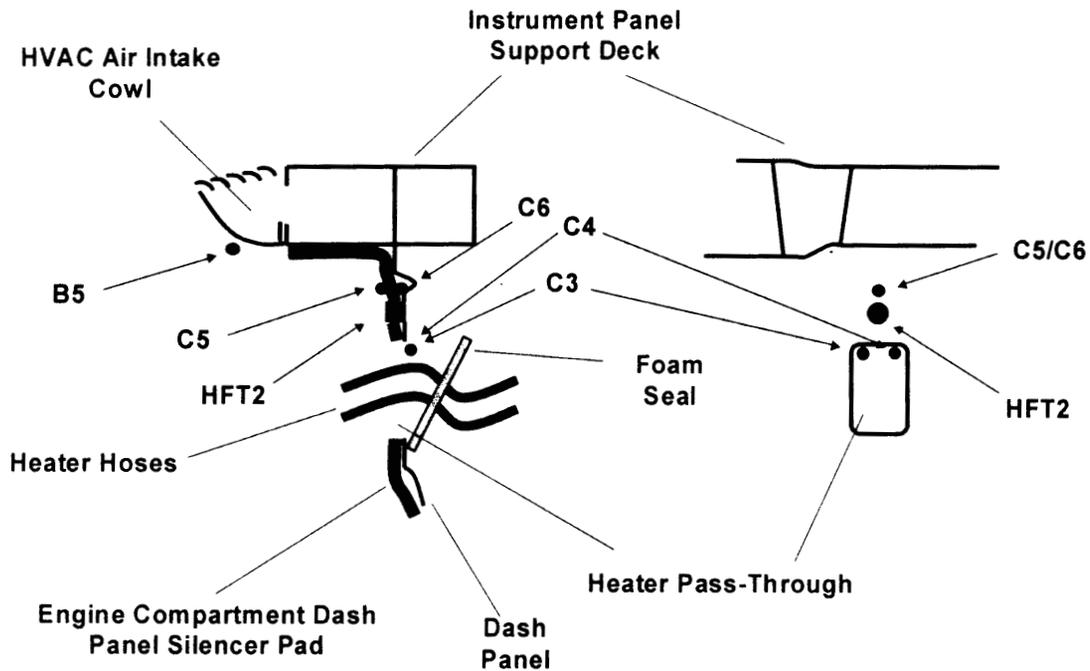
The pattern of fire damage to components in the instrument panel suggested that flames and hot gas entered the passenger compartment through three openings in the dash panel: the heater pass-through, the A/C pass-through, and the HVAC air intake. Figure 46 shows the locations of thermocouples and the heat flux transducer/radiometer assembly around the heater pass-through. The data from thermocouple B5 (Fig. 47) indicates that the outer surfaces of the air intake cowl above the heater pass-through was burning by about 4 minutes post-ignition. The temperature at the exterior surface of the engine compartment dash panel silencer pad above the heater pass-through started to increase about 4 minutes post-ignition, but remained less than 600°C until approximately 6½ minutes post-ignition (Thermocouple C5, Fig. 47). The measured heat flux to the exterior surface of the silencer pad at this location increased from 2 to 4 kW/m<sup>2</sup> at 4 minutes

Figure 46. Fire Test F961115. Diagrams of the instrumentation in the dash panel around the heater pass-through. The diagram at the left is a schematic cross-section of the dash panel through the center of the heater pass-through. The diagram at the right is a schematic view of the interior face of the dash panel showing the heater pass-through. Thermocouple B5 was attached to the lower exterior surface of the HVAC air intake cowl above the heater pass-through. Heat-flux transducer 2 (HFT2) was inserted through the dash panel and engine-compartment-dash-panel-silencer pad just above the heater-hose pass-through. Thermocouples C3 and C4 were positioned in the gap between the dash panel and the dislodged foam seal. Thermocouple C5 was located above HFT2 approximately 1 cm in front of the silencer pad. Thermocouple C6 was located above HFT2 between the silencer pad and dash panel.

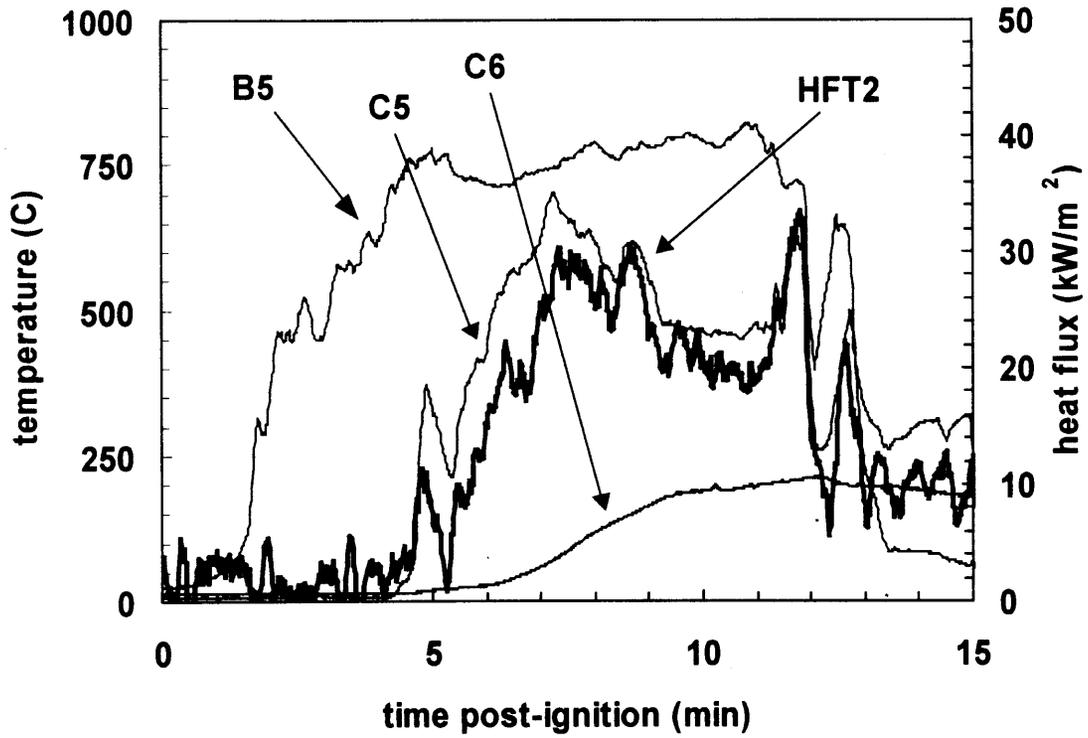
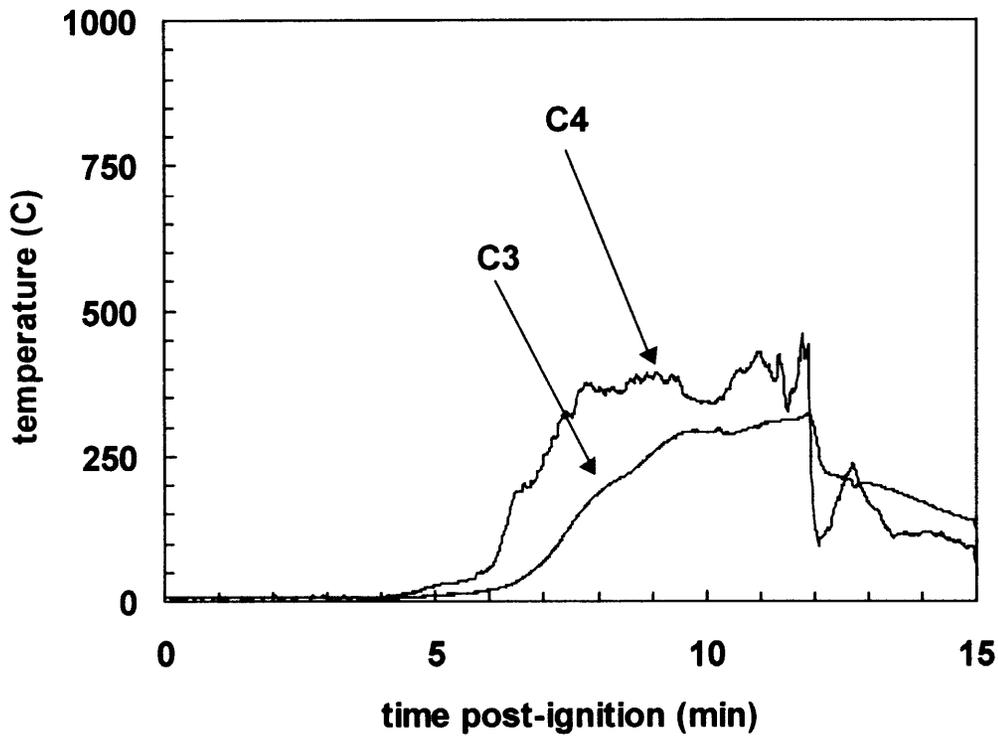
Figure 47. Fire Test F961115. Plots of temperatures recorded by Thermocouples B5, C5, and C6, and the heat-flux measured by HFT2 (upper panel), and temperatures recorded by Thermocouples C3 and C4 (lower panel).

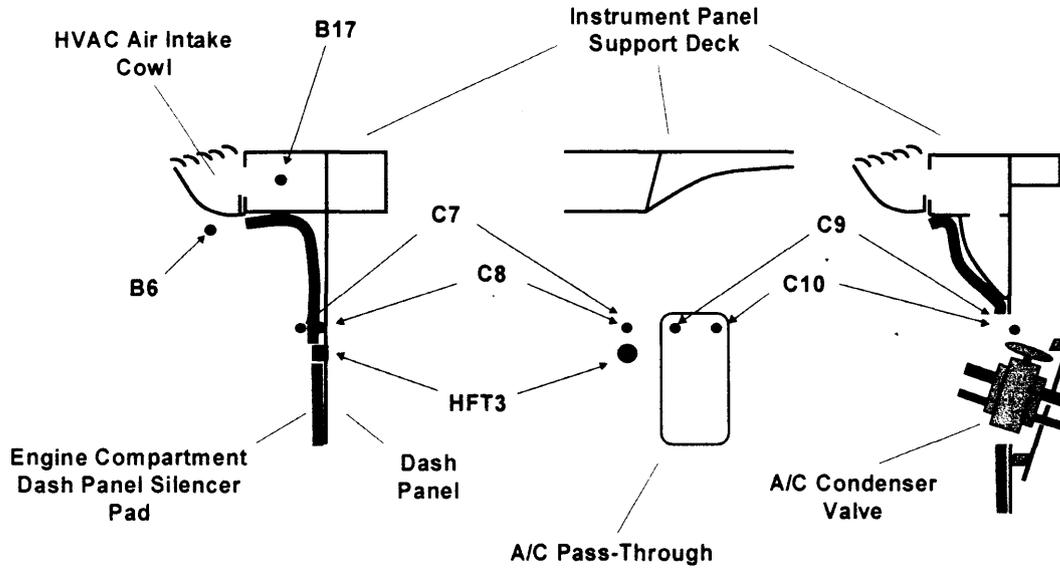
Flames also began to contact the exterior surface of the engine-compartment-dash-panel silencer pad around the A/C pass-through between 6 and 7 minutes post-ignition. Figure 50 shows the locations of the thermocouples and the heat flux transducer/radiometer assembly around the A/C pass-through. The temperature recorded at the surface of the silencer pad (C7, Fig. 51) increased rapidly from ambient to approximately 600°C between 5 and 6 ½ minutes post-ignition. The heat flux to the exterior surface of the silencer pad increased from less than 5 to approximately 30 kW/m<sup>2</sup> at this time (HFT3, Fig. 51). The temperature recorded by thermocouple C8 remained less than 150°C throughout the test. As before, the start of flame contact with the silencer pad correlated closely with the development of a pressure gradient across the dash panel (Fig. 45), and not the presence of flames on the HVAC air intake cowl above this area (B6, Fig. 51).

Figure 50. Fire Test F961115. Diagrams showing the location of instrumentation in the dash panel around the A/C pass-through. The diagram at the left is a schematic cross-section of the dash panel to the left of the A/C refrigerant line pass-through. The diagram in the center is a view of the interior face of the dash panel. The diagram at the right is a schematic cross-section of the dash panel through the A/C refrigerant line pass-through. Thermocouples B6 and B17 were located on the lower exterior surface of the HVAC air intake cowl and inside the metal duct behind the intake cowl, respectively. Heat-flux Transducer 3 (HFT3) was inserted through the dash panel and engine-compartment-dash-panel-silencer pad to the left of the A/C pass-through. Thermocouple C7 was located above HFT2 approximately 1 cm in front of the silencer pad. Thermocouple C8 was located above HFT2 between the silencer pad and dash panel. Thermocouples C9 and C10 were positioned in the gap between the dash panel and the dislodged condenser valve/sealing plate assembly.

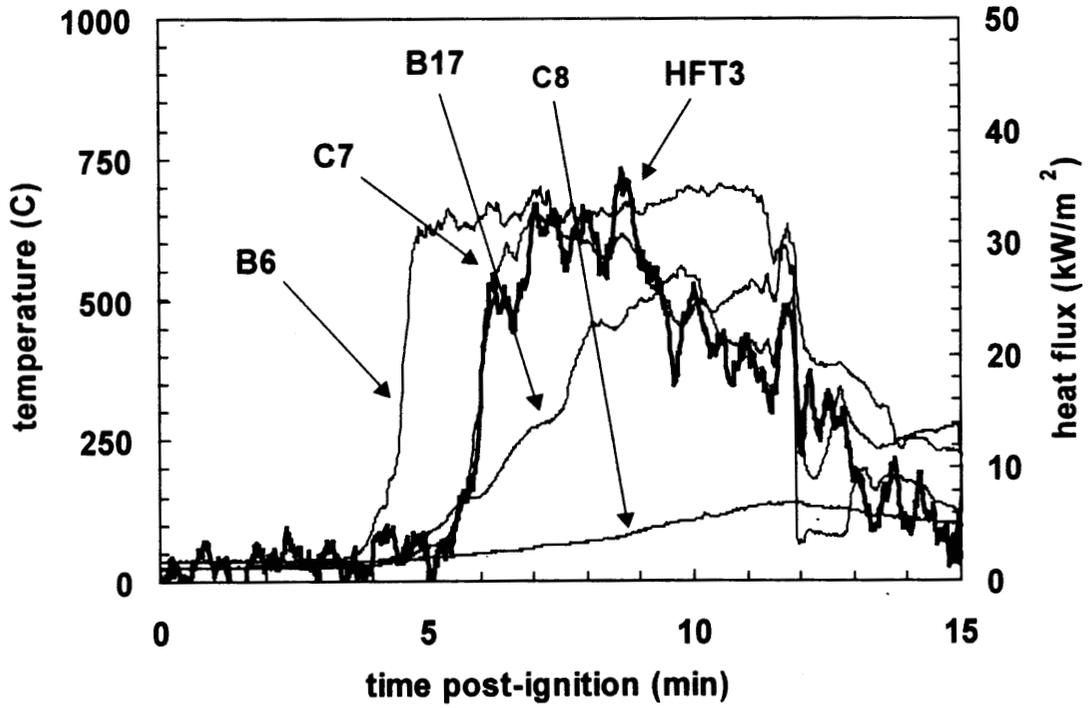
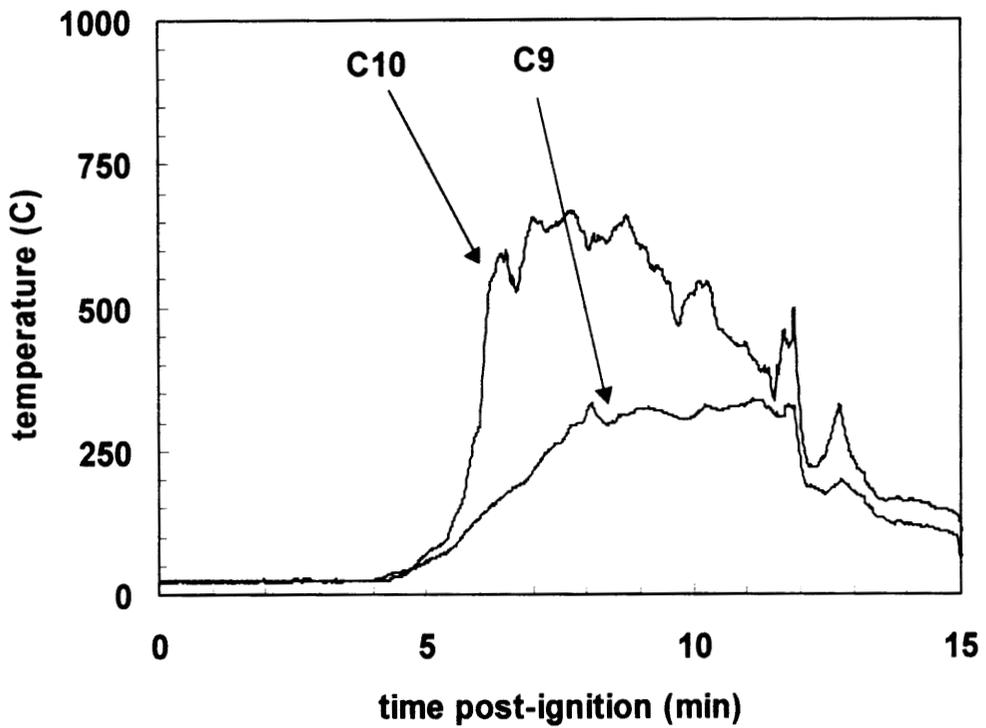
Flames penetrated the dash panel through the upper right corner of the A/C pass-through. Temperatures recorded by the thermocouple in the upper left corner of the A/C pass-through were less than 300°C throughout the test (C9, Fig. 51). In contrast, temperatures recorded by the thermocouple in the upper right corner (C10, Fig. 51) exceeded the flame-threshold of 600°C from approximately 6½ to 9 minutes post-ignition (C7, Fig. 51). The passenger-compartment dash-panel silencer pad was melted and burned-through in this area (Fig. 52, upper photograph). The flexible foam backing was eroded and charred above the A/C pass-through, and a thick layer of

Figure 51. Fire Test F961115. Plots of temperatures recorded by Thermocouples C7 and C8 (upper panel, heat-flux measured by HFT3 (upper panel), and temperatures recorded by thermocouples C9 and C10 (lower panel).

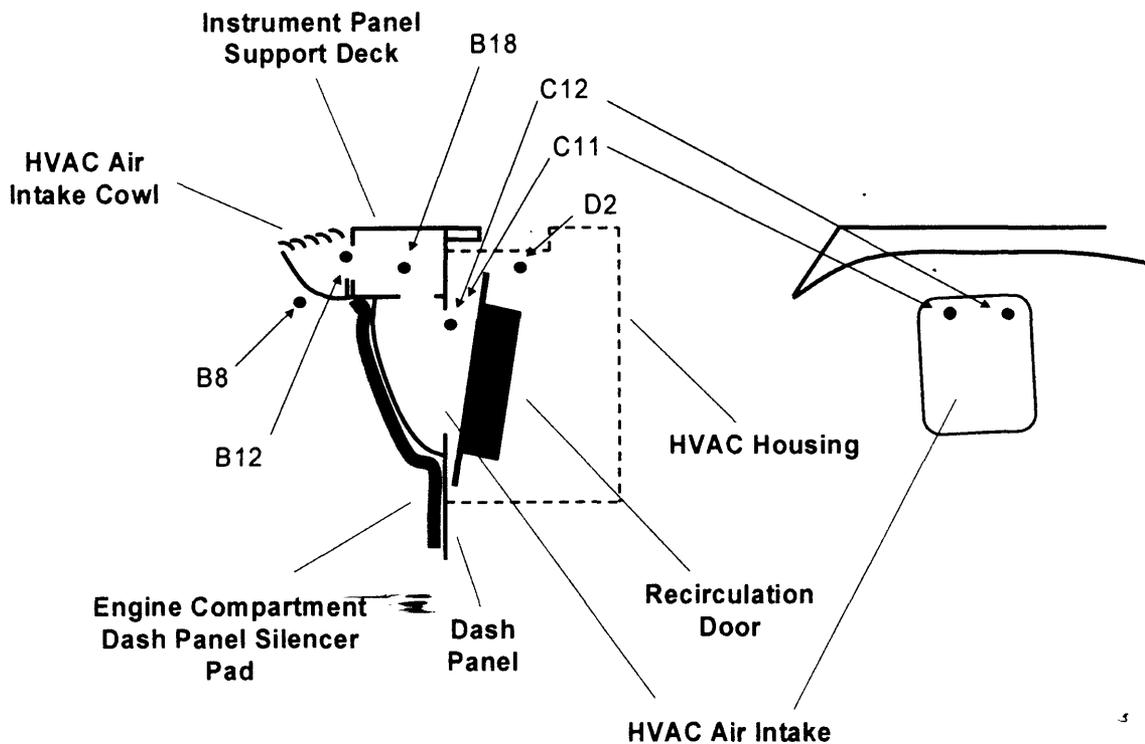
Evidence of flame-spread through the HVAC air intake from the thermocouple data is ambiguous. Figure 53 shows the locations of thermocouples around the HVAC air intake. Thermocouples B8 and B12 indicated flames below and in the air intake cowl above the HVAC air intake from 5 minutes post-ignition to the end of the test (Fig. 54). Although the temperatures recorded by thermocouples B18, and C11 and C12 increased sharply between 5 and 6 minutes post-ignition, they remained less than 600°C throughout the test. These thermocouples were in the path from the cowl to the HVAC air intake, suggesting that flames did not reach the air intake.

Fire damage to the recirculation door (Fig. 55) and the passenger-compartment-dash-panel silencer pad suggest direct exposure to flames (Fig. 56, upper photograph). In addition, thermocouple D2 measured several temperature-spikes exceeding 850°C in the HVAC blower housing from 10 minutes post-ignition to the end of the test, clearly indicating the presence of flames inside the HVAC module. A fire plume entering the center of the HVAC air intake may have missed thermocouples C11 and C12, which were positioned close to the upper-left and upper-right corners of the opening (Fig. 53).

Figure 53. Fire Test F961115. Diagrams showing the locations of thermocouples in the dash panel and HVAC module around the HVAC air intake. The diagram at the left is a schematic cross-section of the dash panel through the HVAC air intake. The diagram at the right is a view of the interior face of the dash panel. The dashed line indicates the approximate outline of the HVAC module. Thermocouples B8, B12, and B18 were located on the lower exterior surface of the HVAC air intake cowl, inside the HVAC air intake cowl, and inside the metal duct behind the intake cowl, respectively. Thermocouples C11 and C12 were positioned in the gap between the air intake and the recirculation door. Thermocouple D2 was in the HVAC module between the recirculation door and blower.

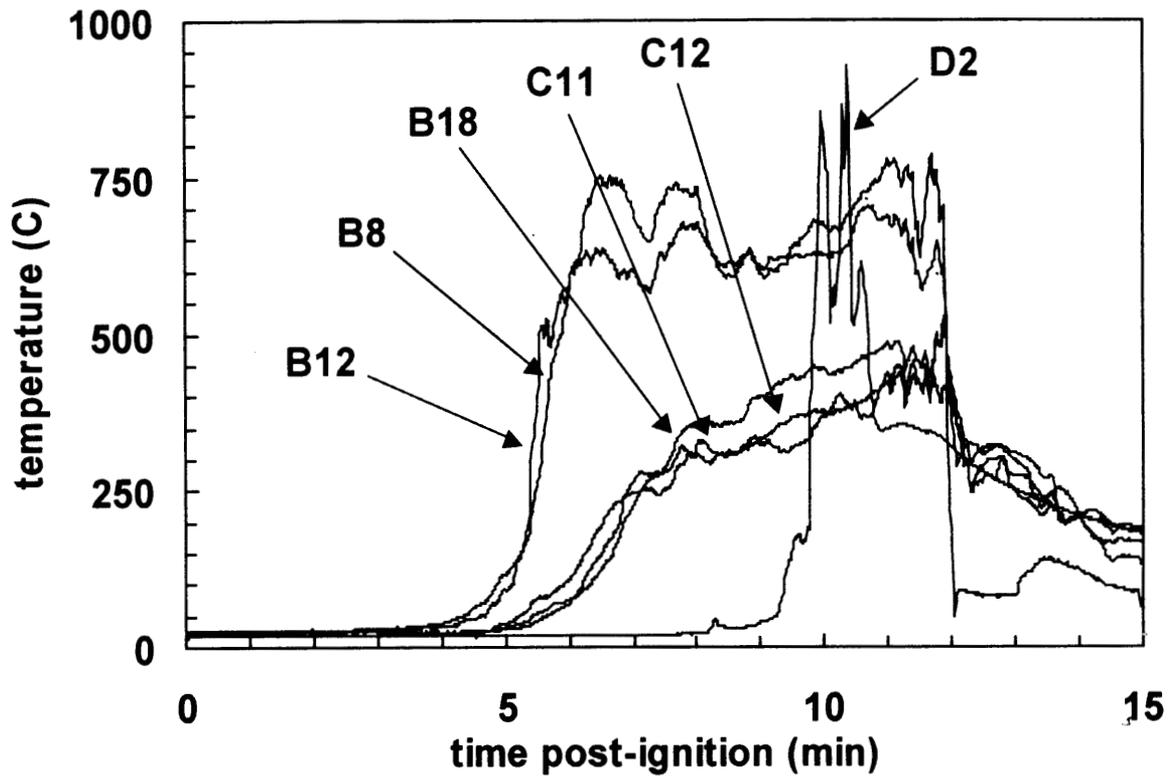
Figure 54. Fire Test F961115. Plots of the data recorded by the thermocouples in the dash panel and HVAC module around the HVAC air intake.

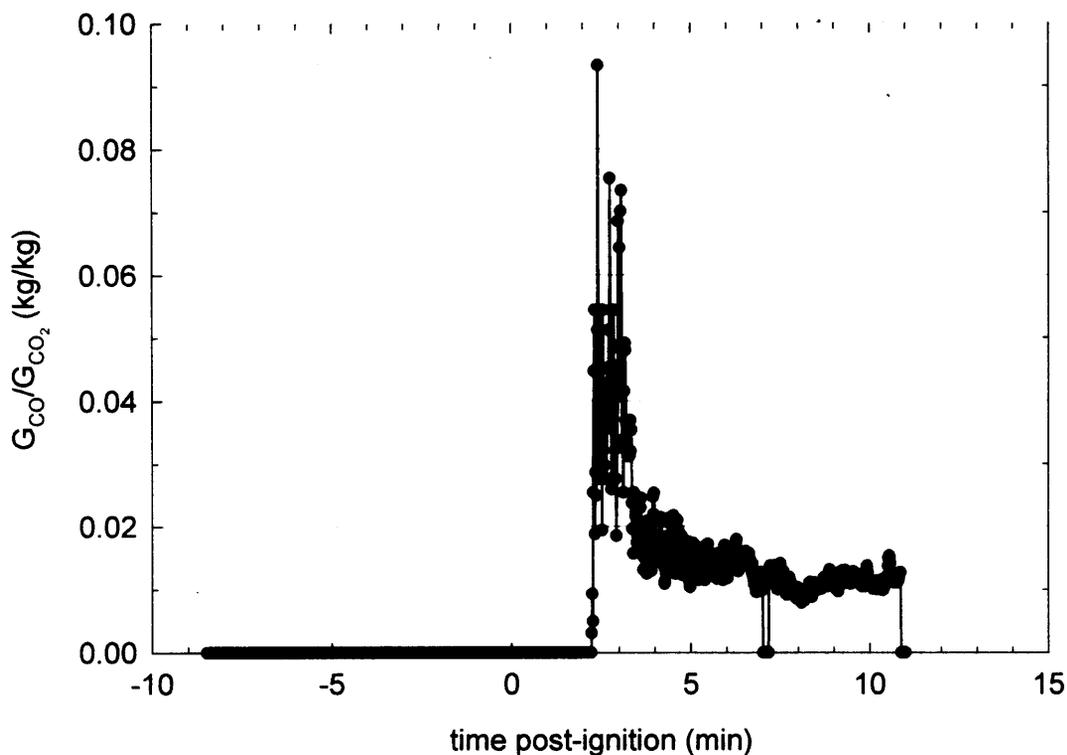
Analysis of the data from the Fire Products Collector suggests that initially, the production of carbon monoxide relative to carbon dioxide was greater than expected for well-ventilated combustion of materials typical of those used in the test vehicle. Figure 58 shows a plot of  $[G_{\text{CO}}]/[G_{\text{CO}_2}]$  versus time post-ignition, where  $G_{\text{CO}}$  and  $G_{\text{CO}_2}$  are the carbon monoxide- and carbon dioxide-release rates measured using the Fire Products Collector (**APPENDIX H**).

Figure 58. Fire Test F961115. Plot of  $[G_{\text{CO}}]/[G_{\text{CO}_2}]$  versus time post-ignition determined from the carbon monoxide and carbon dioxide release rates measured by the Fire Products Collector.

The ratio  $[G_{\text{CO}}]/[G_{\text{CO}_2}]$  is equivalent to the ratio  $[Y(\text{CO})]/[Y(\text{CO}_2)]$  determined for individual materials listed in Table 1. Before ignition,  $[G_{\text{CO}}]/[G_{\text{CO}_2}]$  was undefined because  $G_{\text{CO}} = G_{\text{CO}_2} = 0$ . The value of  $[G_{\text{CO}}]/[G_{\text{CO}_2}]$  increased rapidly starting at approximately  $\frac{1}{2}$  minute post-ignition,

reaching a maximum of almost 0.1 at approximately 1 minute post-ignition. In contrast, the value of  $[Y(\text{CO})]/[Y(\text{CO}_2)]$  determined for well-ventilated combustion of representative materials was in the range of 0.06 to 0.05 (Table 1). The cause of the initial peak in  $[G_{\text{CO}}]/[G_{\text{CO}_2}]$  is unclear; the initial burning did not appear to have been under-ventilated.

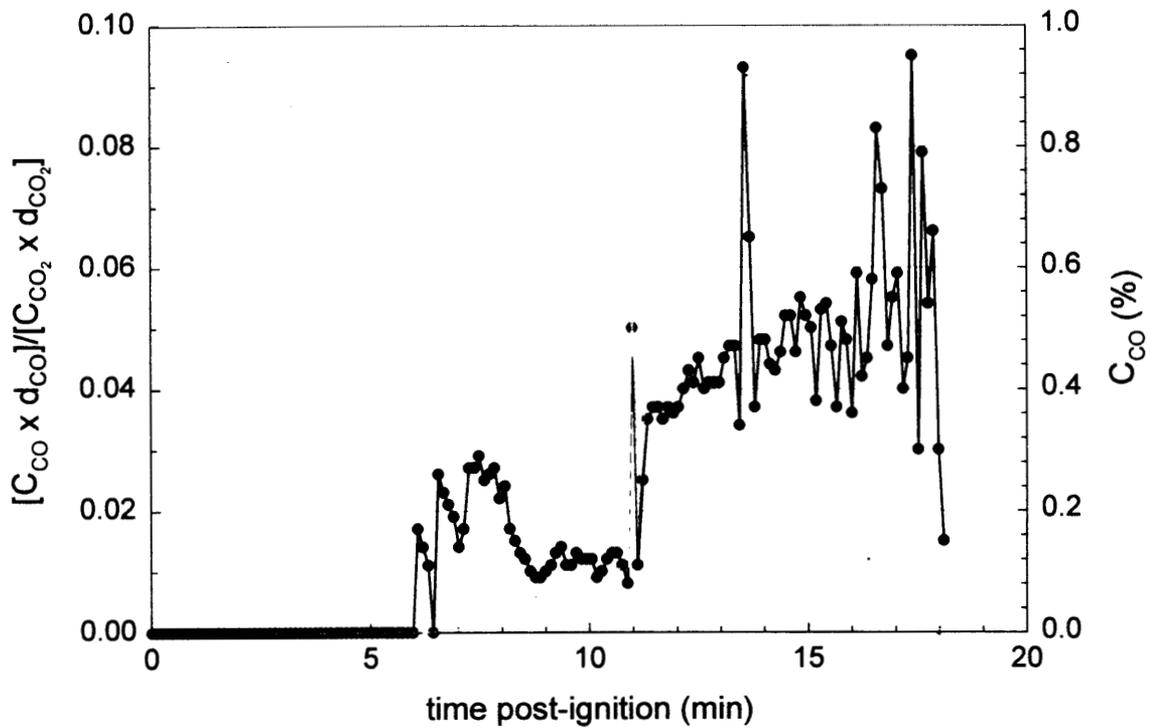
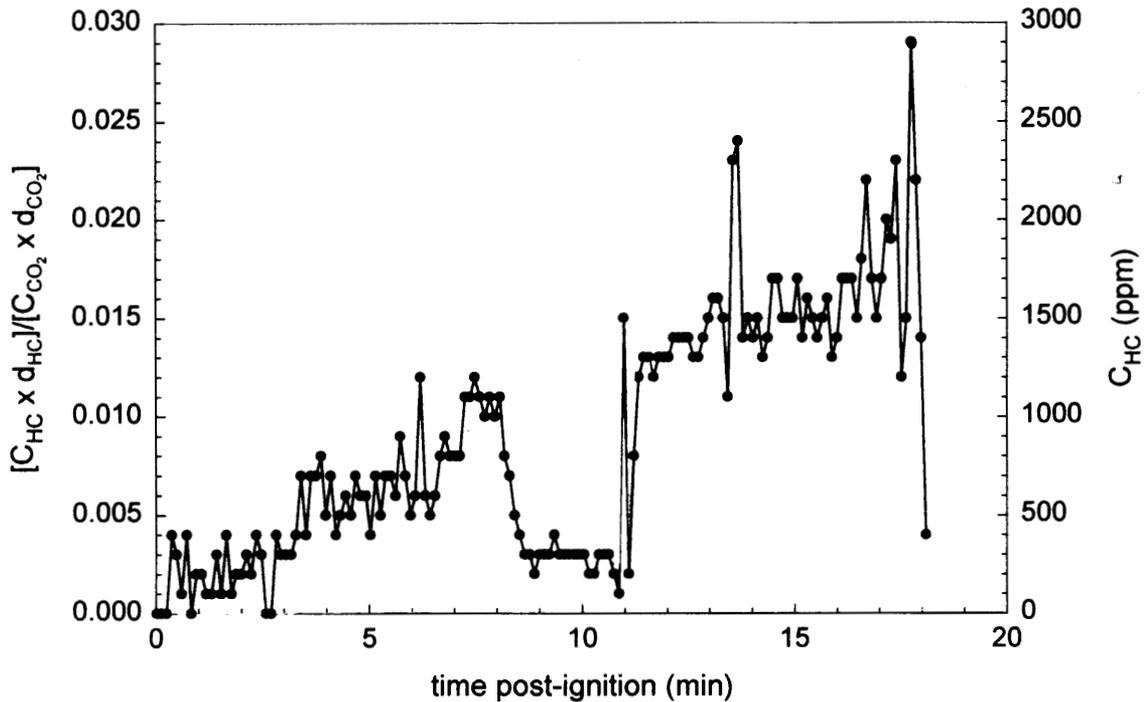
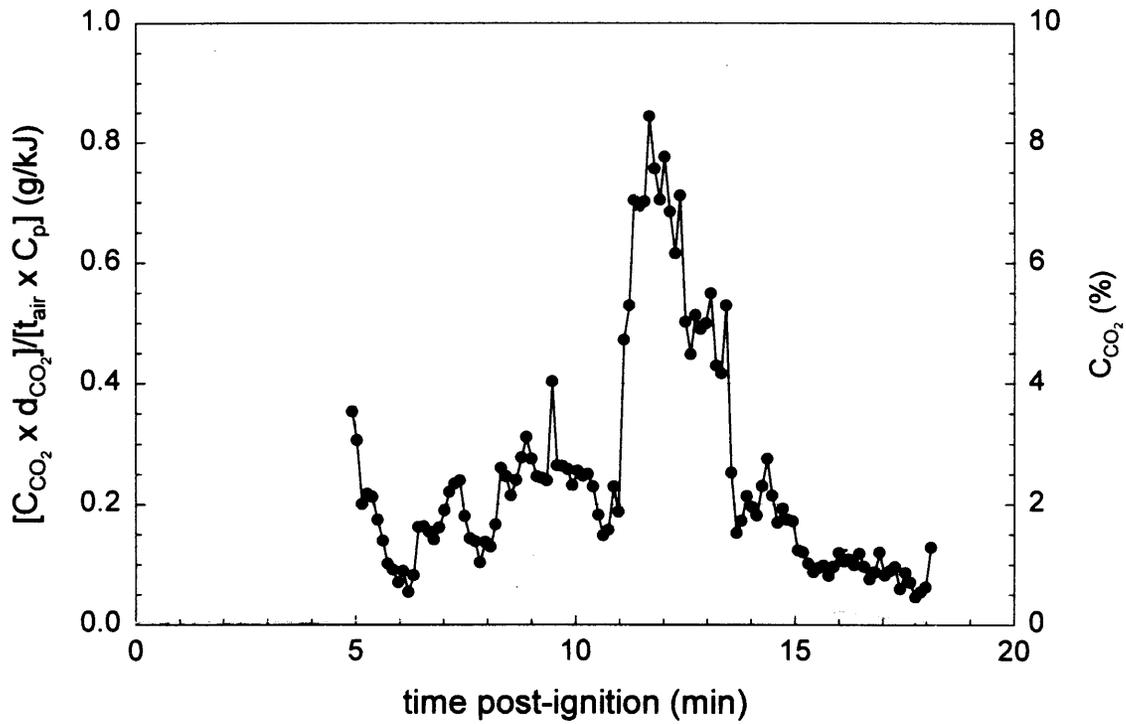
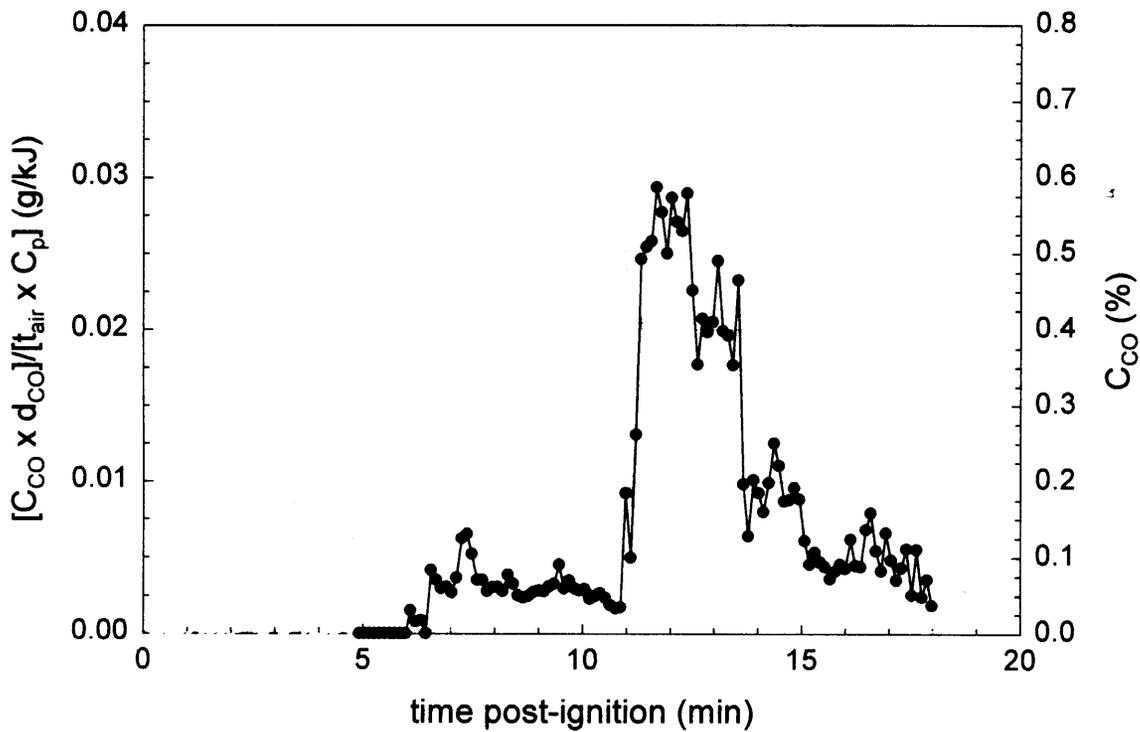
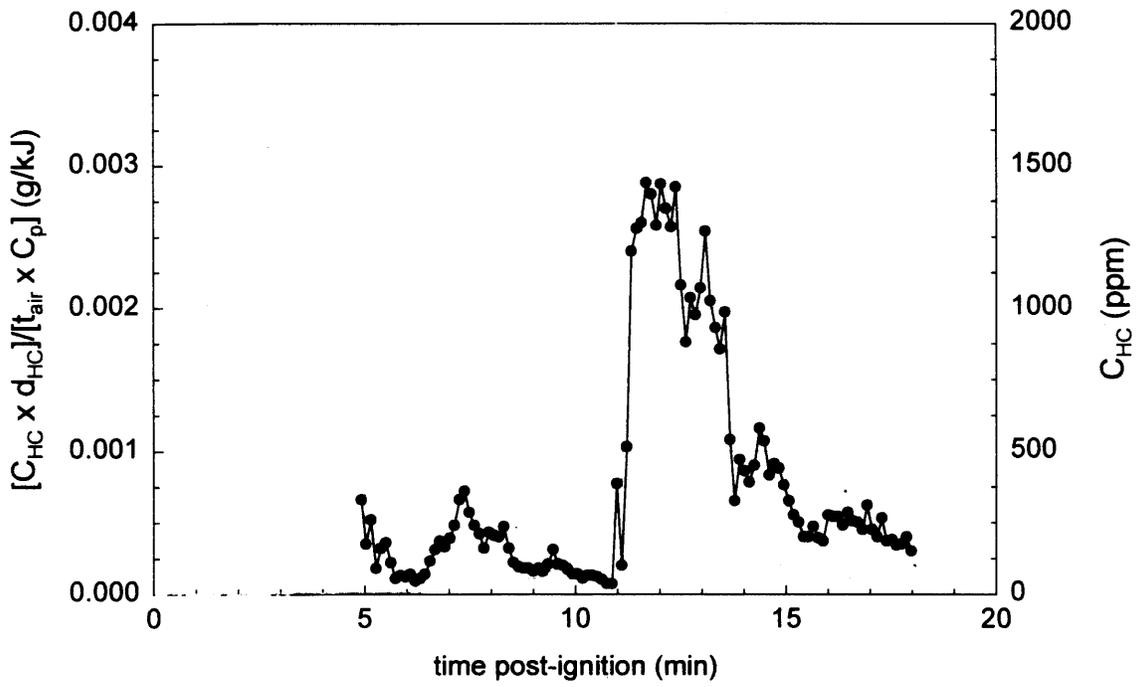
The values of the ratios shown in Figures 59 through 63 were within the ranges expected for well-ventilated combustion from between 7 and 8 minutes post-ignition until flames in the passenger compartment were extinguished at approximately 11 minutes post-ignition:  $0.01 < [C_{\text{CO}} \times d_{\text{CO}}]/[C_{\text{CO}_2} \times d_{\text{CO}_2}] < 0.024$ ;  $0.001 < [C_{\text{HC}} \times d_{\text{HC}}]/[C_{\text{CO}_2} \times d_{\text{CO}_2}] < 0.012$ ;  $0.1 < [C_{\text{CO}_2} \times d_{\text{CO}_2}]/[t_{\text{air}} \times C_p] < 0.3$ ;  $0.025 < [C_{\text{CO}} \times d_{\text{CO}}]/[t_{\text{air}} \times C_p] < 0.005$ ;  $0.0001 < [C_{\text{CO}_2} \times d_{\text{CO}_2}]/[t_{\text{air}} \times C_p] < 0.00075$ . This was coincident with flame-spread to objects in the passenger compartment rearward of the instrument panel. Gaseous combustion products started to accumulate in the passenger compartment between 6 and 8 minutes post-ignition. Initially the fire was localized to the top of the instrument panel, and most of the fire plume escaped through the large hole in the center of the windshield. Several large pieces of the burning windshield fell onto the seat cushion in the front passenger seat and the carpet in forward of the front the passenger seat at about 7½ minutes post-ignition.<sup>17</sup> A greater portion of the fire plume was trapped below the headliner, resulting in an increase in the

The air temperature and concentrations of all combustion gases decreased rapidly when the fire in the passenger compartment was extinguished. The ratios shown in Figures 58 through 63 increased approximately 10 fold at this time, but it is difficult to interpret the meaning of these increases. Although flaming combustion had ceased, several objects in the passenger compartment continued to thermally decompose. Thus, these increases in  $[C_{CO} \times d_{CO}]/[C_{CO_2} \times d_{CO_2}]$  and  $[C_{HC} \times d_{HC}]/[C_{CO_2} \times d_{CO_2}]$  may reflect the transition to non-flaming combustion.

Figure 59. Fire Test F961115. Plots of  $[C_{CO} \times d_{CO}] / [C_{CO_2} \times d_{CO_2}]$  (—●—, left axis) and the concentration of carbon monoxide ( , right axis) in the passenger compartment.

Figure 60. Fire Test F961115. Plots of  $[C_{HC} \times d_{HC}] / [C_{CO_2} \times d_{CO_2}]$  (—●—, left axis) and the concentration of total hydrocarbons ( , right axis) in the passenger compartment.

Figure 61. Fire Test F961115. Plots of  $[C_{CO_2} \times d_{CO_2}] / [t_{air} \times C_p]$  (—●—, left axis) and the concentration of carbon dioxide ( , right axis) in the passenger compartment.

Figure 62. Fire Test F961115. Plots of  $[C_{CO} \times d_{CO}] / [t_{air} \times C_p]$  (—●—, left axis) and the concentration of carbon monoxide ( , right axis) in the passenger compartment.

Figure 63. Fire Test F961115. Plots of  $[C_{HC} \times d_{HC}] / [t_{air} \times C_p]$  (—●—, left axis) and the concentration of hydrocarbons ( , right axis) in the passenger compartment.
