**Evaluation of Motor Vehicle Fire Initiation and Propagation  
Part 3: Propagation of an Engine Compartment Fire in a 1996 Passenger  
Van**

Jeffrey Santrock  
General Motors Corporation

**ABSTRACT**

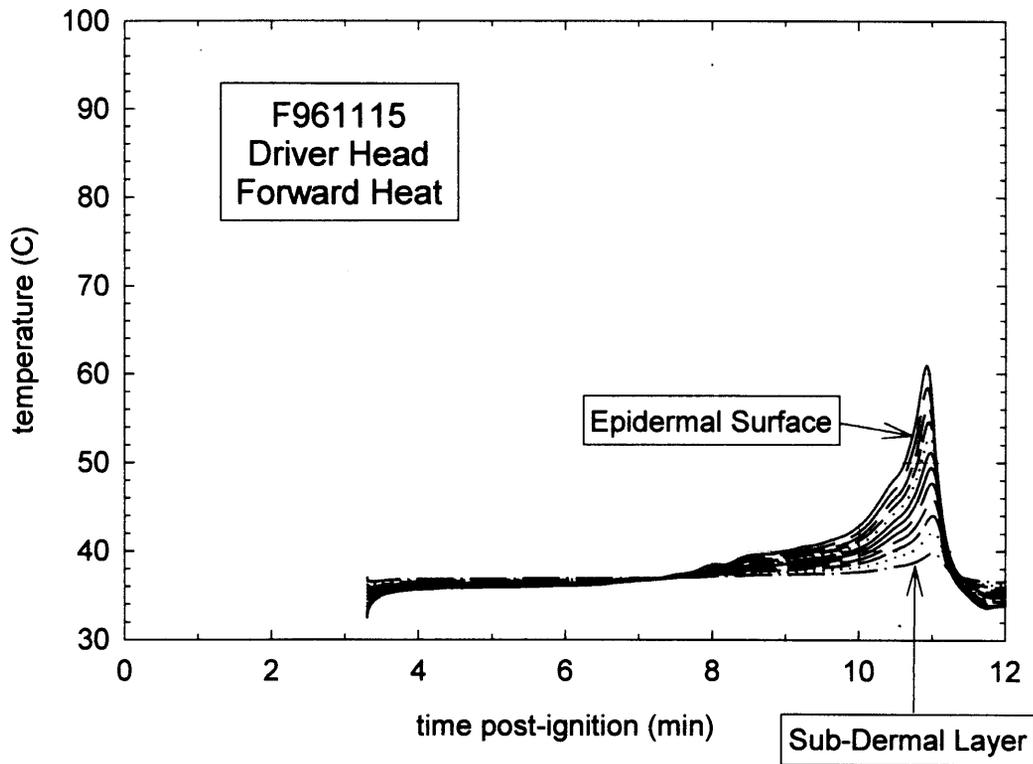
The timing of the estimated increases in skin temperature at head-level generally correlated with the timing of flame-spread across the headliner (Fig.'s 64, 66, and 68). Analysis of the data from the DFT's and the aspirated thermocouples indicated that radiation from the burning headliner accounted for between 80 and 85% of the total heat flux to the DFT's at head level in the front of the test vehicle. The orientation of the DFT affected the view angle and thus the incident radiant heat flux to these transducers. For example, the DFT's above the front seats were facing forward and were perpendicular to the roof of the test.

Figure 64. Fire Test F961115. Skin temperature profile estimated from heat flux to a forward-facing vertical surface at the drivers head level (APPENDIX G, Plot G6).

The orientation of the DFT also effected the estimated skin temperature profile. For example, the maximum estimated skin temperatures for exposed skin at head level in the front of the test vehicle were 87°C for heating from above (Fig. 68) and 89°C for heating from below (Fig.69). The estimated maximum skin temperature of exposed skin at head level facing forward was between 61 and 63.°C (Fig.'s 64 and 66).

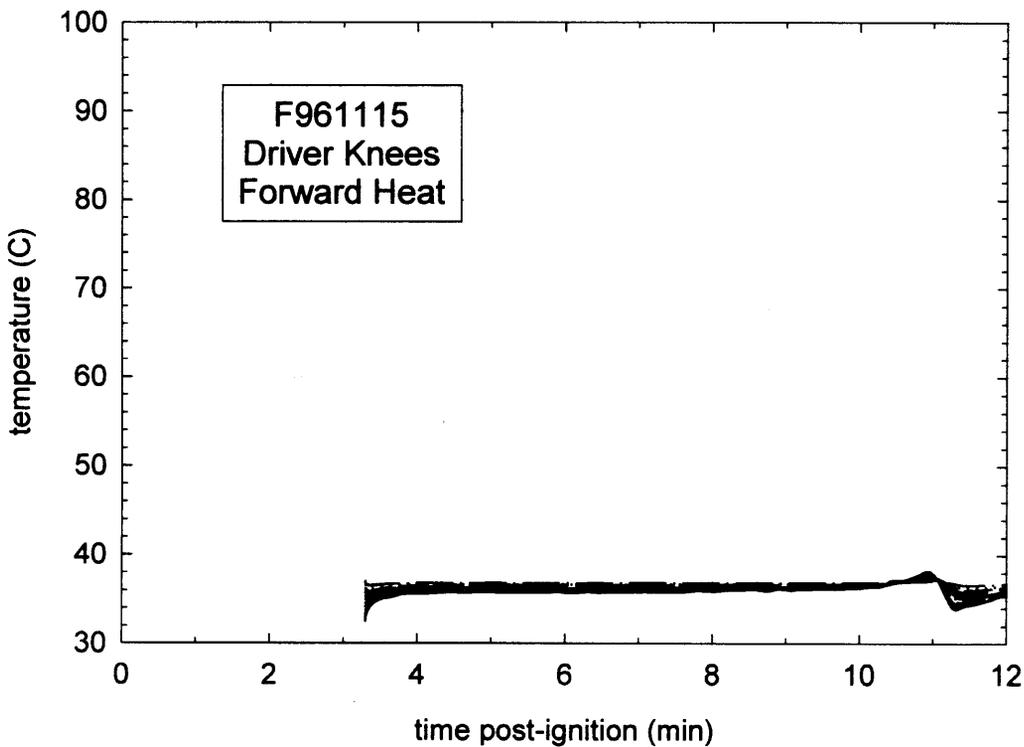
Figure 65. Fire Test F961115. Skin temperature profile estimated from heat flux to a forward-facing vertical surface at the drivers knee level (APPENDIX G, Plot G8).

This analysis indicated that the estimated heat flux to the DFT at knee-level on the driver's seat was low throughout this test (Plot G8, **APPENDIX G**). The maximum estimated temperature of exposed skin at this location was approximately 38°C (Fig. 65).

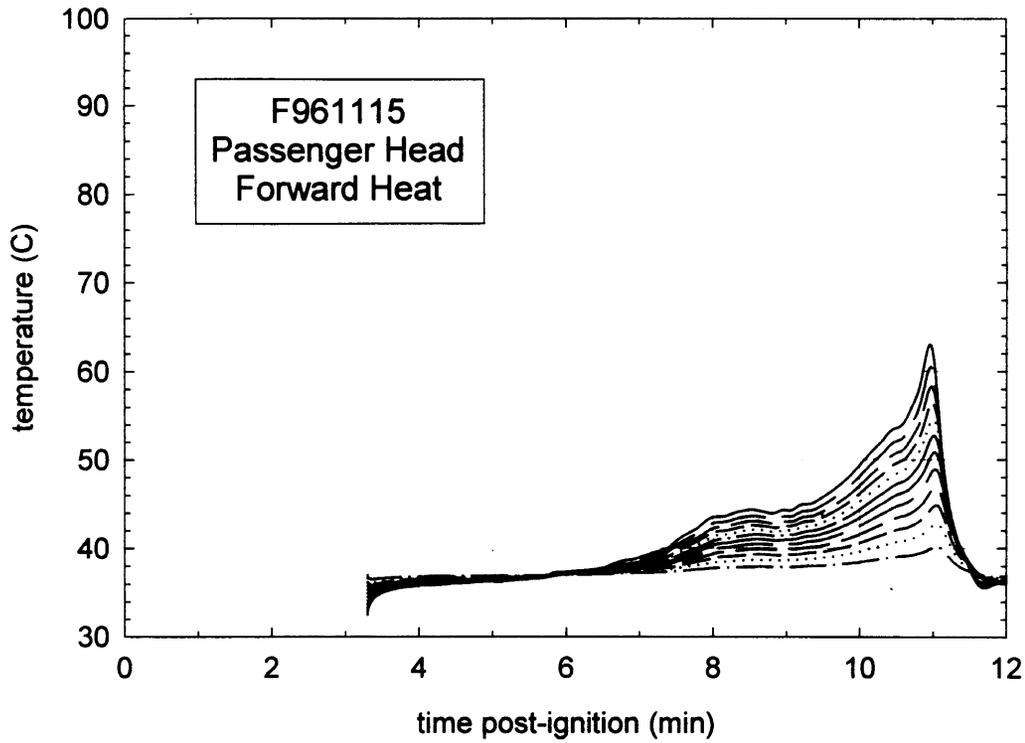
Figure 66. Fire Test F961115. Skin temperature profile estimated from heat flux to a forward-facing vertical surface at the passenger head level (**APPENDIX G**, Plot G2).

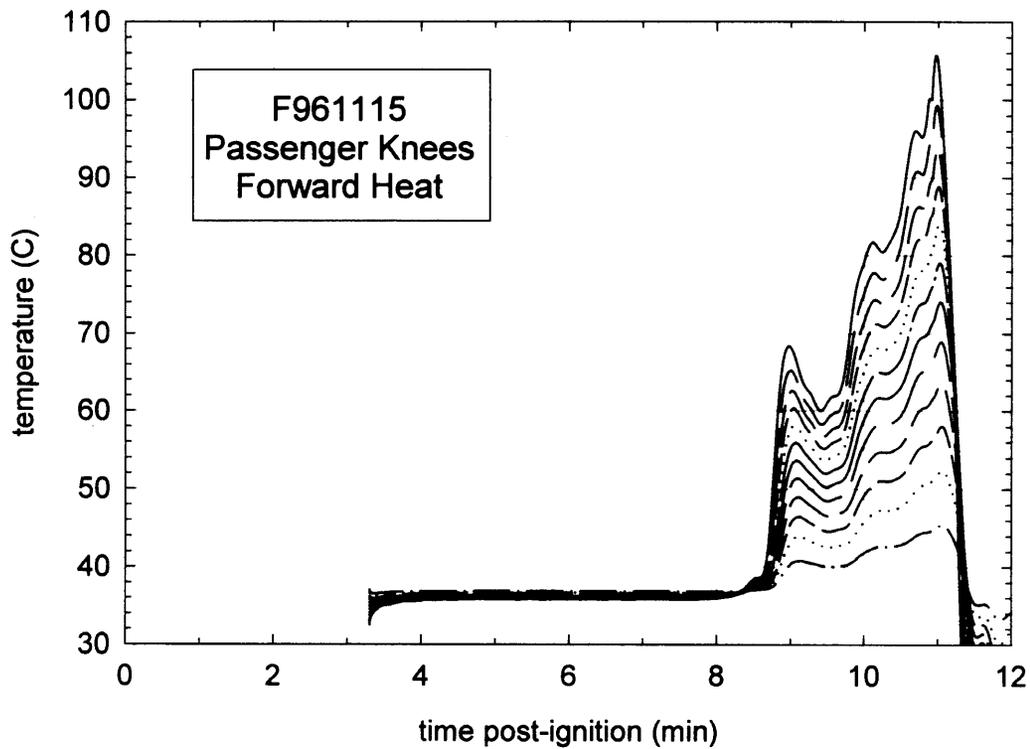
Figure 67. Fire Test F961115. Skin temperature profile estimated from heat flux to a forward-facing vertical surface at the passenger knee level (**APPENDIX G**, Plot G4).

The maximum estimated radiative heat flux to the DTF located at knee level on the front passenger's seat was just under 40 kW/m<sup>2</sup> at 11 minutes post-ignition (Plot G4, **APPENDIX G**), resulting in a maximum estimated skin temperature of approximately 106°C (Fig. 67). The convective heat flux to this transducer was not estimated because air temperature was not measured at this level in the test vehicle. In the estimation of the skin temperature profiles of exposed skin at this location (Fig. 67), it was assumed that the sole mechanism of heat transfer was radiation from the burning passenger air bag just in front of the passenger's seat.

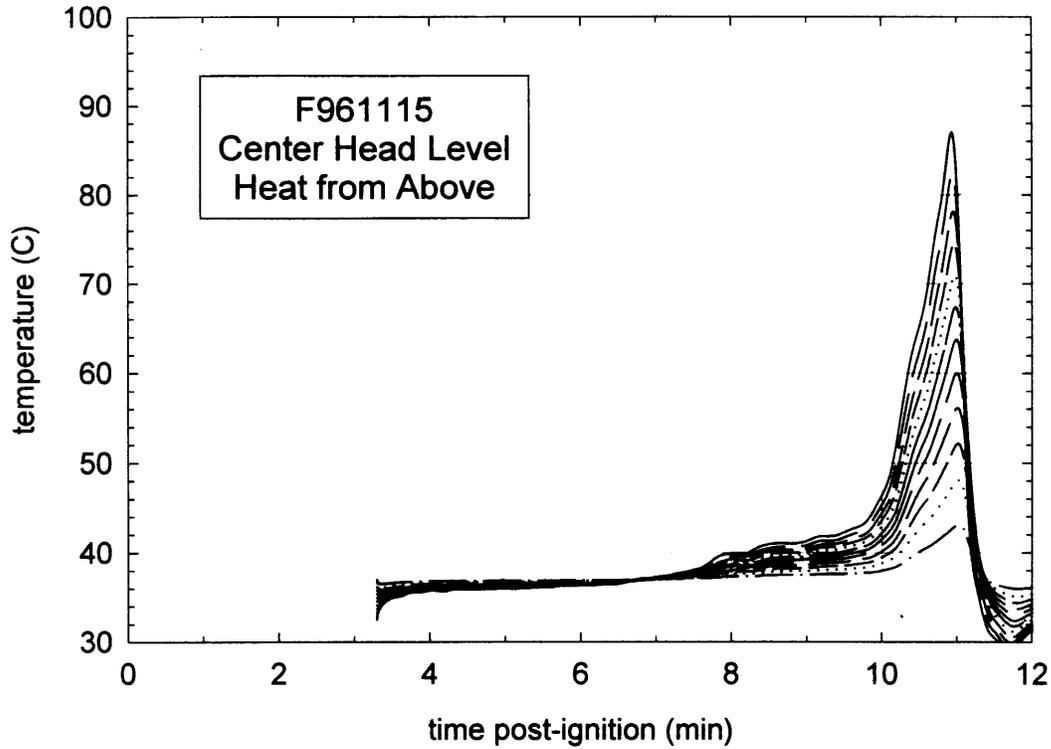
Figure 68. Fire Test F961115. Skin temperature profile estimated from heat flux to a upward-facing horizontal surface at the passenger head level (APPENDIX G, Plot G10).

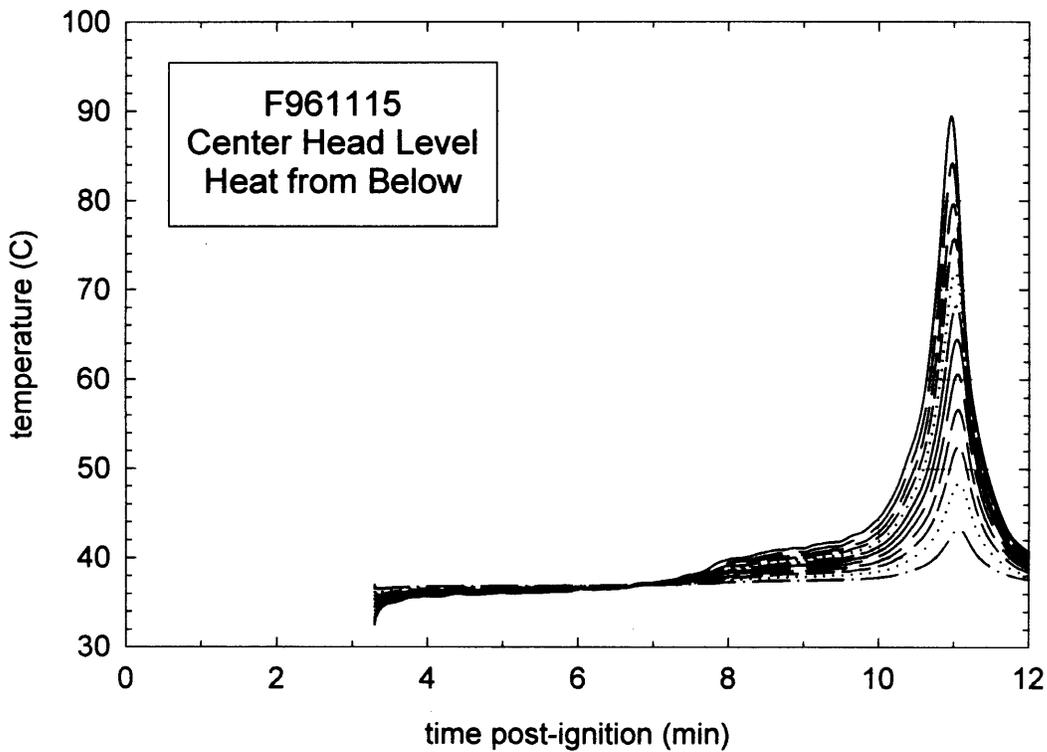
Figure 69. Fire Test F961115. Skin temperature profile estimated from heat flux to a downward-facing horizontal surface at the passenger head level (APPENDIX G, Plot G12).

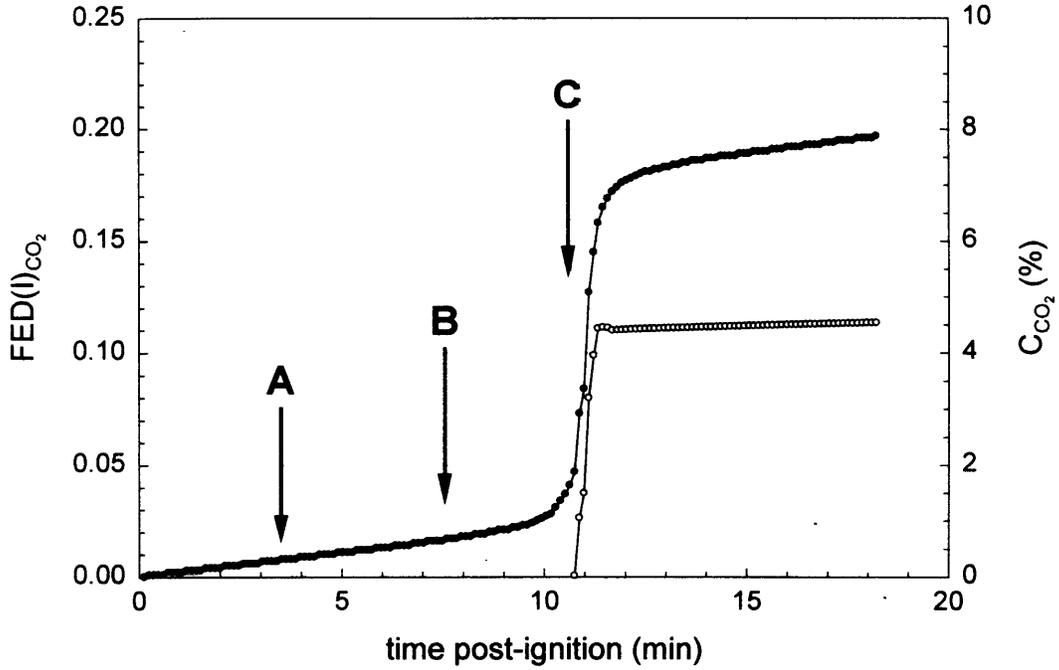
Plots of the  $FED(I)_{CO_2}$  parameters estimated using the FAA Combined Hazard Model and Purser's model are shown in Figure 70. Both models yielded estimates of  $FED(I)_{TOTAL} > 0$  starting at about 10 ½ minutes post-ignition, when  $C_{CO_2} > 5\%$ . And both models yielded estimated of  $FED(I)_{TOTAL} < 1$  from the time of ignition until approximately 18 minutes post-ignition when this gas analysis was stopped.

Figure 70. Fire Test F961115. Plots of  $FED(I)_{CO_2}$  versus time post-ignition: FAA Combined Hazard Survival Model ( $-O-$ ); and Purser's model ( $-●-$ ). A plot of  $C_{CO_2}$  ( $-$ ) is included for reference.

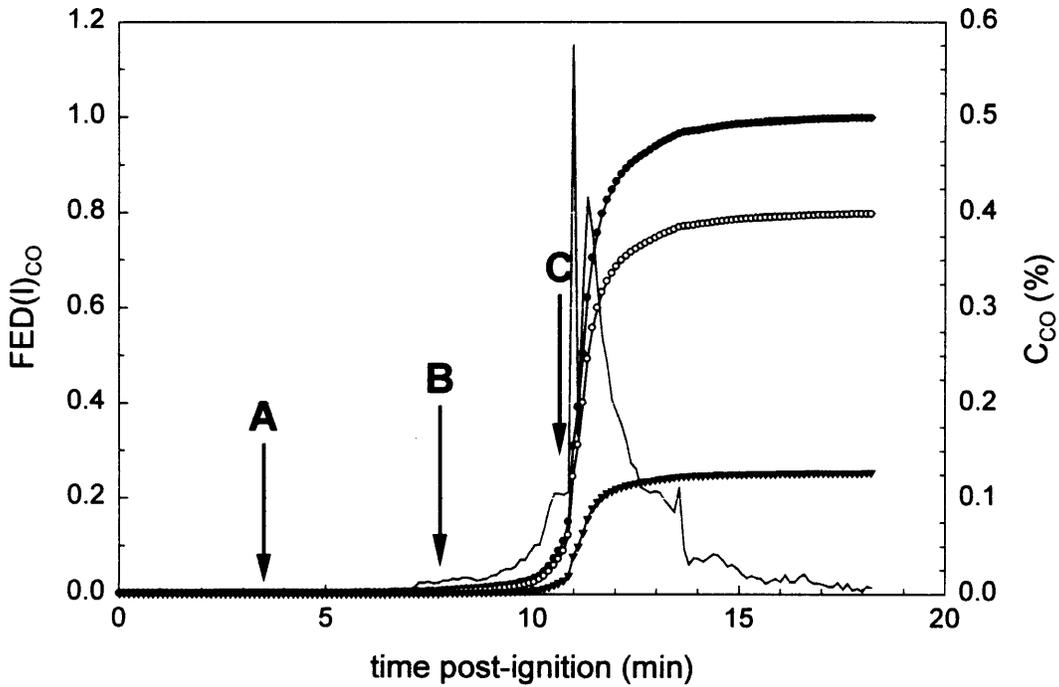
Plots of the  $FED(I)_{CO}$  parameters estimated using both models are shown in Figure 71. The equations presented in the Purser model for computation of  $FED(I)_{CO}$  include a term for respiratory minute volume. Minute volumes corresponding to respiration during rest (8.5 L/min) and light activity (25 L/min) were used in these calculations [9]. Purser's model also accounts for the effect of exposure to carbon dioxide on respiratory rate. The FAA Combined Survival Hazard Model computes only one estimate of  $FED(I)_{CO}$ , which accounts for the effect of exposure to carbon dioxide on respiratory rate [8]. The estimates of  $FED(I)_{CO}$  using these different models differed substantially. For example, calculations using the FAA model yielded estimates of  $FED(I)_{TOTAL} > 0$  starting between 7 and 7½ minutes post-ignition. These estimates of  $FED(I)_{TOTAL} < 1$  throughout this test. Calculations using Purser's model using a respiratory minute volume of 8.5 L/min yielded estimates of  $FED(I)_{TOTAL} > 0$  between 6½ and 7 minutes post-ignition. These estimates of  $FED(I)_{TOTAL} < 1$  throughout this test. Calculations using Purser's model using a respiratory minute volume of 25 L/min yielded estimates of  $FED(I)_{TOTAL} > 0$  between 2 and 2 ½ minutes post-ignition. These estimates of  $FED(I)_{TOTAL}$  asymptotically approached a value of 1 during the final few minutes of data acquisition. At 15 minutes post-ignition, a value of  $FED(I)_{CO} = 0.785$  was computed using the FAA Combined Hazard Survival Model. In contrast, values of  $FED(I)_{CO} = 0.215$  and  $FED(I)_{CO} = 0.983$  were computed using the Purser model with respiratory minute volumes of 8.5 and 25 L/min, respectively.

Figure 71. Fire Test F961115. Plots of estimates of  $FED(I)_{CO}$  versus time post-ignition computed using the FAA Combined Hazard Survival Model ( $-O-$ ), the Purser model with a respiratory minute volume of 8.5 L/min ( $-▼-$ ), and the Purser model with a respiratory minute volume of 25 L/min ( $-●-$ ). A plot of  $C_{CO}$  ( $-$ ) is included for reference.

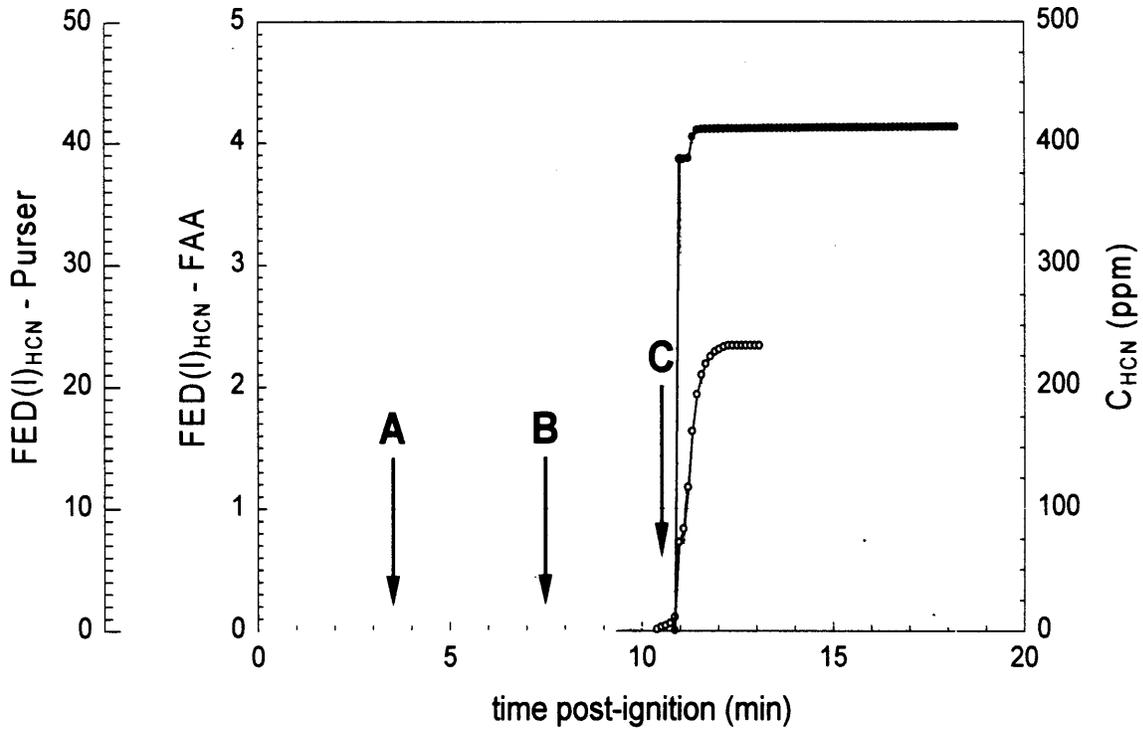
Plots of the  $FED(I)_{HCN}$  parameters estimated using both models are shown in Figure 72. Both the FAA Combined Survival Hazard Model and Purser's model employ a threshold concentrations to determine when to start computing  $FED(I)_{HCN}$  (refer to equations 6 and 14, respectively).

Figure 72. Fire Test F961115. Plots of  $FED(I)_{HCN}$  versus time post-ignition: FAA Combined Hazard Survival Model ( $\circ$ ); and Purser's model ( $\bullet$ ). A plot of  $C_{HCN}$  (—) is included for reference.

As in the estimation of  $FED(I)_{CO}$ , the estimates of  $FED(I)_{HCN}$  using these different models differed substantially. For example, calculations using the FAA model yielded  $FED(I)_{HCN} > 1$  starting between 11 and 11 ½ minutes post-ignition, and these estimates reached values of approximately 2.3 by about 12 minutes post-ignition. Calculations using Purser's model yielded  $FED(I)_{HCN} > 11$  starting between 10½ and 11 minutes post-ignition, and these estimates reached values approximately 41 by 12 minutes post-ignition. That is, the numerical values of the two estimates of  $FED(I)_{HCN}$  differed 18-fold.

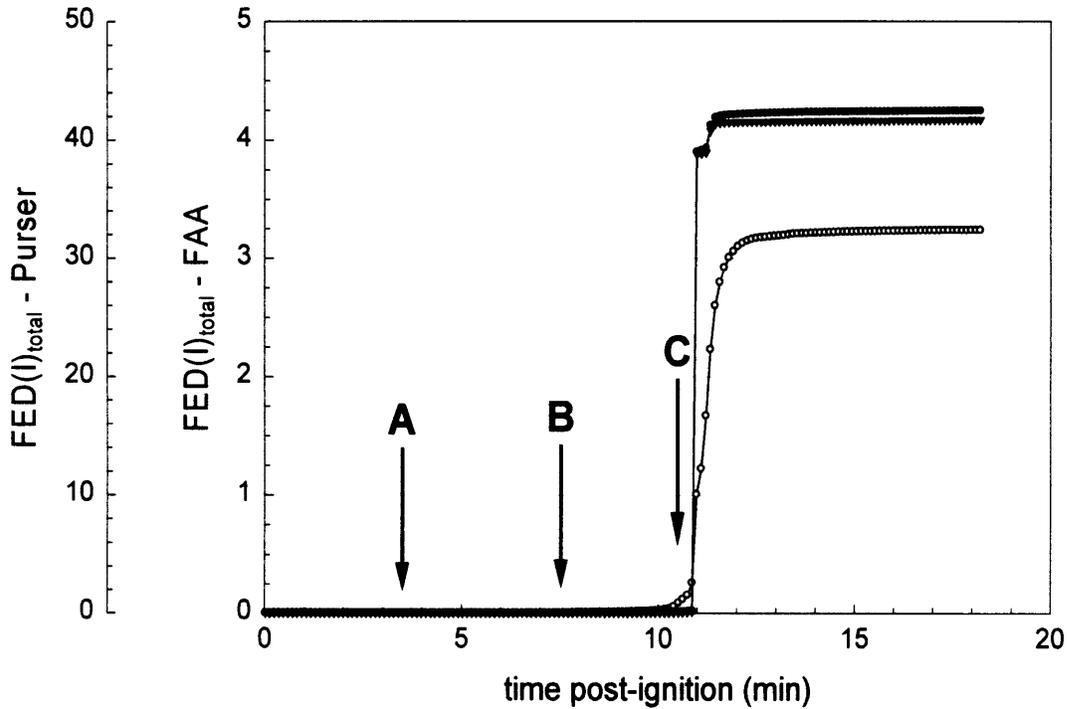
Figure 73. Fire Test F961115. Plots of  $FED(I)_{TOTAL}$  versus time post-ignition: FAA Combined Hazard Survival Model ( $\circ$ ); Purser's model with  $RMV = 8.5$  L/min ( $\blacktriangledown$ ); and Purser's model with  $RMV = 25$  L/min ( $\bullet$ ).

Plots of the  $FED(I)_{TOTAL}$  parameters estimated using both models are shown in Figure 73. The FAA Combined Survival Hazard Model yielded  $FED(I)_{TOTAL} > 1$  at about 11 minutes post-ignition, where  $FED(I)_{HCN}$  accounted for 70% of  $FED(I)_{TOTAL}$ ,  $FED(I)_{CO}$  accounted for approximately 25% of  $FED(I)_{TOTAL}$ , and  $FED(I)_{CO_2}$  accounted for approximately 5% of  $FED(I)_{TOTAL}$ . The estimated  $FED(I)_{TOTAL}$  reached a value of approximately 3.2 between 13 and 13 ½ minutes post-ignition. Purser's model yielded  $FED(I)_{TOTAL} > 1$  starting between 10½ and 11 post-ignition using a respiratory minute volumes of 8.5 L/min and 25 L/min in the calculations. The relative contributions of  $FED(I)_{CO_2}$ ,  $FED(I)_{CO}$ , and  $FED(I)_{TOTAL}$  did not differ substantially with respiratory minute volume:  $FED(I)_{HCN}$  accounted for  $> 97\%$  of  $FED(I)_{TOTAL}$ ;  $FED(I)_{CO}$  accounted for approximately 2.5% of  $FED(I)_{TOTAL}$ ; and  $FED(I)_{CO_2}$  accounted for  $< 1\%$  of  $FED(I)_{TOTAL}$ .

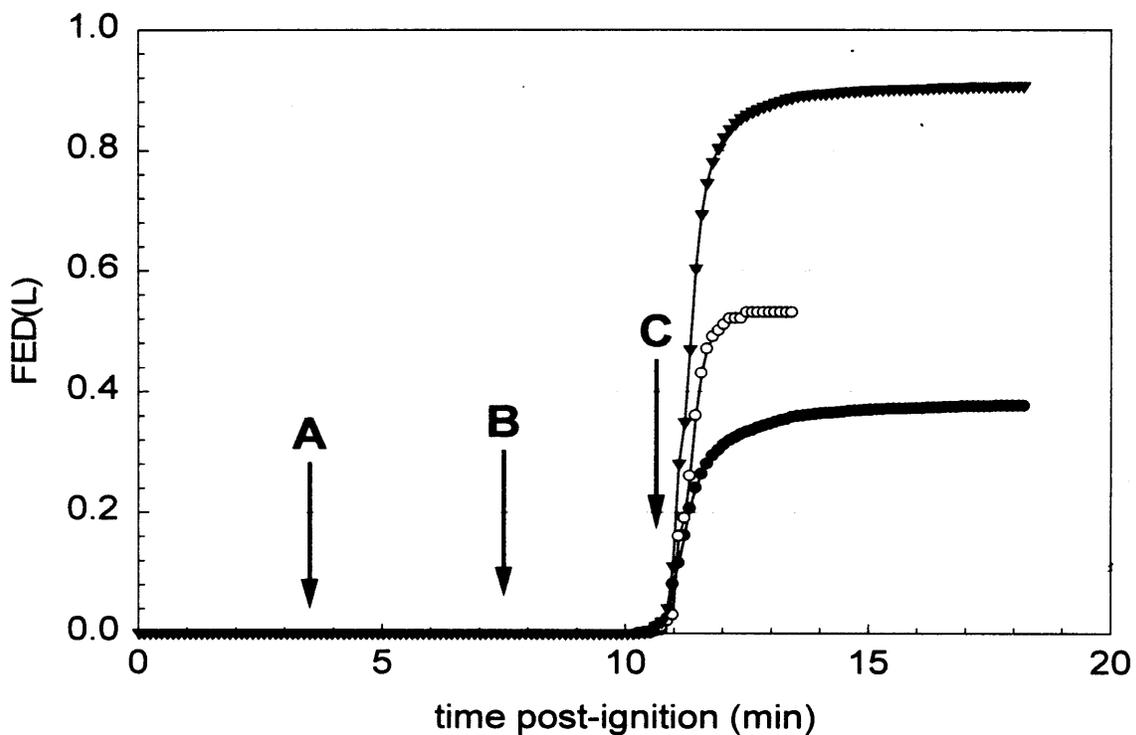
Figure 74 shows plots of  $FED(L)_{CO}$ ,  $FED(L)_{HCN}$ , and  $FED(L)_{TOTAL}$  computed using the FAA Combined Survival Hazard Model. These calculations yielded  $FED(L)_{CO} = 0.38$ ,  $FED(L)_{HCN} = 0.52$ , and  $FED(L)_{TOTAL} = 0.90$  at 15 minutes post-ignition. None of these indices exceeded values of 1 from the time of ignition until this gas analysis was stopped at about 18 minutes post-ignition.

Figure 74. Fire Test F961115. Plots of  $FED(L)_{CO}$  (●),  $FED(L)_{HCN}$  (○), and  $FED(L)_{TOTAL}$  (▼) versus time post-ignition computed using the FAA Combined Hazard Survival Model. Fire. The arrows indicate ignition of the instrument panel top cover (A), ignition of the deployed passenger airbag (B), and the start of flame propagation forward across the head liner (C). Fire suppression began at approximately 11 minutes post-ignition.

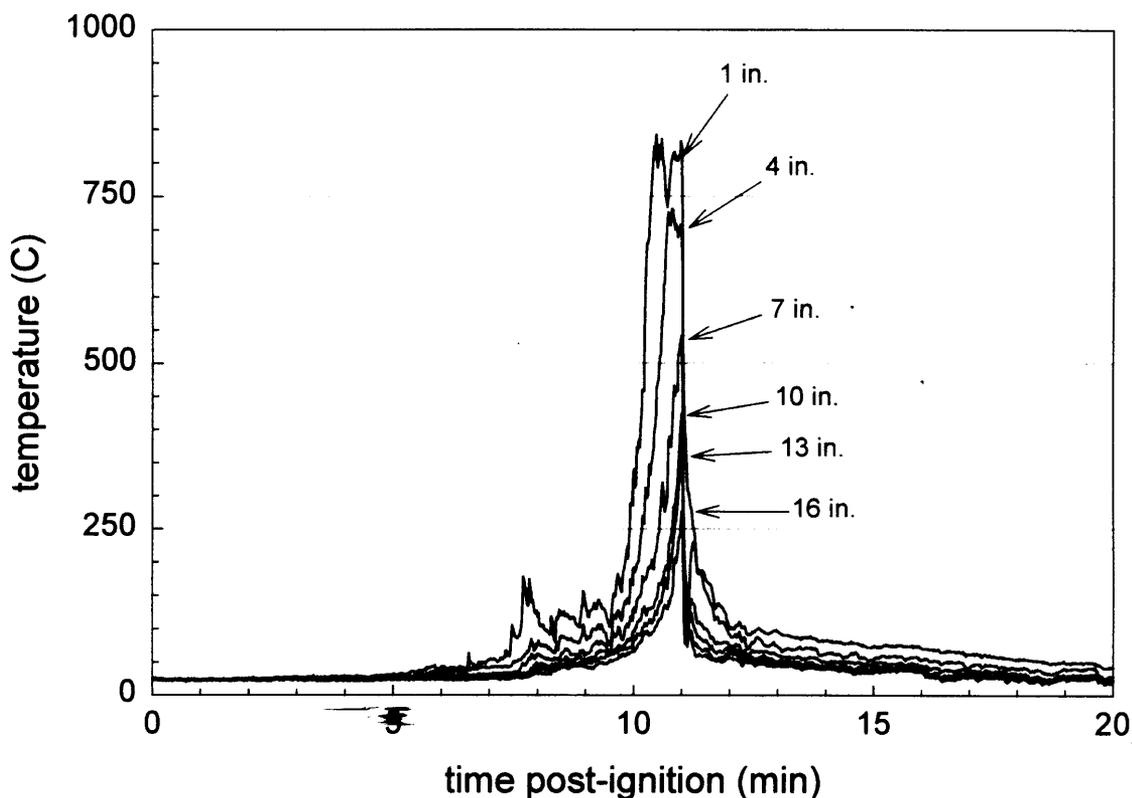
Figure 75 shows plots of the air temperature measured at 1, 4, 7, 10, 13, and 16 inches below the lower surface of the headliner versus time post-exposure. These plots show that the temperature

of the air in the front of the passenger compartment increased between 9½ and 10½ minutes post-ignition. By the end of the test, the air temperature measured 1 inch below the headliner exceeded 750°C, while the air temperature measured 16 inches below the headliner was approximately 250°C.

Figure 75. Fire Test F961116. Plots of air temperature at 1, 4, 7, 10, 13, and 16 inches below the lower surface of the headliner versus time post-ignition.

As the data in Figure 75 clearly shows, the temperature of the air inhaled by an occupant in the front of the test vehicle at this time would have depended on the height of the occupant's head. It is impossible to estimate the potential for burn injury to the respiratory tract caused by inhalation of hot air from air temperature data alone. Water and particulate produced by the fire increase the heat capacity of the air. The concentrations of these species in the inhaled air may affect both the severity and depth of burn injury in the respiratory system. Neither the water- nor the particulate-concentrations in the passenger compartment were measured in this test. Additionally, a robust quantitative relationship between temperature, water content, and particulate concentration of inhaled air and subsequent burn injury to respiratory airways caused by inhaling such a mixture has not been established [9]. A few controlled animal studies indicate that inhalation of steam at 100°C caused burns to the larynx and trachea similar to those

produced by inhalation of dry air at 350°C or flames at 500°C [9]. In these controlled animal studies, death was not immediate, but occurred a few to twenty-four hours after the exposure and resulted from obstructive edema in the burned airways. Given these uncertainties, it is impossible to assess whether and when burn injury to the respiratory airways would occur from the data shown in Figure 75.
