Evaluation of Motor Vehicle Fire Initiation and Propagation

Part 5: Crash Tests on a Rear Wheel Drive Passenger Car

Jack L. Jensen, Jeffrey Santrock

General Motors Corporation

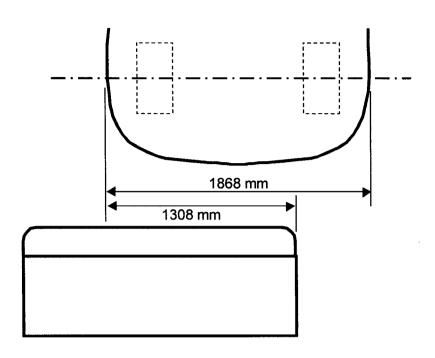
Figure 3
Schematic of Intended Vehicle Overlap
Test C11408

This test was an offset moving deformable barrier rear impact as depicted in Figures 1, 2, and 3. The test vehicle was parked and impacted with a deformable moving barrier similar to what is specified in FMVSS214 [4]. The impact velocity, measured with radar, was 84.7 km/h (52.6 mph). The moving barrier impacted the test vehicle in the rear on the filler neck side (left side) with a 70 % overlap. The overlap was computed by measuring the widest part of the vehicle body vertically in line with the rear axle and multiplying this width by 0.70. For this particular test, the vehicle width vertically in line with the rear wheel centerline was measured to be 1868 mm, resulting in a desired overlap of 1308 mm, as shown in Figure 3. The actual impacted overlap for this test was within 15 mm of the desired.

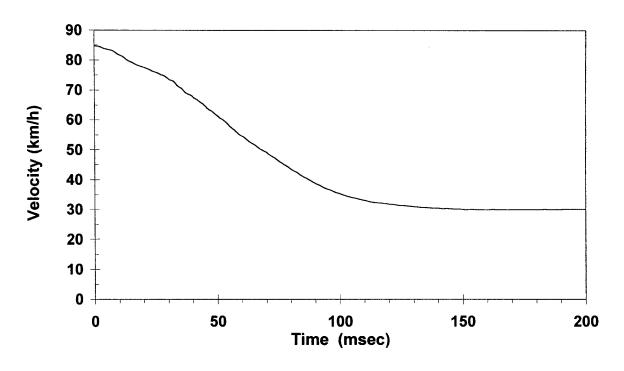
Figure 8

The longitudinal velocity of the barrier's CG is shown in plot 135 and re-created here as Figure 8. The barrier sustained a velocity change of about 55 km/h (34 mph) in 140 msec.

Moving Deformable Barrier Longitudinal Velocity at CG

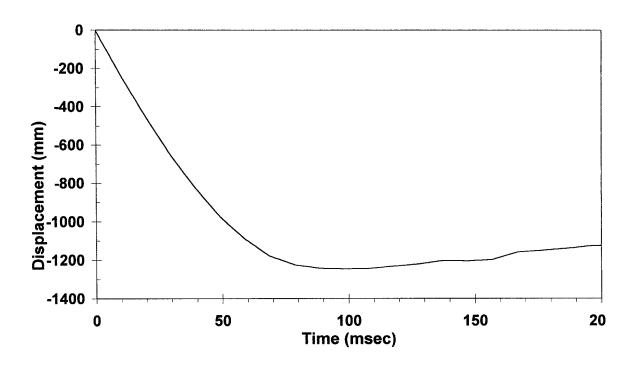
Figure 11

The crush of the vehicle on the left side is represented here as the longitudinal displacement of the vehicle relative to the moving barrier as numerically measured from film. This measurement is shown in Plot 1 and also Figure 11. Approximately 1250 mm of displacement occurred on the left side of the vehicle and represents the combined crush of the deformable barrier face and the vehicle.

Vehicle Displacement Relative to Moving Barrier, Left Side,
Test C11408, Numerically Measured from High Speed Film

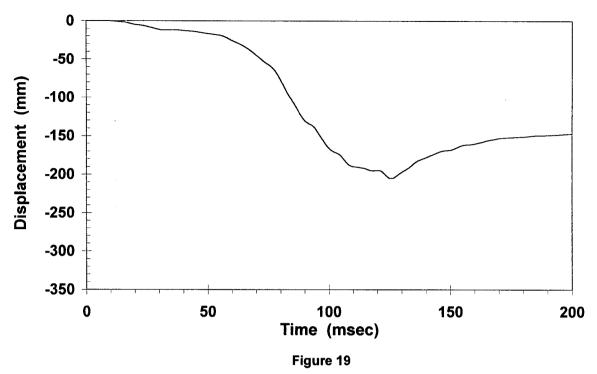
The displacement of the right toe pan, relative to the passenger compartment, was approximately 205 mm and is shown in Figure 19 and also Plot 131, Appendix D.

Right Toepan Displacement, Relative to Floorpan Test C11591, filtered at SAE class 60 [8]

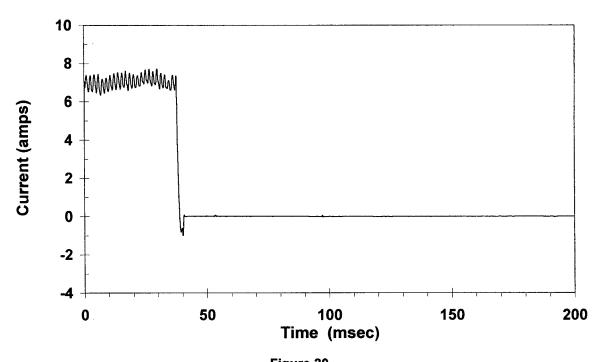
Figure 20 and Plot 163 in Appendix D show the current measured at the auxiliary fuel pump. The fuel pump drew 7 amps before impact until about 40 msec, when the current dropped to zero. The fuel pump voltage measurement malfunctioned and resulted in no valid recorded data, (Plot 135). However, the battery voltage indicated a drop from 13.5 volts to near zero also at 40 msec, as shown in Figure 21 and Plot 133. The fuel pump lost power when the main vehicle electrical power was lost at 40 msec.

Figure 20
Fuel Pump Current
Test C11591

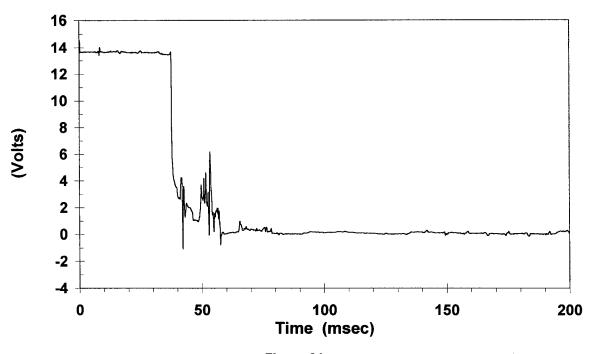
Figure 21Battery Voltage
Test C11591

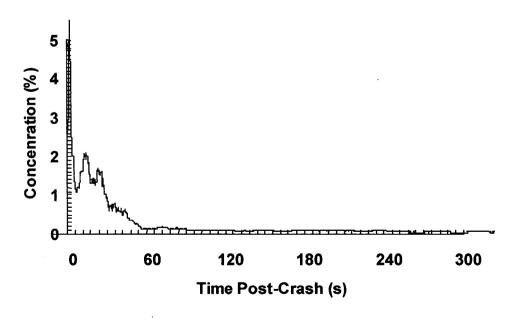
Of the five monitored locations, the left exhaust manifold (location #3) and near descending left exhaust pipe (location #4) indicated the highest concentrations of hydrocarbon vapors. These two measurements are recreated from Appendix E as Figure 22 and Figure 23 respectively. The measurement at location #4 was the highest and exceeded 4% for approximately 1 minute after the impact.

Concentration of Hydrocarbon Gas Measured near Left Exhaust Manifold (Location #3)

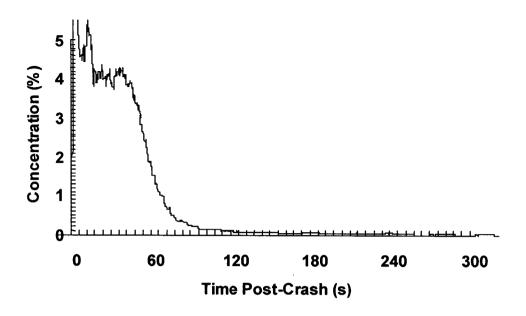
Figure 23

Concentration of Hydrocarbon Gas Measured near Descending Exhaust Pipe (Location #4)

The higher vapor concentration of vapor indicated in **Figure 23** was likely due to vapors released by the washer solvent. The post-test inspection revealed that the washer solvent reservoir was crushed and completely empty following the impact. Vapors from the washer solvent would not be identified during a GC/FID analysis, and thus would not appear in **Figure 25**.

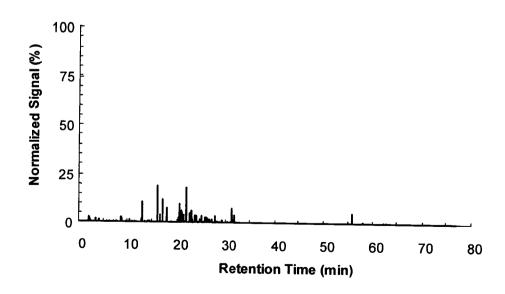
Figure 25 also indicates the presence of gasoline vapors. This is the sample taken after the impact. There were no liquid gasoline leaks identified immediately after the impact or during the post-test inspection. Again, the presence of low concentrations of gasoline vapors could be residual vapors in the engine compartment due to the filling of the auxiliary tank just prior to the test. Another possible source of low concentrations of gasoline vapors, was the air intake duct which was fractured during the impact.

Figure 25
GC/FID Analysis of Hydrocarbon Vapor Sample Collected over Descending Exhaust Pipe
(Location #4) Post-test.

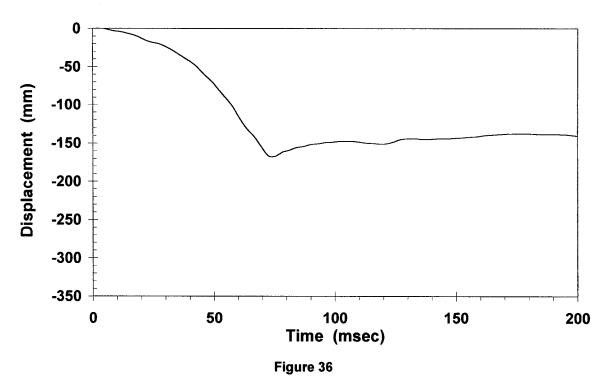
The displacement of the driver's side toe pan was approximately 168 mm as shown in Figure 36 and Plot 79 Appendix G.

Left Toepan Displacement, Relative to Floorpan Test C11647, filtered at SAE class 60 [8]

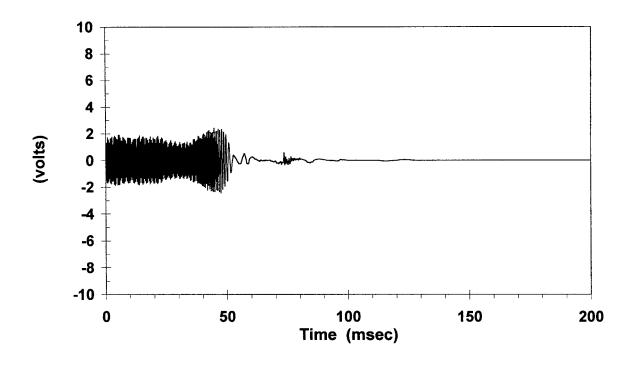
Figure 37

The engine motion measurement is shown in Appendix G, Plot 89 and recreated here as Figure 37. This measurement indicated that the engine was turning at normal speed through about 40 msec after which it began to slow. The engine motion stopped by about 50 msec after impact.

Engine Motion

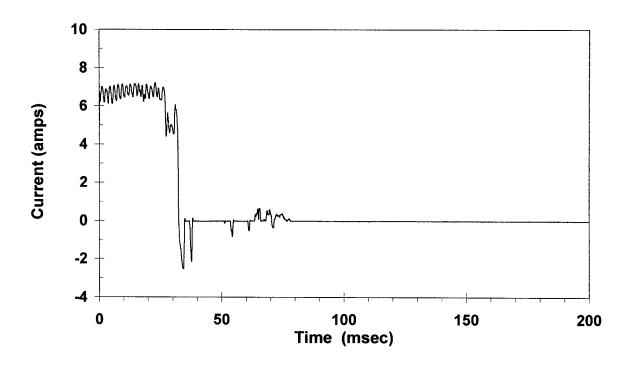
Figure 38 and Plot 105 in Appendix G shows the fuel pump current during the impact. The fuel pump drew about 6.5 amps before impact which continued through about 25 msec after impact. By 30 msec, however, the current had dropped to zero indicating the pump was off. This is consistent with the other frontal tests of this series in that, the fuel pumps have lost electrical power early (well before 100 msec) in every test (not requiring the pumps to be "timed-out" by the powertrain-control-module). For this particular test, the vehicle's electrical system lost voltage temporarily at about 25 msec. (Shown as a drop from 13.5 volts to near zero in Plot 86, and Figure 39). The fuel pump voltage decayed from 121 volts to zero from about 30 msec to 80 msec as shown in Plot 83. This decay of the fuel pump voltage was also similar to other tests conducted for this project. Bench-tests on fuel pumps for this vehicle as well as others indicated a gradual decay (lasting 40-150 msec) when current flow was stopped to the motor. This is likely due to the windings of the motor producing a voltage drop as the motor stops.

Figure 38
Fuel Pump Current
Test C11647

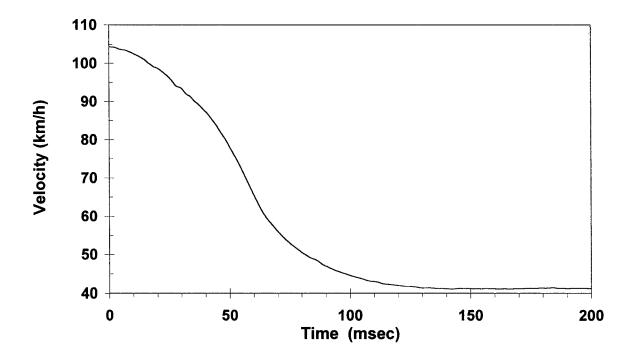
Figure 40

The longitudinal velocity of the barrier's CG is re-created here as Figure 40. The barrier sustained a velocity change of about 63 km/h (39 mph) in 140 msec.

Moving Deformable Barrier Longitudinal Velocity at CG

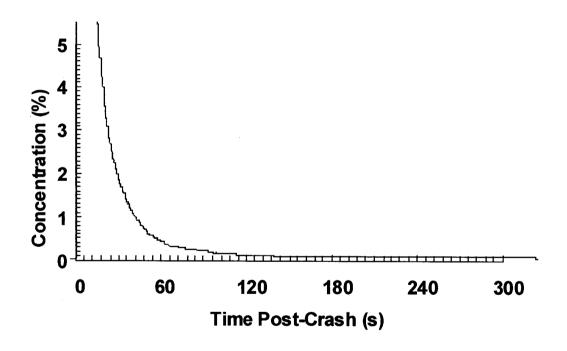
Figure 41

A complete set of the recorded measurements is included in Appendix H, Figures H1 through HH5, and Appendix G, Plots 91 through 100. The signal cable from the vapor sensor located near the fuel line (location #1) was cut during the crash test and no data was recorded. Of the remaining four locations, the measurement near the left exhaust manifold (location #2) was the highest (Appendix H, Figure H2 and Figure 41.) The hydrocarbon gas concentration exceeded 5 % for the first 15 seconds after the impact and exceeded 1% for the first 45 seconds.

Concentration of Hydrocarbon Gas Measured near Left Exhaust Manifold (Location #2)

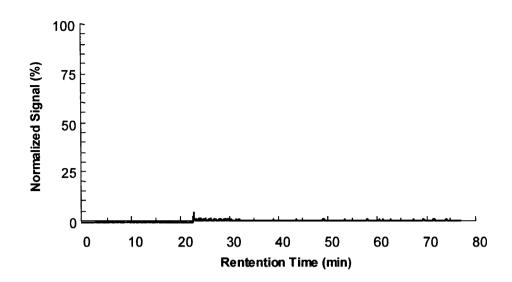
The chromatograms from the GC/FID analysis on samples collected at this location are shown in Figure 42 (background sample taken before the test) and Figure 43 (analysis of sample taken post-test.) The peaks in Figure 43 indicate the presence of vapors from engine coolant and power steering fluid. This was determined by matching the chromatogram peaks to those of head space samples taken in the laboratory.

Figure 42
GC/FID Analysis of Hydrocarbon Vapor Background Sample Collected near Left Exhaust Manifold
(Location #2) Before the Test.

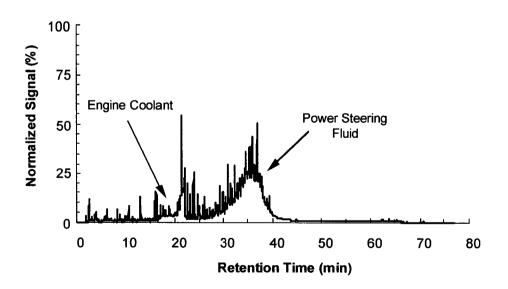
Figure 43
GC/FID Analysis of Hydrocarbon Vapor Sample Collected near Left Exhaust Manifold
(Location #2) Post-test.

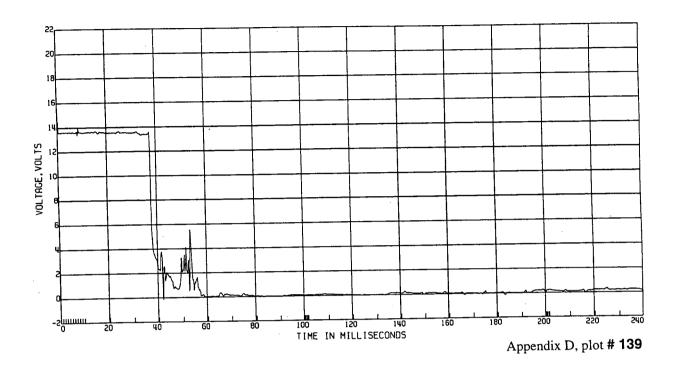
IGNITION VOLTAGE TEST DATE: 05/14/1997

The starter voltage (Plot 80), battery voltage (Plot 81), alternator voltage (Plot 82), and ignition voltage (Plot 86) all indicated a similar waveform. The ignition voltage is recreated as Figure 39. The voltage trace temporarily dropped from 13.5 volts to near zero from 40 msec through 70 msec before incrementally increasing back to over 12 volts. This drop in voltage was likely caused by additional loading on the battery as a result of temporary shorts. During the post-test vehicle inspection, cuts through the insulation on the starter cable were identified in three locations: near the air conditioning accumulator mounting bracket, near the cooling fan motor, and near the frame. Indications of possible grounding were apparent at the accumulator and cooling fan locations. The starter cable current measurement was inconclusive due to overloading and possible damage to the transducer during the impact. (All references to current measurement overload imply an overload of the crash test instrumentation and do not mean an overload of the rated capacity of the circuit.) However, the first indication of current overload is just before 40 msec, which correlates to the first indication of drop in system voltage.
