# Evaluation of Motor Vehicle Fire Initiation and Propagation

## Part 8: Crash Tests on a Sport-Utility-Vehicle

Jack L. Jensen, Jeffrey Santrock

General Motors Corporation

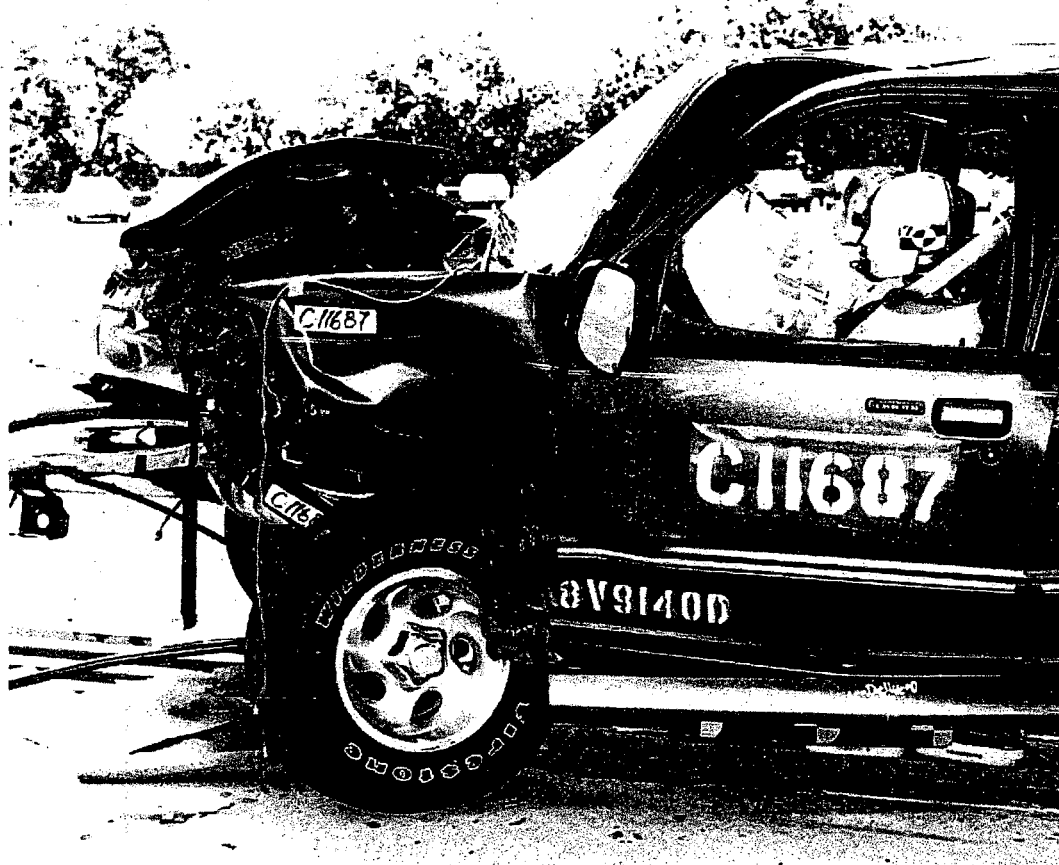
**Figure 4**  
Post-Test Photograph of Test C11687, Front Left View

Post-test photographs of the vehicle are shown in Figure 4 and Figure 5.

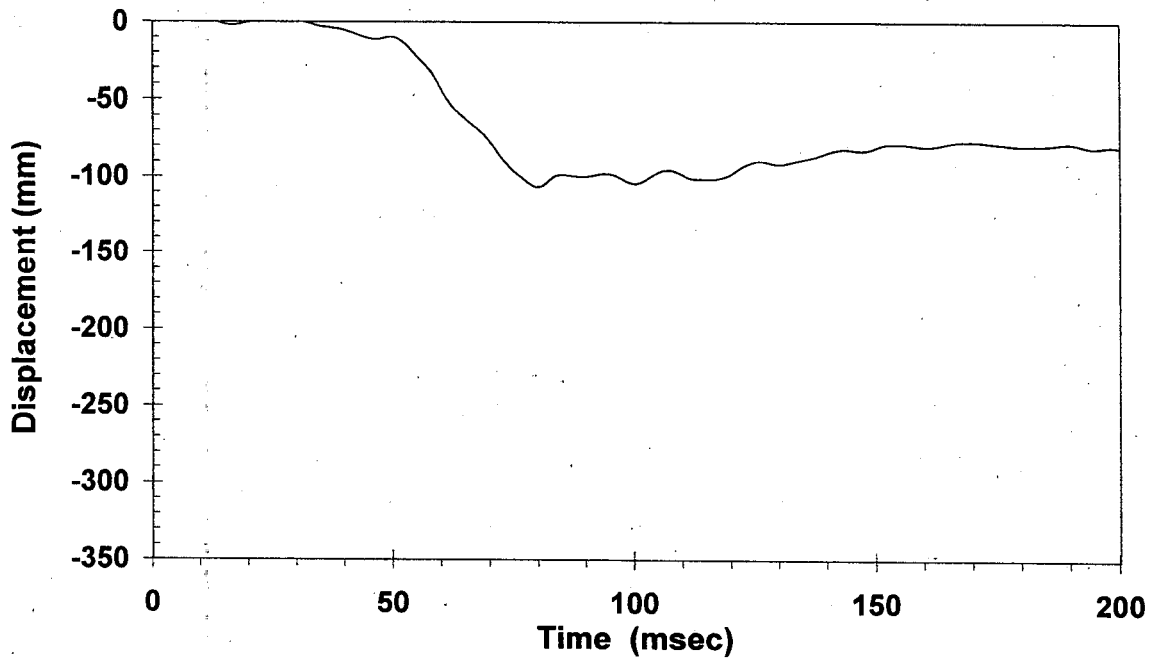
**Figure 11**  
 Left Toe pan Displacement, Relative to Floorpan  
 Test C11687, filtered at SAE class 60 [8]

The displacement of the driver's side toe pan was approximately 107 mm as shown in Figure 11 and Plot 77 Appendix B.

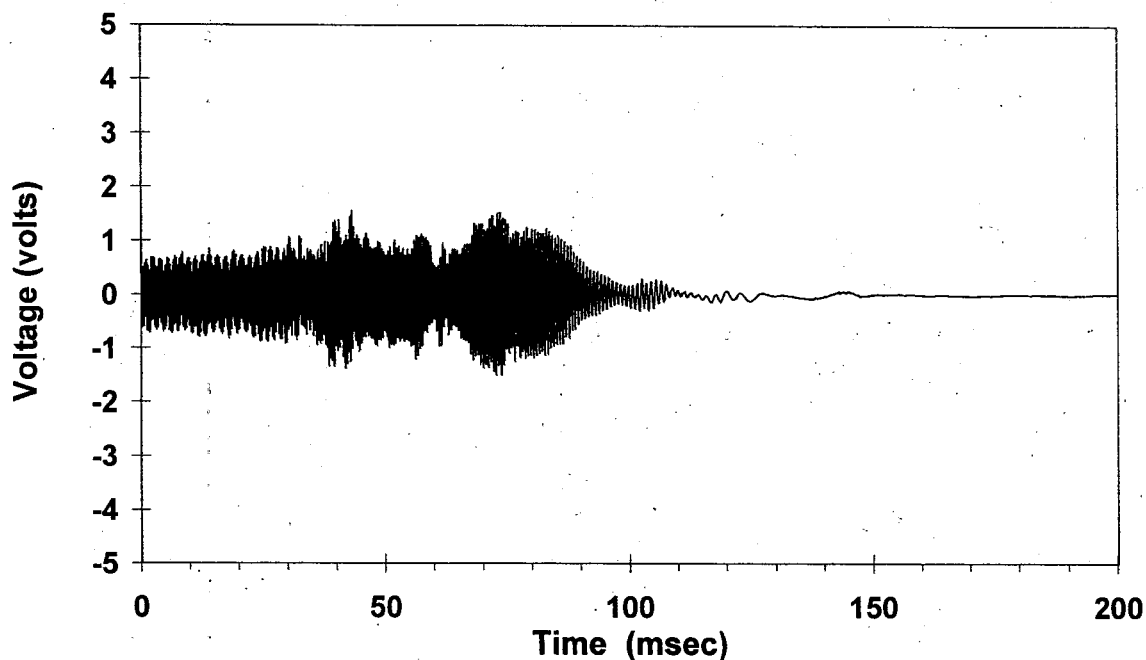
**Figure 12**  
Engine Motion  
Measured using Auxiliary Magnetic Pickup Transducer, Test C11687

The engine motion measurement is shown in Appendix B, Plot 88 and recreated here as Figure 12. This measurement indicated that the engine was turning at normal speed through about 40 msec after which it began to slow. The engine motion stopped by about 110 msec after impact.

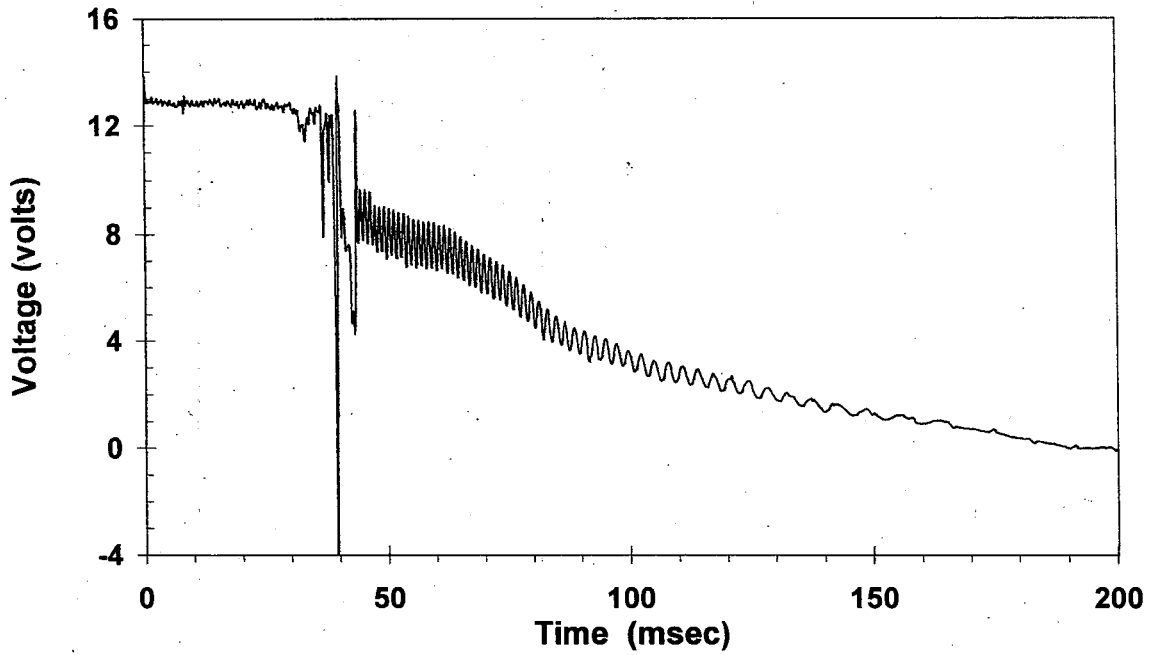
**Figure 15**  
Fuel Pump Voltage  
Test C11687

From 40 msec to 60 msec, the ignition voltage dropped from 13 volts to near zero in a stepwise manner (Figure 14 and Plot 85 in Appendix B). The fuel pump voltage decayed from 13 volts to near zero from about 40 msec to 180 msec as shown in Figure 15 and Plot 81 (Appendix B). Bench-tests on fuel pumps for other vehicles in the project [2], [3] indicated a gradual decay in voltage (lasting 40-150 msec) when current flow was stopped to the motor. This is likely due to the windings of the motor producing a voltage drop as the motor stops. The decay shown in Figure 15 is consistent with the observations from other tests.

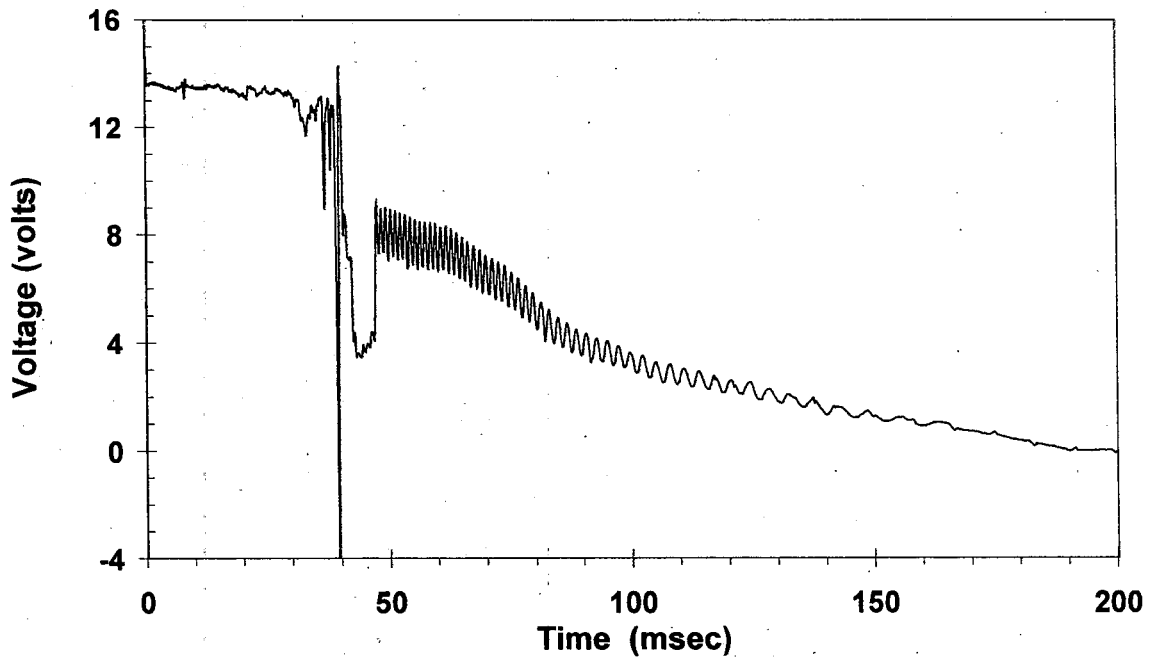
**Figure 16**  
Fuel Pump Inertia Switch Voltage  
Test C11687

The fuel pump inertia switch did activate during the test at about 47 msec after impact. The switch was physically inspected following the test confirming its activation. The fuel pump inertia switch voltage measurement is shown in Figure 16 and Plot 82 in Appendix B. A schematic showing where this measurement was taken is shown in Figure 17. As indicated in the Figure 17, once the inertia switch is activated during the impact the fuel pump voltage (Figure 15) and the fuel pump switch voltage (Figure 16) should be the same. These two traces are nearly identical after about 47 msec, indicating that the switch likely activated at about 47 msec. The fuel pump was already shutting down at this point due to the loss of main vehicle power.

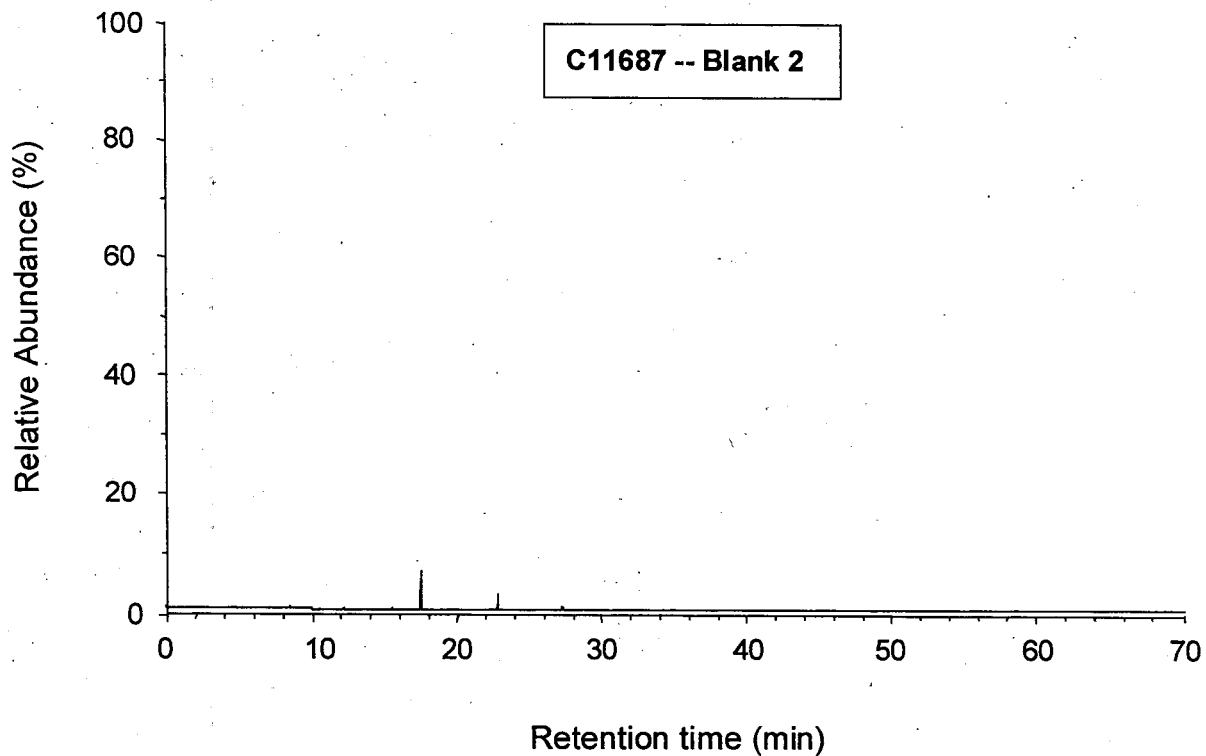
**Figure 21**  
 GCMS Analysis of Vapor Background Sample Collected near Left Exhaust Manifold (Location #2)  
 Before the Test, Test C11687

The vapor concentration at location #1 increased to slightly greater than 1% in the first 60 seconds following the impact, while the concentration at location #2 exceeded 3% during the first 60 seconds. The GCMS analysis was completed on the vapors collected from these same locations [1]. The results of the GCMS analysis for locations #1 and #2 were similar. The results of the GCMS analysis for location #2 is recreated here as Figure 21 and Figure 22. The GCMS analysis indicated the source of the vapors were gasoline, stoddard solvent and oils.

The source of the oil vapor observed in this test could not be positively identified through the GCMS analysis. The analysis does not distinguish vapors with similar molecular makeup. In this case, any of the heavy oils such as power steering fluid, transmission fluid, or motor oil could be the source of the vapor. Of these fluids, only transmission fluid and power steering systems leaked during the impact, so one of those two may have been the likely source. At ambient temperatures, these fluids do not vaporize, thus contact with a hot surface likely occurred vaporizing the fluid.

The source of the Stoddard vapor was likely the Stoddard that leaked out of the fuel tank during the impact. (Section 2.2.6.) Unlike the oils, Stoddard and gasoline will vaporize at ambient conditions, thus the presence of vapor does not necessarily indicate contact with a hot surface.

Gasoline vapor was also indicated in the GCMS analysis. However, there were no leaks identified in the pressurized fuel system (Section 2.2.5.) (The fuel tank contained Stoddard for the test, but the pressurized fuel system contained gasoline.) The source of the gasoline vapor could have been from a damaged (during the impact) air intake or manifold in which the air/fuel mixture could escape to the atmosphere from the normal flow to the engine. Since the fuel pump stopped early, this would result in only a small amount of gasoline vapor (not liquid gasoline) released and does not necessarily present an increased fire risk. An alternate source of the gasoline vapor could have been from contaminated Stoddard Solvent. To reduce the volume of hazardous waste generated in conducting full-vehicle crash tests, Stoddard Solvent is re-used in most crash test laboratories; that is, it is removed from fuel tanks from crash-tested vehicles and re-used for other tests. Thus the Stoddard, over time, can be contaminated with residual gasoline from fuel tanks.

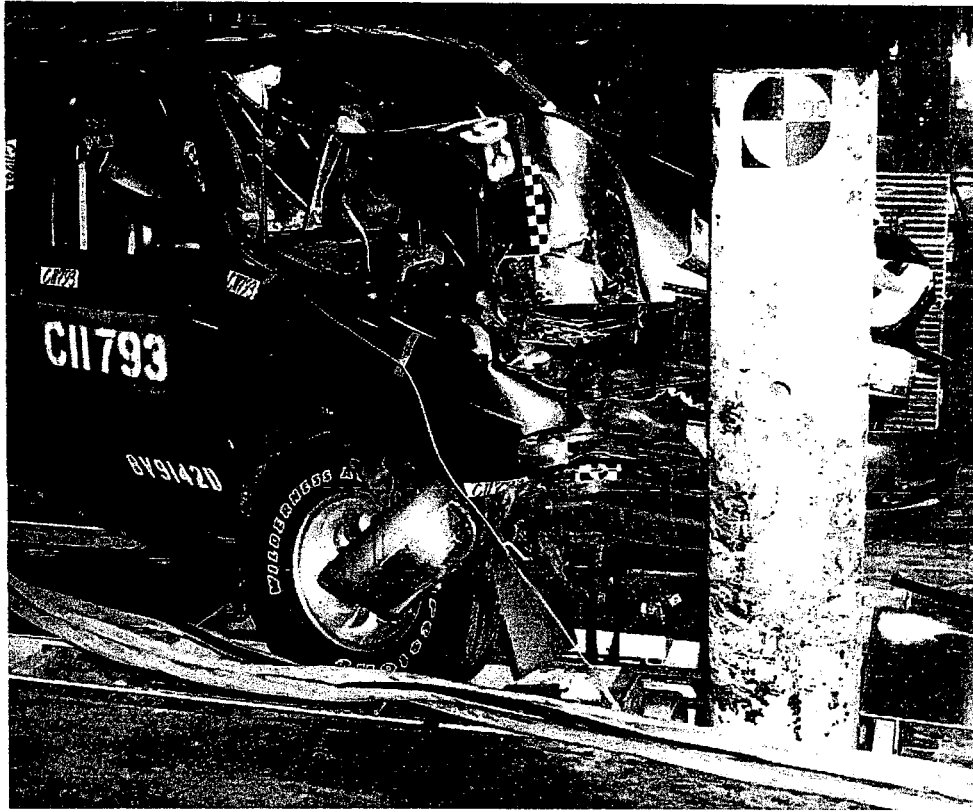
**Figure 24**  
Post-Test Photograph of Test C11793, Front-Right View

Post-test photographs of the vehicle are shown in Figure 24 and Figure 25.

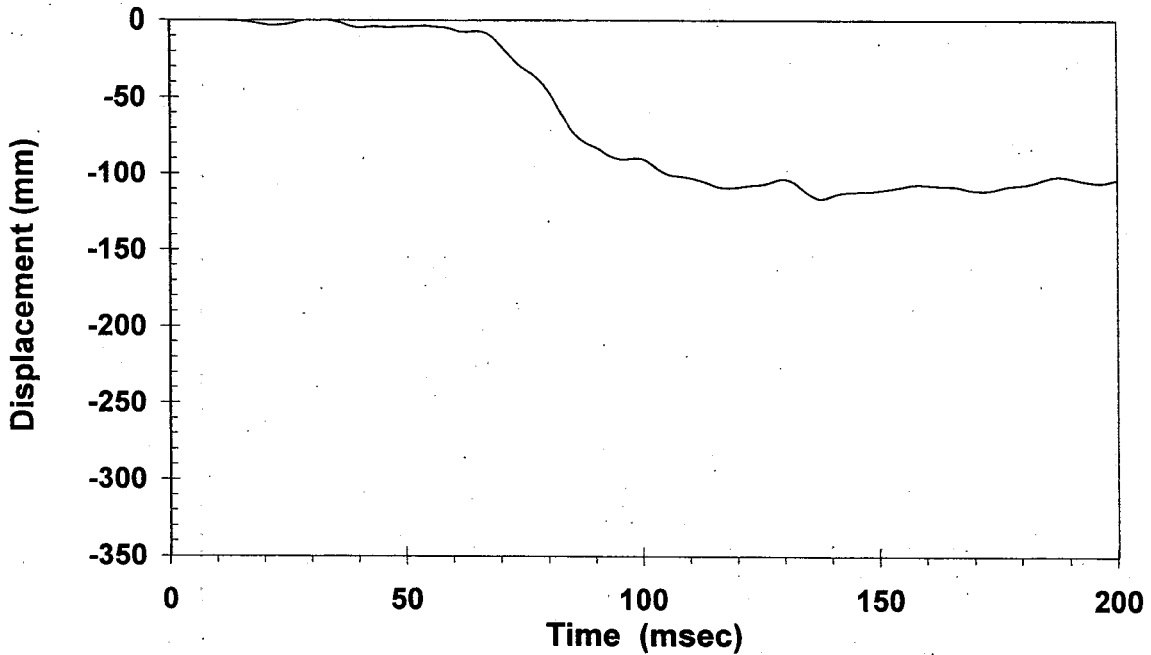
**Figure 28**  
 Right Toe pan Displacement, Relative to Floorpan  
 Test C11793, filtered at SAE class 60 [8]

The displacement of the right toe pan, relative to the passenger compartment, was approximately 118 mm and is shown in Figure 28 and also Plot 77, Appendix D.

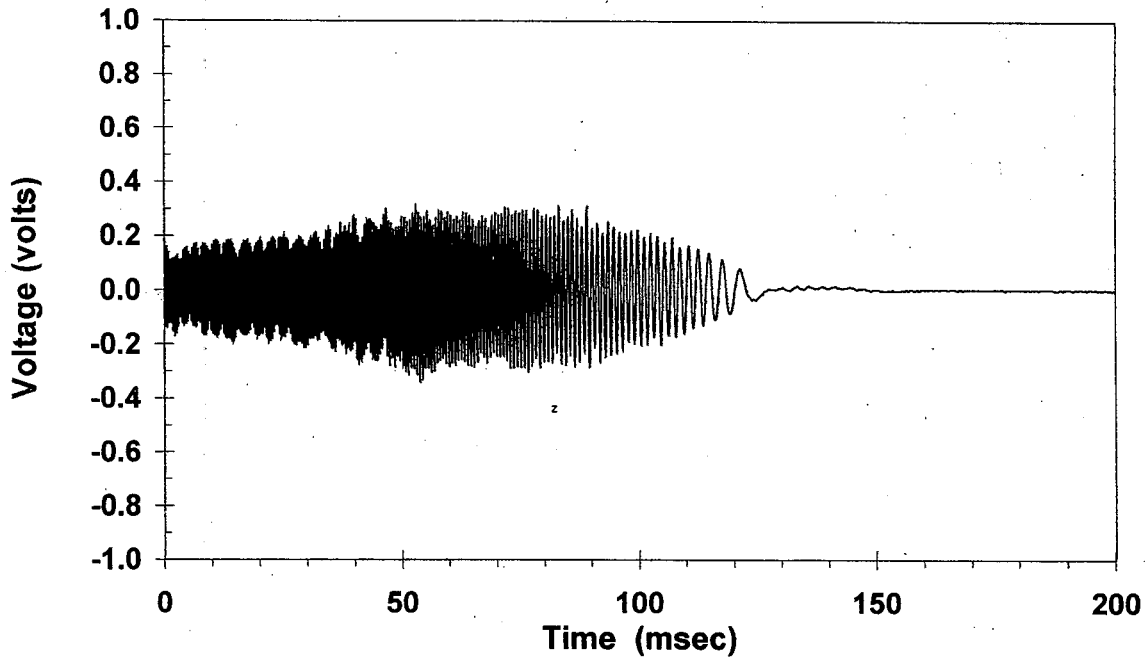
**Figure 29**  
Engine Motion  
Measured using Auxiliary Magnetic Pickup Transducer, Test C11793

The engine motion began to slow at approximately 40 msec after time zero and stopped by 120 msec as shown in Figure 29 and Plot 88.

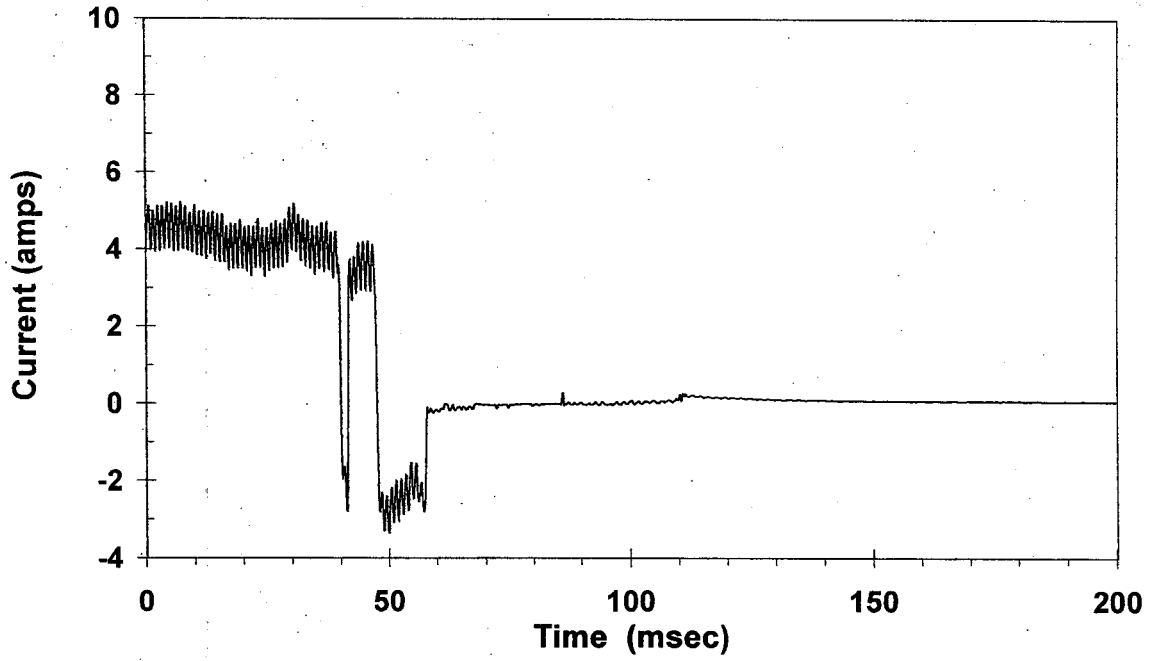
**Figure 30**  
 Fuel Pump Current  
 Test C11793

Figure 30 and Plot 99 shows the current measurement at the auxiliary fuel pump and indicates that the current stopped flowing to the pump at about 48 msec. This correlates with the time at which the main battery voltage dropped from 13 to 9 volts as shown in Plot 79 and Figure 31. Temporary and partial drops in main vehicle voltage have caused fuel pumps to consistently shut down early during the crash tests conducted for this project [2],[3]. In addition, an inertia activated fuel pump cutoff switch protected this fuel pump circuit. This switch activated at about 60 msec after impact. This can be determined by comparing the fuel pump voltage (Figure 32 and Plot 81) and the fuel inertia switch voltage (Figure 33 and Plot 85). These two measurements should be nearly equal after the switch activates as schematically shown in Figure 17. The measurements are indeed nearly identical after 60 msec. In addition, an independent electrical contact circuit was used to monitor the mechanical movement of the switch reset button (Plot 110) also indicated closure at about 60 msec.

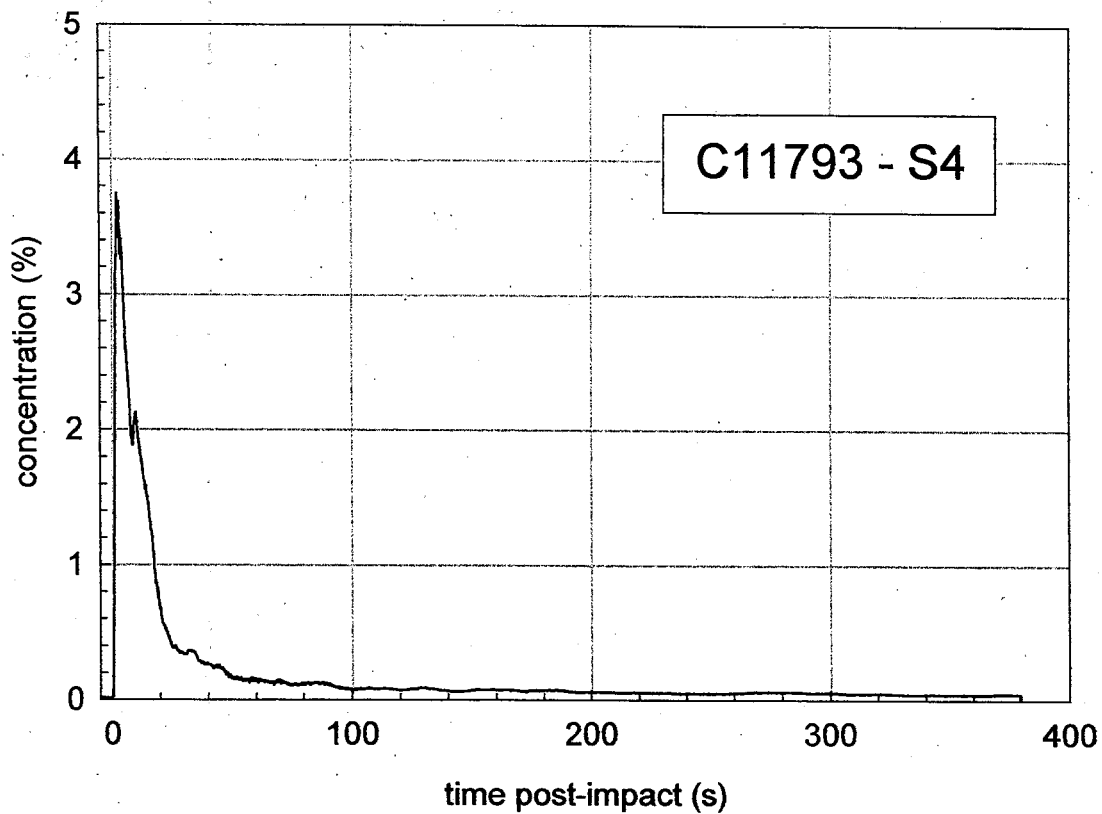
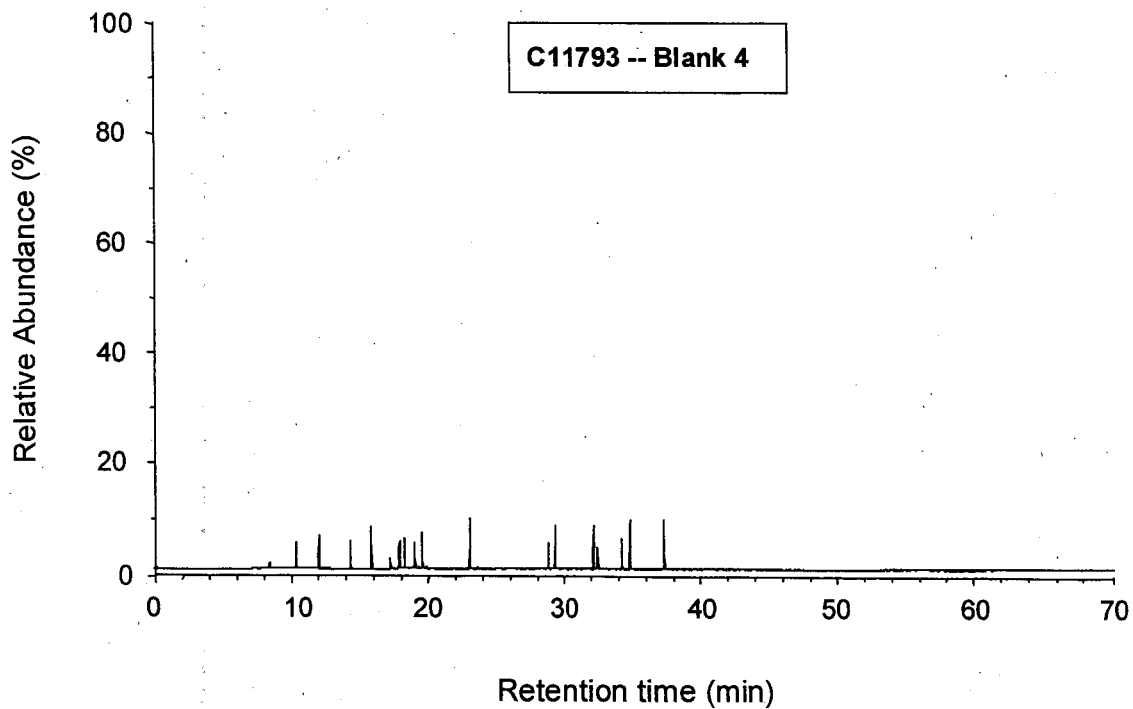
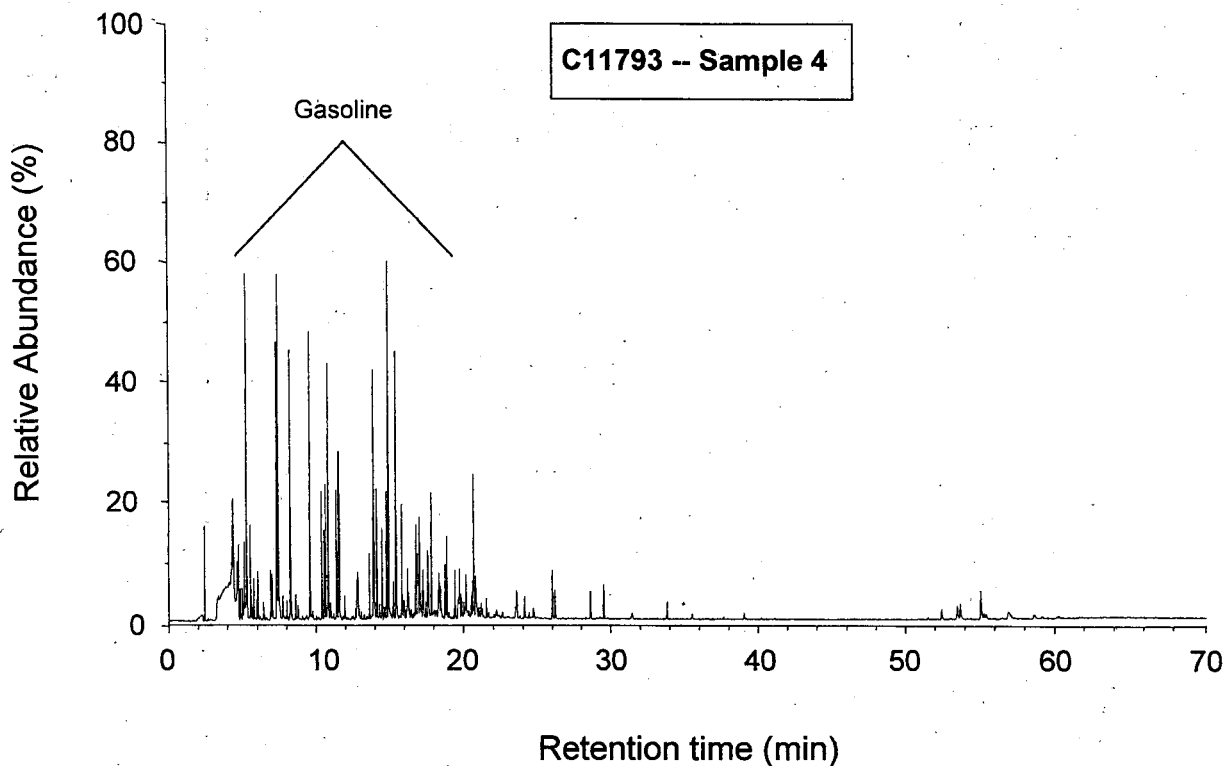
The signal cable from the vapor sensor located near the catalytic converter (location #5) was cut during the crash test and no useful data was recorded. The sensor near the right exhaust manifold (location #2) was sprayed with fluid and resulted in no useful data. Of the remaining three locations, the sensor near the fuel pressure regulator (location #4) indicated the highest concentration of hydrocarbon vapor. This sensor's output is recreated here as Figure 34 and indicates a concentration of hydrocarbon vapor exceeding 2% for the first 20 seconds following the test. The results of the GCMS analysis for location #4 is recreated here as Figure 35 and Figure 36. The GCMS analysis indicated the source of the vapors was likely gasoline.

Similar to test C11687, gasoline vapor was identified in the engine compartment but no leaks in the pressurized fuel system were identified. Since there was no Stoddard leak in this case, the source of the gasoline vapor could not have been contamination of the Stoddard Solvent but was likely an opening in the air/fuel intake path resulting in gasoline vapors being released to atmosphere. Also similar to test C11687, the fuel pump stopped early during the impact, thus only a small amount of vapor was likely released.

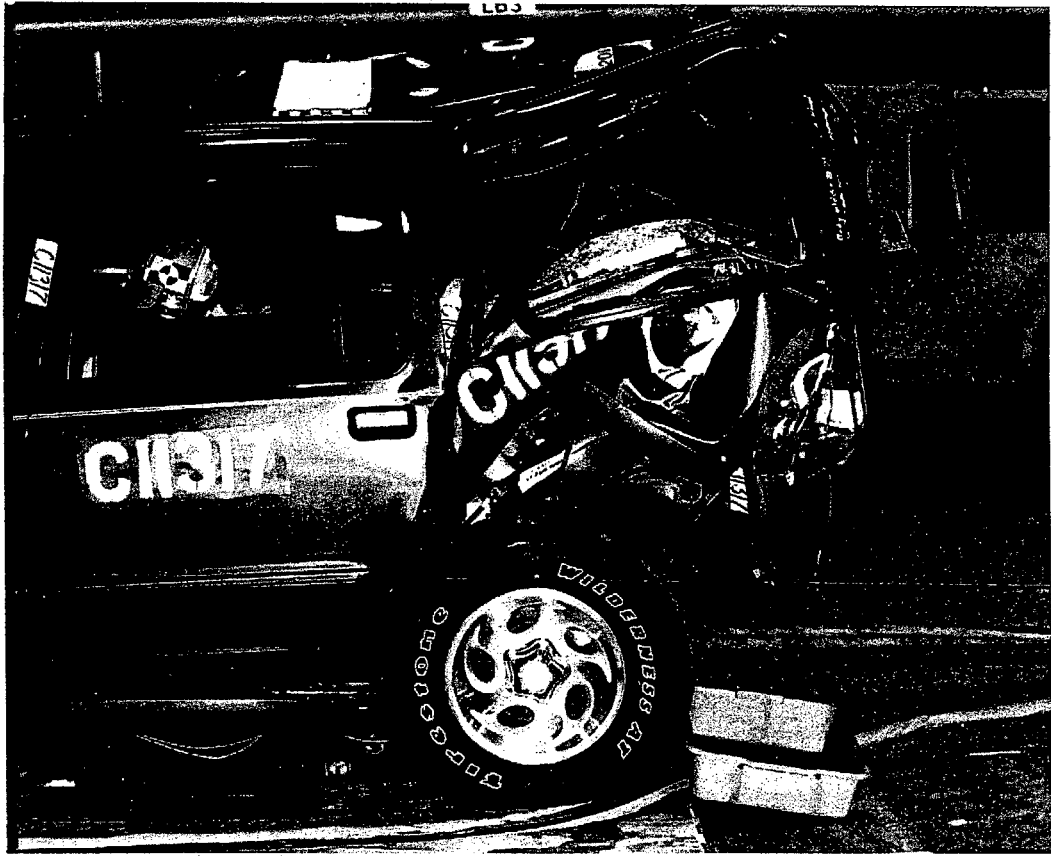
**Figure 37**  
Post-Test Photograph of Test C11317, Left-Rear View

Post-test photographs of the vehicle are shown in Figure 37 and Figure 38.

During the post-test inspection, an approximately 12 mm (0.5 inch) long tear in the rubber portion of the filler neck hose was found. This tear was just below the hose clamp attachment to the metal filler tube. This tear was the likely source of the Stoddard leak during the static rollover. In addition to the leak, the lower rear right corner of the fuel tank was deformed due to contact with the rear axle housing. A small amount of stoddard solvent dye was visible around the deformation indicating the Stoddard likely weeped out of a very small pinhole sized puncture in the tank, but no leakage off of the vehicle was noted at the crash site. The lower rear right hand corner of the tank is where a gasoline leak was simulated for the subsequent fire propagation test, which was reported separately.

The only other fluid leak identified during the post – test vehicle inspection was the rear washer solvent reservoir, which was crushed.

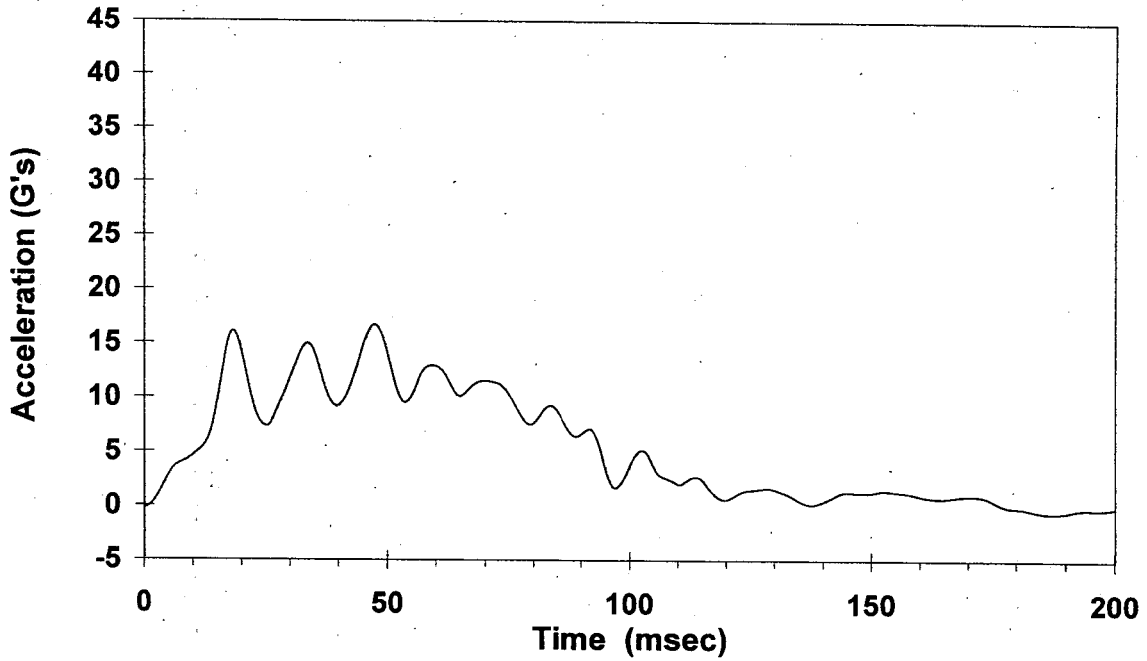
**Figure 39**  
 Averaged (Left & Right) Front Rocker Panel Longitudinal Acceleration,  
 Test C11317, filtered at SAE class 60 [8]

The average of the two front rocker panel longitudinal acceleration measurements (Figure 39) was integrated to compute the change in vehicle longitudinal velocity (Figure 40). The peak vehicle longitudinal acceleration (after filtering at SAE class 60 [8]), was 16.8 g and the maximum longitudinal change in vehicle velocity was 37.0 km/h ( 23.0 mph).

For the rear impact test, the engine was not operating for the test. For this test, the fuel pump inertia switch did not activate. However, the vehicle peak acceleration (16.8 g as shown in Figure 39) and longitudinal velocity change (37 km/h or 23 mph) was significantly lower than for the two frontal tests. (The oblique moving barrier frontal impact acceleration was 36 g with a 45 km/h (28 mph) velocity change and the offset pole impact acceleration was 28 g with a 61 km/h (37.9 mph) velocity change.)

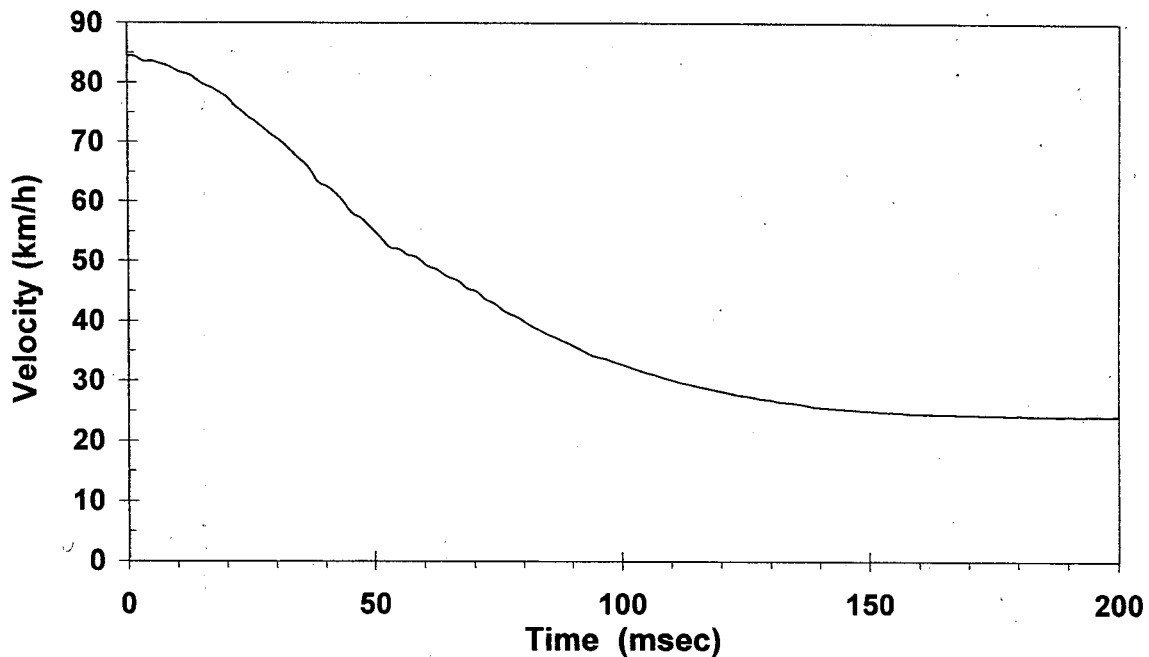
**Figure 41**  
 Moving Deformable Barrier Longitudinal Velocity at CG  
 Test C11317

The longitudinal velocity of the barrier's CG is shown in plot 60 and re-created here as Figure 41. The barrier sustained a velocity change of about 60.4 km/h (37.5 mph).

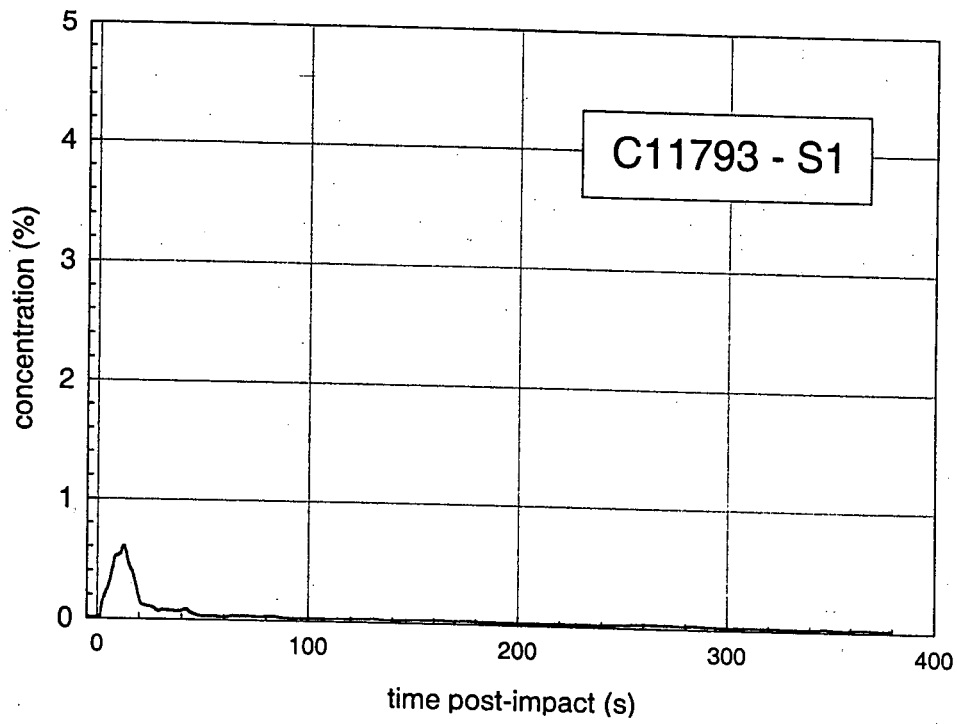
Hydrocarbon vapor sensors were used and identified the presence of underhood vapors in the 2 frontal crash tests. The post-test GCMS analysis indicated the presence of oil vapors, Stoddard vapors and gasoline vapors for the oblique moving barrier frontal impact. Gasoline vapor was identified on the offset frontal pole impact. In neither test was a leak in the pressurized fuel system identified, however. The presence of gasoline vapor does not necessarily indicate the presence of a liquid gasoline leak. The vapor source could be the contamination of Stoddard Solvent with gasoline or the release of gasoline vapors from the intake path as the engine was crushed.

**Figure E1**  
 Concentration Of Hydrocarbon Vapor Above Left Exhaust Manifold (Location #1)  
 Test C11793

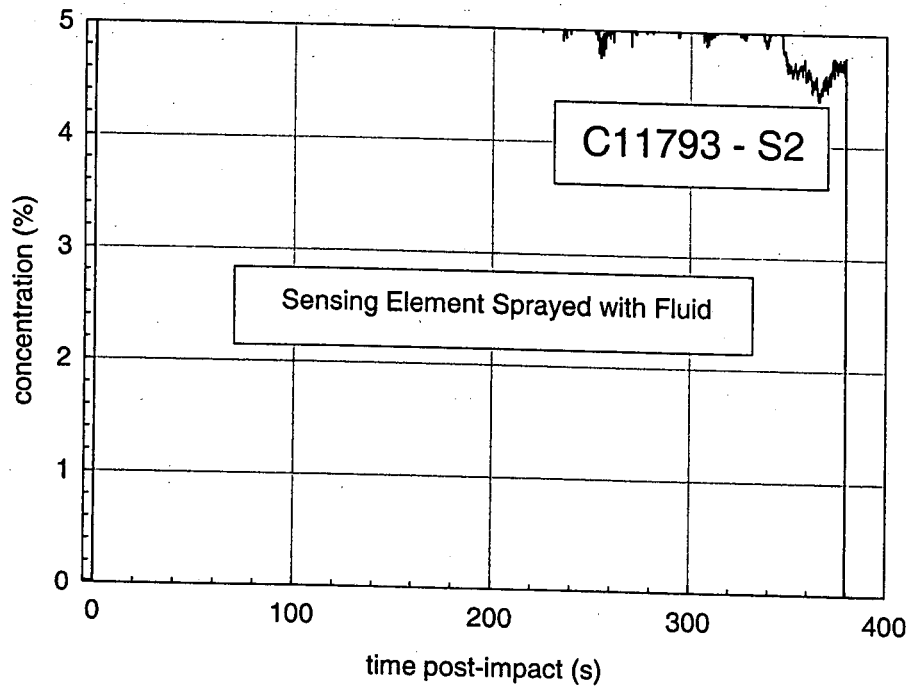
**Figure E2**  
 Concentration Of Hydrocarbon Vapor Above Right Exhaust Manifold (Location #2)  
 Test C11793

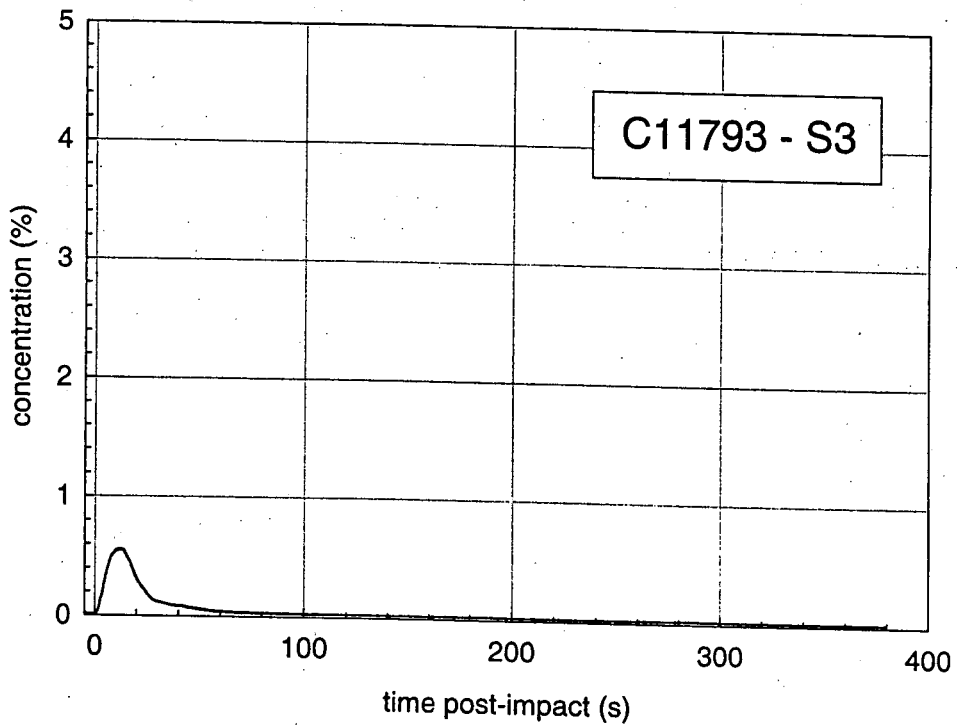
**Figure E3**  
 Concentration Of Hydrocarbon Vapor Above Lower Rear Intake Manifold (Location #3)  
 Test C11793

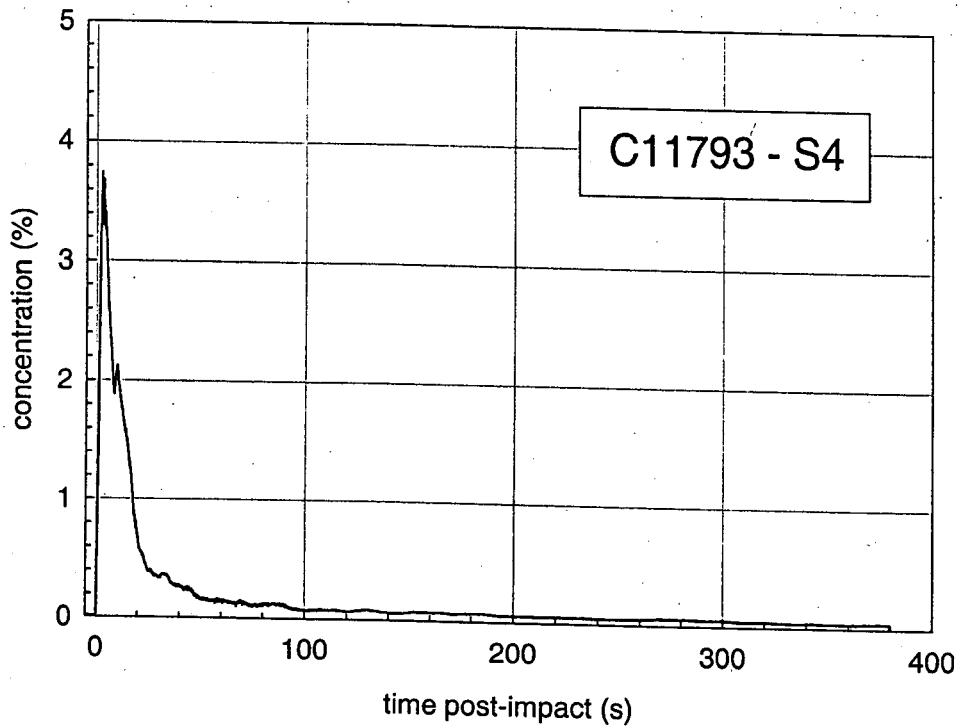
**Figure E4**  
 Concentration Of Hydrocarbon Vapor Near the Fuel Pressure Regulator (Location #4)  
 Test C11793

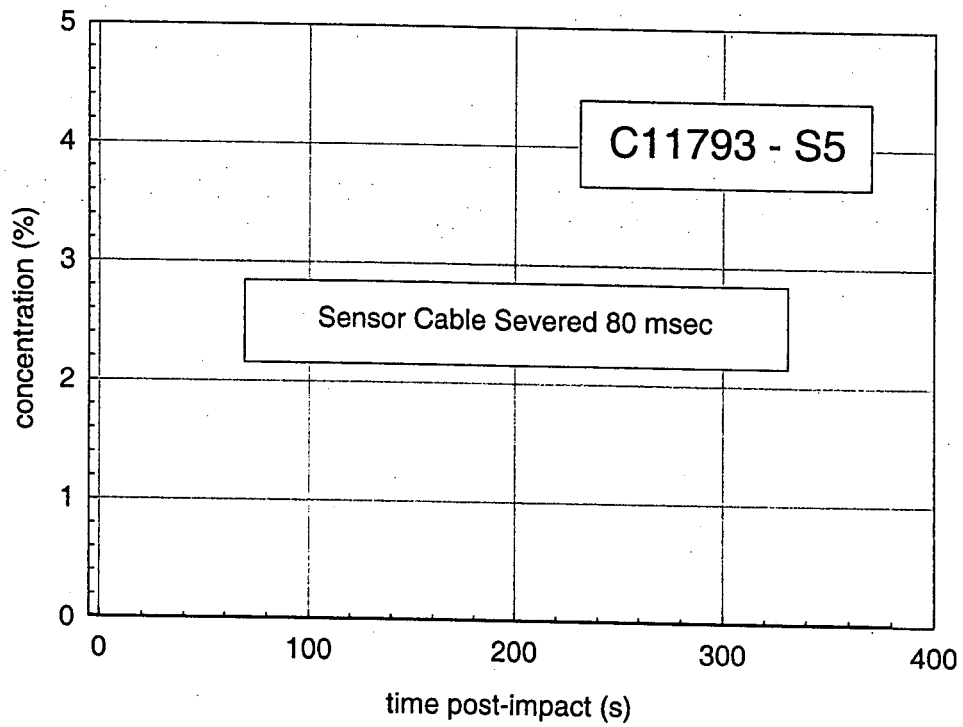
**Figure E5**  
Concentration Of Hydrocarbon Vapor Near the Catalytic Converter (Location #5)  
Test C11793

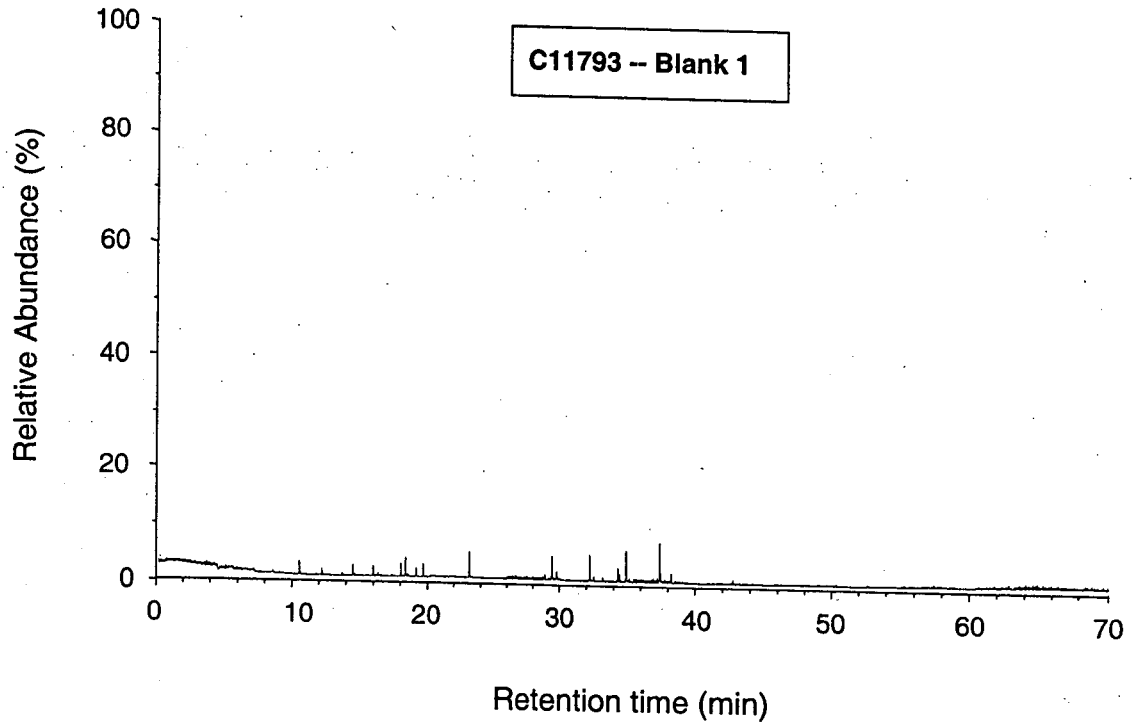
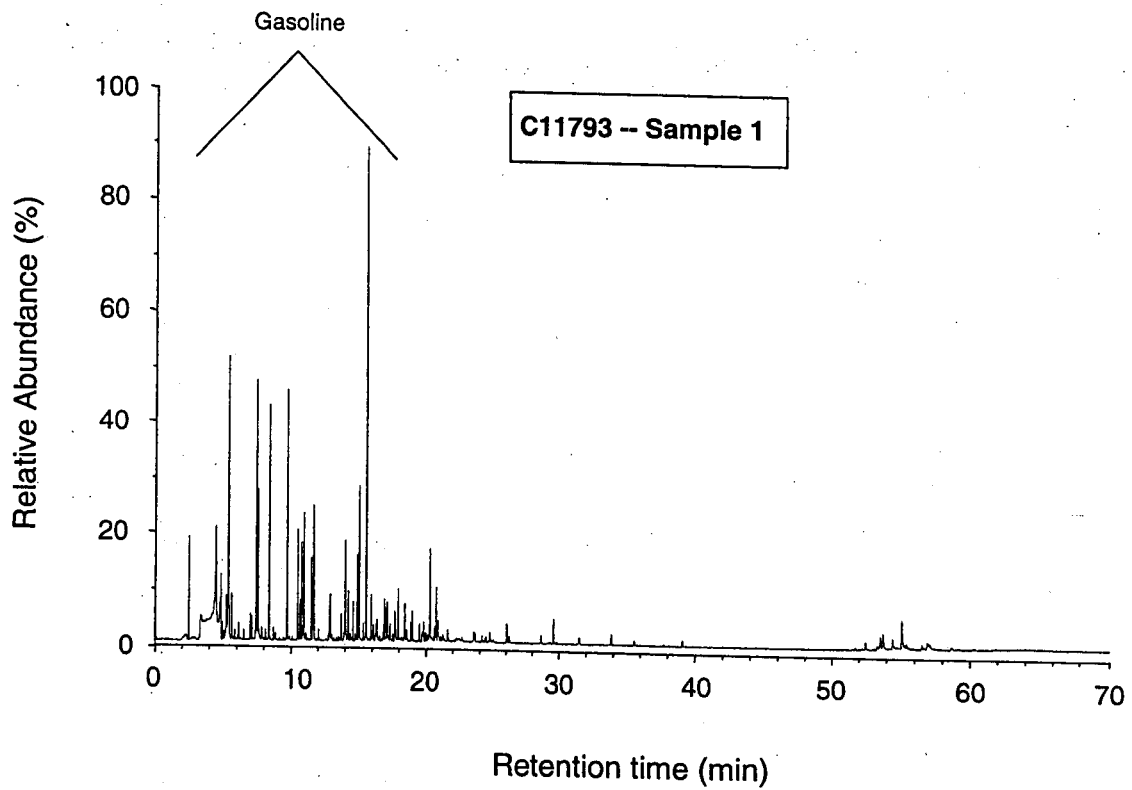
**Figure EE1**  
GC/MS analysis of hydrocarbon vapor sample from above the left exhaust manifold (Location #1) during Crash Test C11793. The top panel is the chromatogram of background sample and the bottom panel is the chromatogram of the post-crash sample.
