# Evaluation of Motor Vehicle Fire Initiation and Propagation

## Part 8: Crash Tests on a Sport-Utility-Vehicle

Jack L. Jensen, Jeffrey Santrock

General Motors Corporation

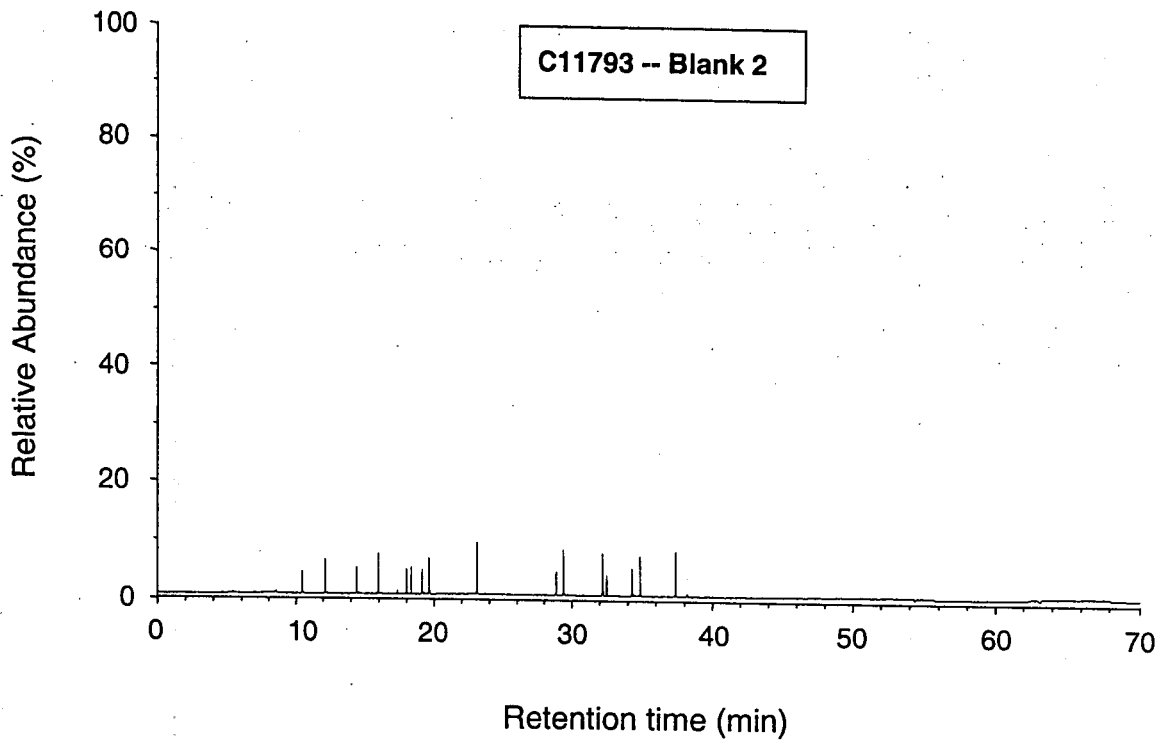
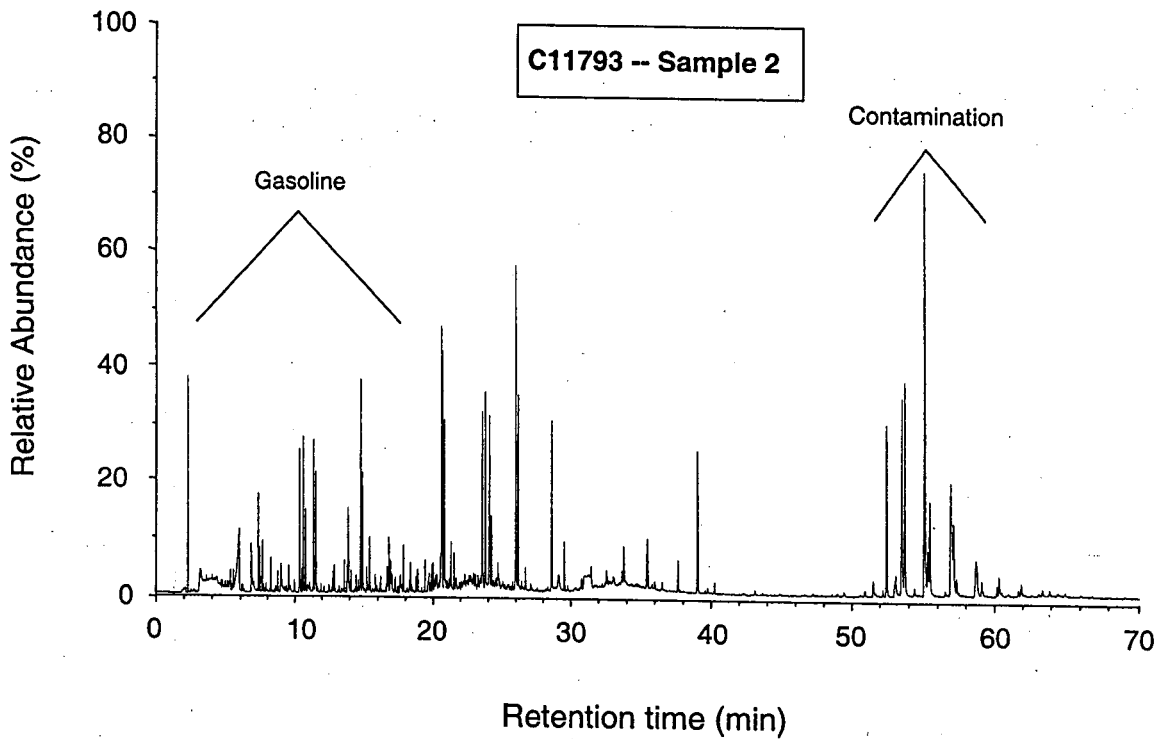
**Figure EE2**  
GC/MS analysis of hydrocarbon vapor sample from above the right exhaust manifold (Location#2) during Crash Test C11793. The top panel is the chromatogram of background sample and the bottom panel is the chromatogram of the post-crash sample.

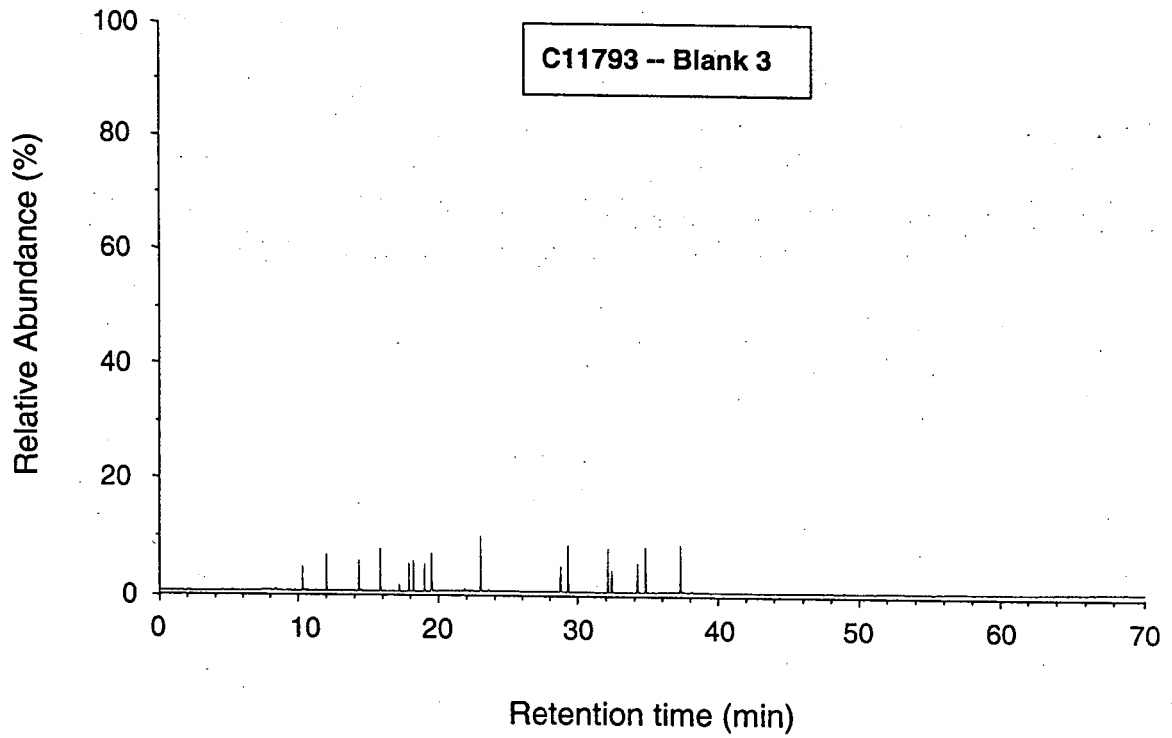
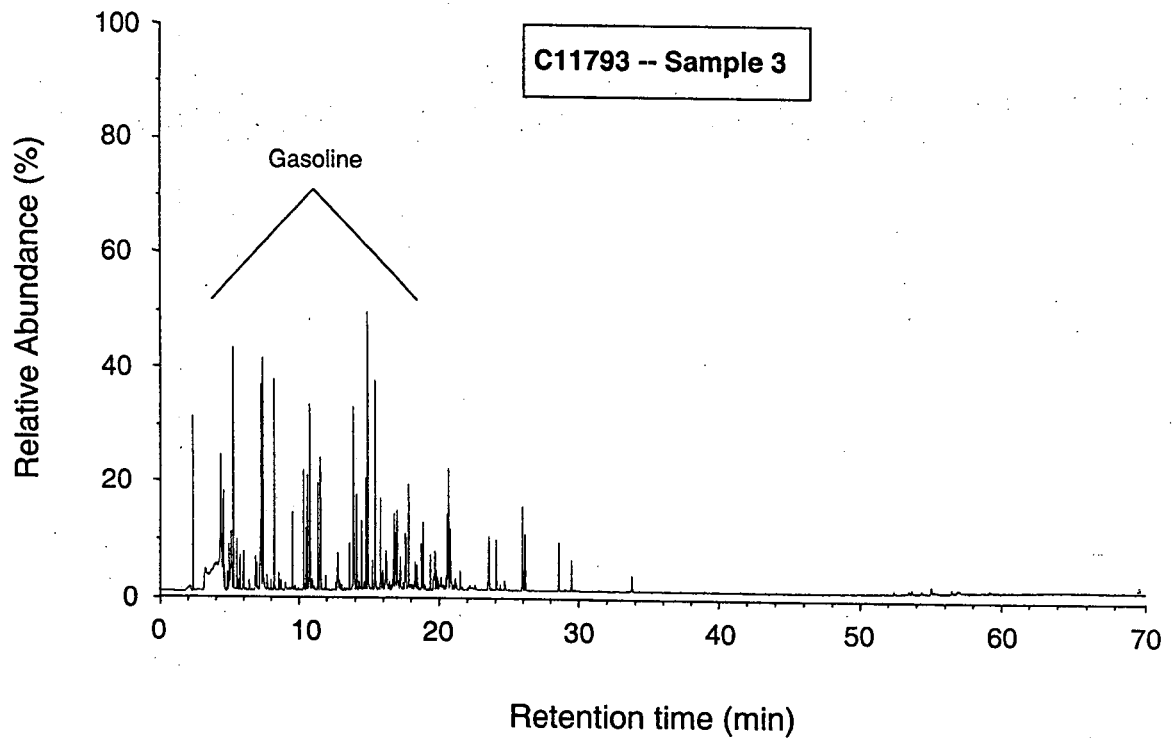
**Figure EE3**  
 GC/MS analysis of hydrocarbon vapor sample from above the lower rear intake manifold (Location #3) during Crash Test C11793. The top panel is the chromatogram of background sample and the bottom panel is the chromatogram of the post-crash sample.

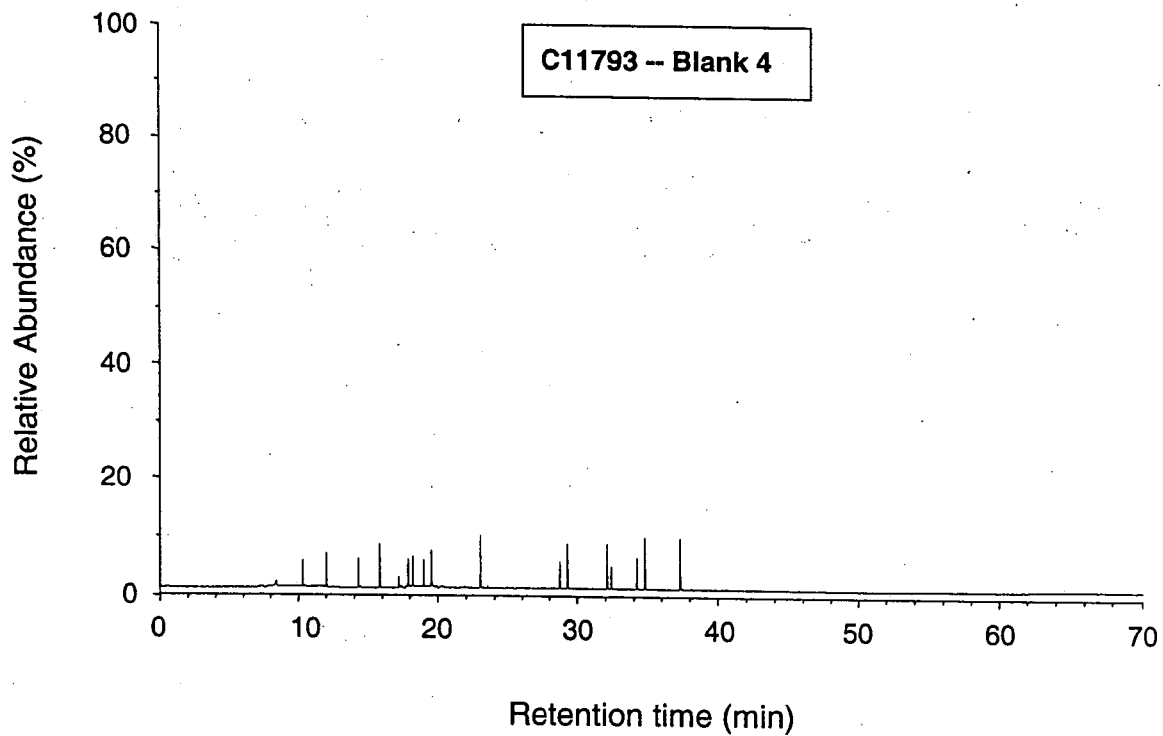
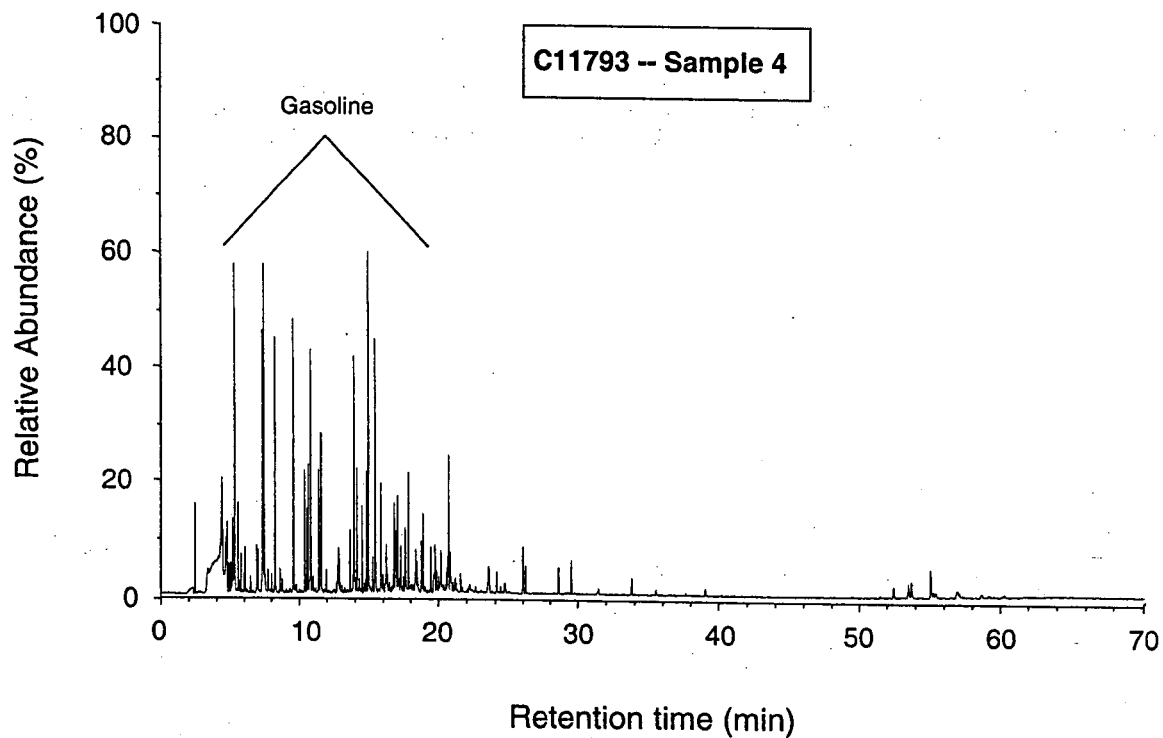
**Figure EE4**  
 GC/MS analysis of hydrocarbon vapor sample from above the fuel pressure regulator (Location #4) during Crash Test C11793. The top panel is the chromatogram of background sample and the bottom panel is the chromatogram of the post-crash sample.

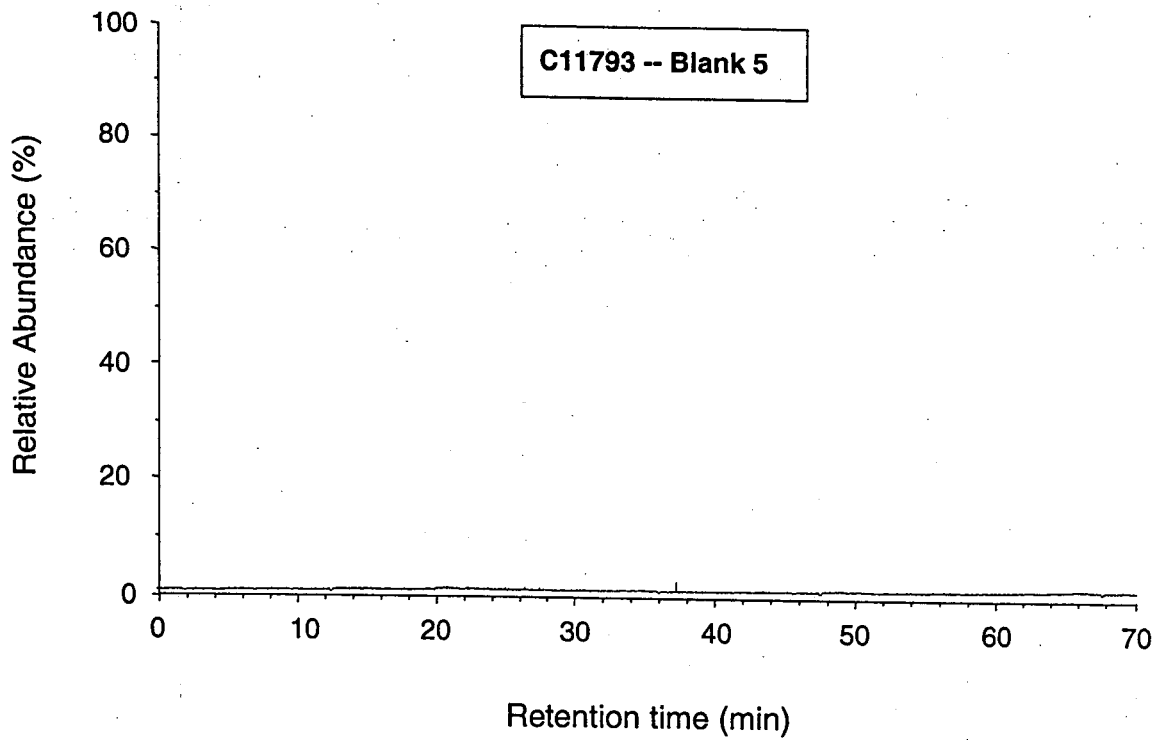
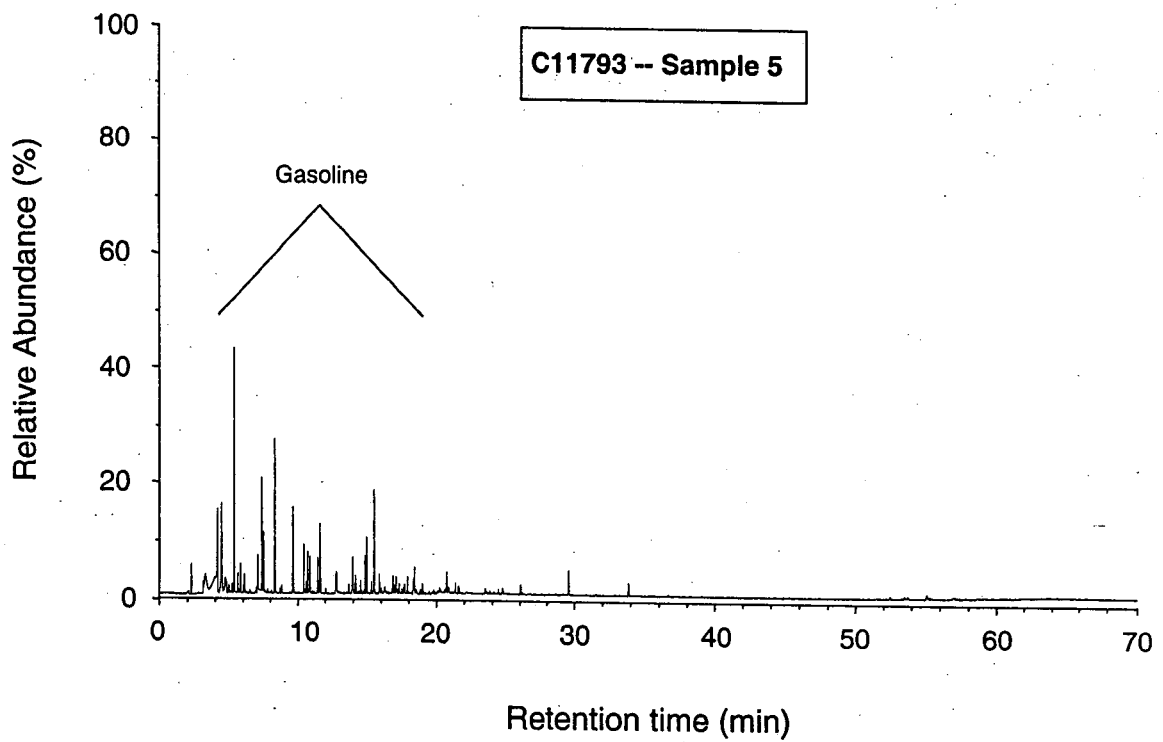
**Figure EE5**  
GC/MS analysis of hydrocarbon vapor sample from above the catalytic converter (Location #5) during Crash Test C11793. The top panel is the chromatogram of background sample and the bottom panel is the chromatogram of the post-crash sample.

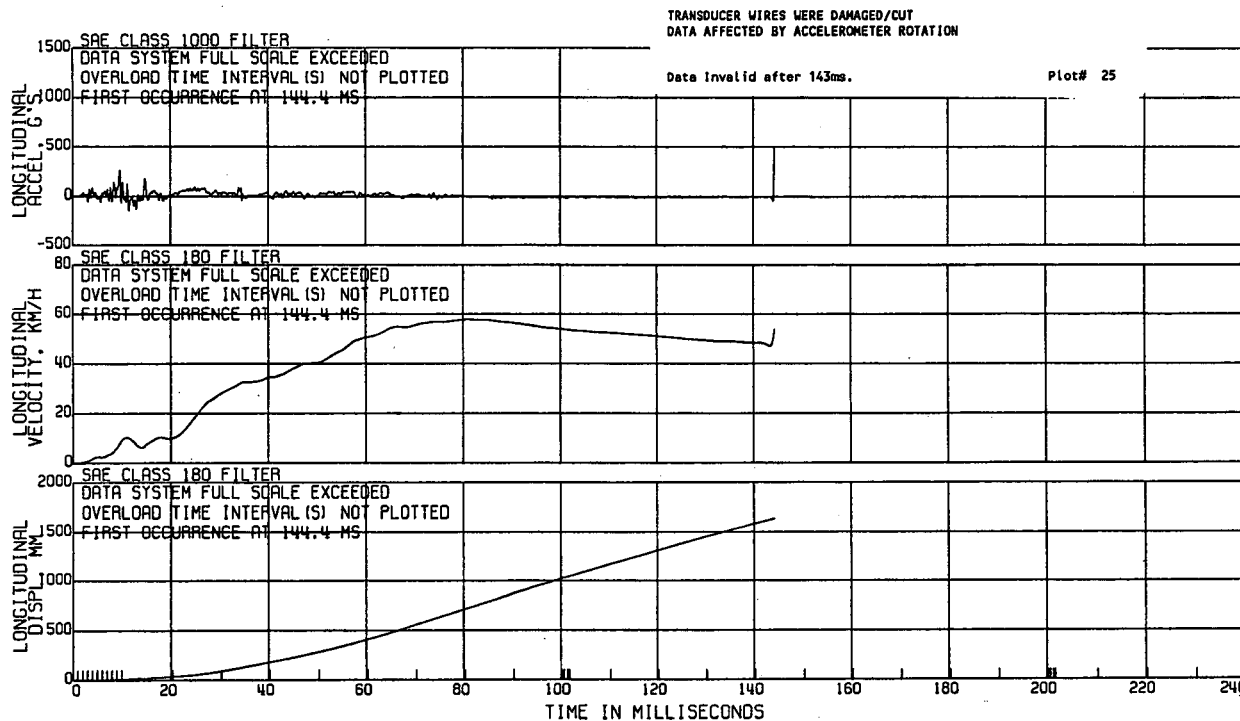
Appendix G, plot # 25

DATA AFFECTED BY ACCELEROMETER ROTATION

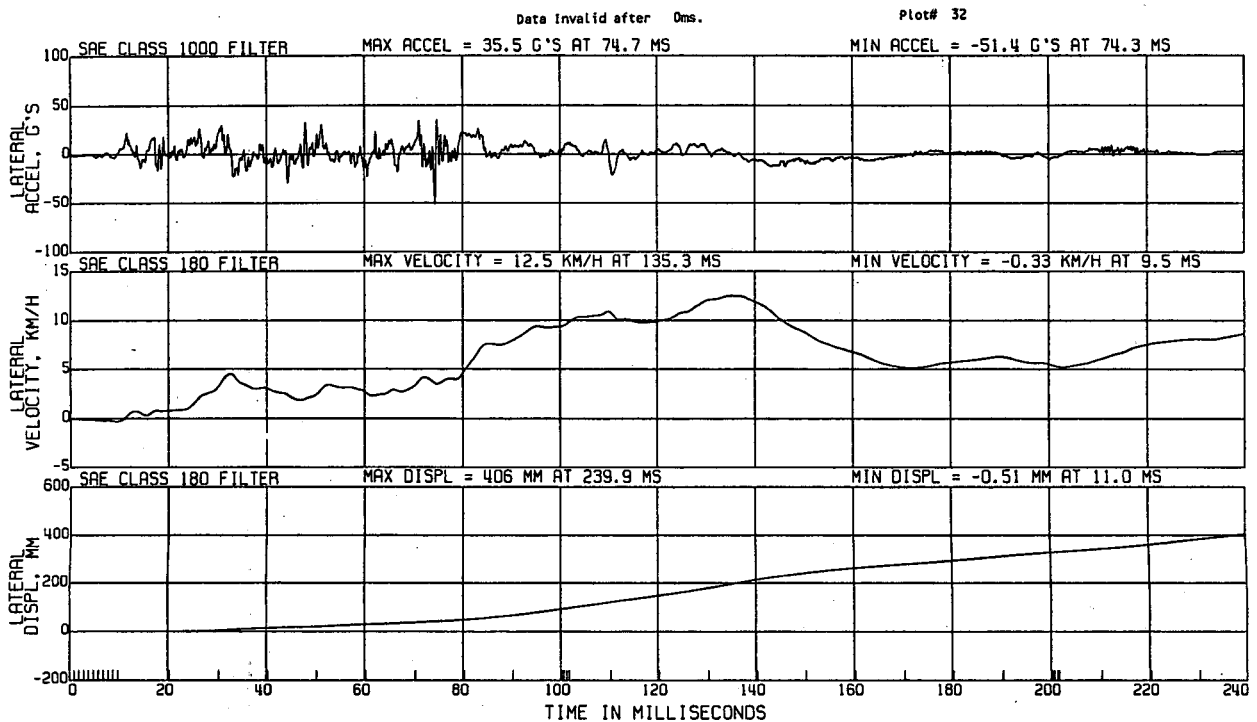
Appendix G, plot # 32

ACCELEROMETER EXHIBITED A DC SHIFT
