Enclosed is a final report prepared by Jeffrey Santrock of General Motors Corporation, entitled, "Evaluation of Motor Vehicle Fire Initiation and Propagation Part 4: Propagation of an Underbody Gasoline Pool Fire in a 1996 Passenger Van."

**Evaluation of Motor Vehicle Fire Initiation and Propagation
Part 4: Propagation of an Underbody Gasoline Pool Fire in a 1996
Passenger Van**

Jeffrey Santrock
General Motors Corporation

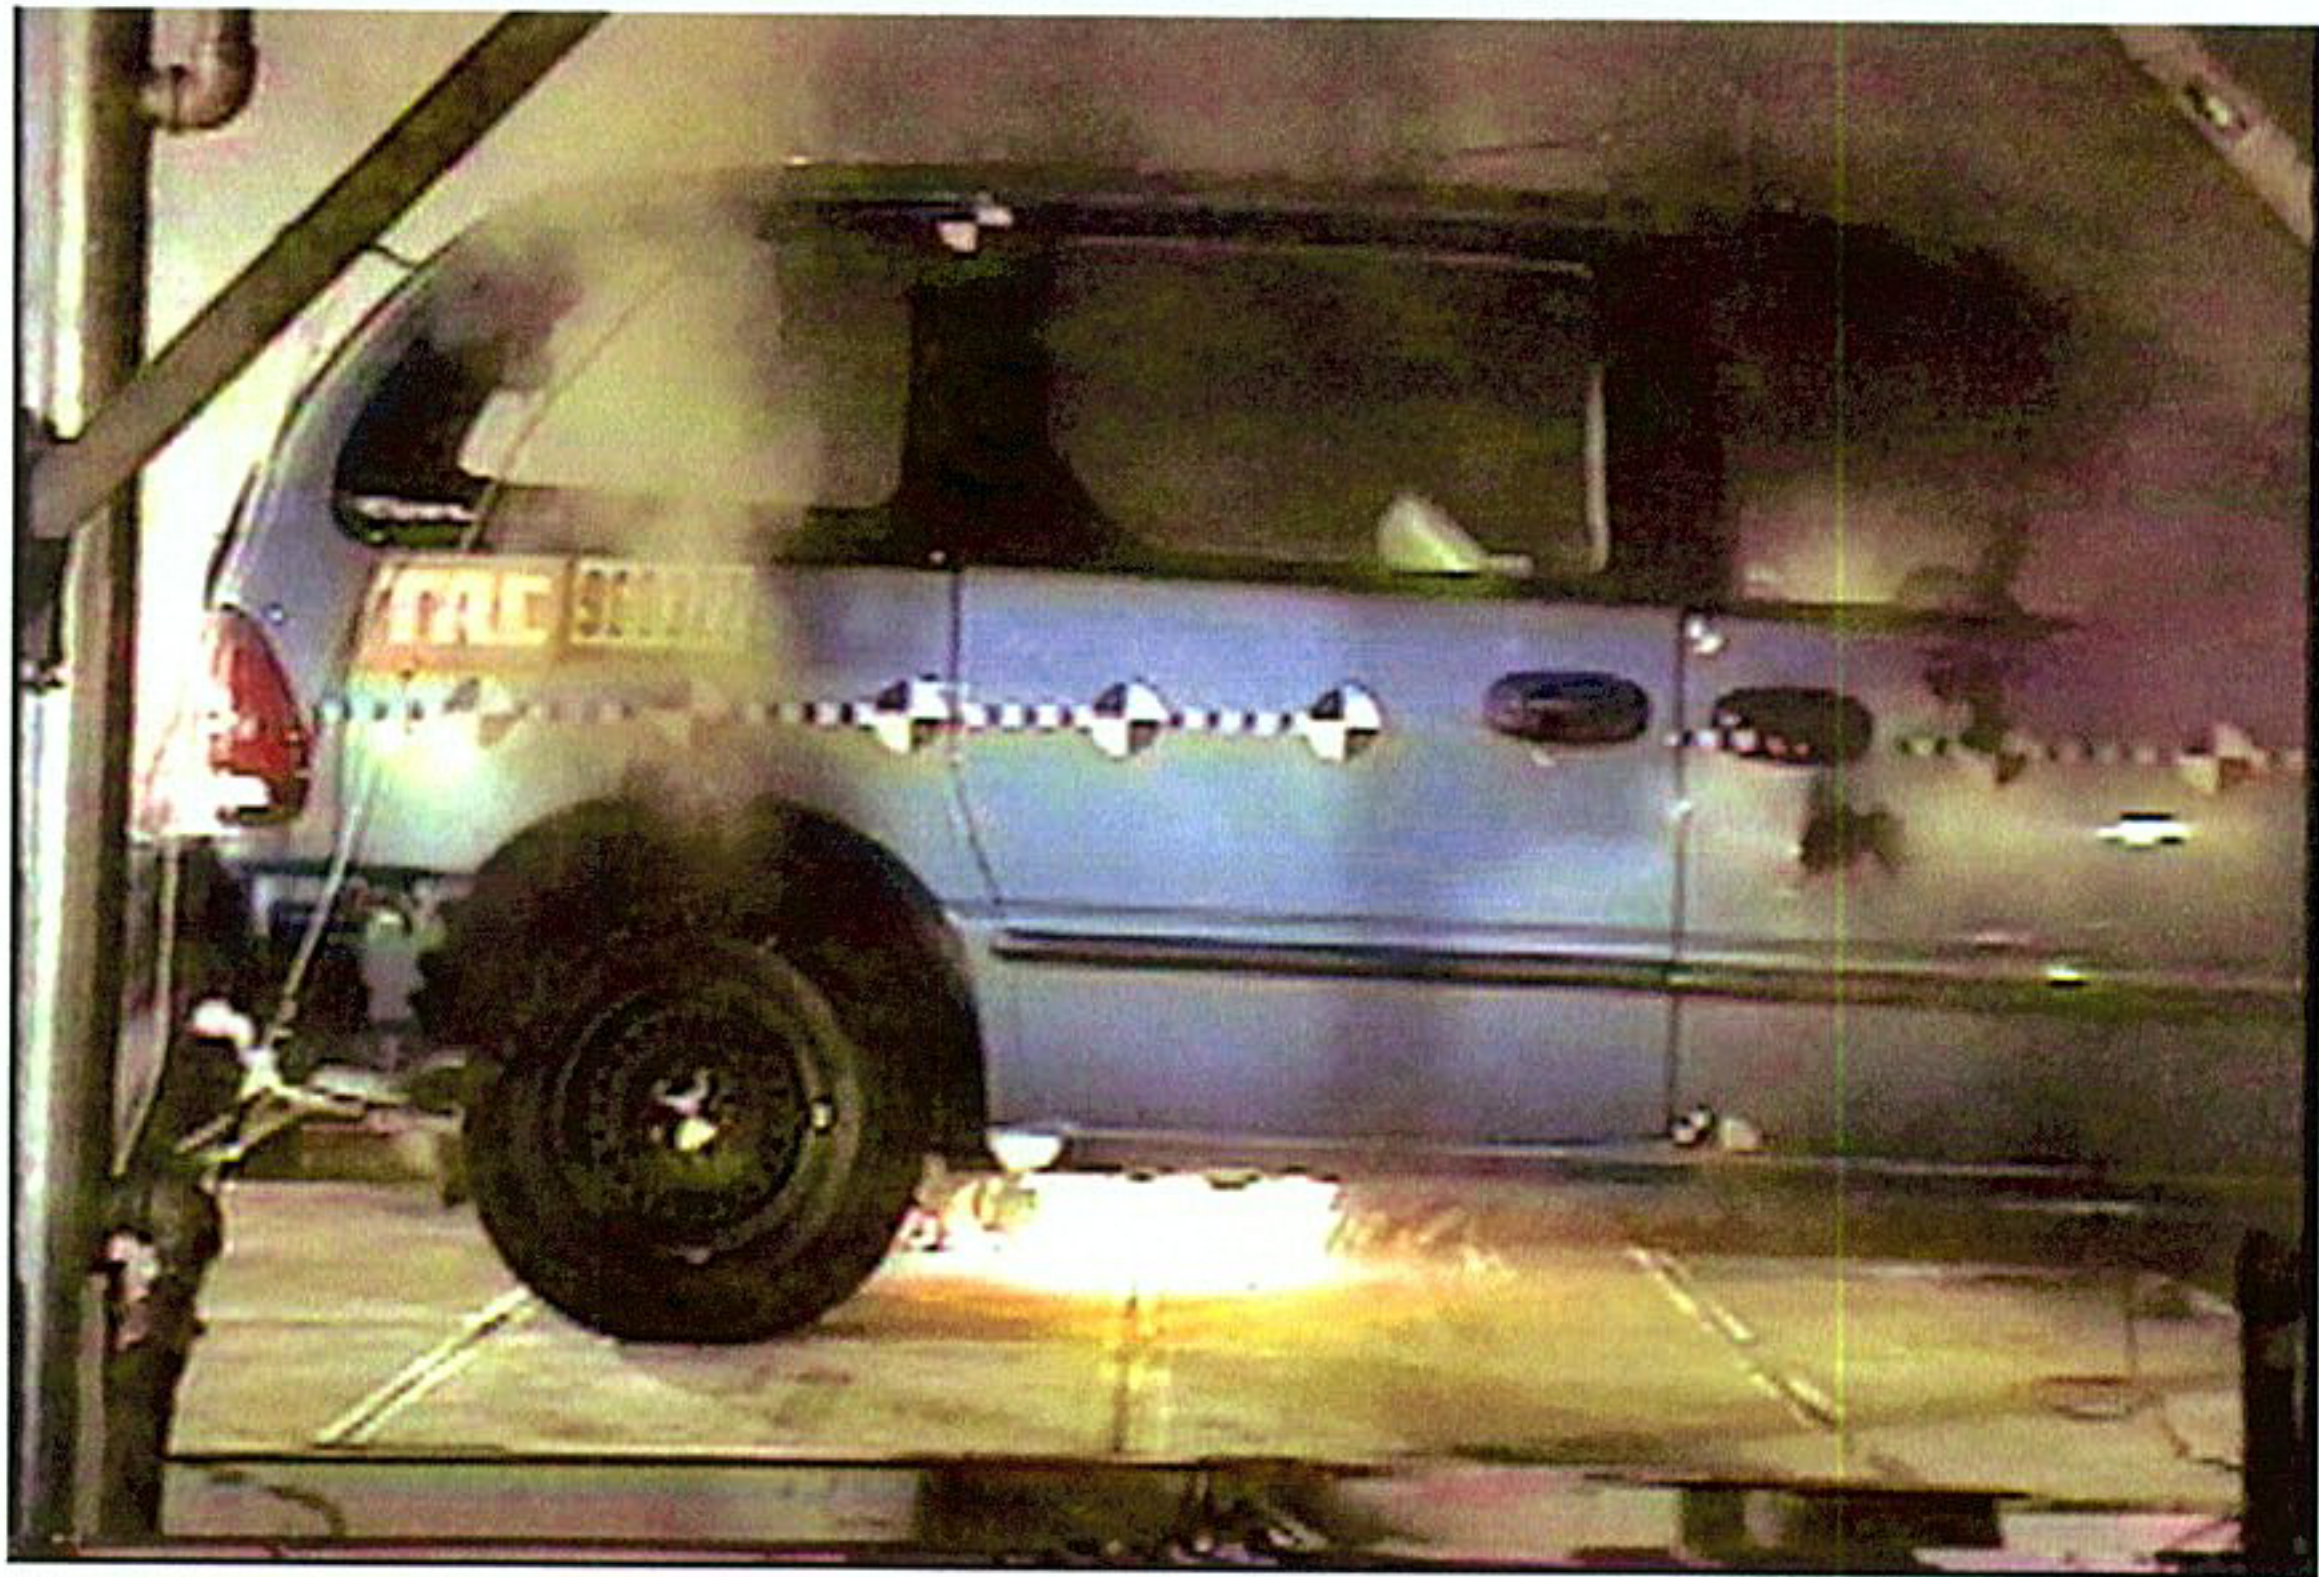
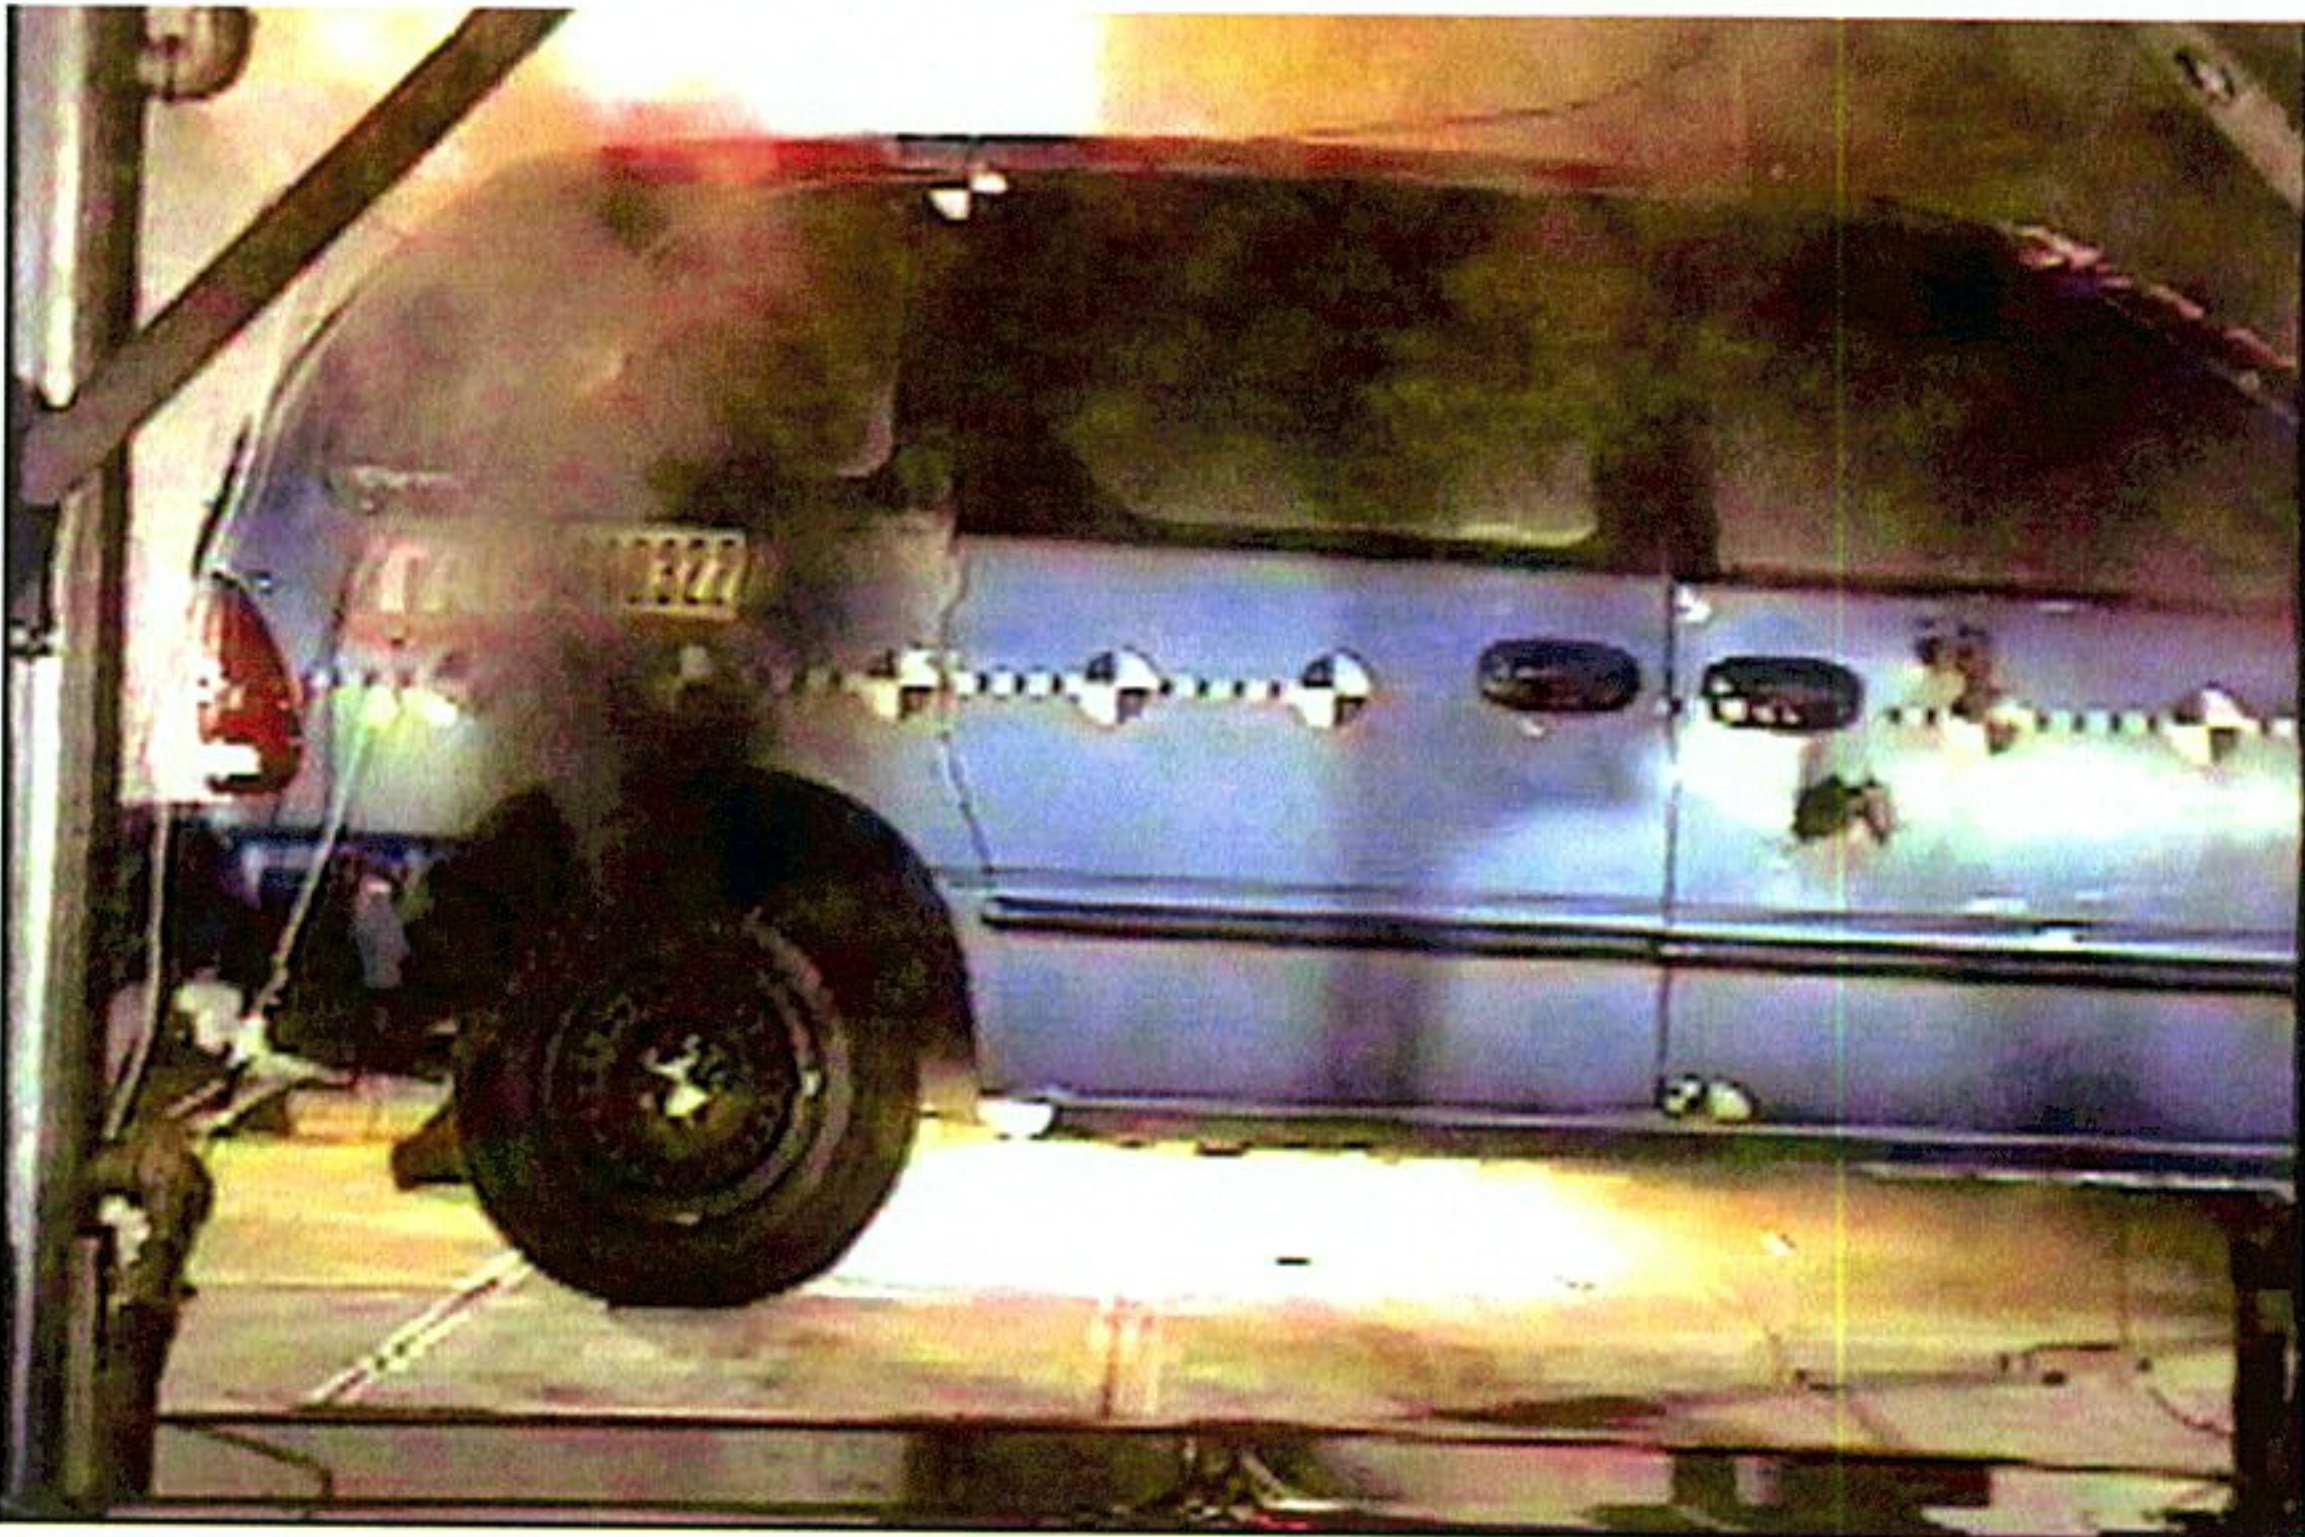
Figure 8. Fire Test F961116. Video stills from Camera 4 showing the right side of the test vehicle at 80 (upper panel) and 200 (lower panel) post-ignition. The diameter of the burning fuel under the vehicle was approximately 40 cm at 80 seconds post-ignition and approximately 80 cm at 200 seconds post-ignition.

Under steady-state burning conditions, a 40 cm-diameter gasoline pool fire would be expected to produce a flame about 1 m high [5]. However, the fuel tank and floor pan of the test vehicle were 15 to 30 cm above the burning pool and obstructed the upward movement of the fire plume. Flames spread radially along the lower surface of the gasoline tank and upward around its sides onto the floor pan.

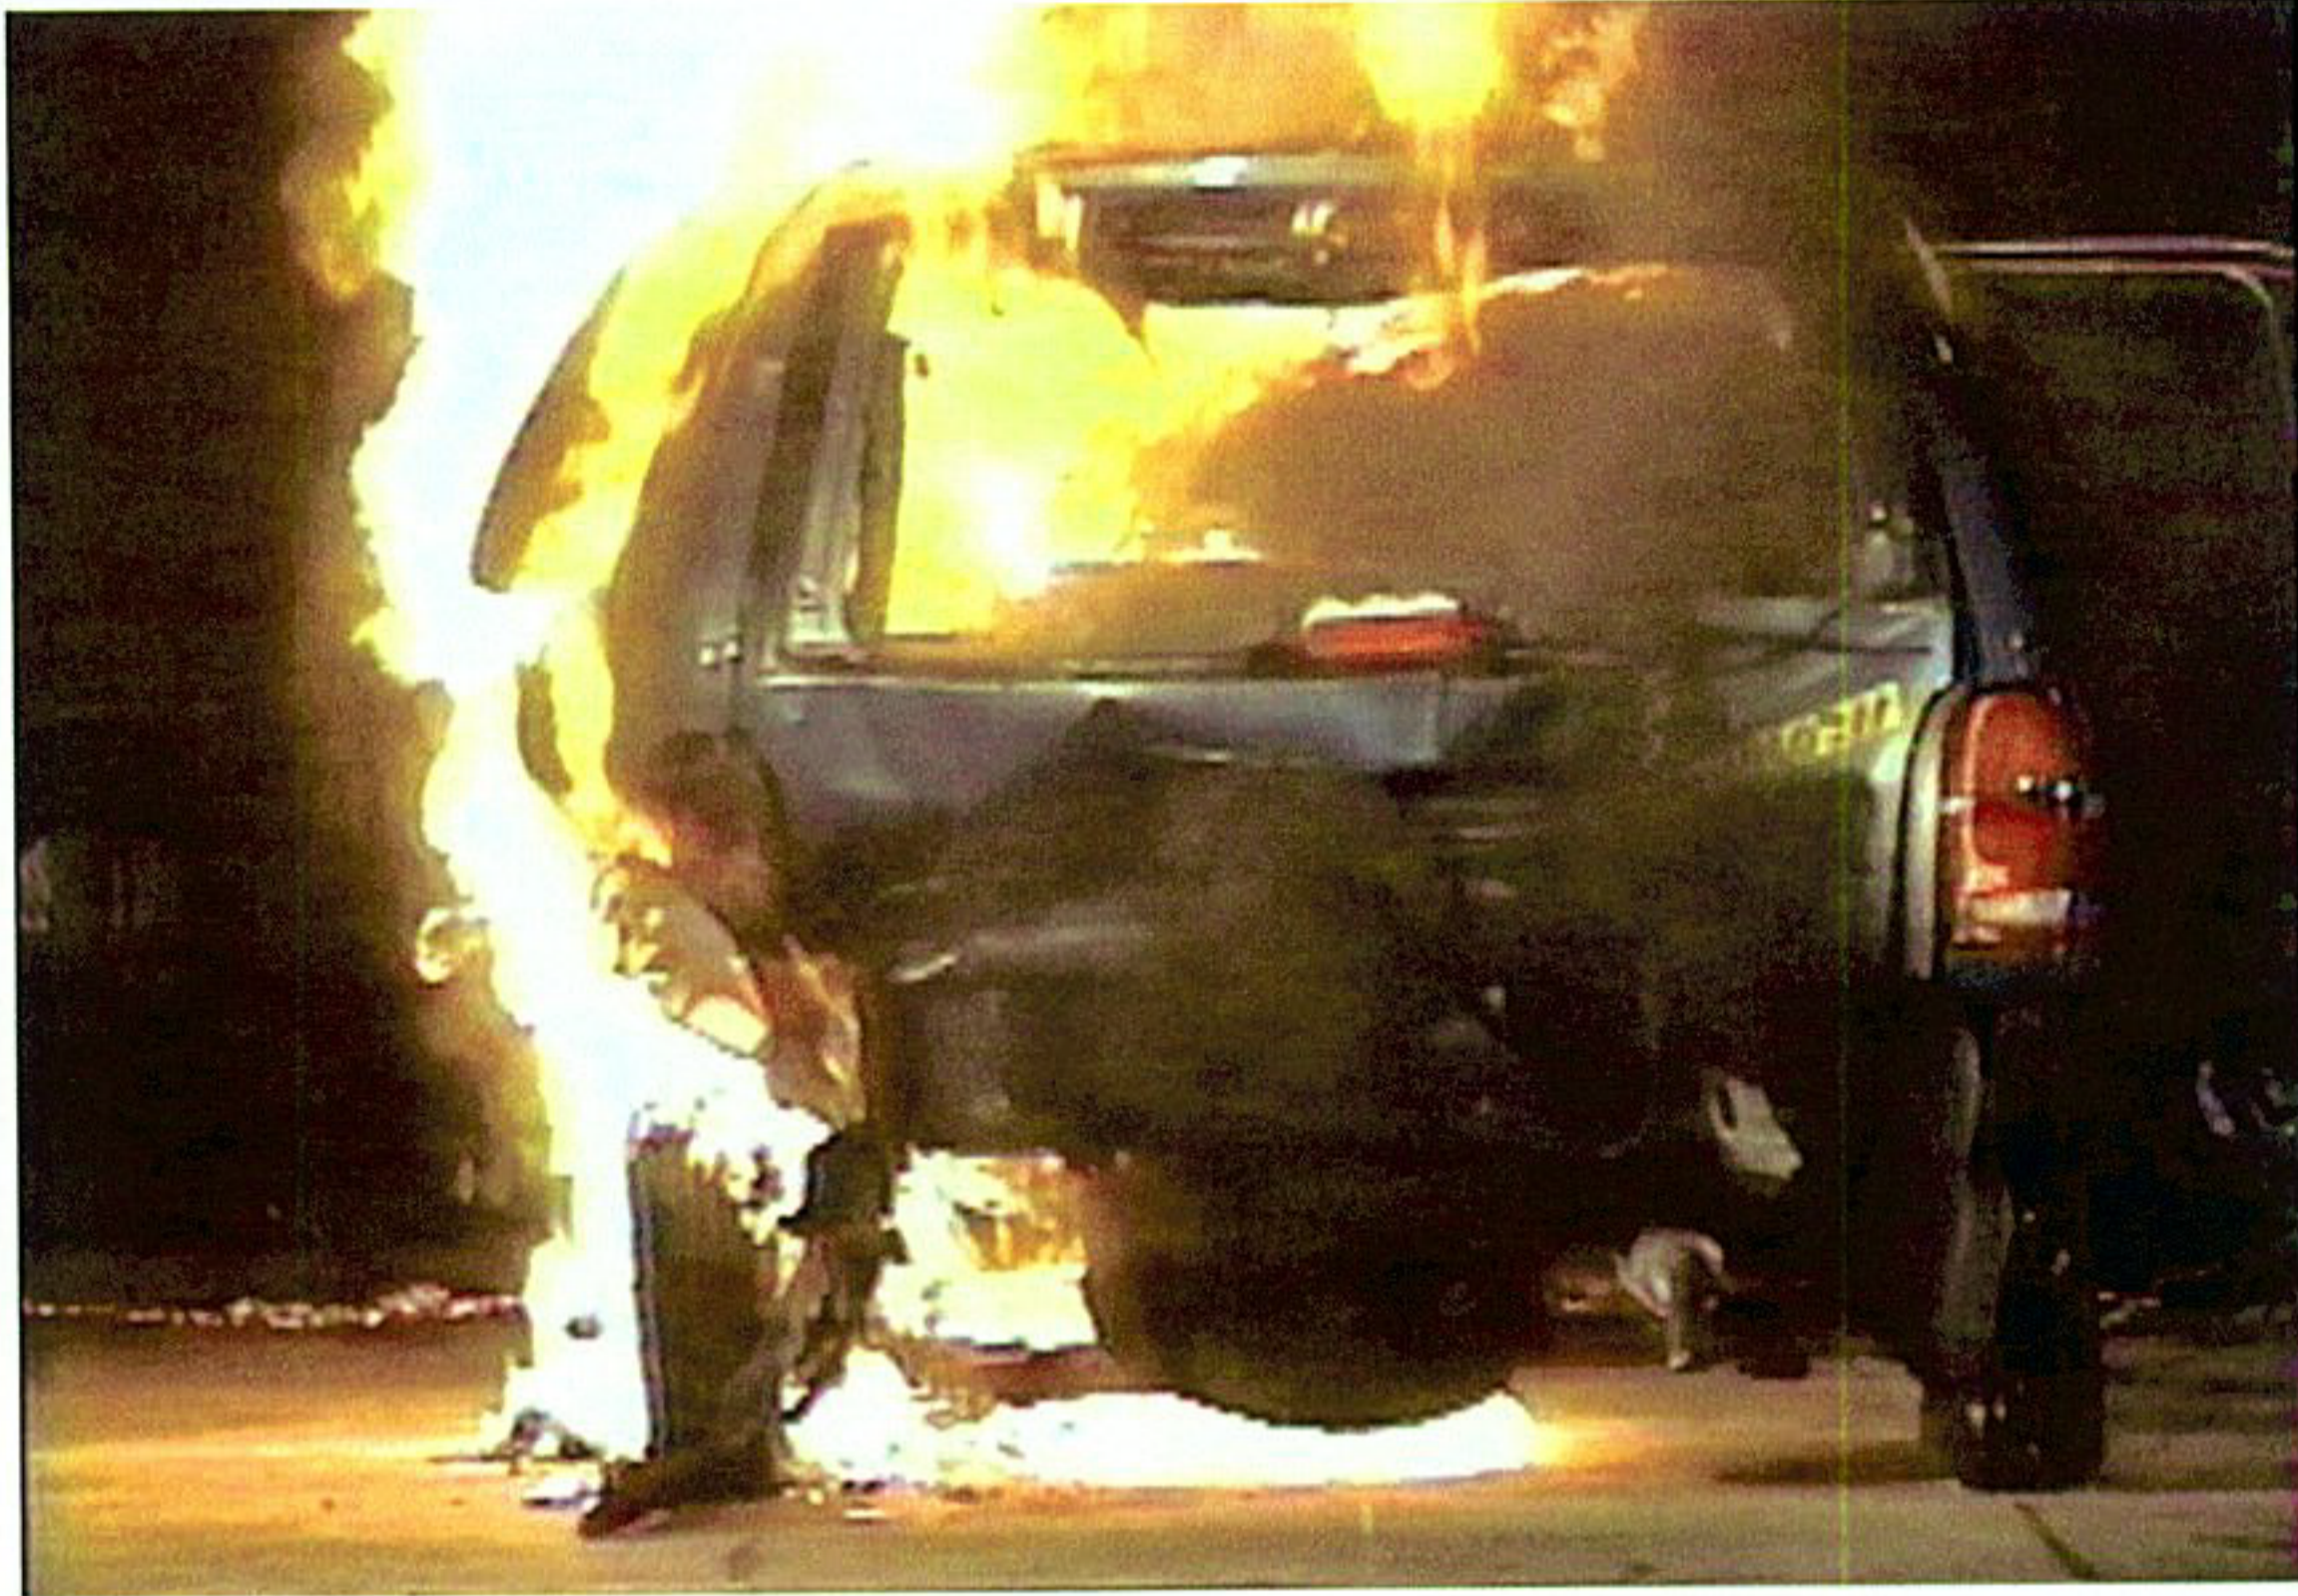
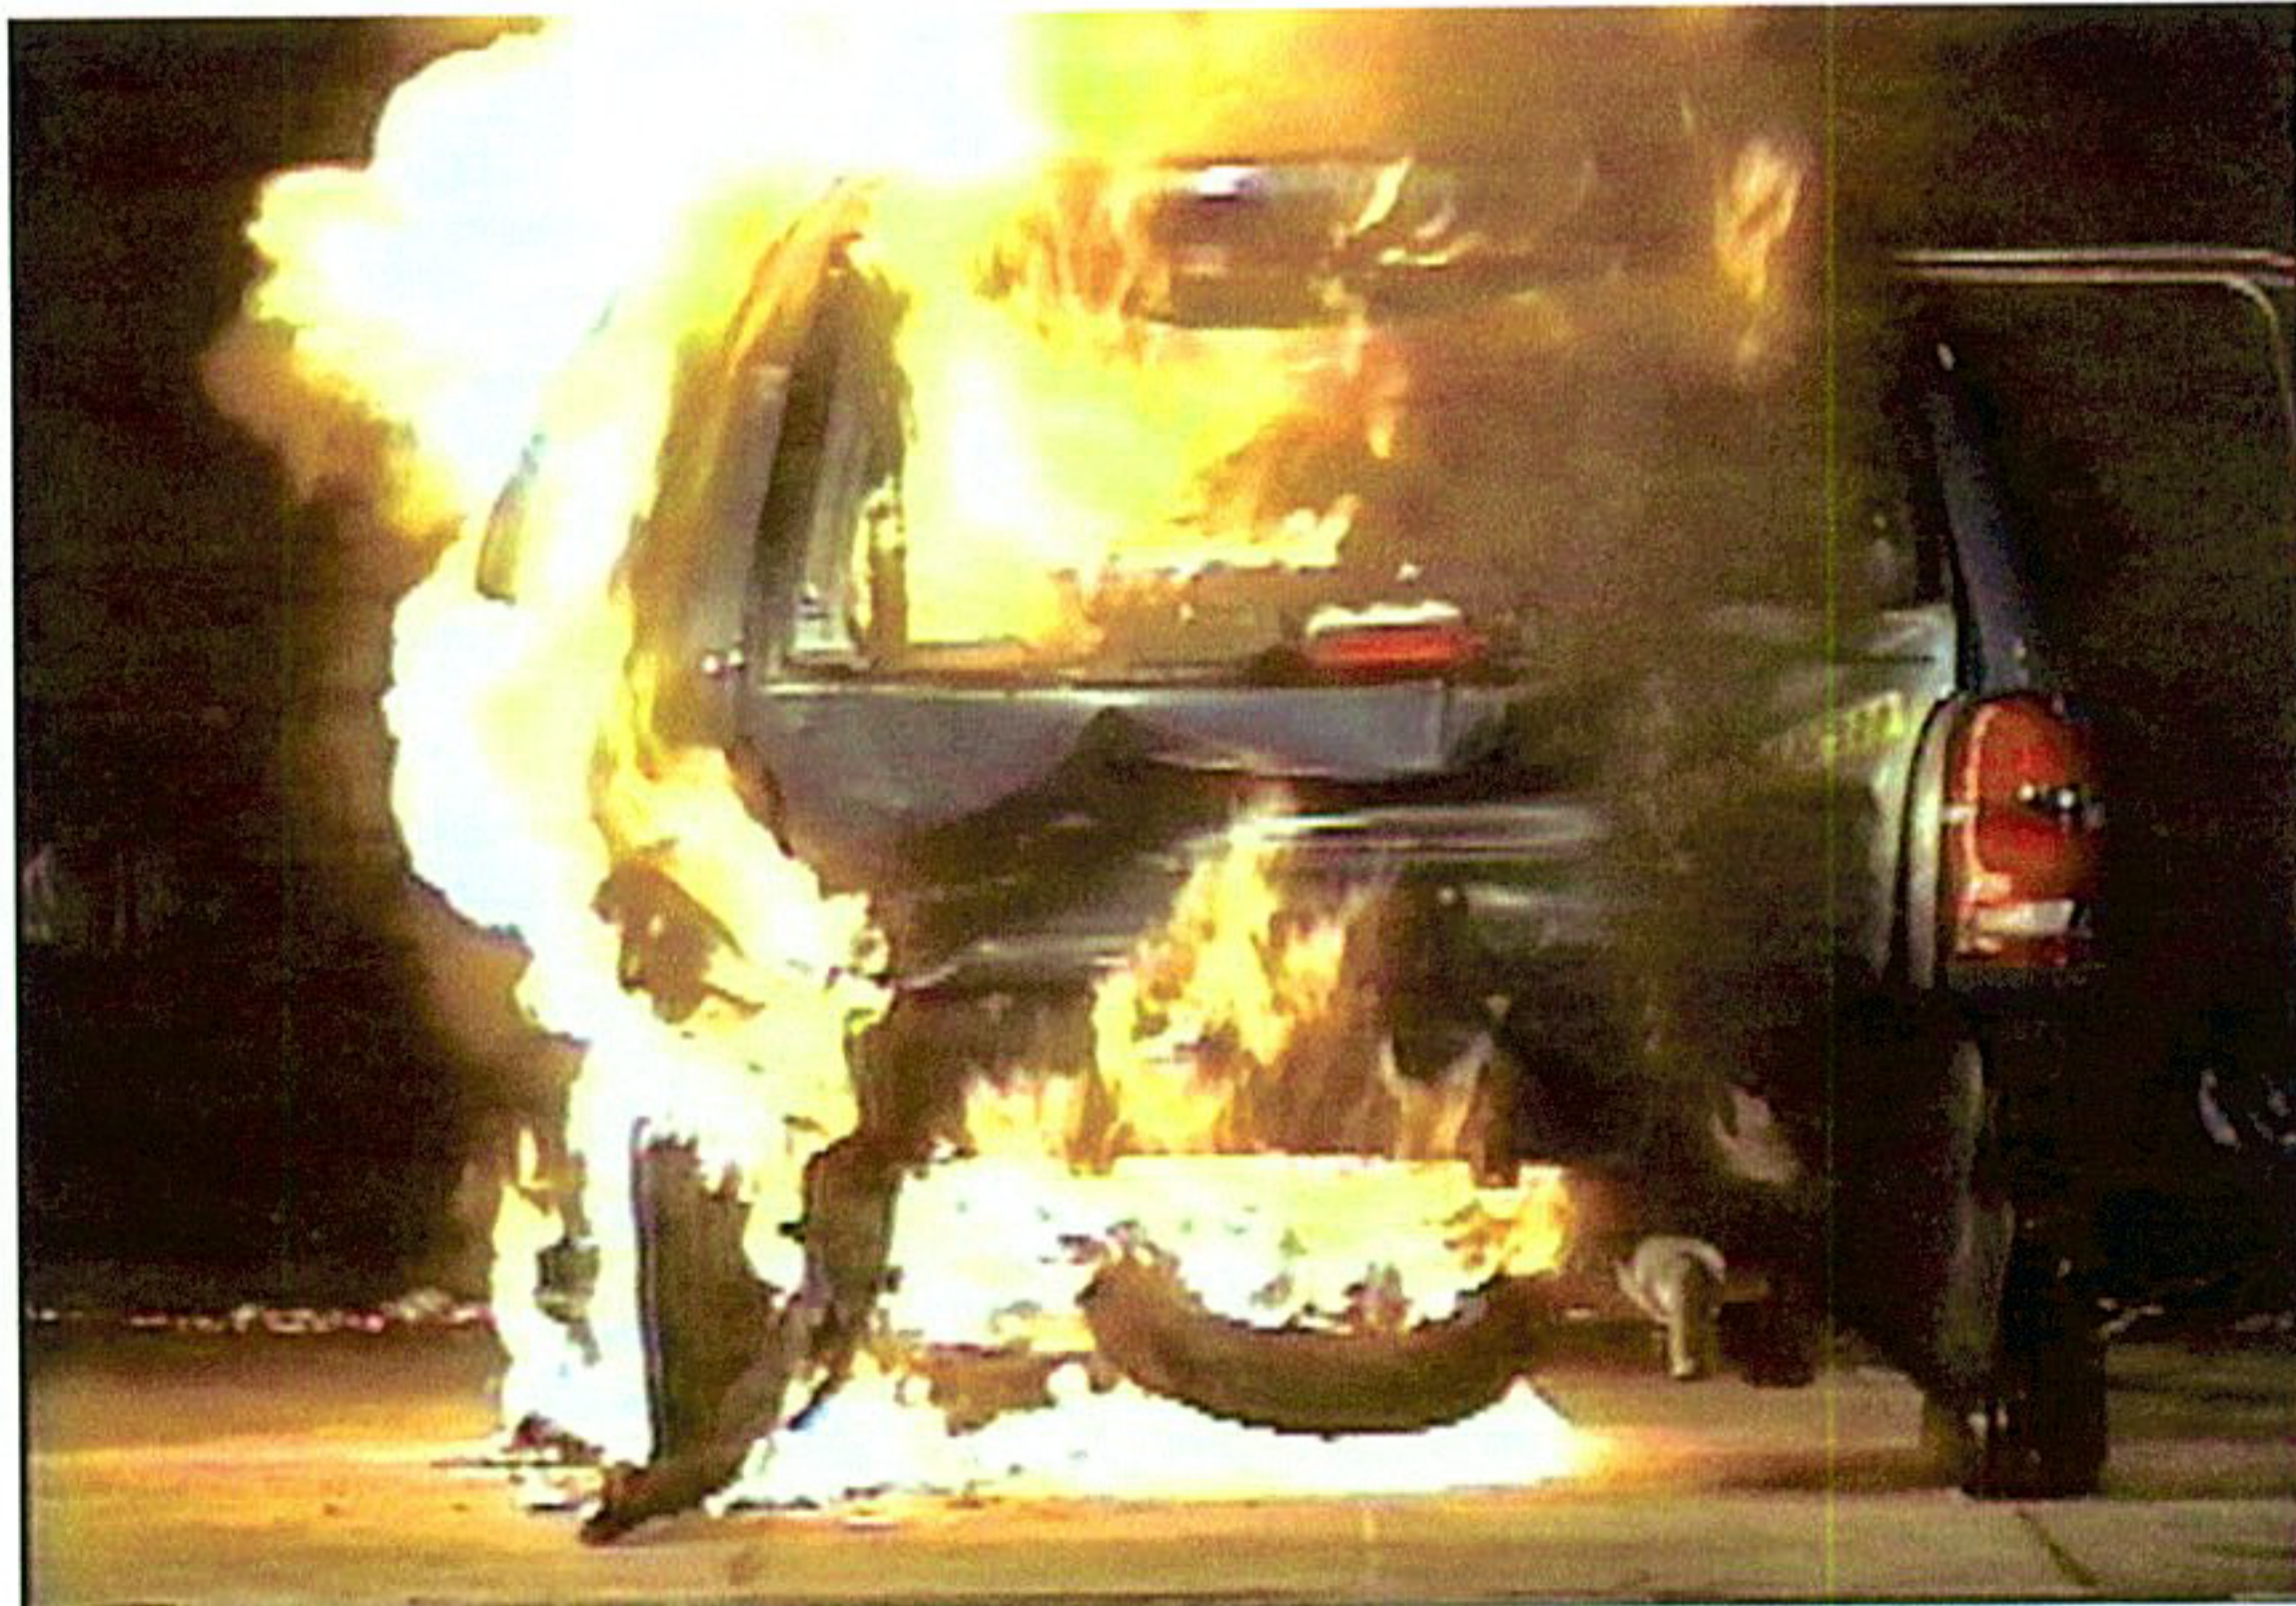
An increase in flame volume in the area between the spare tire and floor pan was observed between 200 and 205 seconds post-ignition (Fig. 15). The diameter of the pool fire below the vehicle did not appear to increase at this time (Fig. 7). Analysis of the temperature data recorded from thermocouples below the floor pan also indicated that the area of the floor pan exposed to flames also increased during this period (Fig. 17). The size and intensity of the fire plume below the vehicle did not change appreciably between 180 and 200 seconds post-ignition. Starting at about 200 seconds post-ignition, an area with temperatures greater than 700°C appeared to the right of the fuel tank and spread forward and rearward along the longitudinal center-line of the floor pan over the next 10 seconds (Fig. 16).

Figure 15. Fire Test F961116. Video stills from Camera 1 at 200 (upper) and 202 (lower) seconds post-ignition.

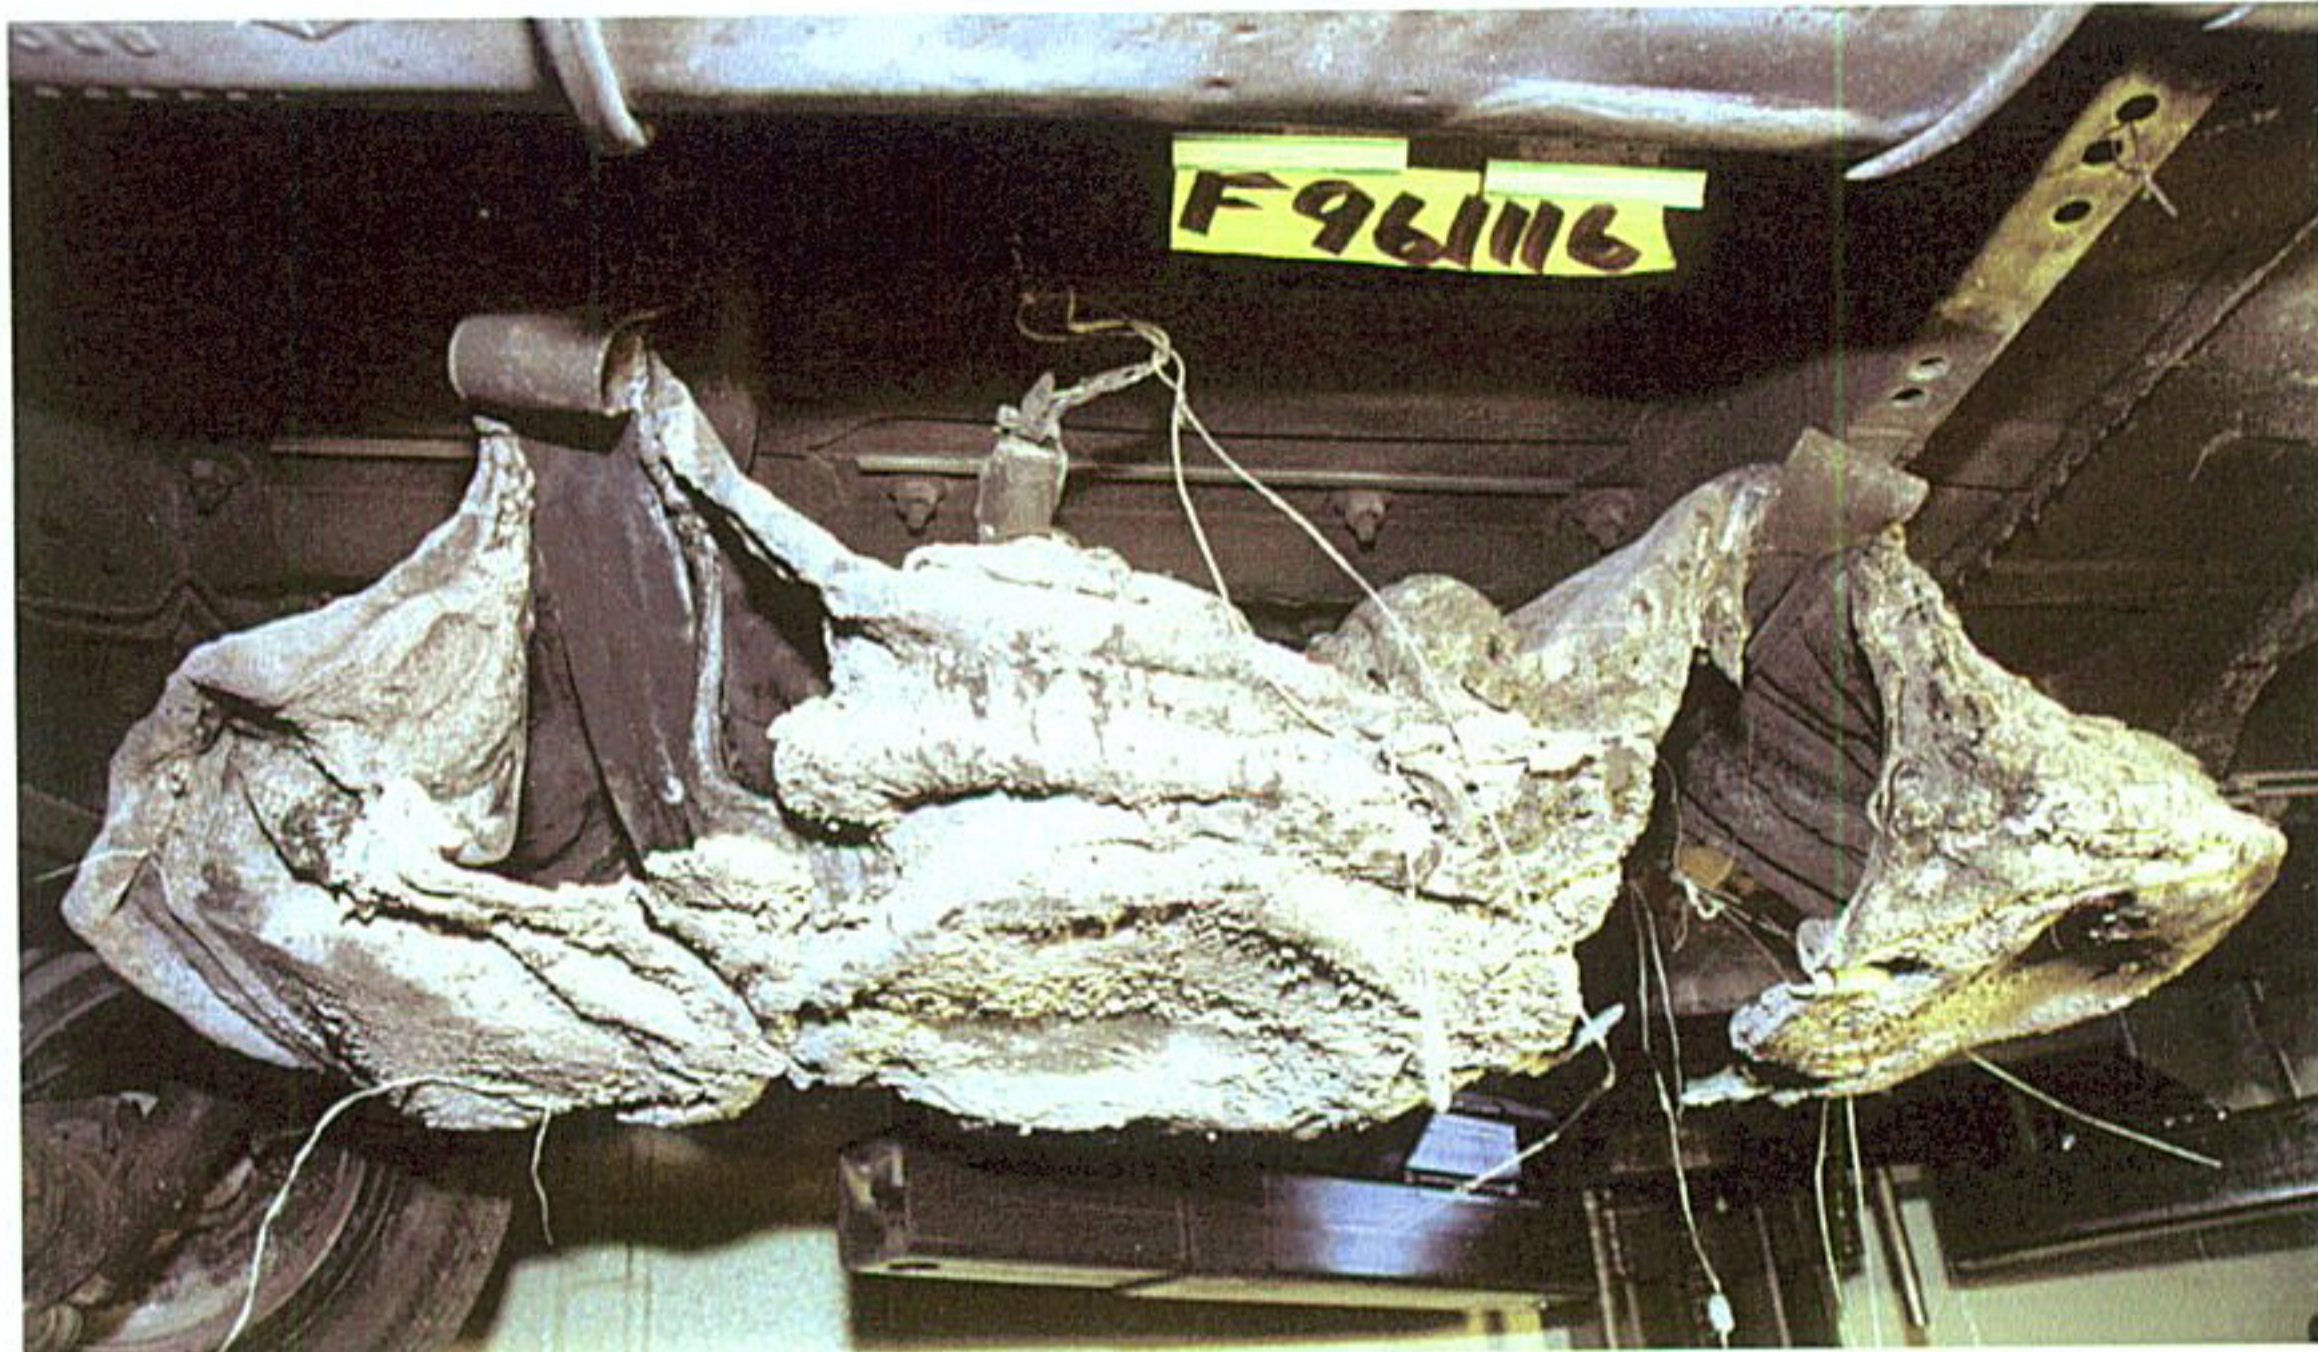
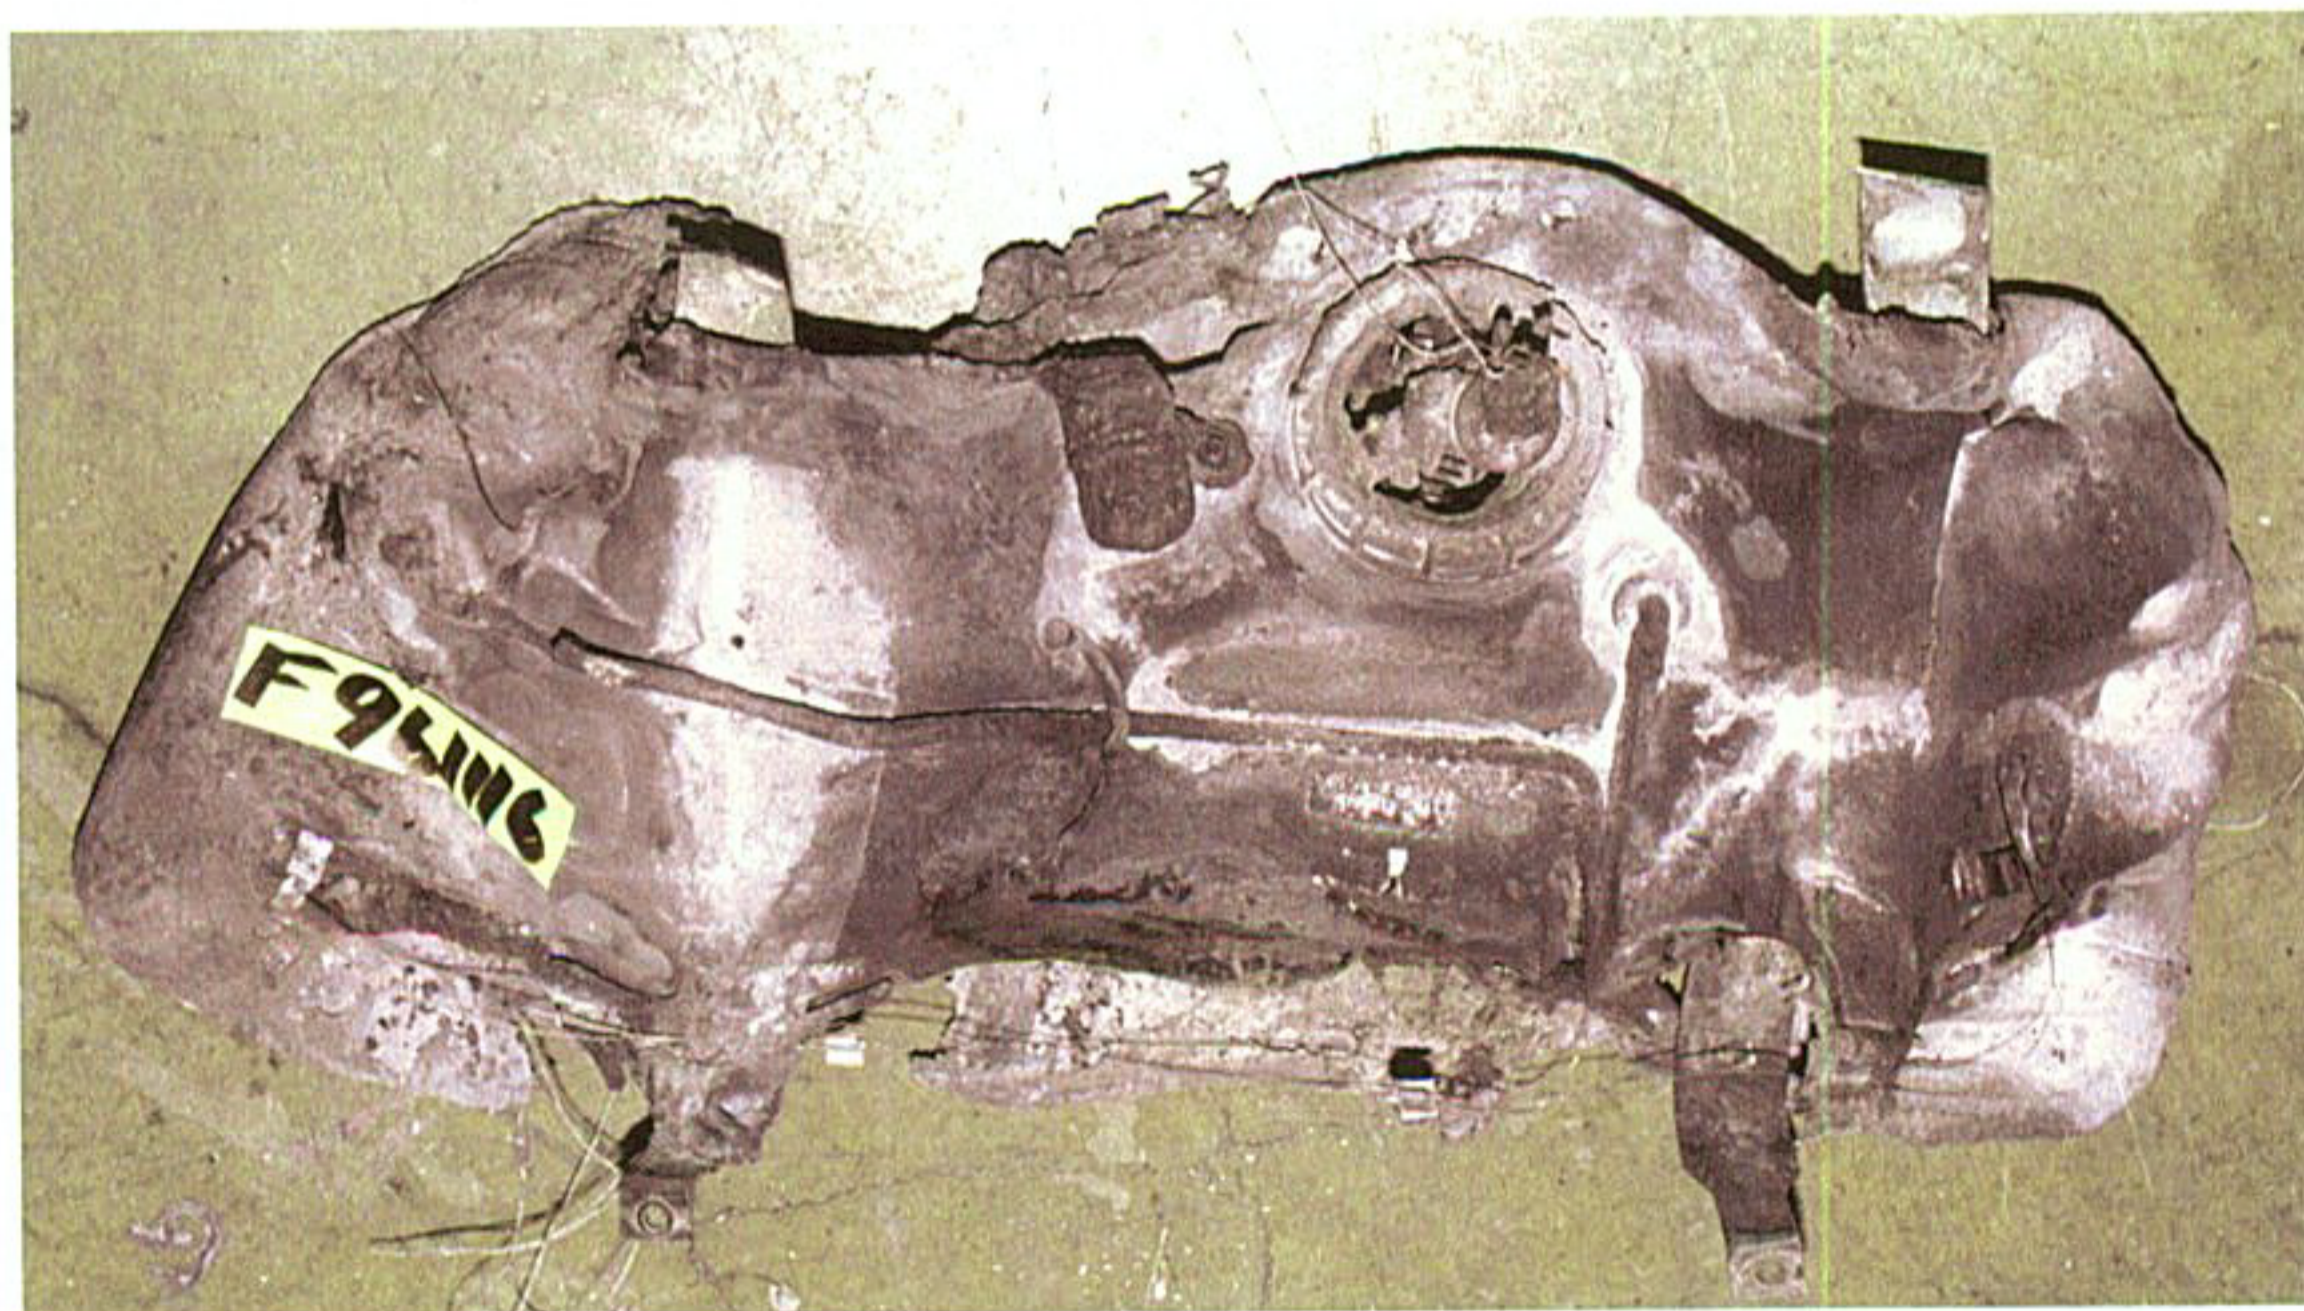
Figure 17. Fire Test F961116. Photographs of the fuel tank after the fire test: an inboard side-view of the fuel tank in place on the test vehicle (upper) and a top-view of the fuel tank removed from the test vehicle (lower).

Inspection of the fuel tank after this test revealed that the exterior surface of the bottom of the tank was melted and charred, but the interior surface was not melted or charred. Two sections were missing from the bottom of the tank, where the fuel tank straps appeared to have contracted when sprayed with water after the test and tore the softened plastic (Fig. 17). The top of the fuel tank also was charred, with some areas showing signs of having melted and flowed. Holes were observed in the fuel pump flange where it had been consumed by fire (Fig. 17). A single hole was observed in the side of the upper panel of the fuel tank just below and forward the fuel pump flange (Fig. 17). The holes in the fuel pump flange and the side of the fuel tank were above the level of the liquid gasoline in the fuel tank at the start of the test, and were at the apparent origin of the flame jet observed between 200 and 205 seconds post-ignition. These results suggest that gasoline vapor issuing from one or more holes that developed in the fuel tank above the liquid level caused the increase in flame volume and intensity under the test vehicle observed between 200 and 205 seconds post-ignition.
