Enclosed is a final report prepared by Jeffrey Santrock of General Motors Corporation, entitled, "Evaluation of Motor Vehicle Fire Initiation and Propagation Part 4: Propagation of an Underbody Gasoline Pool Fire in a 1996 Passenger Van."

**Evaluation of Motor Vehicle Fire Initiation and Propagation
Part 4: Propagation of an Underbody Gasoline Pool Fire in a 1996
Passenger Van**

Jeffrey Santrock
General Motors Corporation

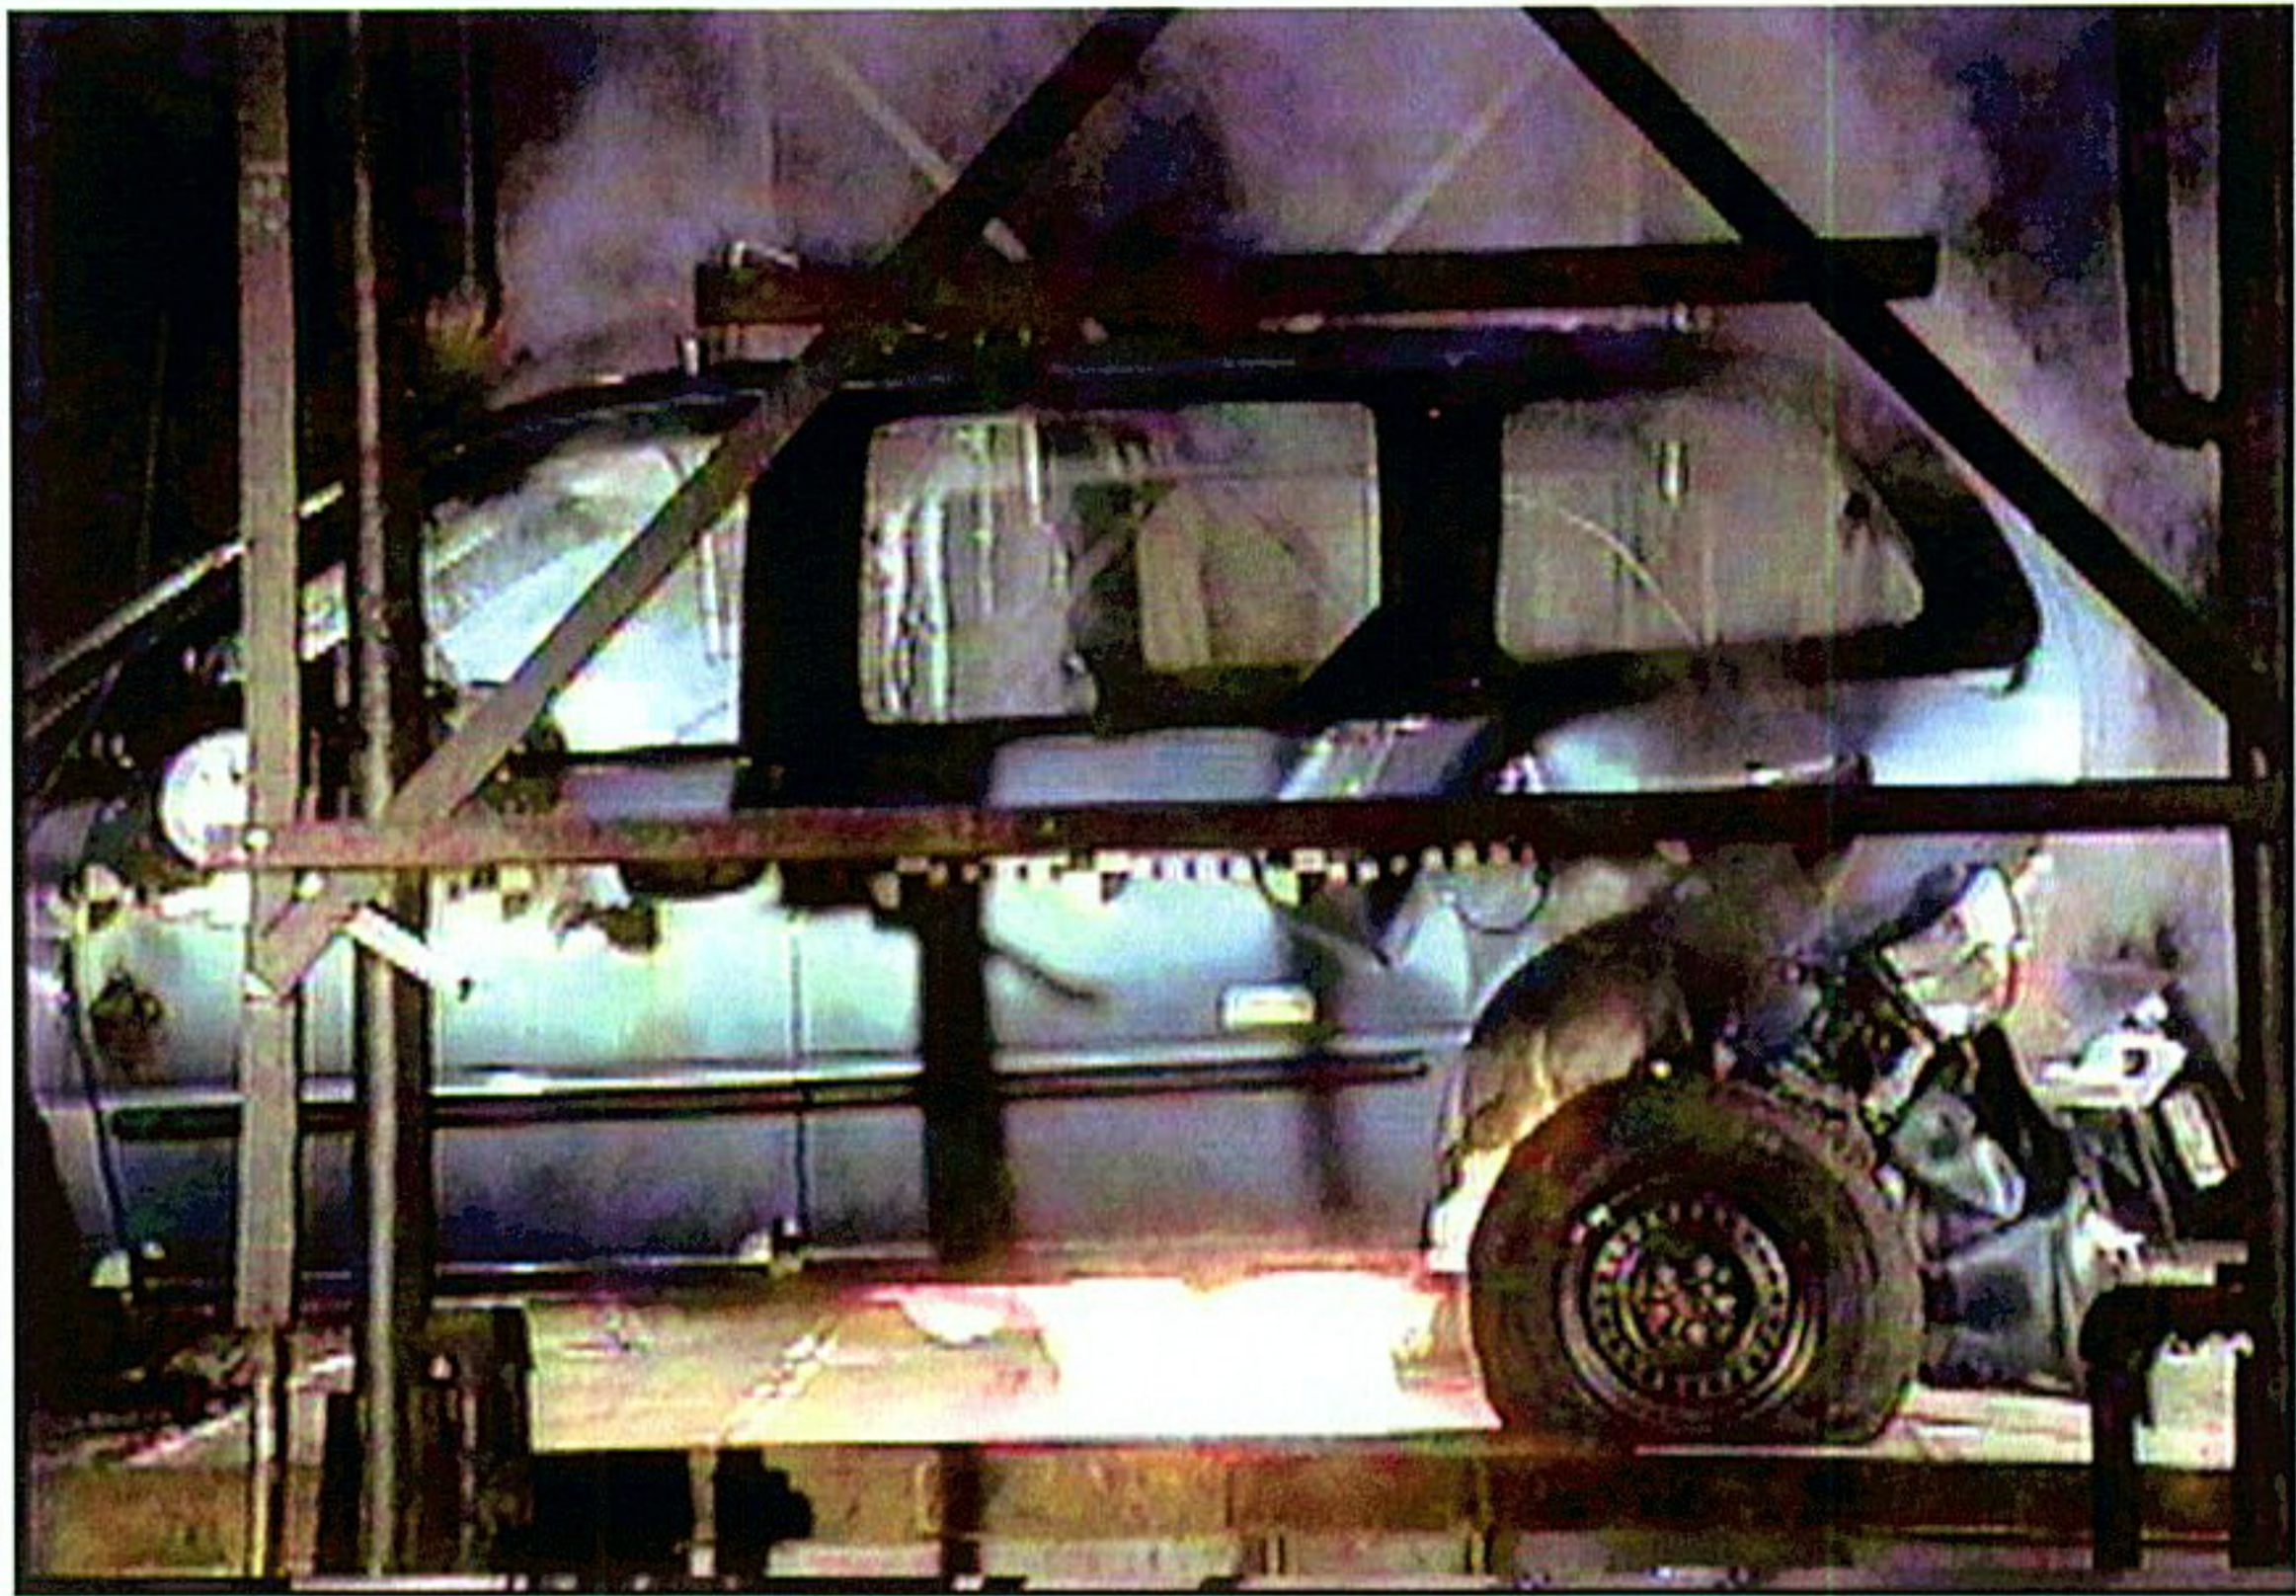
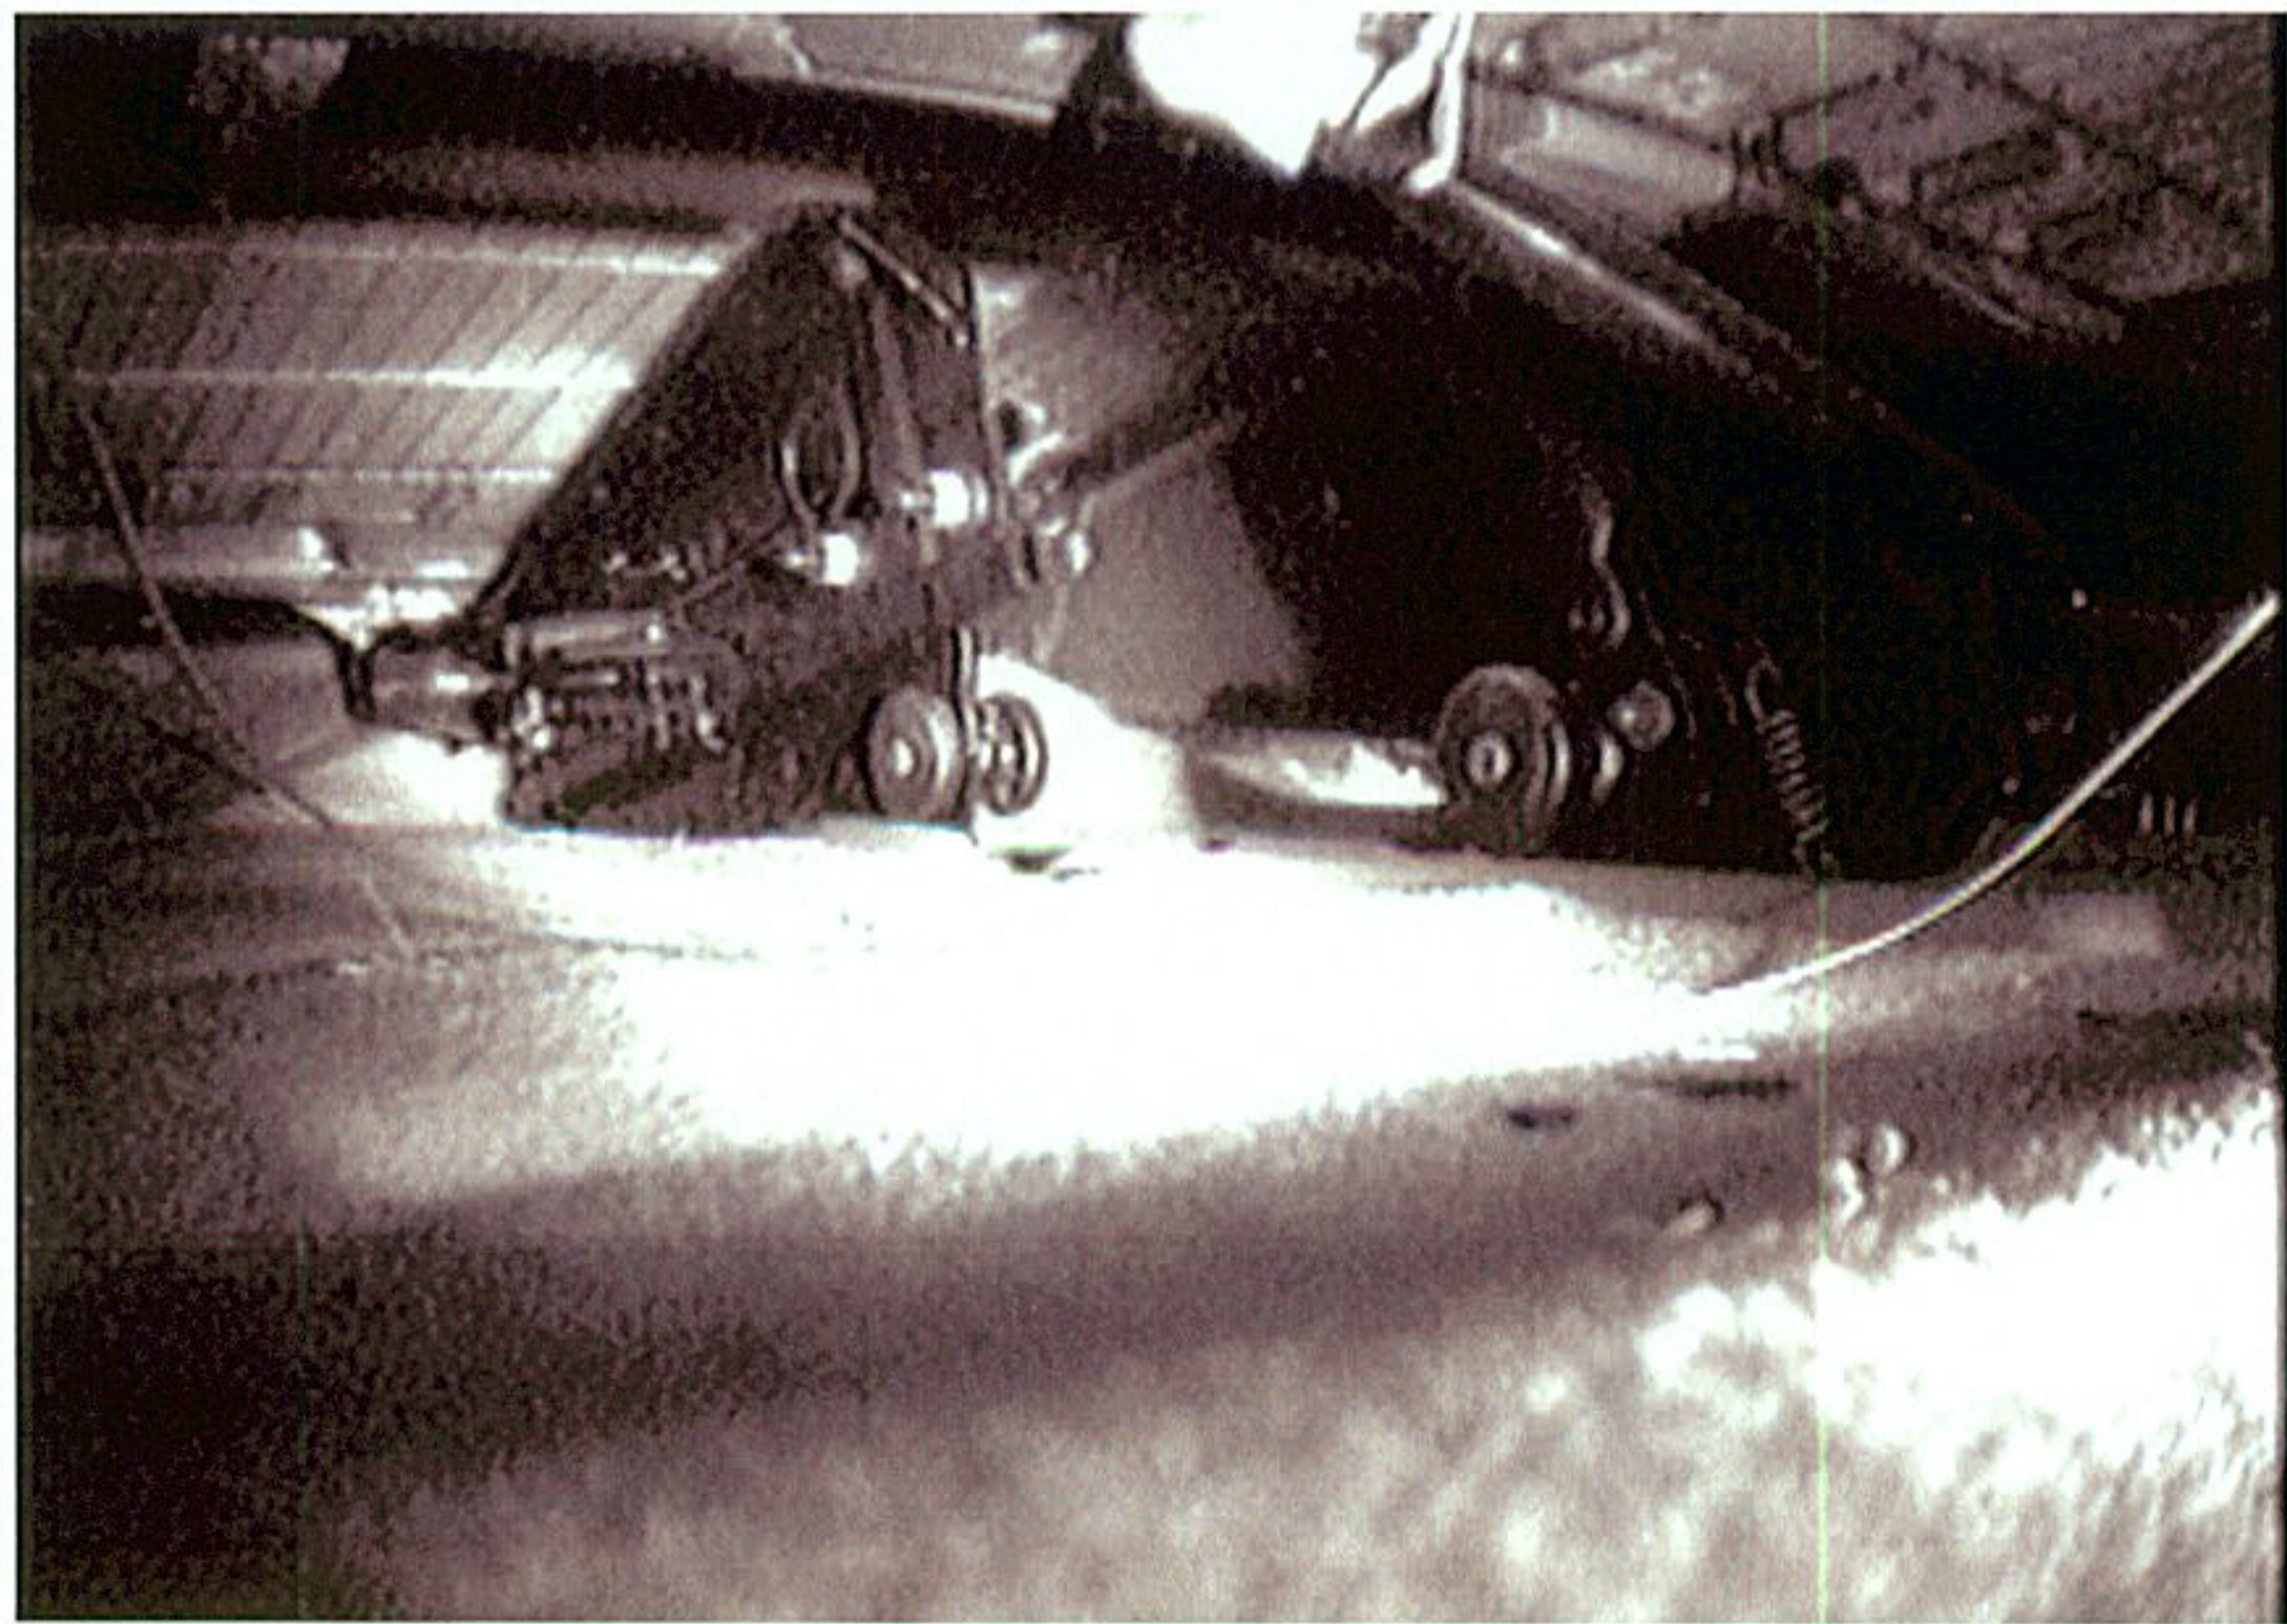
Figure 22. Fire Test F961116. Video stills from Camera 2 (upper) and Camera 6 (lower) at 10 seconds post-ignition.

Flames entered the left rear wheelhouse between 10 and 15 seconds post-ignition (Fig. 22). Although the diameter of the pool fire remained constant for the first 90 seconds of the test, the fire plume in the wheelhouse increased in size during this time (Fig. 23). Flames were visible through the open spot weld seam along the lower edge of the wheelhouse side panel, but did not appear to have spread into the passenger compartment (Fig. 23). As the wheelhouse splash shield sagged onto the left rear tire and started to burn, the fire in the left rear wheelhouse grew substantially (Fig. 24). The intensity of light in the area of the open weld-seam increased during this time (Fig. 24). Details that were visible during the first 50 seconds of the test were now lost when a large area of the field-of-view of Camera 6 became overexposed (Fig.'s 24 and 25). By 100 seconds post-ignition, it was difficult to distinguish between flames actually inside the passenger compartment and light scattered by smoke entering the split spot weld seam (Fig. 24). At 150 seconds post-ignition, flames were discernable in the area around the lower edge of the wheelhouse under the left side of the second bench seat, and along the lower edge of the left quarter trim panel in front of the middle bench seat riser and track (Fig. 25).

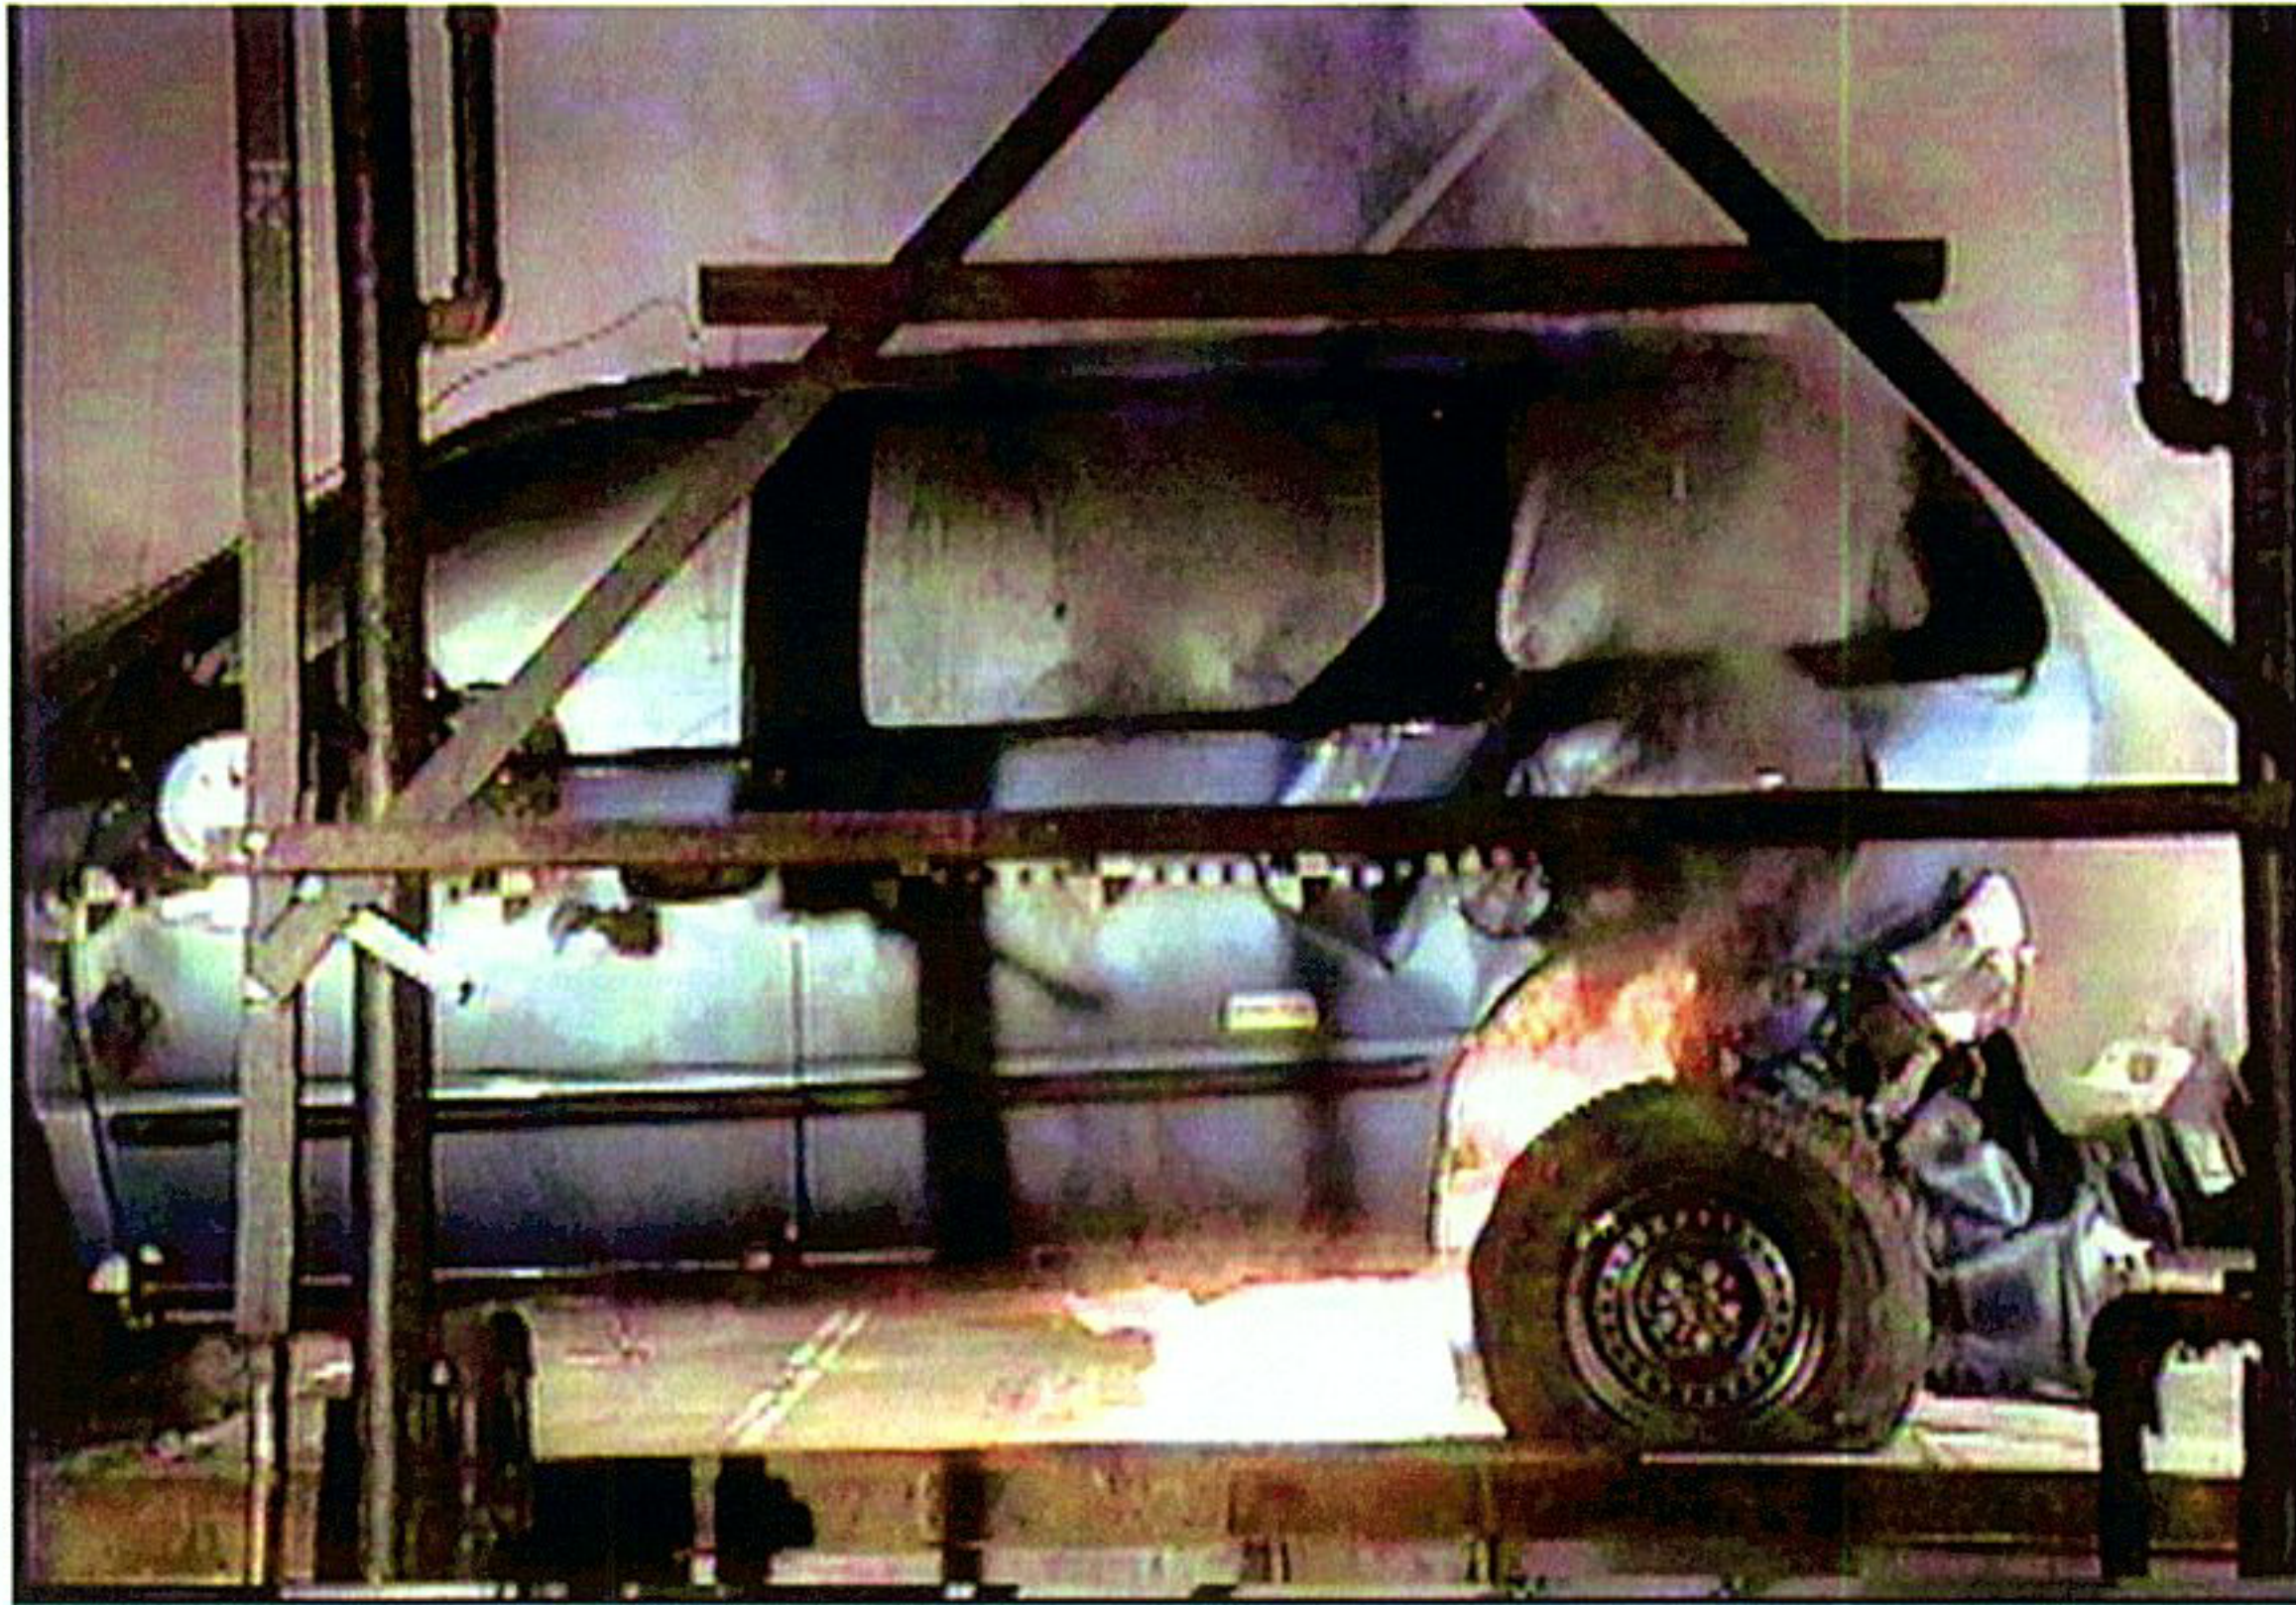
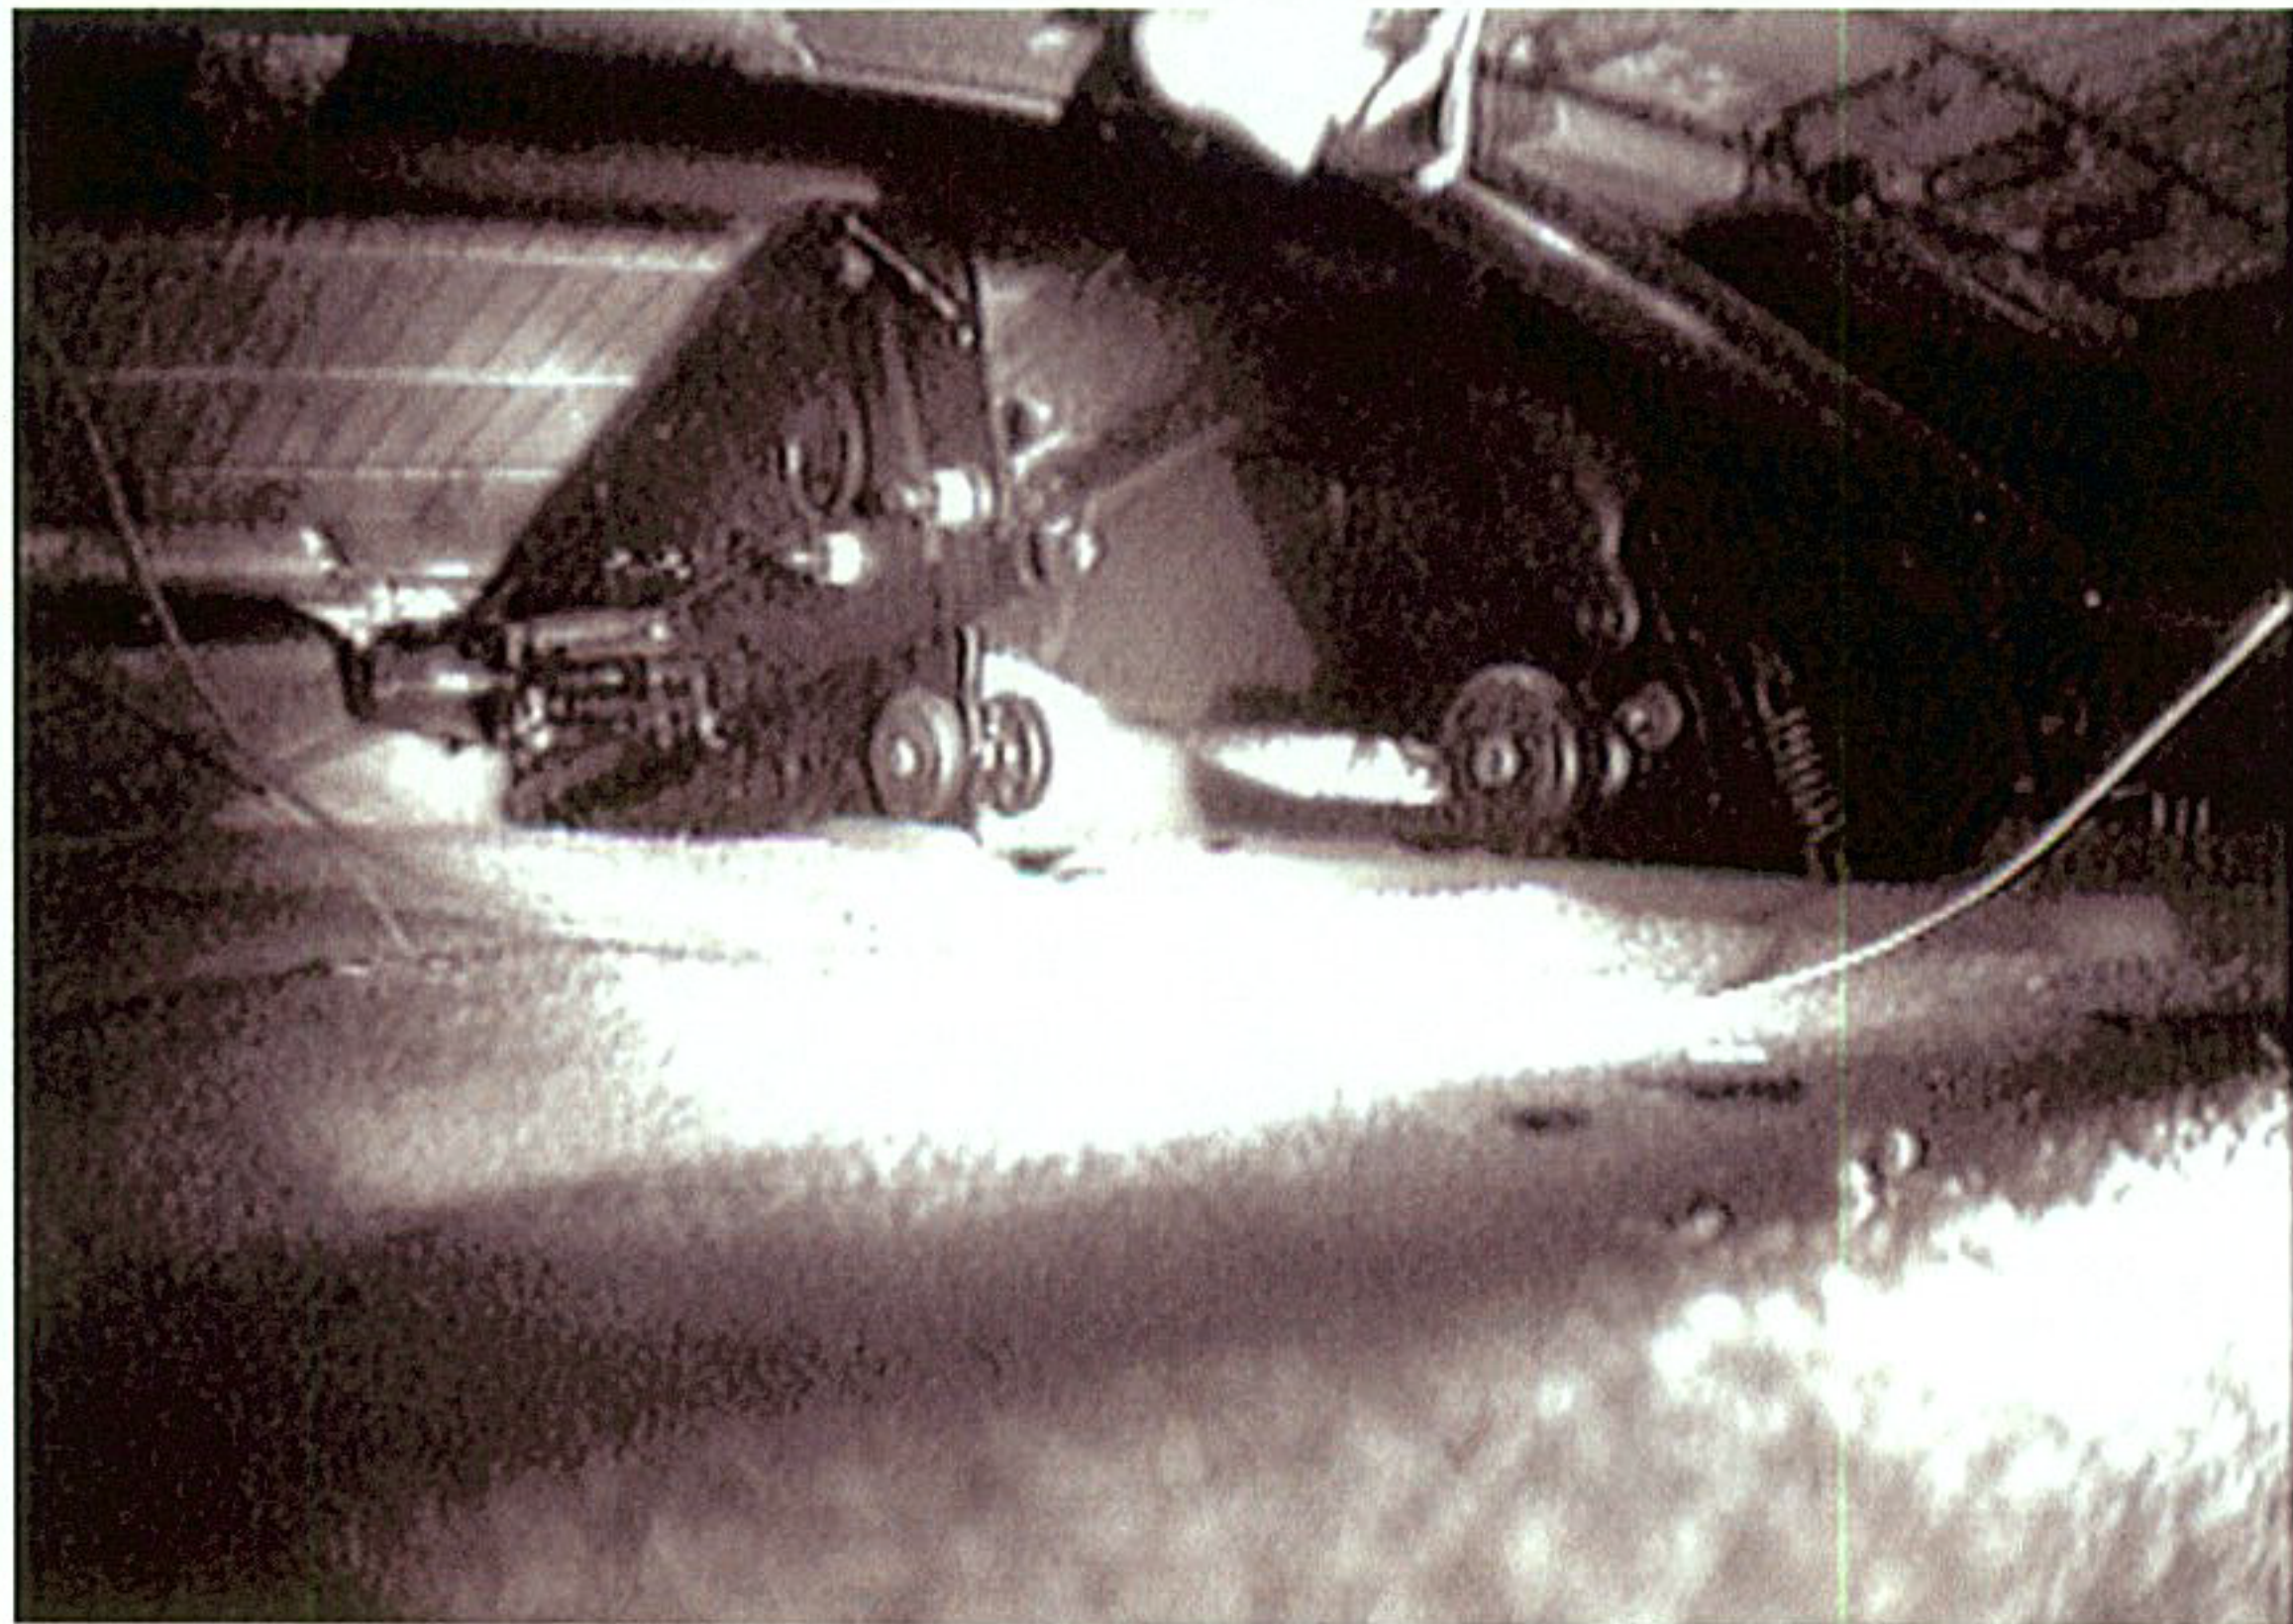
Figure 23. Fire Test F961116. Video stills from Camera 2 (upper) and Camera 6 (lower) at 50 seconds post-ignition.

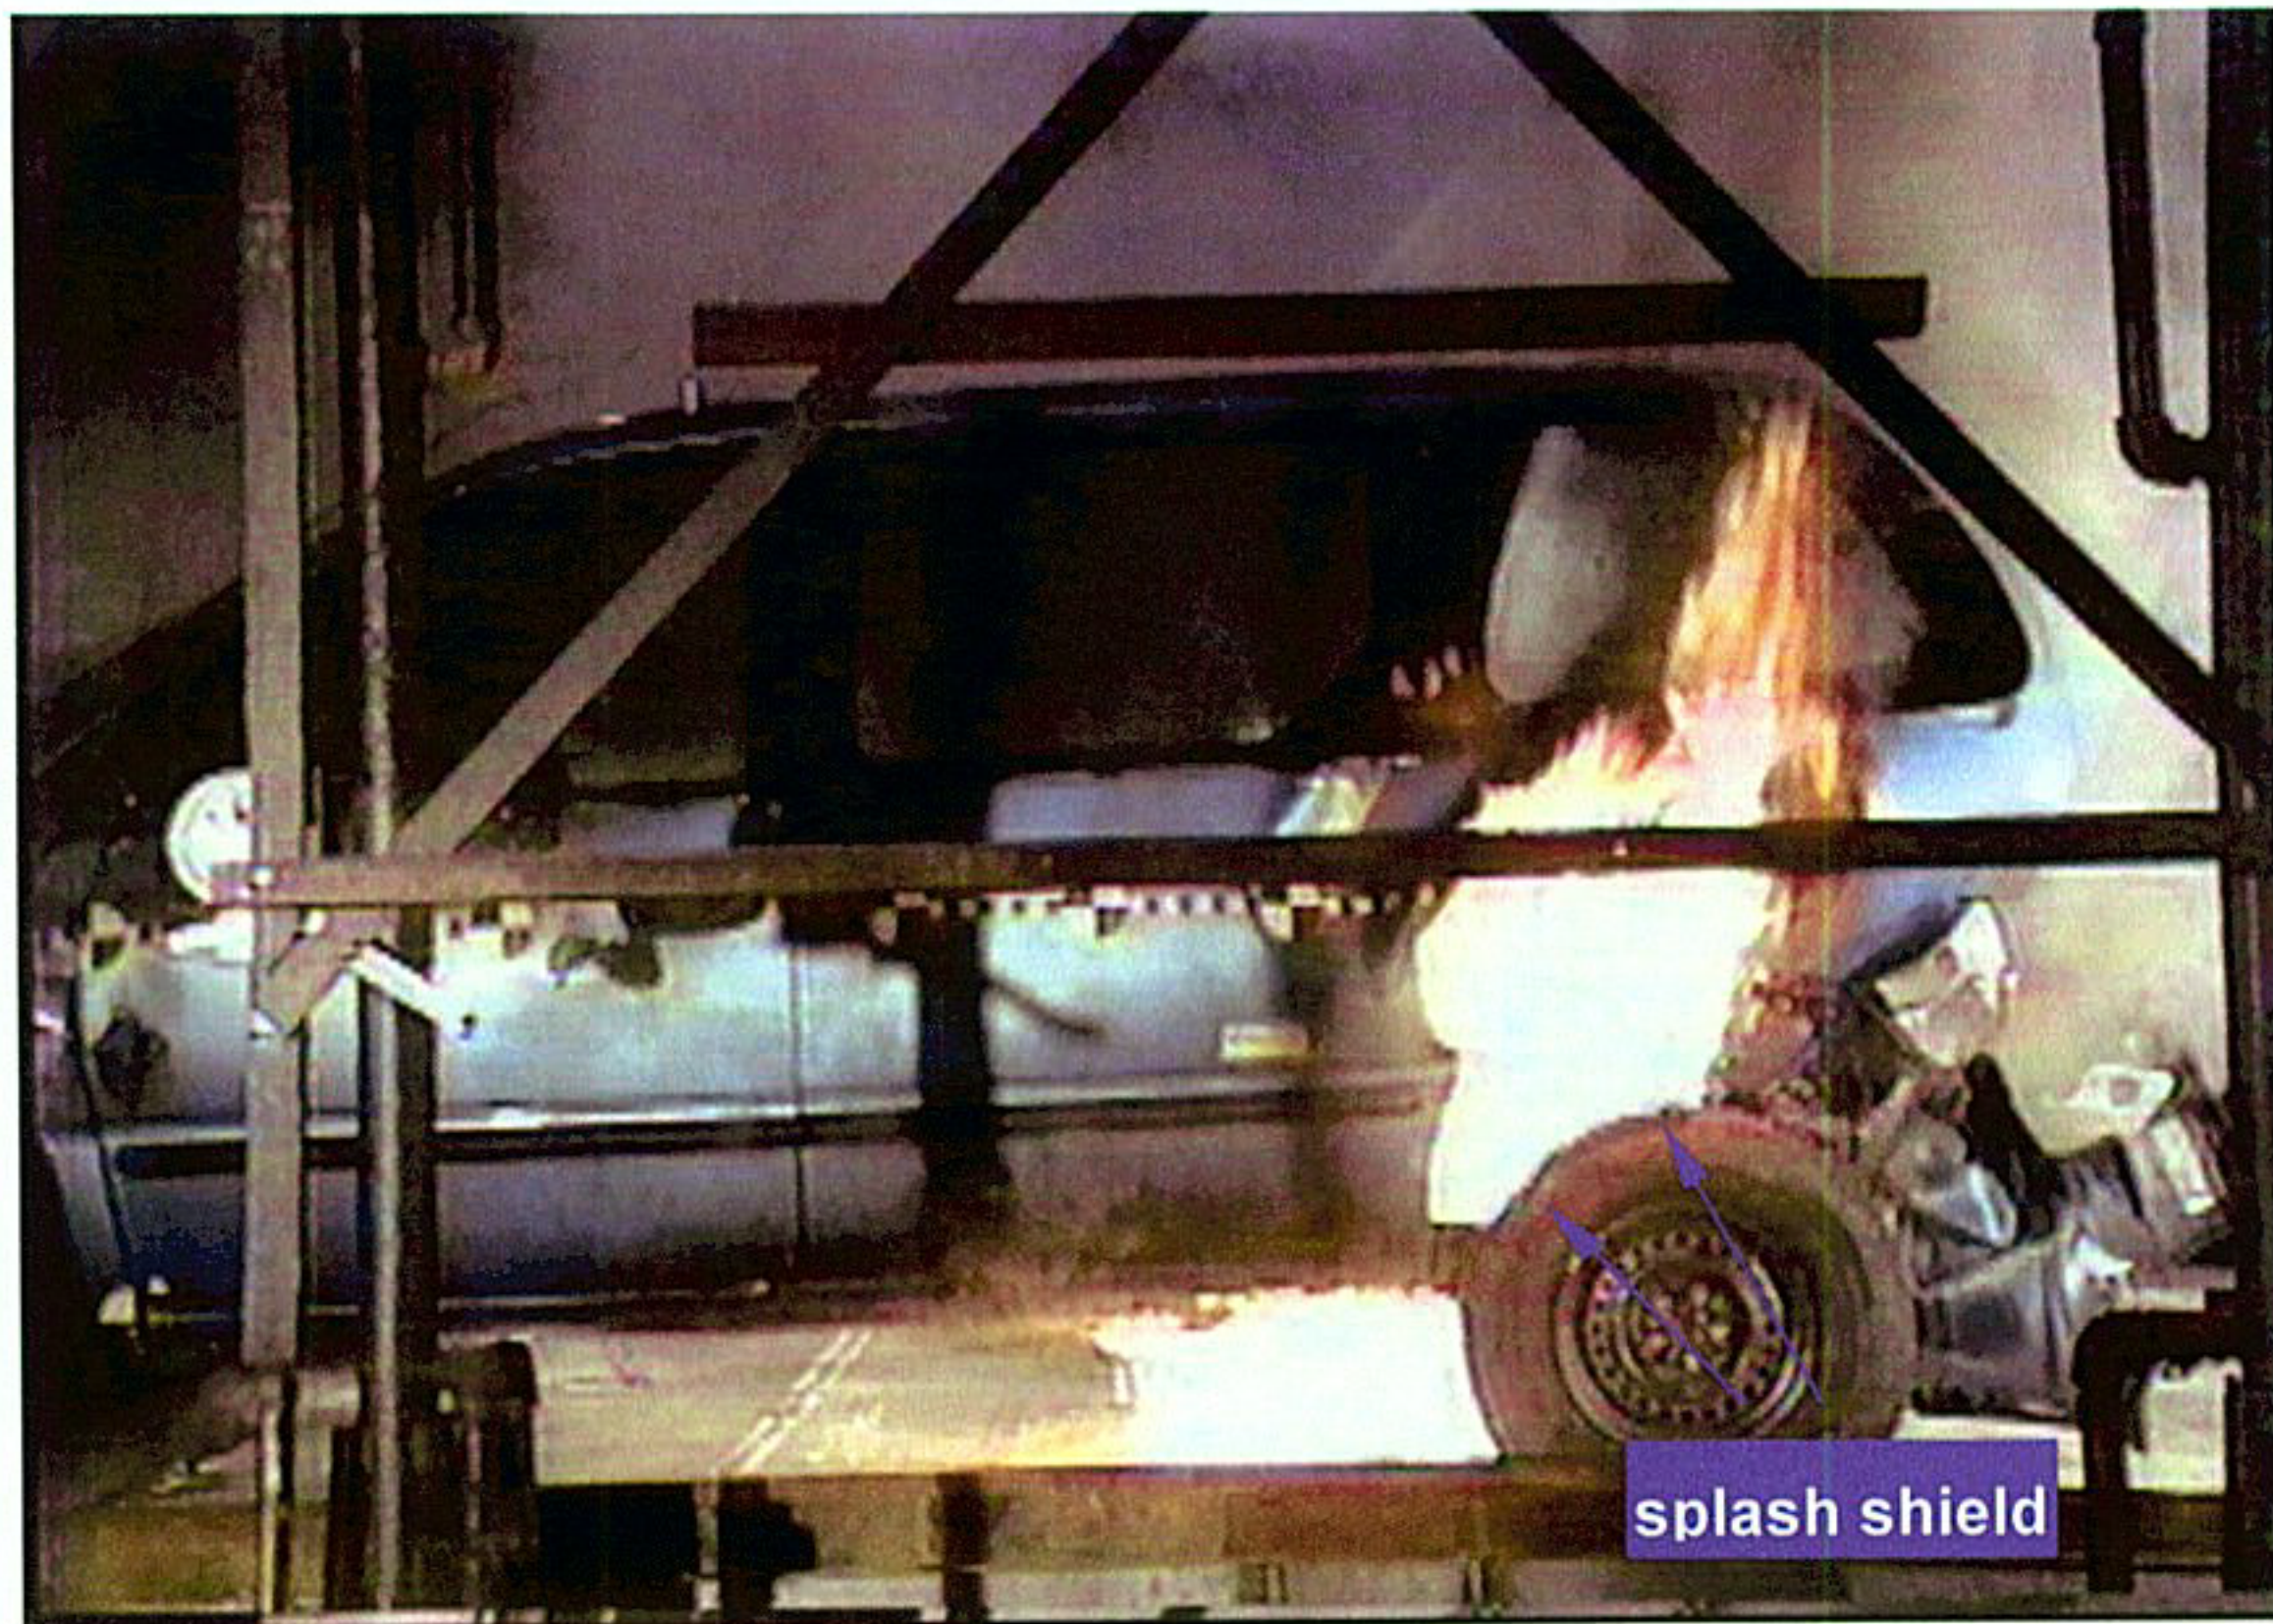
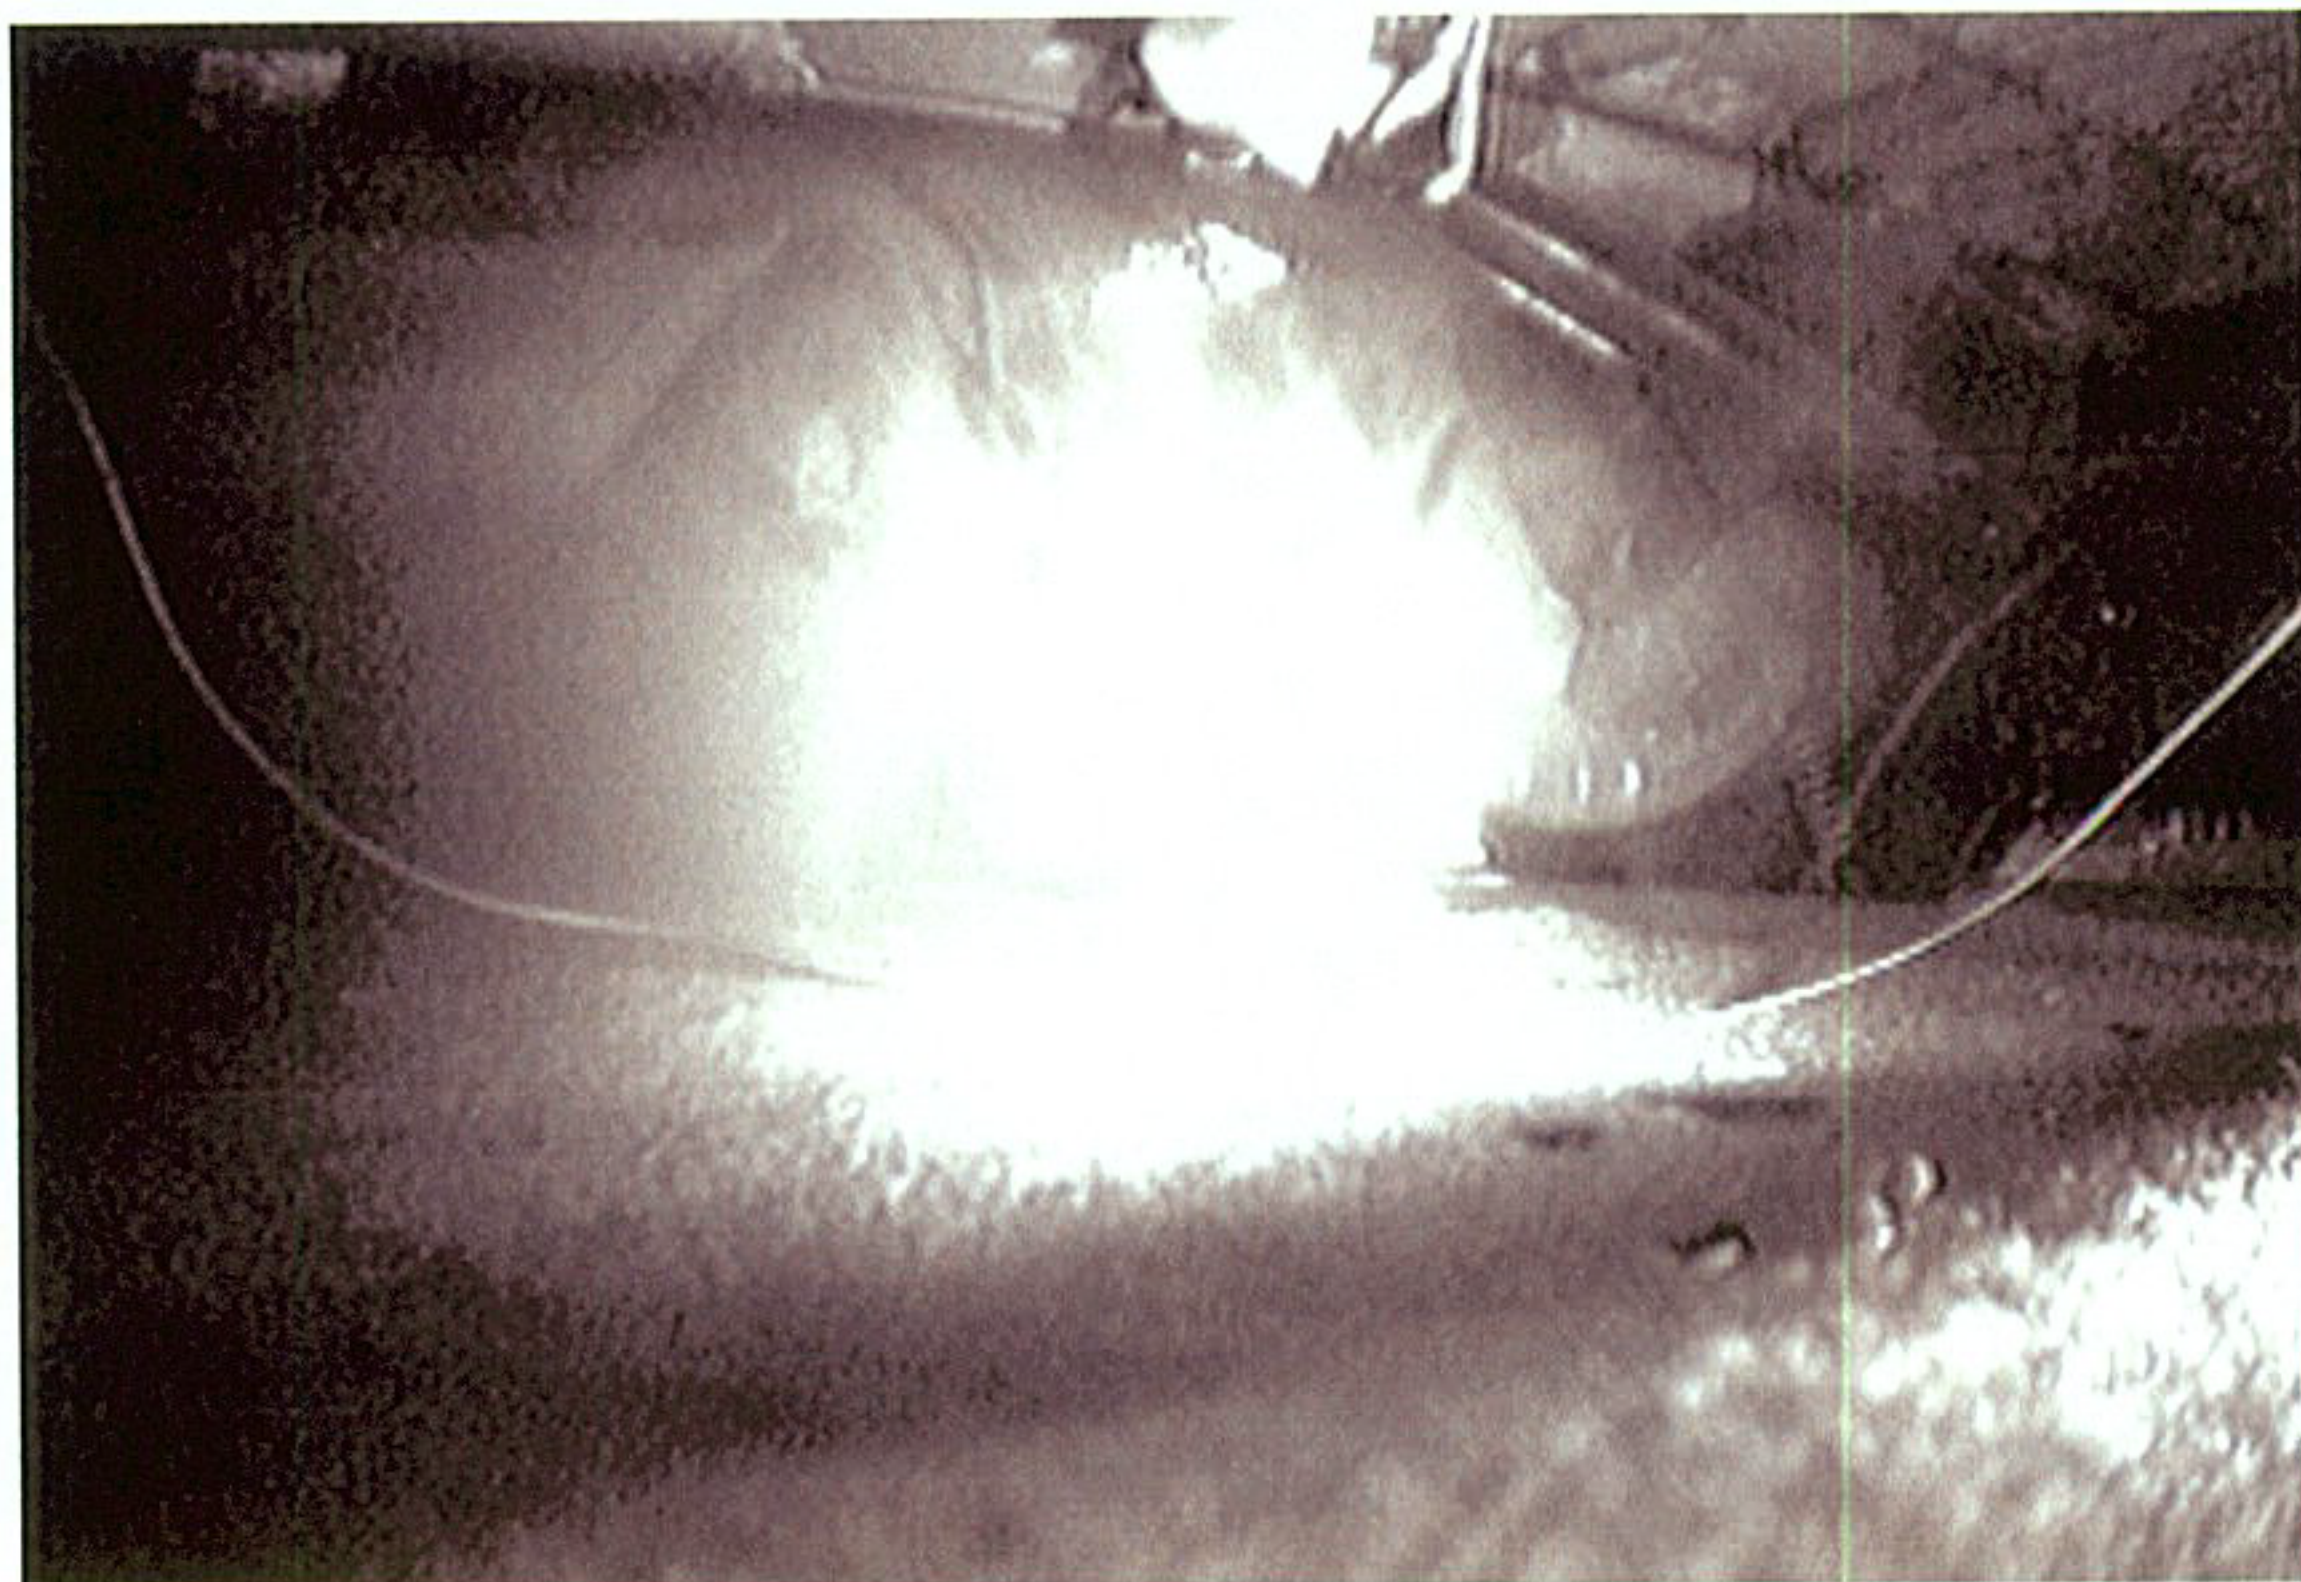
Figure 24. Fire Test F961116. Video stills from Camera 2 (upper) and Camera 6 (lower) at 100 seconds post-ignition.

As the splash shield sagged onto the tire and ignited between 60 and 90 seconds post-ignition, a fire plume was observed outside the left rear wheelhouse (see Fig. 24). Flames spread from the splash shield to the left rear tire between 100 and 150 seconds post-ignition (Fig. 25). An increase in the heat flux to the wheelhouse panels (Fig. 27) indicated that the intensity of the fire in the wheelhouse increased during this time interval. The height of the fire plume emerging from the wheelhouse also increased between 100 and 150 seconds post-ignition (Fig. 29).
