Enclosed is a final report prepared by Jeffrey Santrock of General Motors Corporation, entitled, "Evaluation of Motor Vehicle Fire Initiation and Propagation Part 4: Propagation of an Underbody Gasoline Pool Fire in a 1996 Passenger Van."

**Evaluation of Motor Vehicle Fire Initiation and Propagation
Part 4: Propagation of an Underbody Gasoline Pool Fire in a 1996
Passenger Van**

Jeffrey Santrock
General Motors Corporation

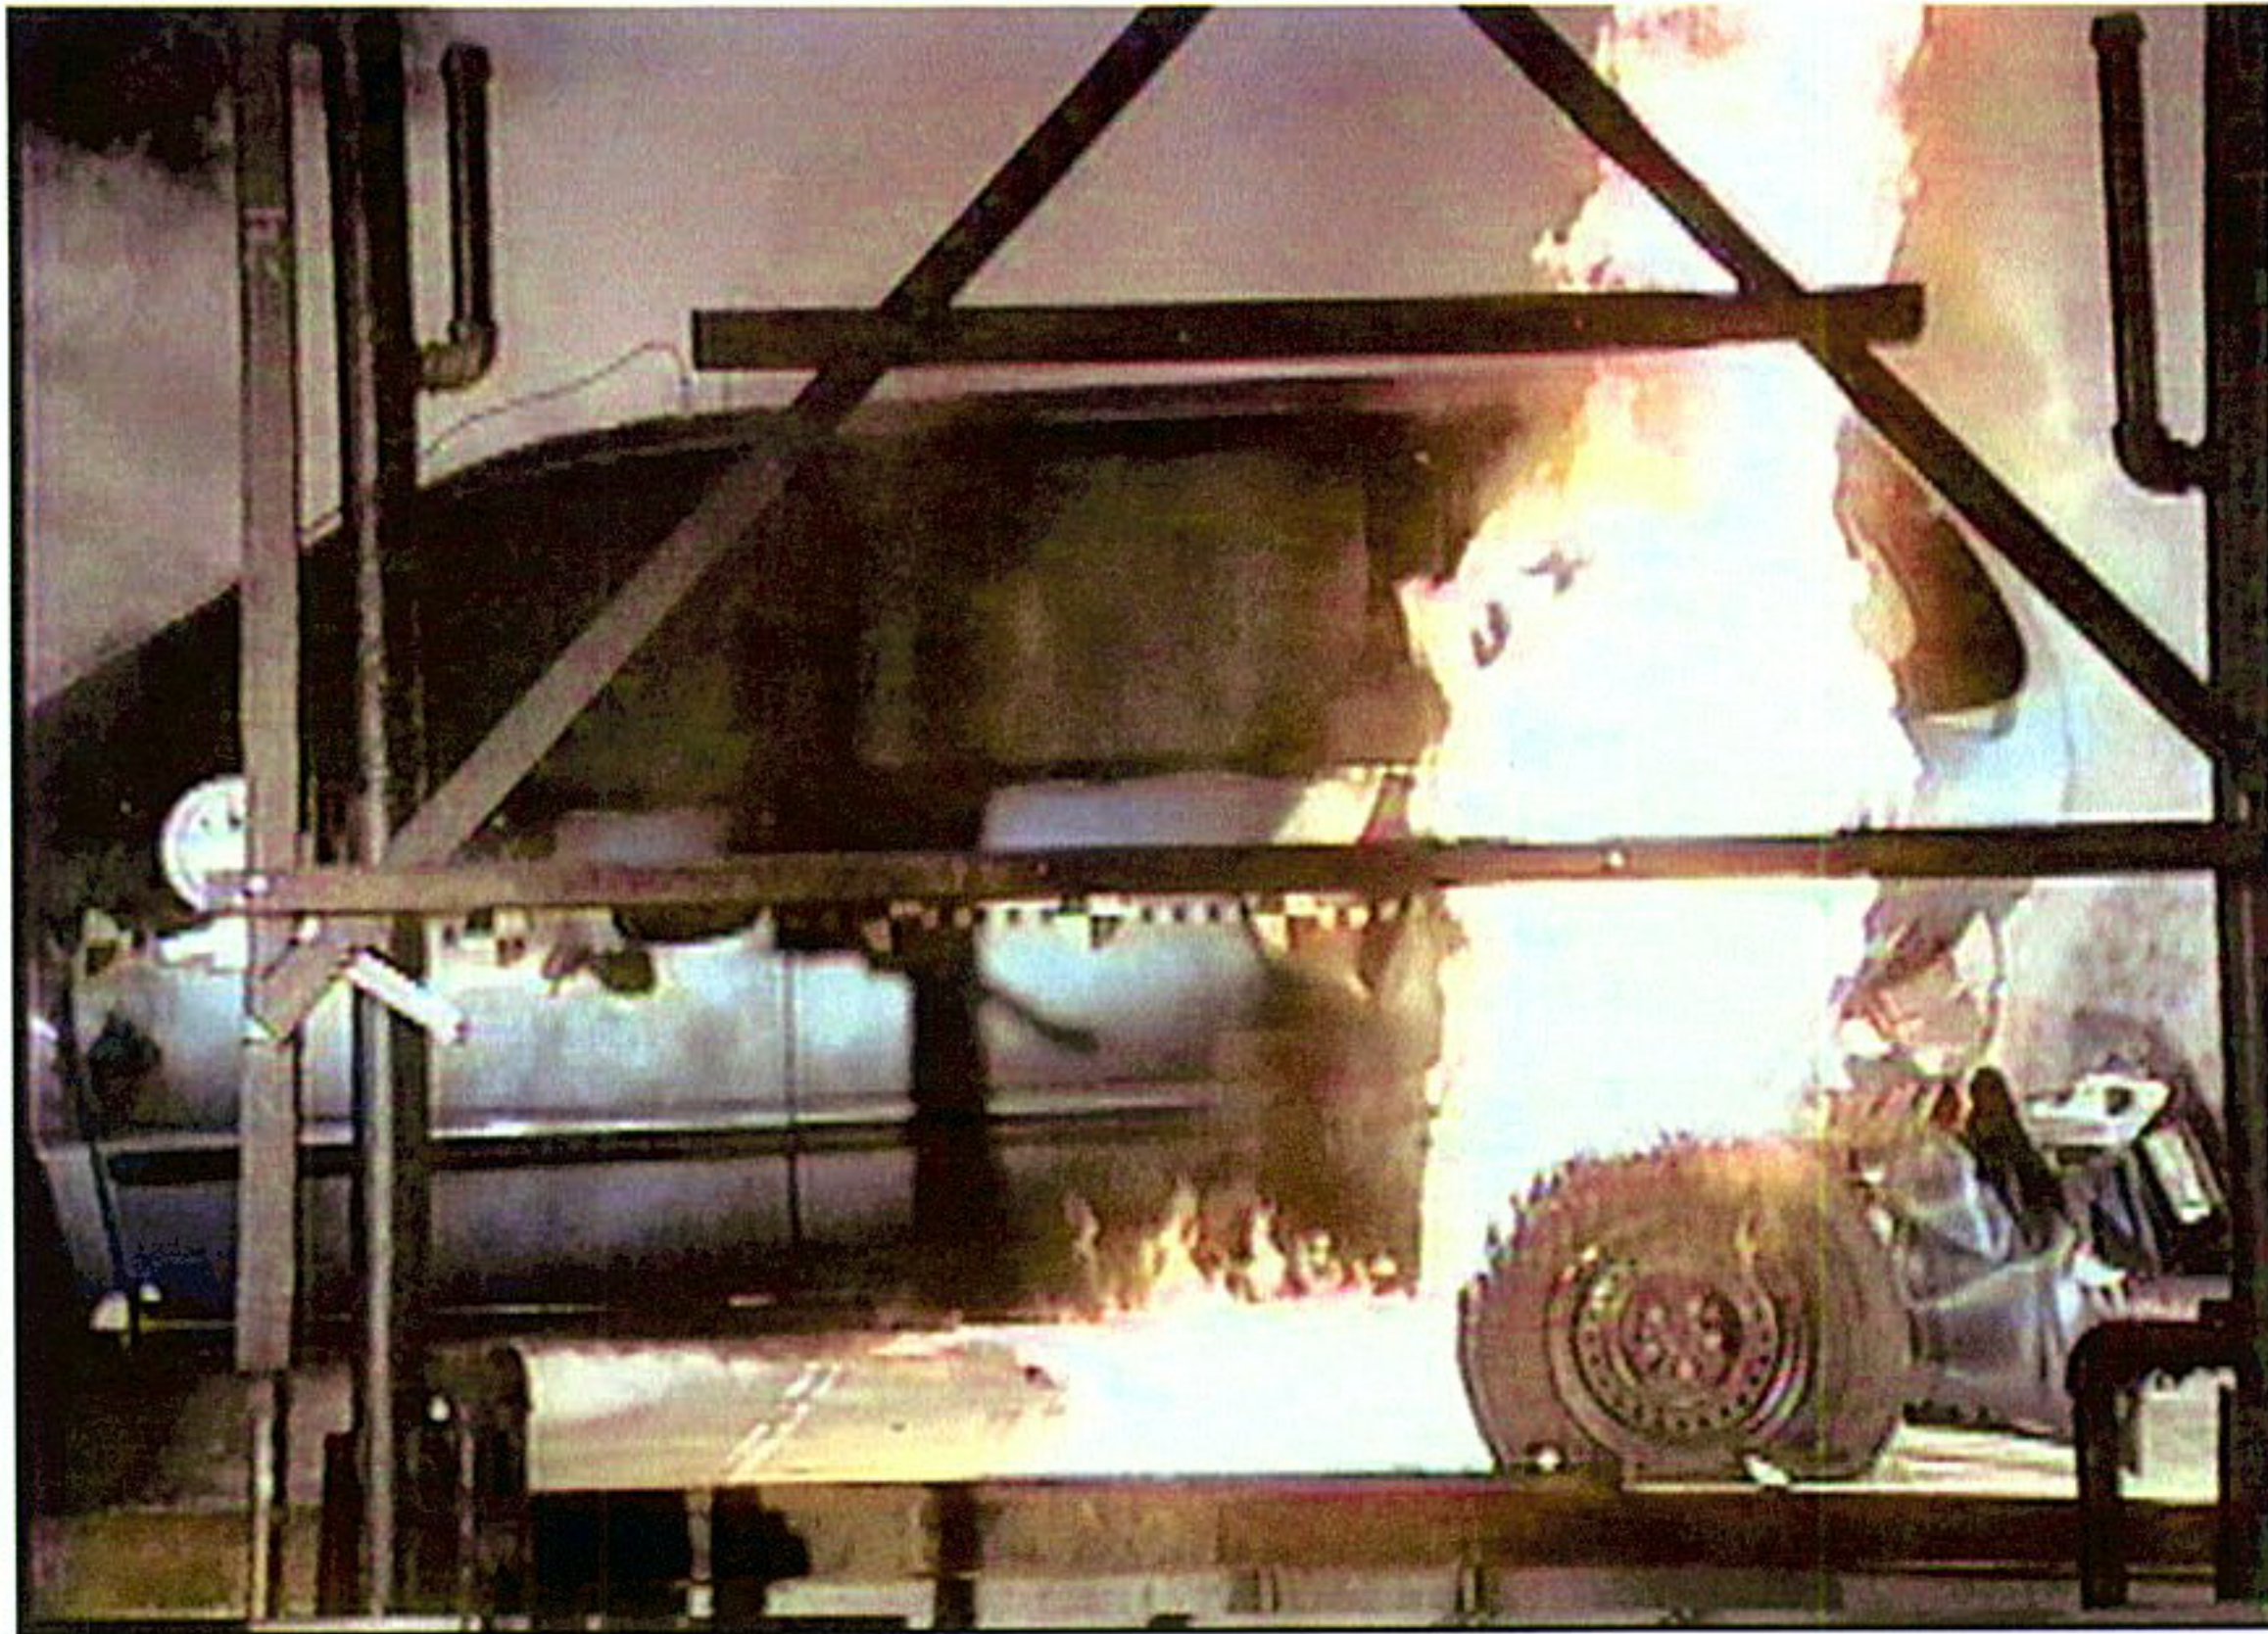
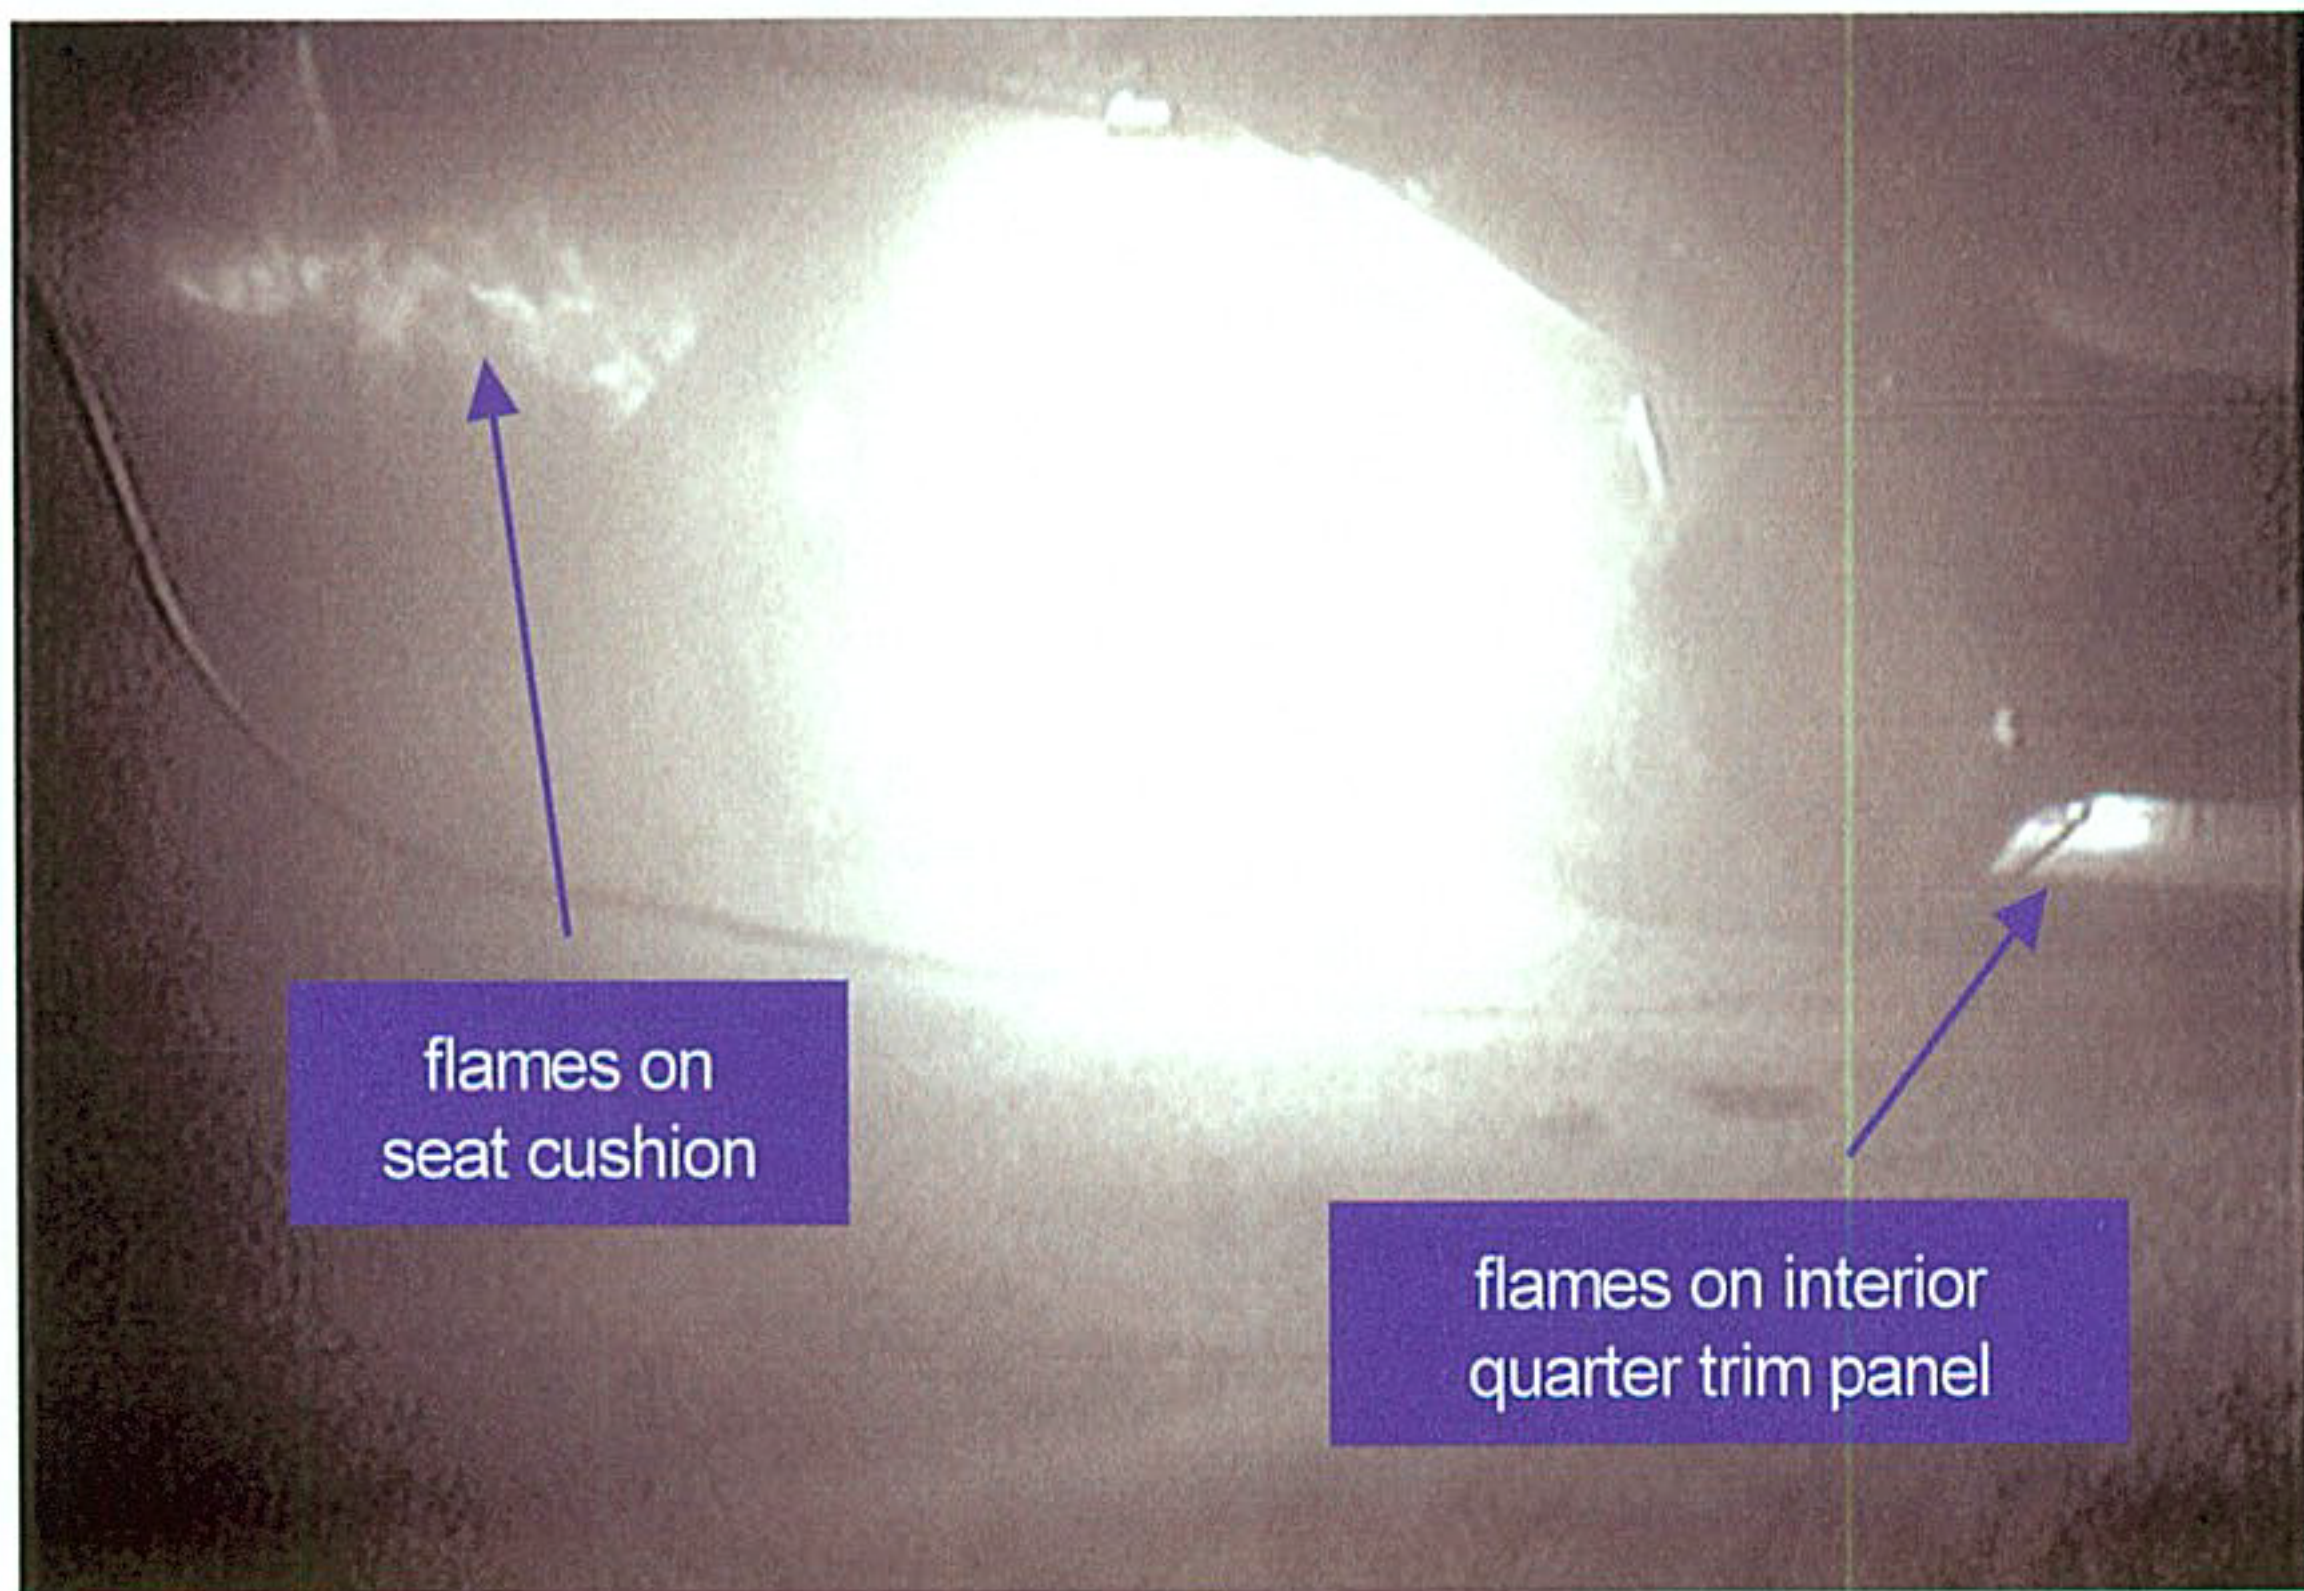
flames on
seat cushion

flames on interior
quarter trim panel

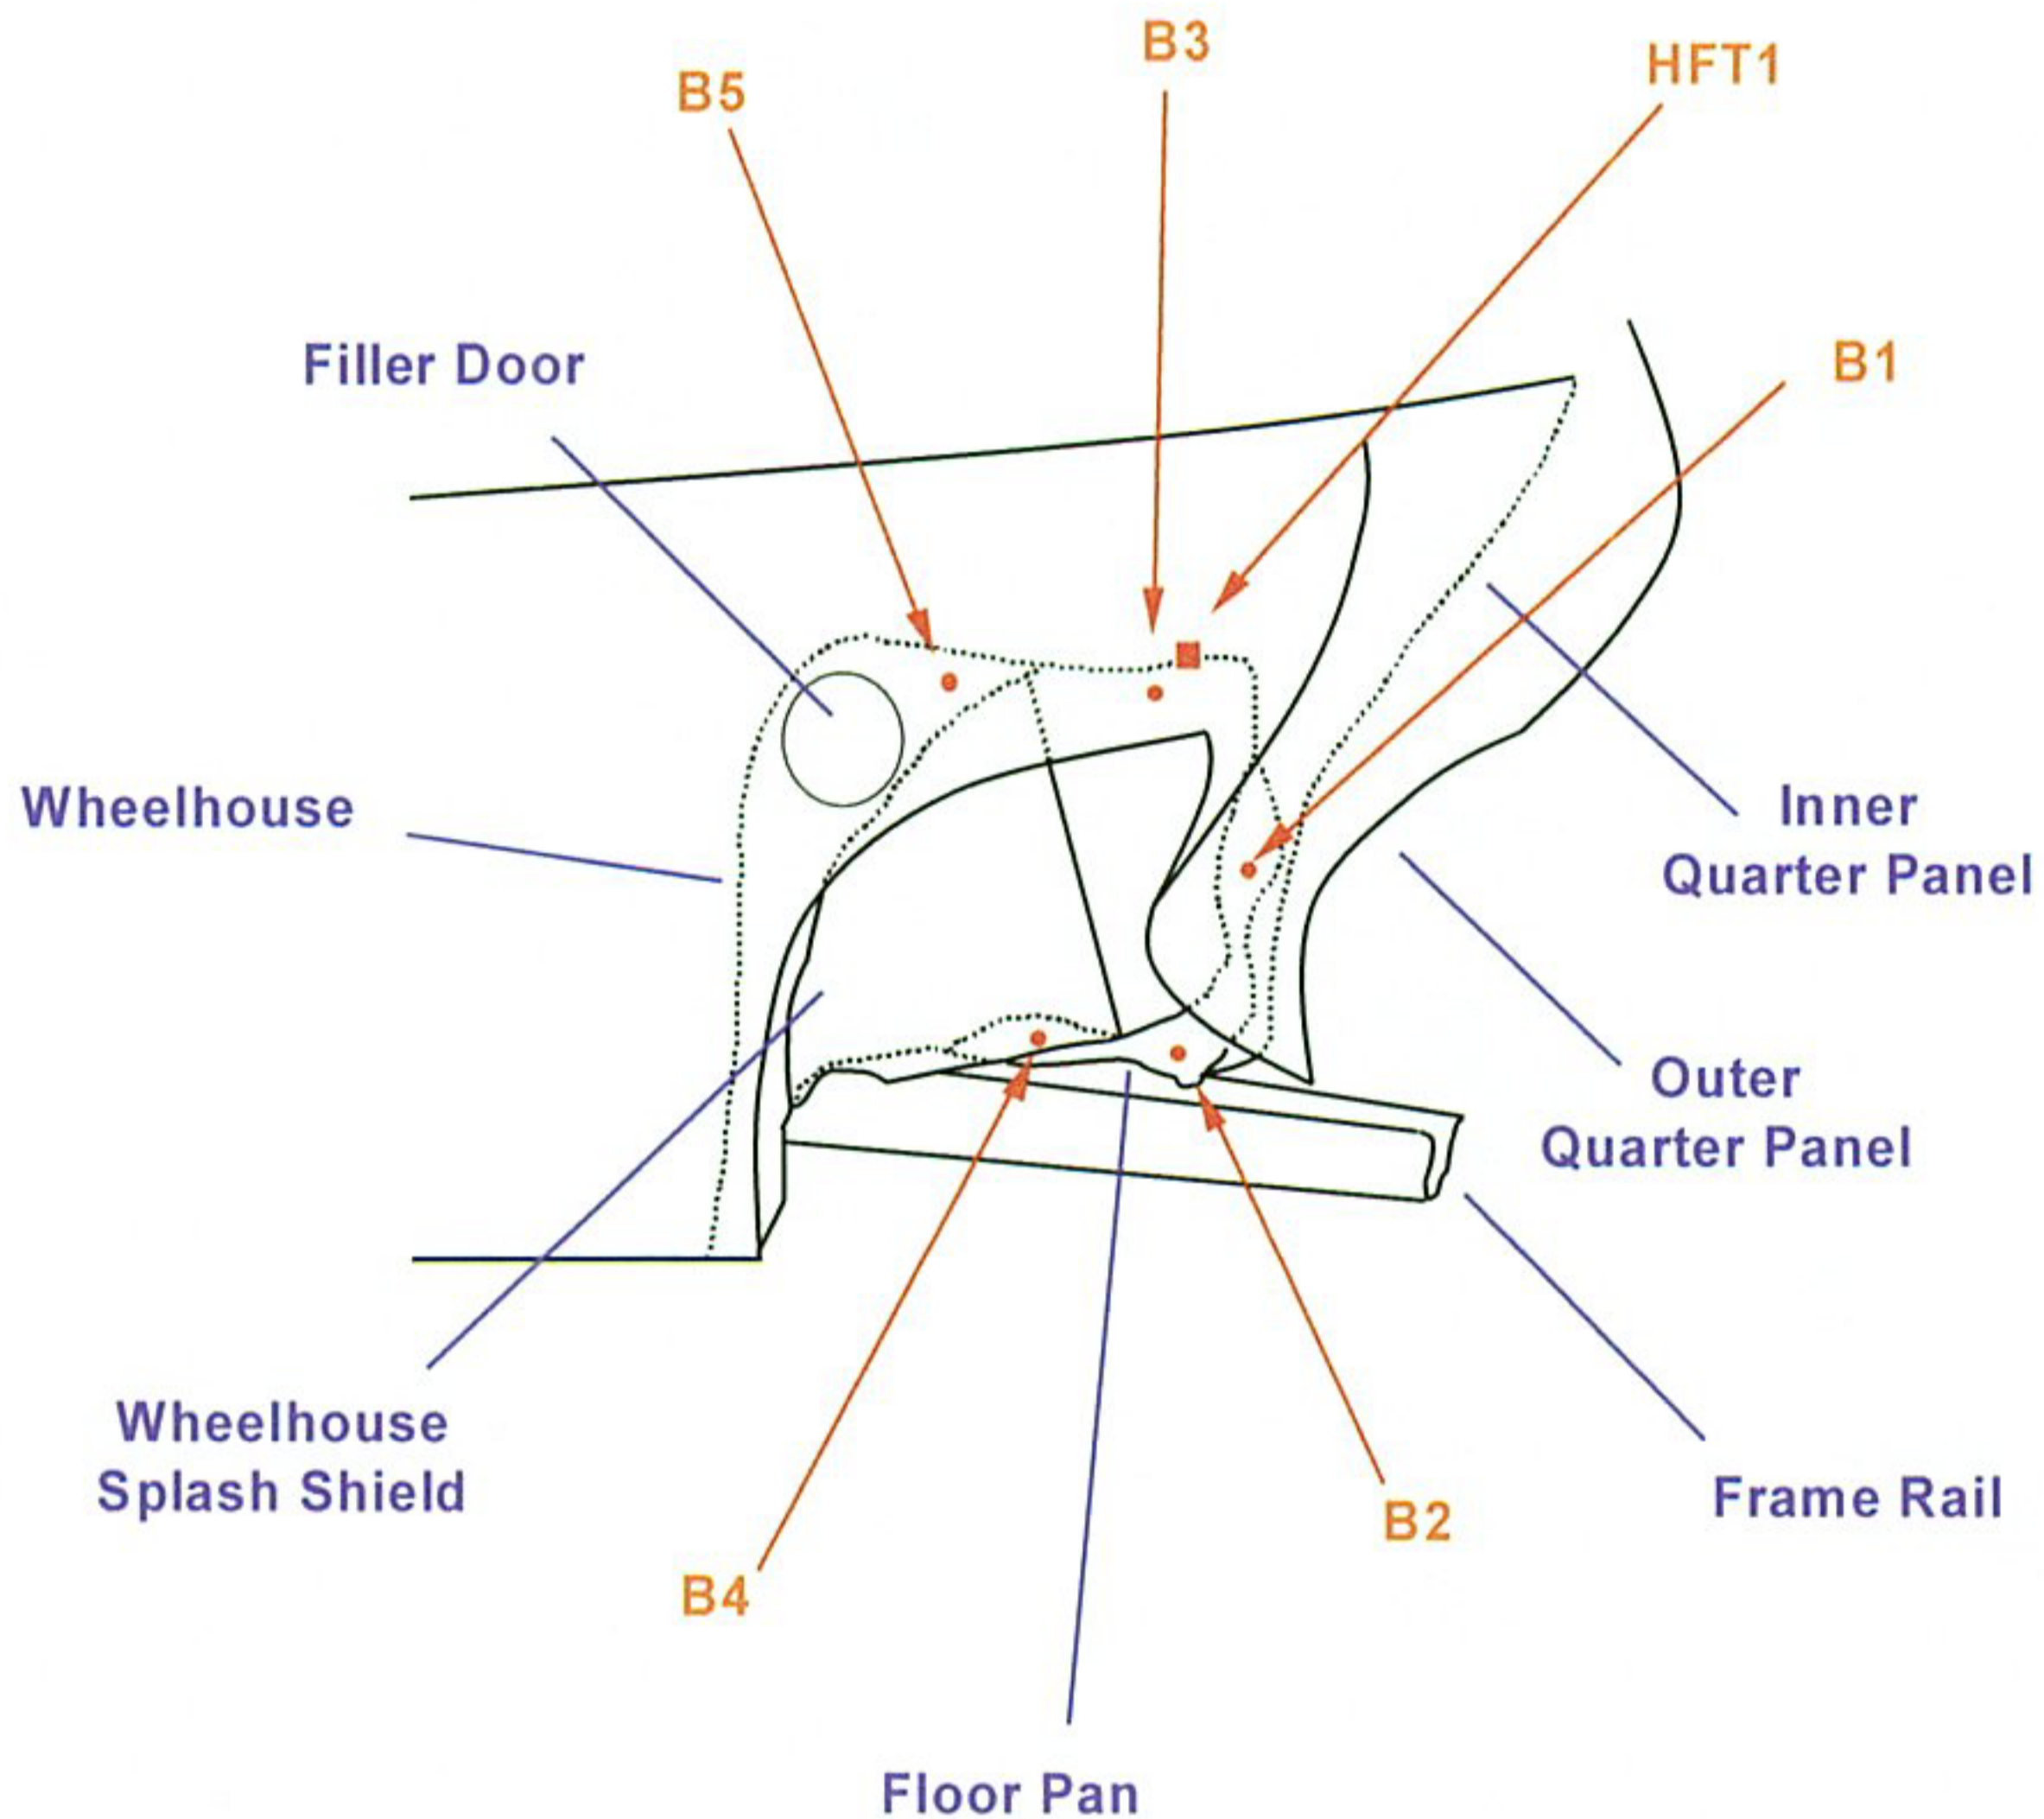
Figure 26. Fire Test F961116. Diagram of the left rear wheelhouse of the test vehicle. The wheelhouse splash shield was a poly(propylene) panel that covered the front of the wheelhouse. Thermocouple B1 was located in a split section of the weld-seam between the wheelhouse and interior quarter panel. Thermocouples B2 and B4 were located in a split section of the weld-seam between the wheelhouse and floor pan. Thermocouple B3 was located in the rear of the wheelhouse, extending approximately 1 cm below its upper, exterior surface. Thermocouple B5 was located in the front of the wheelhouse, extending approximately 1 cm below its upper, exterior surface. Before it melted and sagged onto the tire, the wheelhouse splash shield covered Thermocouple B5. Heat-flux Transducer 1 (HFT1) was inserted through the upper surface of the wheelhouse, rearward of the wheelhouse splash shield.

Data from Thermocouples B1, B2, and B4 indicate that flames first entered the passenger compartment through the split spot weld seams around the left rear wheelhouse between 80 and 120 seconds post-ignition. Hot gases also started to enter the passenger compartment through these openings shortly after the gasoline pool was ignited (Fig. 28). Thermocouples B1 and B2 recorded temperatures in the range of 300 to 400°C between 50 and 90 seconds post-ignition (Fig. 28), while Thermocouple B4, which was behind the wheelhouse splash shield (see Fig. 26), recorded temperatures of < 200°C.

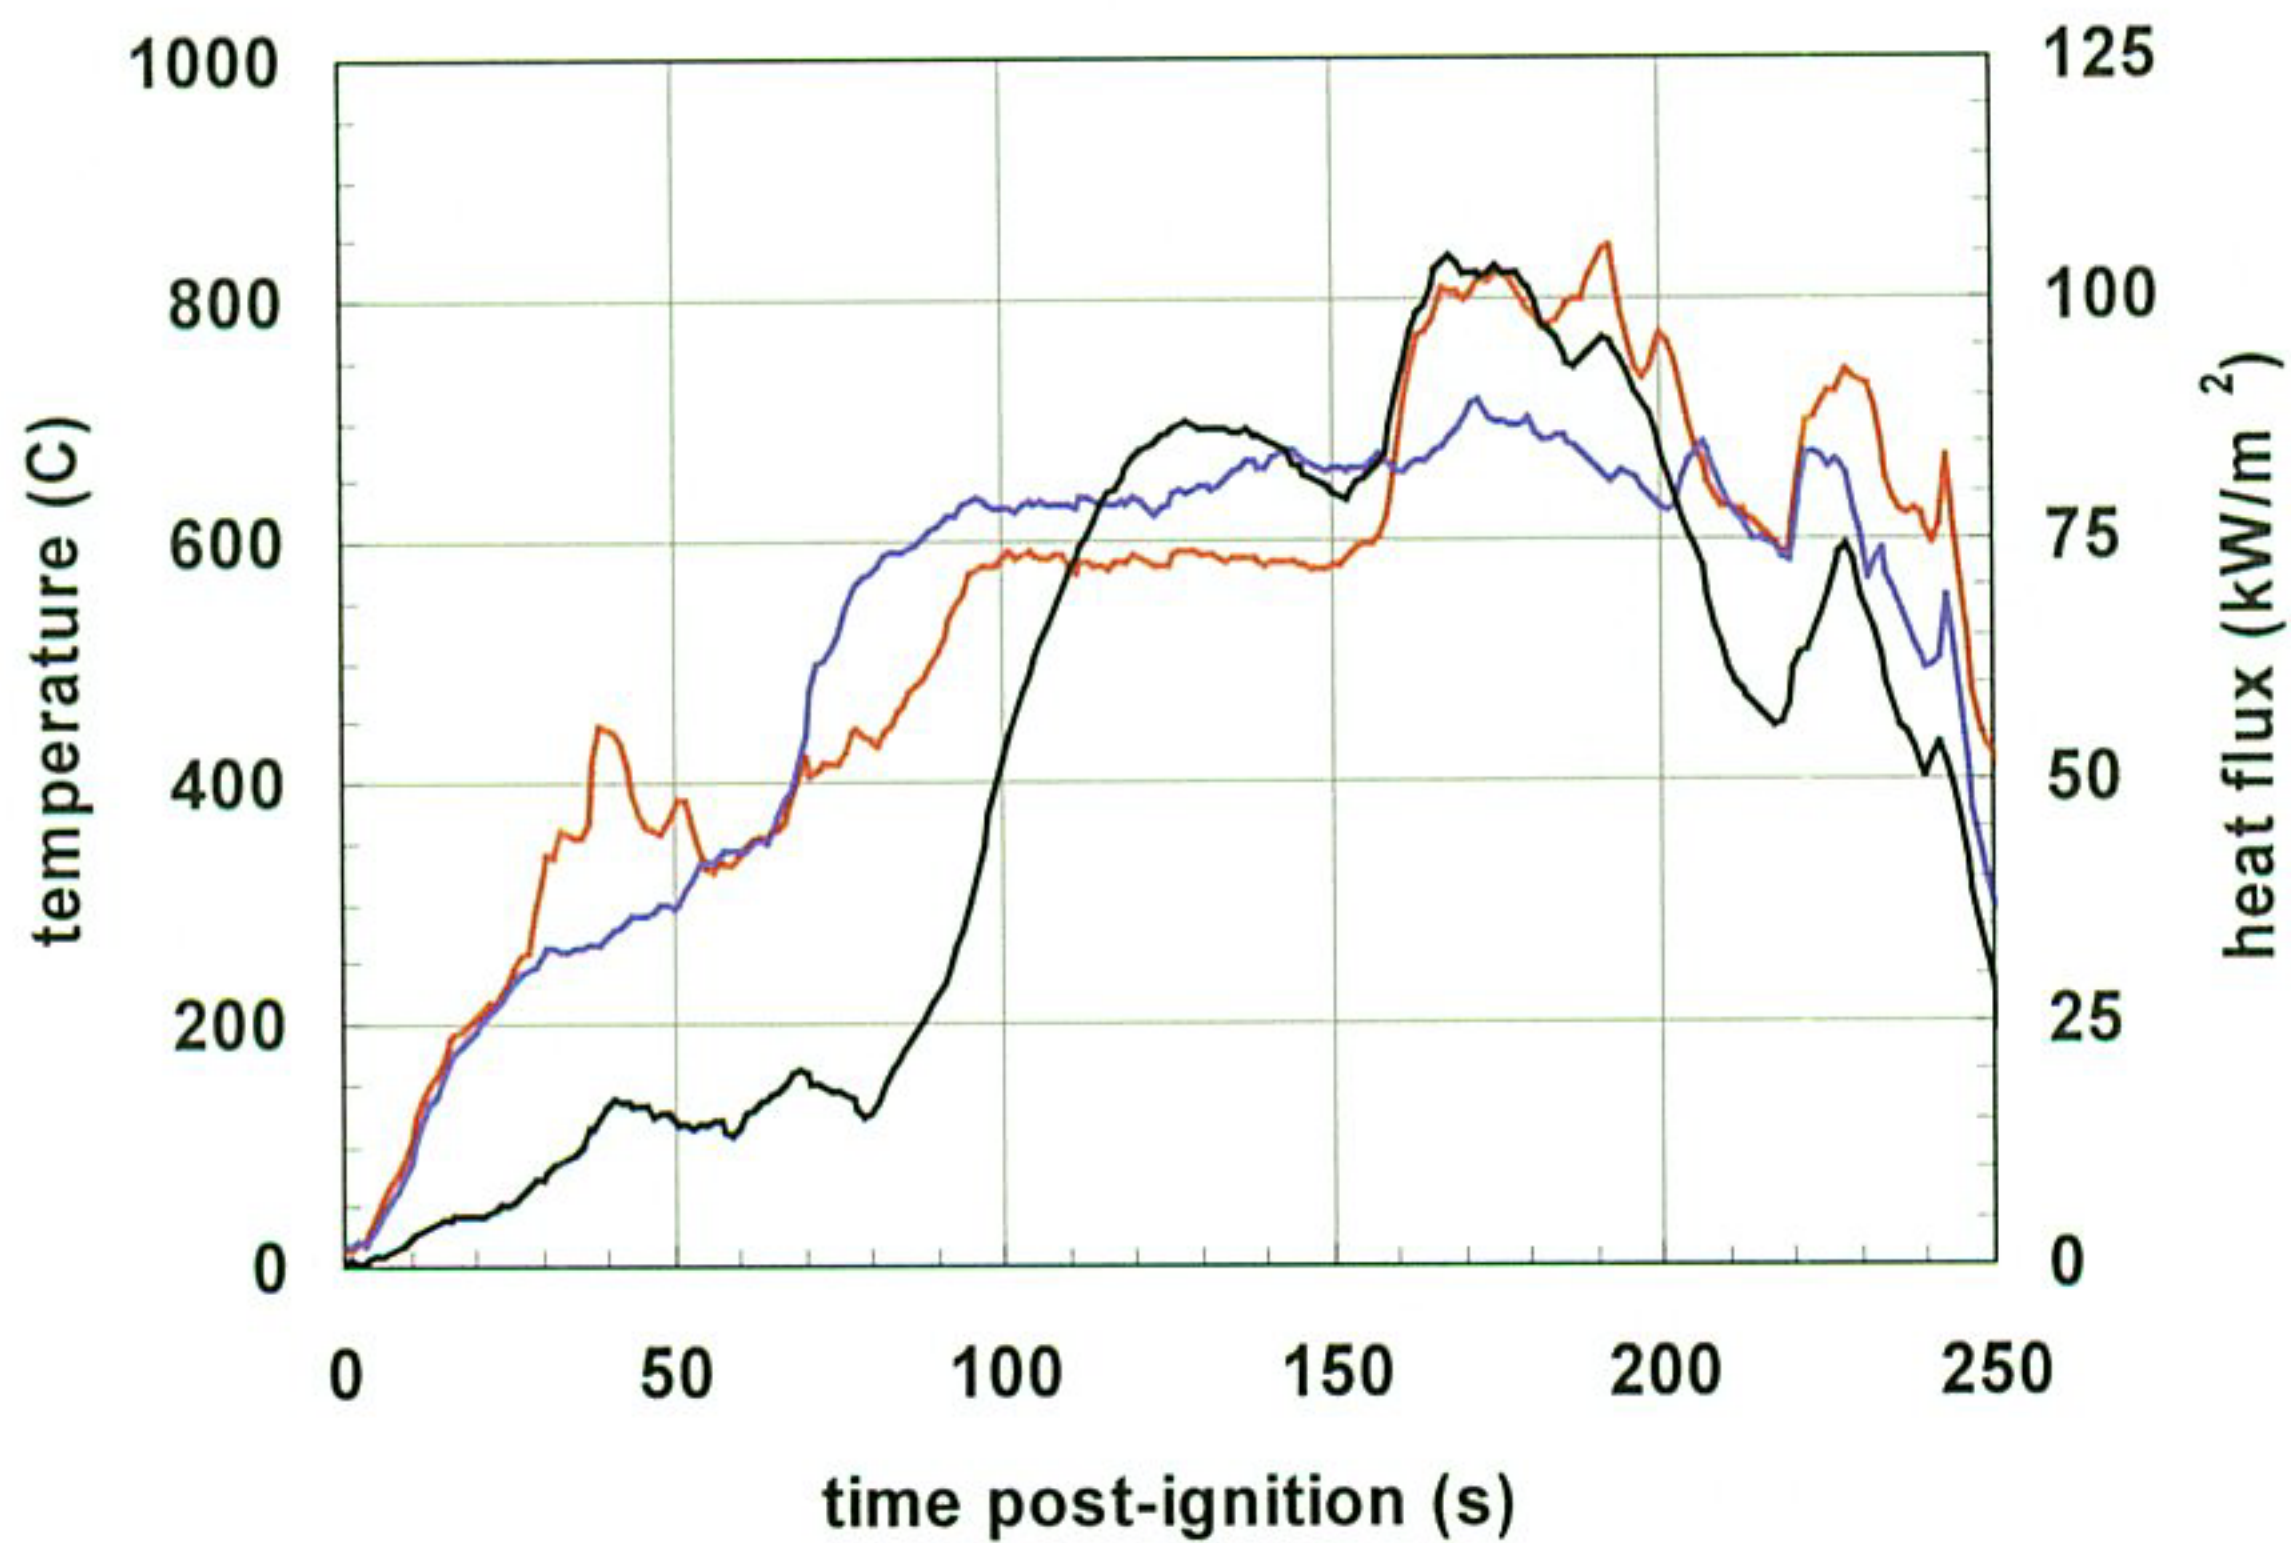
Hot gas started to accumulate in the left rear wheelhouse before the fire plume from the burning gasoline pool entered the wheelhouse. Temperatures recorded by Thermocouples B3 and B5 started to increase shortly after the gasoline pool was ignited (Fig. 27), before flames were visible in the lower front section of the wheelhouse, but remained less than 500°C for the first 60 seconds of this test.⁹ A net positive heat flux to the upper surface of the wheelhouse panel also was recorded approximately 5 seconds after the gasoline pool was ignited, but remained less than 20 kW/m² for the first 70 seconds post-ignition (Fig. 27).

Figure 27. Fire Test F961116. Plots of temperatures recorded by Thermocouples B3 (—, left axis) and B5 (—, left axis), and heat flux recorded by HFT1 (—, right axis).

Ignition of combustible material located in the wheelhouse, namely the wheelhouse splash shield, resulted in a large increase in heat transfer to the wheelhouse panels. As the splash shield sagged onto the tire and ignited between 60 and 90 seconds post-ignition, flames began to fill the left rear wheelhouse (see Fig.'s 23 and 24). Temperatures recorded by Thermocouples B3 and B5 increased rapidly to approximately 600°C during this time interval (Fig. 27). The heat flux to the top of the wheelhouse showed a similar trend, increasing to approximately 85 kW/m² between 80 and 120 seconds post-ignition (Fig 27).

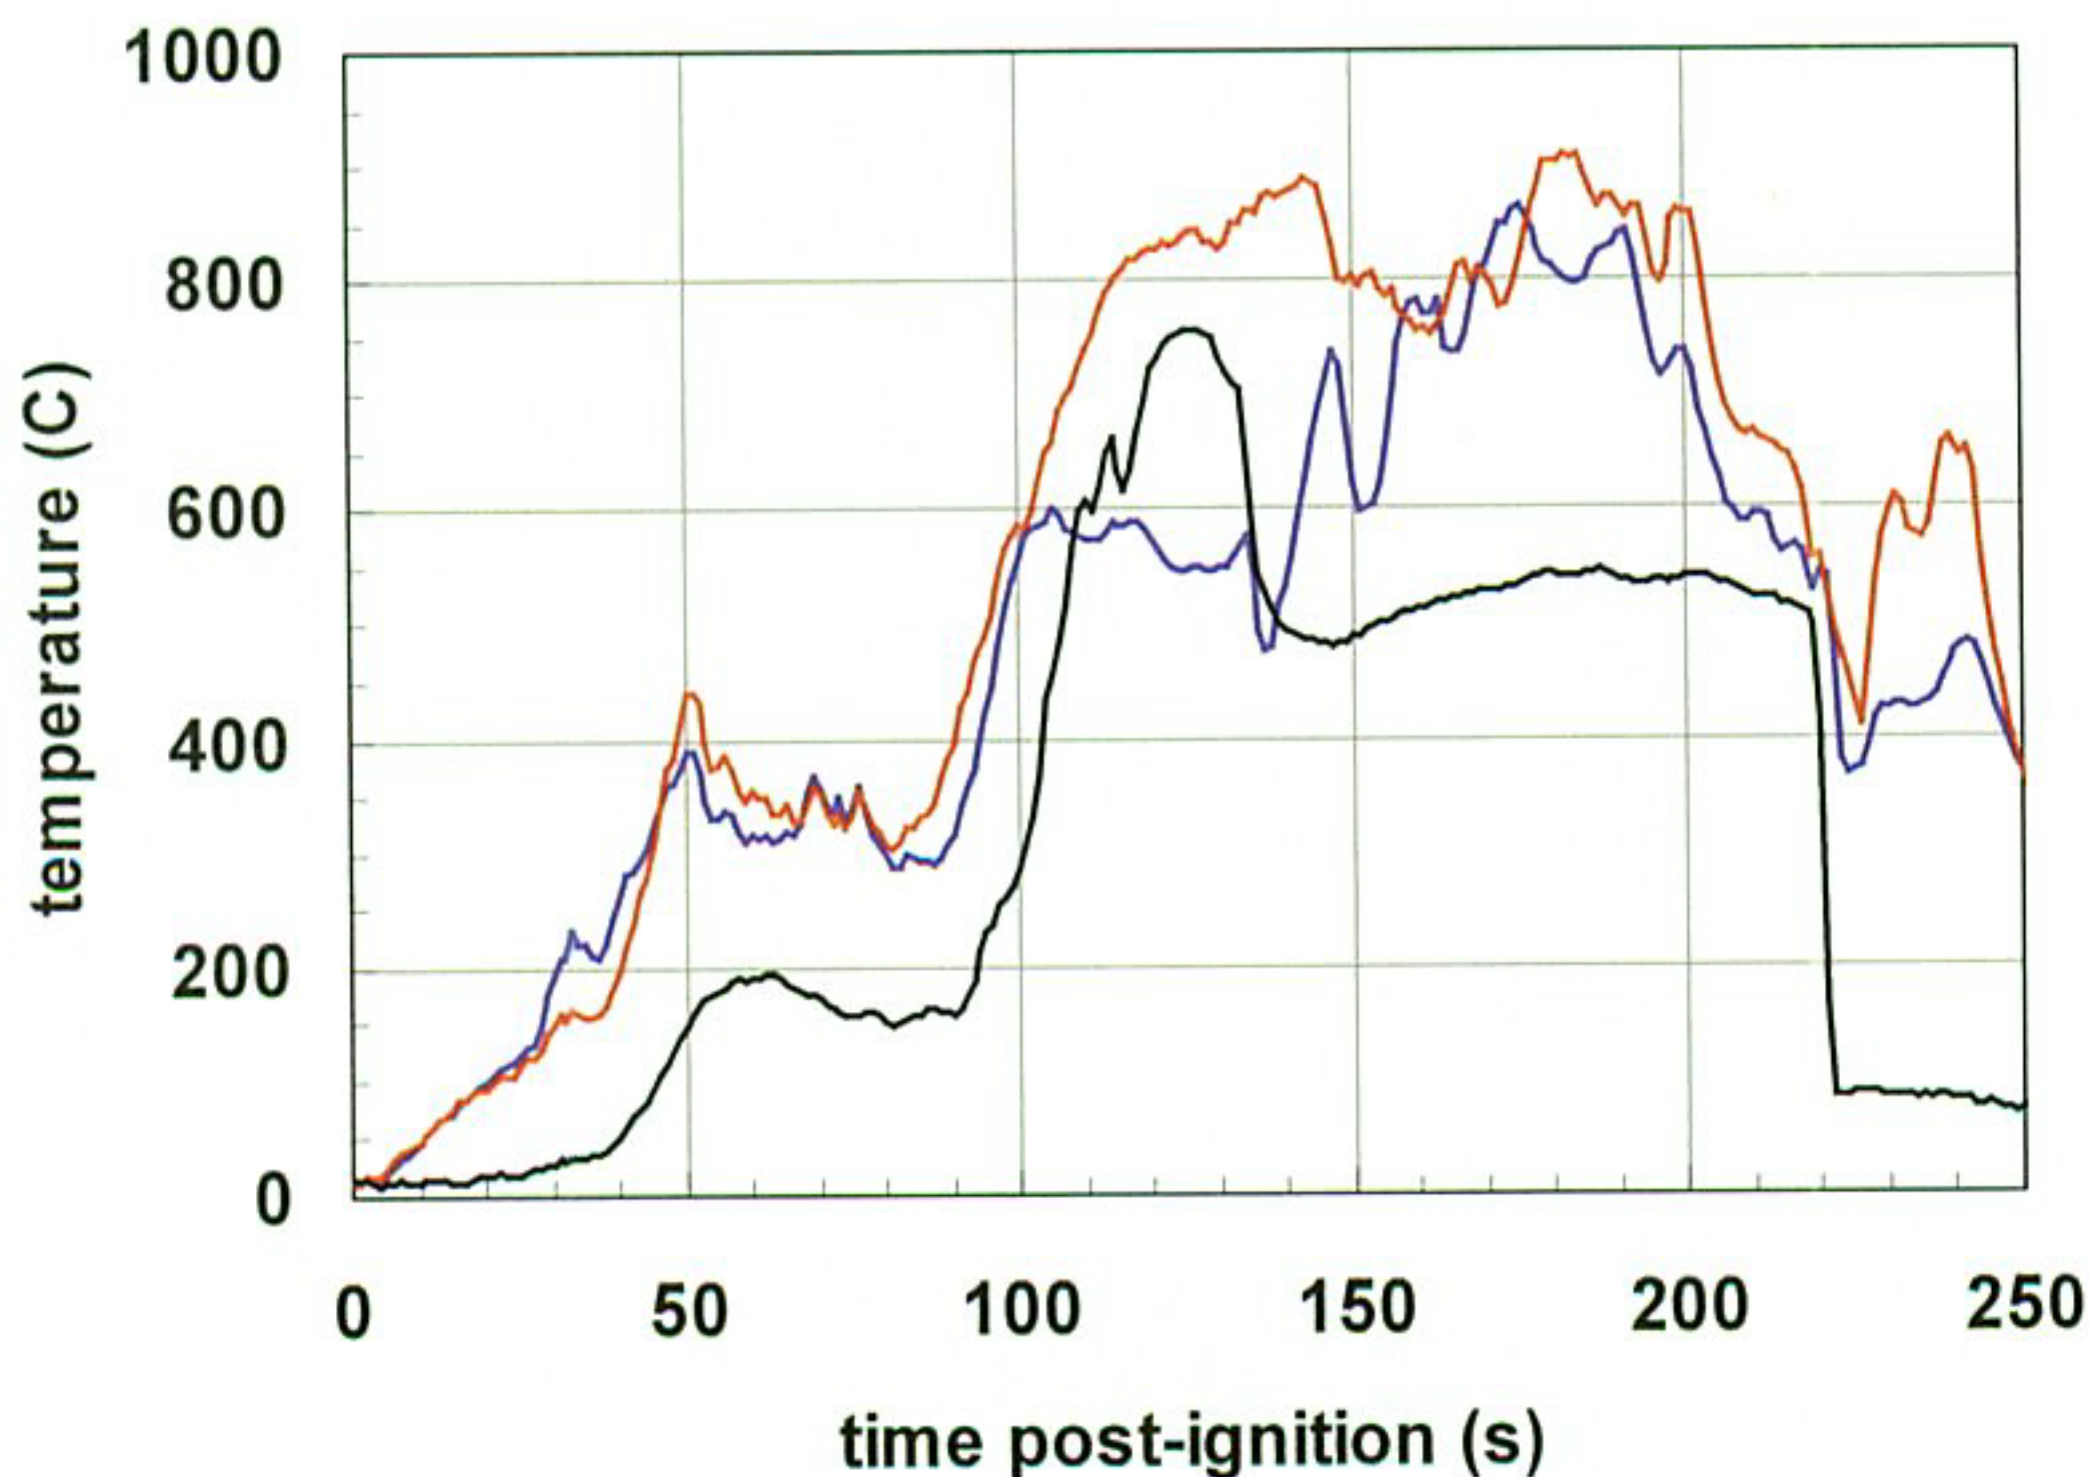
Figure 28. Fire Test F961116. Plots of temperatures recorded by thermocouples B1 (—), B2, (—) and B4 (—).

Thermocouples B1 and B2 recorded rapid temperature increases between 80 and 120 seconds post-ignition, with Thermocouple B1 recording a temperature of greater than 800°C and Thermocouple B2 recording a temperature of slightly less than 600°C at 120 seconds post-ignition (Fig. 28). Thermocouple B4 recorded a rapid temperature increase between 90 and 130 seconds post-ignition, recording a temperature of approximately 750°C at 130 seconds post-ignition.

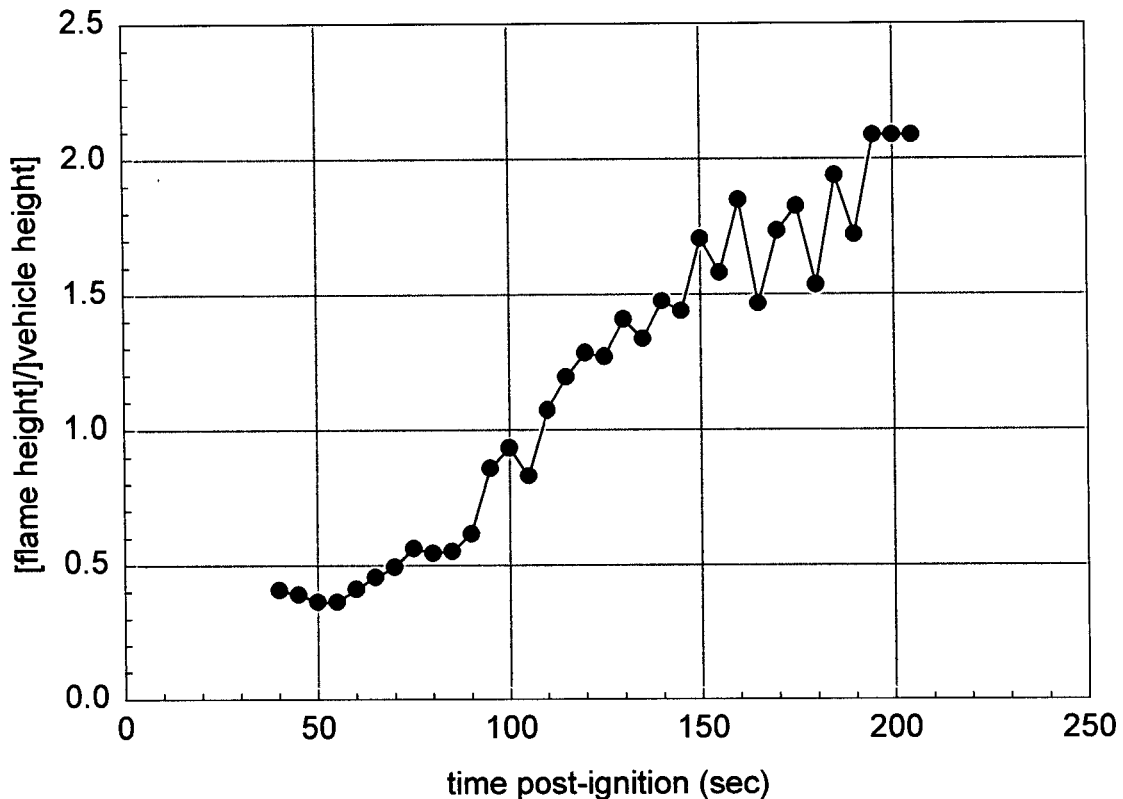
Although the fire plume was approximately $\frac{1}{2}$ the height of the test vehicle by 50 seconds post-ignition (Fig. 29), it had not extended laterally beyond the left rocker panel or the outer edge of the left wheelhouse.

Figure 29. Fire Test F961116. Plot of the height of the fire plume versus time post-ignition. The height of the fire plume was the distance from the simulated road surface below the test vehicle to the highest extension of flame visible in the video from Camera 1.

As the splash shield sagged onto the tire and ignited between 60 and 90 seconds post-ignition, a fire plume was observed outside the left rear wheelhouse (see Fig. 24). Flames spread from the splash shield to the left rear tire between 100 and 150 seconds post-ignition (Fig. 25). An increase in the heat flux to the wheelhouse panels (Fig. 27) indicated that the intensity of the fire in the wheelhouse increased during this time interval. The height of the fire plume emerging from the wheelhouse also increased between 100 and 150 seconds post-ignition (Fig. 29).
