Enclosed is a final report prepared by Jeffrey Santrock of General Motors Corporation, entitled, "Evaluation of Motor Vehicle Fire Initiation and Propagation Part 4: Propagation of an Underbody Gasoline Pool Fire in a 1996 Passenger Van."

**Evaluation of Motor Vehicle Fire Initiation and Propagation
Part 4: Propagation of an Underbody Gasoline Pool Fire in a 1996
Passenger Van**

Jeffrey Santrock
General Motors Corporation

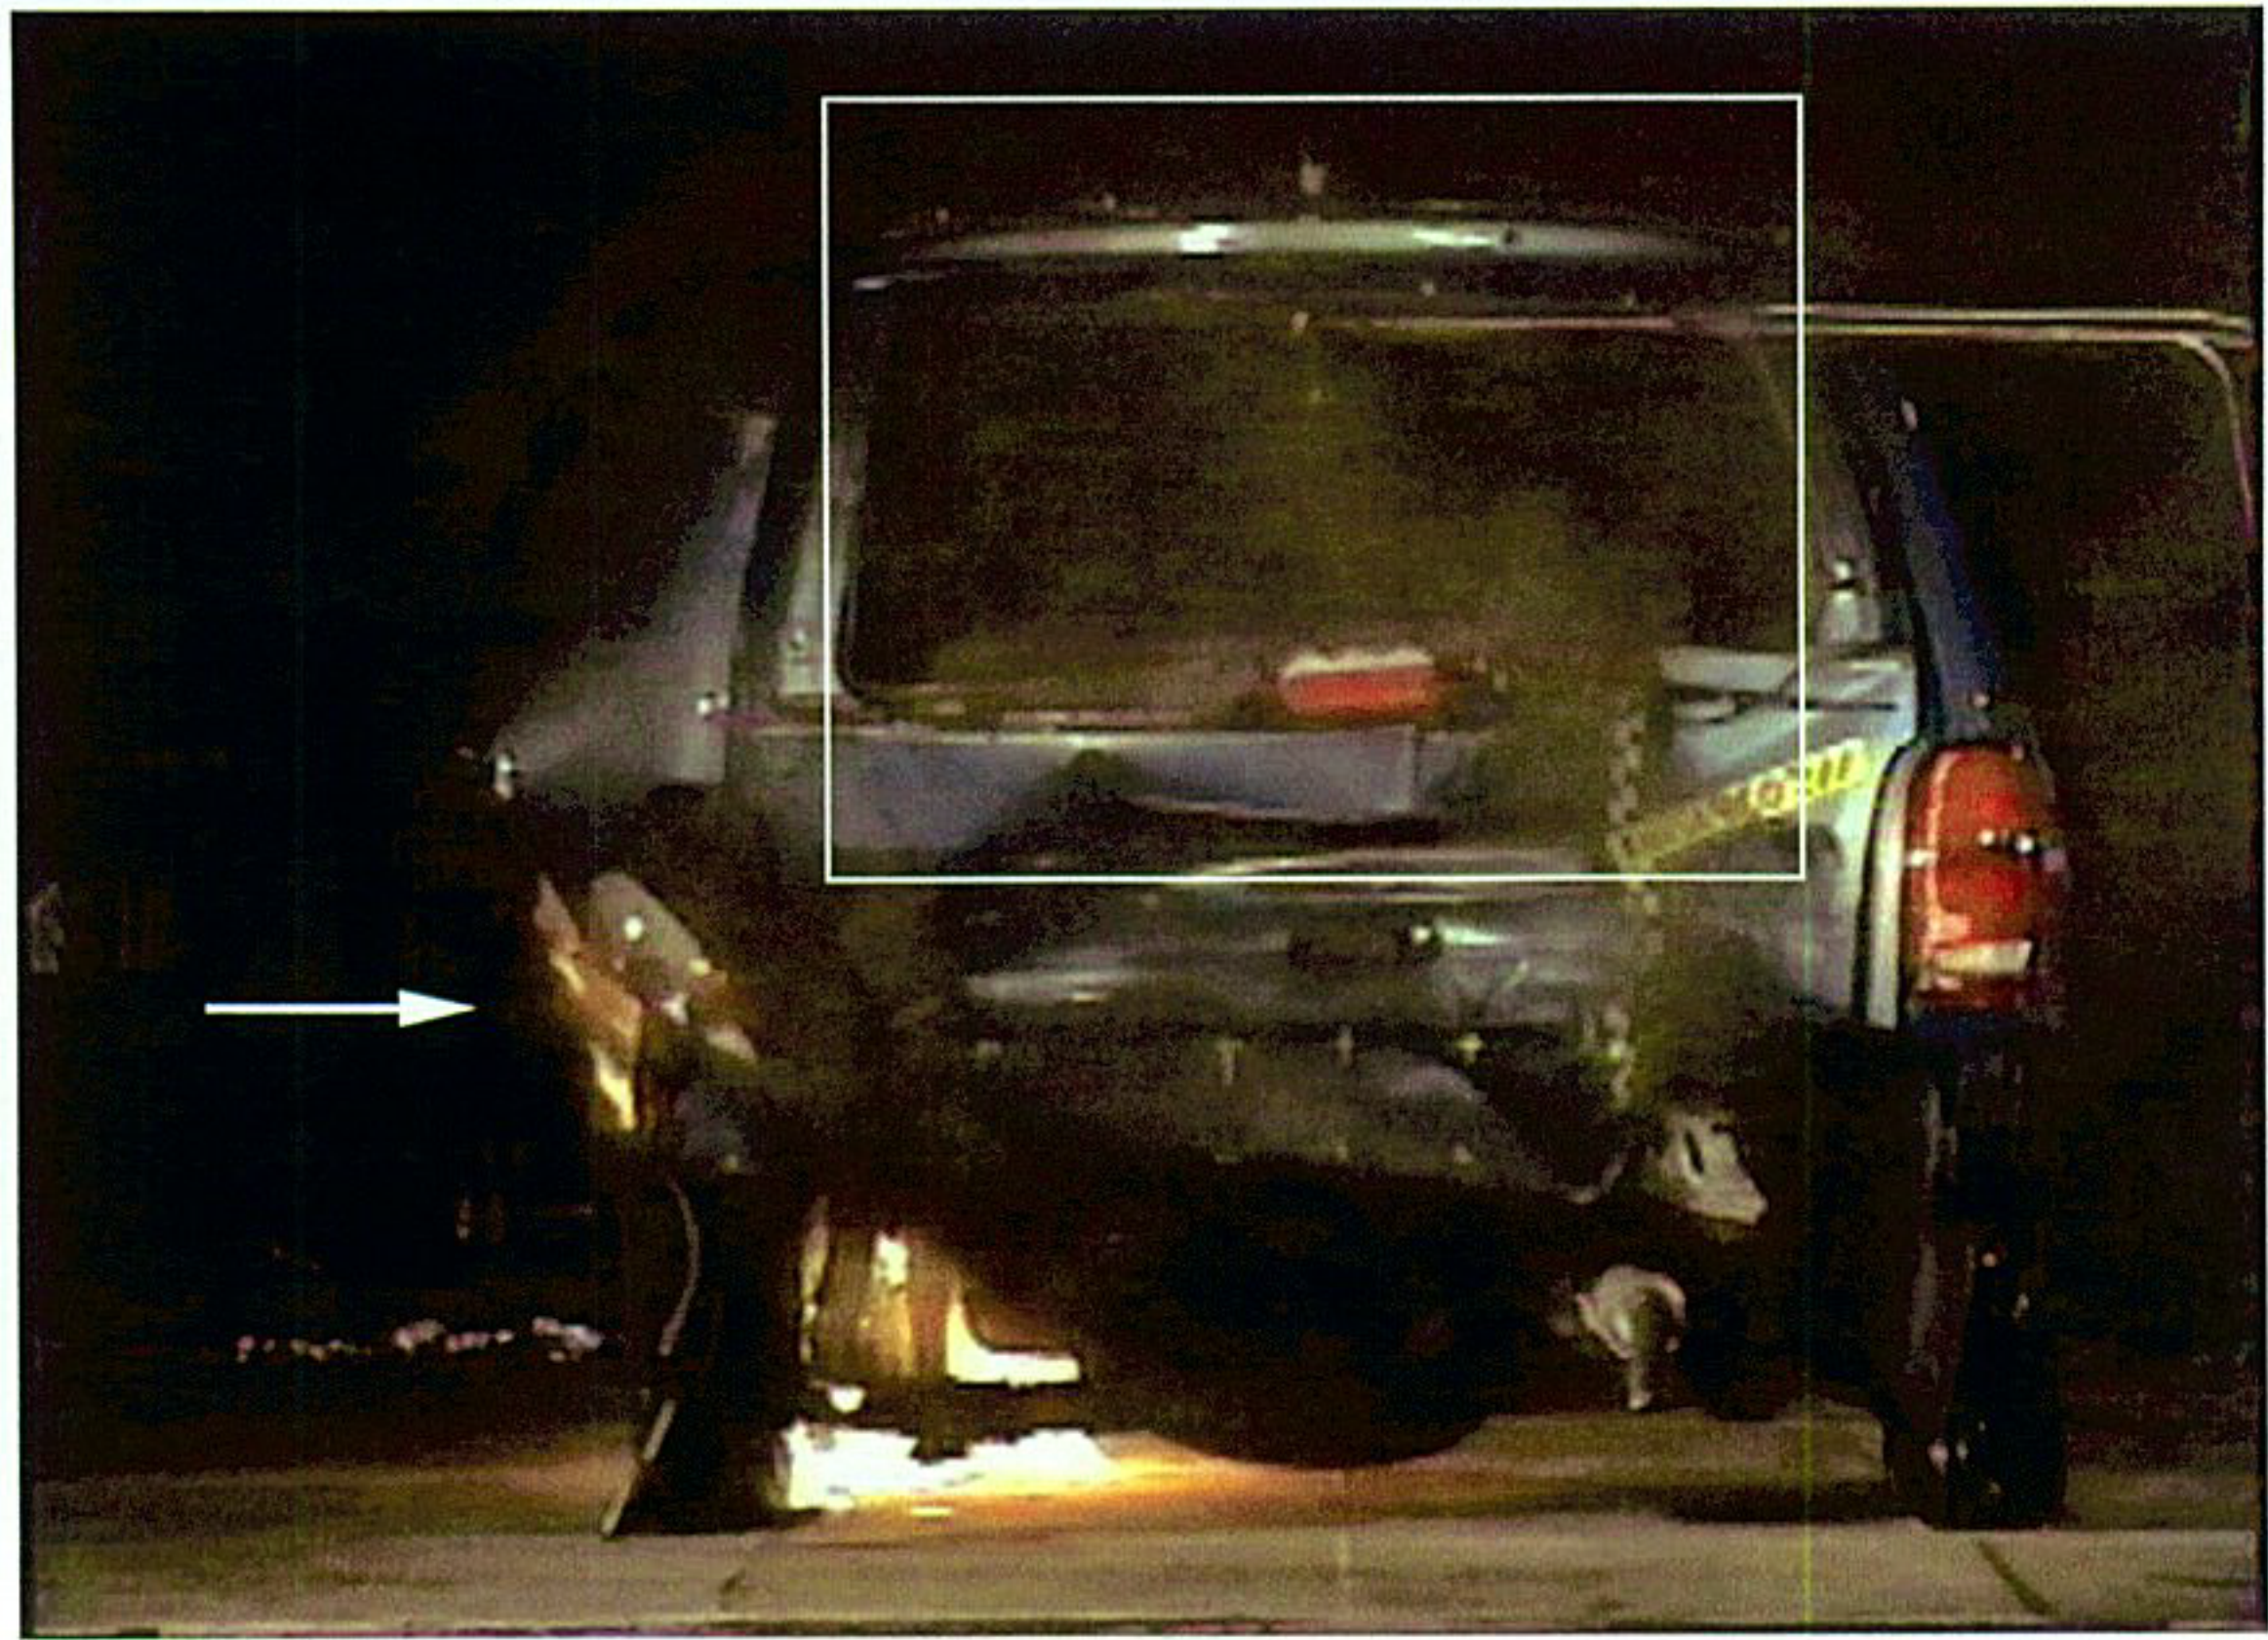
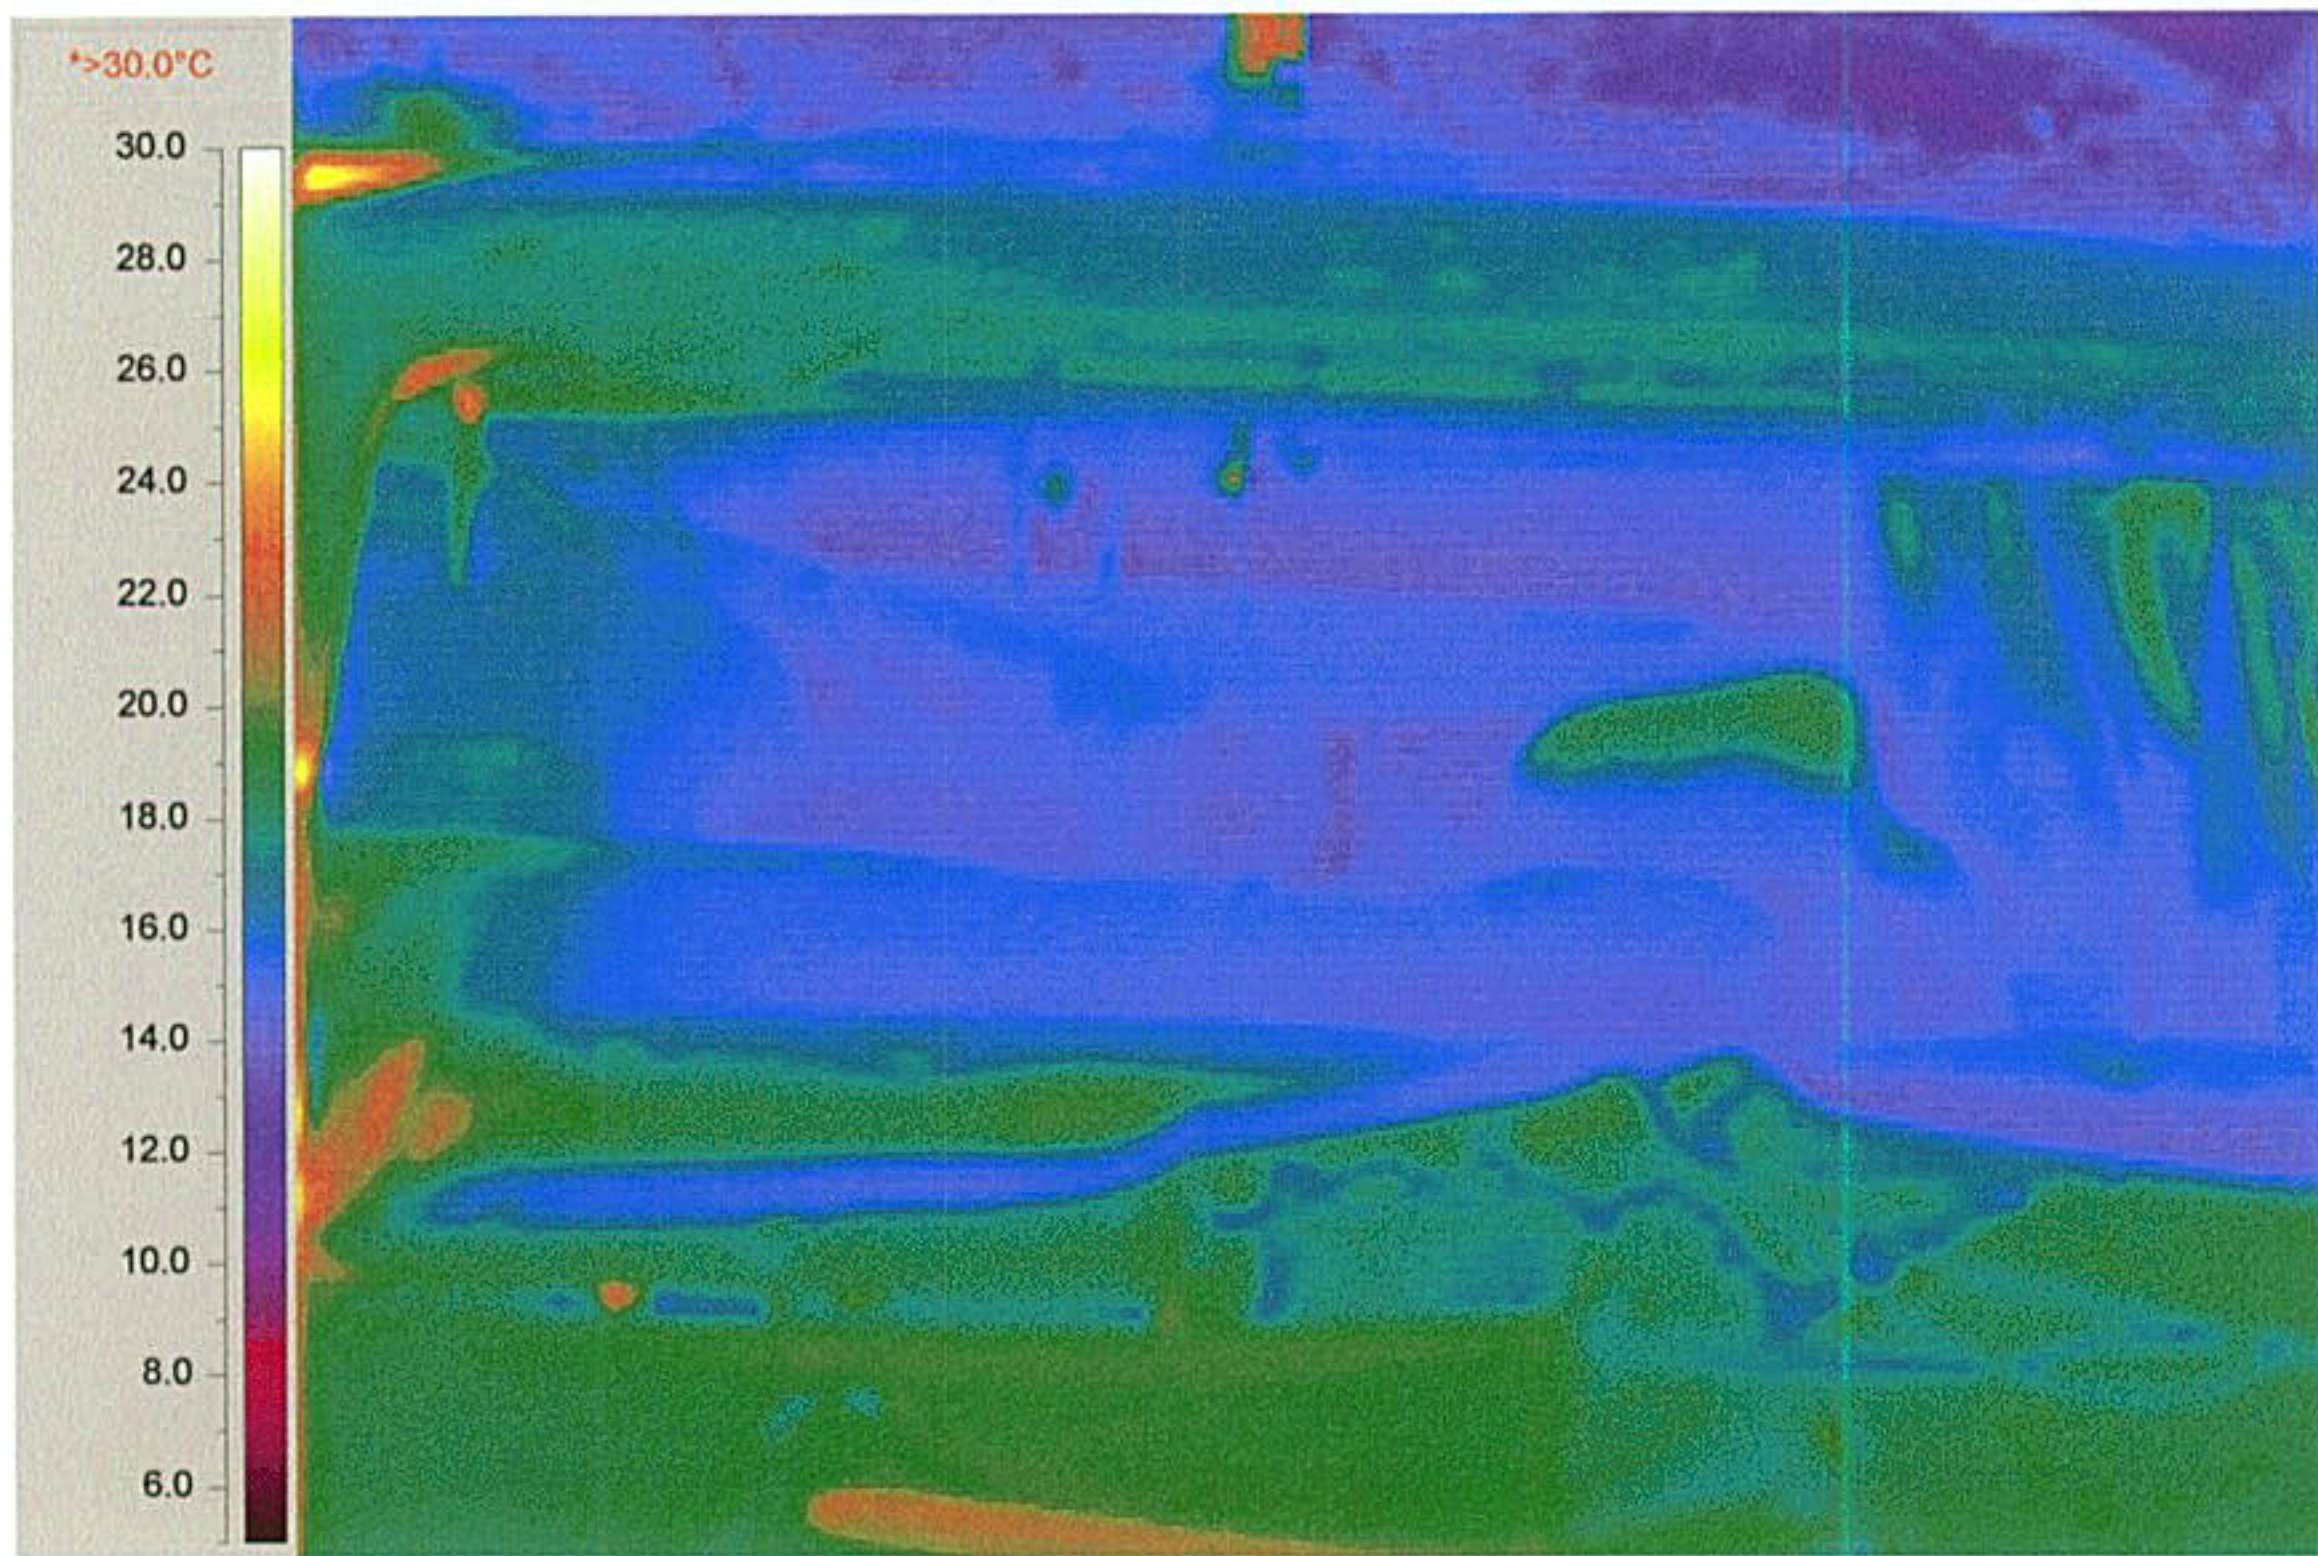
The natural buoyancy of the fire plume emerging from the left rear wheelhouse caused the flames to move upward along the contour of the deformed outer left quarter panel (for example, refer to the video still in Figure 30). The tops of the flames reached the lower edge of the quarter vent glass between 100 and 105 seconds post-ignition. As the height of the flame increased further, the left quarter vent glass split the fire plume. Most of the flames were directed to the outside of the vent glass. However, a small fraction of the split fire plume was directed inward, between the vent glass and the quarter panel. Initially the fire plume did not reach the top of the vent glass, and there was no indication that flames entered the passenger compartment through the open vent (video still, Fig. 31). By 130 seconds post-ignition, flames along the interior surface of the vent glass sporadically reached the top of the vent. The angled glass appeared to have directed a portion of the fire plume into the passenger compartment through the left quarter vent (video still, Fig. 32). By 155 seconds post-ignition, the tops of the flames were consistently above the top of the test vehicle, and flames appeared to enter the left quarter vent continuously (video still, Fig. 33). Flames started to spread laterally to the right across the rear of the headlining between 170 and 180 seconds post-ignition (video still, Fig. 34).

Figure 30. Fire Test F961116. Video still from Camera 1 (upper) and Infrared Thermogram from IR3 (lower) at 80 seconds post-ignition. The box in the video still shows the approximate field-of-view of IR3. The arrow indicates flames in the left rear wheelhouse.

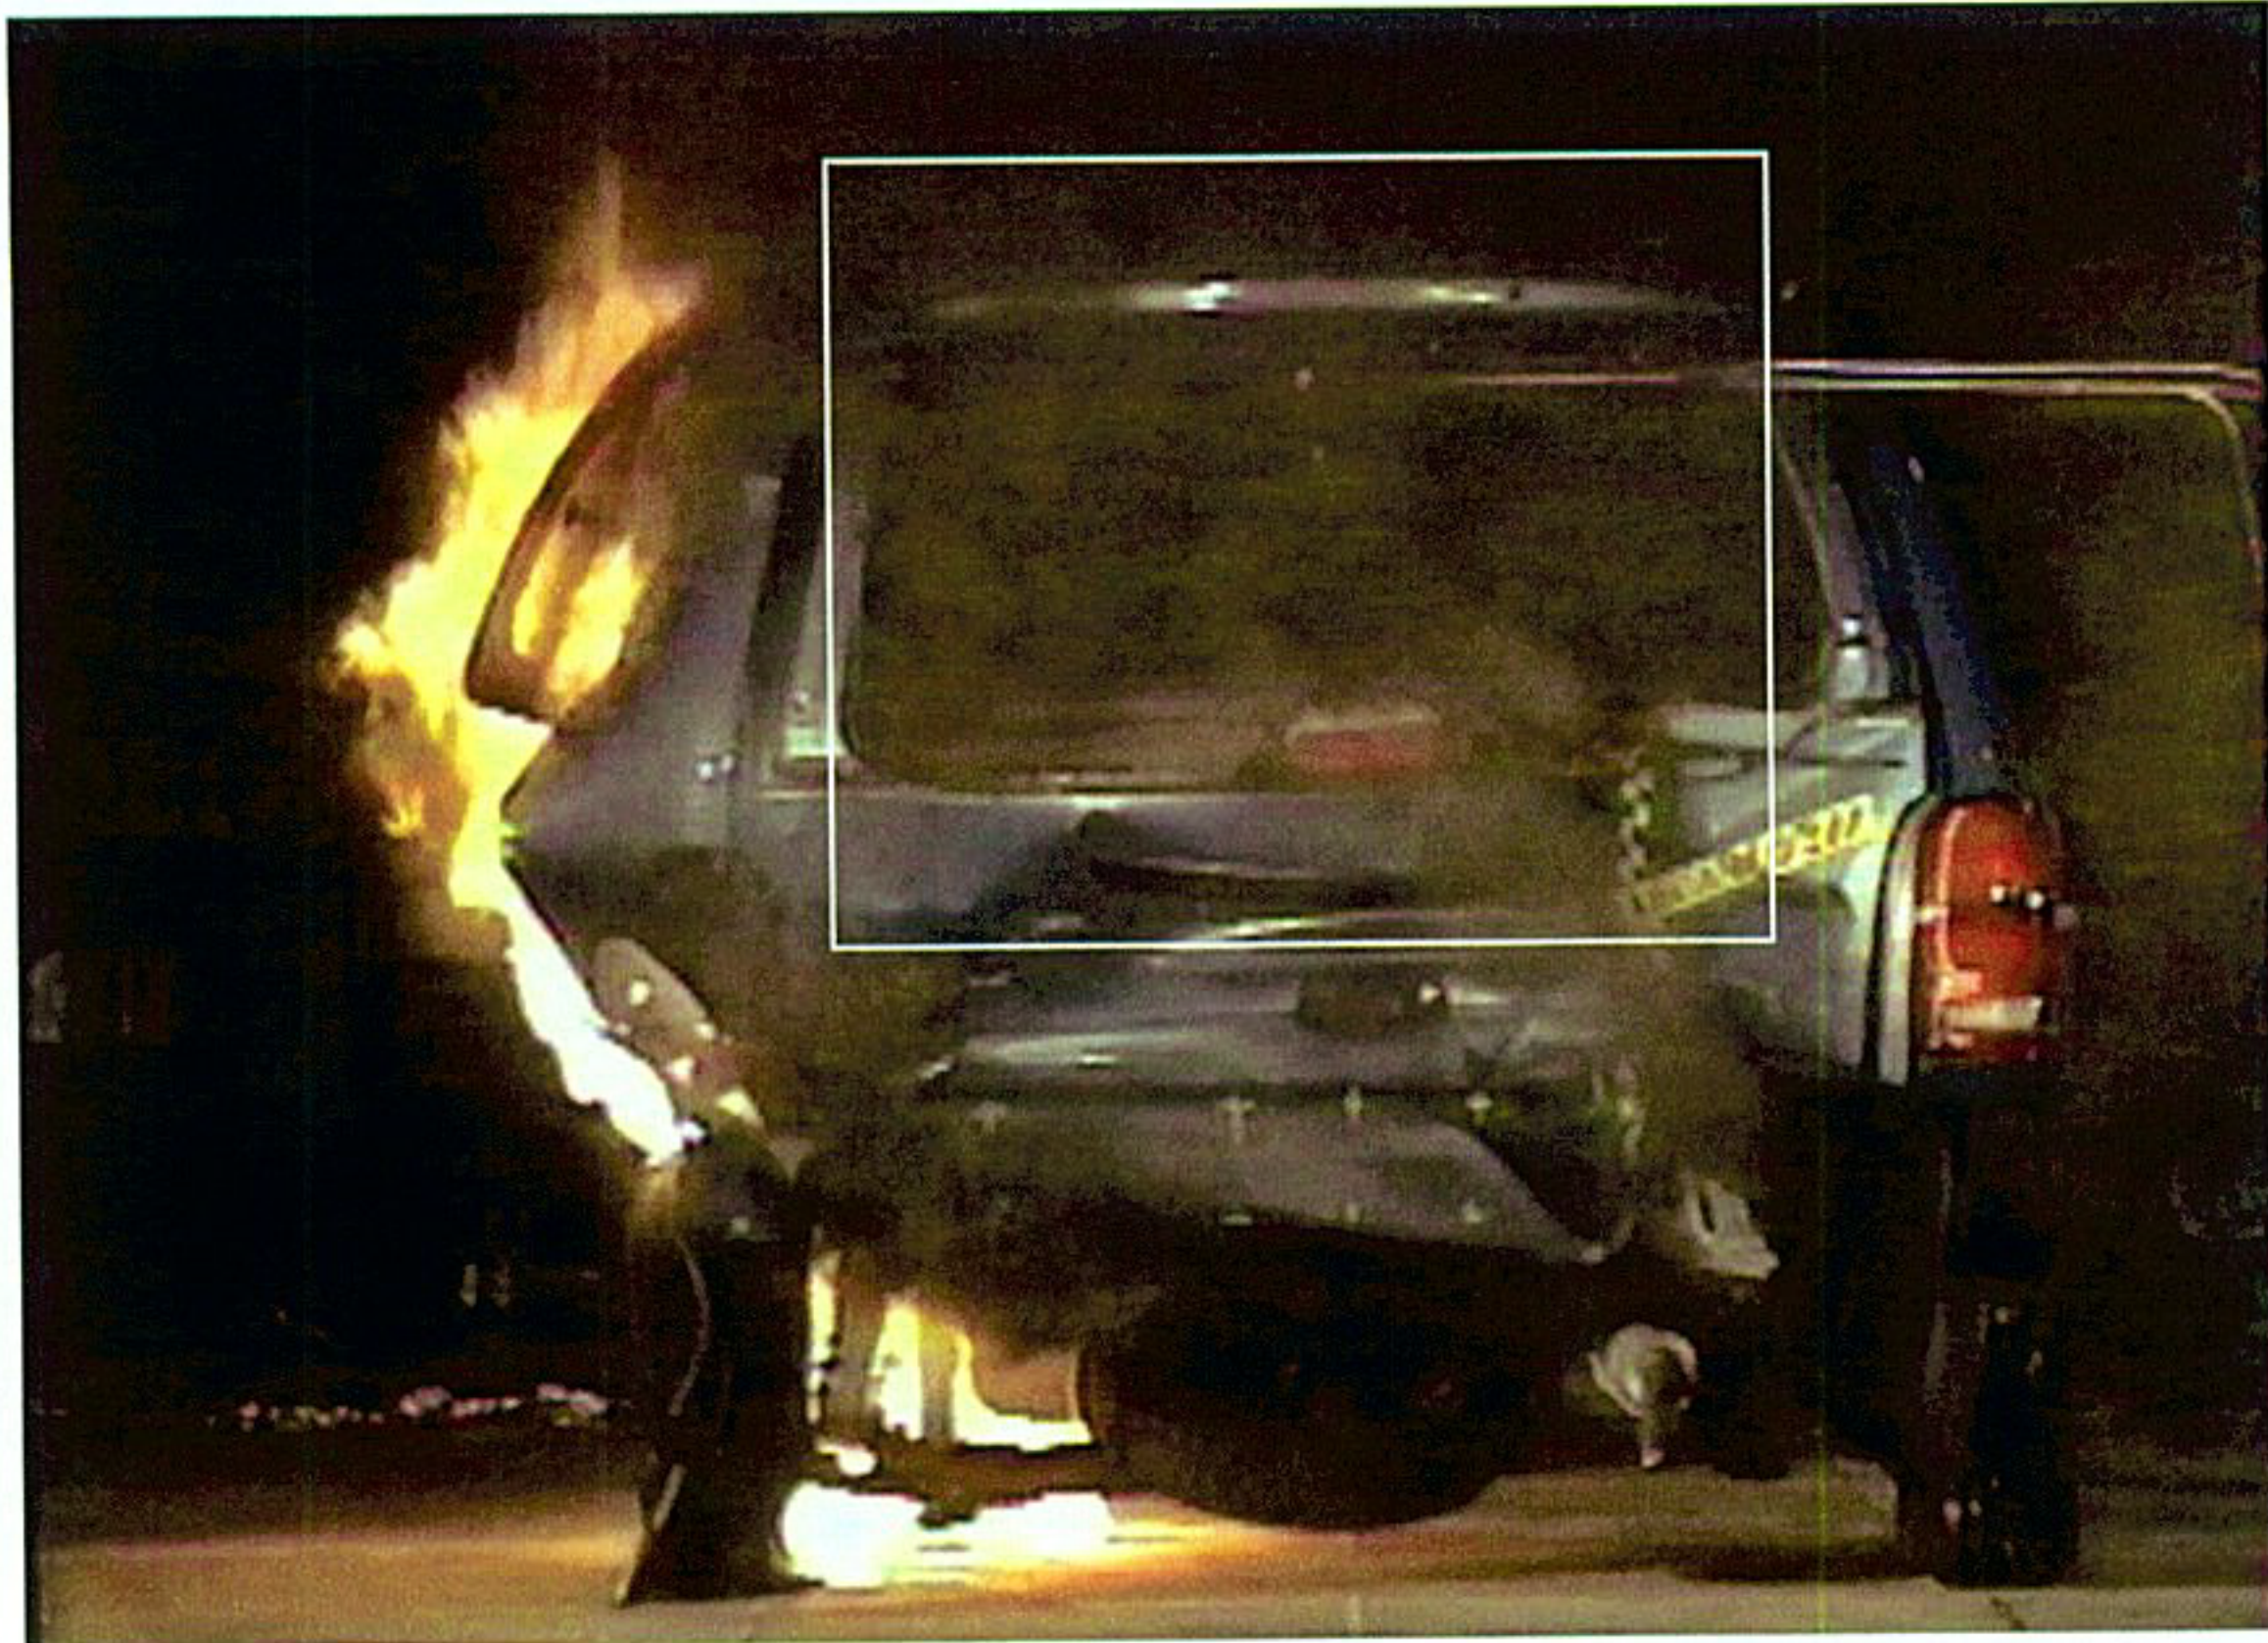
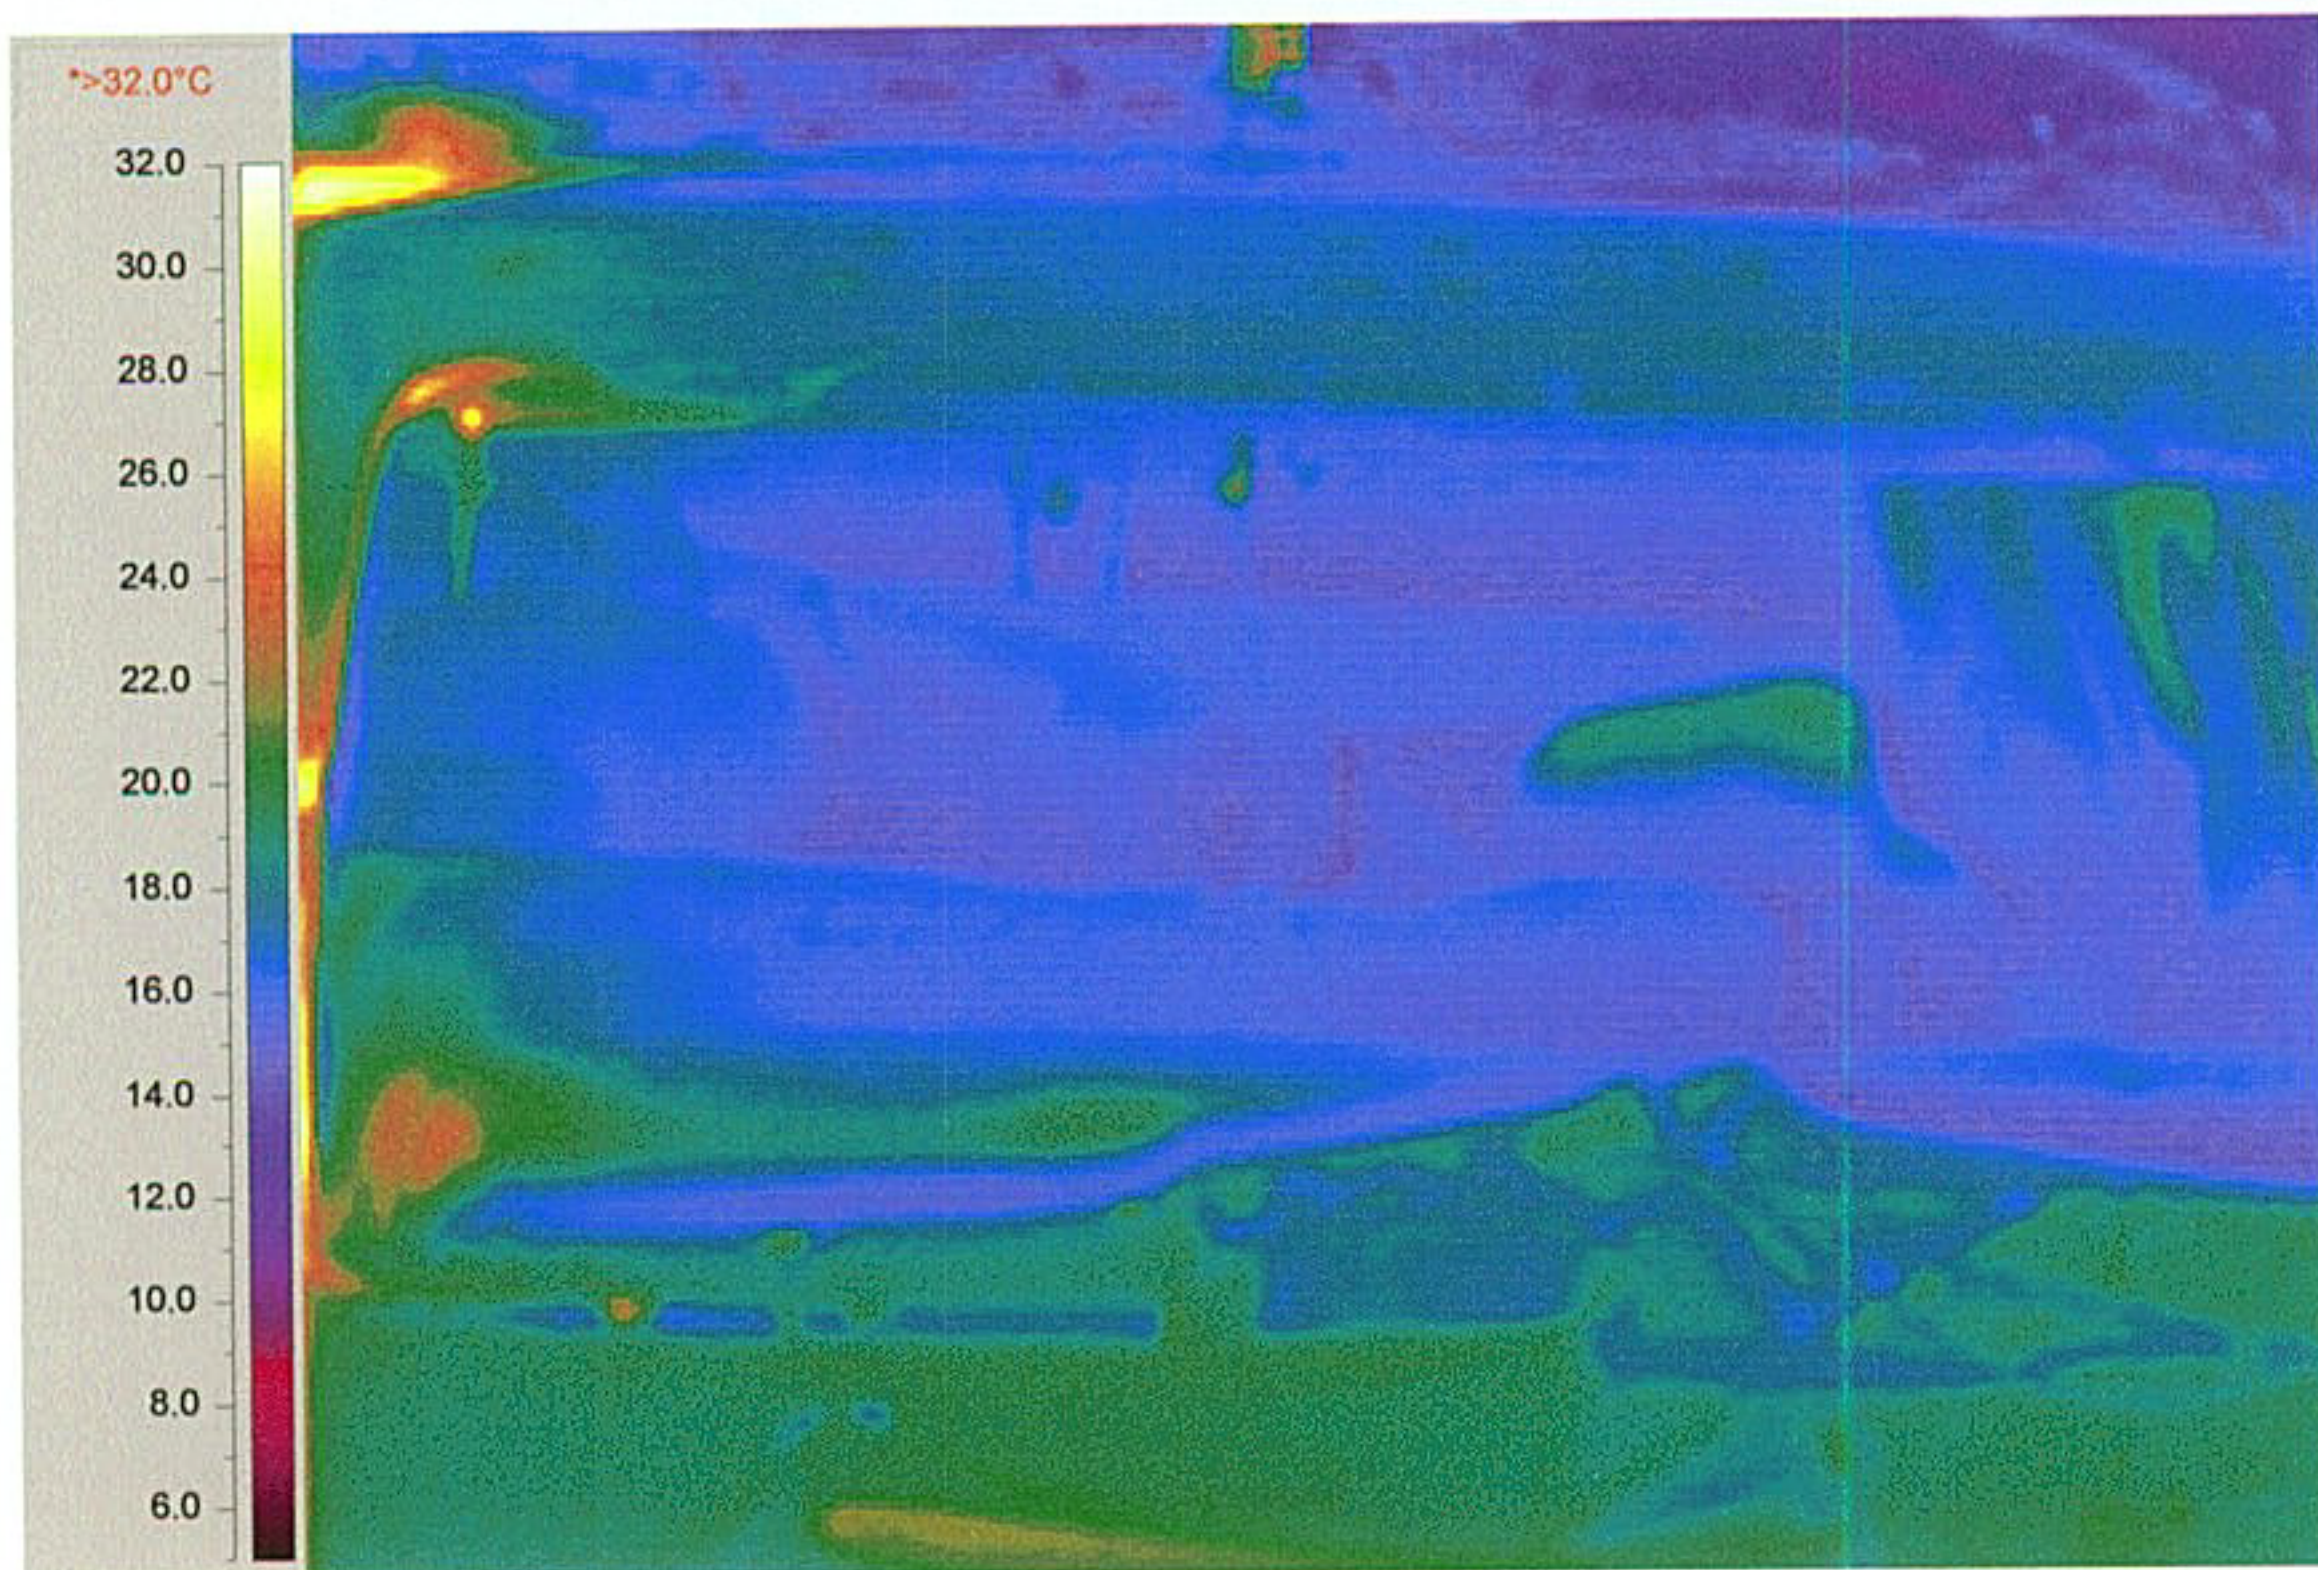
Figure 31. Fire Test F961116. Video stills from Camera 1 (upper) and Infrared Thermogram from IR3 (lower) at 110 seconds post-ignition. The box in the video still shows the approximate field-of-view of IR3.

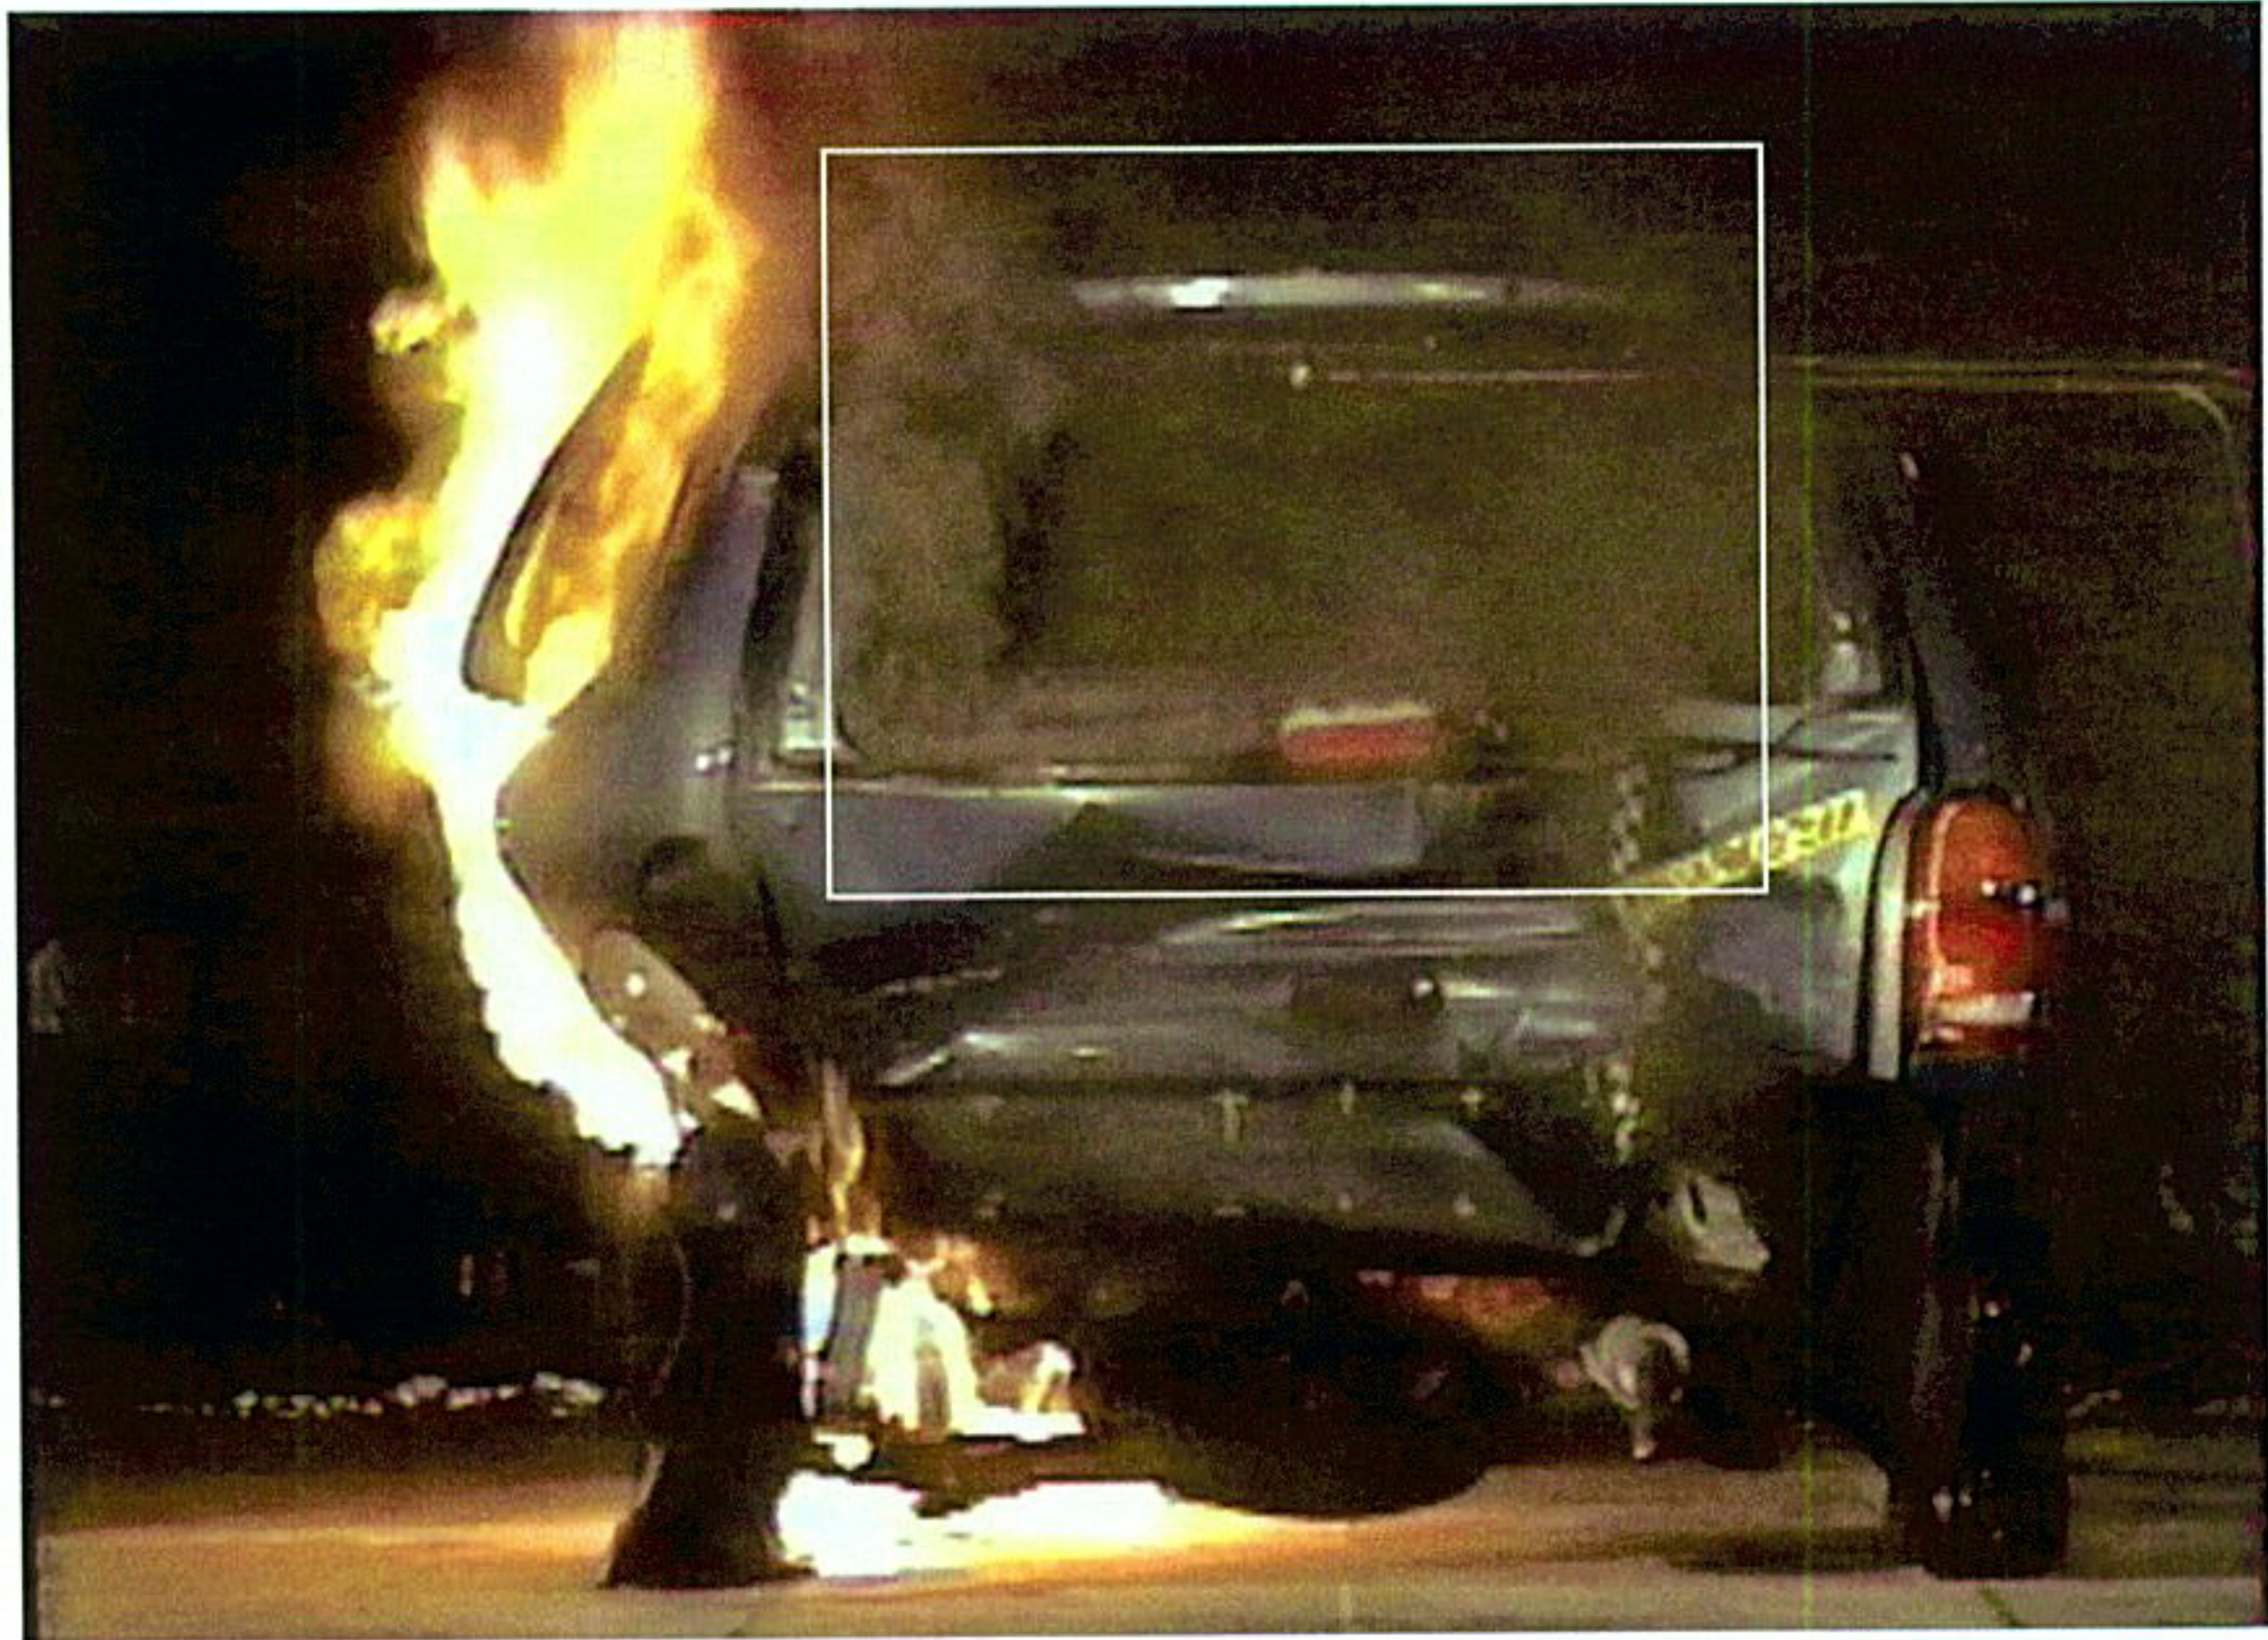
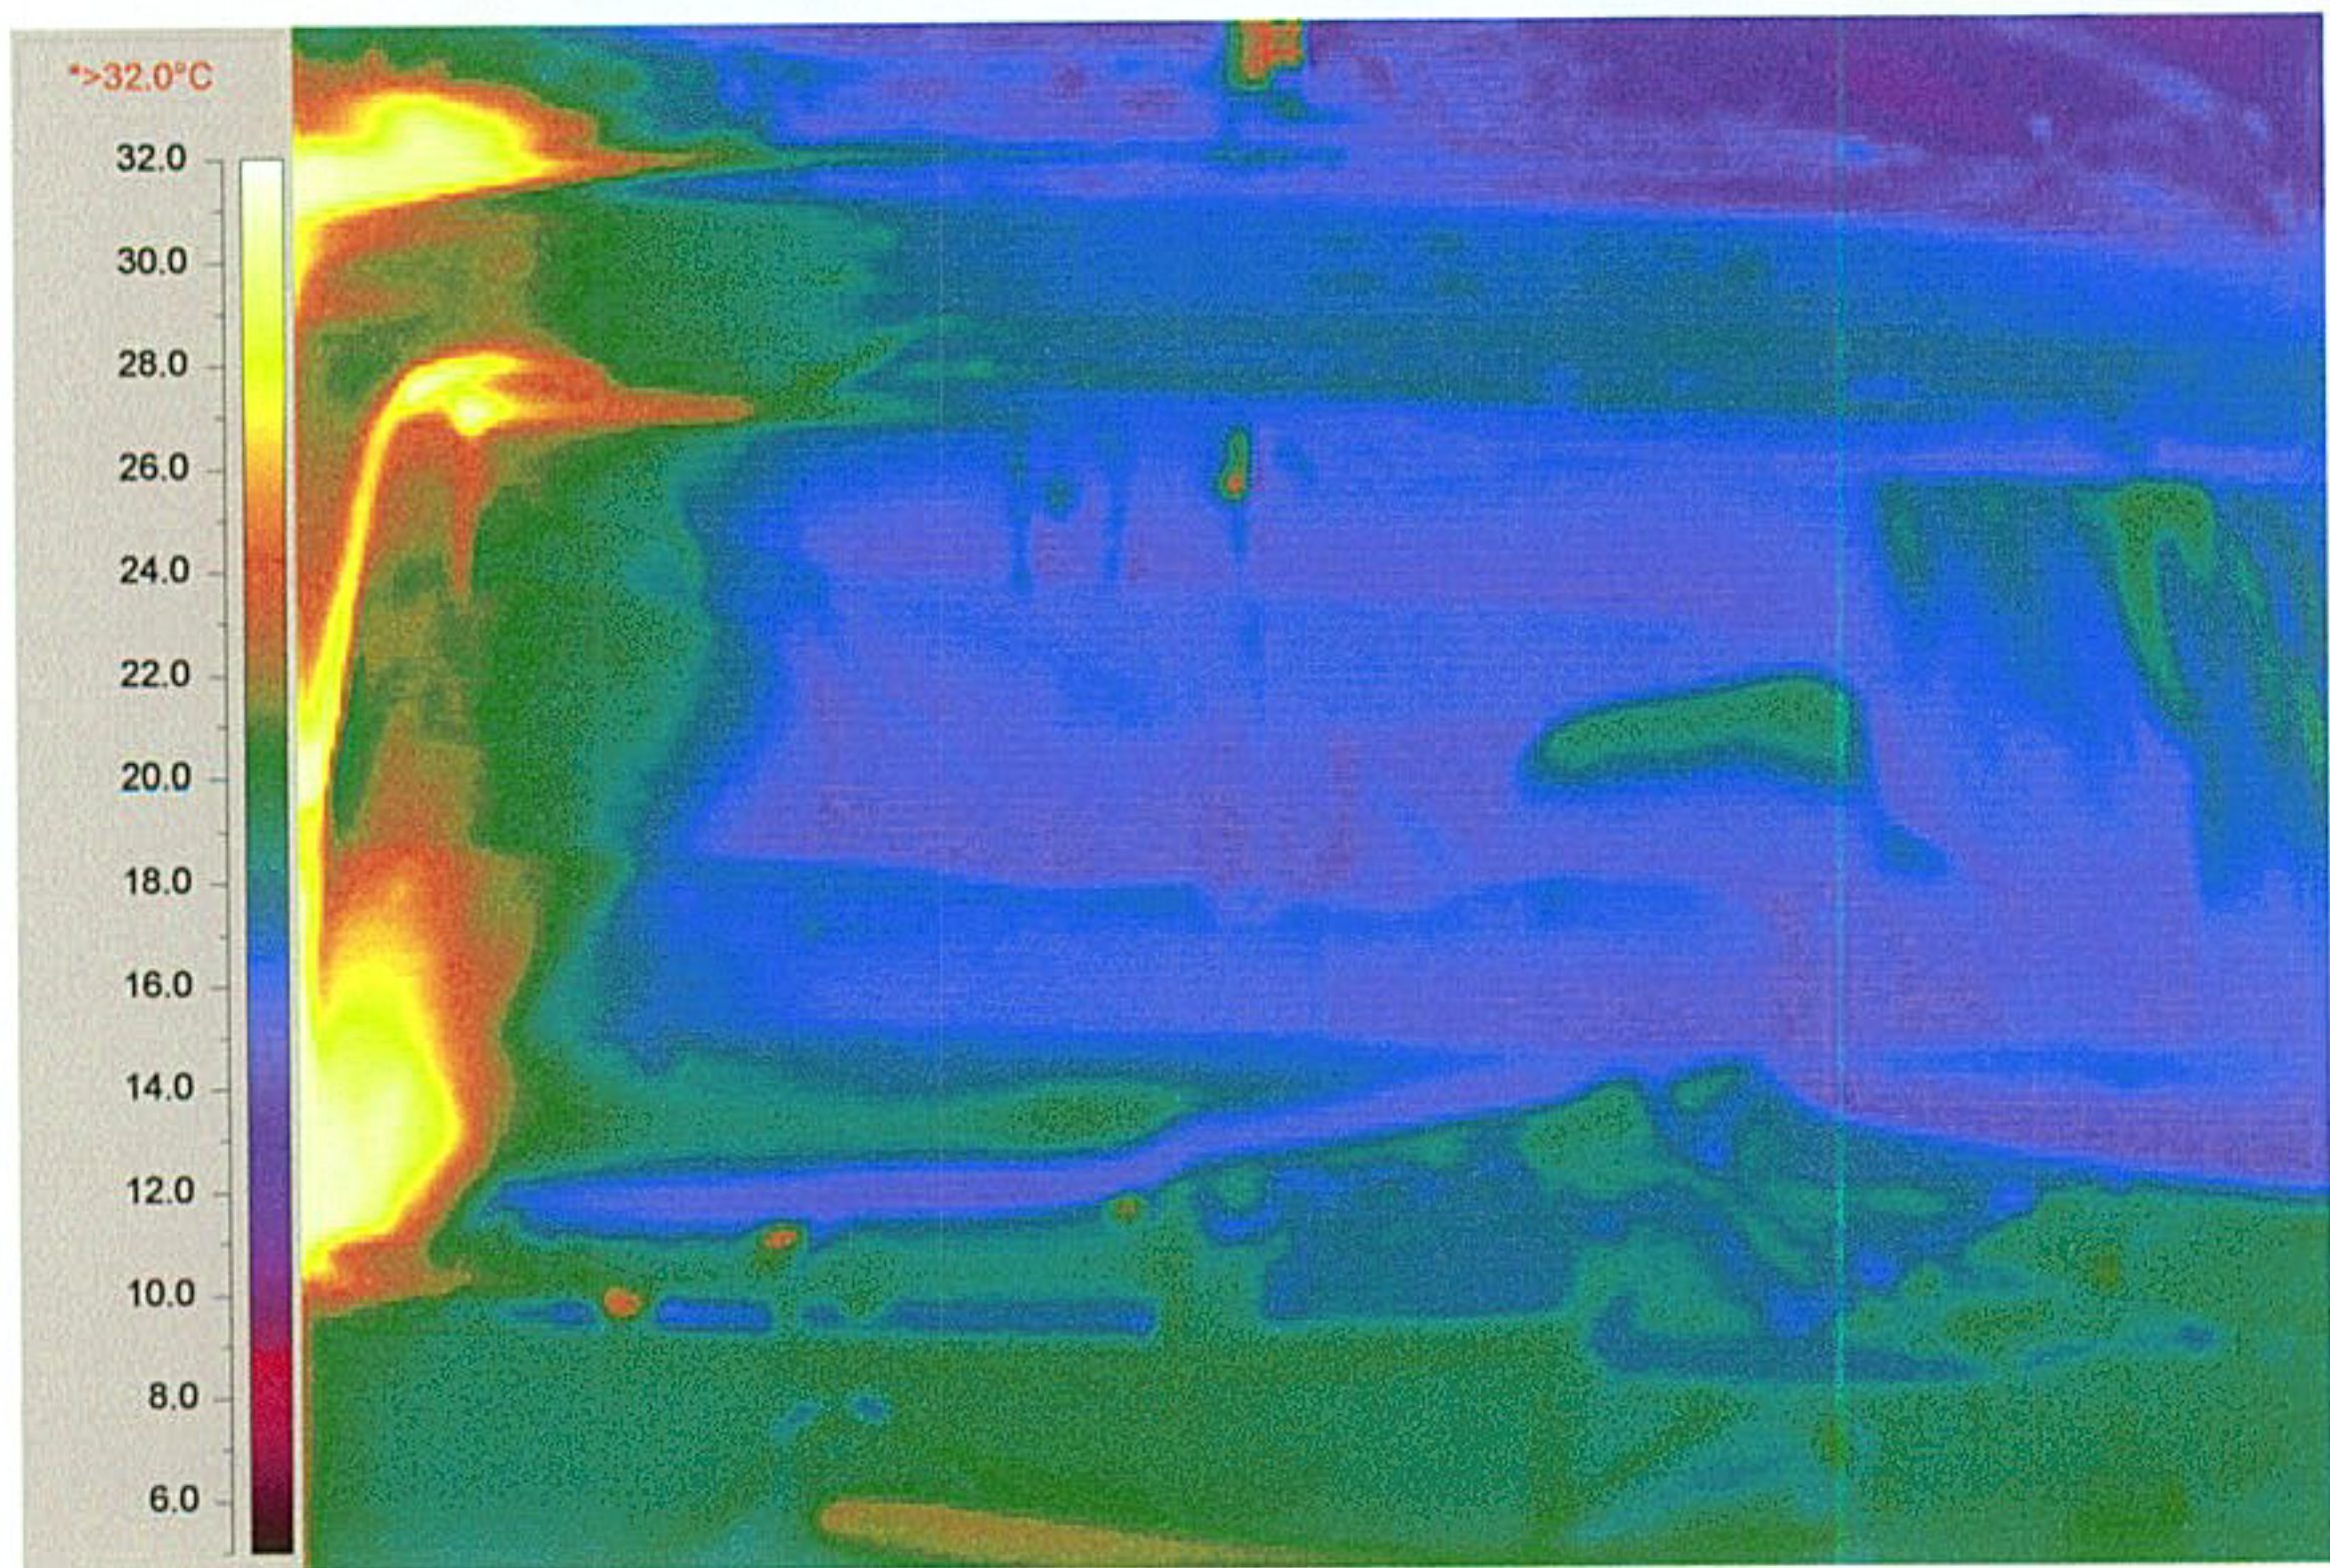
Figure 32. Fire Test F961116. Video stills from Camera 1 (upper) and Infrared Thermogram from IR3 (lower) at 130 seconds post-ignition. The box in the video still shows the approximate field-of-view of IR3.

A thick gray plume of smoke started to emerge from inside the test vehicle between 105 and 110 seconds post-ignition (video still, Fig. 32). The density of the smoke column increased over the next 20 to 25 seconds (Fig. 30) until flames became visible through the left side of the liftgate window between 135 and 140 seconds post-ignition (video still, Fig. 31). The temperature of the upper left corner of the second bench seat back and left edge of the liftgate window opening increased from approximately 24°C to greater than 32°C between 120 and 130 seconds post-ignition – before a fire plume was visible (Infrared thermogram, Fig. 32). The rate of heating of these objects increased rapidly once a fire plume started to emerge from the lower left rear corner of the test vehicle (Fig.'s 33 and 34).
