Enclosed is a final report prepared by Jeffrey Santrock of General Motors Corporation, entitled, "Evaluation of Motor Vehicle Fire Initiation and Propagation Part 4: Propagation of an Underbody Gasoline Pool Fire in a 1996 Passenger Van."

**Evaluation of Motor Vehicle Fire Initiation and Propagation
Part 4: Propagation of an Underbody Gasoline Pool Fire in a 1996
Passenger Van**

Jeffrey Santrock
General Motors Corporation

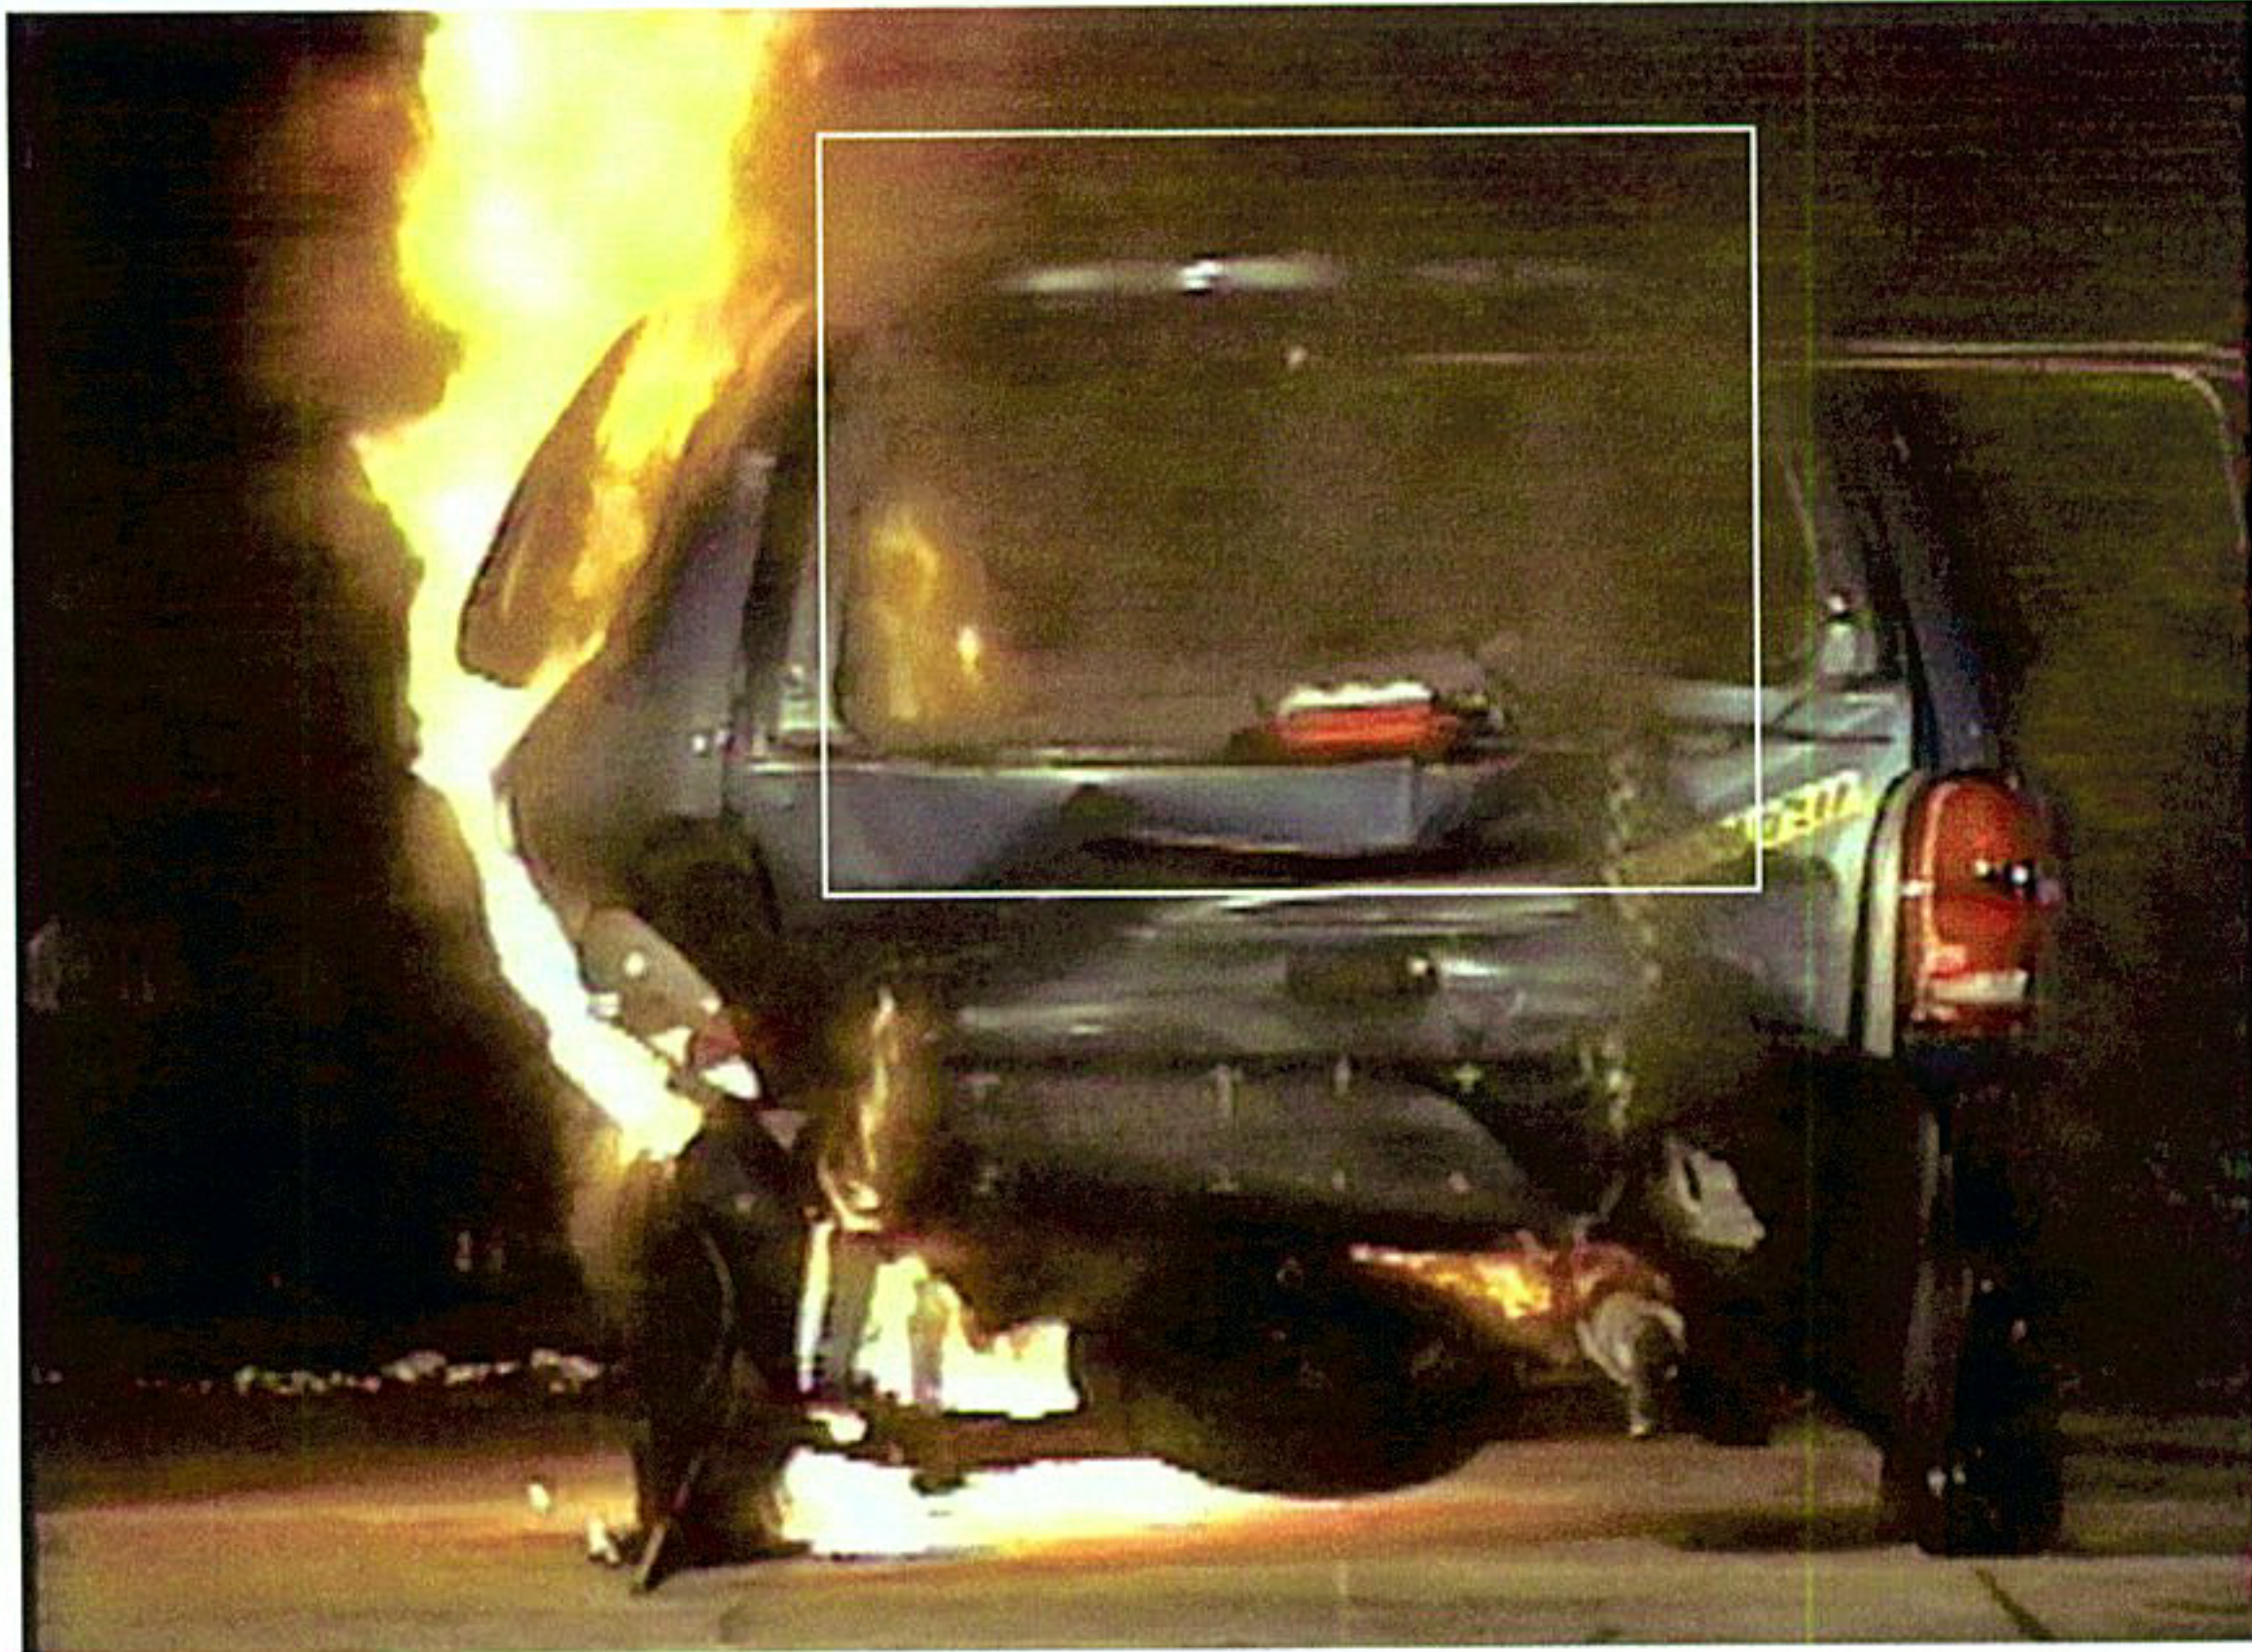
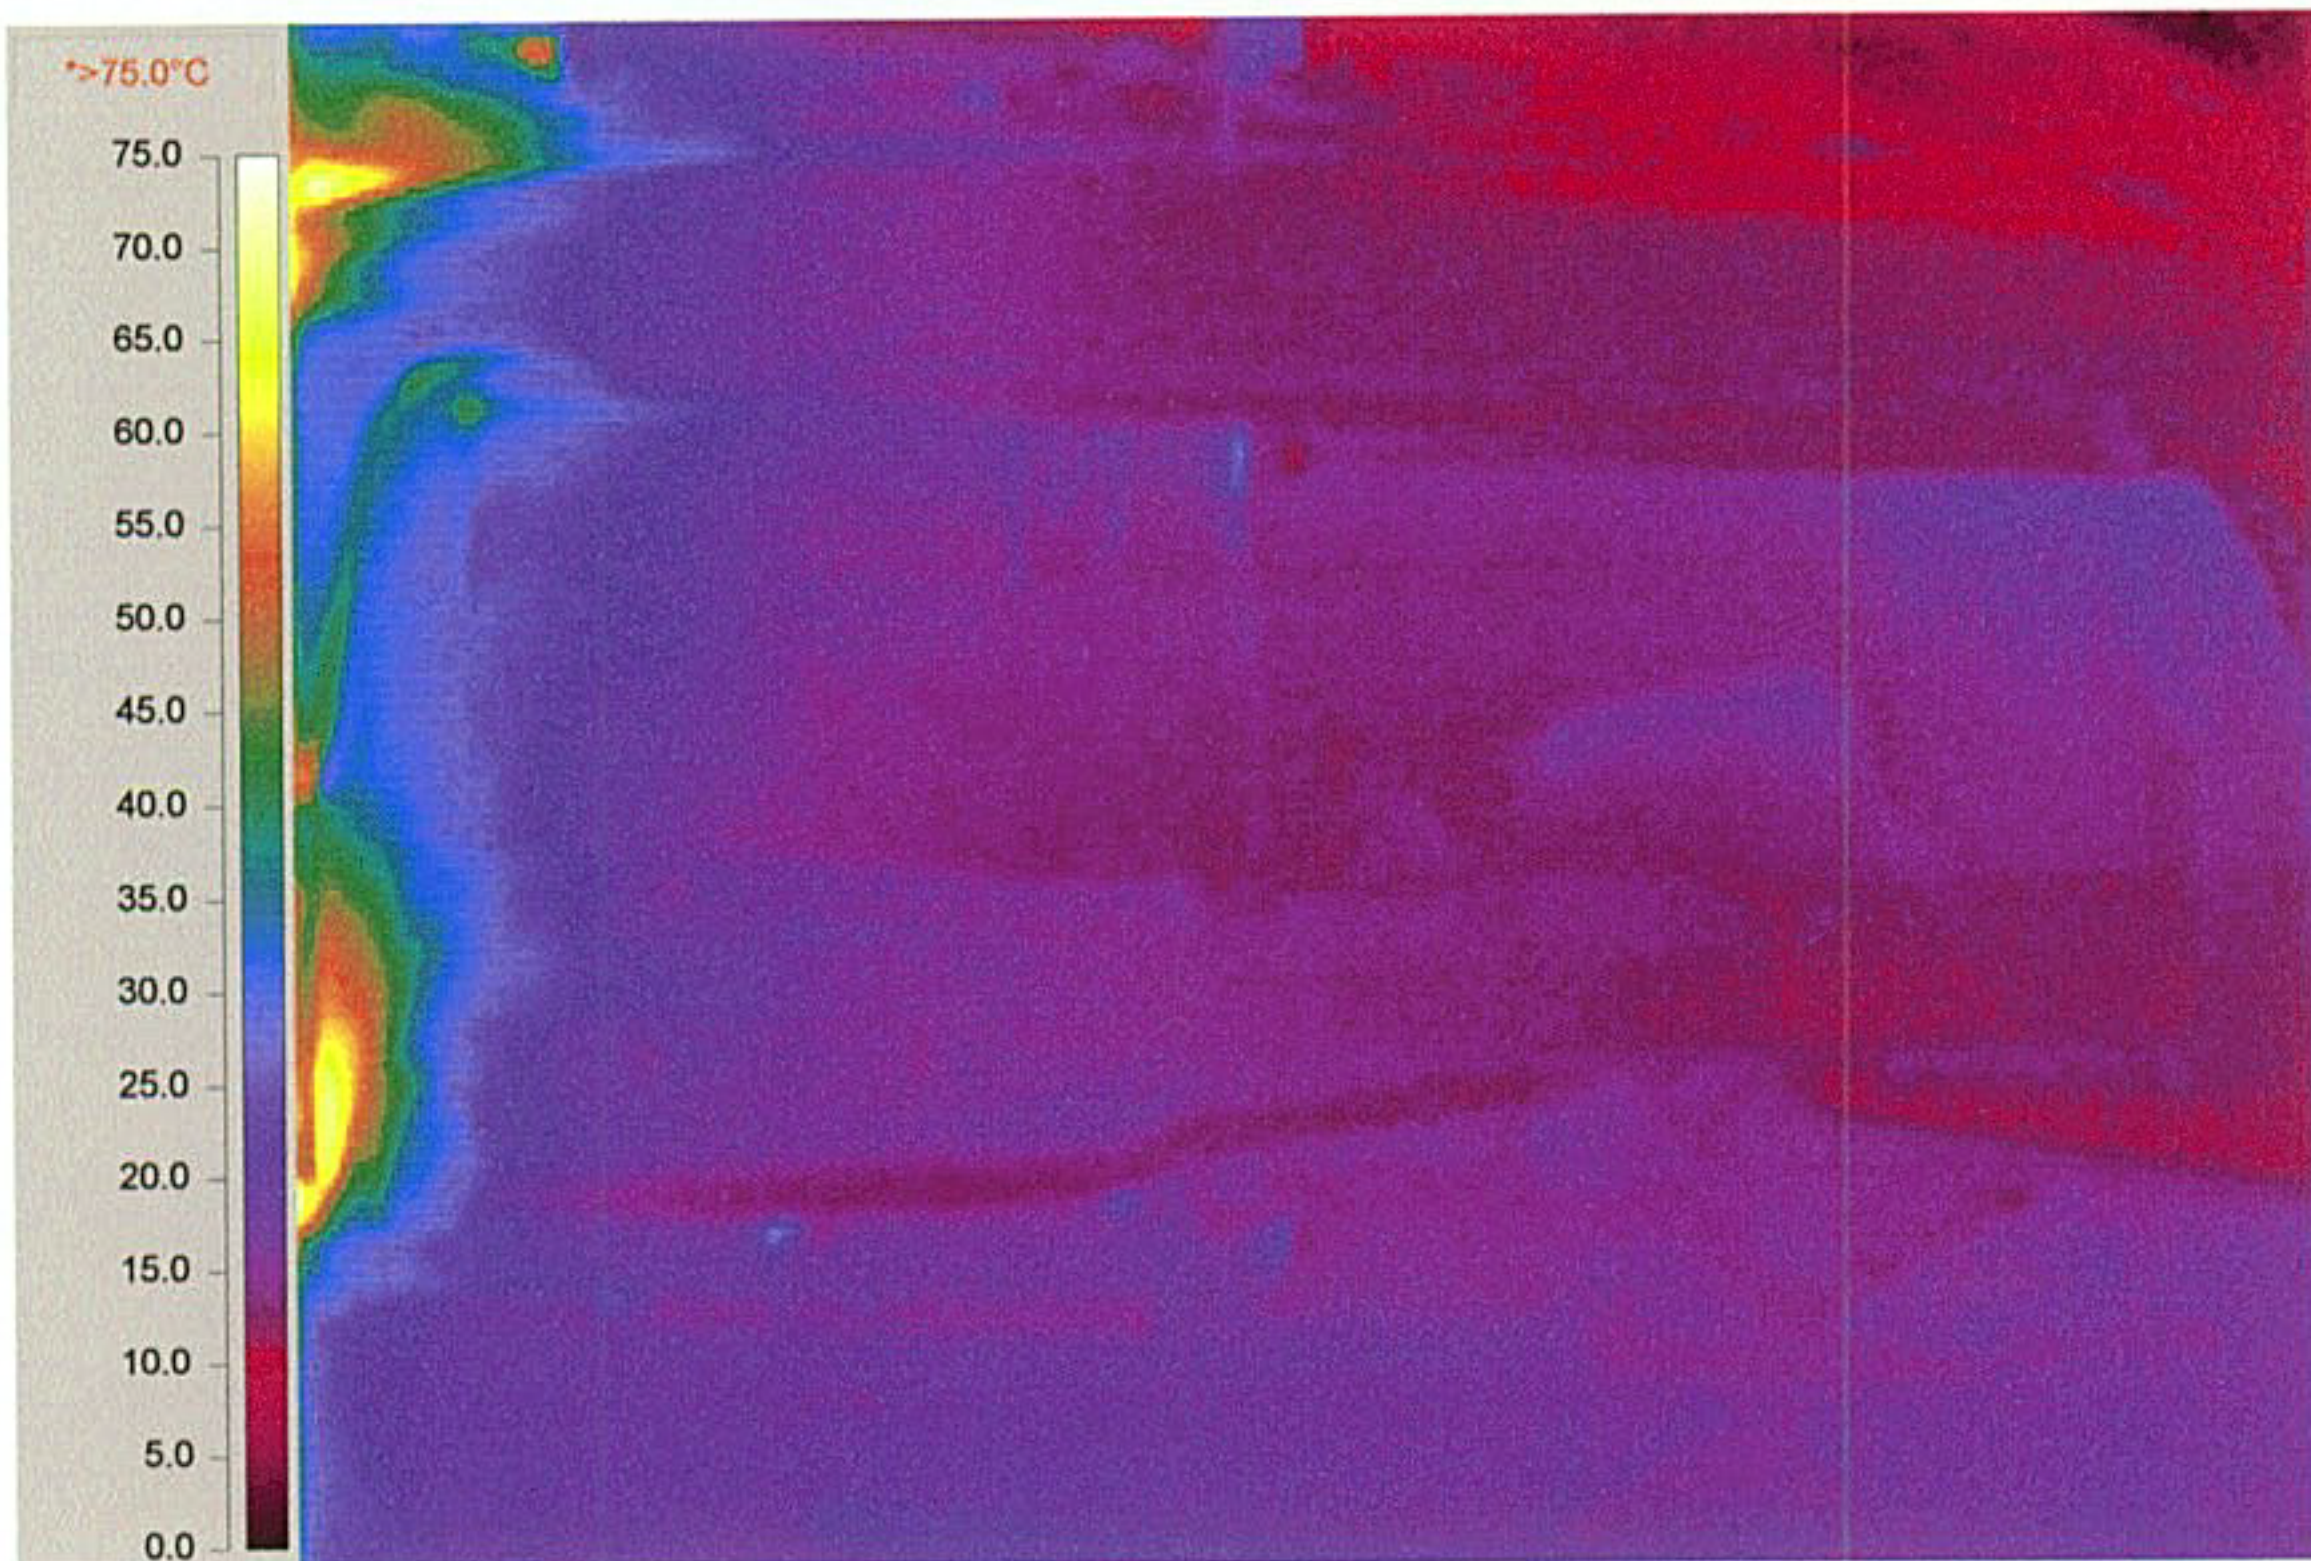
Figure 33. Fire Test F961116. Video stills from Camera 1 (upper) and Infrared Thermogram from IR3 (lower) at 155 seconds post-ignition. The box in the video still shows the approximate field-of-view of IR3. Note the change in temperature scale in the thermogram.

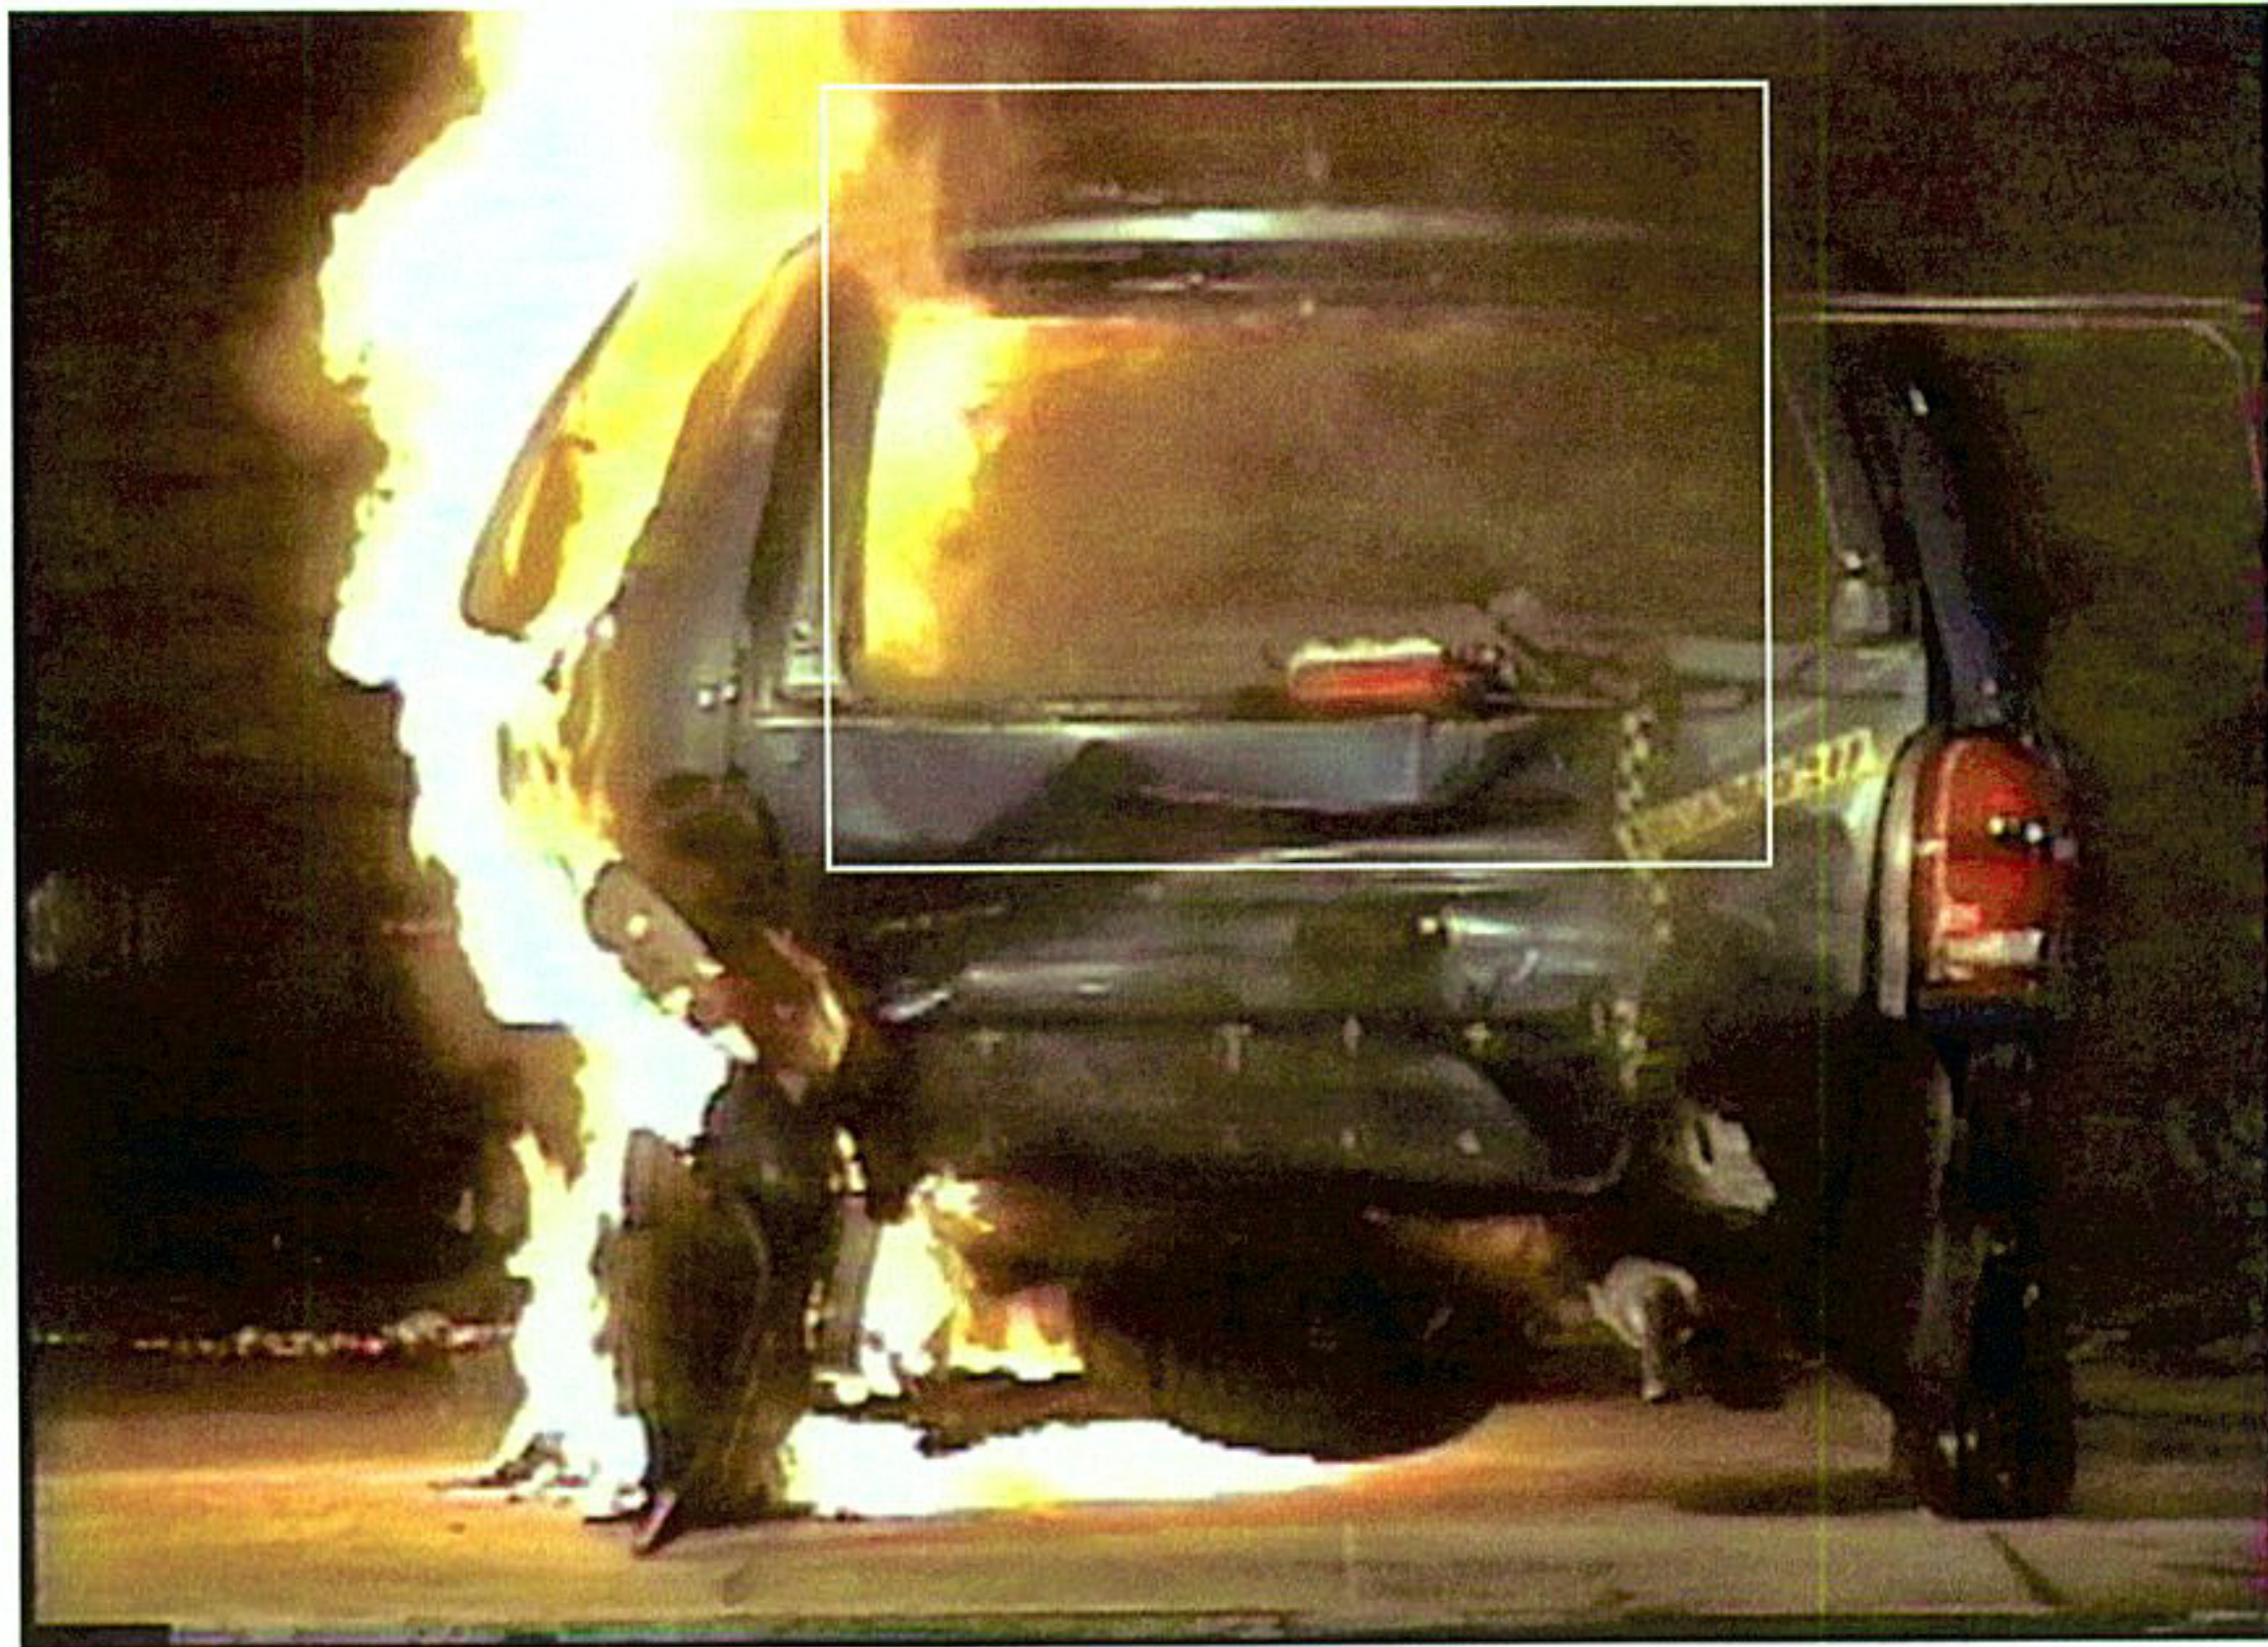
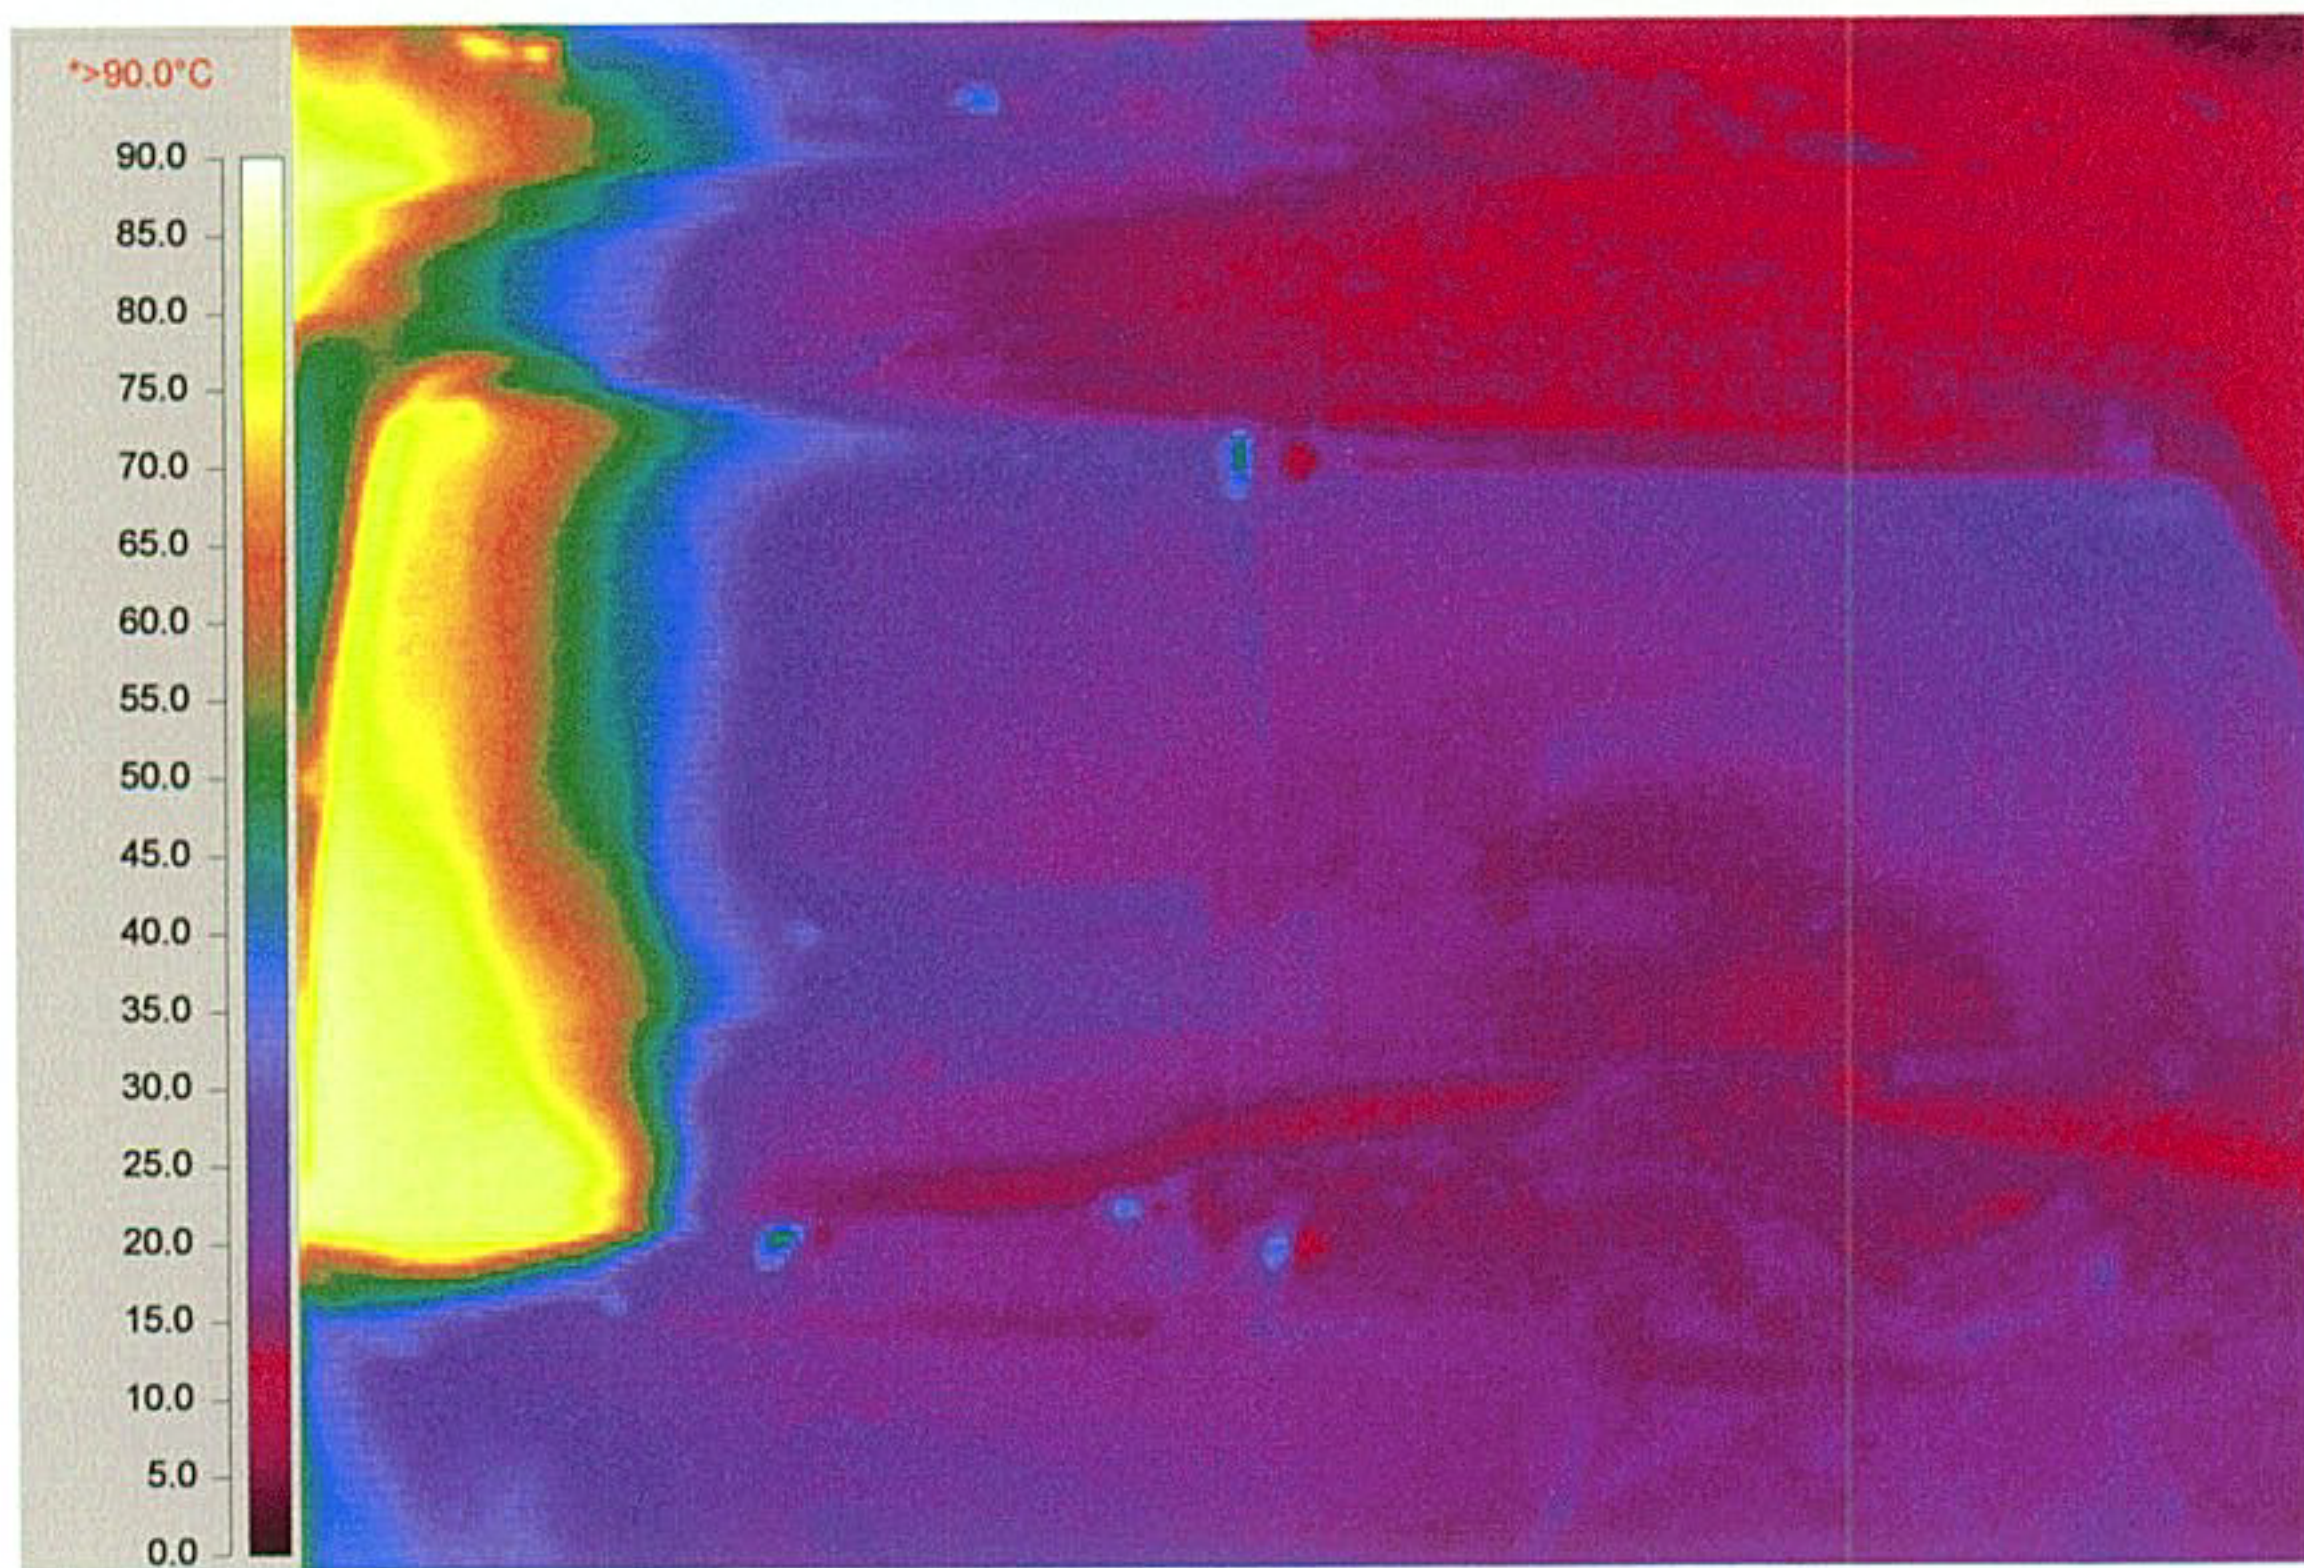
Figure 34. Fire Test F961116. Video stills from Camera 1 (upper) and Infrared Thermogram from IR3 (lower) at 175 seconds post-ignition. The box in the video still shows the approximate field-of-view of IR3. Note the change in temperature scale in the thermogram.

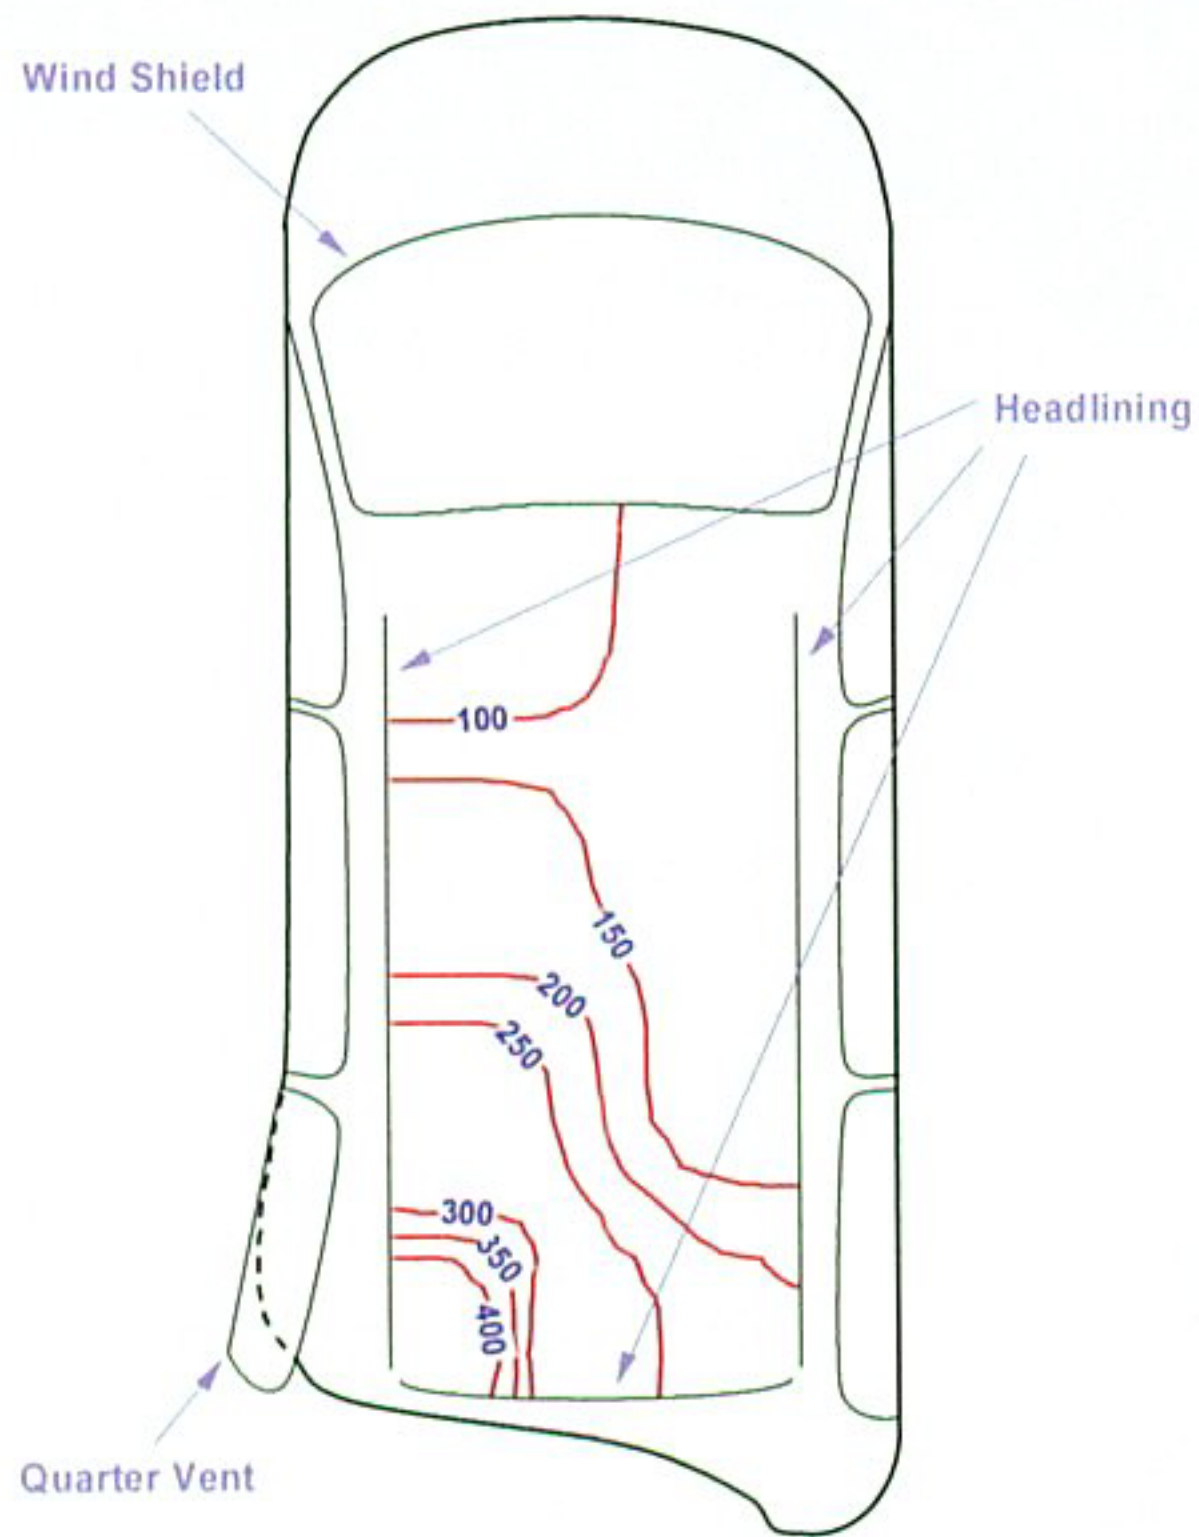
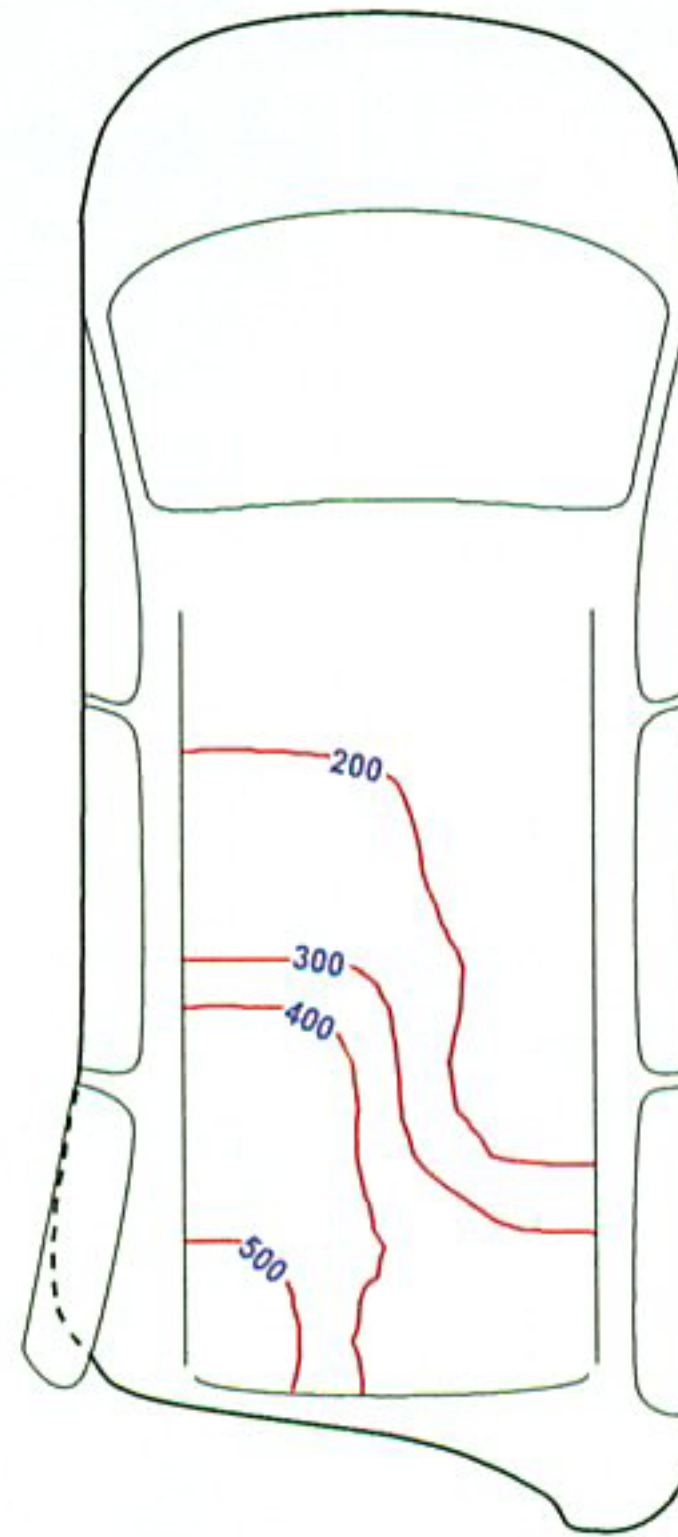
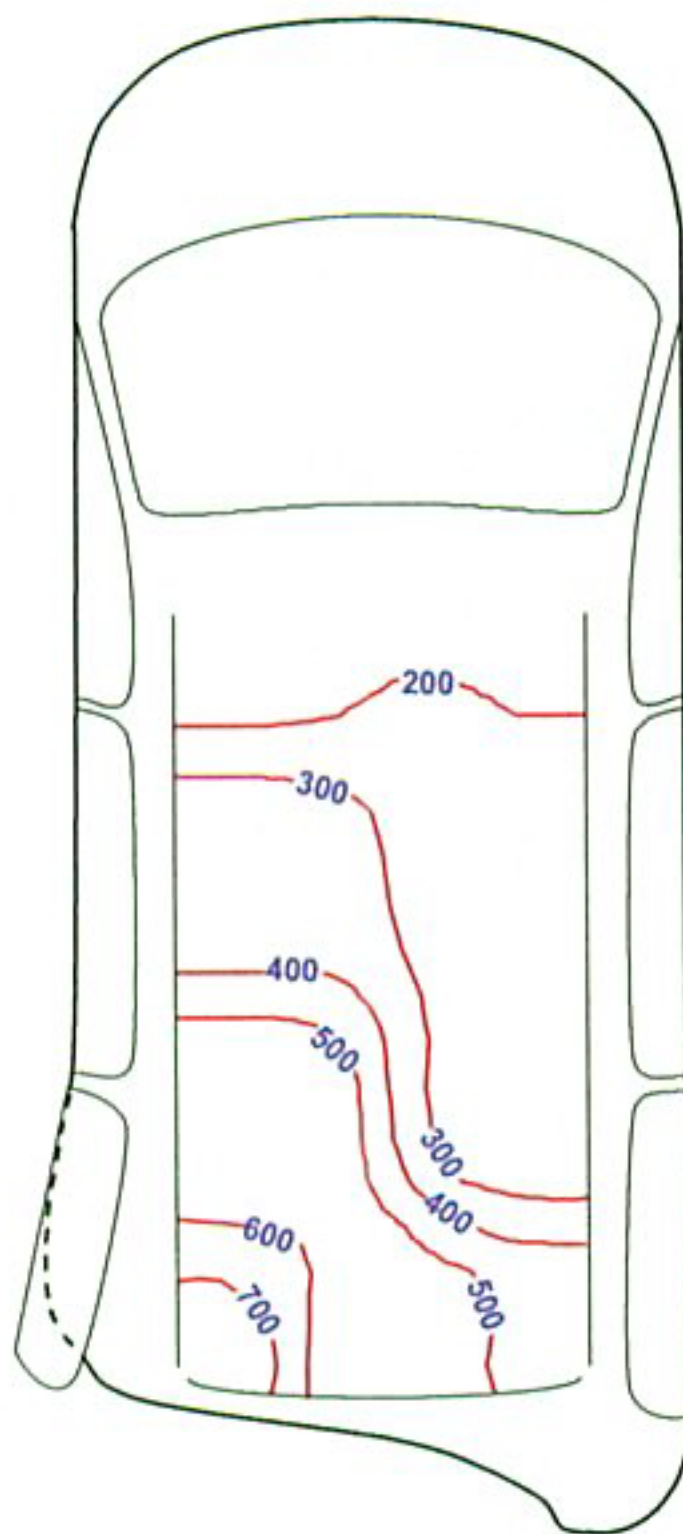
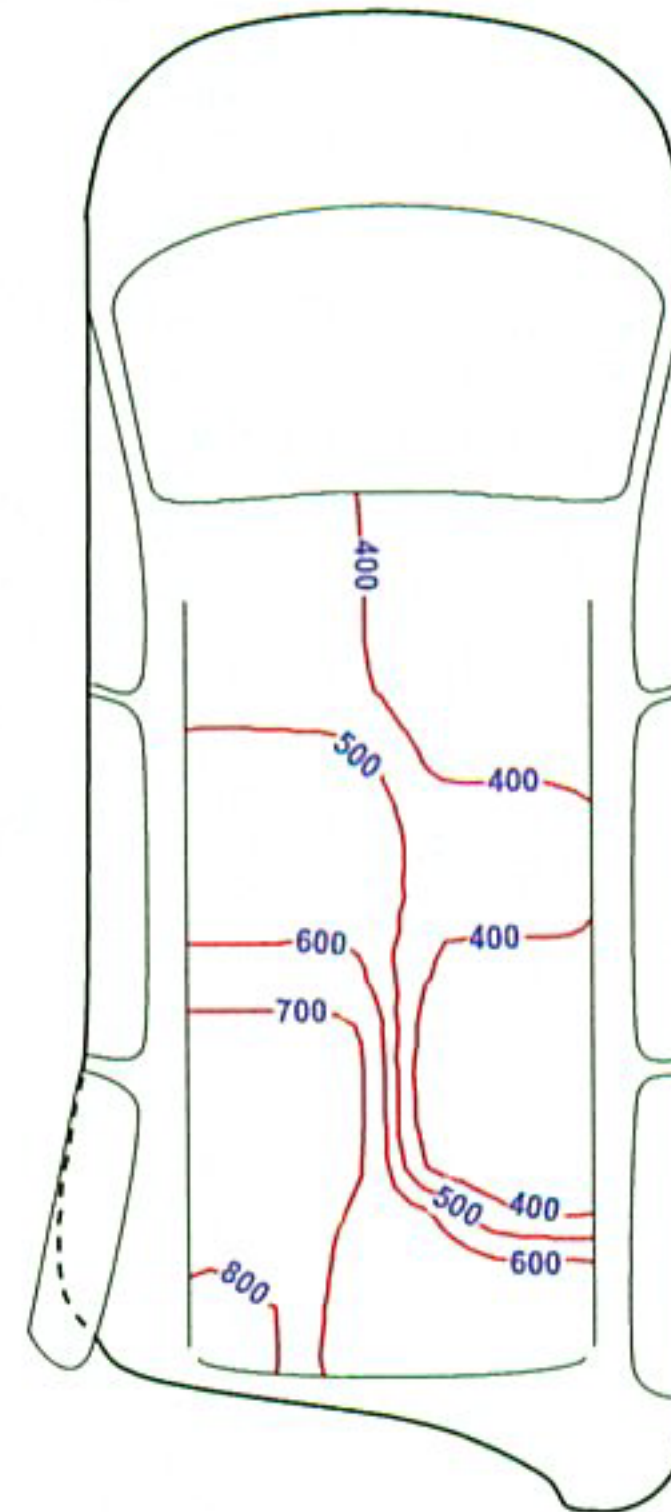
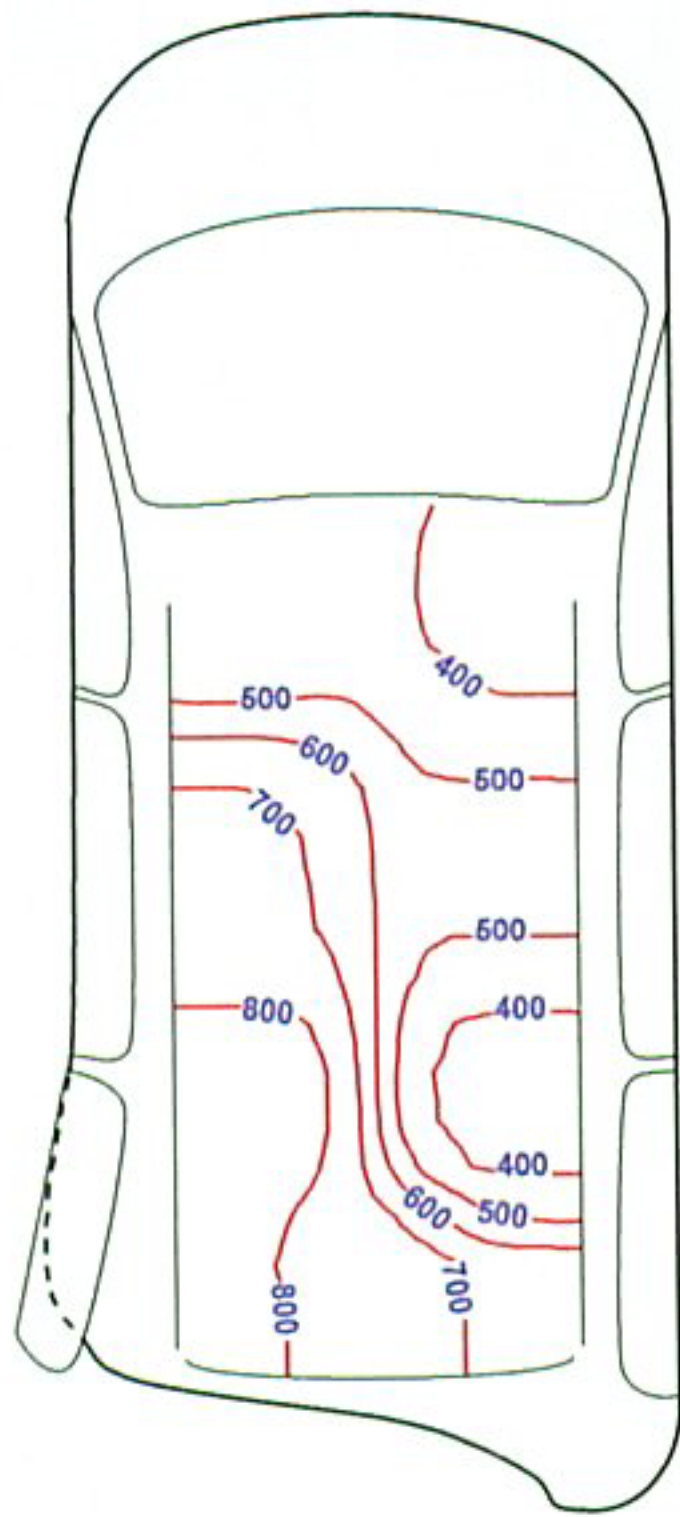
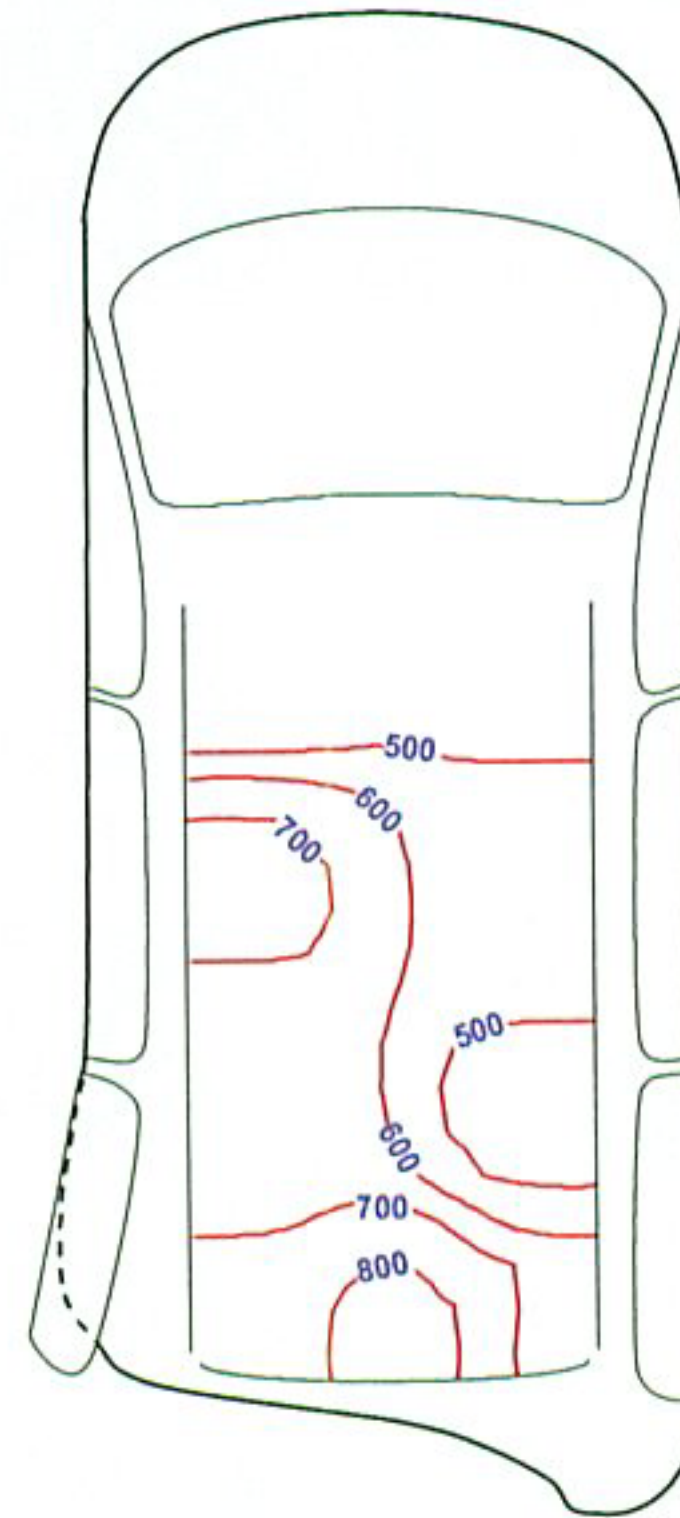
Figure 35. Fire Test F961116. Isothermal contour plots showing temperature profiles along the lower surface of the headlining estimated from the responses of the A-thermocouples.
