Enclosed is a final report prepared by Jeffrey Santrock of General Motors Corporation, entitled, "Evaluation of Motor Vehicle Fire Initiation and Propagation Part 4: Propagation of an Underbody Gasoline Pool Fire in a 1996 Passenger Van."

**Evaluation of Motor Vehicle Fire Initiation and Propagation
Part 4: Propagation of an Underbody Gasoline Pool Fire in a 1996
Passenger Van**

Jeffrey Santrock
General Motors Corporation

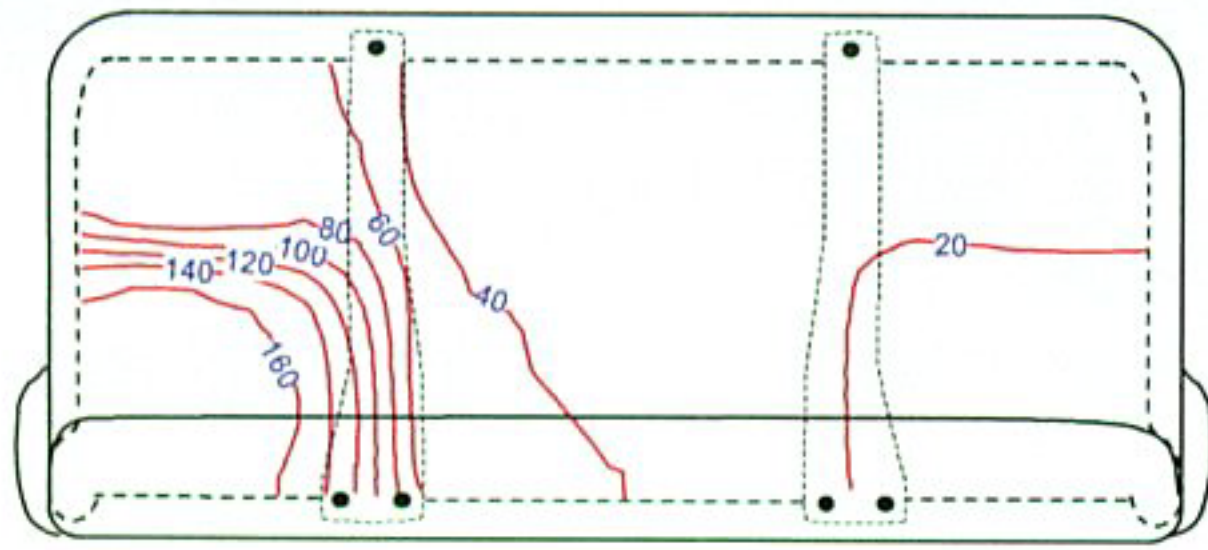
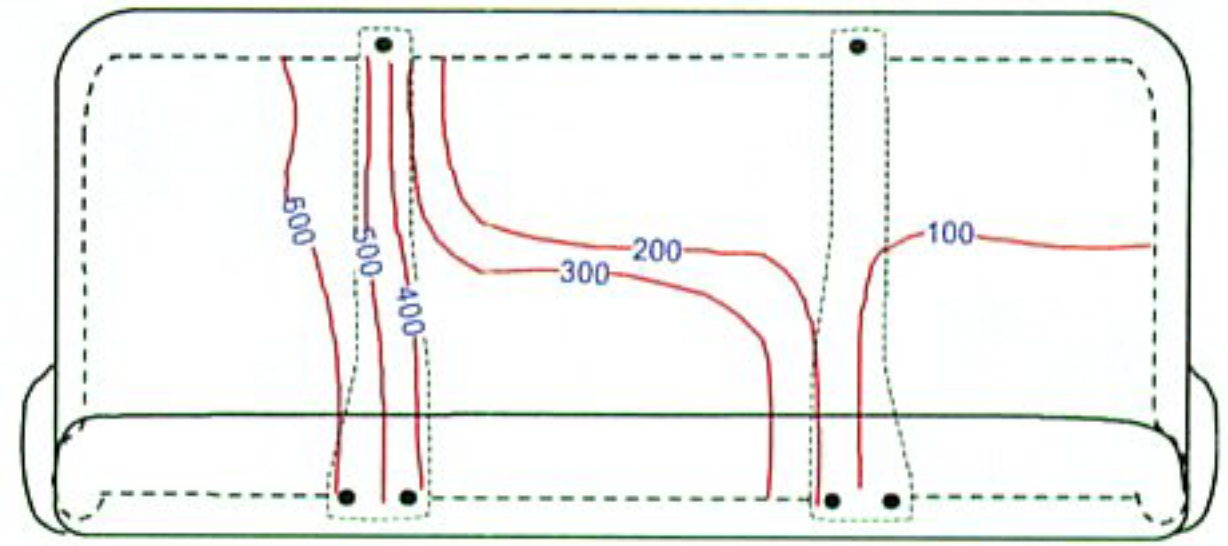
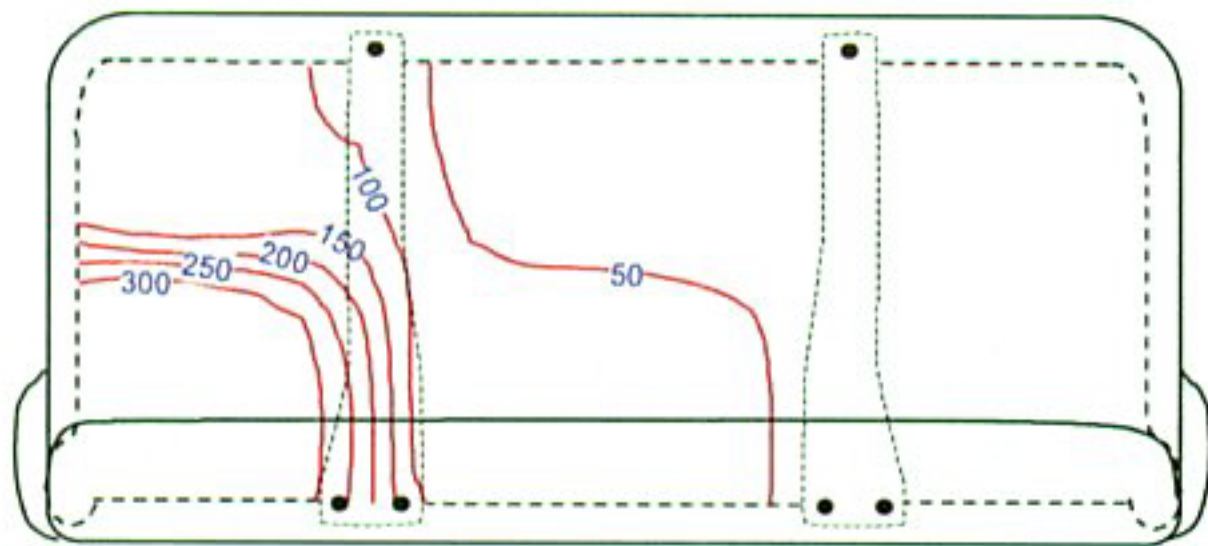
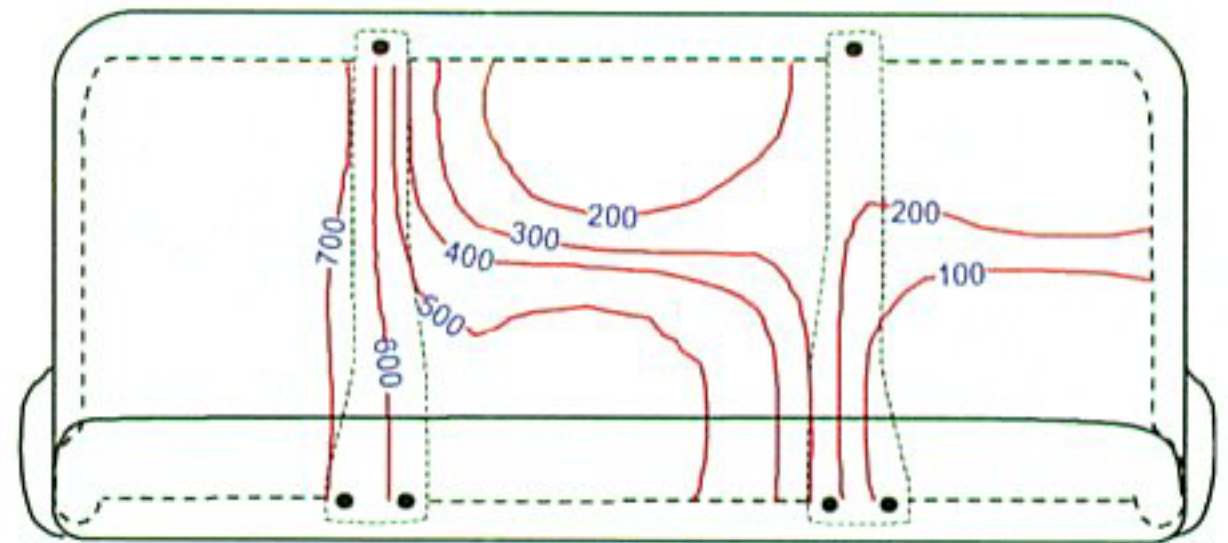
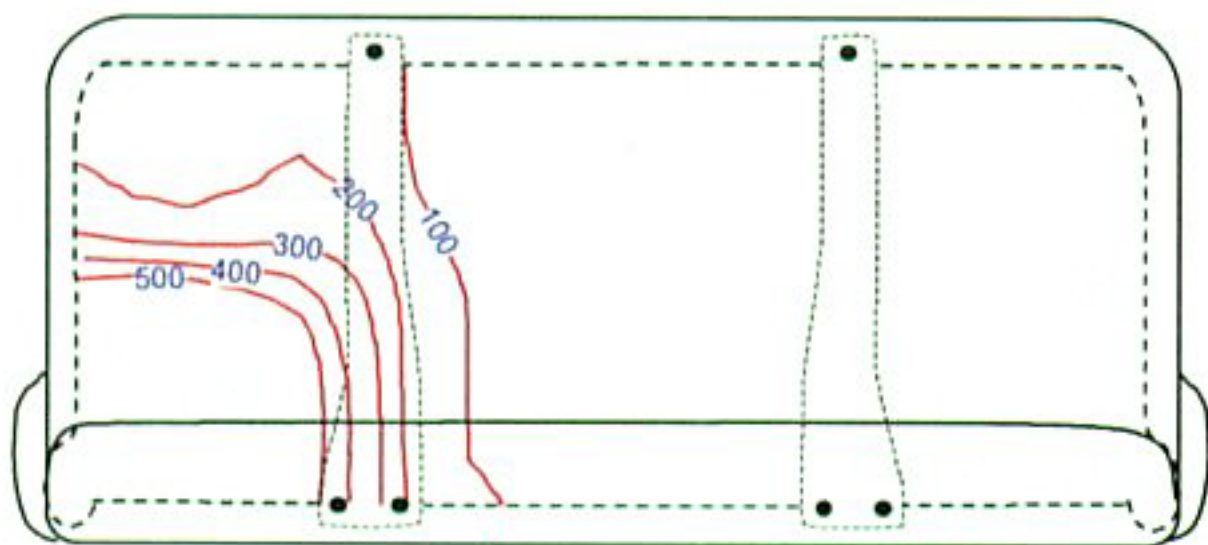
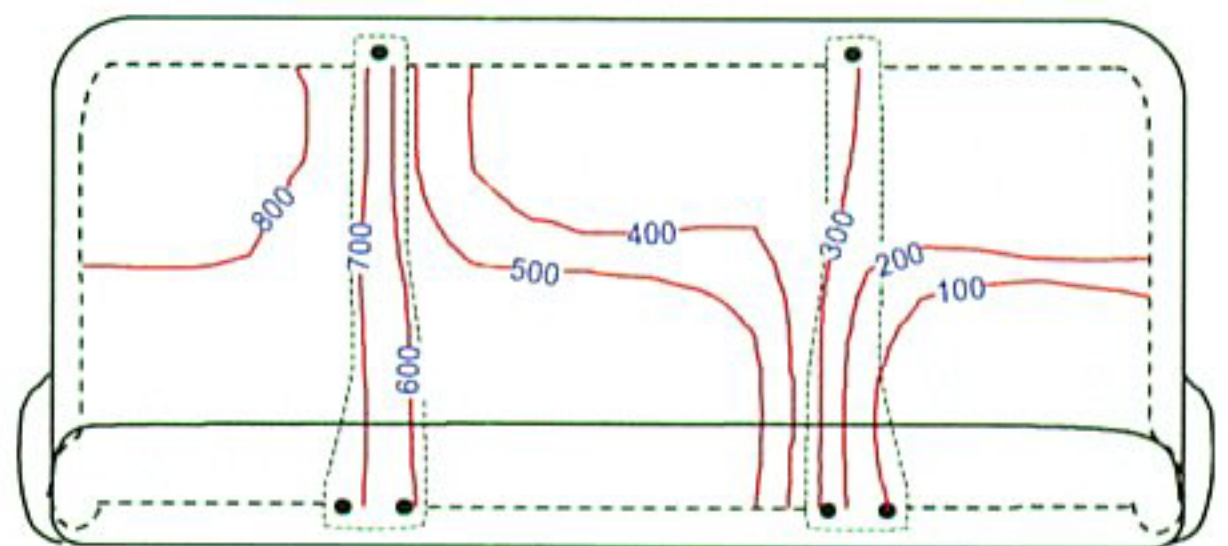
Isothermal contours estimated from thermocouple data gave a clearer indication of time of ignition and rate of flame spread. Figure 38 shows a series of diagrams of the second bench seat with estimated isothermal contours of the temperature along the lower surface of the seat cushion. The isothermal contour plots in these diagrams are projected through the seat cushion.

Figure 38. Fire Test F961116. Diagrams showing isothermal contours along the lower surface of the foam pad in the second bench seat cushion between 100 and 170 seconds post-ignition. The view in these diagrams is from the top of the bench seat looking down through the seat cushion.

Figure 40 is a photograph of the under-side of the second bench seat removed from the test vehicle after this fire test. The pattern of smoke and fire damage observed on the lower surface of the foam pad in the seat cushion is consistent with the pattern of flame-spread inferred from the estimated isothermal contours shown in Figure 38. Inspection of the seat revealed that material was eroded from lower surface of the foam pad¹⁵ along the central (between the risers) and left (outboard of the left riser) sections¹⁶ of the seat cushion (Fig. 40). Deposits of brown and black soot were observed evident on the right section. The isothermal contour plots in Figure 38 suggest that flames spread along the lower surface of the seat cushion up to the left riser by 170 seconds post-ignition. Smoke and gases produced in the fire plume spread to the right along the central and right sections of the seat cushion. The estimated temperatures along the central section of the seat cushion (Fig. 38) were greater than the thermal decomposition temperature of

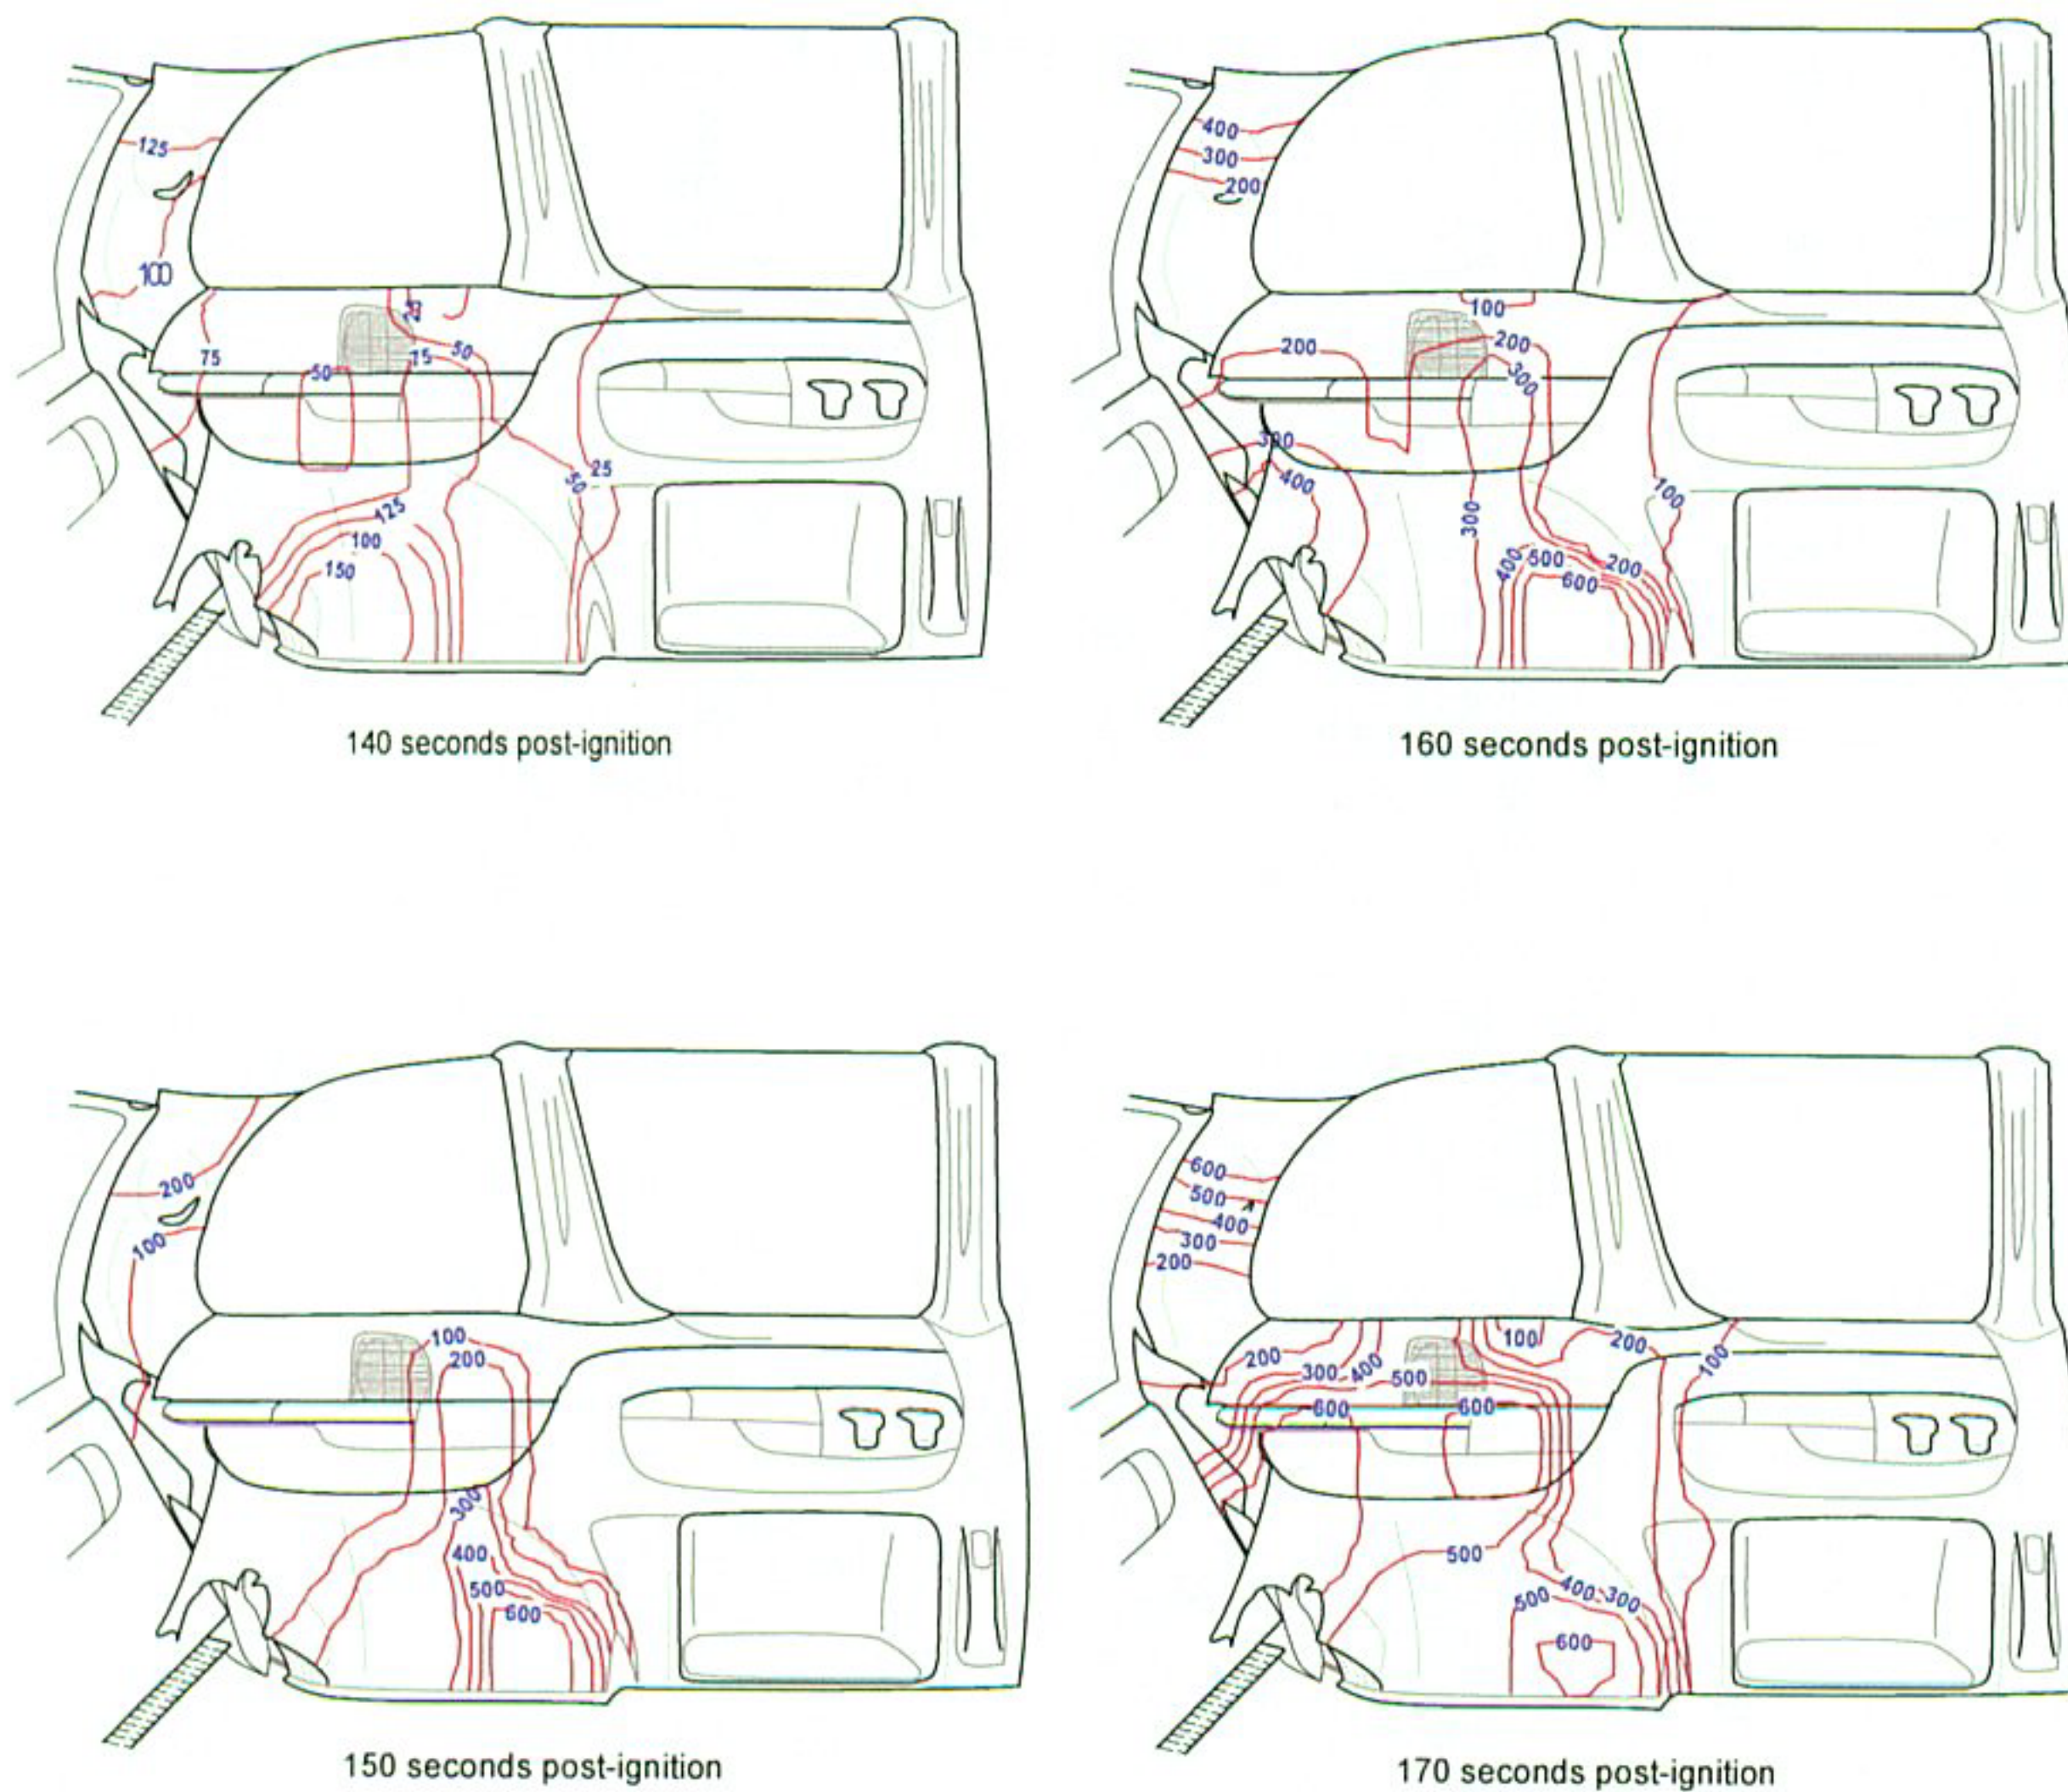
Figure 41 contains a series of four diagrams showing the left side of the test vehicle interior. The isothermal contours¹⁷ in these diagrams indicate that the interior (exposed) surfaces of the left quarter trim panel, the left bolster, and the left D-pillar trim were burning by 170 seconds post-ignition. Hot gas entering the split spot weld seams around the wheelhouse was heating the upper section of the D-pillar trim and the lower edge of the left quarter trim panel along the wheelhouse at 140 seconds post-ignition. By 150 seconds post-ignition, flame temperatures (i.e., temperatures $\geq 600^{\circ}\text{C}$) were recorded on the interior (exposed) surface of the quarter trim panel near the front of the left wheelhouse. The temperatures recorded on these components increased so that, by 170 seconds post-ignition, flame temperatures were recorded on a number of areas on the left quarter trim panel, the left bolster, and the left D-pillar trim panel.

Figure 41. Fire Test F961116. Diagrams showing isothermal contours on the interior (exposed) surfaces of the left quarter trim panel, the left quarter trim bolster, and the left D-pillar trim between 140 and 170 seconds post-ignition.

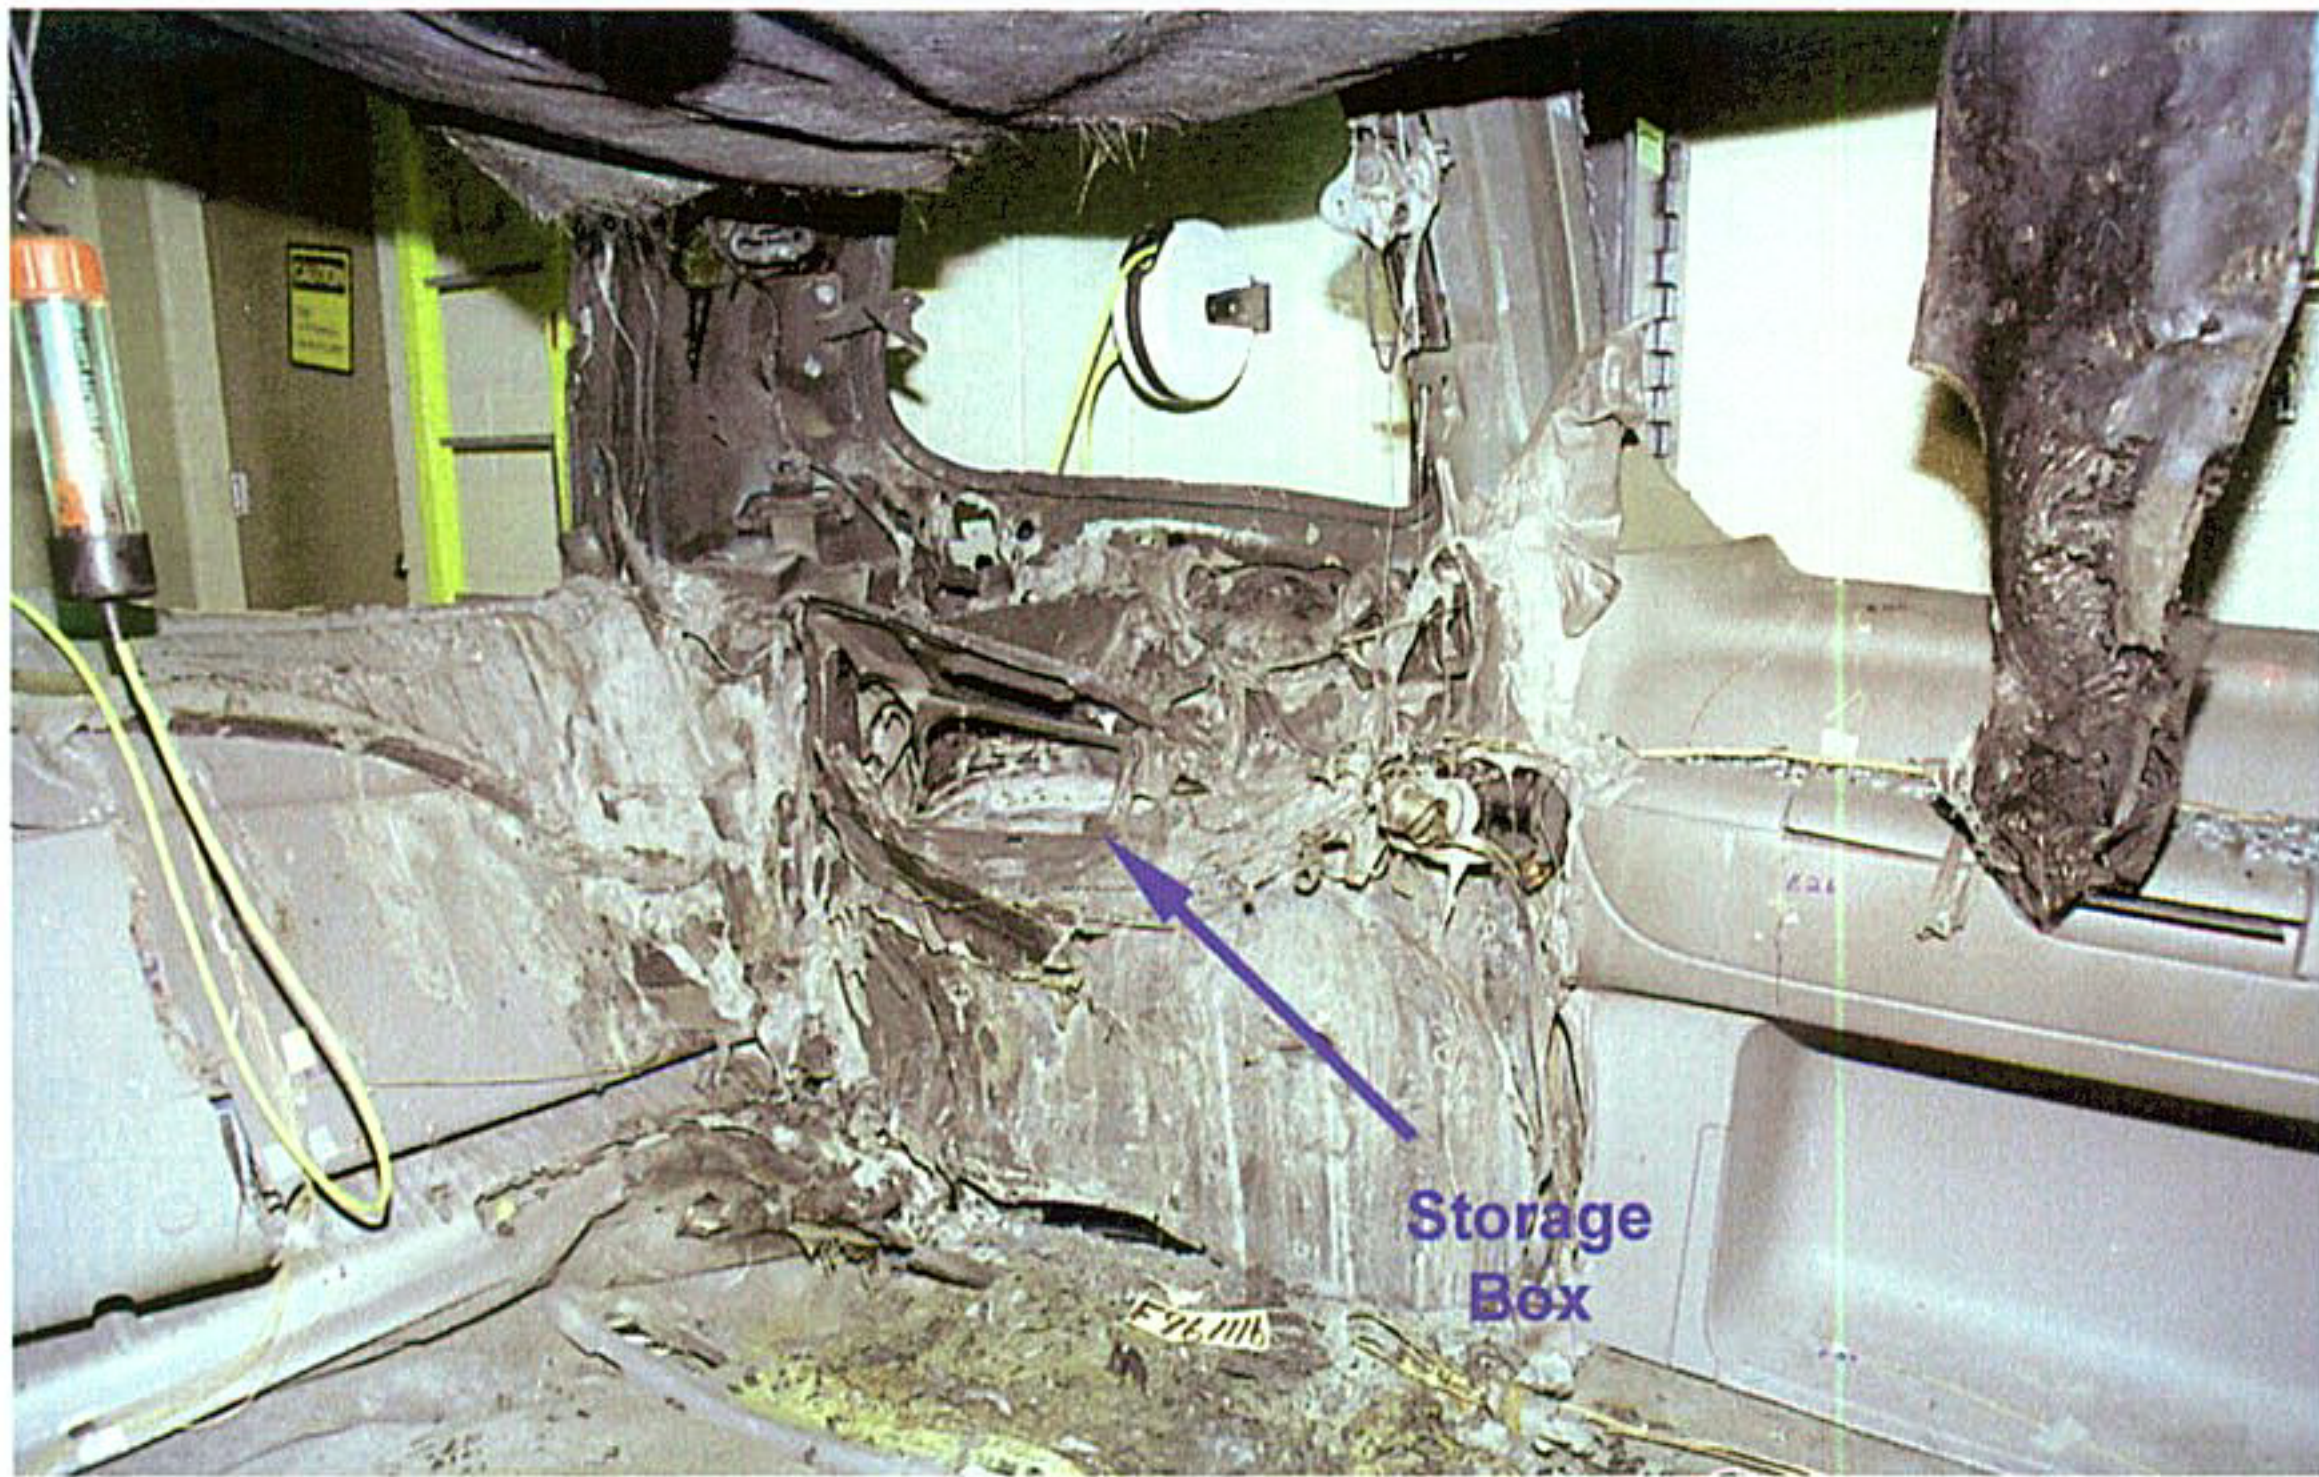
The pattern of smoke and fire damage observed in Figure 42 indicates that the rear half of the left quarter trim panel, the left C- and D-pillar trim panels, and the left edges of the liftgate trim panel and liftgate sill plate had ignited by the time flames in the interior of the test vehicle were extinguished. Inspection of the test vehicle after the fire was extinguished revealed that fire damage to the interior trim panels was localized to the left rear corner and headlining (Fig. 42). The section of the left quarter trim panel that was rearward of the C-Pillar was consumed by fire. The left C-pillar trim had ignited around the left quarter vent. Material covering the front-surface of the left C-pillar appeared to have melted and sagged, but not to have ignited. The left D-pillar trim

also had ignited, and was largely consumed by fire. And as mentioned in **SECTION 5.1**, residue from the left D-pillar trim was noted on the upper left corner of the second bench seat back. The exposed metal surfaces around the left quarter vent contained heavy deposits of black soot. The paint on the exposed inboard and forward surfaces of the left C-pillar was discolored by heat, but these surfaces were almost devoid of soot. Material along the left edge of the liftgate trim panel and sill plate was melted, and the melted material appeared to have trapped gas bubbles as it solidified when the fire was extinguished.

Figure 42. Fire Test F961116. Photograph showing the rear left corner of the passenger compartment of the test vehicle after this fire test. The storage box was not completely consumed by fire.

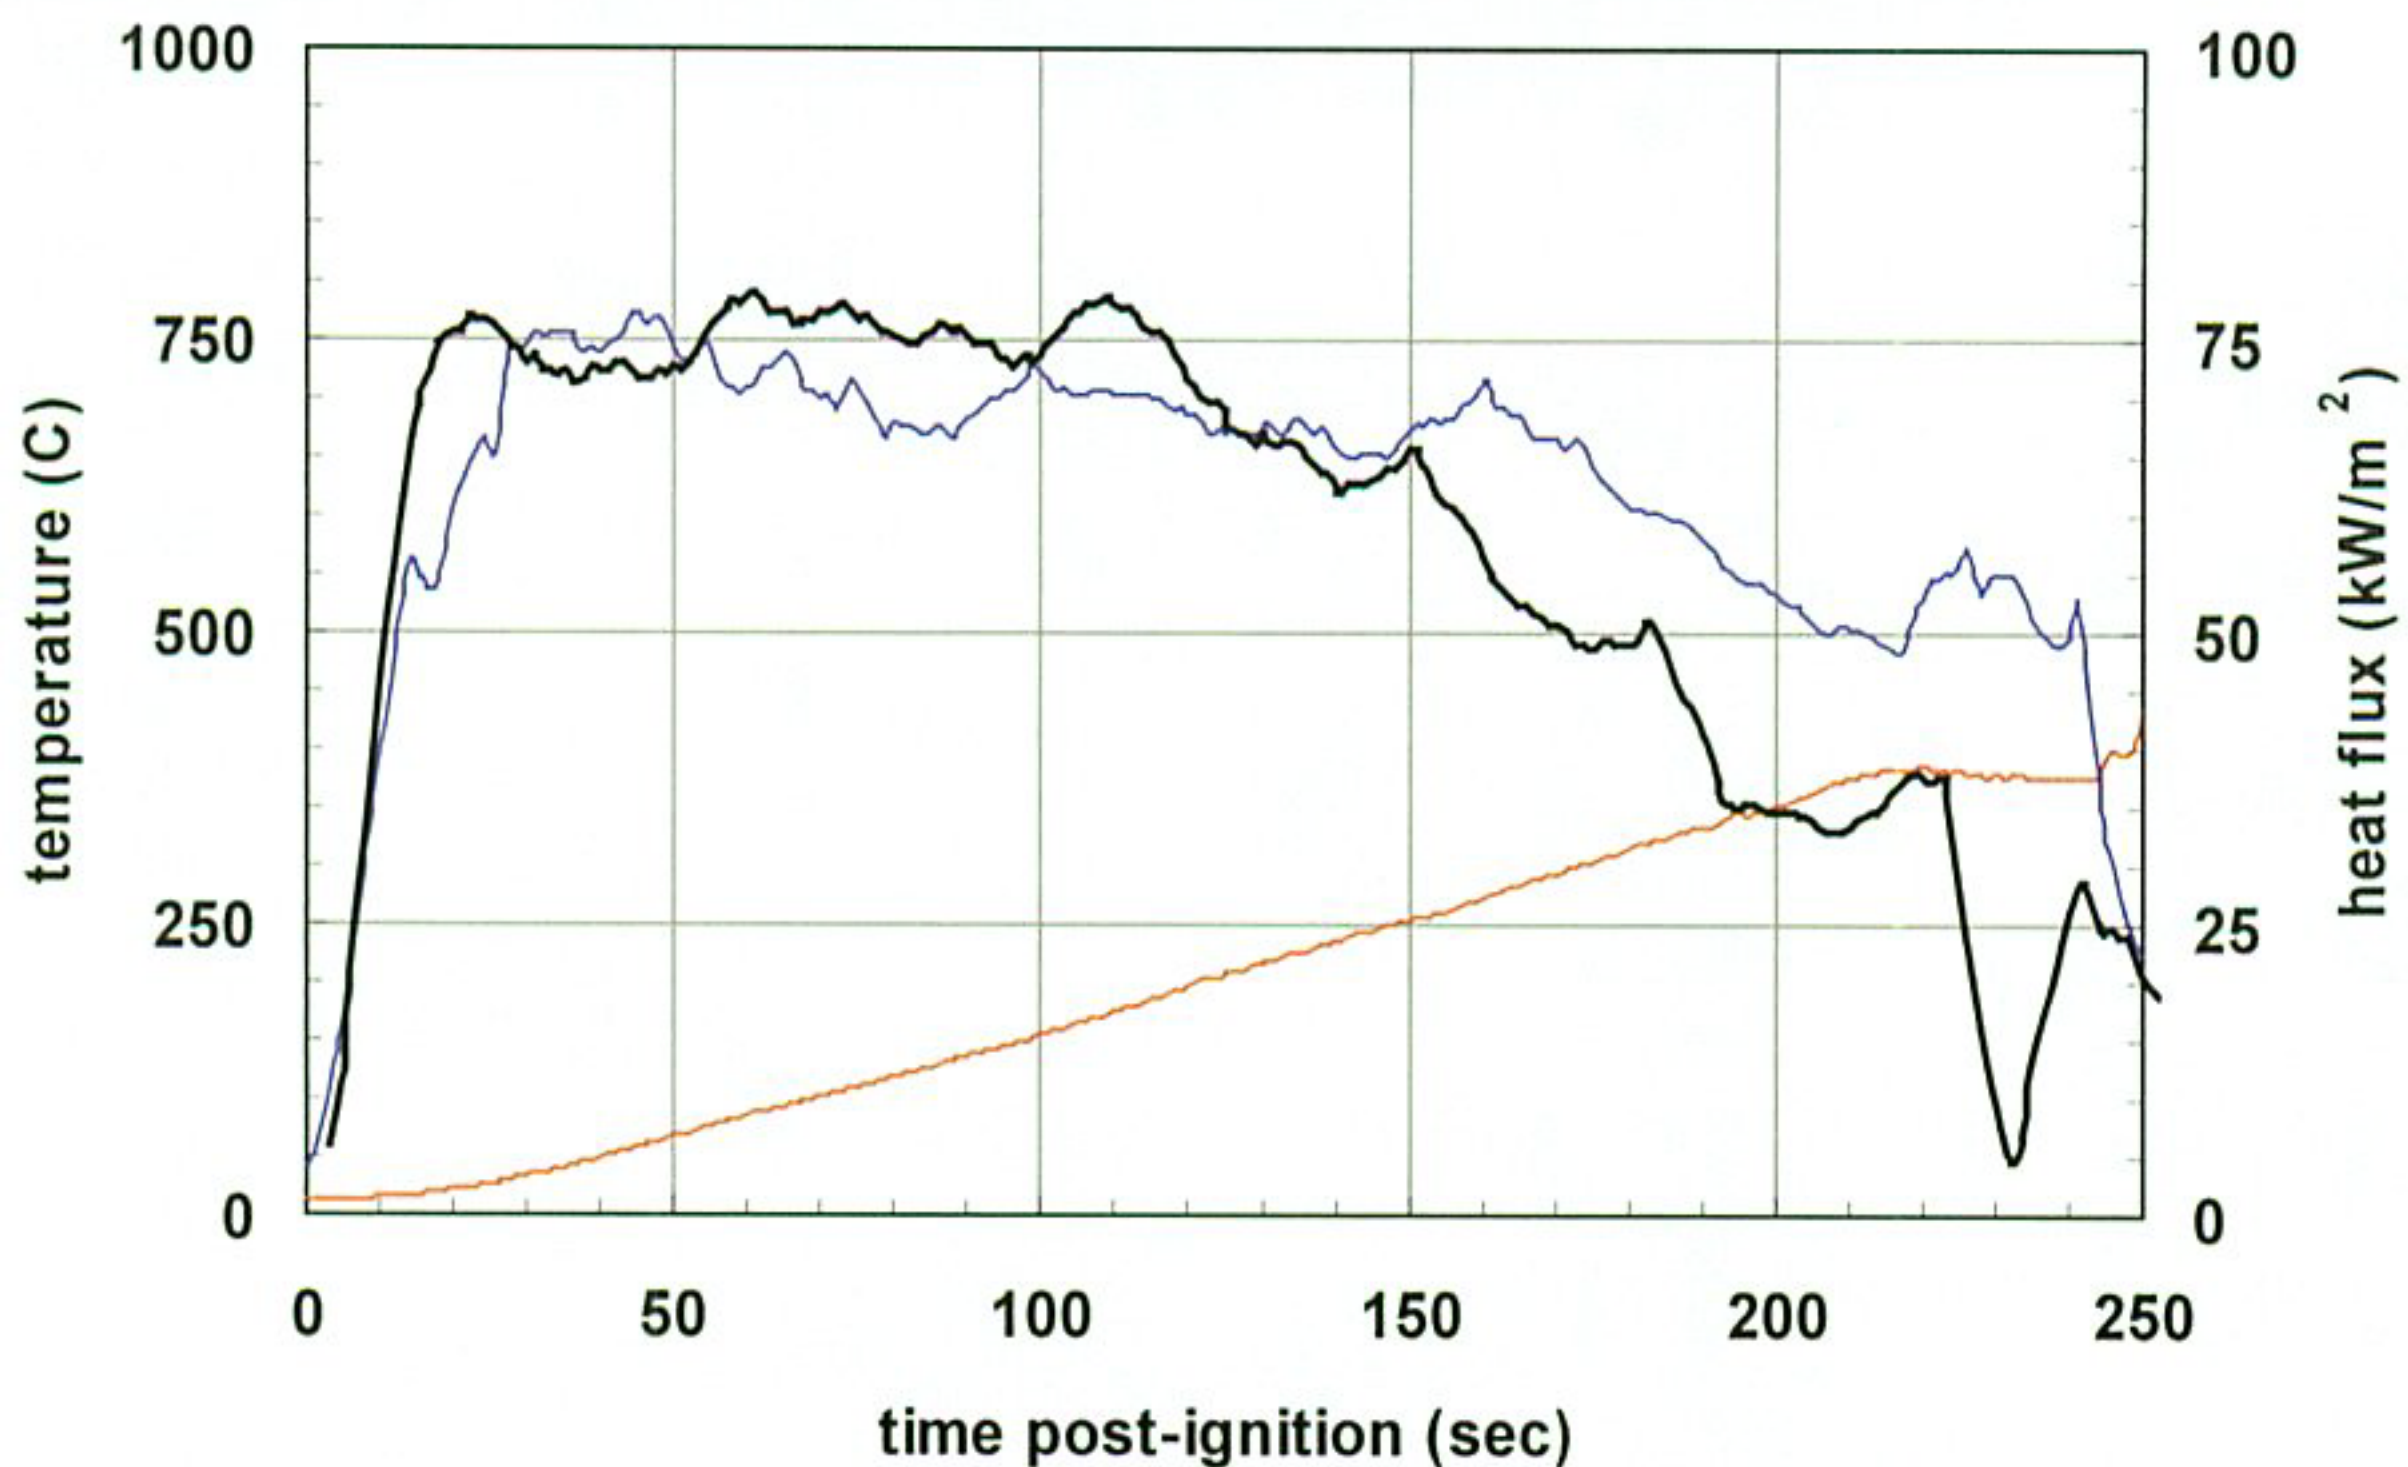
These data indicate that this area of the floor pan was exposed to flames starting at approximately 15 seconds post-ignition, and continued to be exposed to flames until the test was ended and the burning gasoline pool was extinguished. The heat flux to the lower surface of the floor pan ranged from approximately 75 kW/m^2 shortly after ignition to approximately 35 kW/m^2 just before fire suppression began.

Figure 45. Fire Test F961116. Plots of the heat flux recorded by HFT 3 (—), the temperature recorded by Thermocouple C3 (—), and the temperature recorded by Thermocouple B9 (—). Refer to **APPENDIX E** for the location of and data from HFT3. Refer to **APPENDIX C** for the locations of and data from thermocouples C3 and B9.

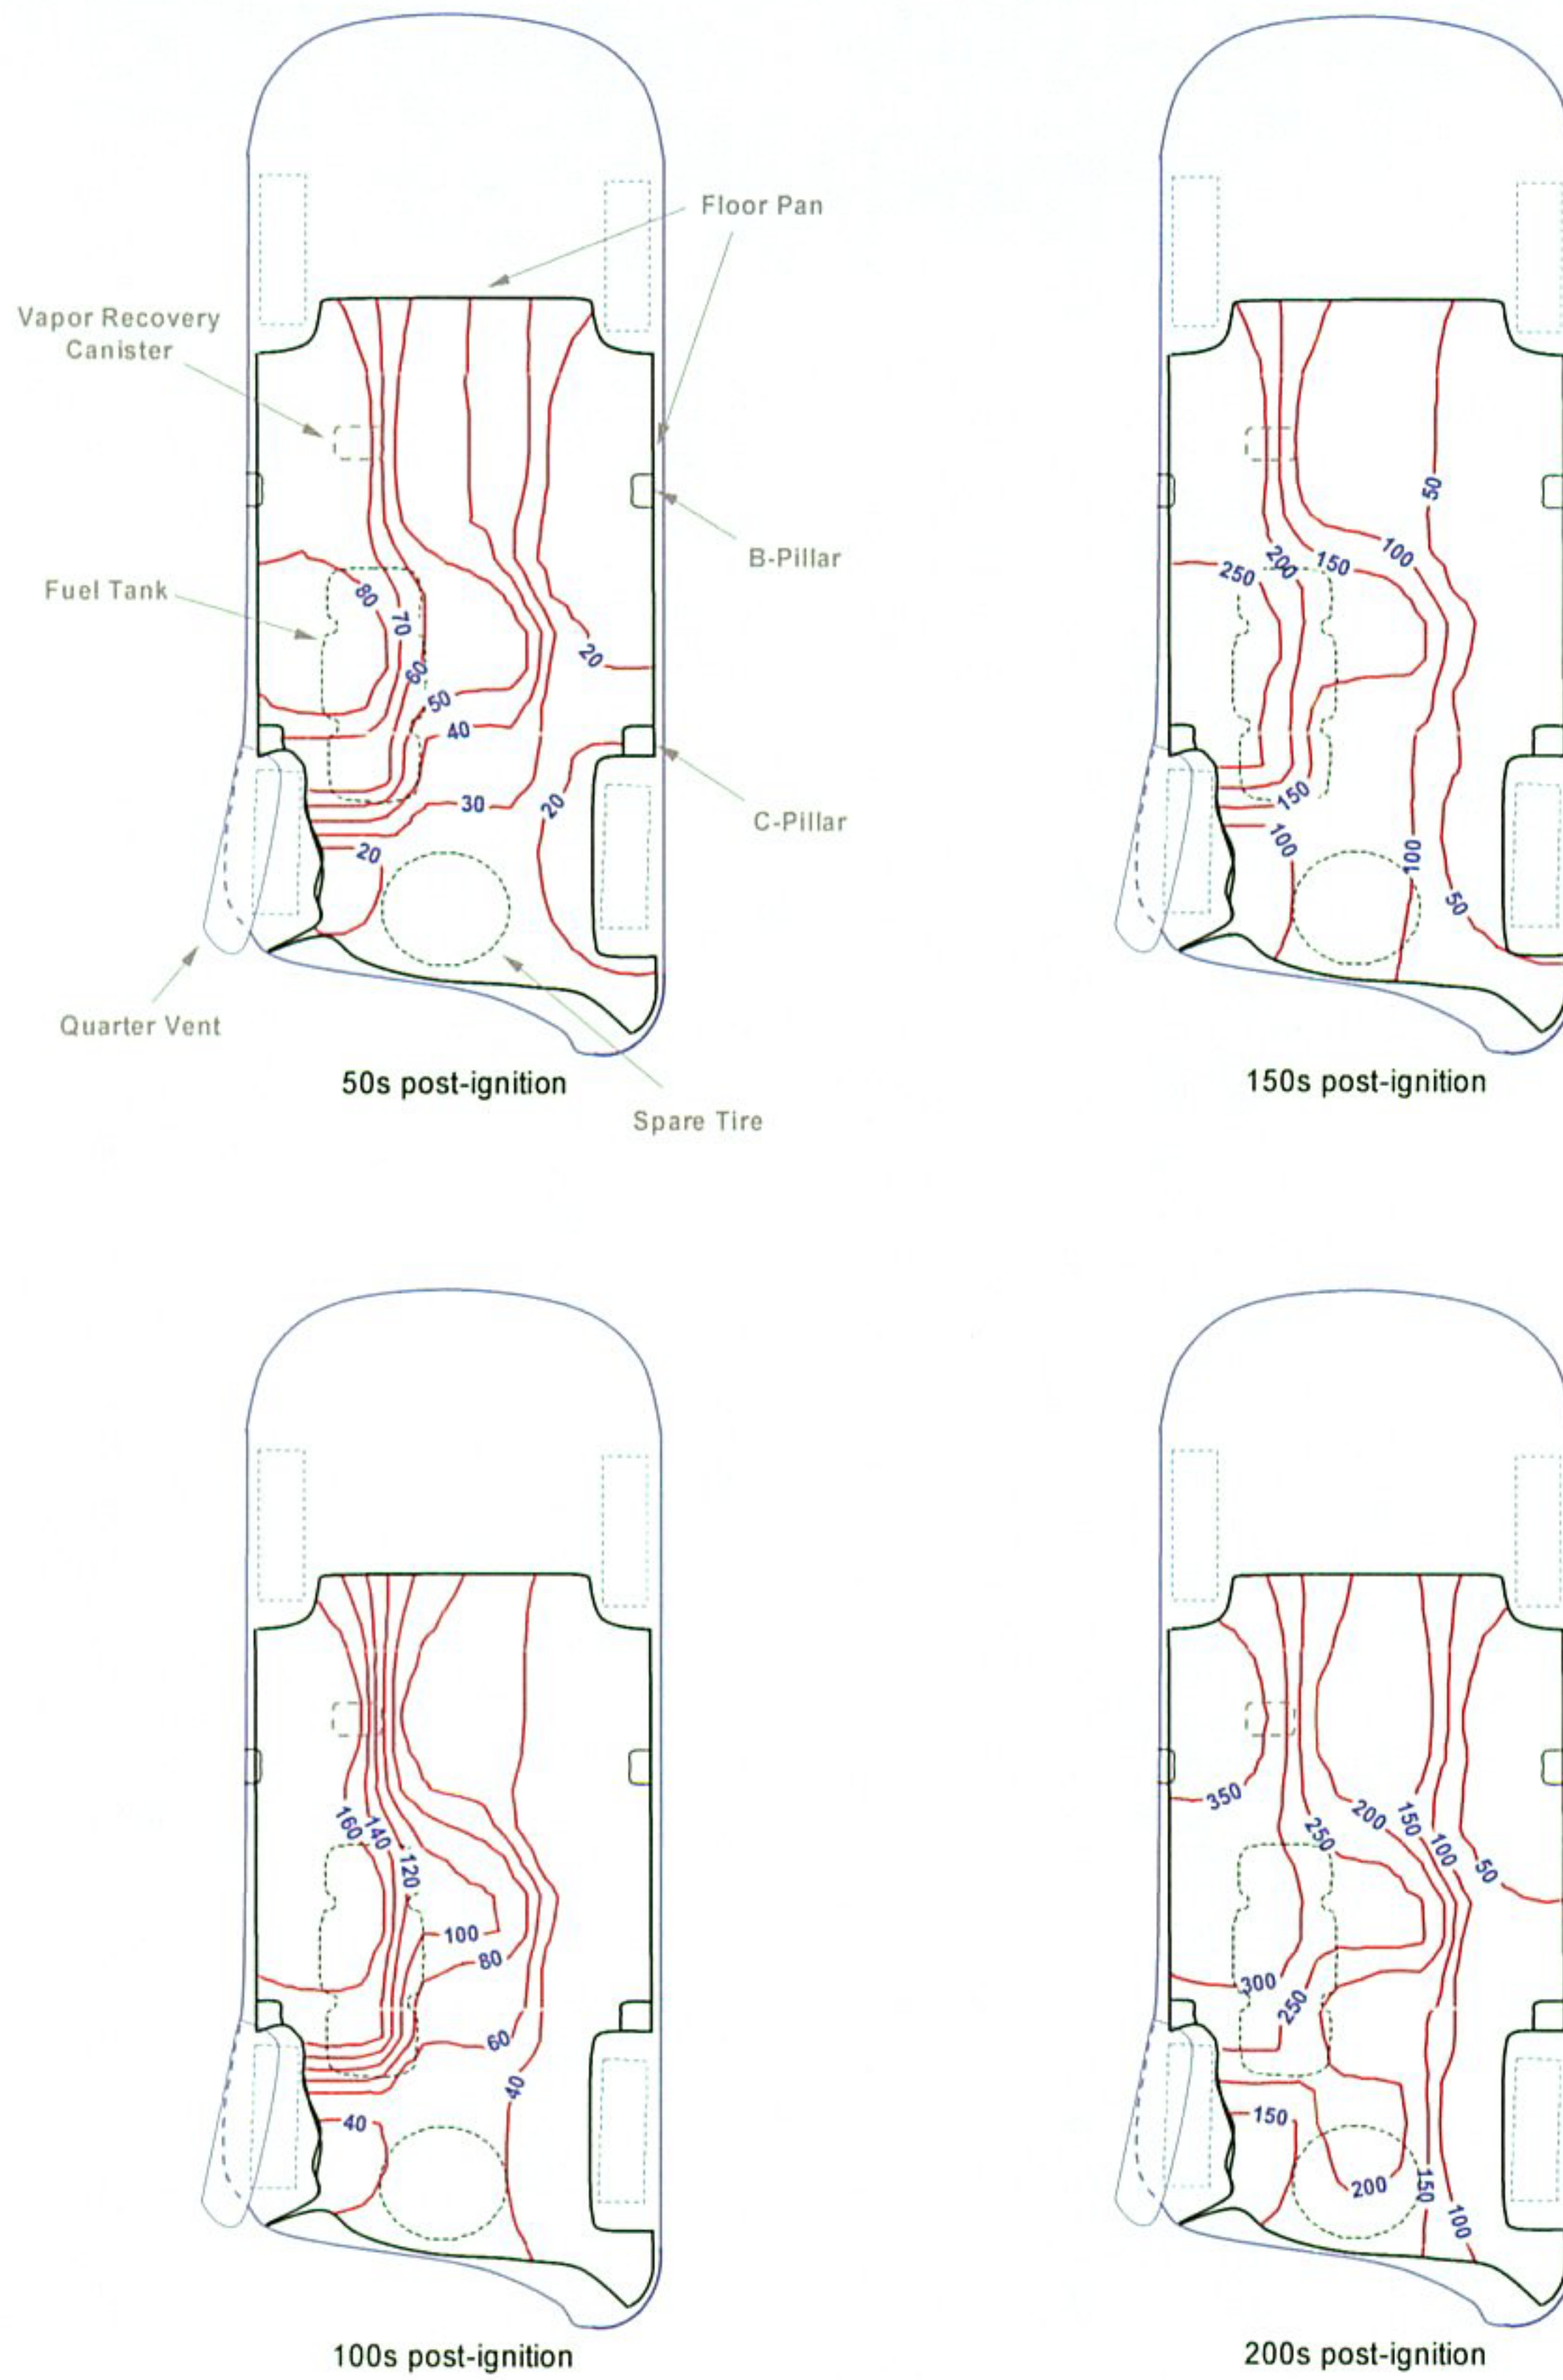
Conduction through the floor pan heated the upper surface of the body mastic. Figure 46 shows isothermal contours¹⁸ on the upper surface of the body mastic at 50, 100, 150, and 200 seconds post-ignition. The area of maximum conduction through the floor pan and temperature recorded on the upper surface of the floor pan (Fig. 46) corresponds roughly to the area of the floor pan that was above the hottest flames below the test vehicle (see Fig. 16).

Figure 46. Fire Test F961116. Isothermal contours on the floor pan of the test vehicle.

The area of the carpet that abutted the left rear wheelhouse was burned and charred. In several areas (indicated by arrows in Figure 47), the temperature of the upper surface of the mastic on top of the floor pan was sufficiently high to have caused the carpet pad to char. In one area, under the inboard riser under the drivers seat where the carpet backing was not covered by pad, the carpet appeared to have ignited. The areas where the carpet pad was charred coincided with the sections of the floor pan where the surface temperature was greater than 200°C at 200 seconds post-ignition (Fig. 46).
