Enclosed is a final report prepared by Jeffrey Santrock of General Motors Corporation, entitled, "Evaluation of Motor Vehicle Fire Initiation and Propagation Part 4: Propagation of an Underbody Gasoline Pool Fire in a 1996 Passenger Van."

**Evaluation of Motor Vehicle Fire Initiation and Propagation
Part 4: Propagation of an Underbody Gasoline Pool Fire in a 1996
Passenger Van**

Jeffrey Santrock
General Motors Corporation

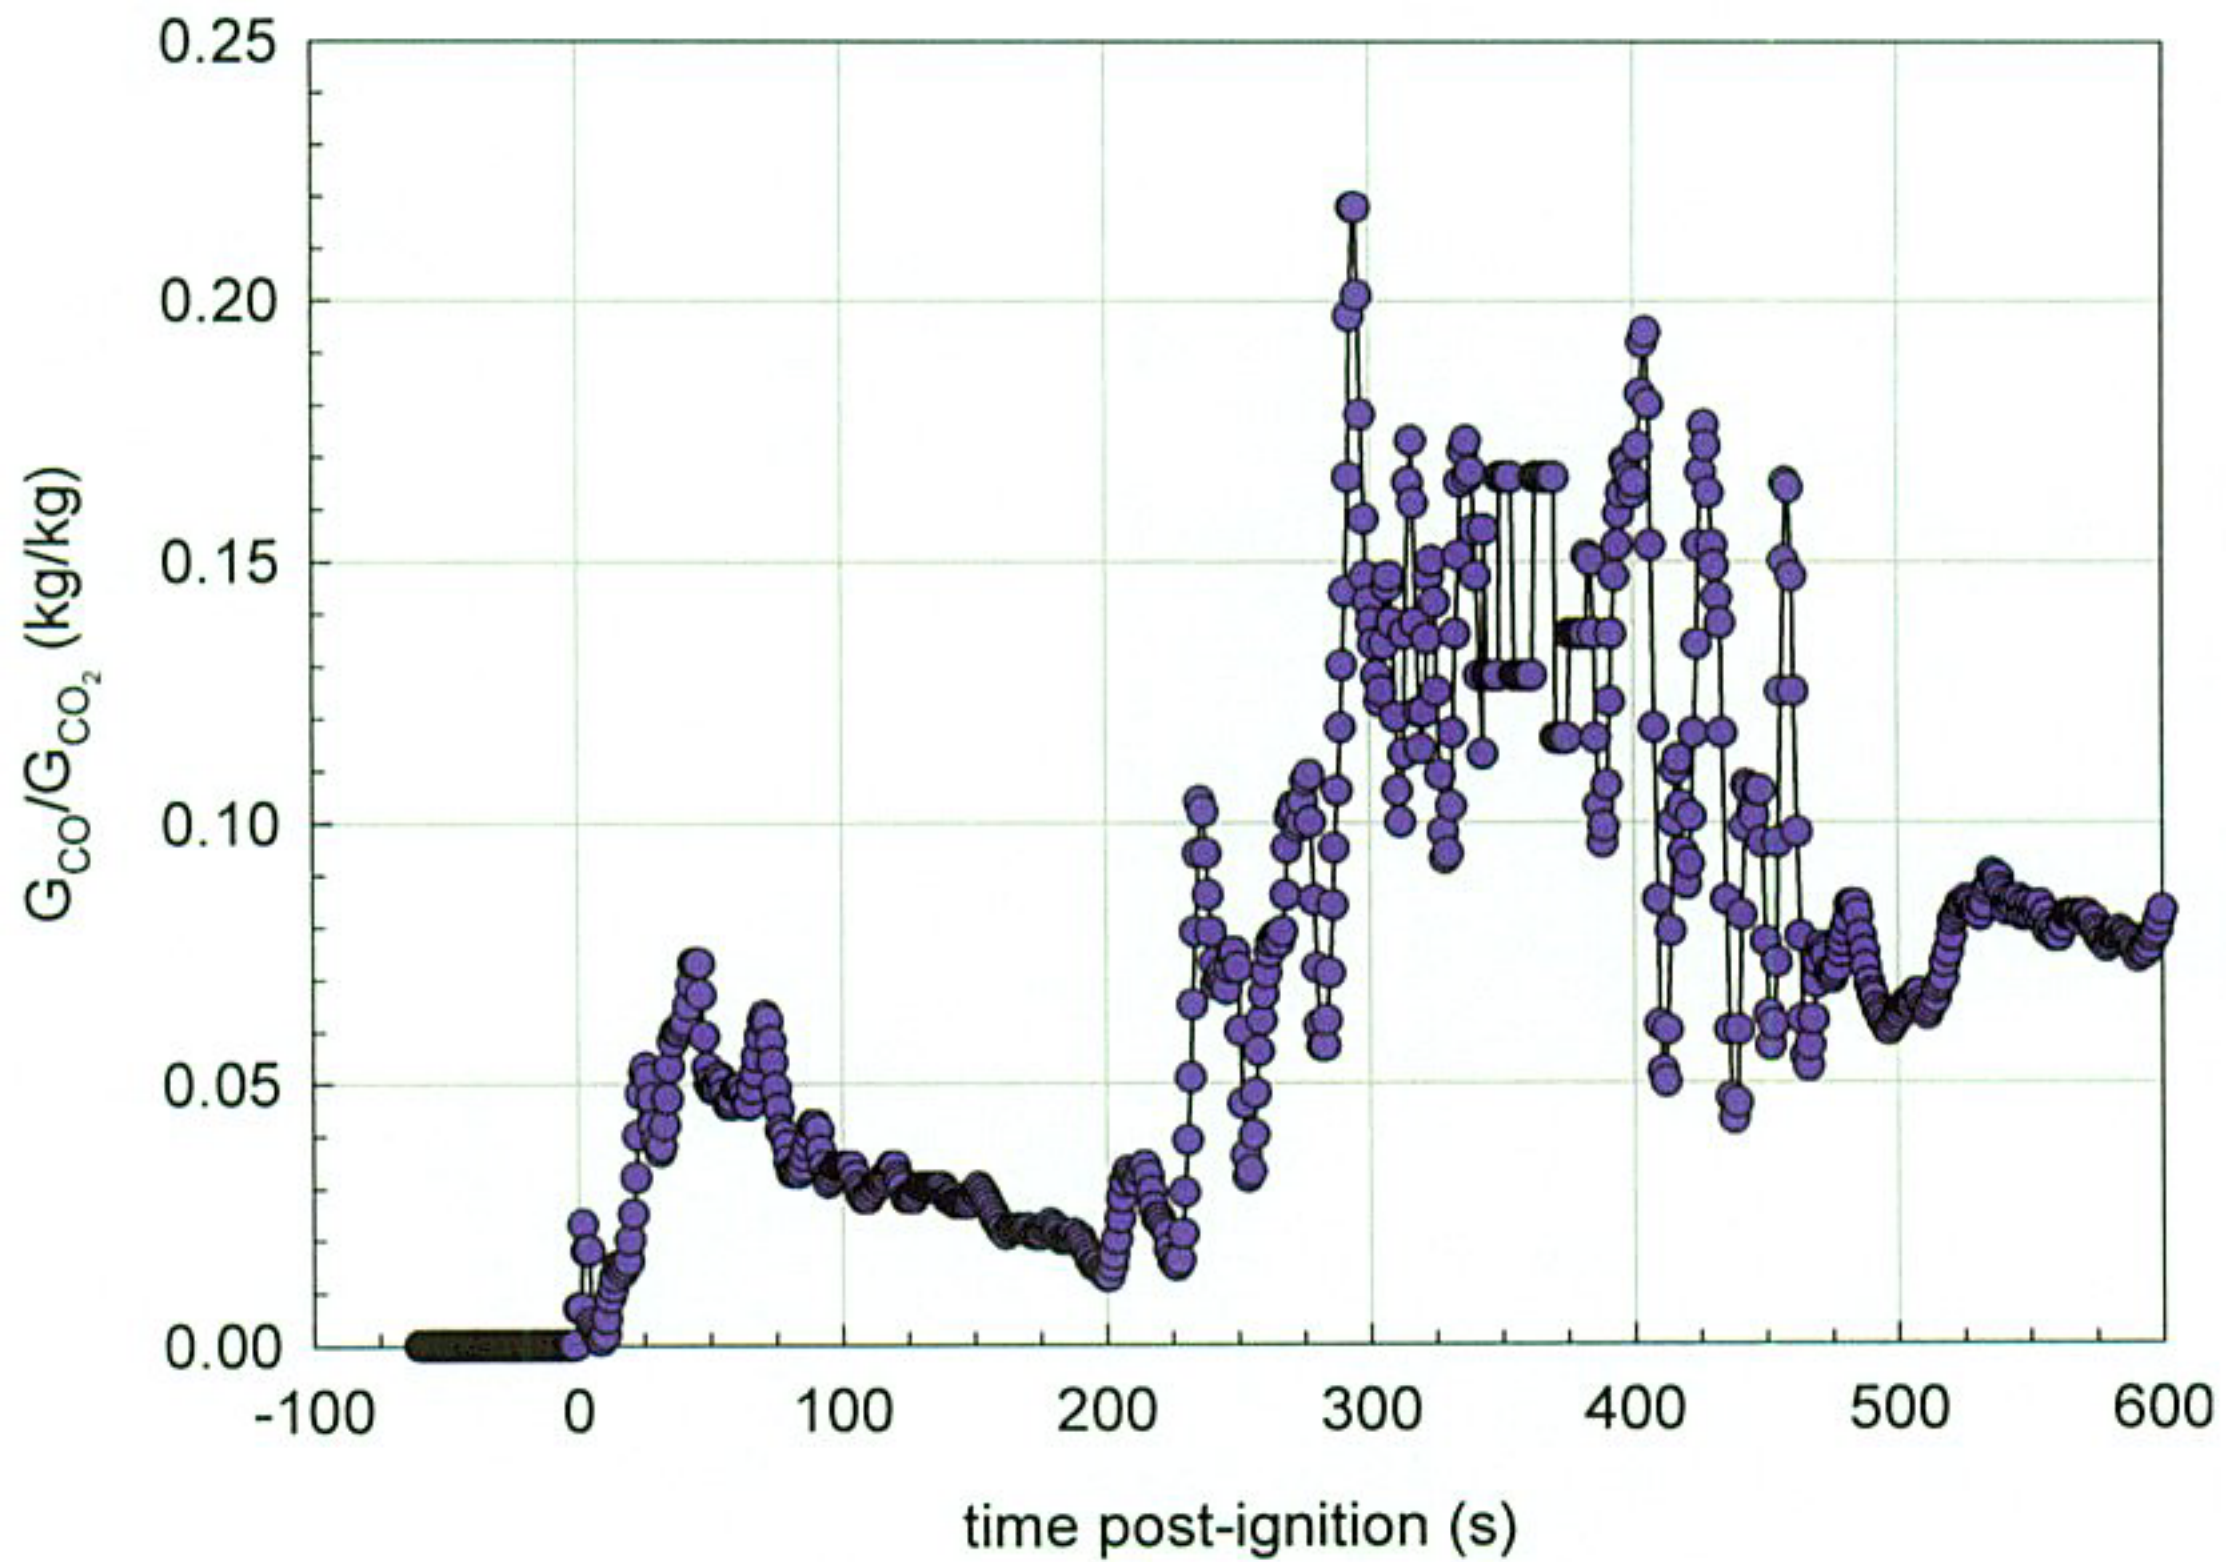
The values of $[G_{\text{CO}}]/[G_{\text{CO}_2}]$ and $[G_{\text{HC}}]/[G_{\text{CO}_2}]$ in Figure 48 are greater than the reference values for $[Y(\text{CO})]/[Y(\text{CO}_2)]$ and $[Y(\text{HC})]/[Y(\text{CO}_2)]$ in Table 2 for the first 60 to 90 seconds after ignition. Gasoline was the predominant material burning during this time. Values of $[G_{\text{CO}}]/[G_{\text{CO}_2}] > 0.011$ to 0.014 and $[G_{\text{HC}}]/[G_{\text{CO}_2}] > 0.0032$ to 0.0039 indicate that airflow into the flame was insufficient for stoichiometric combustion of the hydrocarbons vaporizing from the gasoline pool. Values of $[G_{\text{HC}}]/[G_{\text{CO}_2}] > 0.0032$ to 0.0039 also indicates that unoxidized or partially oxidized gasoline vapor was entrained in the air drawn into to the Fire Products Collector. At least two factors may have contributed to the under-ventilated combustion conditions. The low clearance between test surface and the underbody of the test vehicle may have restricted airflow into the flames.

Figure 48. Fire Test F961116. Plot of $[G_{CO}]/[G_{CO_2}]$ versus time post-ignition determined from the carbon dioxide- and carbon monoxide-release rates measured by the Fire Products Collector.

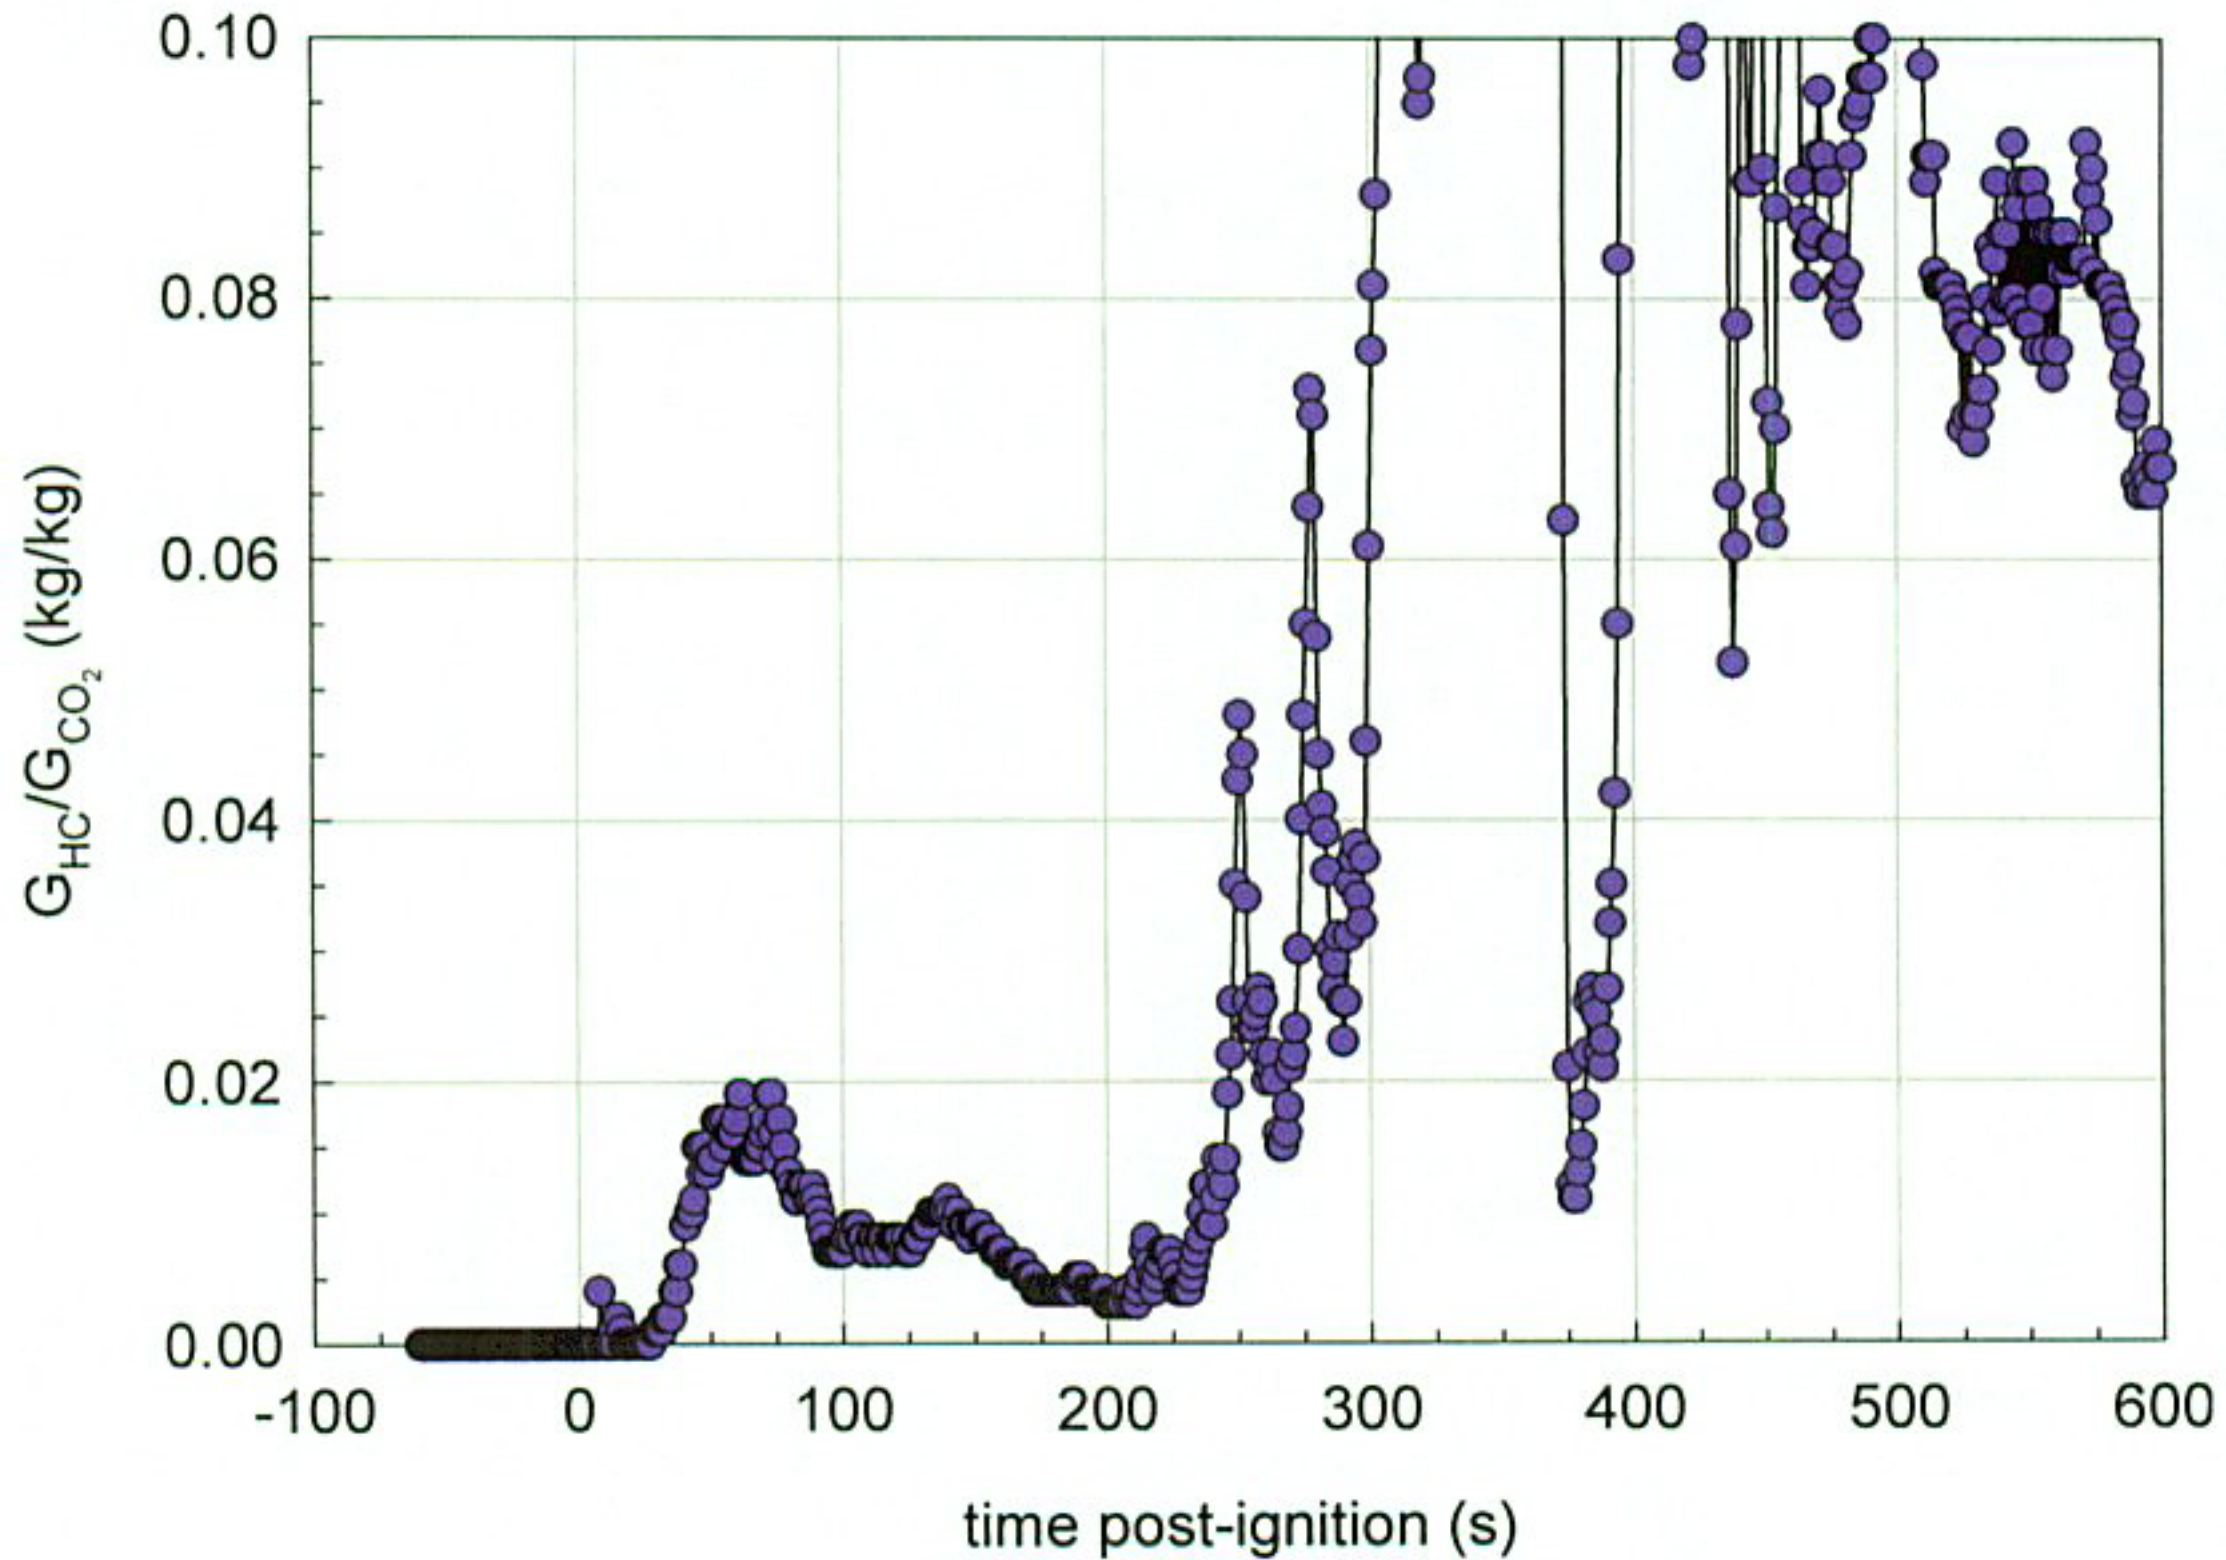
Figure 49. Fire Test F961116. Plot of $[G_{HC}]/[G_{CO_2}]$ versus time post-ignition determined from the carbon dioxide- and carbon monoxide-release rates measured by the Fire Products Collector.

The values of $[G_{CO}]/[G_{CO_2}]$ and $[G_{HC}]/[G_{CO_2}]$ increased sharply at the onset of fire suppression, indicating a transition from well-ventilated combustion to non-flaming combustion or pyrolysis occurred as the flames were being extinguished. Although flames were visibly suppressed relatively quickly, many materials in the test vehicle remained hot enough to produce smoke, indicating thermal decomposition of the materials continued after the flames were visibly extinguished.

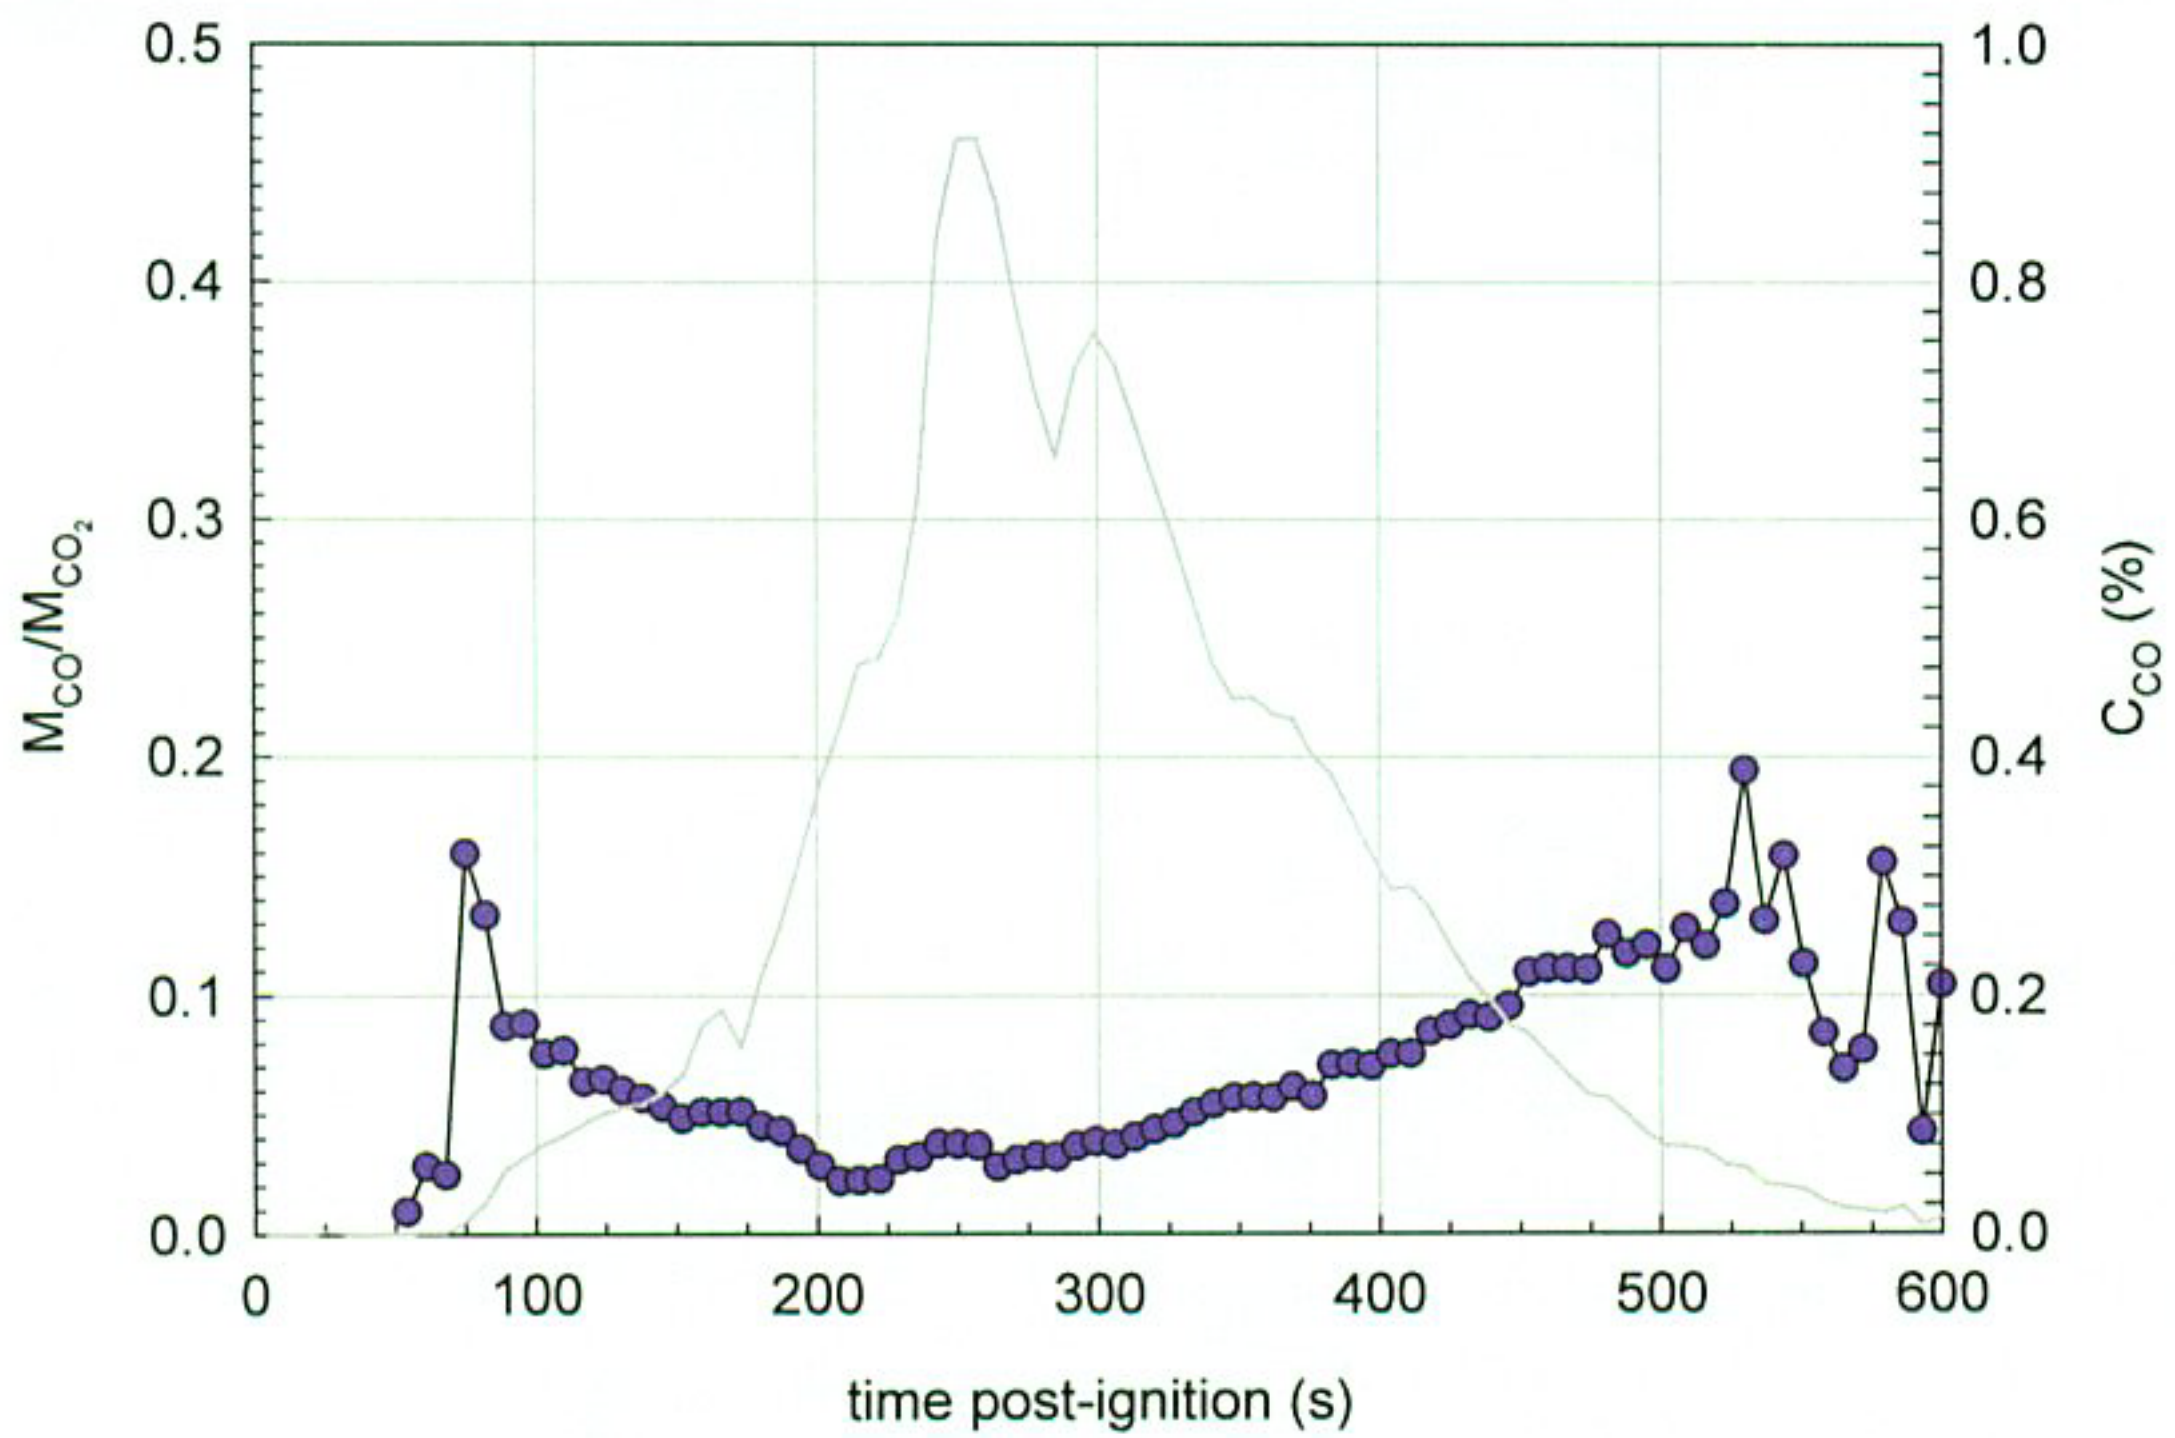
Figure 50. Fire Test F961116. Plots of $[M_{CO}]/[M_{CO_2}]$ (—●—, left axis) and C_{CO} (—, right axis) in the passenger compartment.

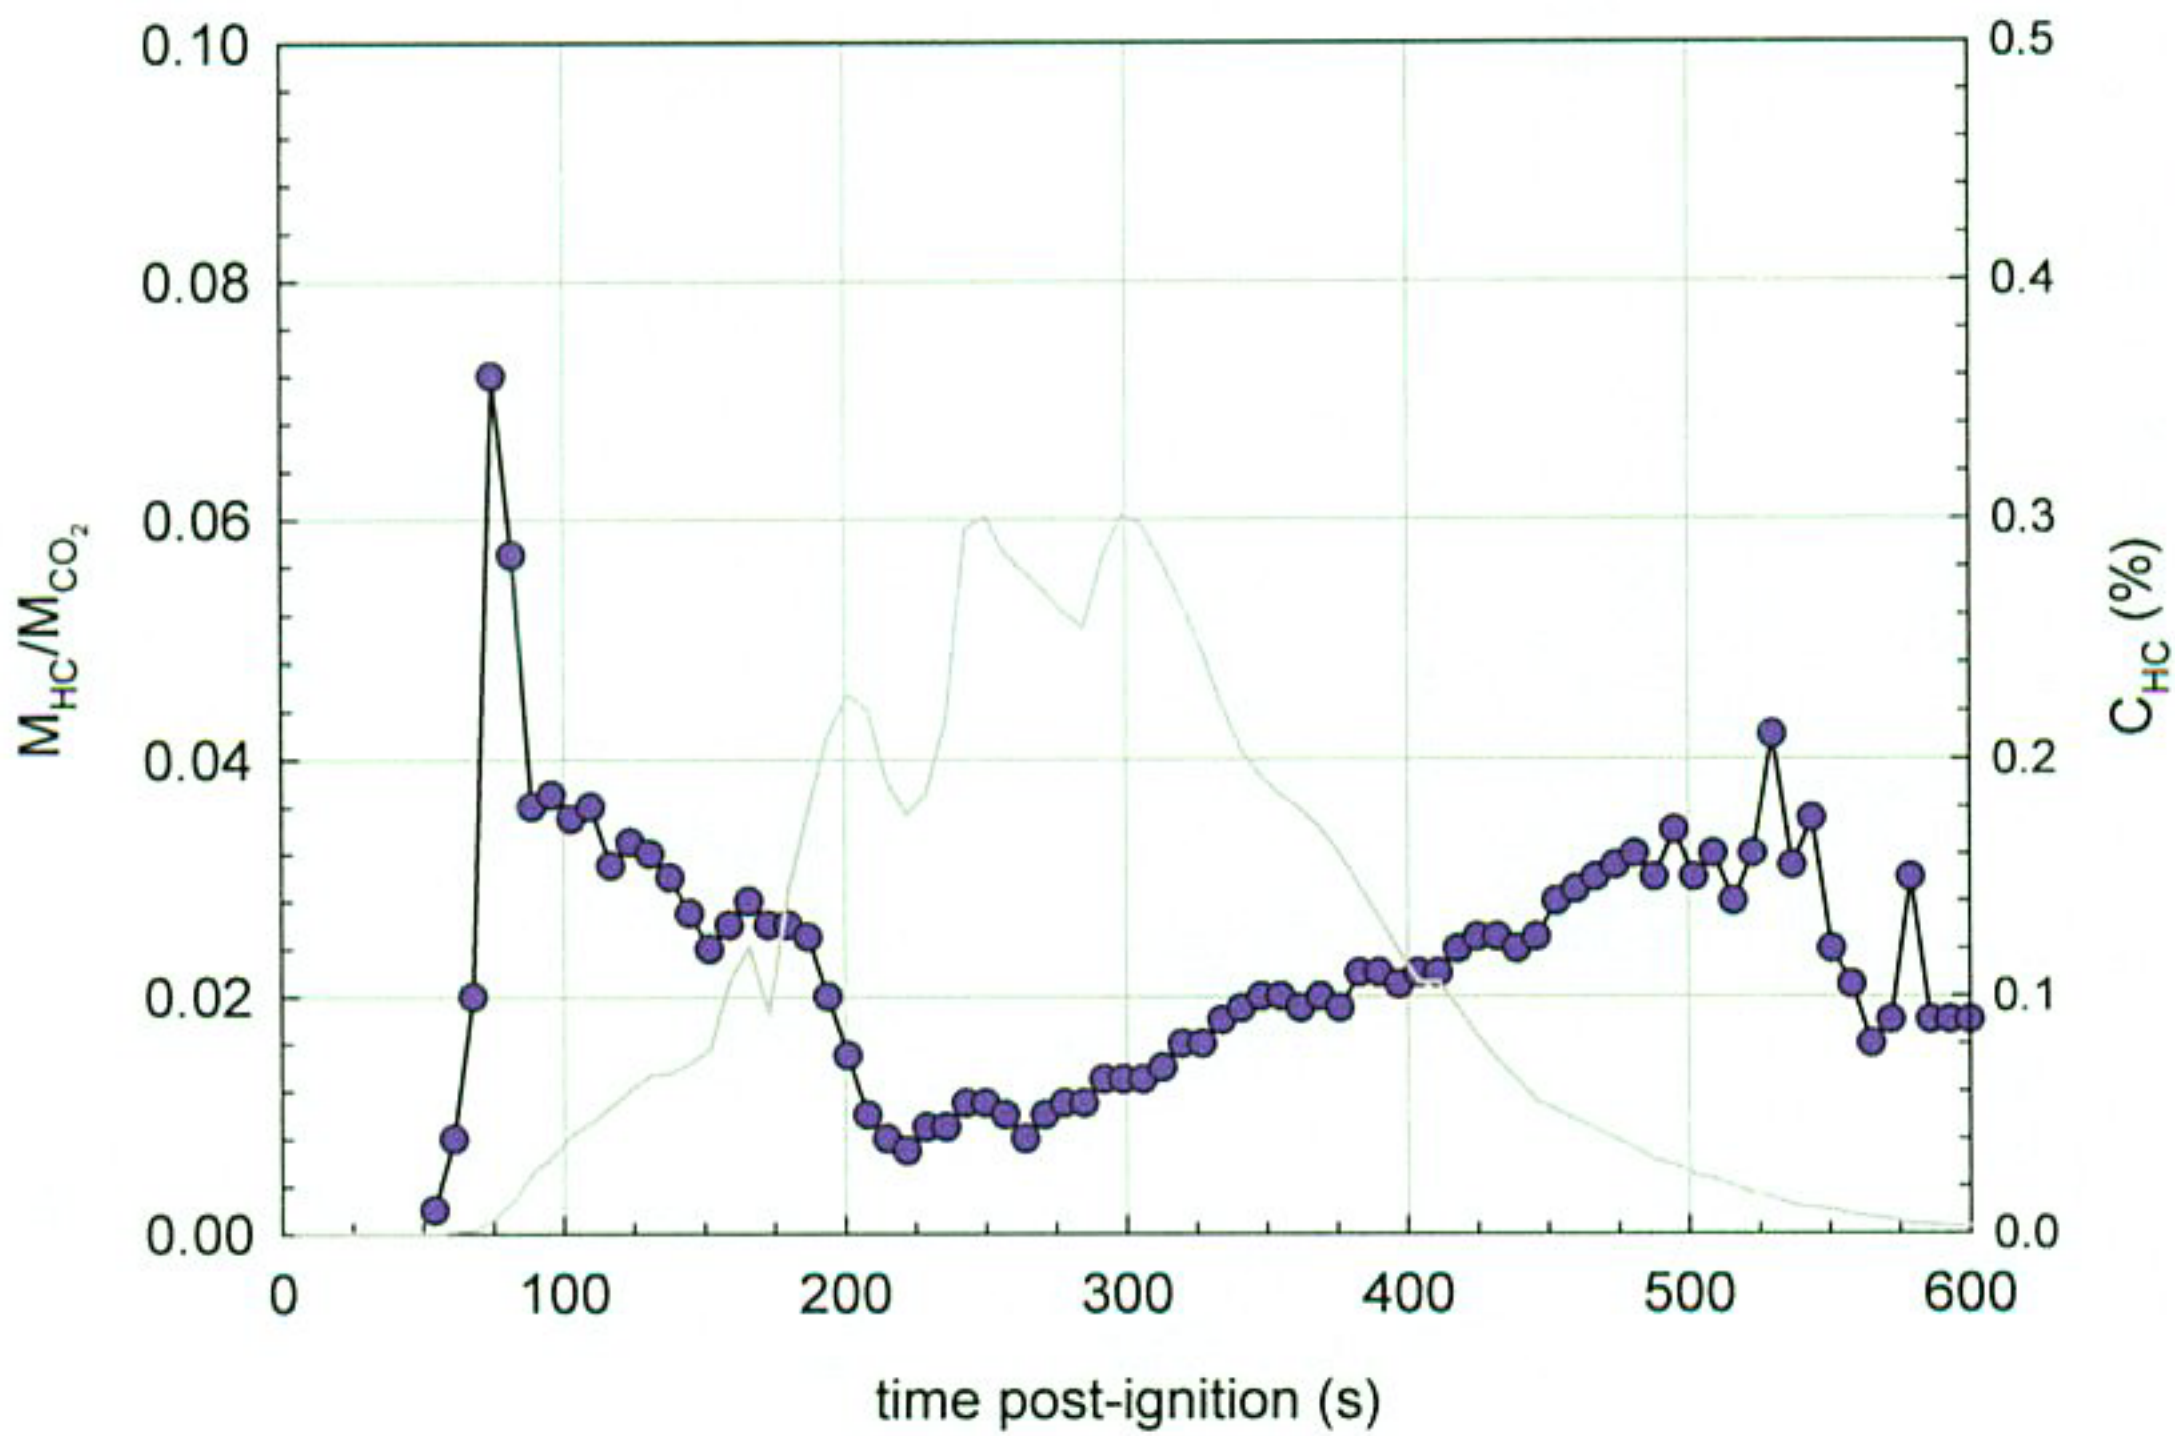
Analysis of the gas concentration and air temperature data in the passenger compartment suggests that combustion of materials inside the test vehicle progressed from an under-ventilated toward a well-ventilated condition. Figures 50 through 54 show plots of M_{CO}/M_{CO_2} , M_{HC}/M_{CO_2} , $[C_{CO_2} \times \rho_{CO_2}]/[t_{air} \times Cp]$, $[C_{CO} \times \rho_{CO}]/[t_{air} \times Cp]$, and $[C_{CO_2} \times \rho_{CO_2}]/[t_{air} \times Cp]$ calculated from this data. These ratios are equivalent to $Y(CO)/Y(CO_2)$, $Y(HC)/Y(CO_2)$, $Y(CO_2)/\Delta H_{CON}$, $Y(CO)/\Delta H_{CON}$, $(HC)/\Delta H_{CON}$, respectively, shown in Table 2. In these calculations, the quantity $M(HC)$ was the

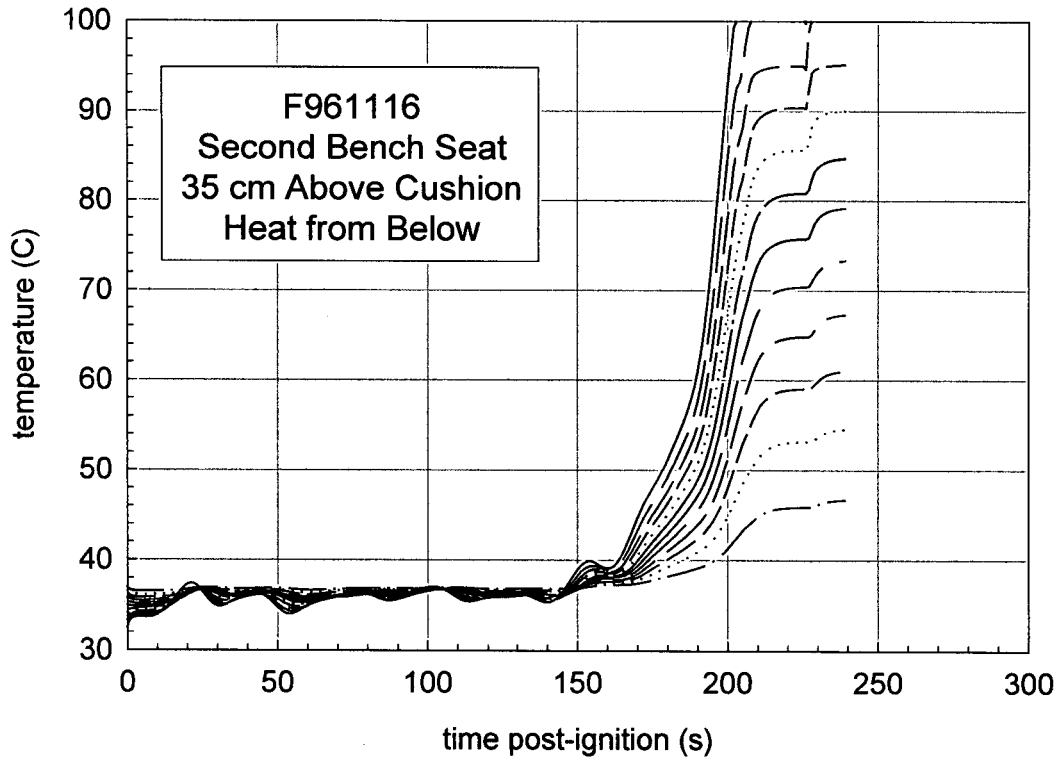
The DFT located above the center of the second bench seat was oriented so that the active surface of the transducer was parallel to the seat cushion and facing downward (Plot F12, **APPENDIX G**). Toward the end of the test, this transducer was heated by radiation from the flames on the seat cushion and by convection from hot gases accumulating just below the headlining. The estimated radiative and convective heat fluxes peaked between 200 and 210 seconds post-ignition at approximately 42 and 8 Kw/m², respectively (Plot G12, **APPENDIX G**). The estimates of skin temperature at the epidermal surface and sub-dermal interface reached maximums of 137 and 46°C, respectively, between 210 and 230 seconds post-ignition.

Figure 55. Fire Test F961116. Skin temperature profiles estimated from the heat flux to a downward-facing horizontal surface approximately 35 cm above the second bench seat.

It should be noted that this analysis did not account for the presence of an occupant in the second bench seat. An occupant below the transducer would have attenuated radiative heat transfer from the burning seat cushion upward to the transducer.

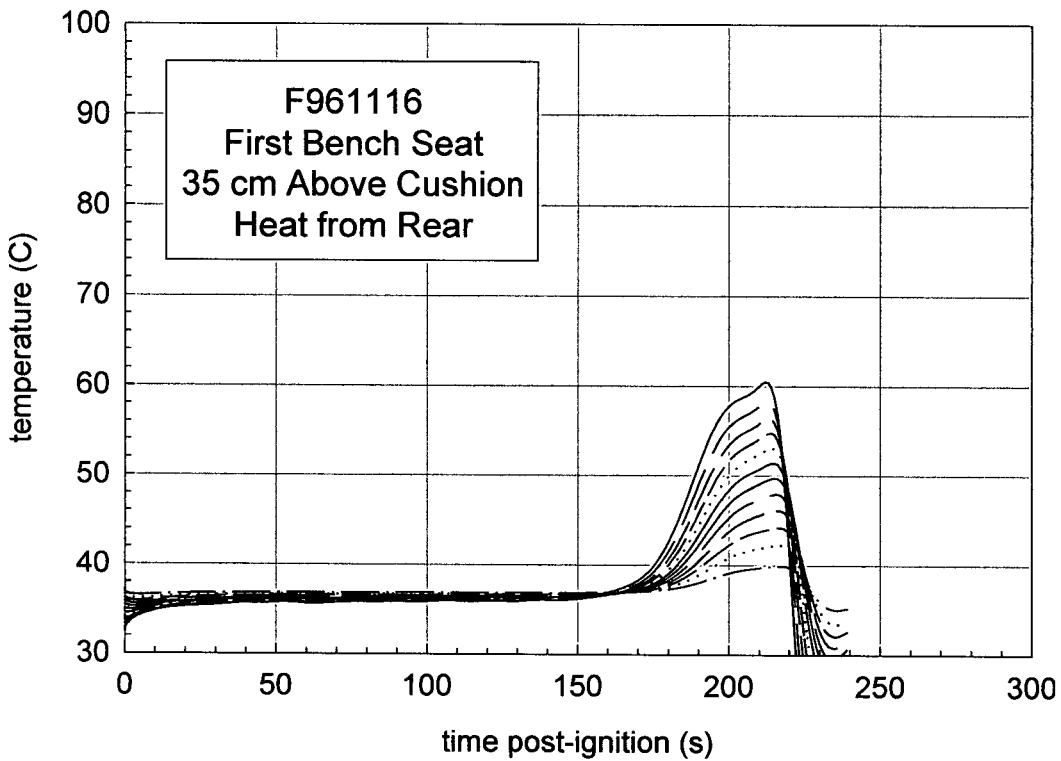
Figure 56. Fire Test F961116. Skin temperature profiles estimated from the heat flux to a rear-facing vertical surface approximately 35 cm above the first bench seat.

The skin temperature depth profile estimates from the BURNSIM analysis correlated directly with the total (convective + radiative) heat flux estimates. In general, the highest estimated skin temperatures were obtained with data from the transducers that were facing upward: approximately 71 and 62°C for the first bench and driver's seats, respectively, and both occurring at approximately 210 seconds post-ignition (fig.'s 57 and 61, respectively). The maximum skin temperatures estimated using data from the other DFT's were lower (Fig.'s 56, 58, 59, 60, and 62).

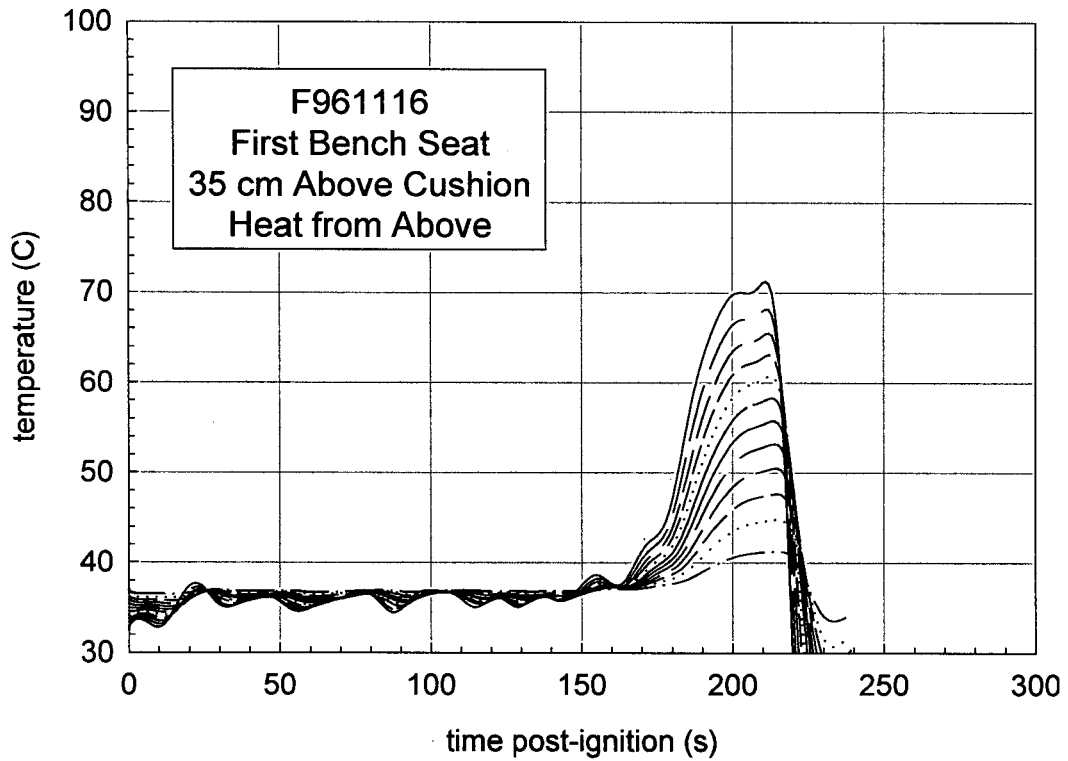
Figure 57. Fire Test F961116. Skin temperature profiles estimated from the heat flux to an upward-facing horizontal surface approximately 35 cm above the first bench seat.

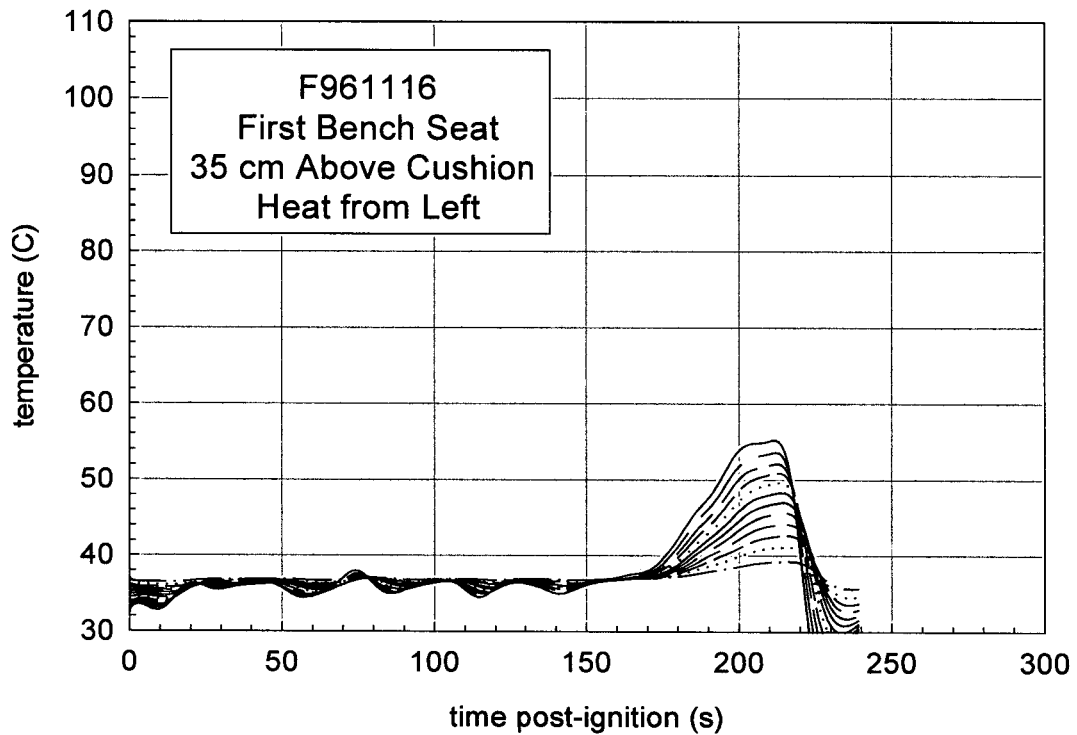
Figure 58. Fire Test F961116. Skin temperature profiles estimated from the heat flux to a left-facing vertical surface approximately 35 cm above the first bench seat.

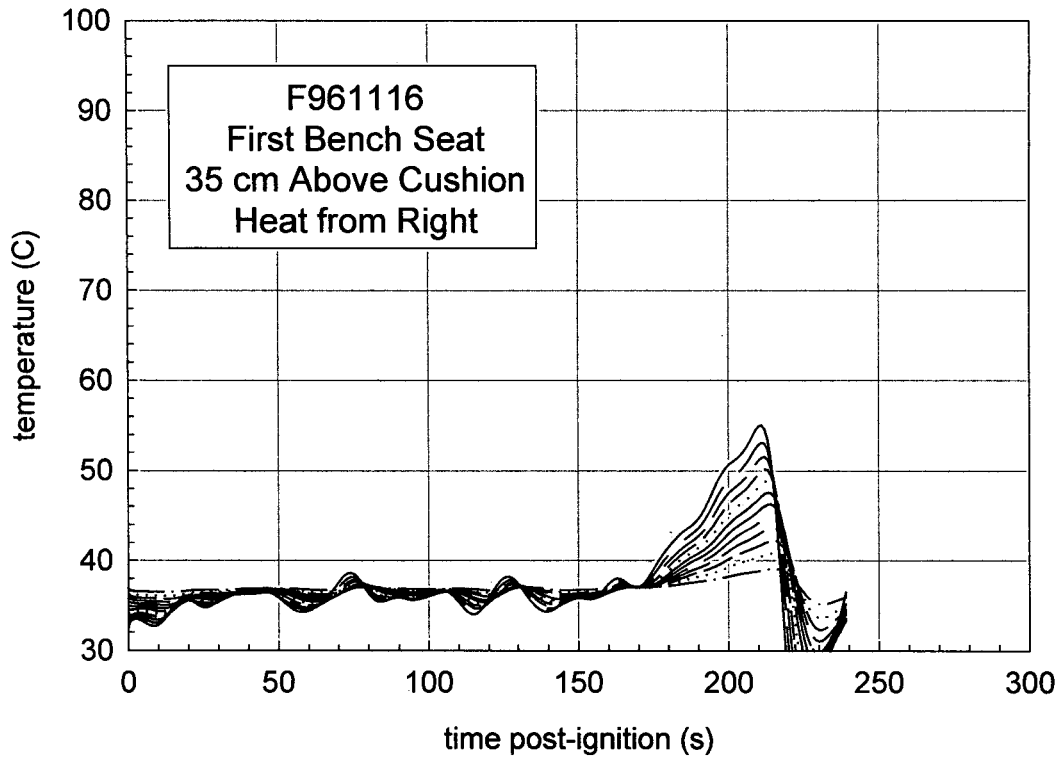
Figure 59. Fire Test F961116. Skin temperature profiles estimated from the heat flux to a right-facing vertical surface approximately 35 cm above the first bench seat.

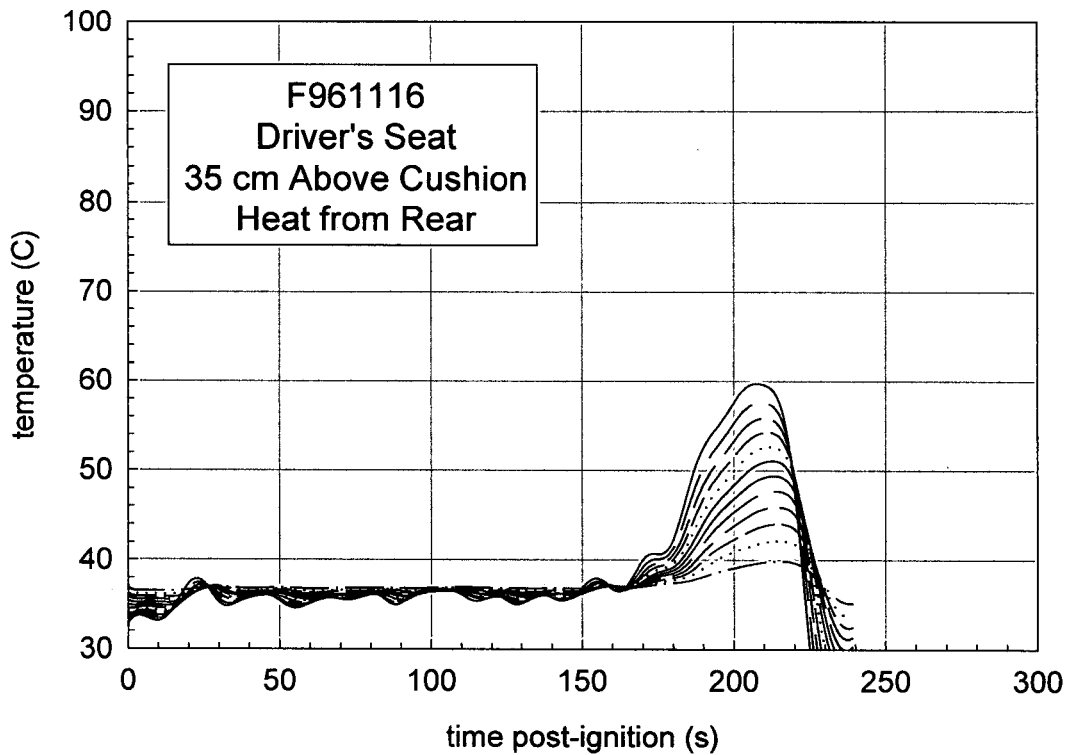
Figure 60. Fire Test F961116. Skin temperature profiles estimated from the heat flux to a rear-facing vertical surface approximately 35 cm above the driver's seat.

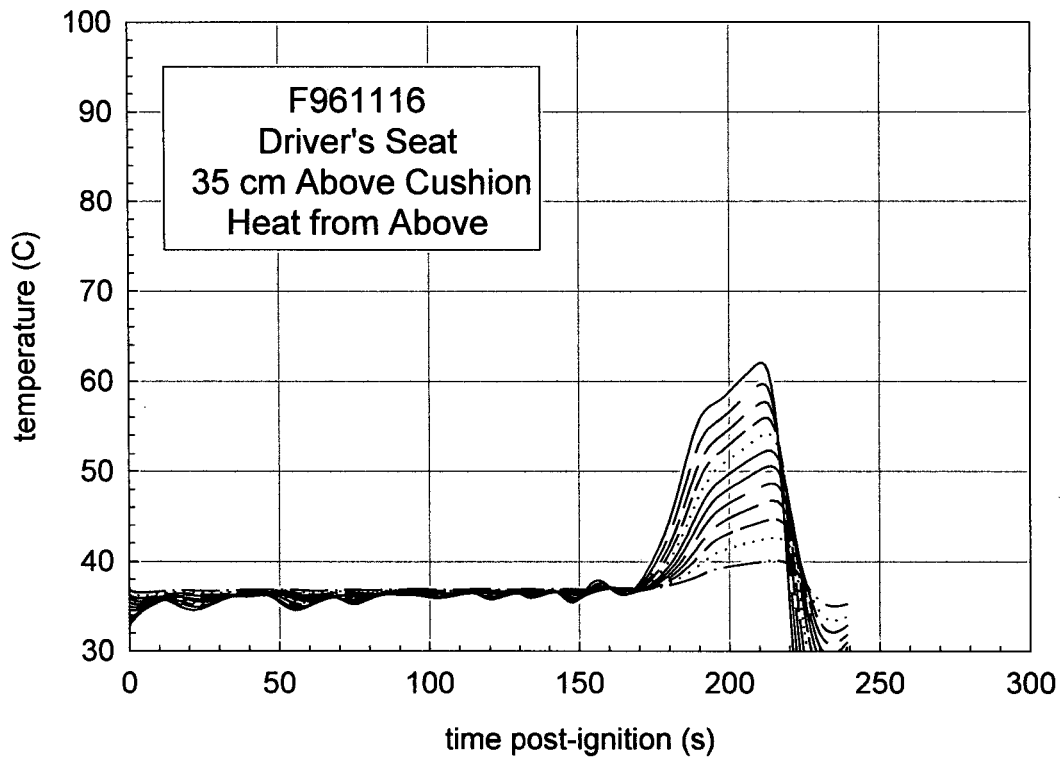
Figure 61. Fire Test F961116. Skin temperature profiles estimated from the heat flux to an upward-facing horizontal surface approximately 35 cm above the driver's seat.

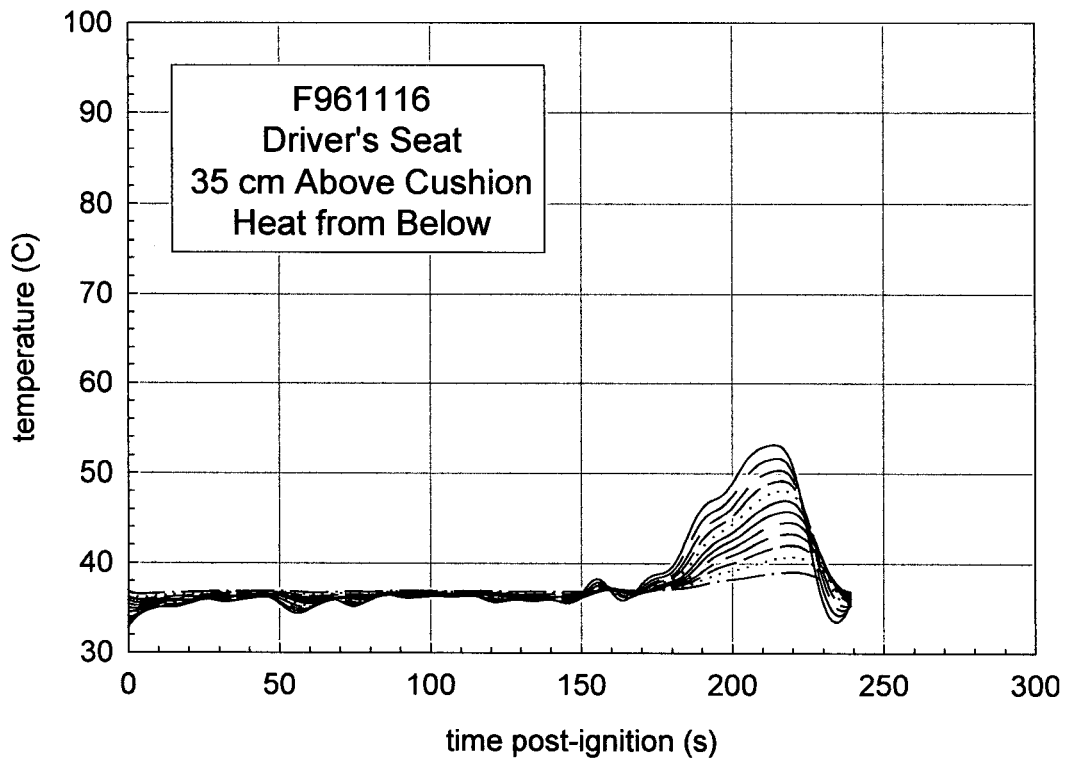
Figure 62. Fire Test F961116. Skin temperature profiles estimated from the heat flux to a downward-facing horizontal surface approximately 35 cm above the driver's seat.

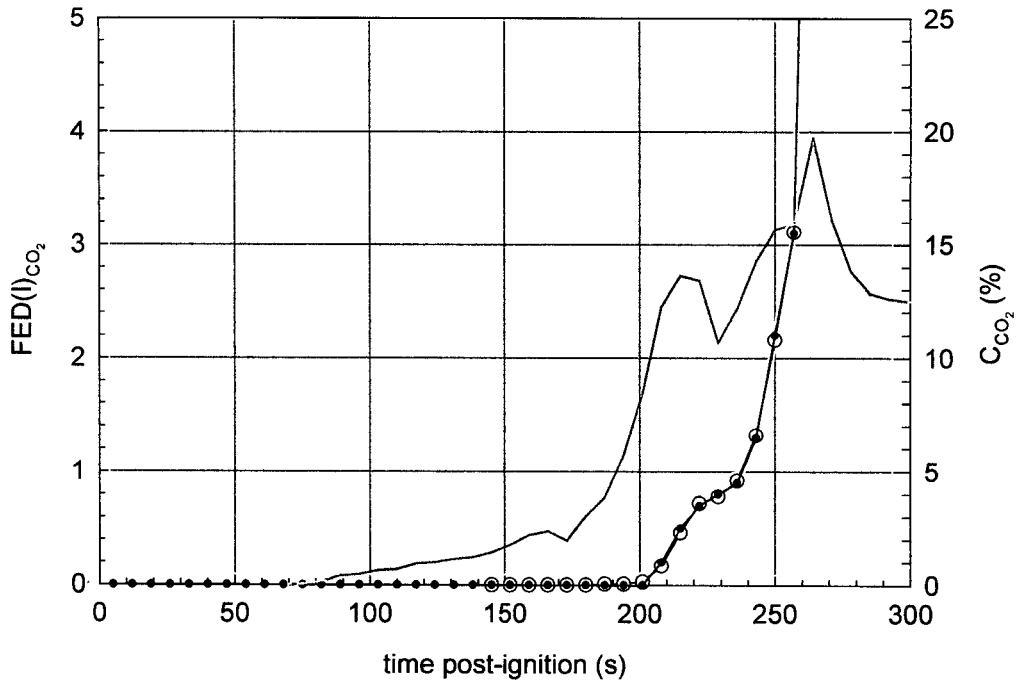
Figures 63 through 66 show plots of the estimated $FED(I)_{CO_2}$, $FED(I)_{CO}$, $FED(I)_{HCN}$, and $FED(I)_{TOTAL}$ computed using the FAA Combined Hazard Survival Model and Purser's model for assessment of the toxicity of combustion products. Both models predicted values of $FED(I)_{CO_2} > 1$ starting at approximately 240 seconds post-ignition, and exceeded a value of $FED(I)_{CO_2} \approx 5$ at about 260 seconds post-ignition (Fig. 63). The FAA Combined Hazard Survival Model and Purser's model yielded different estimates of $FED(I)_{CO}$ (Fig. 64). In Purser's model, the equation for computation of $FED(I)_{CO}$ includes a term for respiratory minute volume. Values of 8.5 and 25 L/min, representing rest or light activity, respectively [11], were used to calculate $FED(I)_{CO}$. Purser's model yielded estimates of $FED(I)_{CO} > 1$ starting at approximately 245 seconds post-ignition with a respiratory minute volume of 8.5 L/min and $FED(I)_{CO} > 1$ starting at approximately 210 seconds post-ignition with a respiratory minute volume of 25 L/min. The FAA Combined Survival Hazard Model yielded estimates of $FED(I)_{CO} > 1$ starting at approximately 215 seconds post-ignition. Both yielded estimated $FED(I)_{HCN} > 1$ starting between 200 and 210 seconds post-ignition, and $FED(I)_{HCN} \approx 5$ by 220 seconds post-ignition (Fig. 65).

Figure 63. Fire Test F961116. Plots of $FED(I)_{CO_2}$ versus time post-ignition: FAA Combined Hazard Survival Model (—○—); and Purser's model (—●—). A plot of C_{CO_2} (—) is included for reference.
